Master's Project: Guiding Recreation at Travertine Hot Springs: An Environmental Assessment and Photo Monitoring Protocol

**AN ENVIRONMENTAL ASSESSMENT AND
PHOTO MONITORING PROTOCOL**

EA NUMBER: DOI-BLM-CA-C070-2017-0002-EA

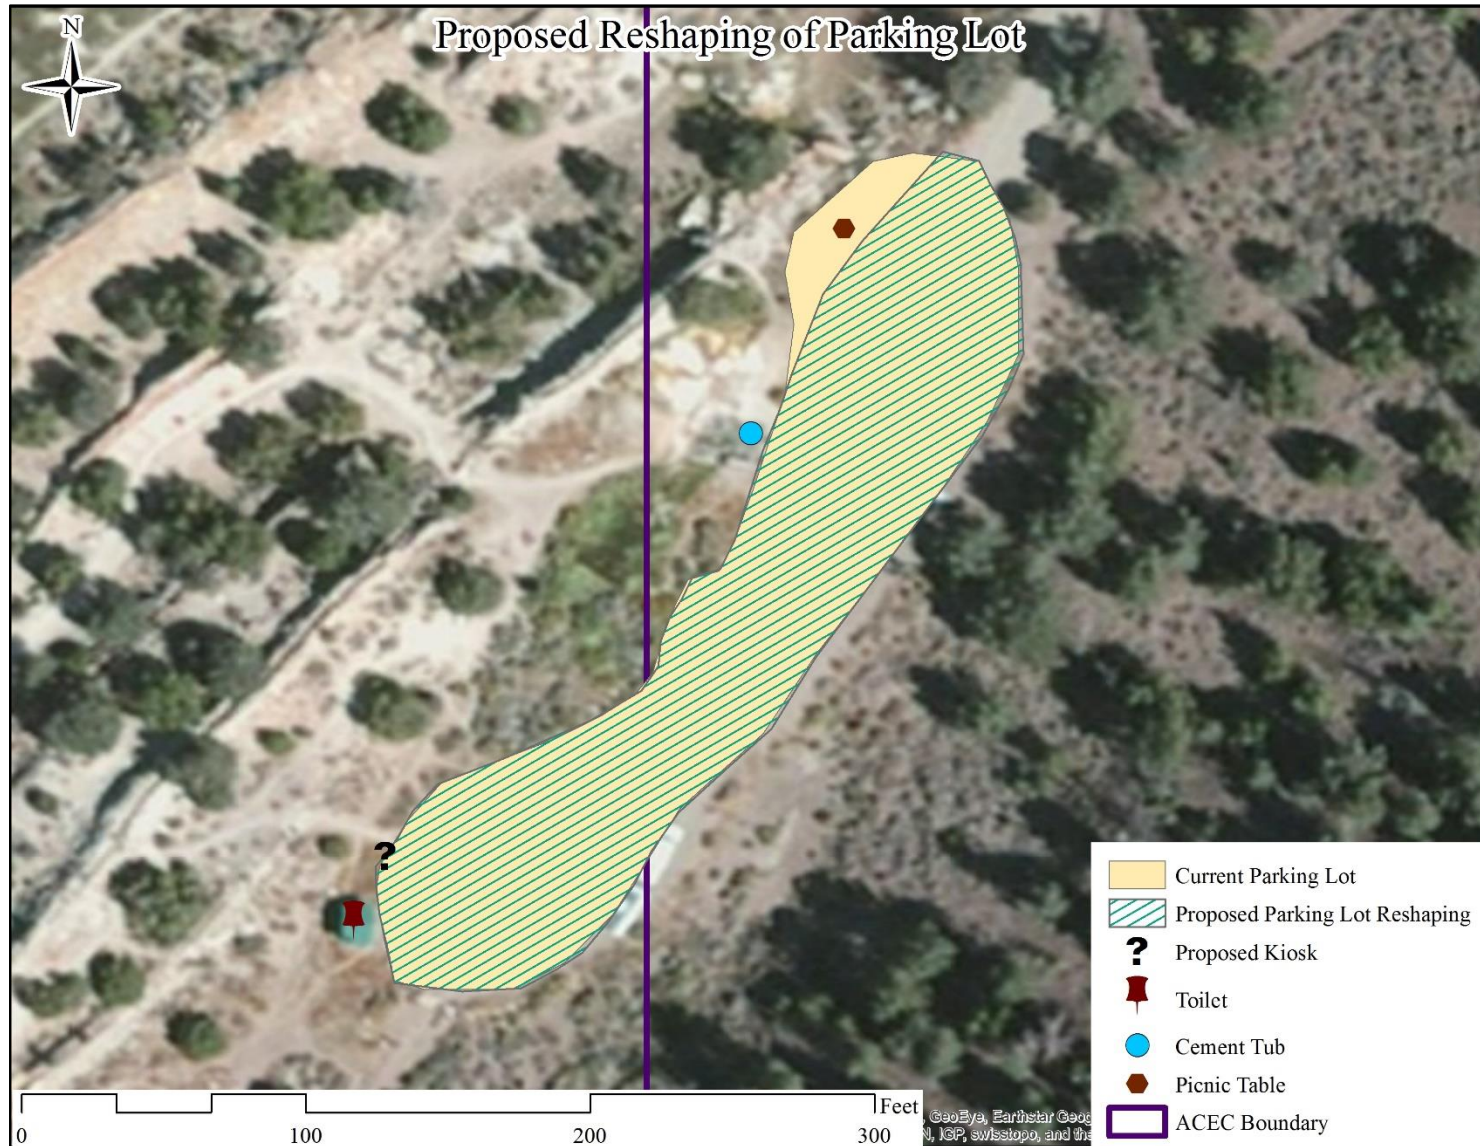
Figure 8. Proposed reshaping of ACEC parking lot.

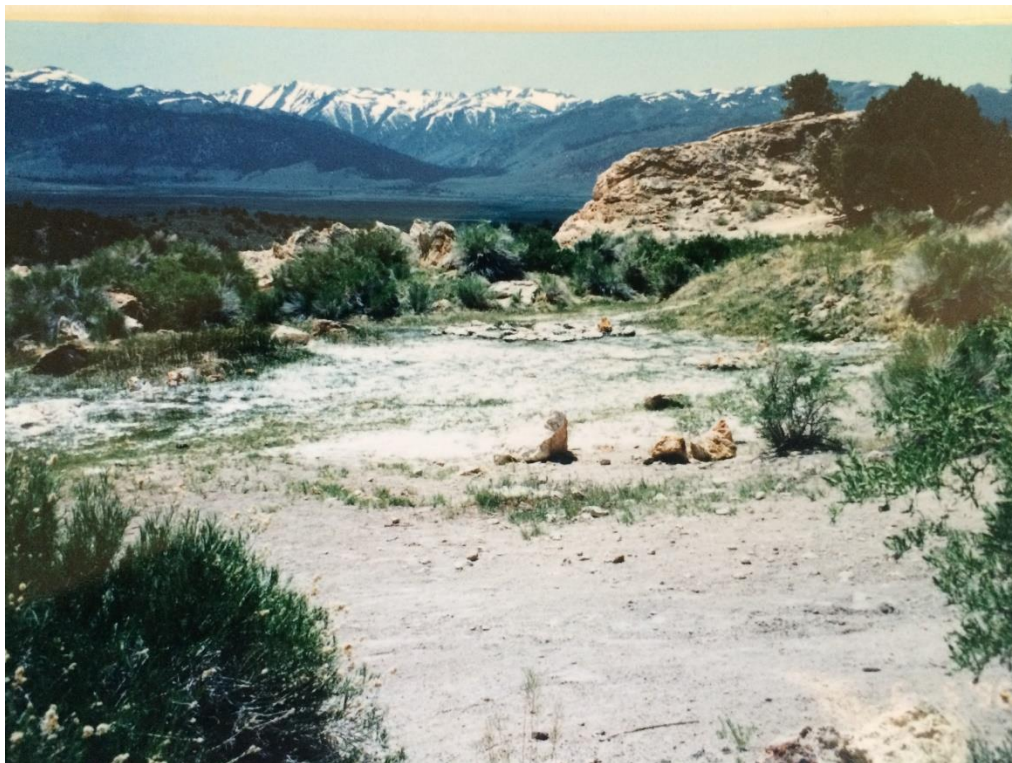
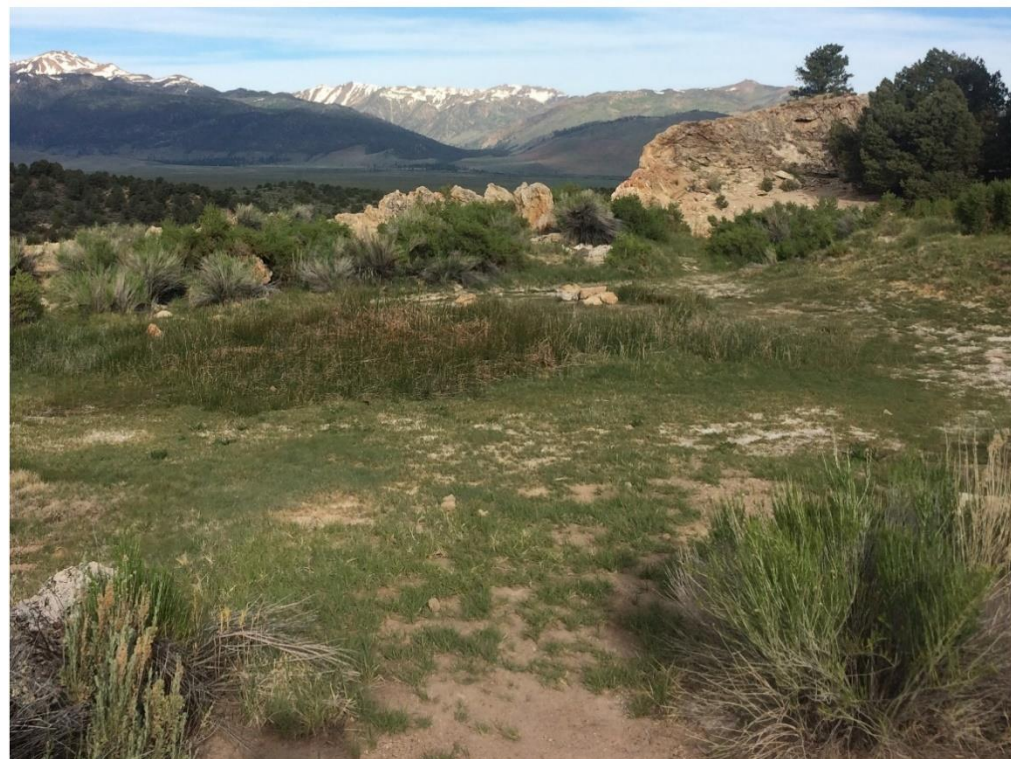
Figure 13. a) June 1996 and b) June 2016

Twenty years after roads within the ACEC were closed, photo monitoring provides evidence that native vegetation has recovered substantially within the old road beds (Figures 13, 14, and 15). It is likely that efforts to reduce foot traffic on redundant trail segments would allow vegetation to recover and result in the eventual disappearance of superfluous trails.

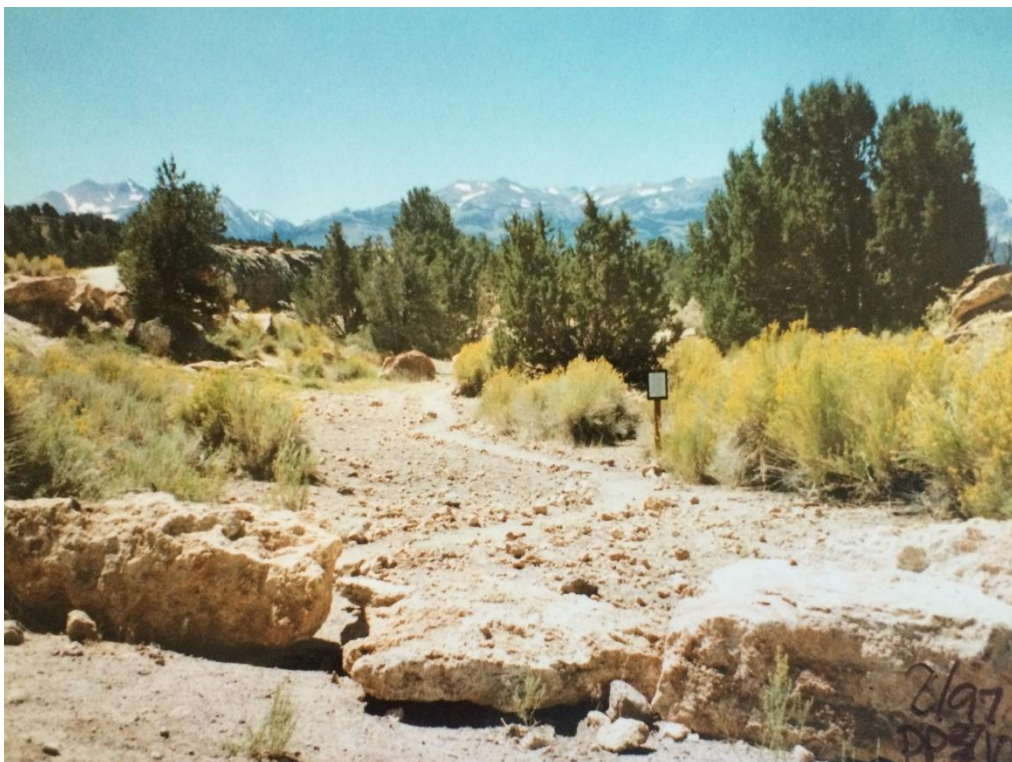
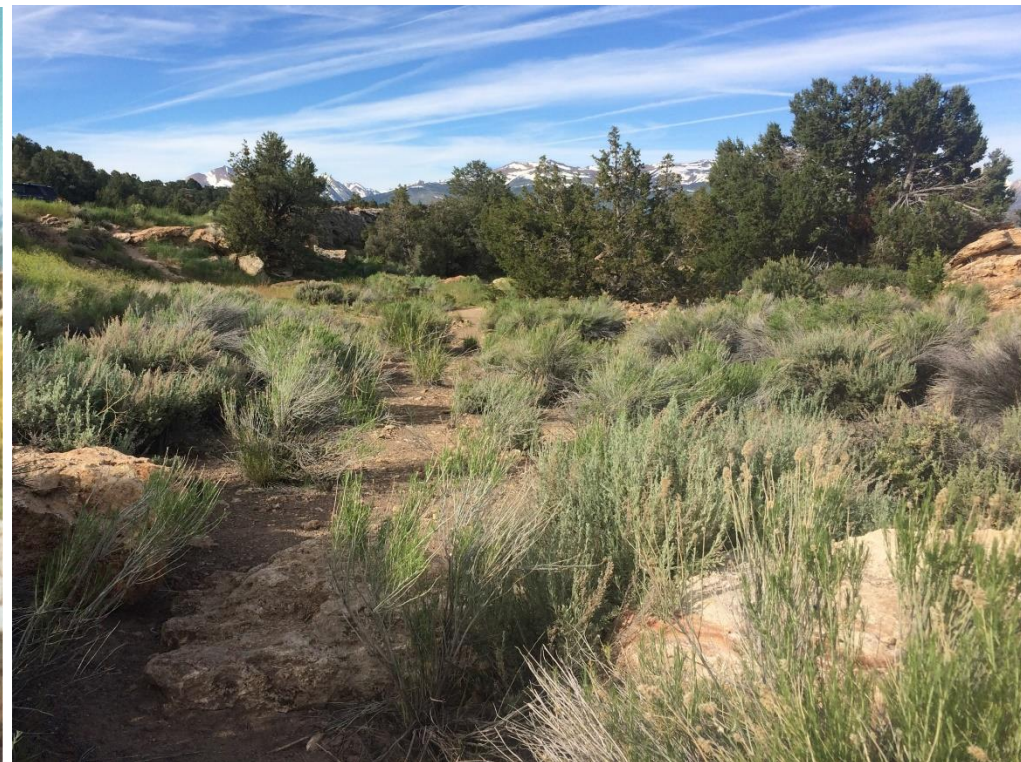
Figure 14. a) August 1997 and b) June 2016.

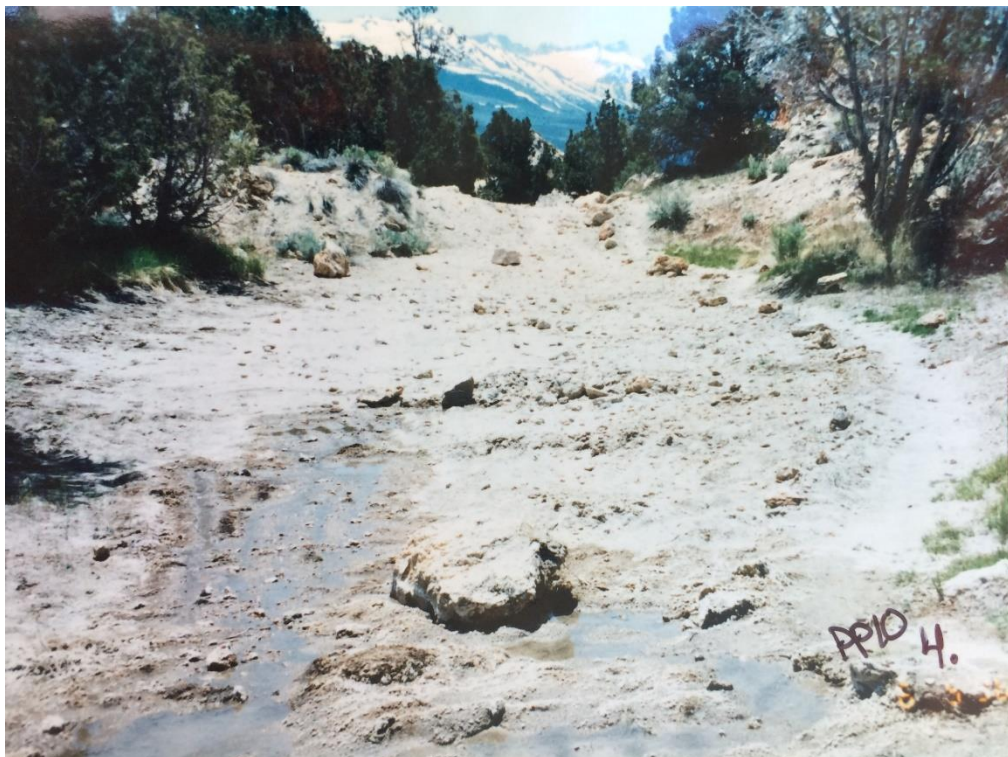
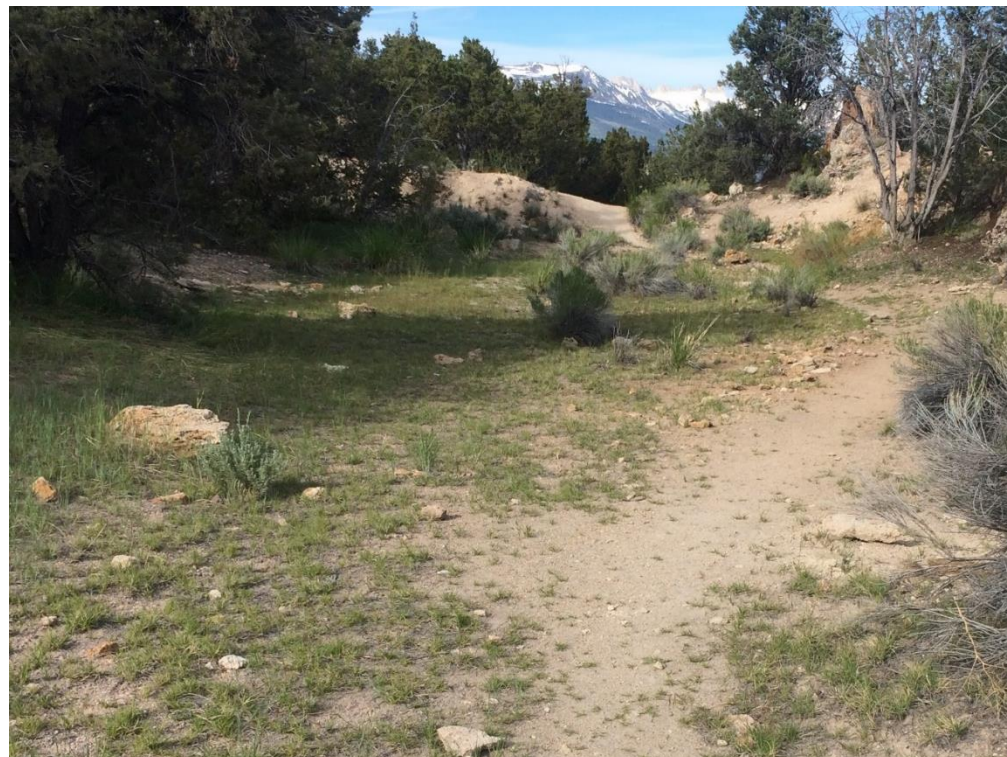
Figure 15. a) June 1996 and b) June 2016.

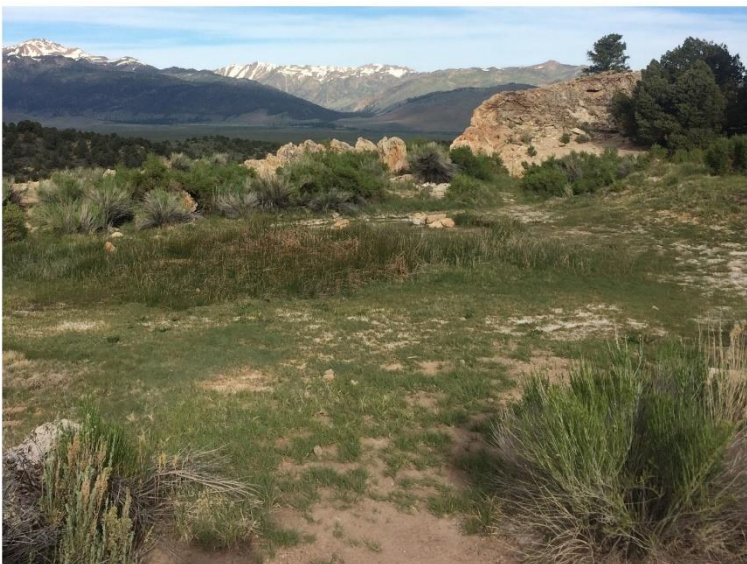
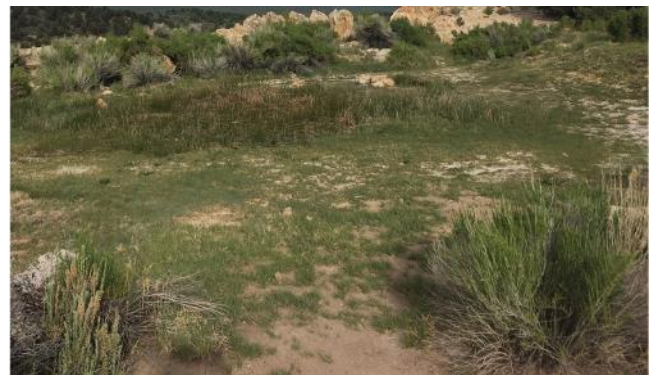
A less time-consuming method of quantitative photo comparison uses two softwares as described by Fenn (2015): an image classifier (available at <https://www.inf.uszeged.hu/~kato/software/colormrfdemo.html>; Kato et al. 2001) and a pixel counter (available for download at <https://forums.civfanatics.com/threads/need-color-counting-tool.112771>). First, crop each photo to the area you wish to classify, removing large areas of sky or distant background. The cropped area should be identical in both photos. For example, photo point 2 in 2016 might be cropped as follows:

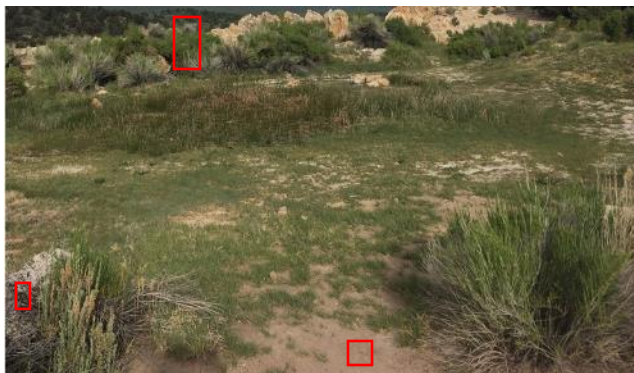
Once you've assigned a representative area to each class, click the button labeled **Do it** to generate a simplified image where each color represents a cover type:

You may have to repeat this step several times before the software correctly classifies all pixels in the image. In the example above, the shadow cast by the rabbitbrush in the bottom right corner is too similar in color to the grey travertine rock, and the software has incorrectly classified the shadow as rock.

Once you're confident in the classification, save the resulting image and load it into the pixel counter software. This software will generate a list of the number of pixels per color, identifying the colors using three numbers: their red, green, and blue balance (for example, the green color in the example above is referred to as (70, 72, 45). A quick Google search can help you identify which color is which. Divide the number of pixels in each class by the total number of pixels to get a percentage for each cover class. Then compare the percentage vegetation in the two photos. In the example above, vegetation covers 78% of the pixels in the image. In the photo taken at this photo point in 1996, vegetation covered only 47% of the pixels in the image.

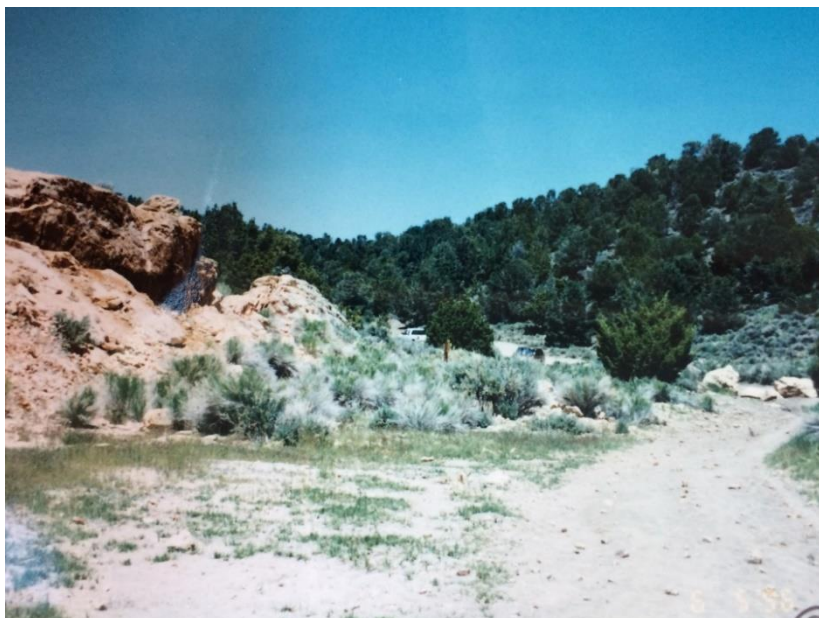
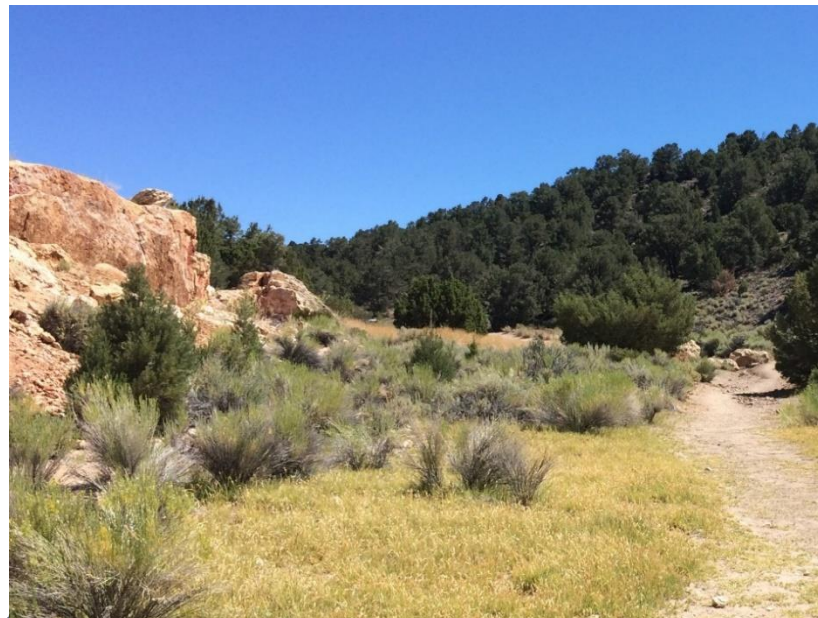
Photo Point 1: Trail from Parking Lot

Potential problems: vegetation damage due to foot traffic, proximity to invasive tansy mustard source in parking lot

If native vegetation cover decreases, consider reseeding or replanting.

If tansy mustard invades, remove it annually.

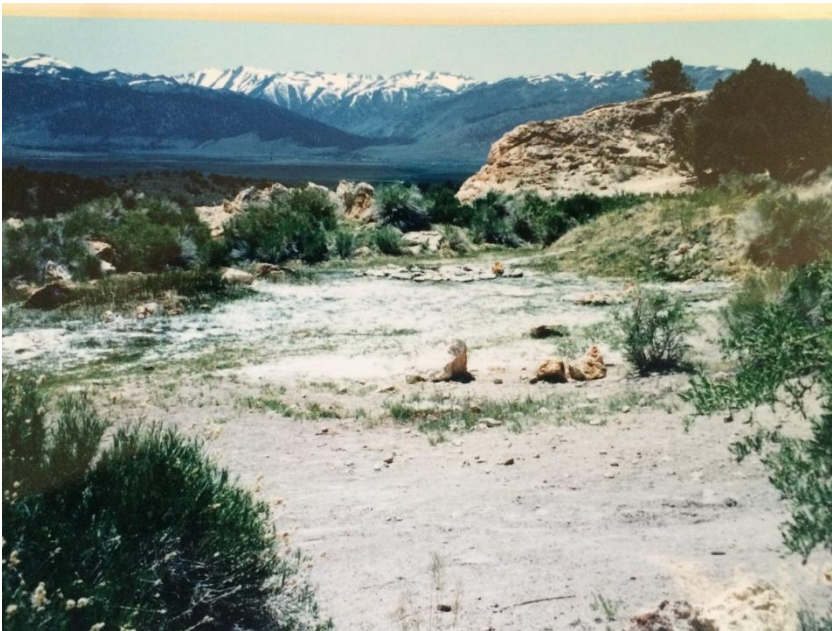
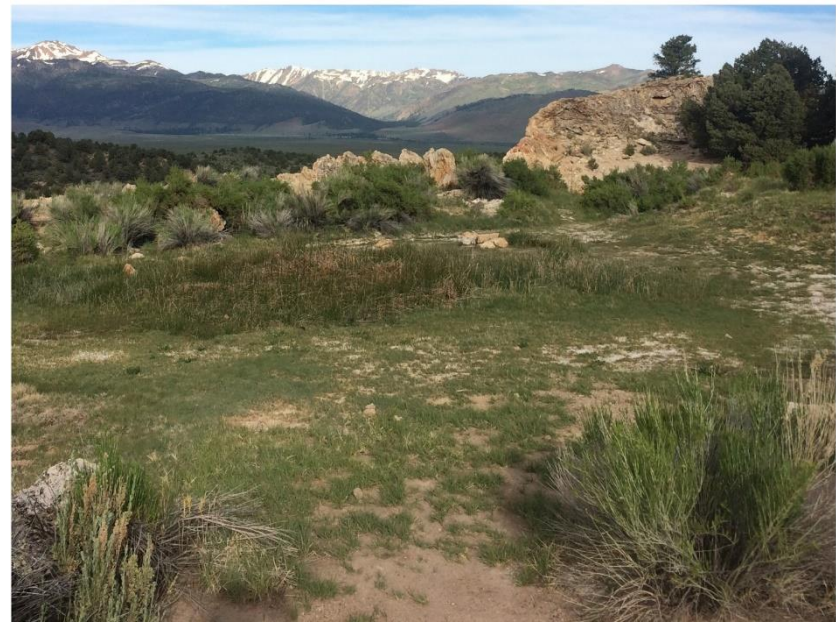
Photo Point 2: Revegetated Spring

Potential Problems: vegetation damage due to foot traffic, proximity to invasive tansy mustard source in parking lot

Photo Point 2 in June 1996

Photo Point 2 in June 2016

If native vegetation cover decreases, consider bordering the site with a symbolic fence of stones.

If tansy mustard invades, remove it annually.

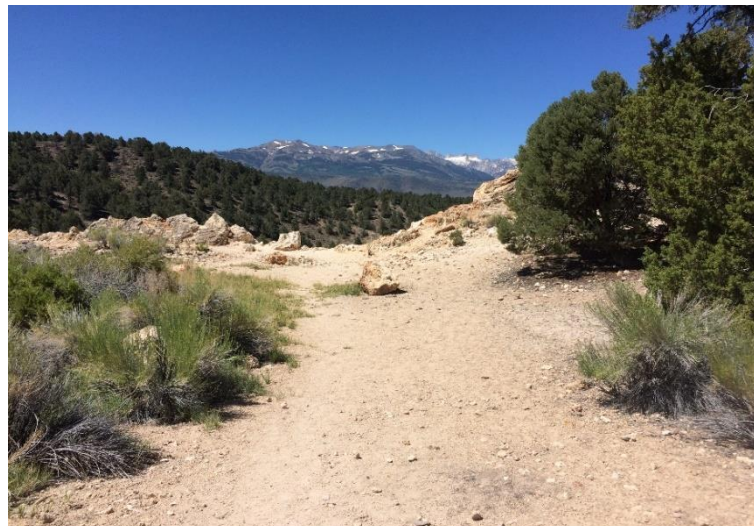
Photo point 3 in June 2016

If height of travertine ridge decreases substantially, consider installing a sign or symbolic fence to discourage visitors from crossing the ridge.

If tansy mustard invades, remove it annually.

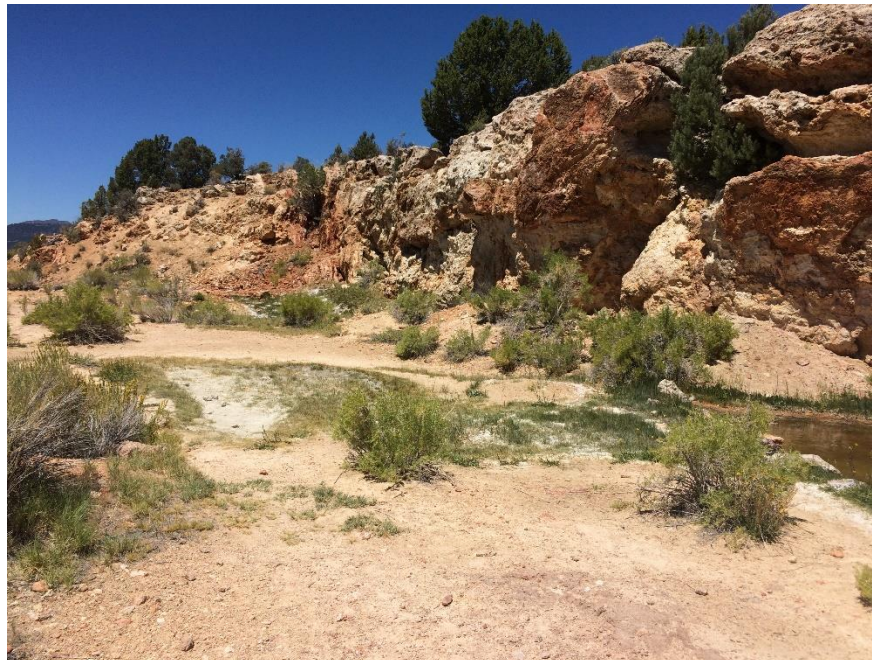
Photo Point 4: Muddy Spot

Waypoint: 306936 E, 4235263 N. Bearing: 325°. Landmarks: end of ridge at left edge of photograph, edge of seep pond at right edge. Here an informal trail passes between a large seep and its drainage, and foot traffic may cause erosion (ruts, gullying, slope failure).

Photo Point 4 in June 2016

If erosion is evident, consider installing stepping stones across muddy section.

If erosion is severe or hydrologic pathway is altered, consider installing a sign or symbolic fencing to discourage visitors from walking here.

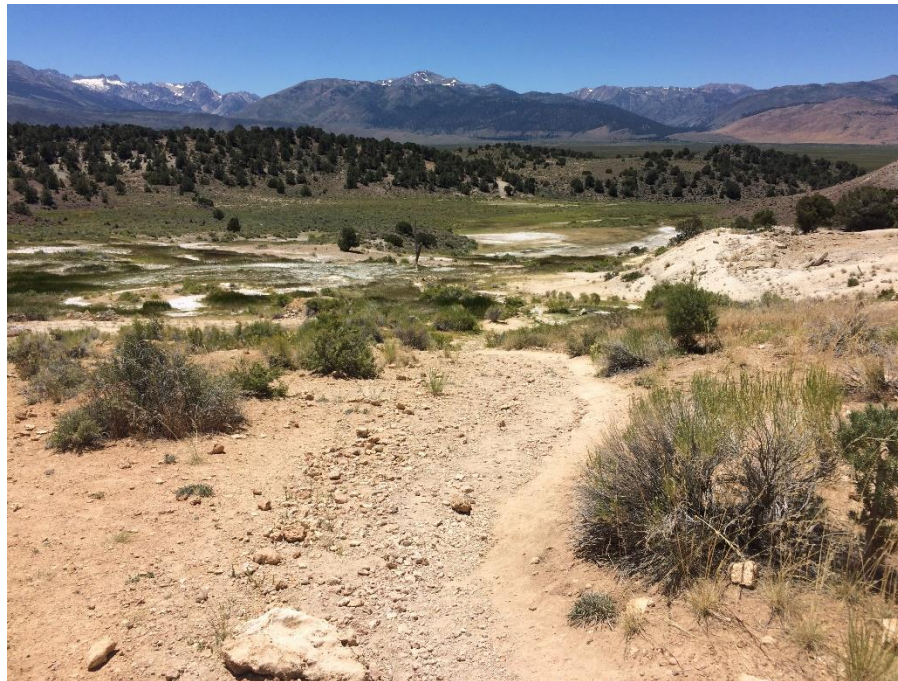
Photo Point 5: Steep Hill

Photo Point 5 in August 2016

If erosion is evident, consider installing water bars to reroute stormwater.

If erosion continues or worsens, consider reshaping the path with switchbacks to decrease slope steepness.

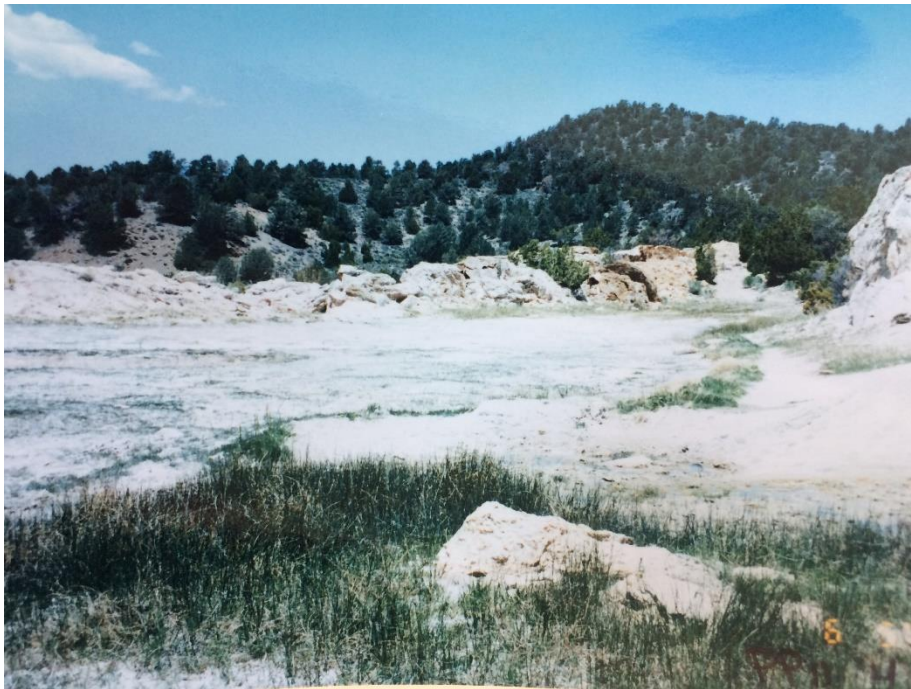
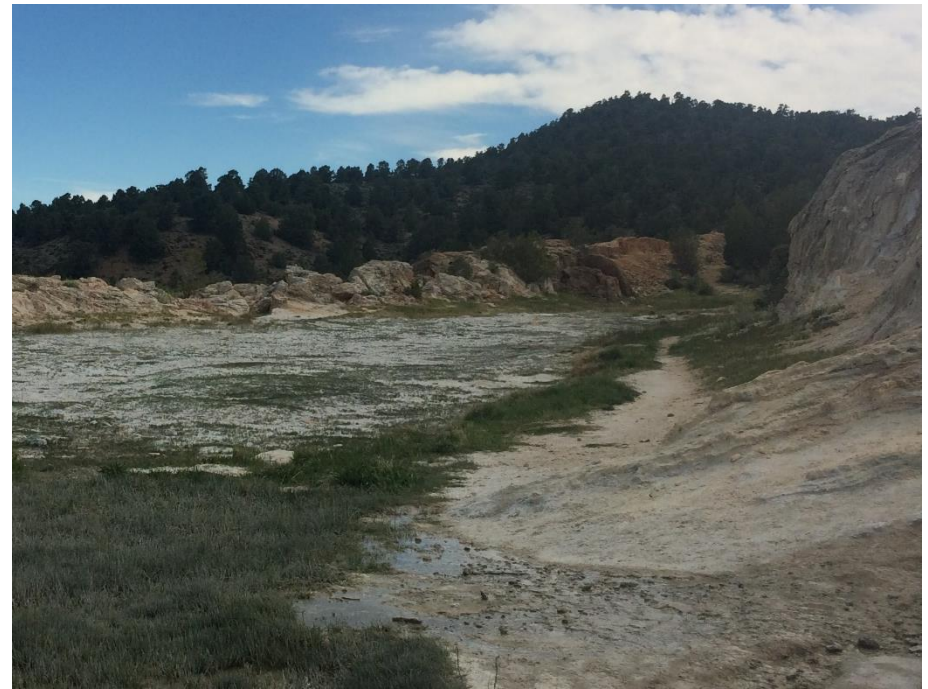
Photo Point 6: Meadow

Photo Point 6 in June 1996

Photo Point 6 in June 2016

If informal path is not substantially reclaimed by vegetation within 5-10 years, consider reseeding or replanting the trail tread. Consider blocking the path and meadow with a symbolic fence of stones.

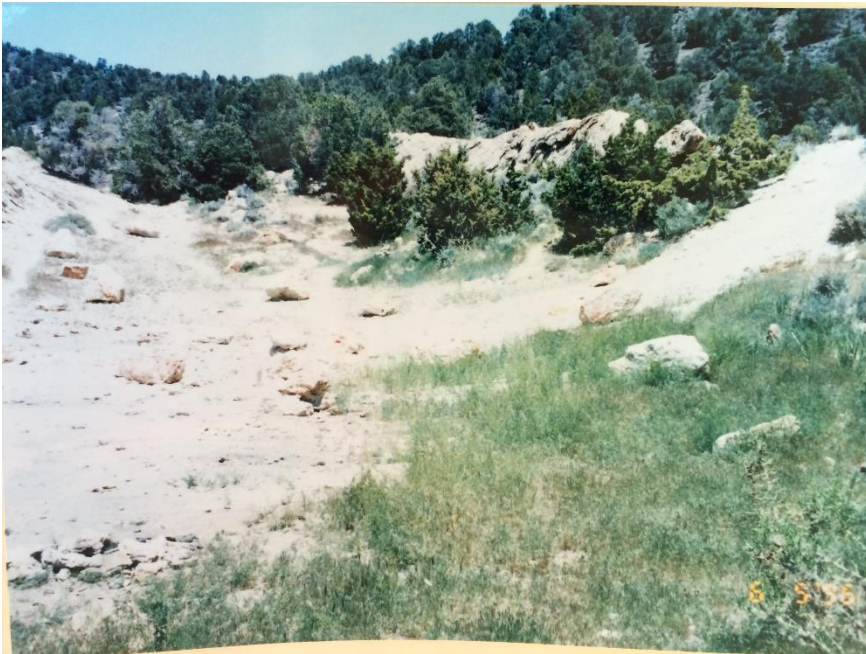
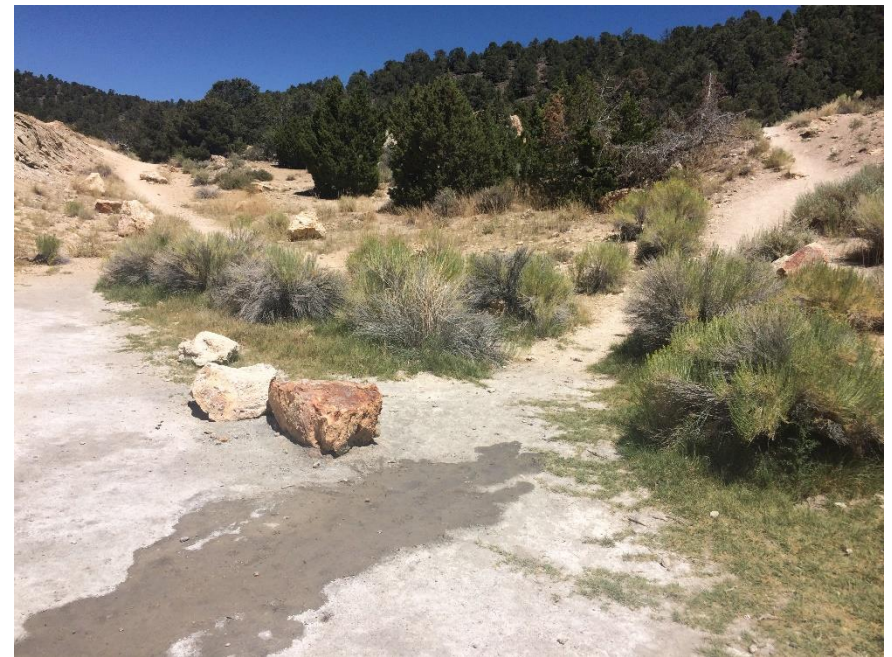
Photo Point 7 North in June 1996

Photo Point 7 North in August 2016

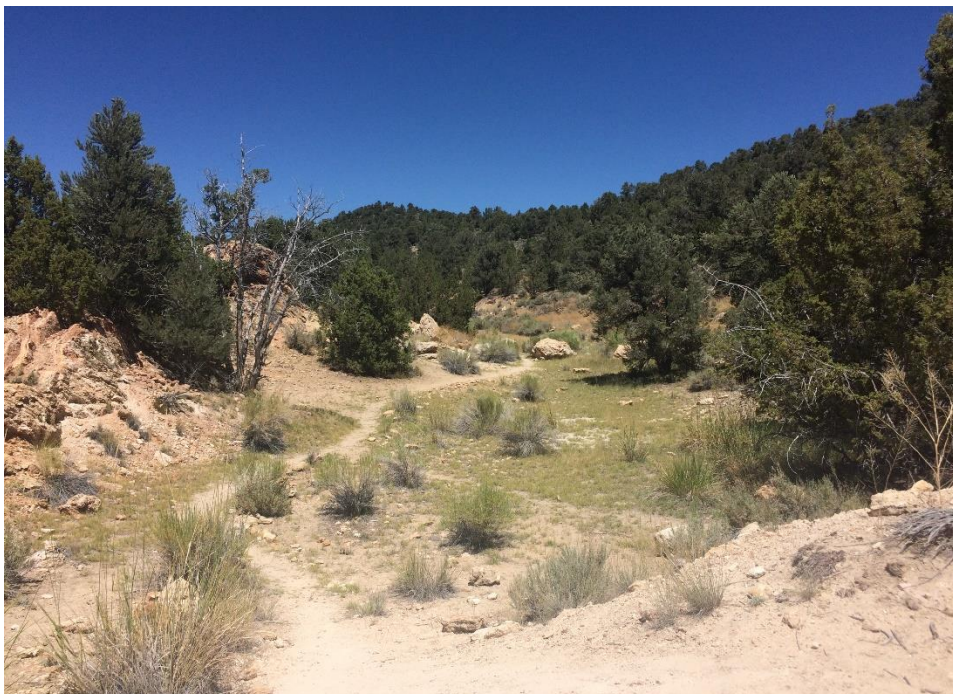
Photo Point 8 in August 2016

If the informal path is not substantially reclaimed by vegetation within 5-10 years, consider reseeding or replanting the trail tread.

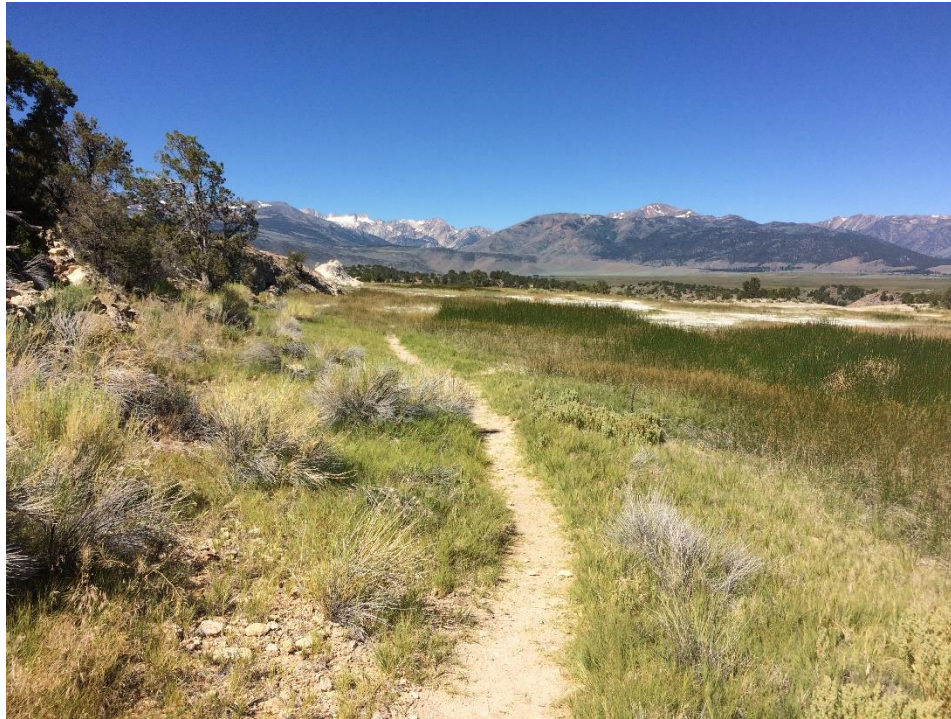
Photo point 9 in August 2016

If the informal path is not substantially reclaimed by vegetation within 5-10 years, consider reseeding or replanting the trail tread.

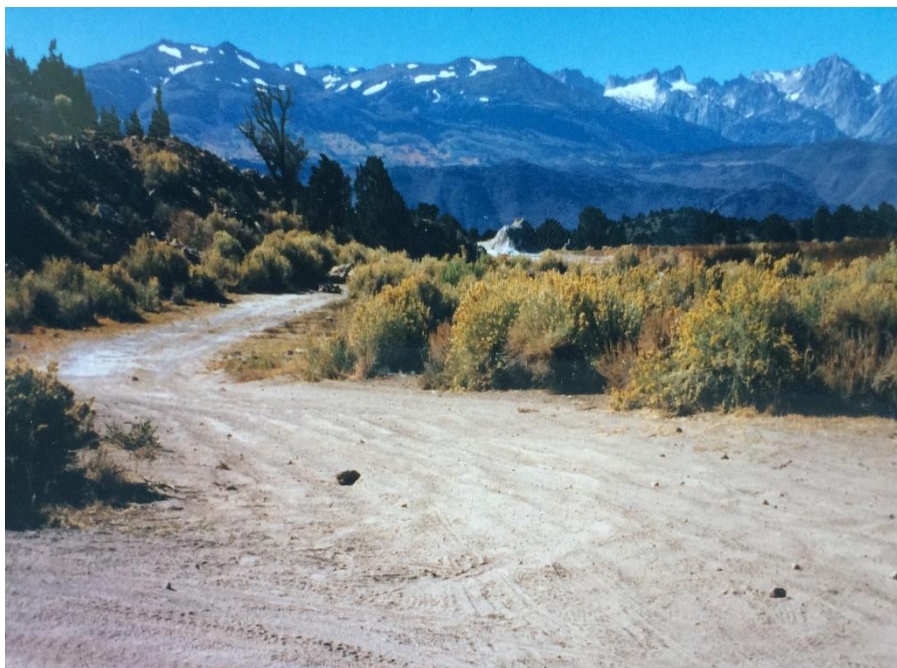
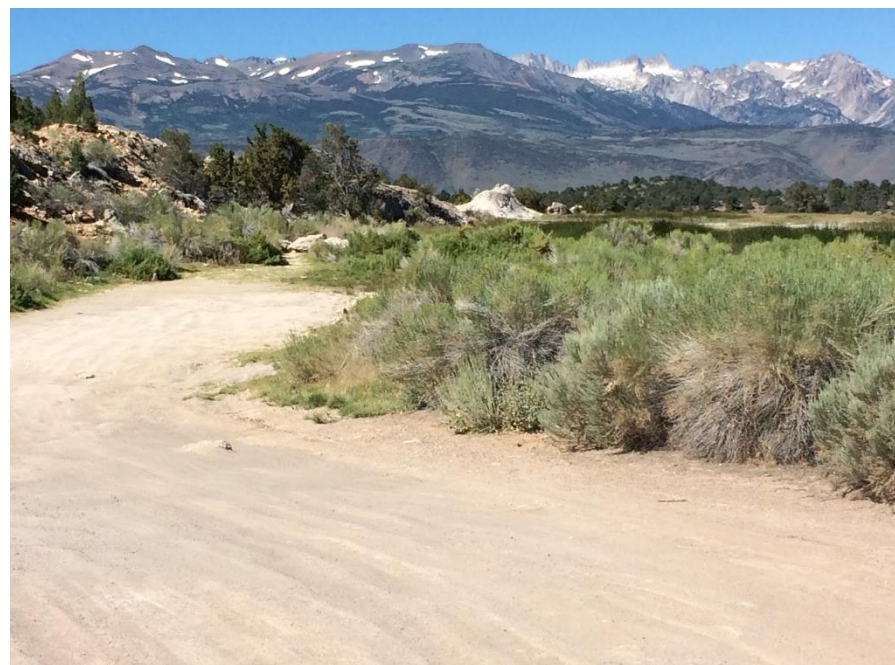
Photo Point 10: Old Pullout

Photo Point 10 in October 1996

Photo Point 10 in June 2016

If native vegetation cover does not increase, consider decompacting the soil using hand tools and reseeding or replanting.
