Landscape Archaeology at the Doak House

A Final Report Prepared for

Nicholas Honerkamp, Ph.D.
Jeffrey L. Brown Institute of Archaeology
University of Tennessee at Chattanooga
Chattanooga, TN

September, 2003

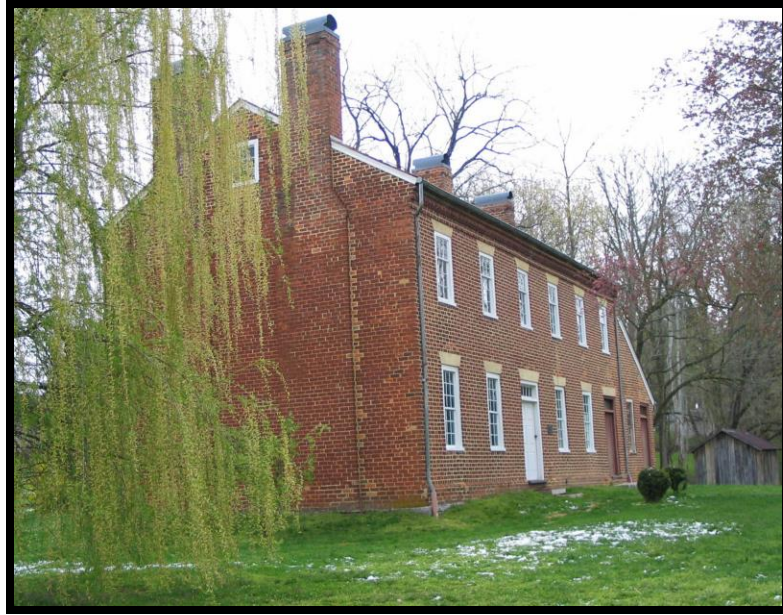
Figure 1. The Doak House Museum. Facing northeast.

The Doak House Museum is housed in an impressive brick structure located on the campus of Tusculum College in Greene County, Tennessee (Figures 1 and 2). Built about 1829-30, this large two-story mansion was owned until the mid-1970s by descendants of the Samuel W. Doak family, the original occupants. Doak was a minister and pioneer educator in east Tennessee who, with his father, established Tusculum Academy (later College) in 1818 (Fuhrmann 1986:43). Samuel W. Doak built a second academy adjacent to his residence in 1835; oral tradition has it that this restored wooden building sits on its original limestone foundations (George Collins: personal communication) approximately 41 m south of the house. A restored springhouse about 60.5 m east of the academy building is the third extant structure associated with the antebellum Doak occupation; its construction date is unknown.

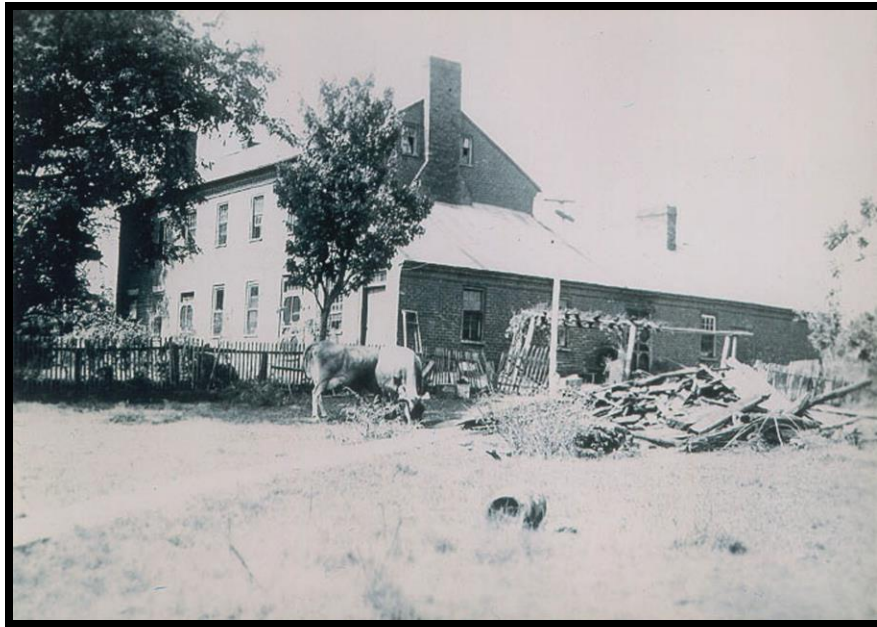
Figure 4. Doak House and Ell, facing northwest. The “full” ell is shown in this pre-1930s image.

Another important objective involved investigating the ell attached to the east end of the Doak House. The Figure 4 photograph is believed to have been taken during the late 19th century and clearly shows the ell extending farther north than it does today. Cindy Lucas (personal communication) reports that a former resident in the house indicated that the northern end of the ell was demolished in the 1930s because it had rotted away, presumably from water damage to the roof. Backhoe trenching followed by hand excavation was proposed to reveal the subsurface foundation elements, if any, that still remained from the demolished portion of the ell.

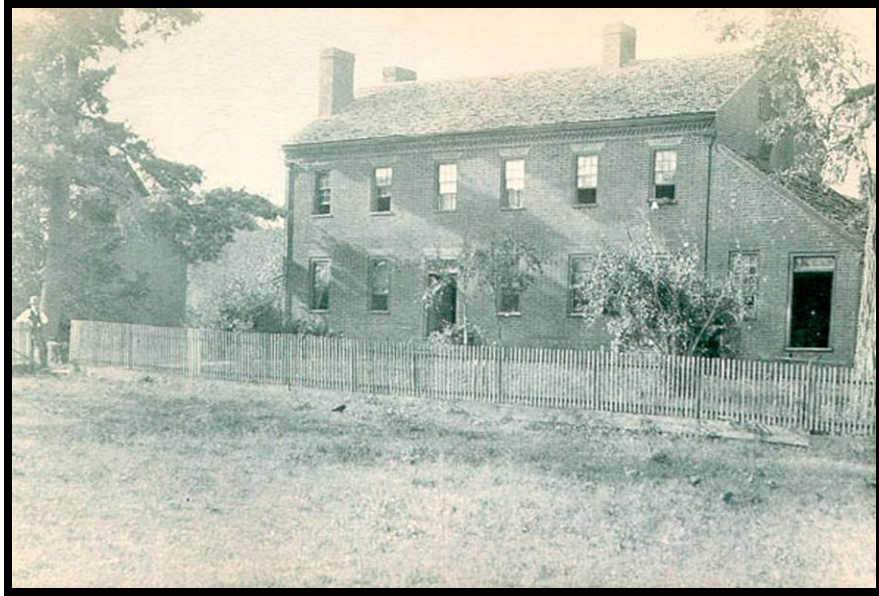
Figure 5. Doak House and Barn, facing northwest.

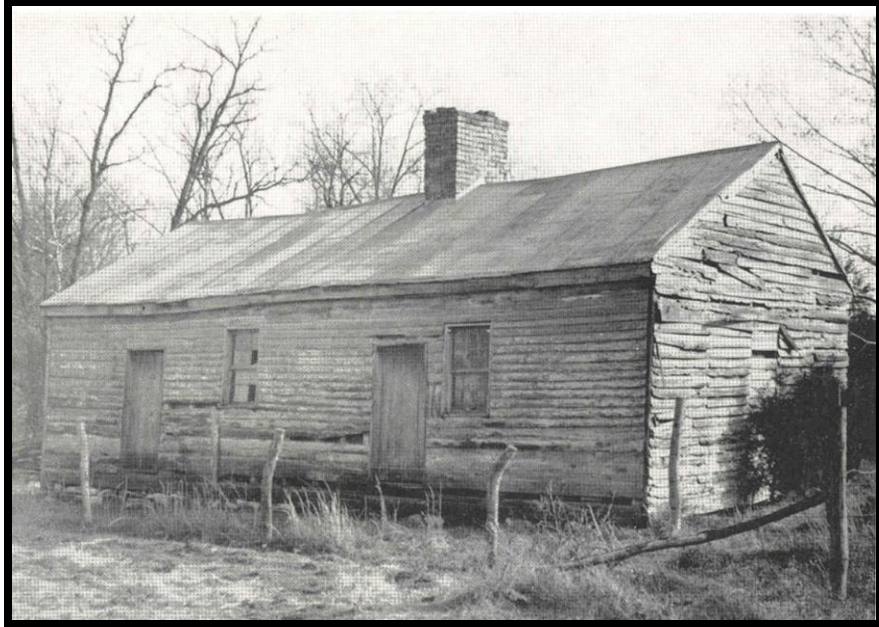
Figure 7. The Doak Academy. Undated photograph, facing southeast.

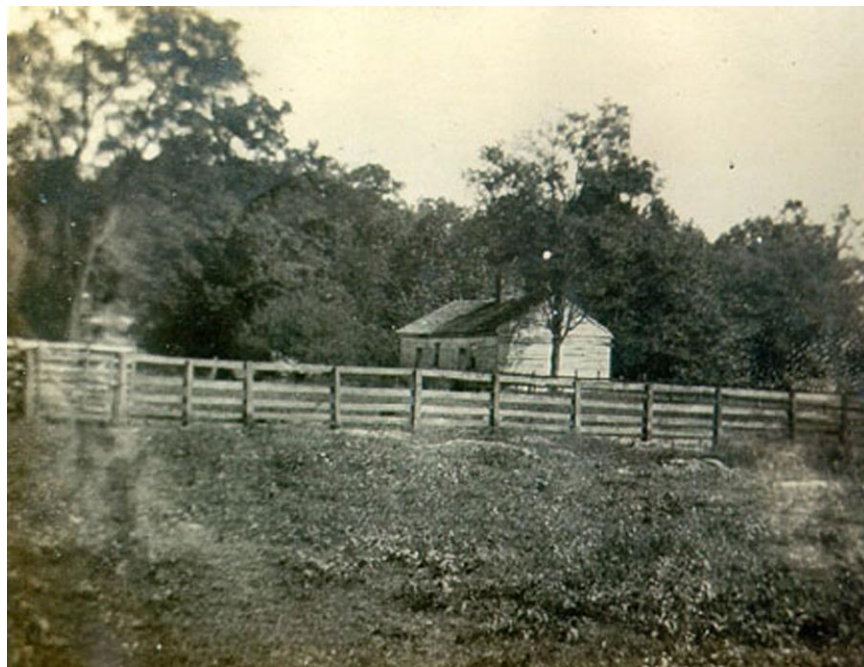
Figure 8. Doak Academy and Fences. Undated photograph, facing southeast.

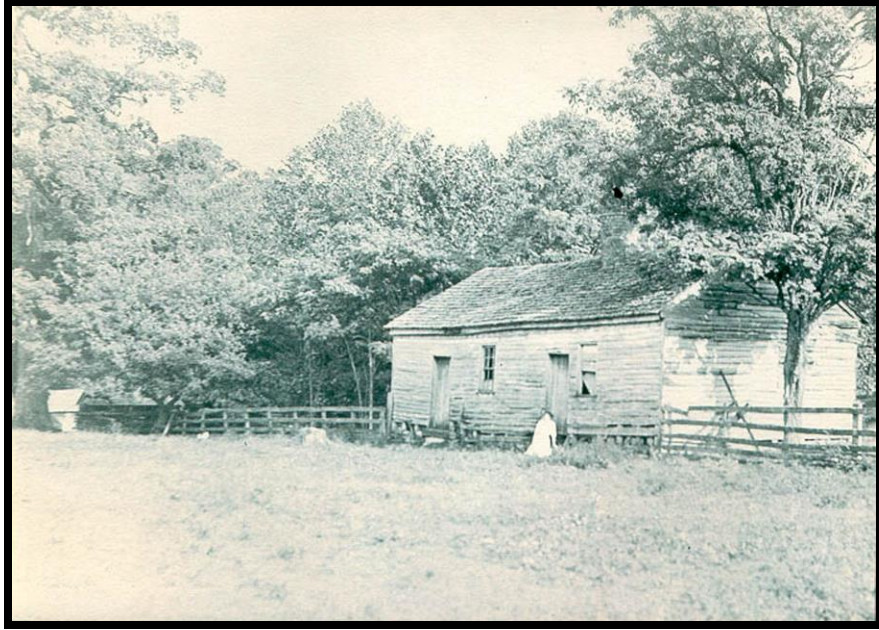
Figure 9. Doak Academy and Springhouse. Undated photograph, facing southeast.

Trench 4 (originally 13.7m x 1.25m) was oriented east-west and was dug one meter off the northeast corner of the academy in the hope of identifying postholes from the fence line shown in Figure 9. A series of 10 regularly-spaced postholes were revealed at six-foot intervals (3 were doubled, probably due to replacement). This spacing was so consistent that we were able to predict the locations of two additional postholes by expanding the trench on its east and west ends. On the west end, the expansion consisted of shoveling about a half a meter of soil without screening. On the east end, a one-meter expansion of the trench was screened, and this was designated as Unit 7. Unfortunately, due to time constraints only these two extrapolated postholes were excavated. Artifacts from the 40-cm-deep posthole in the west end of Trench 4 did not provide much dateable material, consisting of 9 window glass fragments, 2 clear flat glass fragments, a cut nail, a brass wire, 6 small brick fragments, and a clay pipe bowl fragment (see Figure 16). The fill from the 37-cm-deep posthole identified in Unit 7, on the east end of the trench, contained a higher density of artifacts. This reflects its location in an area adjacent to the academy that was apparently used for refuse disposal, most likely in the form of sheet deposit. A sherd of dark blue transfer printed pearlware, two transfer printed whiteware sherds, and a sherd of Albany slip stoneware were found, and a whopping 41 glass fragments are associated with this features (more on glass below). Two of the 12 postholes were found to actually contain wood from former posts, leading us to conclude that the entire fence line in Trench 4 is most likely of relatively modern, that is, late 19th/early 20th century, origin.

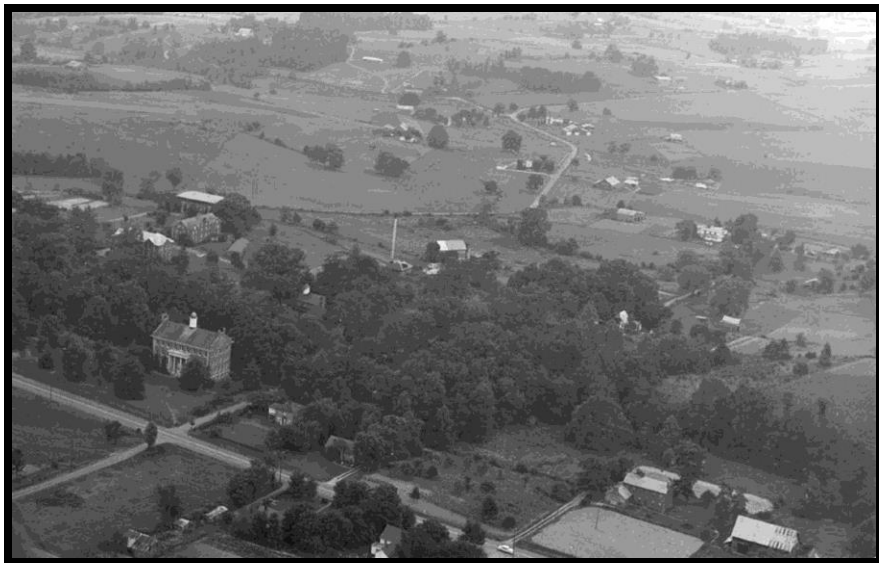
Figure 10. Aerial Photograph (c. 1950) of Tusculum College Vicinity. View is to the southeast. Note large barn and plowed fields on each side of main house, located in the bottom right corner.

Survey units and test trenches in the front area of the academy and house (excluding those sections mentioned above) did not encounter significant archaeological remains. Not surprisingly, this roughly corresponds to the plowed area shown in Figure 10. An area south of the tool shed, where Unit 6 was placed, is also of archaeological interest based on the early and unusual artifacts recovered there. Although mixing with later time periods has occurred to some extent, a larger sample is certainly desirable, as is a further exploration of the mystery of Feature 1 in Test Unit 6. If possible, a roughly 10 x 10 m area south of Unit 6 should be preserved.

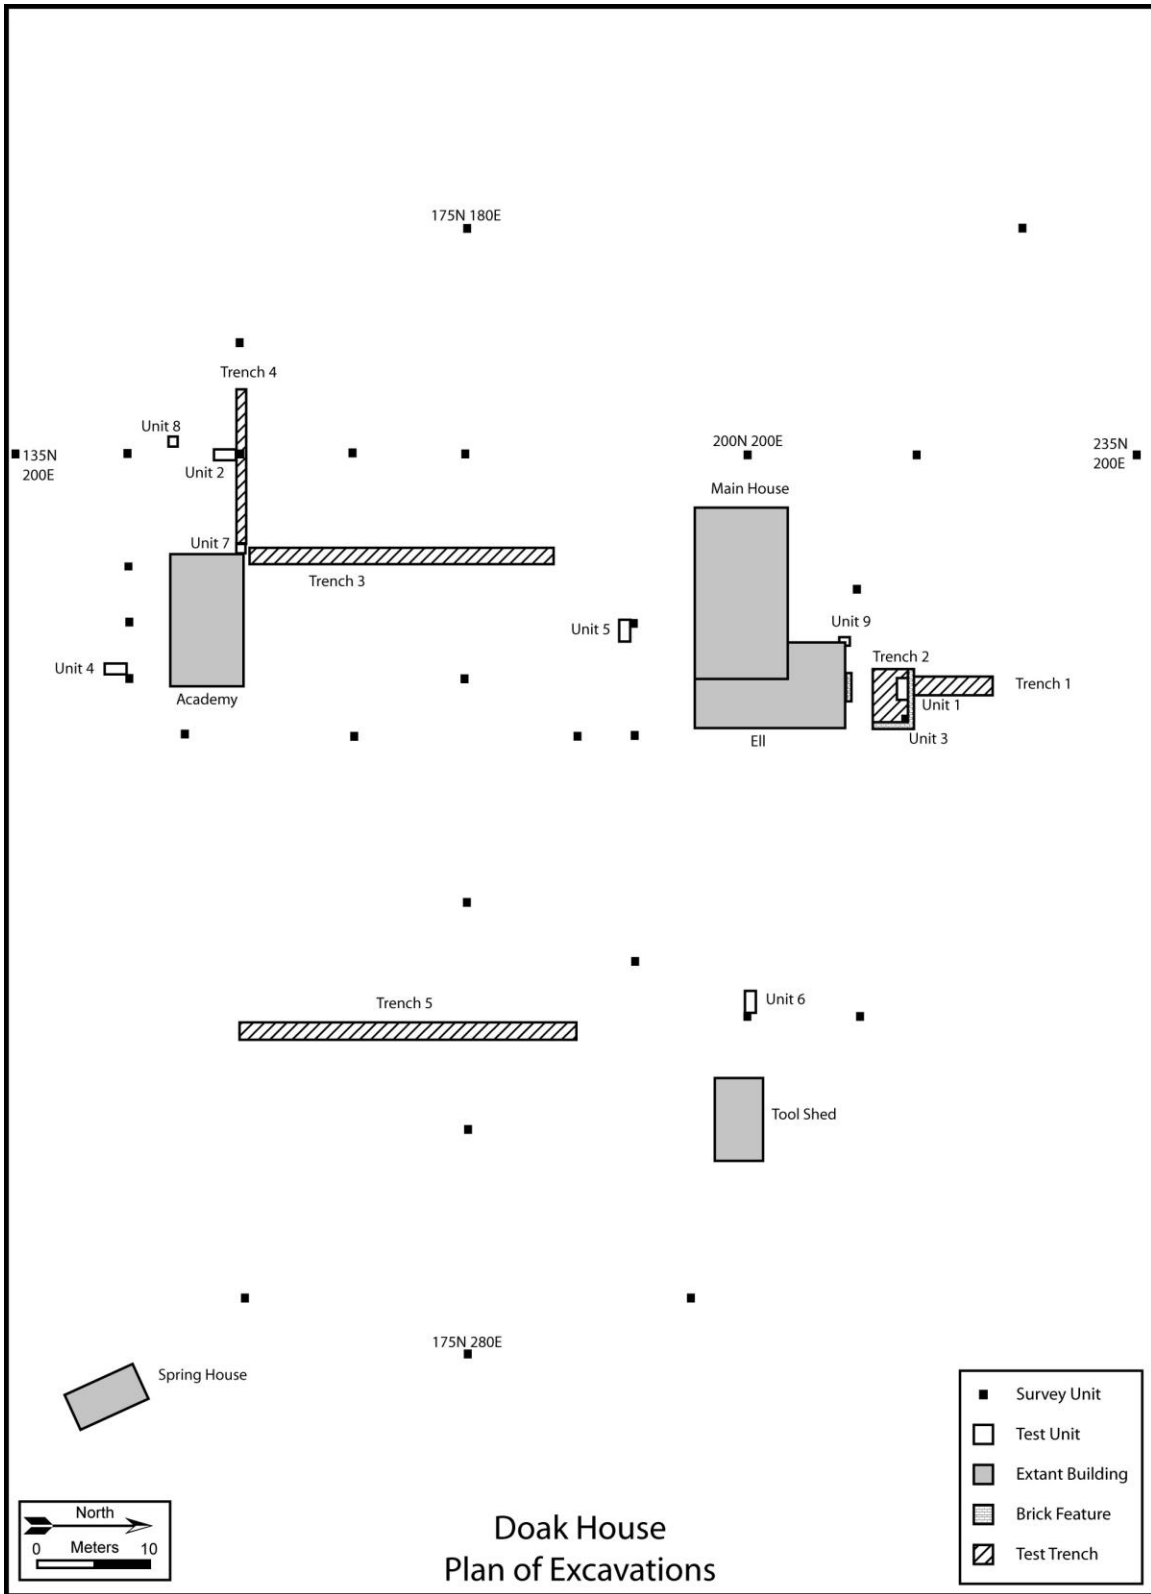
Figure 11. Composite Plan View Map Of Excavations.

Two backhoe trenches were dug adjacent and north of the main house using a Tusculum College backhoe and operator under the watchful eyes of the UTC archaeologists. Trench 1 (9.6m x 1.25m) and Trench 2 (c. 5.0m x 2.6m) were designed to expose foundations associated with a “missing” portion of the east ell to the house. The former extend at least 0.5 m into sterile clay and revealed only a power line to an adjacent light pole. Adjoining this lackluster trench on the south was the second trench, which opened 13 square meters by removing only overburden. This backhoe search ultimately proved successful and is covered in detail below. Three more extensive trenches were also machine excavated in order to identify roadbeds and/or fence lines. Trench 3 (27m x 1.2m) and Trench 5 (30m x 1.2m) were oriented north-south and were placed in the “front” (south) of the Doak house in order to intercept a presumed east-west road between the house and academy. Despite cleaning the trench profiles and a close inspection of same, no furrows or other unambiguous indications of a road were detected in either trench (refer to Figure 11 for trench locations).

The three test units associated with the investigation of the missing ell—1, 3, and 9—have already been discussed, as have Test Units 7 and 8, which were dug to provide architectural information about the early academy. The remaining units measured 1 x 2 m and were located in areas of high artifact densities, as indicated from the survey. Their locations are indicated on Figure 11.

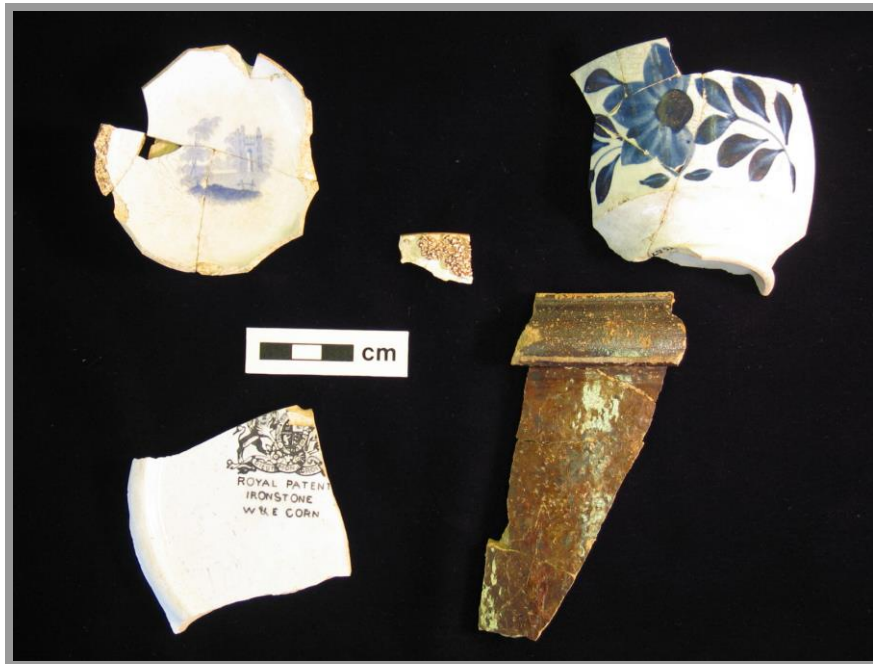
Figure 13. Miscellaneous Ceramics. Top, left, blue on white transfer print whiteware (FS 68); center, unidentified refined earthenware (FS 62); right, blue on white hand painted pearlware (FS 57). Bottom, left, plain whiteware with maker's mark (FS 58); right, brown lead glazed earthenware jar fragment (FS 62). All except FS 57 are from Test Unit 6.

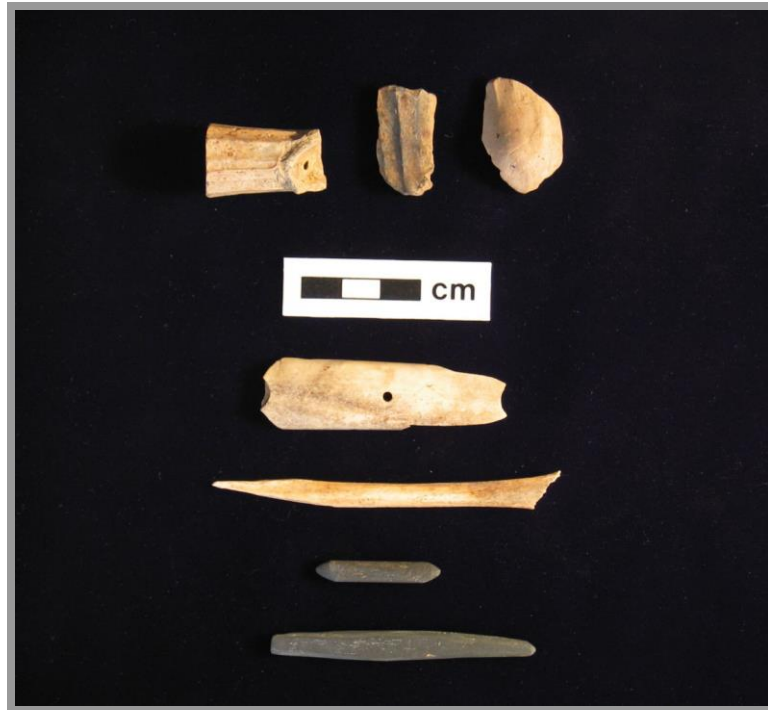
Figure 16. Miscellaneous Personal Items. Top, left and center, terra cotta stub-stemmed ribbed pipe stem and bowl fragments (FS 22, 44); right, smooth stub-stemmed bowl fragment (FS 81). Center top, bone handle from knife (FS 23), center bottom, bone awl (FS 57). Bottom, slate pencils (FS 57, 23).

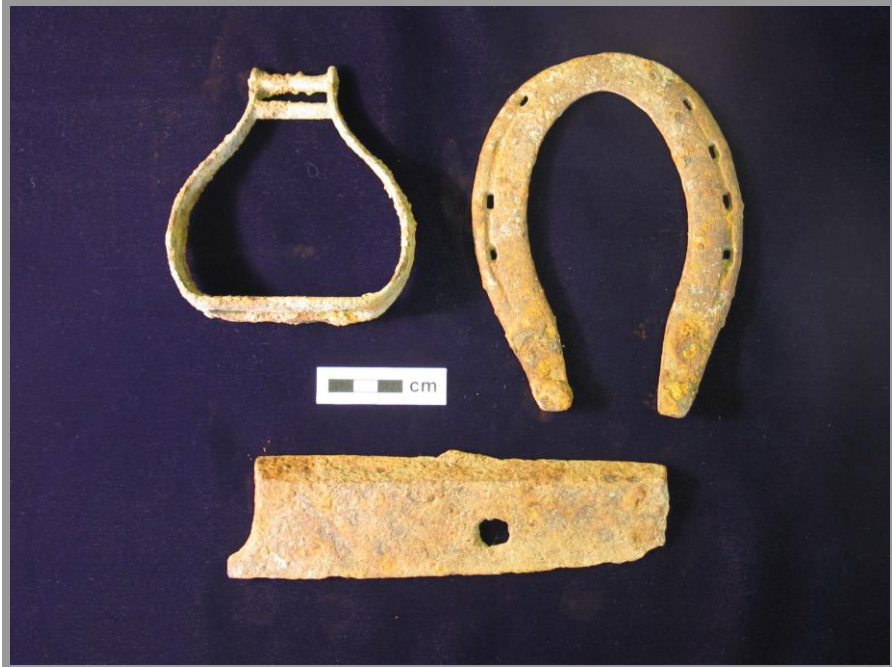
Figure 17. Miscellaneous Iron Artifacts. Top, left, iron stirrup (FS 33); right, horseshoe (FS 57). Bottom, harvester blade fragment (FS 57).

Other artifacts derived from Unit 1 include an iron stirrup (Figure 17), a considerable number of miscellaneous/unidentified iron fragments (including 110 band/strap pieces), part of a bed spring, and 33 bone fragments. As a matter of fact, despite the removal of part of Zone 1 without benefit of screening, more bone was found in this unit than in any other 1x 2 m test, and this no doubt can be attributed to the close proximity of the kitchen in the south ell. Of considerable interest was the bone button blank shown in Figure 15. Bone buttons are commonly

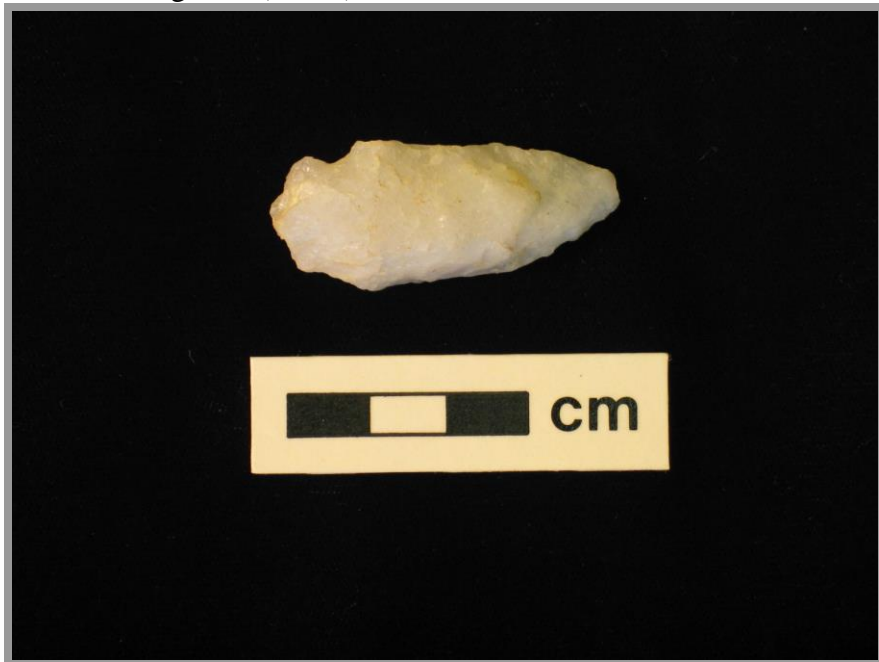
Figure 18. Middle Archaic Quartz Projectile Point (FS 42).

As does the presence of so much brick in the Zone 1 plow layer, the recovery of 89 partial and whole nails is thought to support demolition activity in this vicinity. Seven were wire rather than cut, and indicate that later deposition took place here as well. So also does the barbwire ($n=12$) from this unit, reflecting the presence of a fence or fences. The 180 patinated window glass fragments, out of a total glass count of 204, are also evident of a former structure. Other artifacts from Unit 2 include part of an iron knife tang, the pipe bowl fragment and quartz projectile point discussed above (Figure 15), 5 bone fragments, and, curiously, a fragment of shell.

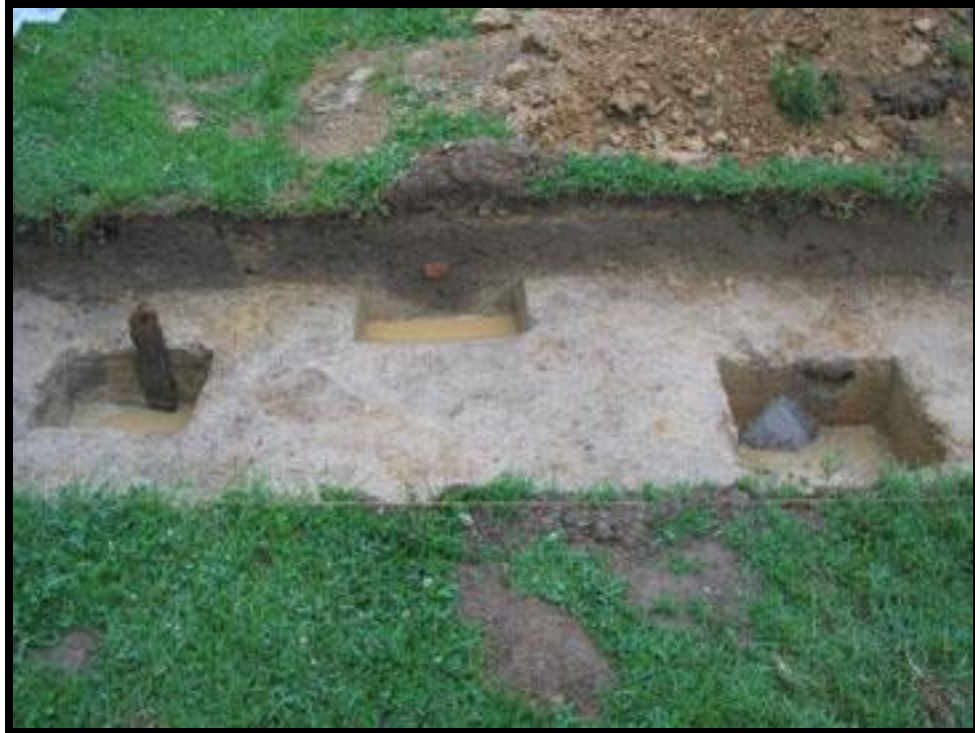
Figure 19. Postholes in Trench 3. Facing west, Posthole 1 (left) contains an extant wooden post; a brickbat appears in the center of Posthole 2 on the trench west wall. The bottom of Posthole 3 (right) abuts a naturally occurring rock.

Trench 3 did produce three postholes in the south end of the excavation. The center of Posthole 1 was located 2.42 m north of the north Academy wall (Figure 19). This apparently modern feature clearly shows an extant post in its accompanying hole; a ditch with trench appears just to the north (right) of the posthole. The wooden post fragment was 67 cm long when removed. This item probably corresponds to the fence post shown just north of the academy northwest corner in Figure 7. On the west wall of the trench, at 3.17 m from the Academy, a 35-cm-deep posthole was noted, with a brickbat in the fill that was presumably used to brace the post. Four sherds of coarse lead glazed earthenware and one swirled whiteware fragment, and nothing else, were associated with the fill from this feature. The latter sherd provides a *terminus post quem* (hereafter TPQ) of 1831 for the filling of this feature, which is quite distinct from the other two postholes in terms of its form and obvious nonalignment. This feature is a likely candidate (and the *only* candidate at that, for an early posthole at the site. Posthole 3, four meters north of the academy wall, is similar in form to Posthole 1, but has a shallower bottom, no doubt due to the presence of the large rock. Fill material included several small brick fragments, a flint chip and a single sherd of alkaline glazed stoneware, a folk pottery type that is firmly dated to the 19th century (Greer 1970). Although Postholes 1 and 3 may be part of the same fence line, the historic photo in Figure 7 does not seem to show a second post to the north of the academy, and no other postholes were noted in the test trench. Either the fence line ends at Posthole 3 or it veers off of the alignment of the trench. Since Posthole 1 is rather recent, as evidenced by the post being intact, Posthole 3 is probably recent as well. But whatever their dates, the presence of Postholes 2 and 3 demonstrate use of the “front yard” area that is not previously indicated in either photographs or documents.

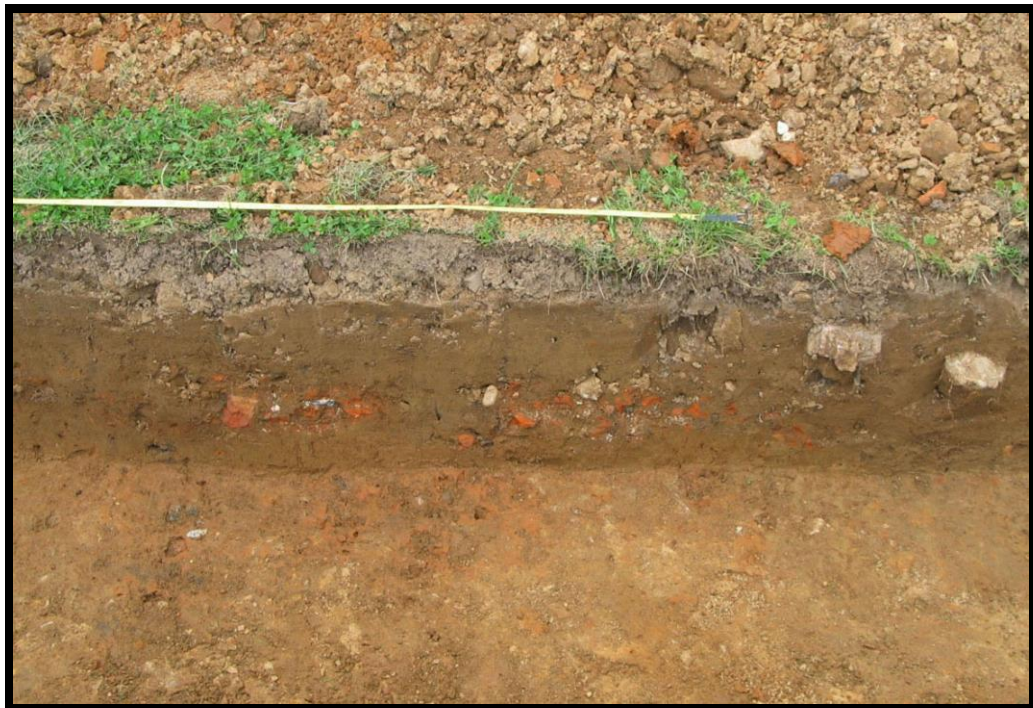
Figure 20. Brickbat Deposits, East Wall of Trench 5.

Although Trench 5 showed no positive evidence of a roadbed, a curious anomaly was observed in its northern half. Two discontinuous lenses of brickbats appeared about 42 cm below surface on the east wall of the trench (Figure 20). When first noted, we eagerly contemplated the possibility that the presence of these subsurface brick fragments might correspond to filled-in wagon wheel ruts. There is a faint depression adjacent to (north of) a removed concrete walkway to the springhouse (the same walkway shown in Figure 4) that might be a topographic signature of just such a hypothesized road. However, that contour dissipates as it approaches Trench 5 from the southeast, and there certainly is no evidence of it advancing toward the main house. And upon more sober reflection, the archaeological correlates for a “roadbed” attribution possess some fatal flaws: the deposits are very irregular and fairly wide (about 1.10 m and 2.40 m), and even more significantly, neither lens extends across the trench into the west profile. Instead, they

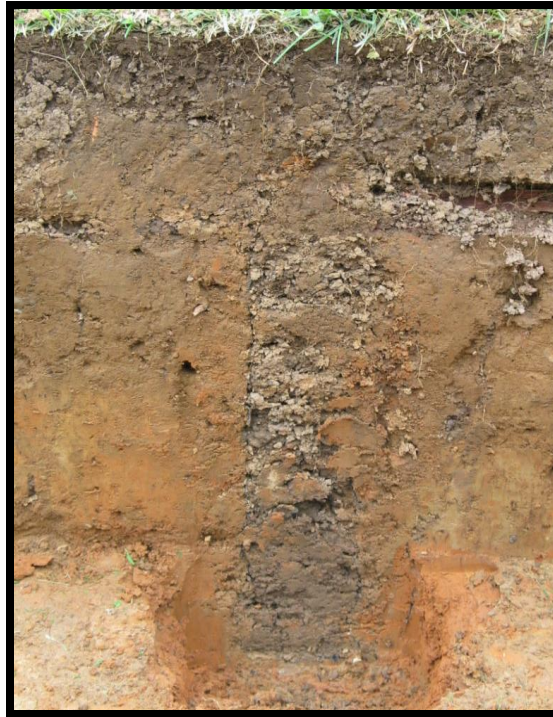
Figure 21. Posthole 1 Profile, Trench 5. Bottom is 80 cm below surface. Facing west.

By chance the north half of this trench also intercepted a north-south line of unanticipated postholes, one of which is illustrated in profile in Figure 21. All were noted in profile on the west wall of the trench. Due to time constraints (they were recorded on the last day of fieldwork), no excavation of profiled posthole fills could be attempted. If this fence line was slightly angled away from the trench orientation, that would account for the absence of a fence line in the south half of the Trench 5. Although there is a faint suggestion of a second north-south fence line in Figure 8, it is very indistinct, and none of the other historic photographs of the site show this line. On the other hand, in Figure 4 the two robust and untethered cows seen munching grass next to a concrete sidewalk connecting the springhouse to the mansion required a fence behind the camera to prevent them from escaping to open range. According to George Collins (personal communication), the concrete walkways that at one time were ubiquitous at the site were laid by Charlie Doak in the mid-1890's, and the Figure 4 photograph is believed to date to about 1895. Five of the six postholes noted in Trench 5 are markedly straight-sided with flat bottoms, and all originate in the sod zone, indicating a relatively recent origin. The form of these features suggest that they may have been mechanically dug, which also points to a more modern provenance.

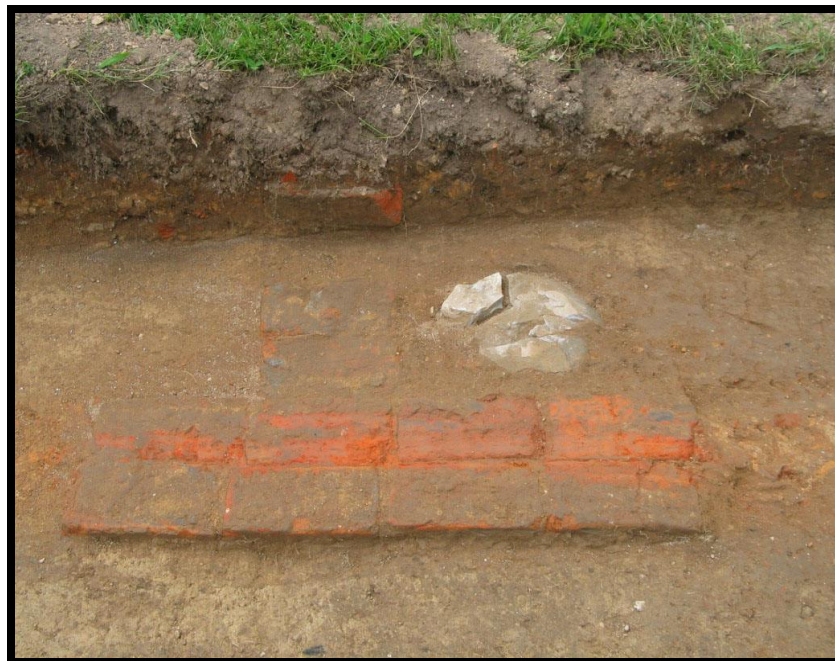
Figure 22. Trench 4 Brick Foundations. The “T” shape of this foundation indicates an interior wall division. The bright orange appearance of some of the bricks was produced by the backhoe. The function of the limestone rock, if any, is unknown. Facing south.

Older, and certainly more surprising, was the discovery of a brick foundation in Trench 4 that was aligned with the current academy structure. As shown in Figure 22, an approximately 90-cm section of parallel bricks (Feature 1) abutting a single-course right angle foundation (Feature 2) was uncovered by the backhoe. These are hand-made bricks with sandy mortar that are identical with the bricks from other early architectural components at the site. Once the entire trench was hand-cleaned with shovel and trowel, a faint suggestion of a robber's trench (Feature 3) could be seen running east-west. All three features are visible in Figure 23. Our interpretation of Feature 3 is that it is a foundation trench (as opposed to a builder's trench, which is wider than the foundations) that was robbed of bricks when the building was demolished. Features 1 and 2

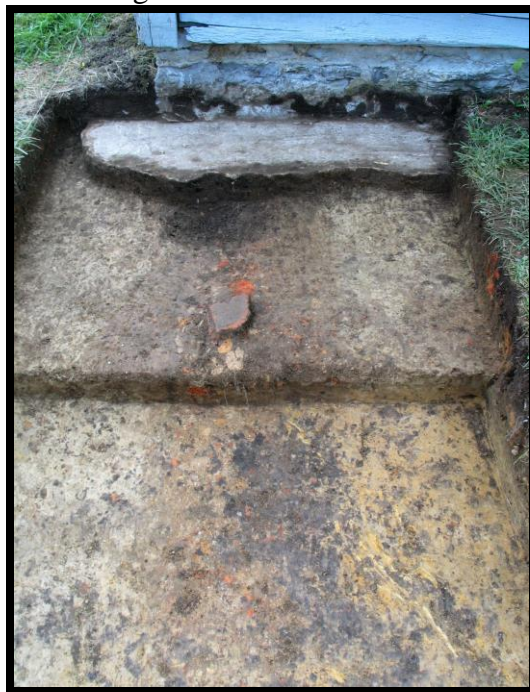
Figure 24. Unit 7 Features in Trench 4. From top, extant academy wall and stone foundation; Feature 6 modern concrete footing pad; Posthole 12; Feature 3 robber's trench with brickbat. The extent of the Unit 7 excavation area is indicated by the stepped shelf. Facing east.

We think it is significant that Features 1, 2, and 3 align very closely with the orientation of the extant academy. To determine the critical relationship between Feature 3 and the academy foundation, the 1 x 1 m Test Unit 7 was laid out and excavated. Unfortunately, modern restoration work associated with the academy included the laying of a concrete spread foot foundation, as shown in Figure 24. Labeled Feature 6, it obscured the association, if any, of the academy foundation with the Feature 3 foundation/robber's trench. As might be expected, the top 10-cm level that was screened produced several modern artifacts, including one fragment of modern porcelain, 2 Coke bottle caps, 3 pull tabs, a piece of plastic and numerous cellophane fragments. But 4 fragments of lead glazed earthenware, 2 alkaline glazed and an Albany slipped stoneware sherds (both presumably 19th century), a hand painted polychrome pearlware (1795-1840) and 3 blue transfer printed pearlware sherds, 25 plain and 3 transfer printed whiteware sherds attest to the historical component in the artifact assemblage. In addition to the Doak-period ceramics reflecting a midden-like disposal location, a remarkable 2130 fragments of glass were counted, 96% of which came from Level 1. Clearly this spot was more than simply a part of a generalized sheet deposit: it apparently was designated as a specific place to get rid of broken glass.

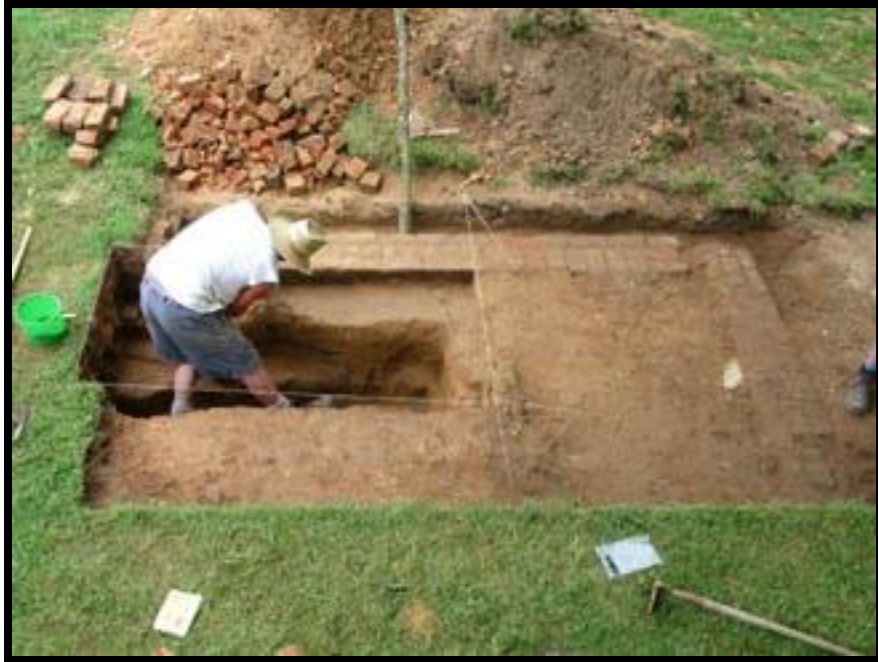
Figure 25. Excavation in the Missing Ell Foundation. Field school student Jim Greene trowels out a feature in Unit 1. Facing north.

One of the project objectives was to locate the foundations to the northern portion of the ell attached to the house. As mentioned earlier, historic photographs and oral history indicated an unknown portion of this building extended past the extant end chimney and was believed to have been demolished in the 1930s. A backhoe trench extending north at a right angle to the north ell wall located a parallel subsurface brick end wall foundation 5.42 m (interior) from the extant wall. A second trench was machine excavated to the east to expose the northeast corner of the buried foundation. Finally, after removal of overburden, a 1 x 2 m unit adjacent and interior to the buried north ell foundation (see Figure 25) was excavated by 10 cm levels. It is argued that the extant ell and its now absent northern extension were constructed separately, so each ell segment will be referred to as the south and north ell, respectively.

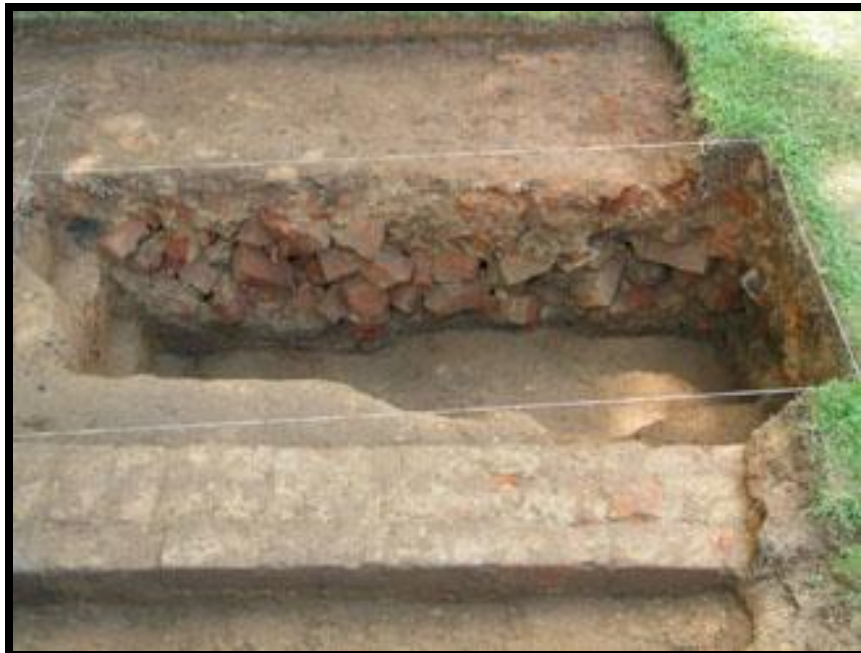
Figure 26. Unit 1, North Ell Foundation. The north brick foundation, adjacent sterile brown clay, and rubble-filled demolition pit are clearly visible in this view. Facing south.

When the floor of Trench 2 was carefully shoveled and troweled, a clear distinction was noted between the demolition fill and a layer of undisturbed clay adjacent to the ell foundation. The rubble fill, composed primarily of brickbats and mortar fragments—none of them modern—extended to a depth of 65 cms (Figure 26). Since the south ell possessed a crawl space but no basement, the presence of a deep rubble-filled pit inside the demolished section was unexpected. The irregular appearance of the fill outline and the depth of the deposit suggested that it was created with a backhoe, possibly during the restoration of the extant ell chimney and end wall in the 1970s (demolition of the northern ell in the 1930s would probably have been by hand). Artifacts recovered from Unit 1 confirm this temporally later attribution: besides a sherd of pearlware, two examples of lead glazed earthenware, and three fragments of whiteware, the fill contained dark cloth and plastic. Although invented more than a decade earlier (American Plastics Council 2003), this latter material establishes a disappointingly late *terminus post quem* of the early 1940s for backfilling the restoration pit, when Dupont produced the first nylon stockings to great popular acclaim; thereafter, plastic became ubiquitous in American life, and American sites. Why restoration of the ell required this pit to be dug and filled to begin with is unknown.

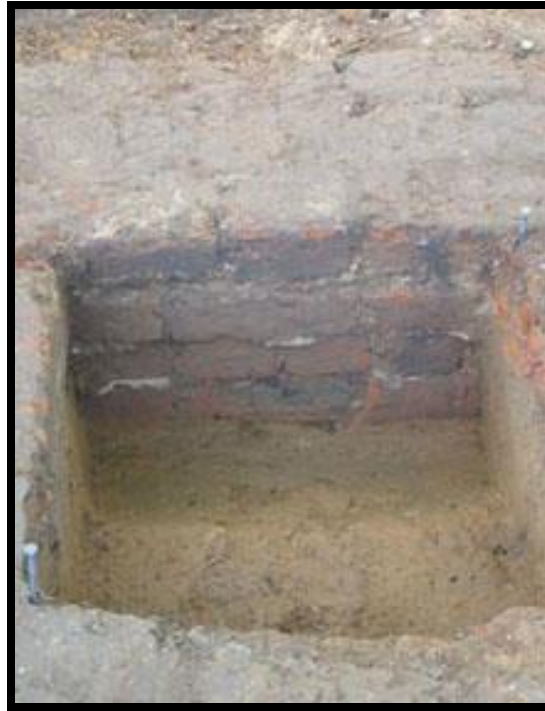
Figure 27. Northeast Foundation Corner of Ell Extension. View is to the east in Unit 3.

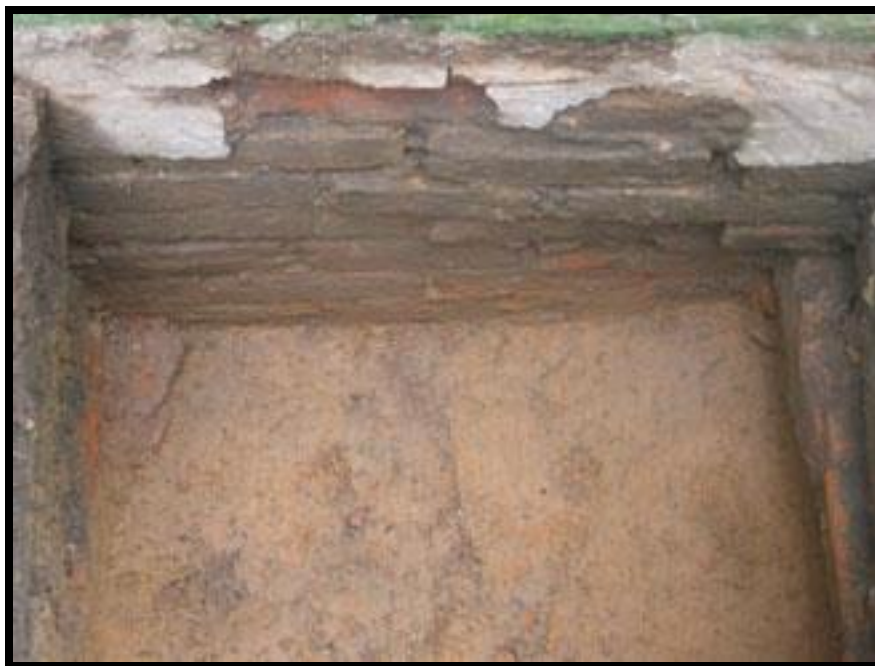
Figure 28. North Foundation of the Extant Ell. Note the bottom courses in their original locations, and the later displaced restored courses above. Facing south in Unit 9.

Unit 9, an informal (unscreened) test pit, was placed on the northeast external corner of the extant south ell. It measured approximately .75 m on each wall. This location unfortunately had been subject to considerable restoration disturbance, but it was still possible to confirm the four-course-deep west foundation of the north extension, similar to the companion east wall. Interestingly, although the upper courses of the extant ell north wall were somewhat carelessly restored, as seen in Figure 28, the lower courses were apparently still in their original location, with no limestone footings present. They are at least three courses deeper than the foundations for the north extension, which provides additional support for the “discontinuous construction” theory: it demonstrates a lack of consistency that would be expected with separate construction sequences. Unit 9 was also notable for producing the largest restorable vessel in the entire ceramic assemblage, the green shell edged whiteware plate shown in Figure 12.

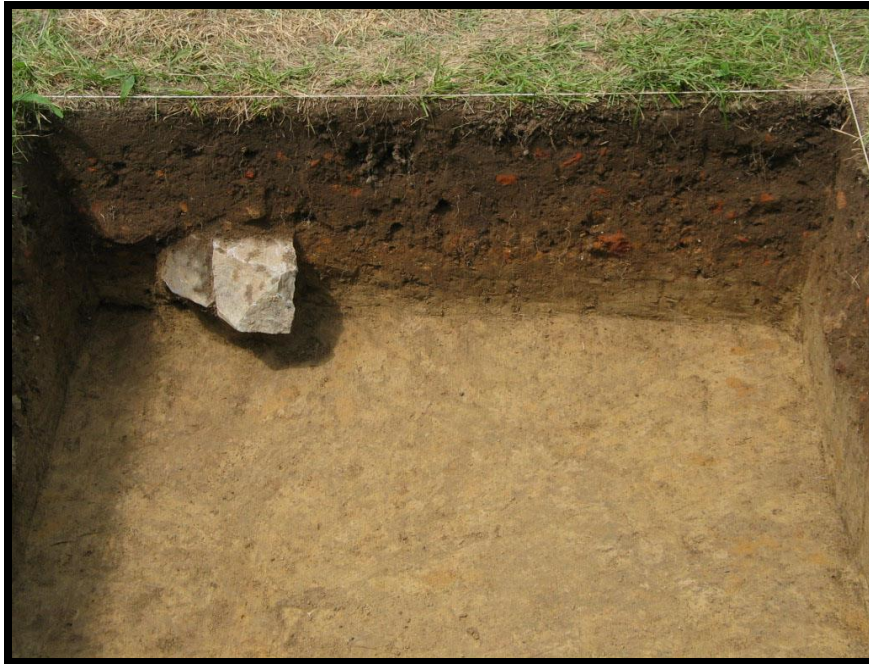
Figure 29. Unit 2 North Profile. Note brick demolition fill in Zone 1.

Unit 2 was excavated in 10 cm levels, and ended at about 35 cm below surface, in sterile Zone 2 clay. There was no obvious vertical sequences of artifacts that could be detected within Zone 1, as is usually the case in a plow zone. Figure 29 illustrates the sharp distinction between Zones 1 and 2, as well as the occurrence of a foundation stone at the juncture between the two layers. The ceramic assemblage provides evidence of disposal from the first half of the 19th century, and includes 24 lead glazed earthenware, 1 each of blued edged pearlware and plain creamware (1762-1820), 10 plain pearlware and 26 whiteware, 9 sponged whiteware, 7 transfer printed whiteware, and 1 alkaline glazed stoneware sherds. For the 28 sherds for which firm manufacturing dates are established—admittedly a small sample—a mean ceramic date (South 1977) of 1830 was calculated. This provides at least some confirmation for “early” disposal behavior near the academy, although excluding nearly 70% of the ceramics that were found may guarantee an early date: later types are simply omitted from the calculation because their manufacturing ranges are unknown. This drawback, as well as the problems associated with small samples in general, should be kept in mind with other MCD calculations are presented below.

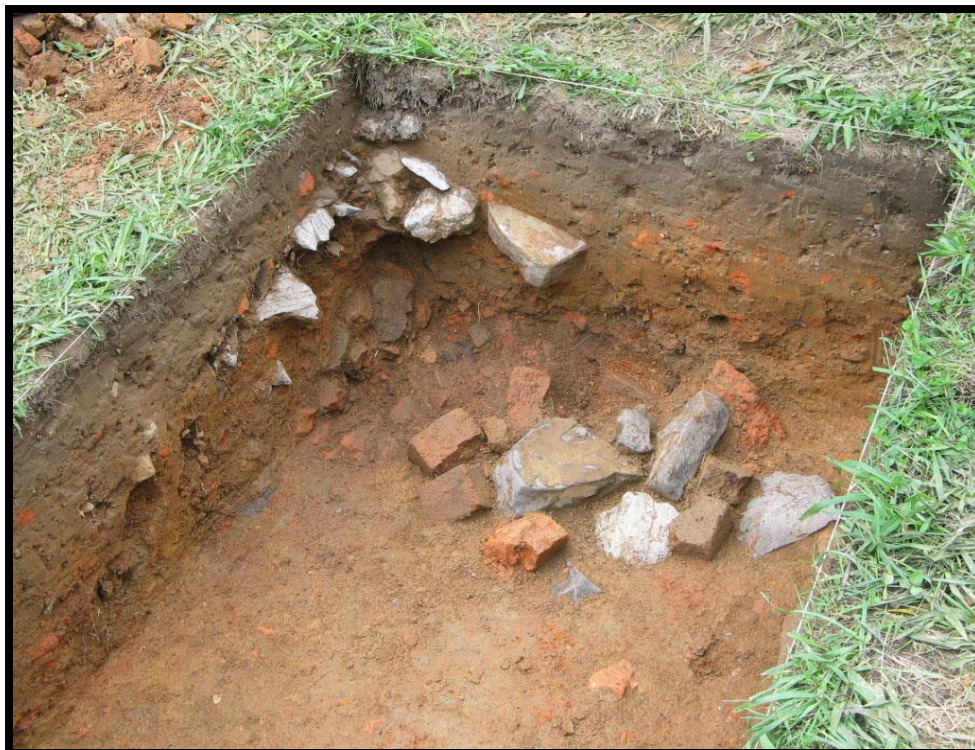
Figure 30. Unit 5 Demolition Fill. Facing west.

Figure 30 shows the extensive fill that was revealed in the southwest area of the unit, beginning but primarily beneath Zone 1. It was composed of large handmade brickbats, bits of fragmentary brick and mortar, and in the upper portion of the rubble deposit, foundation stone fragments. Not only was the presence of such a deposit completely unexpected, but an even more surprising discovery came when the extent of the demolition deposit was determined: Unit 5 did not bottom out until we had dug through over a meter of fill. Only in the northwest corner of the unit was sterile reached sooner, at about 60 cm. The bottom of Feature 1 was uneven, and the lower 80 cm of the deposit contained only two transfer printed whiteware sherds and four fragments of patinated window glass. Corroboration that this was indeed a demolition deposit

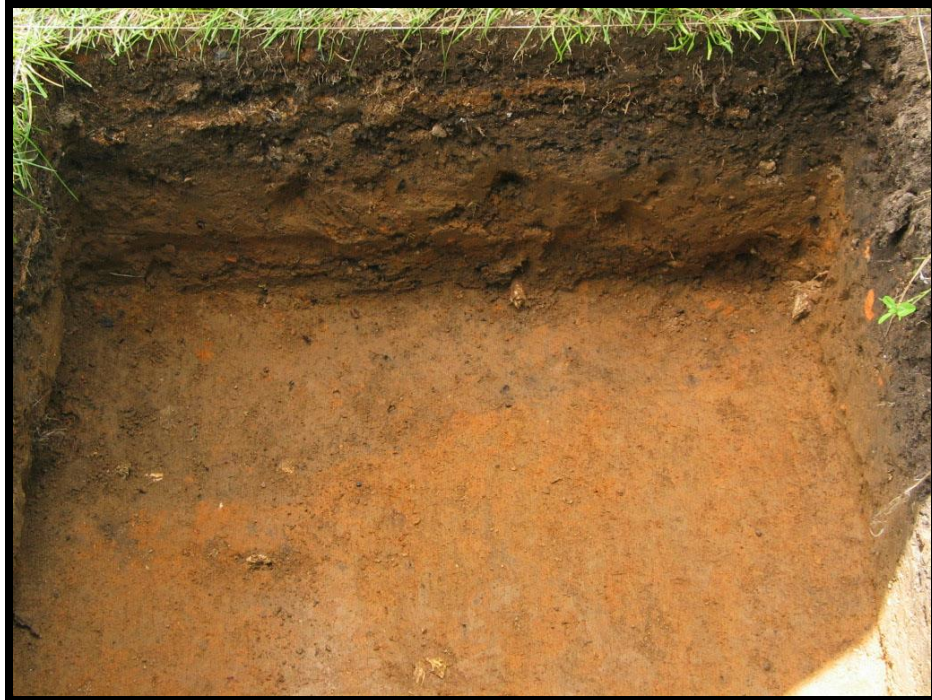
Figure 32. West Profile, Test Unit 6. Feature 1 is apparent as the darker-stained clay extending north-south across the floor. Photo taken at 54 cm below surface.

Ironically, the limestone fragment seen in the west wall of the survey unit was a skinny one, and did not extend 10 cm into the test unit excavation. But on the west end of the Test Unit 6 a linear feature was observed after Zone 1 was completely excavated. As shown in Figure 32, it angled across the west end of the unit from southeast to northwest, as photographed at 54 cm

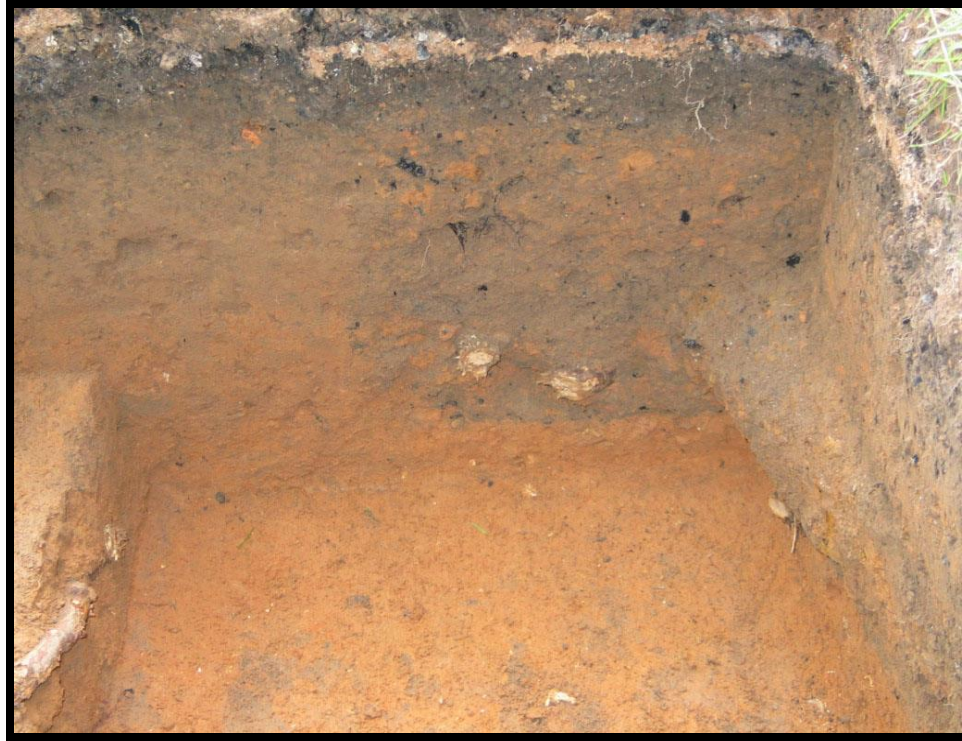
Figure 33. Test Unit 6 Southwest Corner. The Feature 1 pit is clearly visible in the south wall.
