Experimental study on corroded steel beams rehabilitated using BFRP wrap

A Thesis
Submitted to the Faculty of Graduate Studies
through the Department of Civil and Environmental Engineering
in Partial Fulfillment of the Requirements for
the Degree of Master of Applied Science
at the University of Windsor

2017

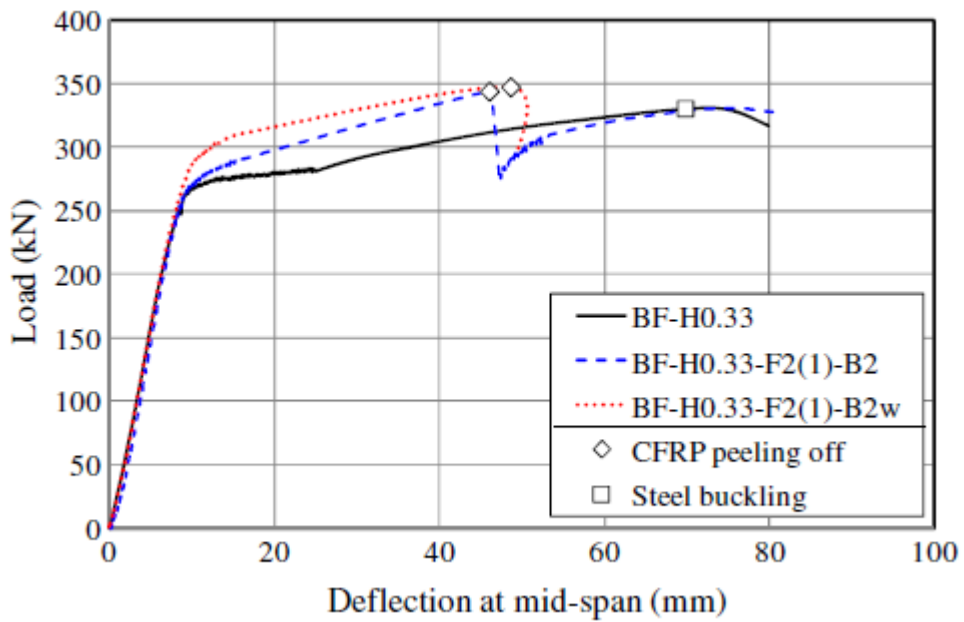
Figure 2.5: Load-deflection curve (Galal et al. 2012)

Galal et al. (2012) tested thirteen W150x30 steel (reference) beams to evaluate the behaviour of deteriorated and CFRP-retrofitted steel girders. These beams had a span length of 1.6 m and were tested in four-point bending. The different amounts of simulated corrosion were 33% and 50%. These corrosion percentages were achieved by simulating an area loss in the tension flange. Local corrosion and spread corrosion were simulated by creating holes or notches in the tension flange. One of the objectives was to evaluate the effectiveness of transverse wrapping for delaying the debonding of CFRP fabrics, thus allowing the beam to carry a larger load. This objective was accomplished by varying the layers of transverse CFRP fabric. Figure 2.5 shows load-deflection curves for the control corroded beam as well as the two beams tested with and without transverse layers of CFRP. These results indicated that the transverse layers of CFRP fabric did not have a significant effect on delaying the debonding of longitudinal CFRP plates. The yield and ultimate load capacities were slightly increased from 250 kN to 260 kN and 344 kN to 347 kN,

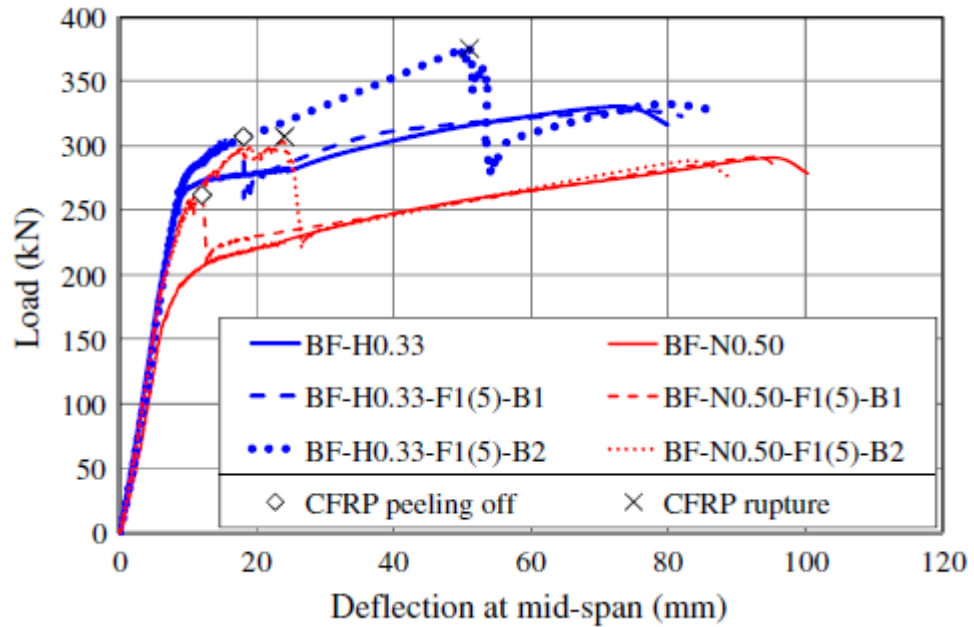
Figure 2.6: Load-deflection curve using two different epoxies (Galal et al. 2012)

respectively. The mode of failure for these beams was the debonding of CFRP plates. Another objective of this study was to determine the effectiveness of different epoxies on the load carrying capacity of retrofitted steel beams. Beams with spread and local corrosion were tested with five layers of CFRP fabrics while the type of epoxy was varied (viscous and saturating epoxies). Figure 2.6 shows the load-deflection curves of the beams with two different epoxies. It was found that the type of adhesive had a slight influence on the yield load capacity, while displaying a significant influence on the ultimate load capacity and mode of failure. Beams bonded with viscous epoxy showed a higher ultimate load than beams bonded with saturating epoxy. For beams with 33% area loss, the P_u/P_y ratio for saturating and viscous epoxies were 1.25 and 1.48, respectively. For 50% area loss, the P_u/P_y ratio for saturating and viscous epoxies were 1.45 and 1.57, respectively. The modes of failure of these beams were either rupture of CFRP fabrics or debonding.

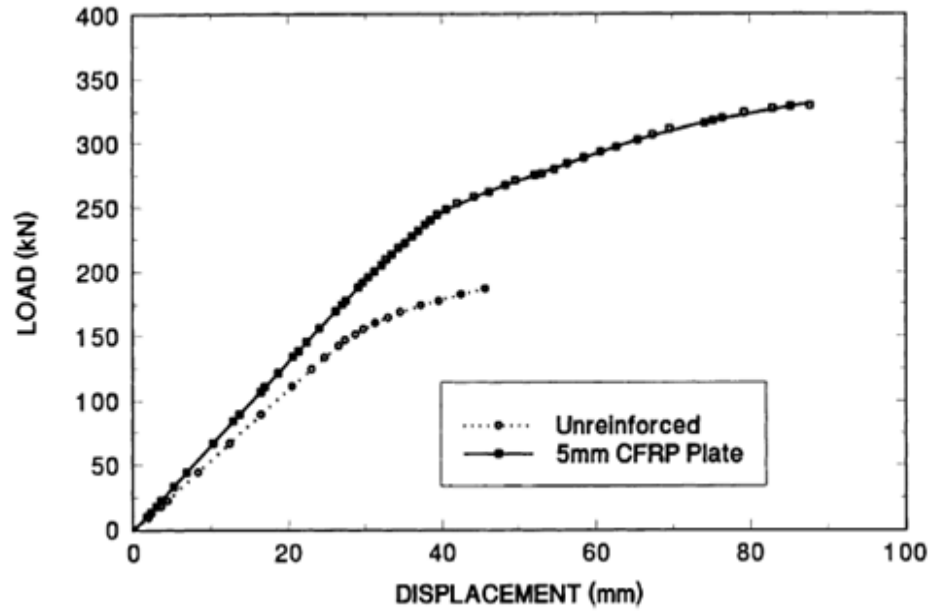
Figure 2.8: Load-displacement curve of beam repaired with 5 mm CFRP (Sen et al. 2001)

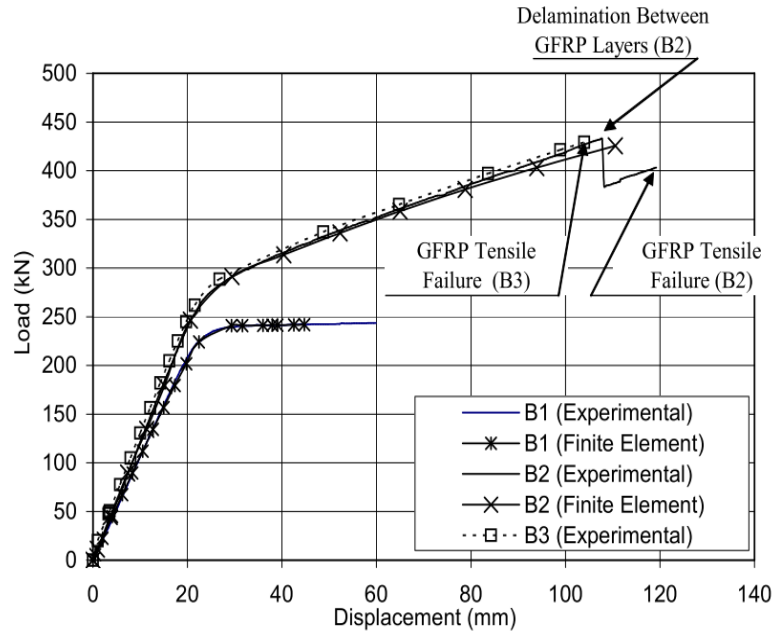
Figure 2.10: Load-deflection curves (El Damatty et al. 2003)

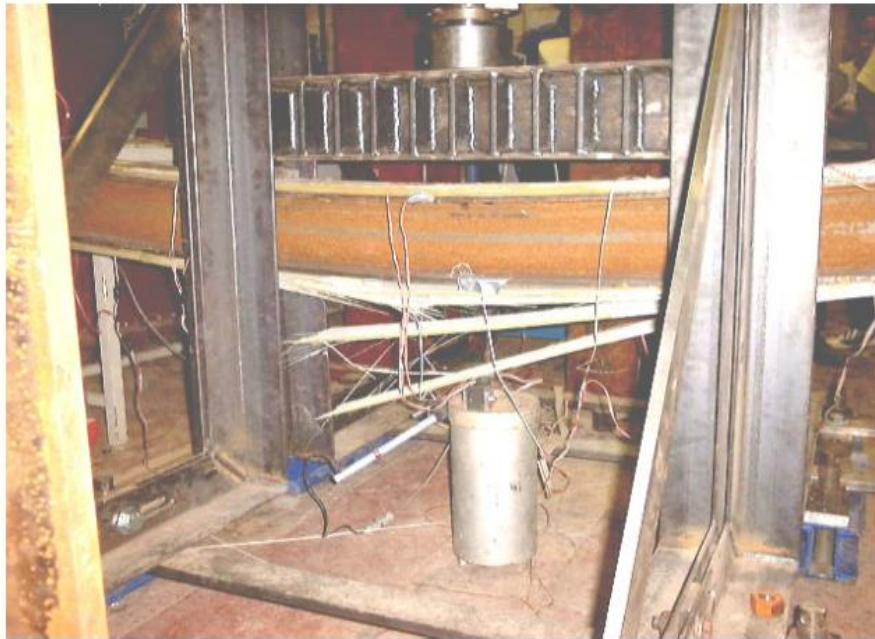
Figure 2.11: Failure of strengthened beam (El Damatty et al. 2003)

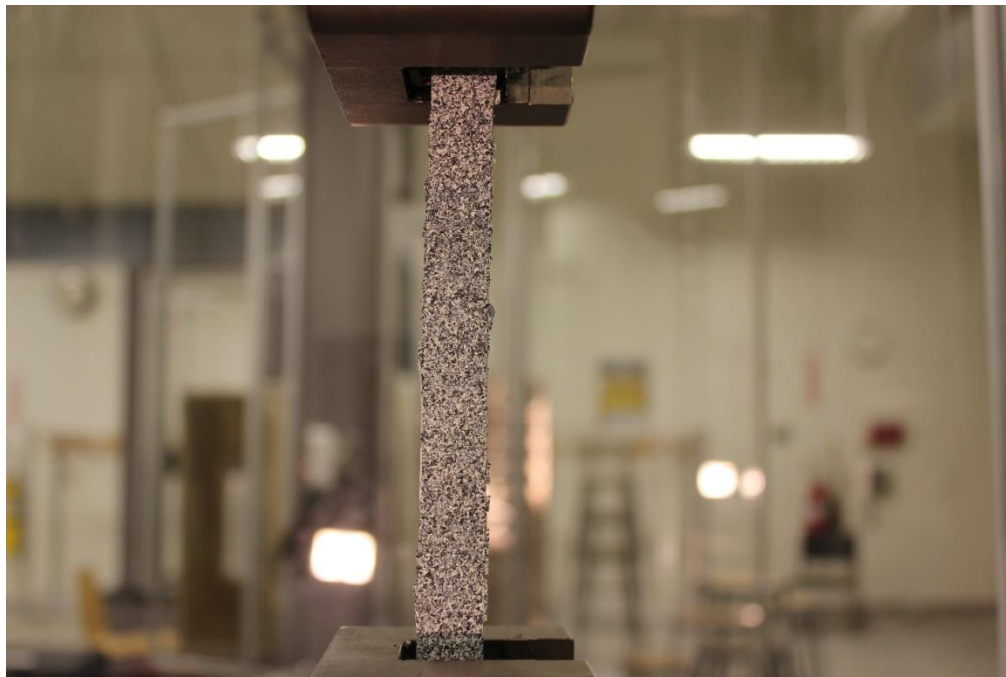
Figure 3.6: Basalt coupon before test

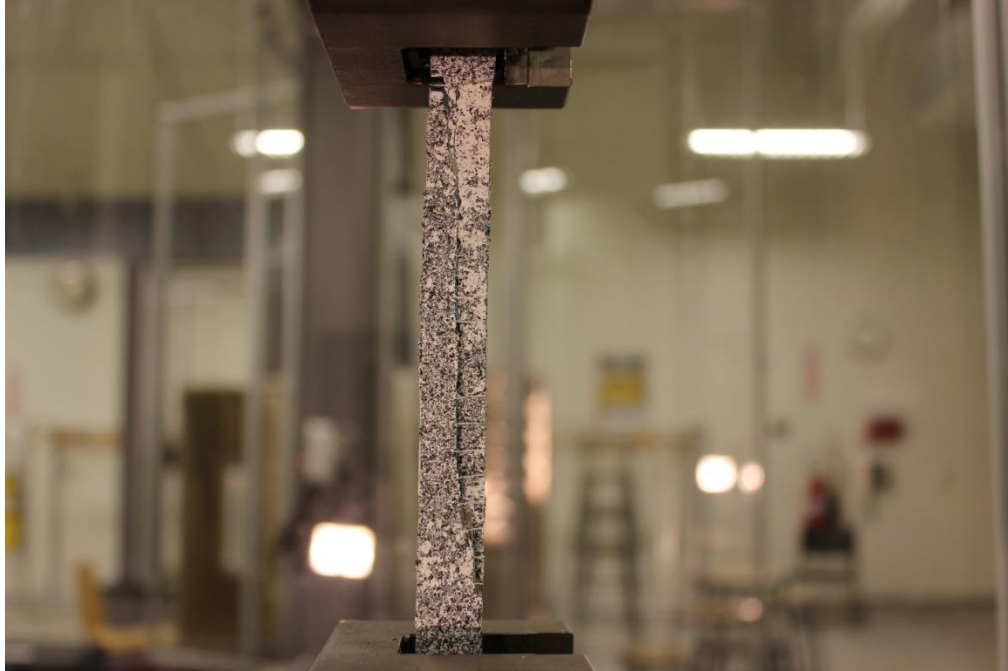
Figure 3.7: Basalt coupon after test

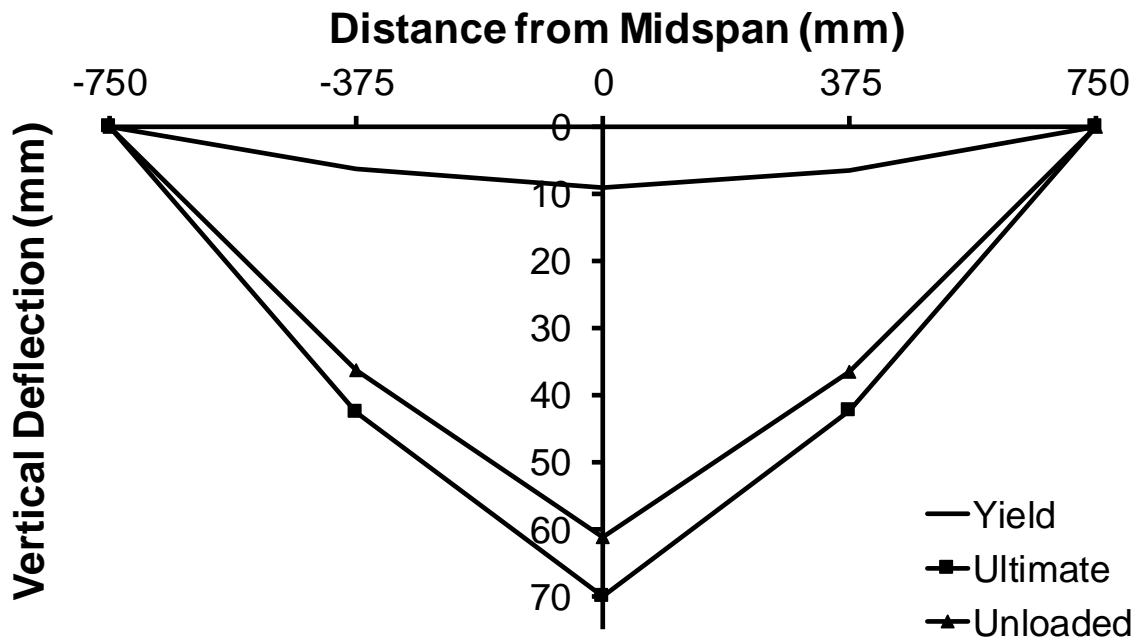
Figure 4.2: Deflection profile of control specimen

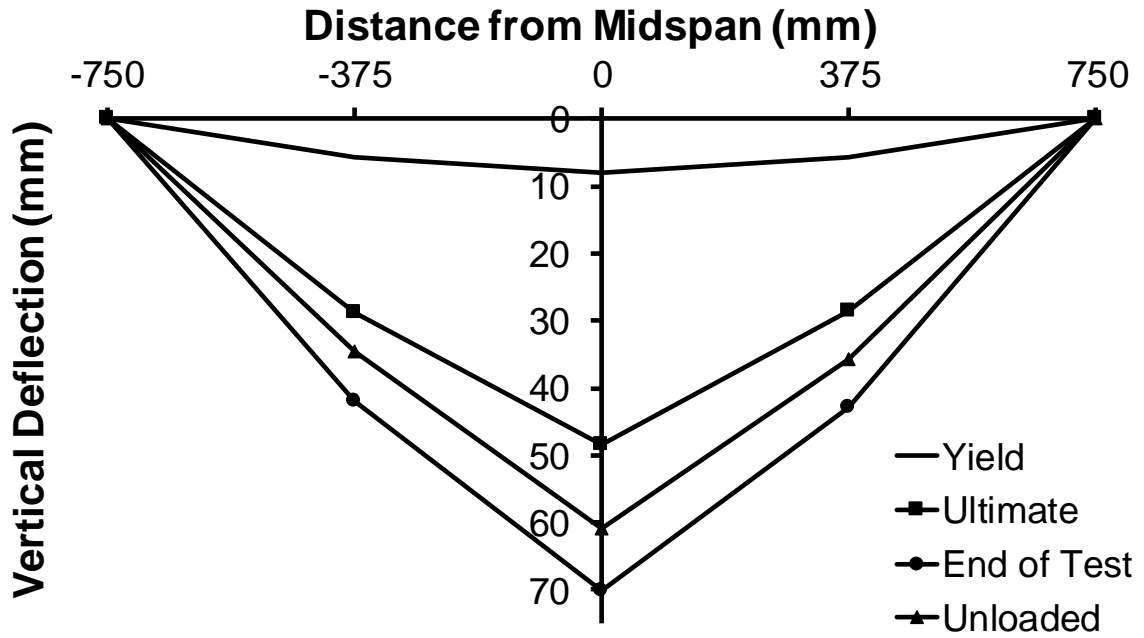
Figure 4.7: Deflection profile of 40CC specimen

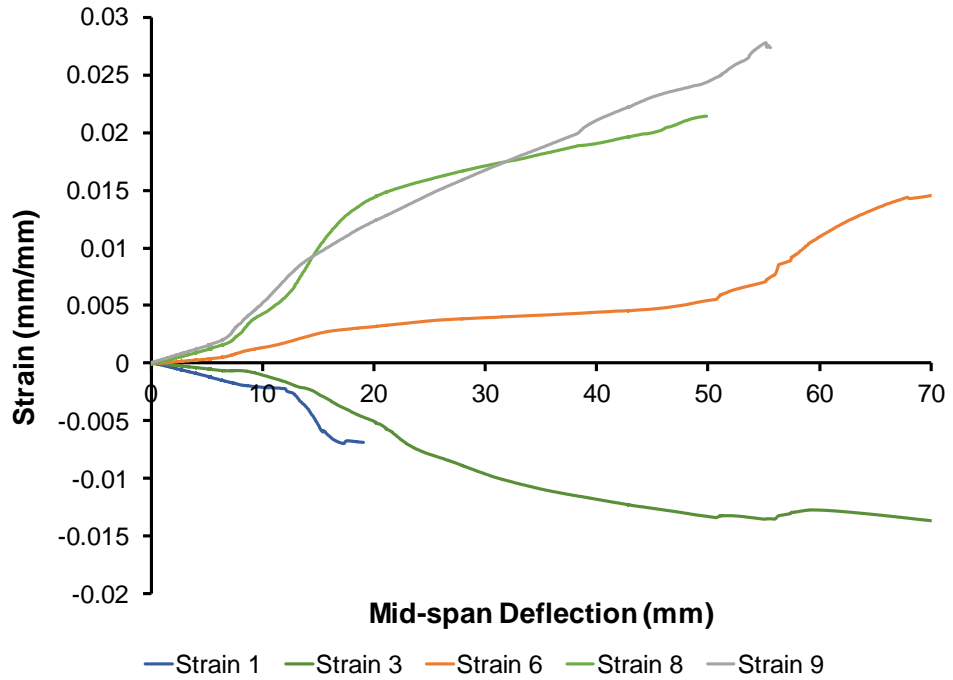
Figure 4.25: Strain-deflection curve of 0RB7L-B specimen

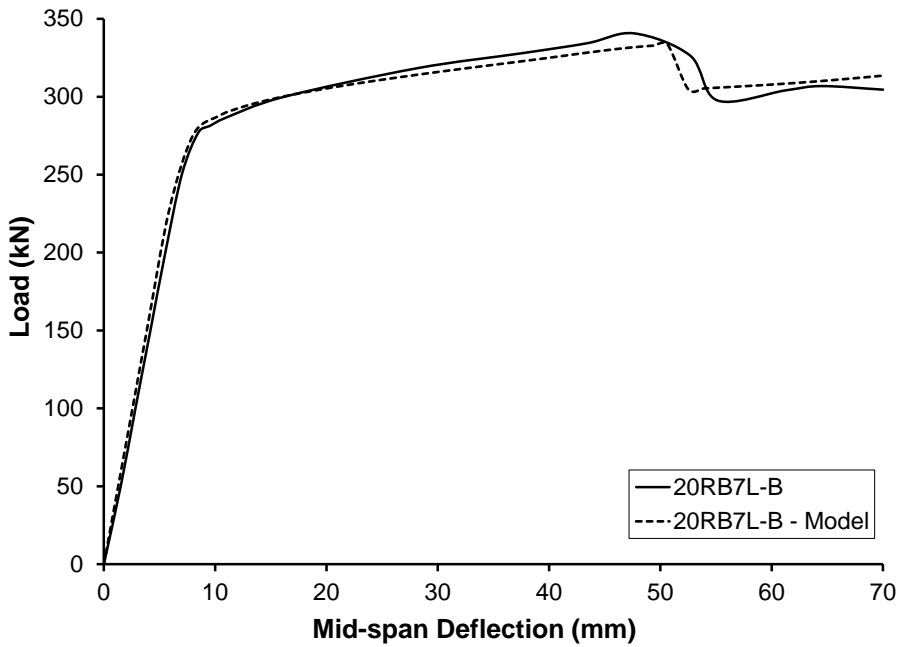
Figure 5.11: Finite element model of 20RB7L-B specimen

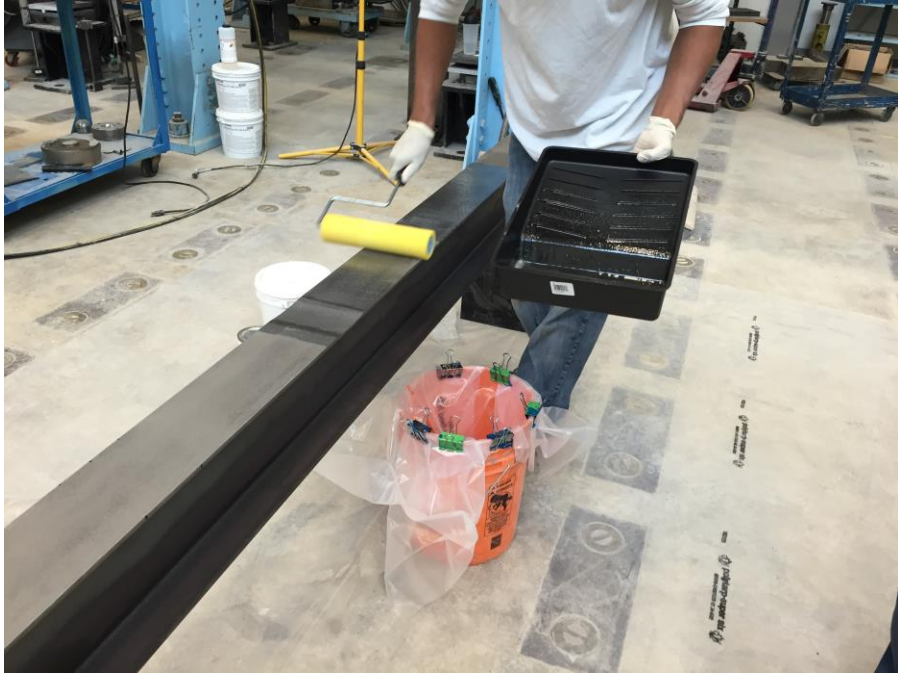
Application of primer to sandblasted beam

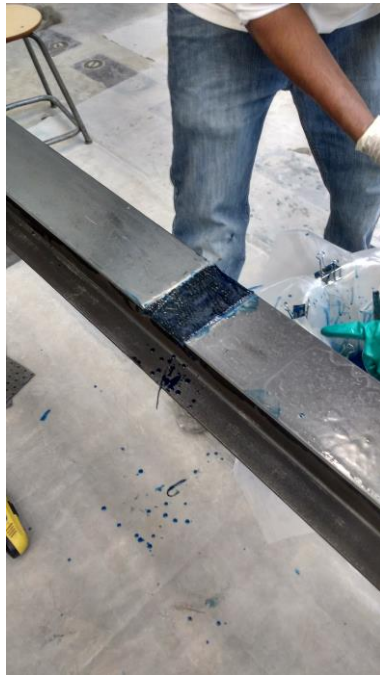
Application of small fabric pieces to corrosion gap

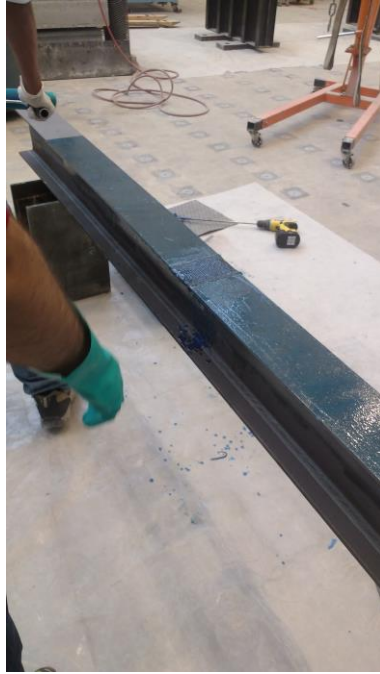
Saturation of base layer prior to applying longitudinal fabrics

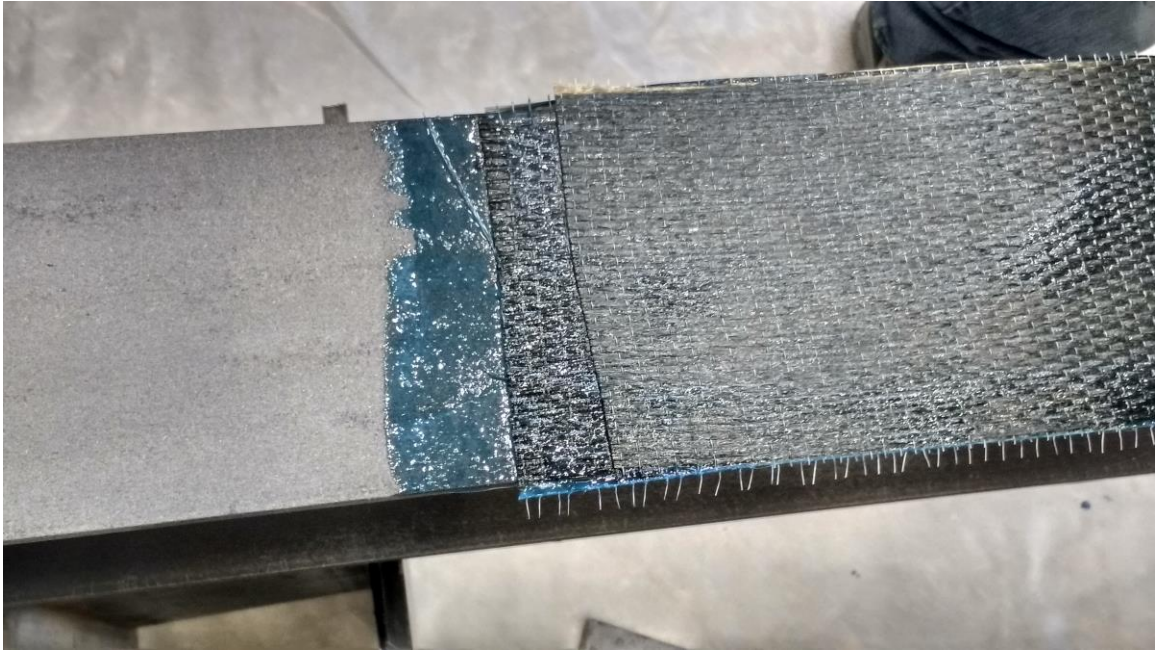
Tapering of longitudinal fabric endpoints between layers

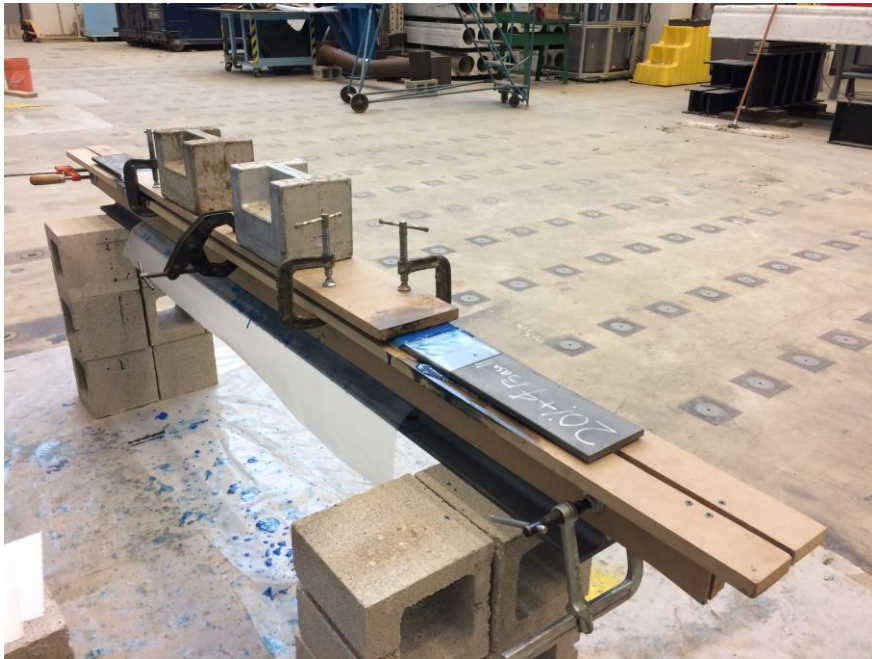
Rehabilitated beam after the application of clamps
