Strength And Fatigue Of Three Glass Fiber Reinforced Composite Bridge Decks With Mechanical Deck To Stringer Connections

Final Report

SR 500-490

February 2012

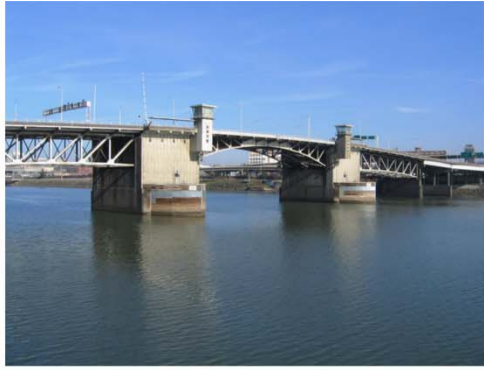
(a) Morrison Bridge with lift span down

The Morrison Bridge of Portland, Oregon is undergoing a retrofit of the steel-grating deck on the draw span by Multnomah County. This report details an experimental program sponsored by the Oregon Department of Transportation and undertaken by the *infra*Structure Testing and Applied Research Laboratory at Portland State University in collaboration with Multnomah County, which influenced the deck replacement selection during the design stage. The pre-retrofit version of the Morrison Bridge was completed in the late 1950s. The draw span incorporated a 144.3mm (4.5 in) thick steel-grating deck. Pictures of the Morrison Bridge (TripWow 2012, Fanpop 2009) and a schematic of the draw span cross section provided by Multnomah County are shown in Fig. 1.

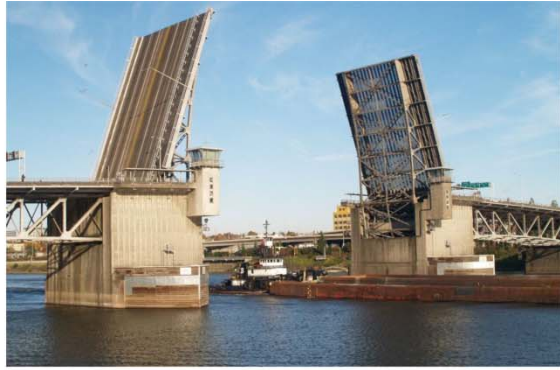
(b) Morrison Bridge with lift span up

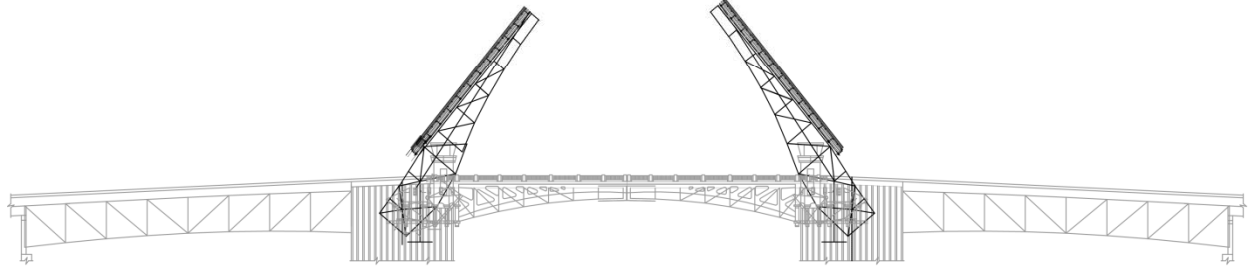
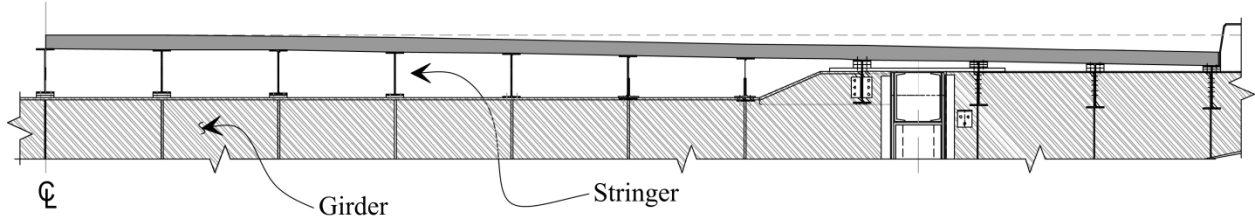
Fig. 1: Morrison Bridge (drawings courtesy of Multnomah County)

(c) General elevation view

(d) Typical transverse cross section

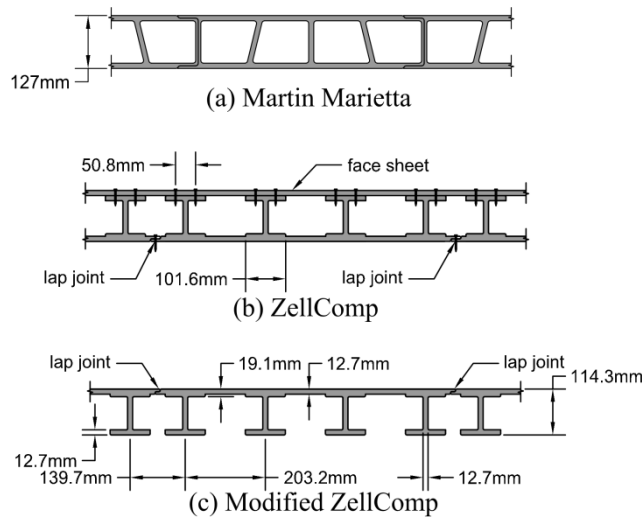
Fig. 3: FRP deck cross sections

A detail of the cross sections for the three FRP deck choices is shown in Fig. 3. The Martin Marietta deck panel was 610 mm (24 in) wide on-center and 127 mm (5 in) thick. The ZellComp deck panel was 749 mm (29.5 in) wide on-center and 127 mm (5 in) thick. The modified ZellComp deck departed from the original intent of the manufacturer by an inverted orientation and exclusion of a 13 mm (0.5 in) face sheet layer. The modifications resulted in an open web application of the bridge deck. The deck panel cross section measured 114 mm (4.5 in) in depth and 749 mm (29.5 in) in width on-center. A 13 mm (0.5 in) lap joint occurred between panels.

Typical panel-to-panel connection called for screws through the lap joint. However, because of the undesirability of screws under the thin wearing surface, the lap joint allowed one panel to bear on the other with no additional connection.

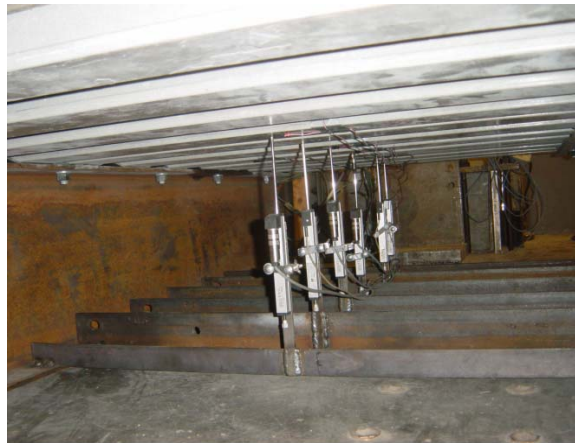
Fig. 8: Deck displacement measurements

For panel tests (flexure, shear, stiffness, and fatigue), the displacement instrumentation was accomplished with linear voltage displacement transducers (LVDT). The LVDTs were clamped to angles. The angles were clamped or welded to the bottom flange of the stringers. A representative picture of the typical approach for displacement measurement is shown in Fig. 8. As such, the deformation measured was relative to the stringers and represented the deformation of the FRP panel.

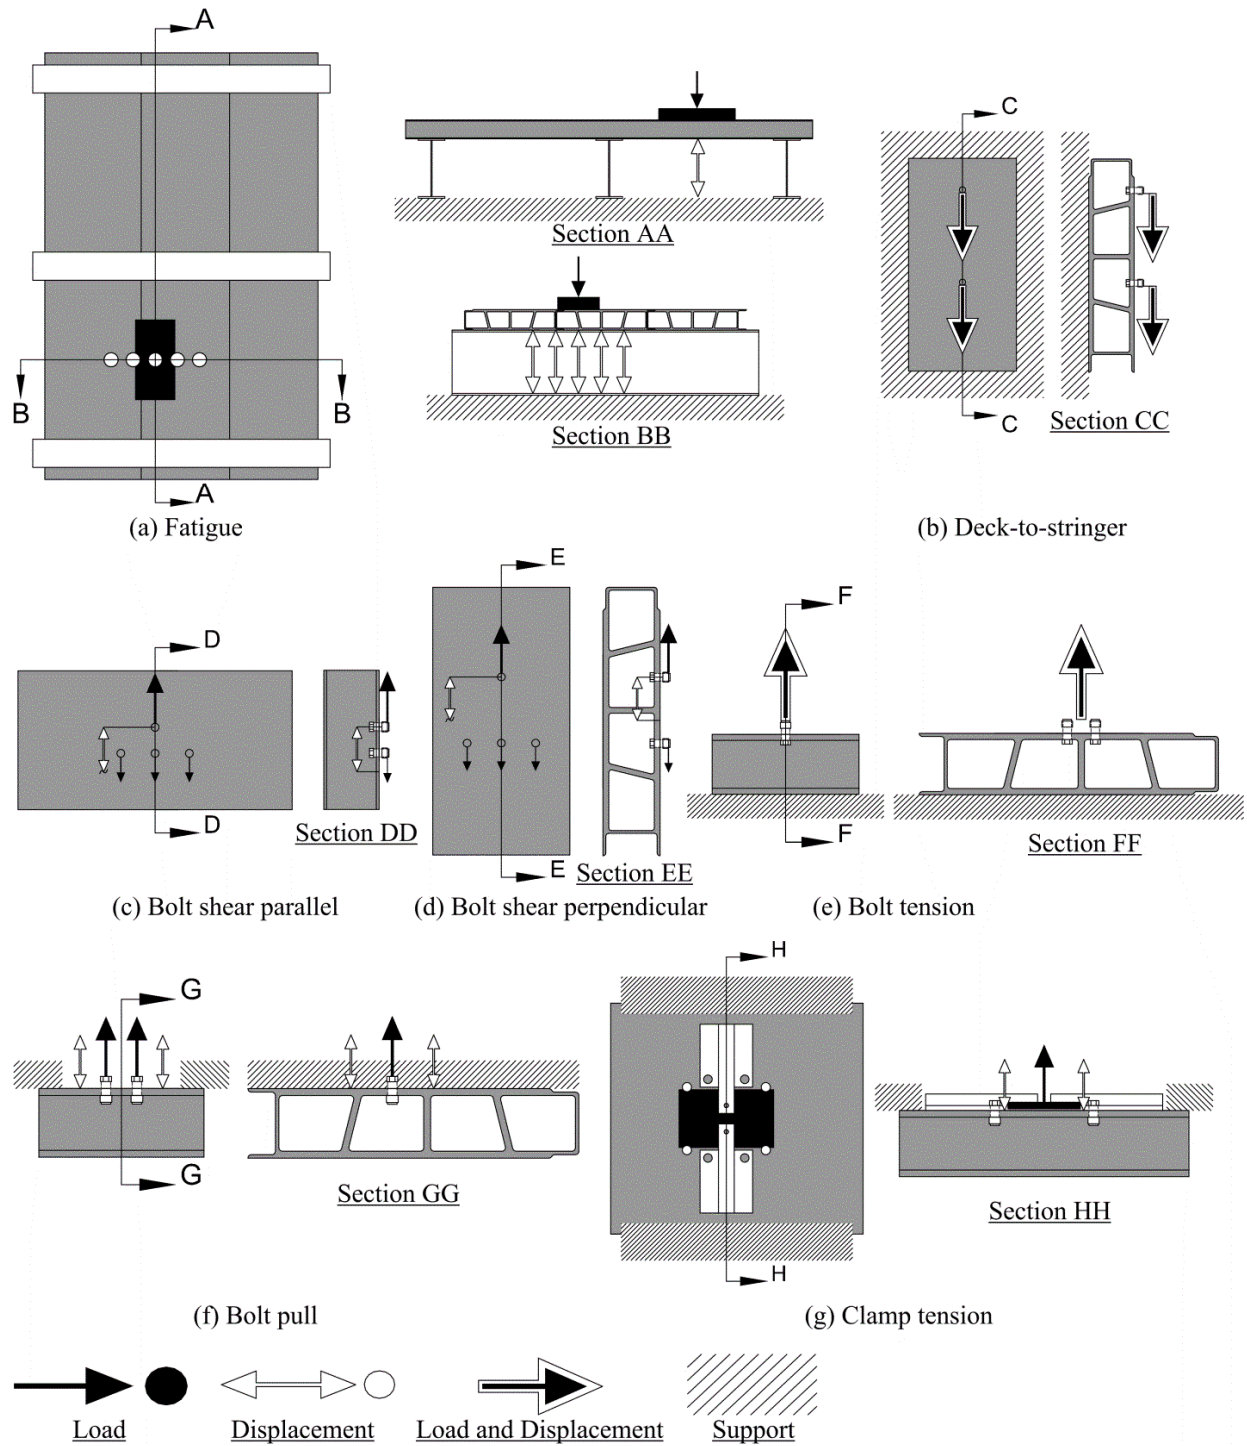
Fig. 9: Martin Marietta loading and instrumentation

In the Martin Marietta clamp test, which is shown in Fig. 9(g), the load was applied to the steel bracket. From the steel bracket, the load traveled through the two clamps. The dowel pins prevented any slip between clamp and bracket. From the clamp, the load was applied to the FRP deck. The displacements were measured at the four corners of the steel bracket and averaged.

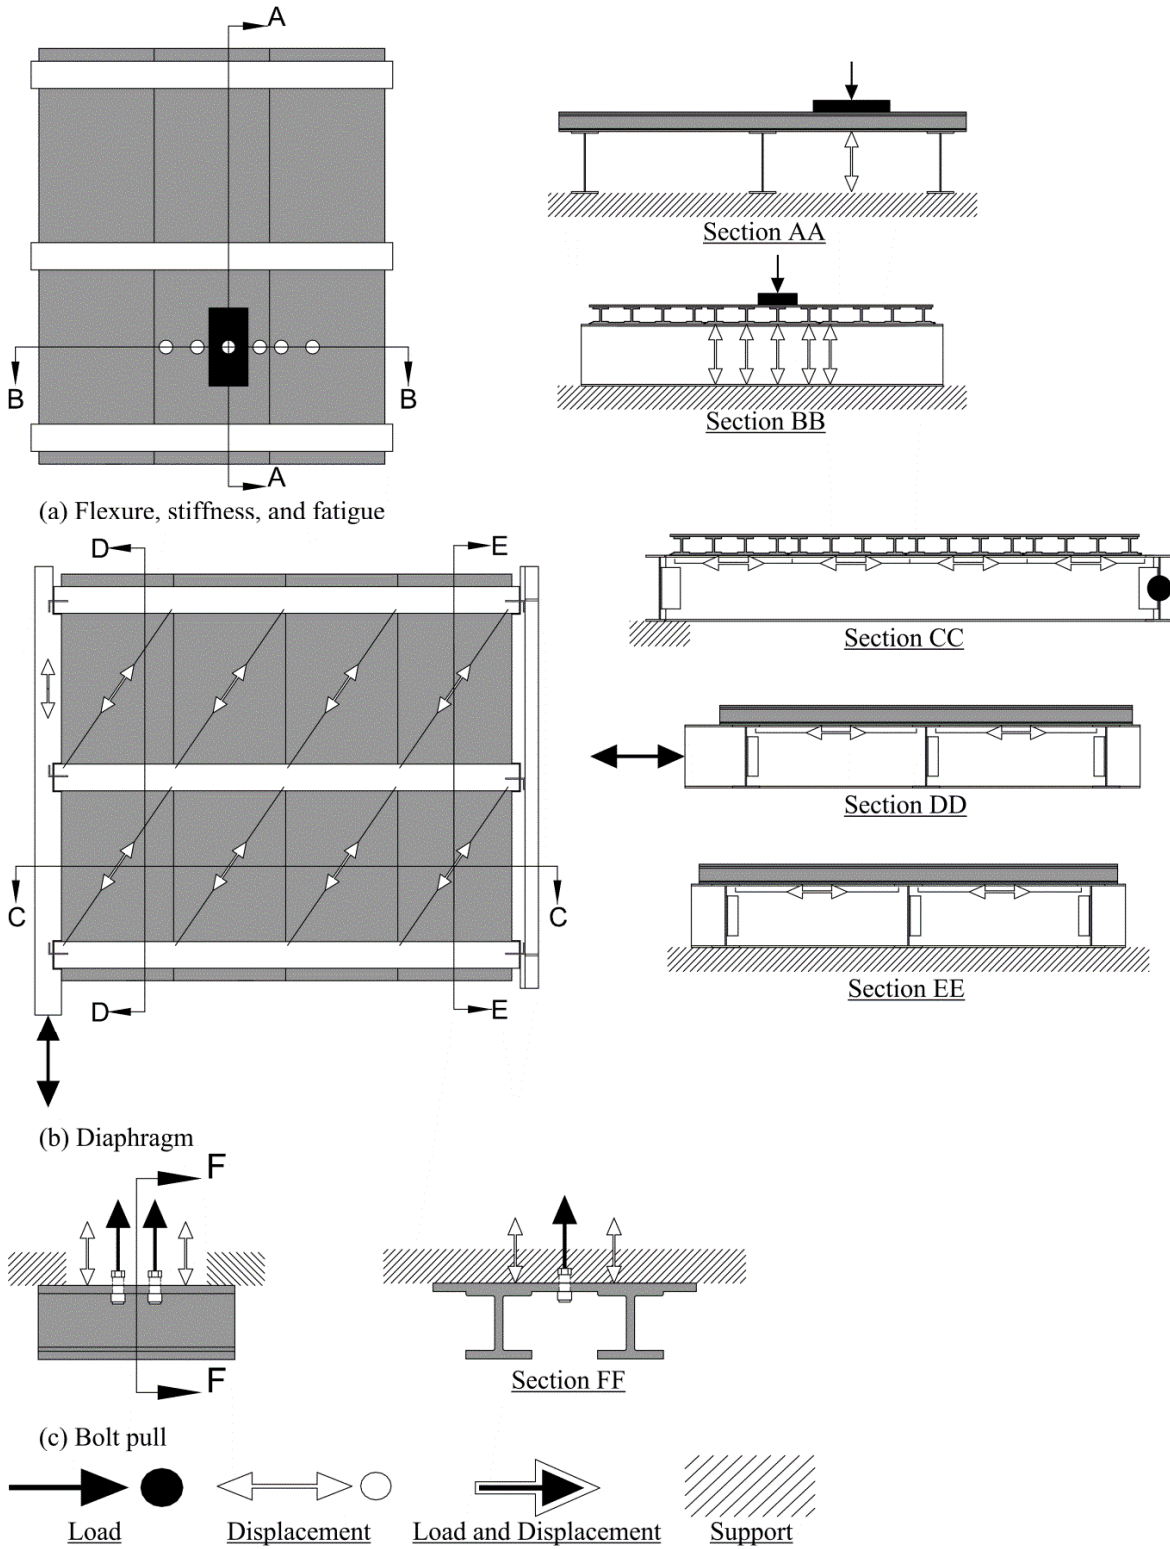
Fig. 10: ZellComp loading and instrumentation

The loading and instrumentation for the ZellComp diaphragm test is shown in Fig. 10(b). The load was applied to the web of the girder which was allowed to move freely in the plane of the FRP deck. The load transferred through the web-to-web welded angle connection of the girder to the stringer and caused the stringers to try to rotate. The rotation imposed on the stringers was resisted by the four FRP ZellComp panels attached to the stringers. The opposite girder was fixed from movement by a weld along the bottom flange. Displacement was measured for the free girder. Displacements were also measured between stringer flanges directly under FRP deck joints.

The load application and displacement measurements for the ZellComp bolt pull test are shown in Fig. 10(c). The load was applied to two bolts with a steel bracket. The FRP face through which the bolts were attached was restrained from movement with steel angles. Displacements were measured at the four corners of the steel bracket and averaged.

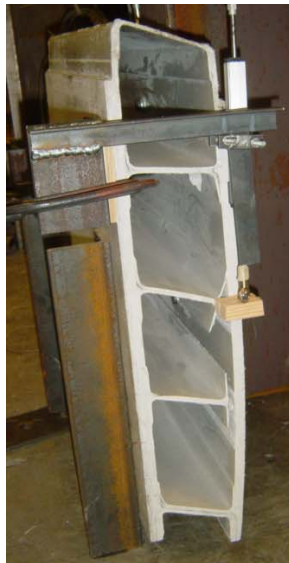
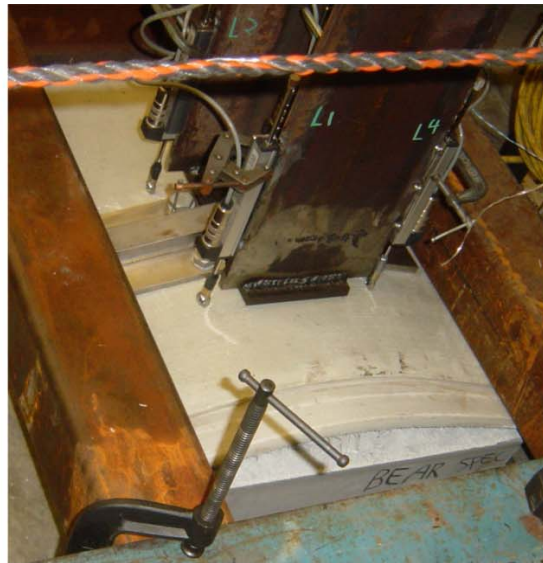
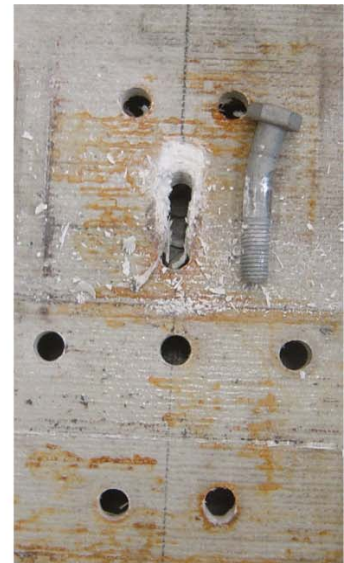
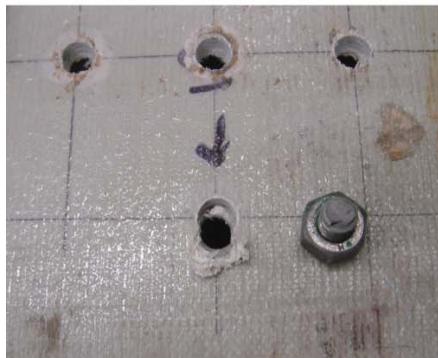
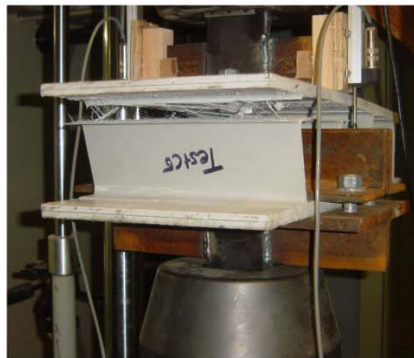
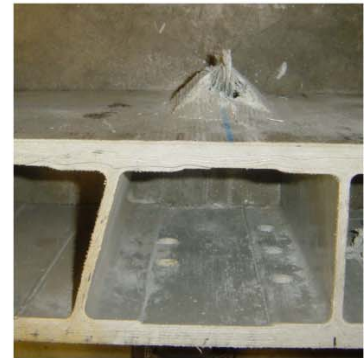
Fig. 13: Martin Marietta failure modes

The load deflection curves, failure loads, and failure modes for the Martin Marietta tests are shown in Fig. 12, Table 2, and Fig. 13 respectively. The results of the deck-to-stringer test performed on the Martin Marietta FRP deck are shown in Fig. 12(a). The load was divided by four and presented on a per bolt basis for easy comparison with the other connection tests. Failure started at a load of 18.9 kN (4.25 kip) per bolt where the load deflection curve starts to become nonlinear. The ultimate load took place at 23.7 kN (5.3 kip) per bolt. The failure modes, as shown in Fig. 13(a), were delamination of webs and web bending.

The bolt shear perpendicular to the FRP fibers test results are shown in Fig. 12(b). The major failure was FRP bearing. Also, the bolt was noticed to deform plastically. The damaged FRP and bolt are shown in Fig. 13(c). The ultimate load took place at 77.4 kN (17.4 kip) per bolt. Although both the parallel and perpendicular tests had similar ultimate loads, the parallel test failure was bolt sensitive, while the perpendicular failure was FRP sensitive.

For the Martin Marietta bolt tension test, the major failure, which is shown in Fig. 13(e), was delamination of the 305 mm (12 in) long web from the FRP flange. The original intent of the test focused on pulling two bolts out of the deck. However, delamination of webs and top sheet occurred first. The longer length of a full size deck would give the web to top sheet connection more capacity. So the ultimate load of 11.6 kN (2.6 kip) per bolt serves as a lower bound for pulling bolts out of the deck.

The bolt pull test results are shown in Fig. 12(c). The major failure was bolts pulling through the FRP. The initial failure, however, resulted from bending and delamination of the FRP and is shown in Fig. 13(f). The longer length of a full size deck would increase the capacity and could negate the initial failure. The ultimate load of 27.1 kN (6.1 kip) per bolt occurred as the bolts pulled through the deck.

(a) Deck-to-stringer

(b) Clamp

(c) Bolt shear perpendicular

(d) Bolt shear parallel

(e) Bolt tension

(f) Bolt pull

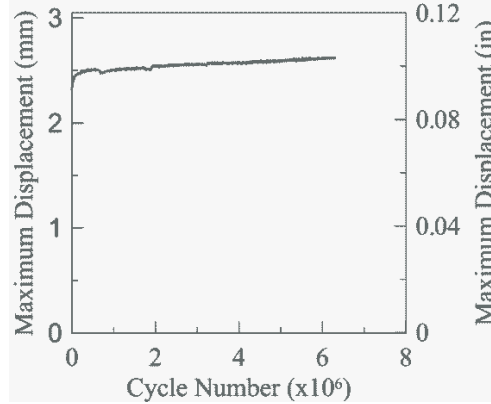
Fig. 14: Martin Marietta fatigue test

The maximum displacement for each cycle of the Martin Marietta fatigue test is shown in Fig. 14. The average maximum displacements of the first and last ten minutes were 2.33 mm (0.092 in) and 2.62 mm (0.103 in) respectively. From these two averages, the degradation was measured at 13%. No visible damage to deck, overlay, or deck-to-stringer connection was noticed.

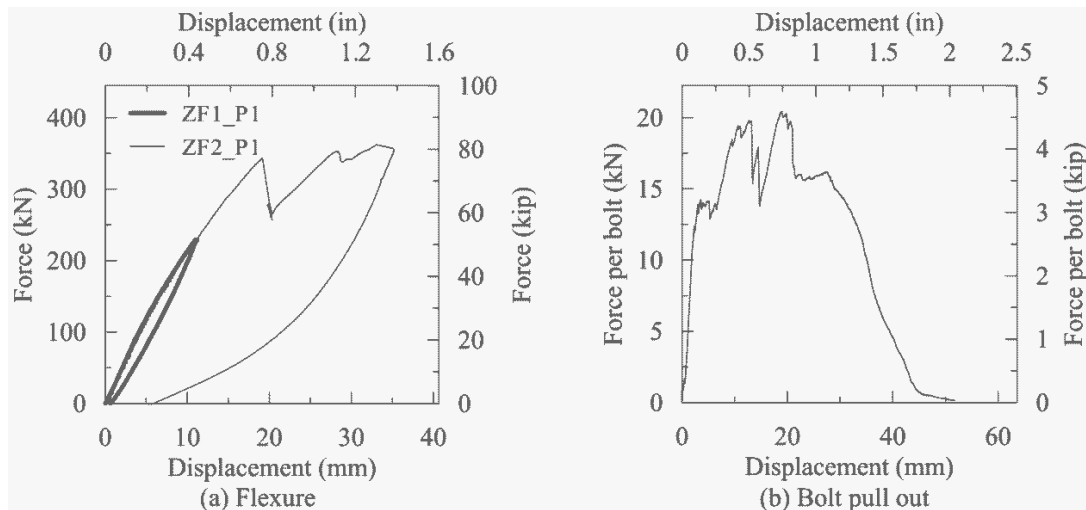
Fig. 15: ZellComp load deflection curves

The ZellComp load deflection curves, failure loads, and failure modes are shown in Fig. 15, Table 3, and Fig. 16 respectively. The results for the ZellComp flexure tests are shown in Fig. 15(a). The first test, Z_F1_P1, was performed on unfatigued side panels, but reached the capacity of the actuator before significant failure occurred. The test was performed a second time (Z_F2_P1) on the center fatigued panel, and failed the deck initially at 343 kN (77.1 kip). The failure occurred under the joint of the attached top sheet, and appeared to be a web shear failure.

The results of the bolt pull test performed on the ZellComp deck are shown in Fig. 15(b). The major failure resulted from shear flow and delamination of the FRP and started at a load of 13.3 kN (3 kip) per bolt. The test ended as the bolts pulled through the FRP. An ultimate load of 20.5 kN (4.6 kip) per bolt occurred. The longer length of a full size deck would increase the capacity and could negate the initial shear flow failure.

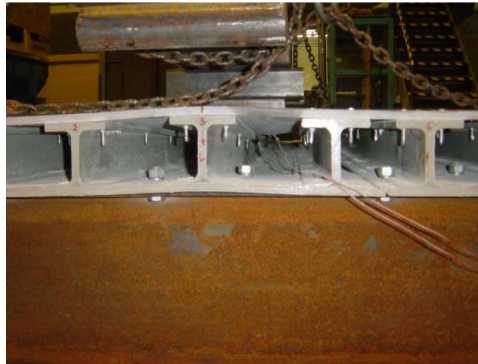
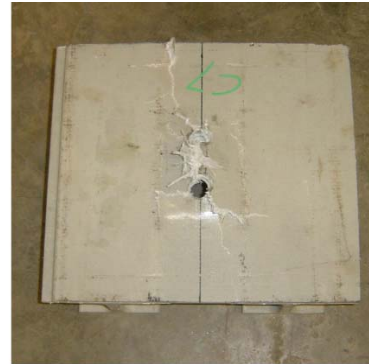
Fig. 16: ZellComp failure modes

(a) Web shear

(b) Bolt pull

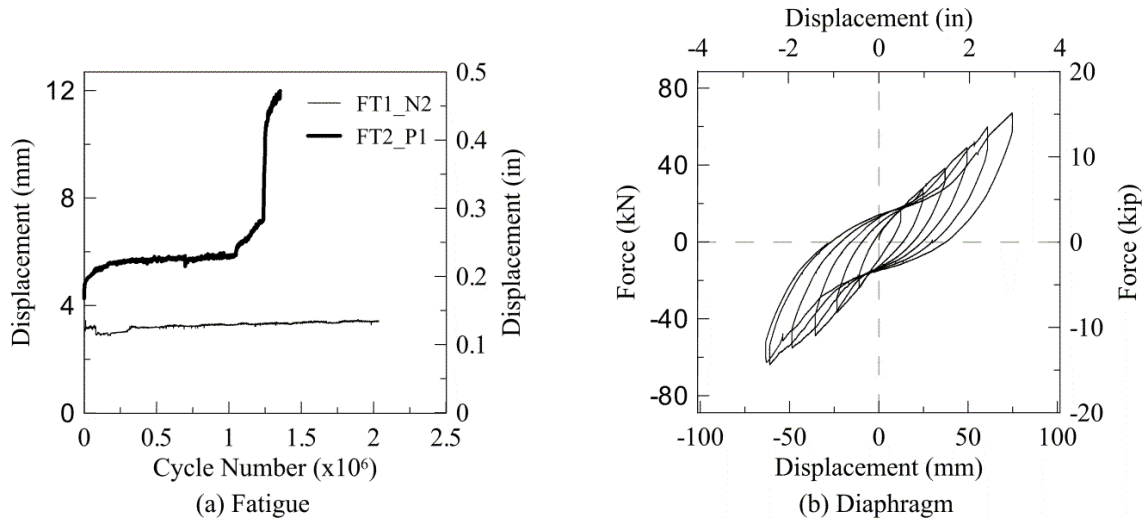
Fig. 20: Modified ZellComp fatigue and diaphragm tests

Two fatigue tests were performed. The maximum displacement for each cycle of loading is shown in Fig. 20(a). The fatigue test with the loading patch in the N2 orientation successfully completed all two million cycles. Some cracking appeared in the overlay along the lap joint of the decks. By feeling with the hand, the length of the crack extended along the joint for 254 mm (10 in) to 381 mm (15 in). The largest visible crack measured 50.8 mm (2 in) long. Several smaller visible cracks measured 3.2 mm (0.125 in) to 6.4 mm (0.25 in). Upon completion of the first fatigue test, the observation was made that a bolt, which connected the deck to the stringer, had broken. By examining the test photographs, the cycle of the bolt failure was estimated to be within the last one hundred thousand cycles. The beginning and ending cycle displacement, estimated from the first and last ten minutes of testing, were 3.02 mm (0.119 in) and 3.40 mm (0.134 in) respectively. The total degradation of the deck was, therefore, measured at 0.38 mm (0.015 in) or 13% of the initial displacement. The HITEC evaluation procedure recommends a maximum deflection increase of 10% for fatigue testing (Reynaud and Karbhari 2001).

The load deflection for the cyclic diaphragm test is shown in Fig. 20(b). The displacement shown is the displacement of the free girder and the load is the load applied to the free girder. Five and one half cycles were completed before the test was ended. A subsequent test without the deck showed that the stringer and girder steel frame resisted less than 2.7 kN (0.6 kip) showing that the great majority of the load was carried by the deck. Starting at ± 12.7 mm (0.5 in), each cycle added 12.7 mm (0.5 in) until the last cycle accomplished ± 63.5 mm (2.5 in). An additional half cycle was completed before the steel frame failed.

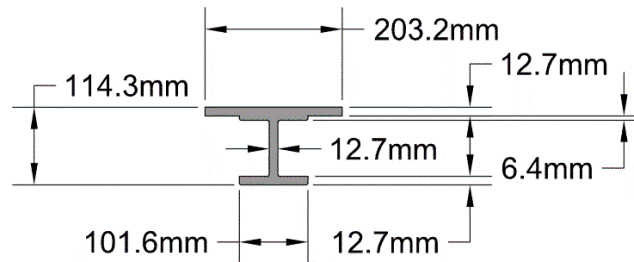
Fig. 22: Modified ZellComp I-beam cross section

With better understanding of the load distributions to a single I-beam within a panel, calculating failure stresses for the flexure specimens became possible. The quantities of interest were bending stress, given the flexural nature of the test setup, and shear flow, due to the subsequent observed failure mode. Initially the load was considered a point load; however, given the relative length, 508 mm (20 in), of the loading patch compared to the spacing between stringers of 1,181 mm (46.5 in), additional calculations were made taking the distributed load into account. The single I-beam cross section dimensions are presented in Fig. 22.

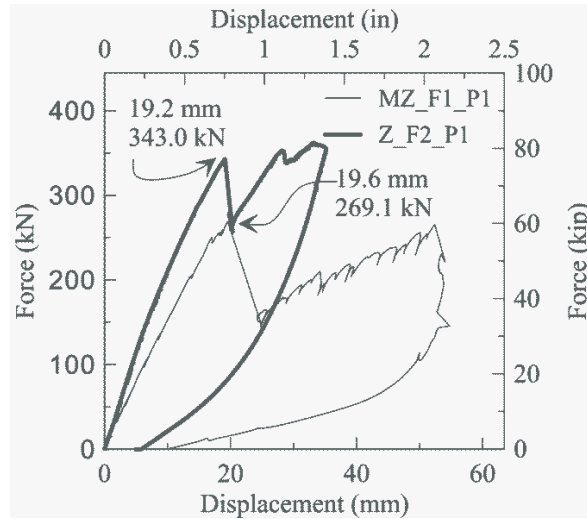
Fig. 23: ZellComp and modified ZellComp flexure comparison

Now that flexure load distribution and failure stresses for the modified ZellComp have been quantified, a comparison between the flexure strengths of the modified ZellComp and ZellComp FRP decks was undertaken. Direct comparisons between tests was more difficult when comparing the flexure tests of the ZellComp and modified ZellComp decks due to the change in the test setup made to accommodate the available FRP sections. The ZellComp tests used a double span fatigued specimen while the modified ZellComp test used a single span unfatigued specimen. Nonetheless, the flexure tests MZ_F1_P1 and Z_F2_P1 were performed on the modified ZellComp and ZellComp decks with similar load orientation and placement. The two test graphs are shown in Fig. 23. The ZellComp had a failure strength that was 27% higher than the modified ZellComp, and the failure mode changed from a shear flow failure in the modified ZellComp test to a web shear failure in the ZellComp test.

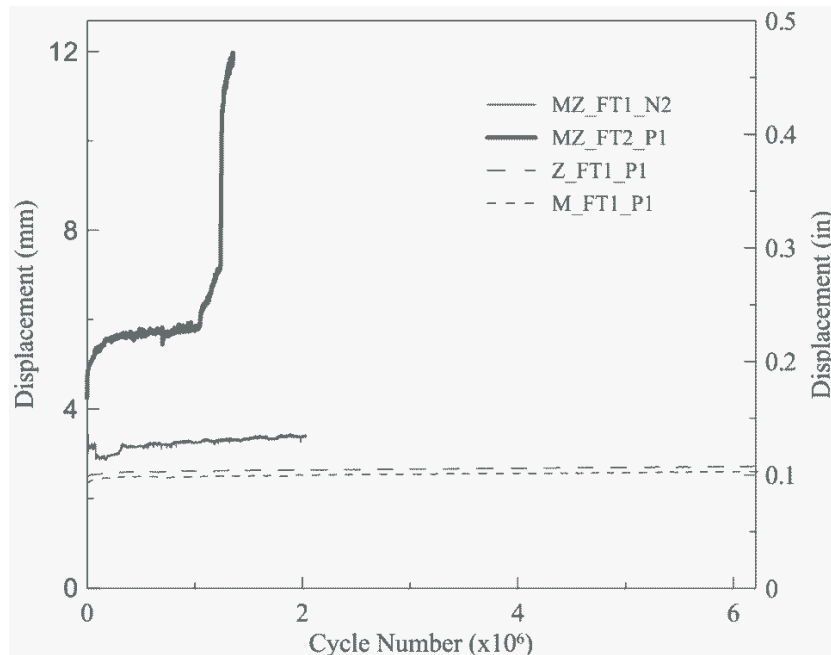
Fig. 24: Fatigue comparison

Four fatigue tests were completed – one with Martin Marietta, one with ZellComp, and two with modified ZellComp decks. The Martin Marietta and ZellComp tests used the AASHTO fatigue testing procedure and the modified ZellComp used the HITEC fatigue evaluation approach. Of the four tests, three completed the full amount of cycles while one of the modified ZellComp tests failed at 1.4 million cycles. The maximum deflection per cycle is shown for all four tests in Fig. 24. Fatigue displacement degradation measured between 9% and 13% for the three completed fatigue tests. Based on the two modified ZellComp fatigue tests, broken bolts were found to be a common sign that the deck to stringer system is susceptible to fatigue degradation and possible deck failure could follow.

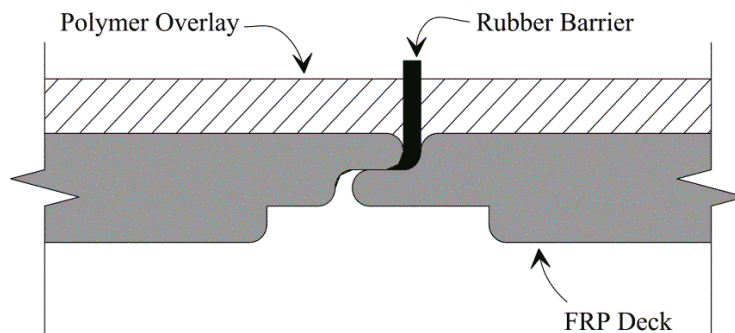
Fig. 25: Modified ZellComp joint overlay cracking solution

The cracking problem was a result of stiffness change across the deck lap joint. Based on this experience, cracking problems would be expected if the overlay was used over a transition from FRP to stiffer material. This cracking would need to be addressed since freeze-thaw cycles could cause the crack to grow and eventually pry the overlay off the deck. A possible solution would be to place a flexible material, like rubber, in the joint during installation and force a break in the overlay. This solution would allow each side of the joint to act independently and prohibit significant amounts of water from getting into the joint. A sketch of this option is shown in Fig. 25, but was not physically tested.

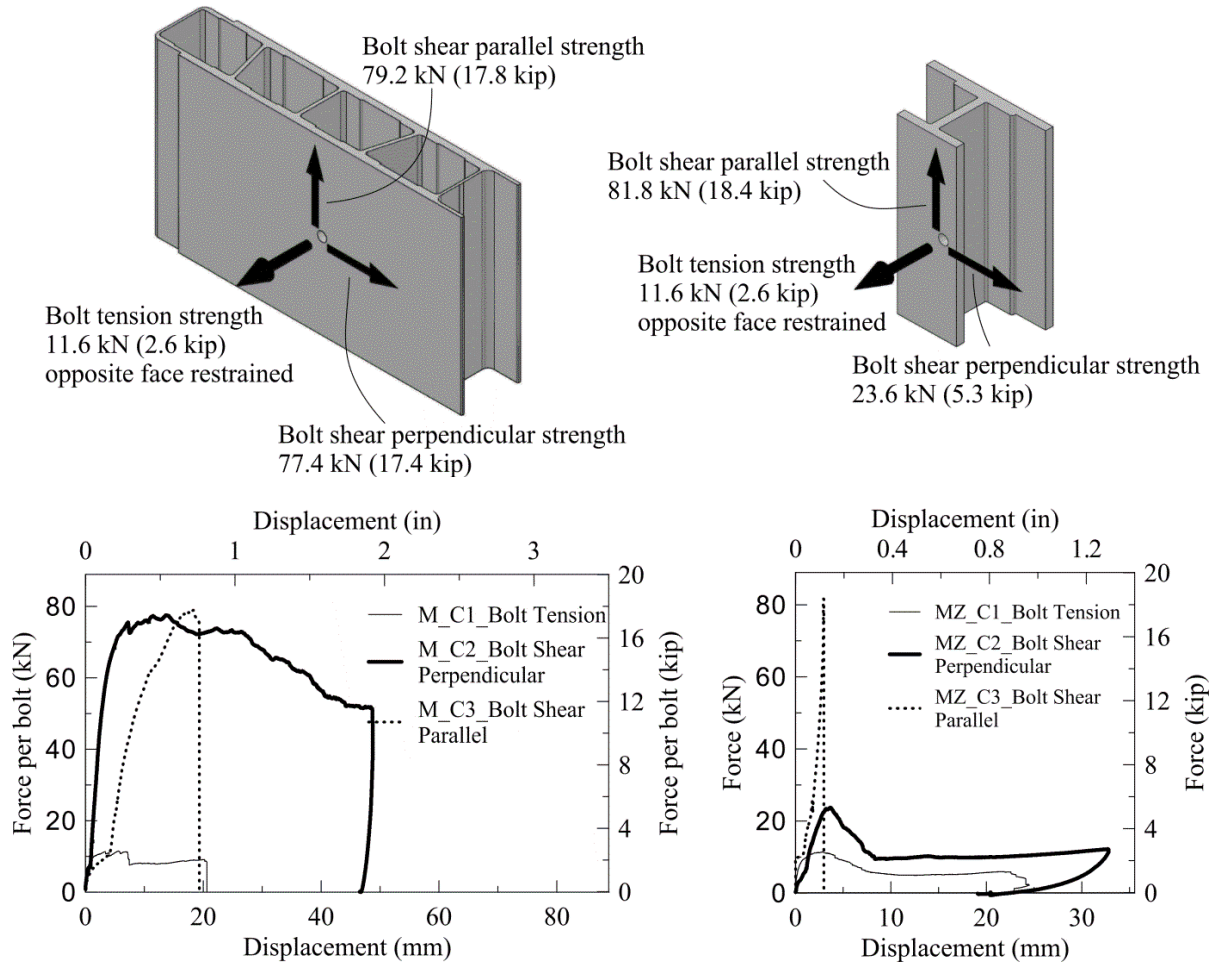
Fig. 26: Martin Marietta and modified ZellComp connection strength comparison

Of the six tests, three reached bolt loads of 75.6 kN (17 kip) or greater. One of these high bolt load tests failed a bolt while the rest failed the FRP. The nominal bolt shear strengths were 65.4 kN (14.7 kip). The reason that the bolts were able to take loads greater than the nominal bolt strength was that as the large deformations resulting from the test began to rotate the bolt, the bolt loads were no longer in pure shear. From the results of these tests, the conclusion can be made that the FRP thickness of 12.7 mm (0.5 in) for these decks is sufficient to reach the bolt shear strength of a 15.9 mm (0.625 in) in both fiber directions, provided that there is sufficient edge distance.

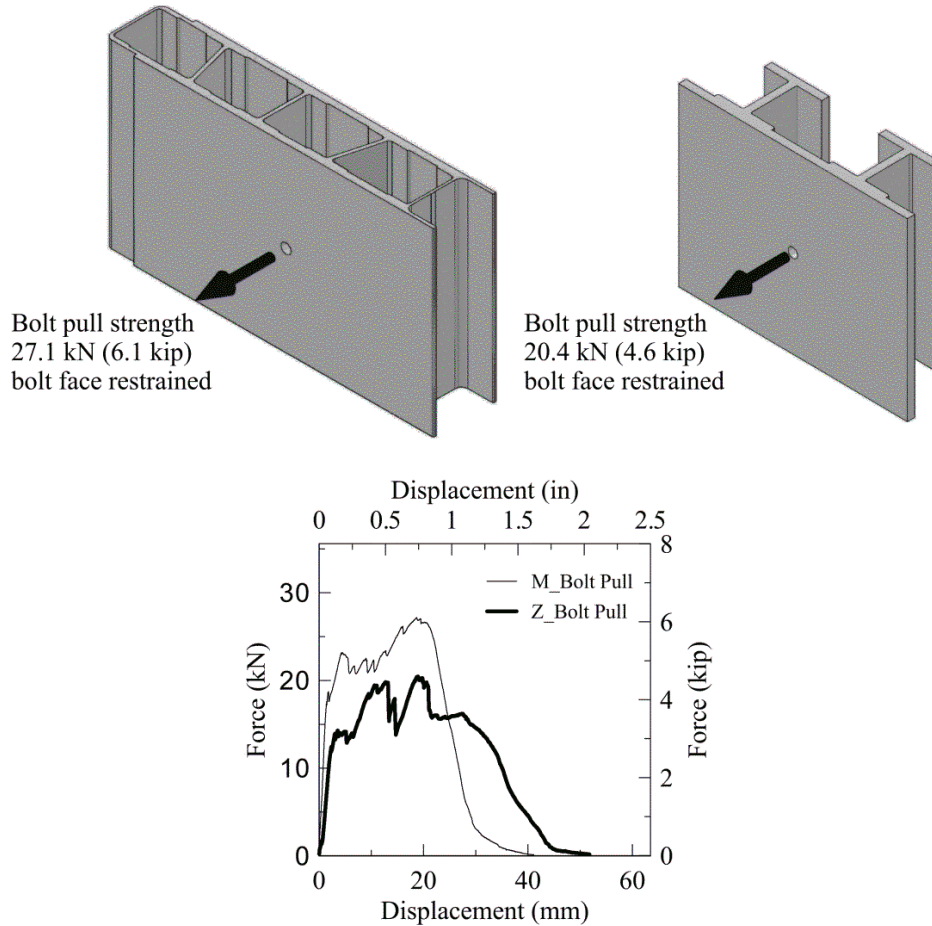
Fig. 27: Martin Marietta and ZellComp bolt pull strength comparison

Regarding the shape of the load deflection curves shown in Fig. 27, the jagged portions of the curves were where progressive delaminations occurred. In the case of the ZellComp, the ultimate strength dropped from 23 kN (5.1 kip) in the bolt tension test to 20 kN (4.6 kip) in the bolt pull test. Again the failure modes were affected by delamination failure as opposed to bolts pulling through the FRP. Longer specimen sizes would increase the failure loads. In the case of the Martin Marietta, the bolt pull test strength increased from 23 kN (5.1 kip) to 27 kN (6.1 kip). Although delamination played a significant role in the failure mode, the bolts pulling through the FRP was the final and most significant failure. Consequently, the 27 kN (6.1 kip) bolt pull strength was a good gauge of the bolt pull strength for the 13 mm (0.5 in) thick FRP.

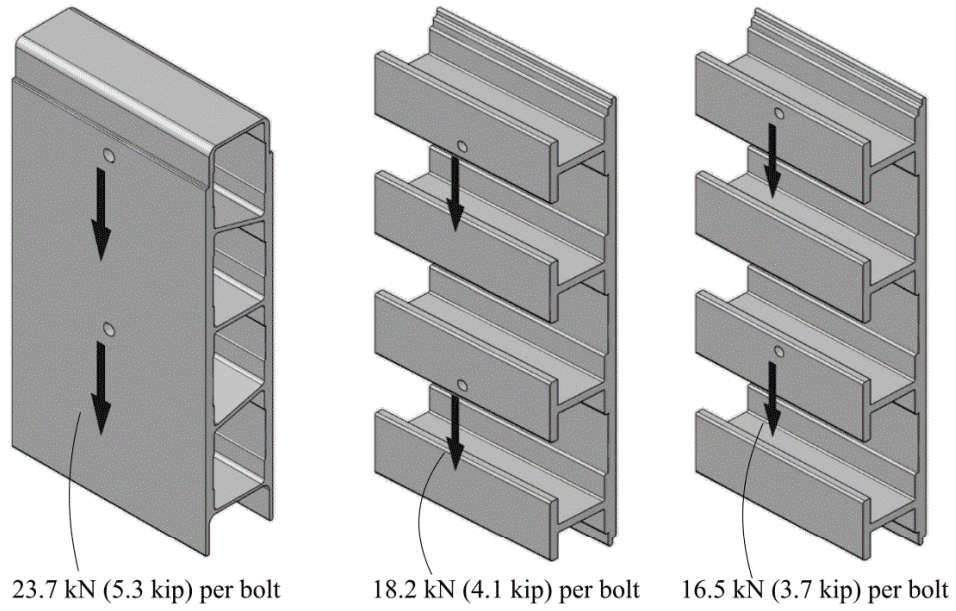
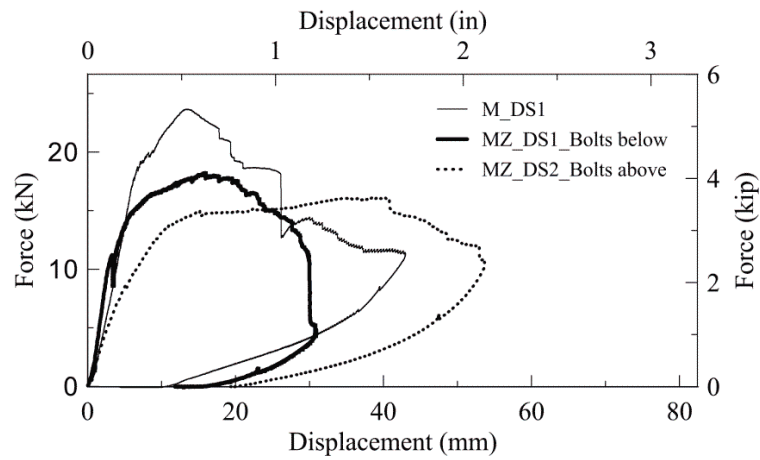
Fig. 28: Martin Marietta and modified ZellComp deck-to-stringer strength comparison

After the ultimate load for the modified ZellComp was estimated, a comparison of the Martin Marietta and modified ZellComp deck-to-stringer strengths was undertaken. The Martin Marietta had an ultimate load of 23.7 kN (5.3 kip) per bolt or 47.4 kN (10.6 kip) per panel. The modified ZellComp was estimated to have an ultimate strength of 65.8 kN (14.8 kip) per panel. Thus, the ultimate load was increased by 40% from the Martin Marietta to the modified ZellComp. The failures were not bolt related and would not be expected to increase with more bolts. Rather the failures were functions of FRP web bending and delamination of the FRP web from the flange. Given this failure, mode appropriate quantification would be to normalize the total load by the length of the deck. The Martin Marietta test was bending five 762 mm (30 in) long webs with a combined thickness of 25.4 mm (1 in). The modified ZellComp bends four webs of similar length but with a combined web thickness of 50.8 mm (2 in). Thus, stronger modified ZellComp tests was attributed to significantly thicker webs.

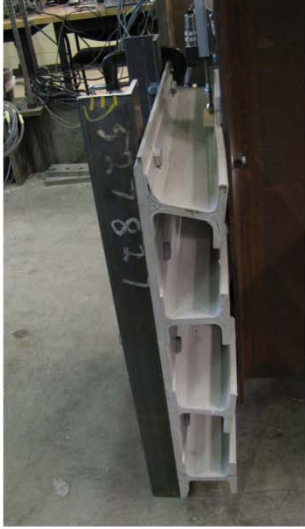
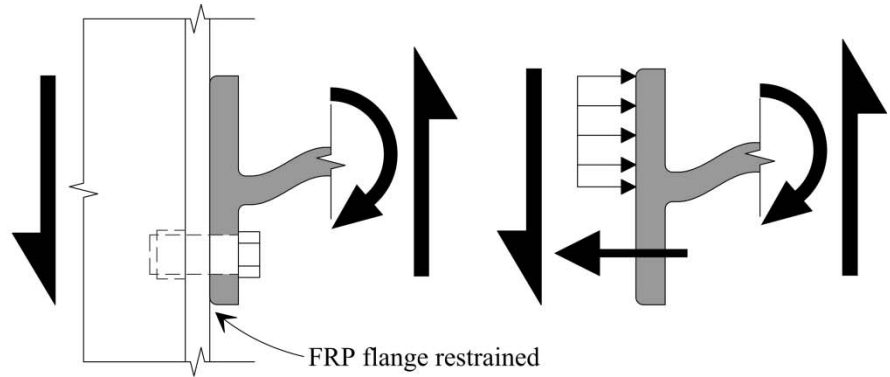
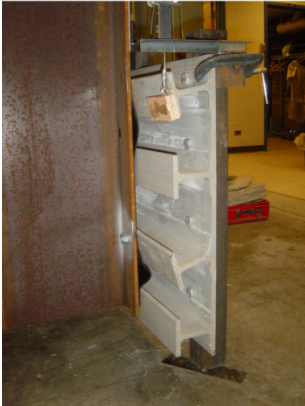
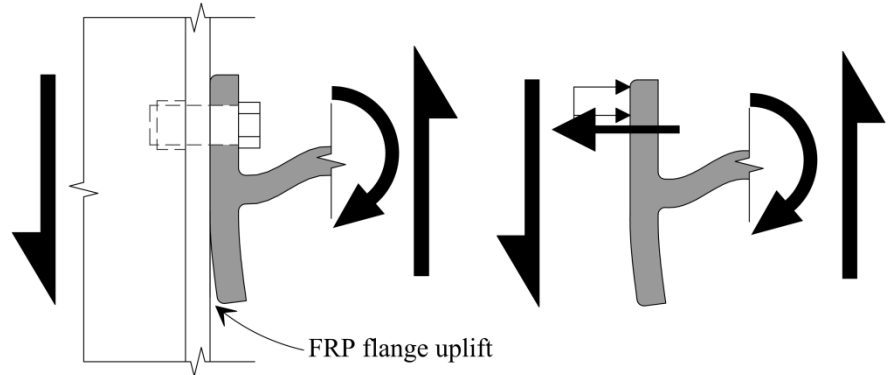
Fig. 29: Modified ZellComp deck-to-stringer discussion

(a) Modified ZellComp deck-to-stringer bolts below web

(a) Modified ZellComp deck-to-stringer bolts above web

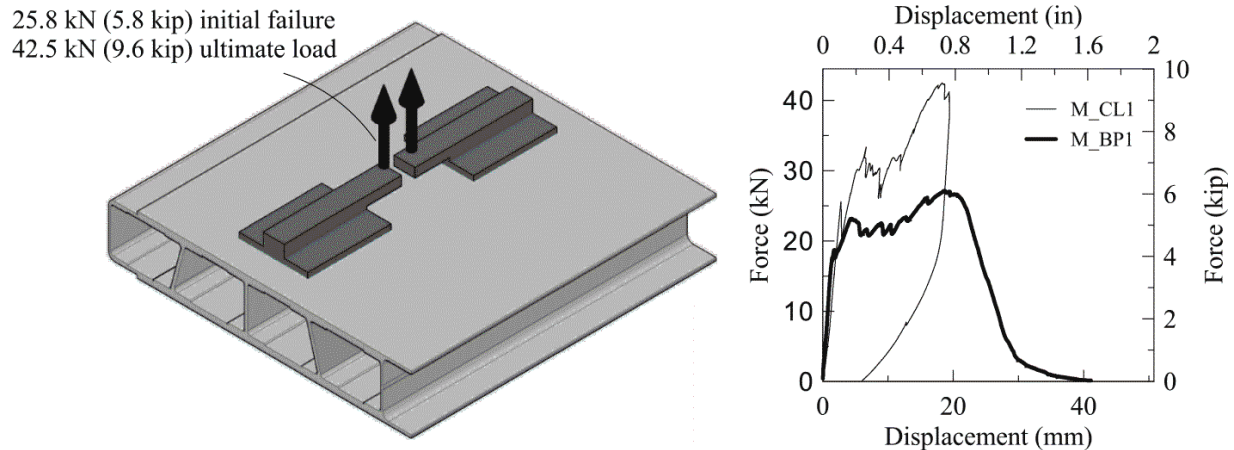
Fig. 30: Martin Marietta clamp strength comparison

One of the problems identified with FRP deck-to-stringer connections over time is uplift of the FRP from the stringer caused by loads between adjacent stringers. Since all decks to date have been closed cell and not accessible to tighten any of the bolts, a proposed solution for this connection problem is the use of a steel clamp. A proposed design by ODOT is shown in Fig. 30. For a gauge of how well the clamp performed, the load deflection graphs for the clamp and the bolt pull tests were compared and are shown in Fig. 30. Both of these tests were performed with the same load application and displacement measurement apparatus. The difference between the tests was that the bolt pull test used bolts to attach the FRP to the stringer while the clamp test used clamps. The initial stiffness similarity was accounted for in the fact that the clamp test had a span that was 83% longer than the bolt pull test. Thus, the clamp stiffens and strengthens the deck-to-stringer connection.

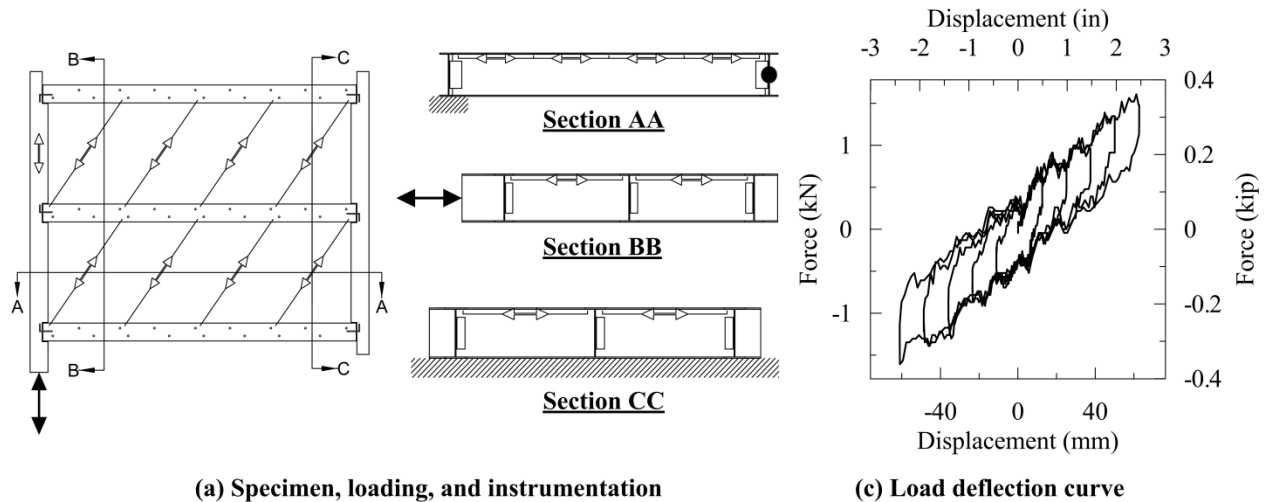
Fig. A1: Diaphragm steel frame

A drawing of the specimen used for the steel frame diaphragm test is shown in Fig. A1(a). The test specimen was assembled in a similar manner as those discussed for the modified ZellComp deck diaphragm specimen in section 3.2. One girder was fixed from movement via a weld. The other girder was free to move in the plane of the deck but was restrained from out of plane motion through wheels. Fig. A1(a) shows the loading and instrumentation of the test. The load was applied at the free girder end, and the displacement was measured from the ground to the free girder. Fig. A1(b) shows the displacement of each cycle for the diaphragm test. The maximum displacement was measured to be 63.5 mm (2.5 in) at a load of 1.6 kN (0.35 kip).

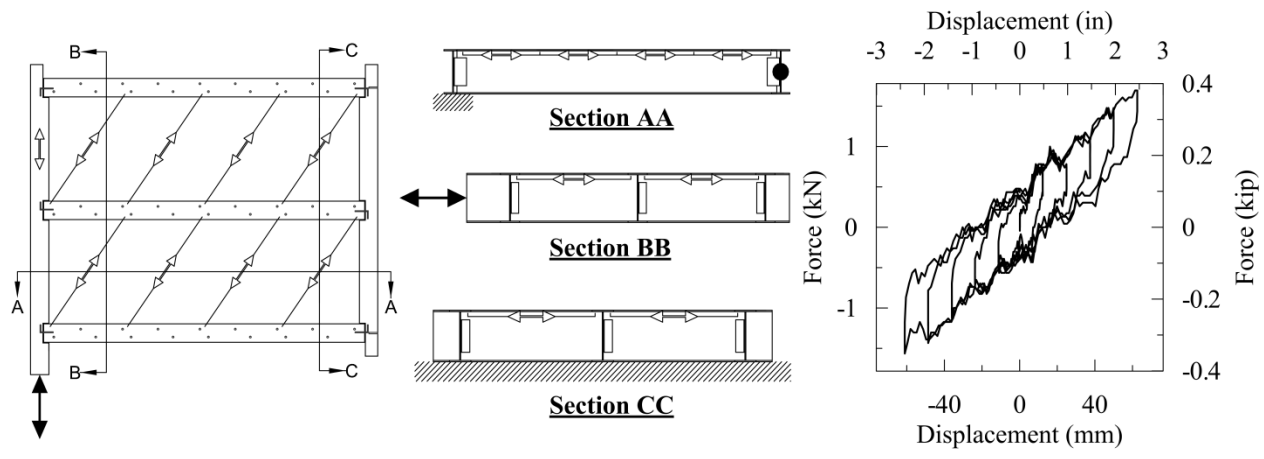
Fig. A2: Modified diaphragm steel frame

A drawing of the specimen used for the steel frame diaphragm test is shown in Fig. A2(a). The test specimen was assembled in a similar manner as those discussed for the modified ZellComp deck diaphragm specimen in section 3.2. One girder was fixed from movement via a weld. The other girder was free to move in the plane of the deck but was restrained from out of plane motion through wheels. Two stiffeners were added and a weld fixed after the modified ZellComp diaphragm test. Fig. A2(a) shows the loading and instrumentation of the test. The load was applied at the free girder end, and the displacement was measured from the ground to the free girder. Fig. A2(b) shows the displacement of each cycle for the diaphragm test. The maximum displacement was measured to be 63.5 mm (2.5 in) at a load of 1.7 kN (0.375 kip).
