Nielsen, A. H., & Vollertsen, J. (2016). *In-situ test methods for assessment of surface pH of corroding sewer pipes*. Poster presented at Microorganisms-Cementitious Materials Interactions, Delft, Netherlands.

IN-SITU TEST METHODS FOR ASSESSMENT OF SURFACE pH OF CORRODING SEWER PIPES

A.H. Nielsen & J. Vollertsen
Department of Civil Engineering,
Aalborg University,
Sofiendalsvej 9-11, DK-9200 Aalborg SV, Denmark

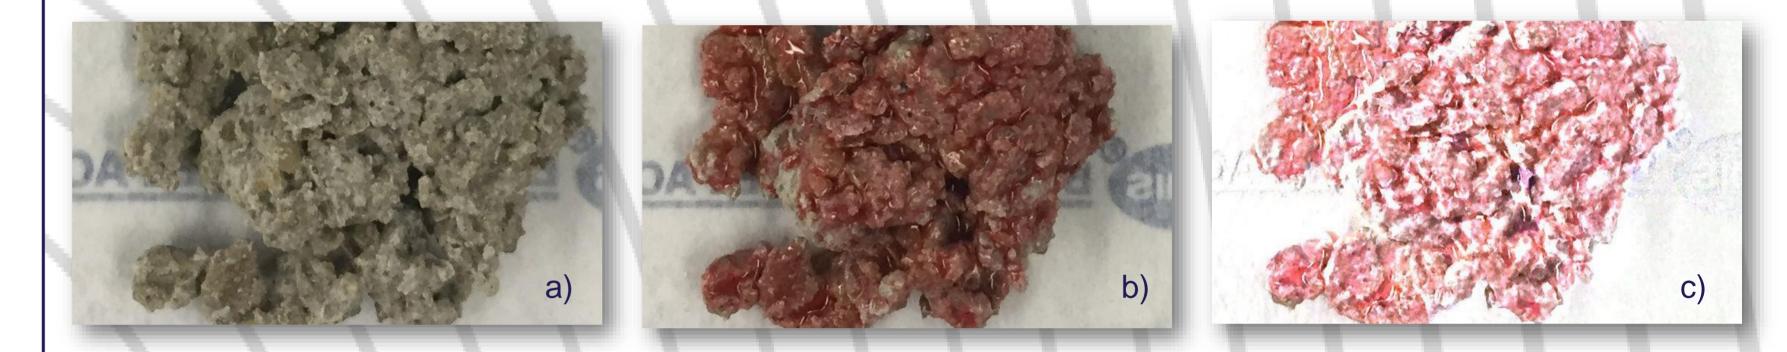
Figure 3. Images of corroding concrete before (a) and after (b) application of the pH indicator. Colour enhancement by "divide filtering"; i.e., dividing the intensity of each color channel (R,G,B) in every pixels (c).

The (corroding) concrete can attain different colours according to the state of corrosion, composition of the cement and type of aggregate material used, etc. This can complicate the assessment of the surface pH. It was therefore attempted to enhance the colour by digital image processing techniques. For this purpose, a set images were taken before and after application of the pH indicator. Subsequently, the two images were merged using different filter algorithms (Fig. 3).

As evident from Figure 3, it is possible to enhance the colour by digital filtering. Preliminary testing has indicated that the method gives best results on a greyscale background (before image).
