Climatic Reliability of Electronics:

Early Prediction and Control of Contamination and humidity effects

PhD Thesis

Section of Materials and Surface Engineering
Department of Mechanical Engineering
Technical University of Denmark (DTU)
DK-2800, Kgs. Lyngby

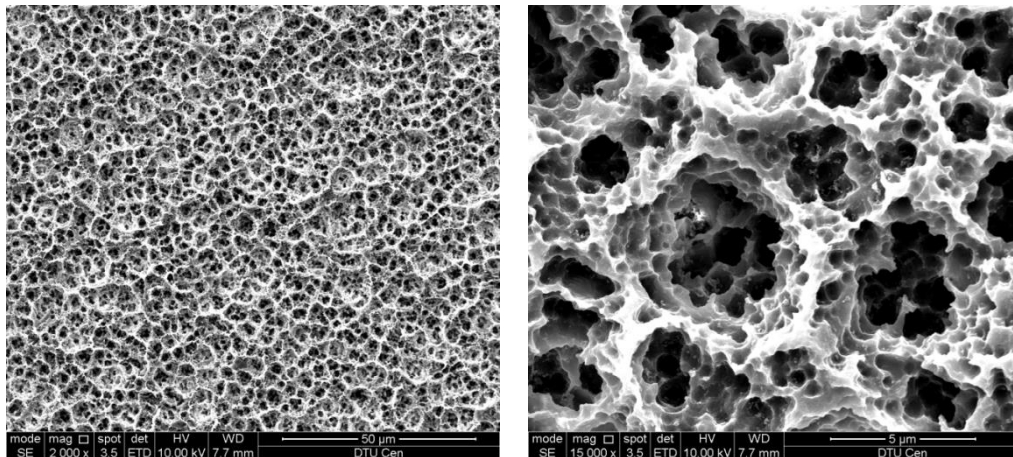
Figure 2.2: Surface morphology of a FR-4 laminate

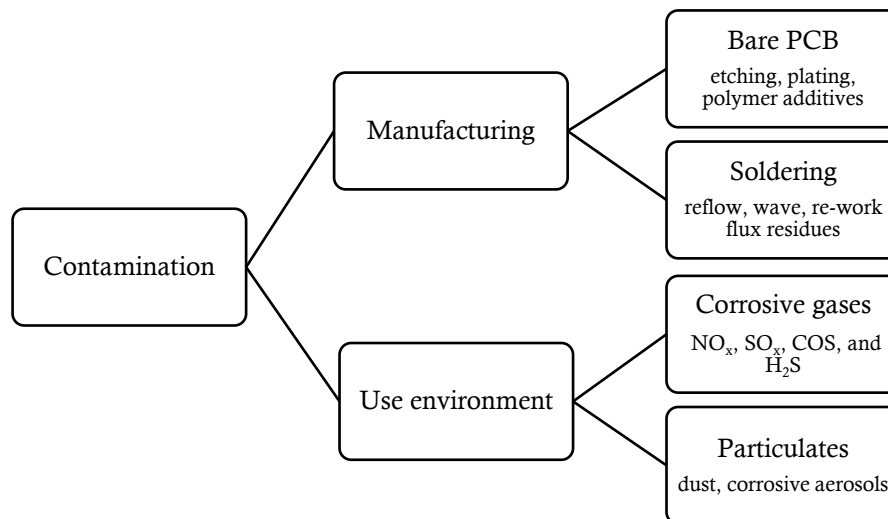
Figure 2.4: A generalised view of contamination on PCBA arising from manufacturing process and service life

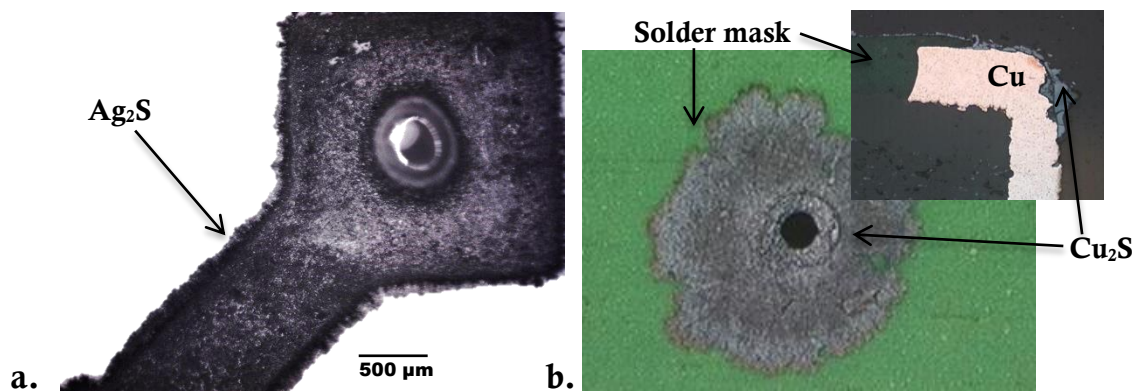
Figure 3.3 Examples of creep corrosion: a. Ag corrosion in H_2S environment, b. Cu corrosion (OSP surface finish) [122]

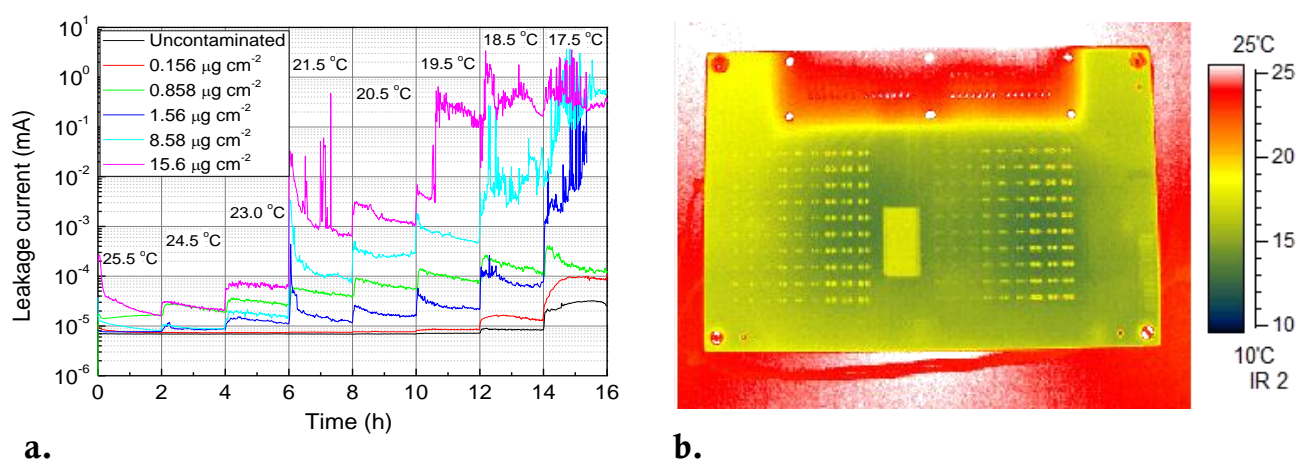
Figure 7.1: a. Leakage current as a function of NaCl contamination and temperature of the PCBA (ambient is kept at 25 °C and 60 %RH), and b. Infrared image of PCBA cooled from ambient of 25 °C

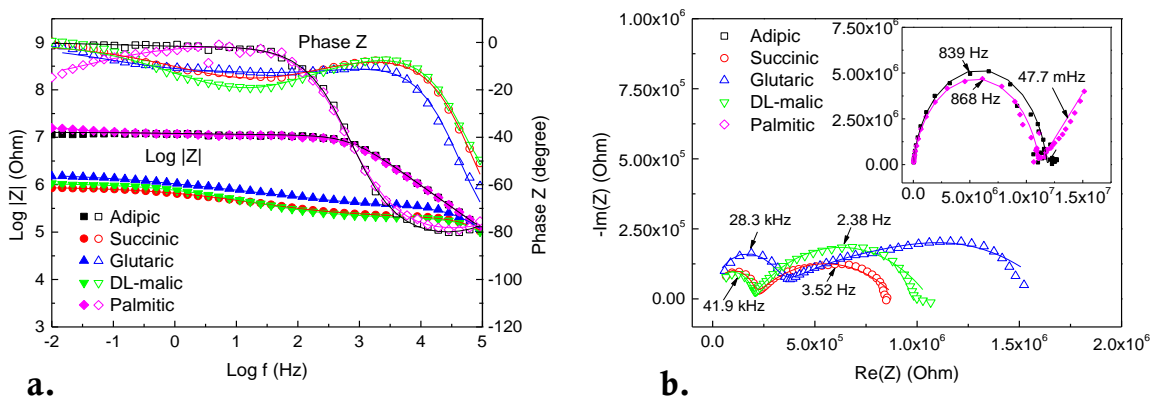
Figure 7.2: Impedance data for test PCB contaminated with $100 \mu\text{g}\cdot\text{cm}^{-2}$ of WOAs at $\sim 99\%$ RH/25 °C: a. Bode plots and b. Nyquist plots

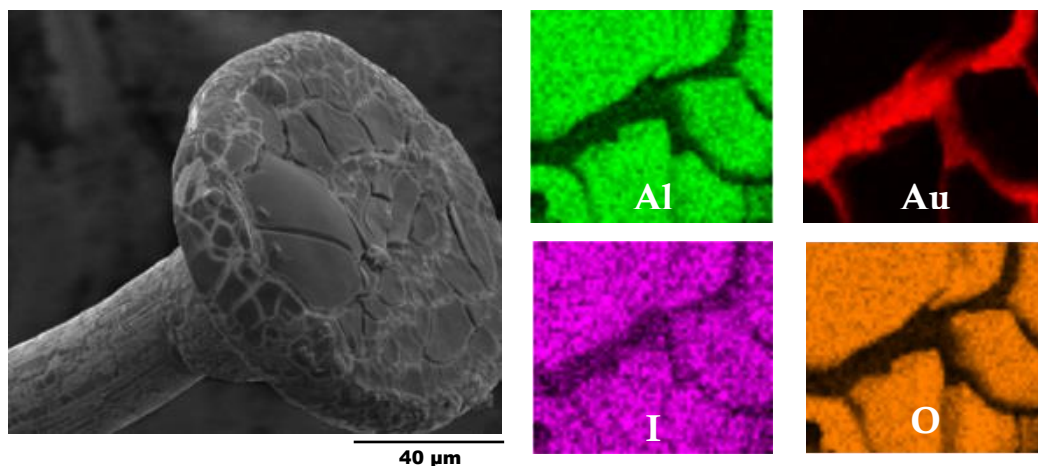
Figure 7.7: SEM EDS mapping of the wire bond after ball lift off (after 24 h exposure to $1 \text{ mg}\cdot\text{L}^{-1}$ of iodine at $85^\circ\text{C}/85\%\text{RH}$)

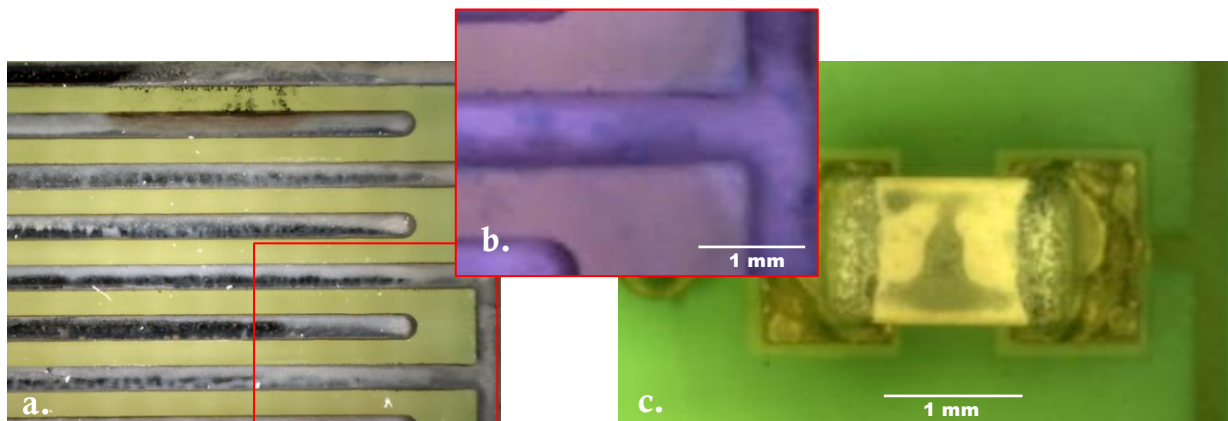
Figure 7.8: Corrosion of tin revealed by tin ion indicator: a. Initial appearance of corroded SIR pattern contaminated with DL-malic acid, b. Corrosion nearby electrodes revealed by tin ion indicator, and c. Corrosion of surface mount capacitor contaminated succinic acid and exposed to humid conditions

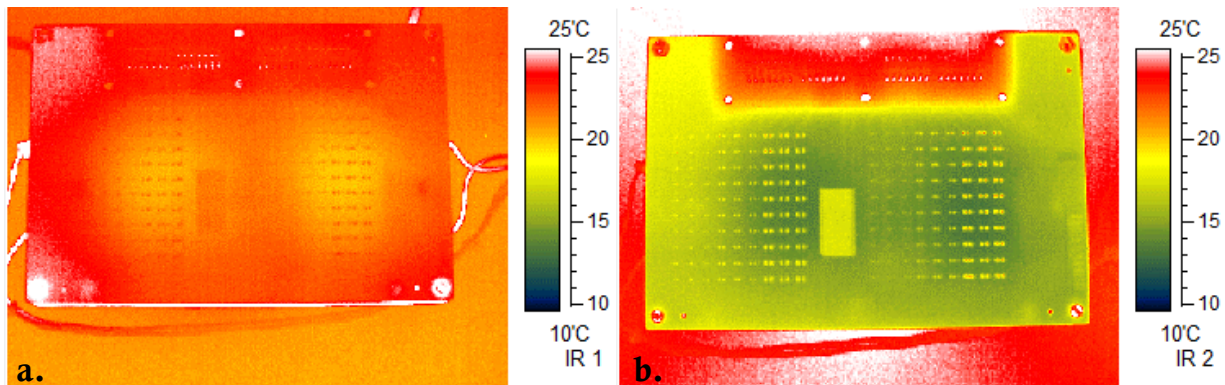
Figure 8.3: Cooling effect on aluminium block with embedded Peltier elements: a. PCBA on aluminium block without cooling and b. 3 V DC is applied on Peltier elements reducing temperature of PCBA to approximately 17 °C

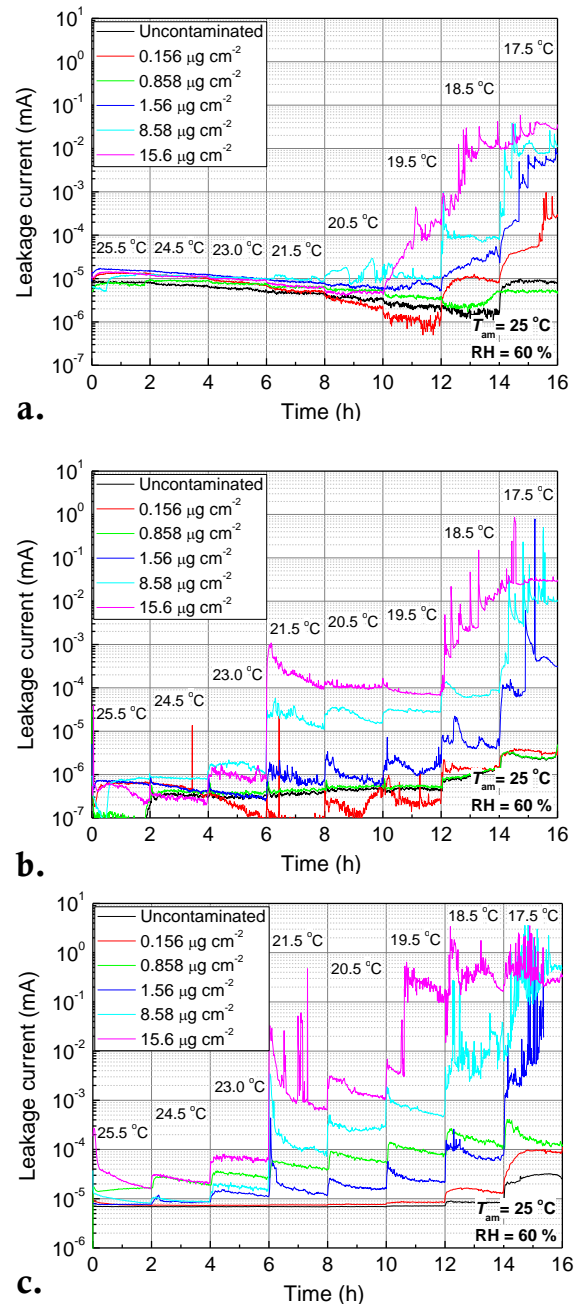
Figure 8.8: Effect of contamination and temperature difference on LC measured on test PCBA components biased at 5 V DC: a. size 0805 $1\text{M}\Omega$ resistors, b. size 0805 $100\ \text{nF}$ capacitors, and c. open SIR comb pattern

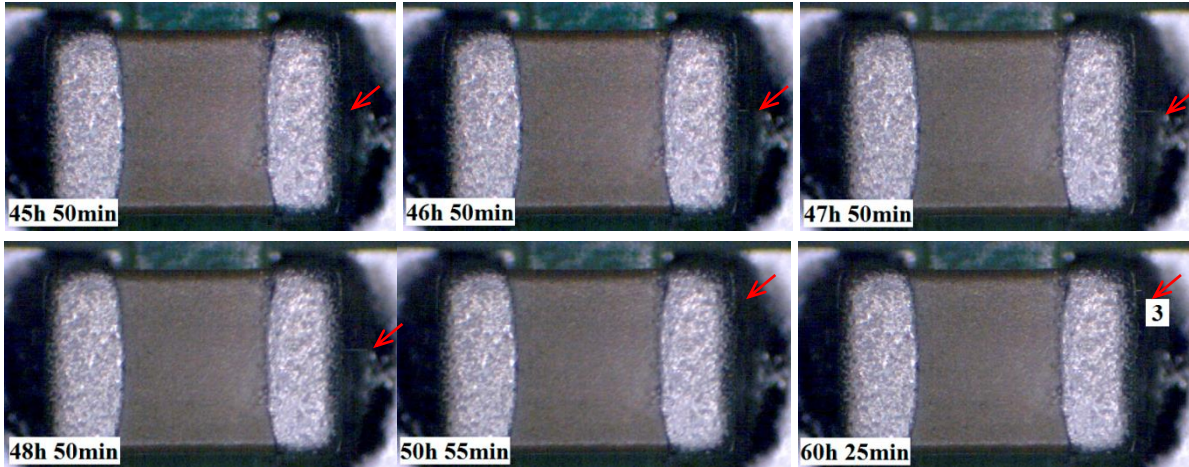
Figure 8.12: Tin whisker growth observed on the capacitor precontaminated with $15.6 \mu\text{g}\cdot\text{cm}^{-2}$ of NaCl

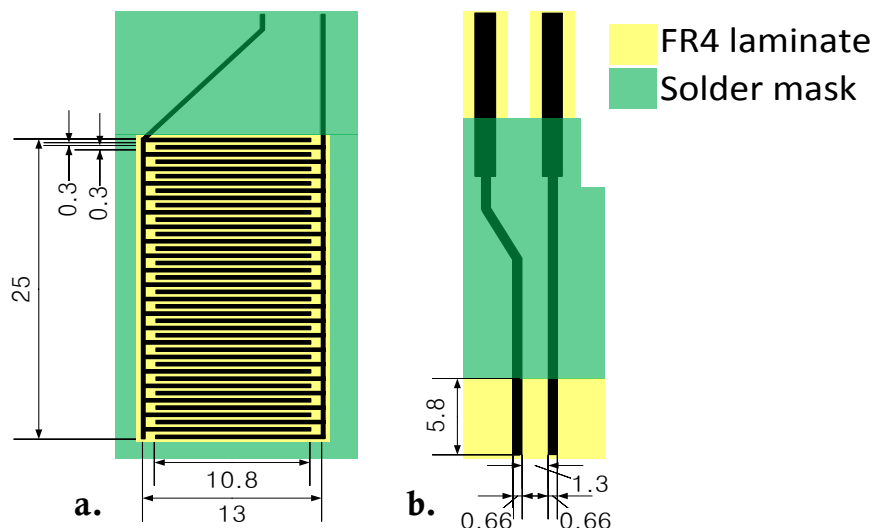
Figure 9.1: Test boards: a. SIR pattern and b. PCB with two electrodes used for impedance spectroscopy. The dimensions provided in the drawing are in millimetres (mm).

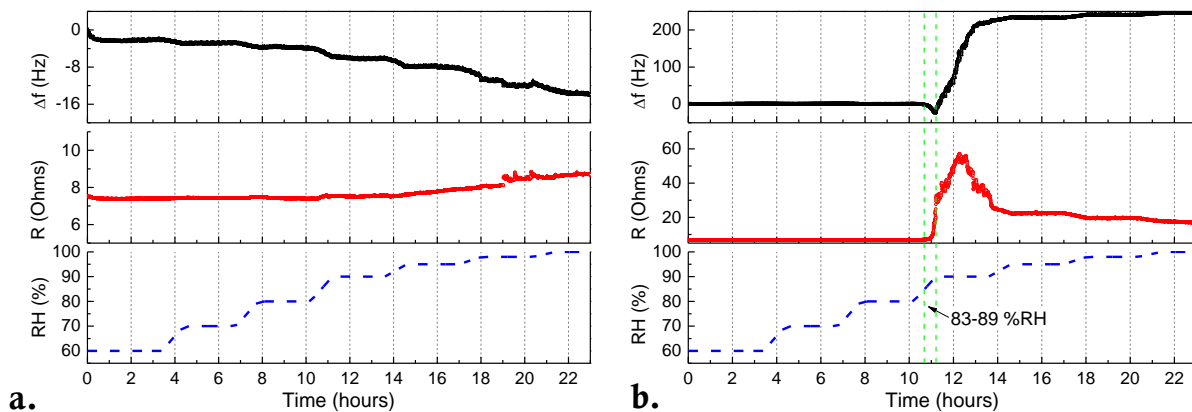
Figure 9.2: Representative graphs from QCM measurement: a. adipic and b. glutaric acids

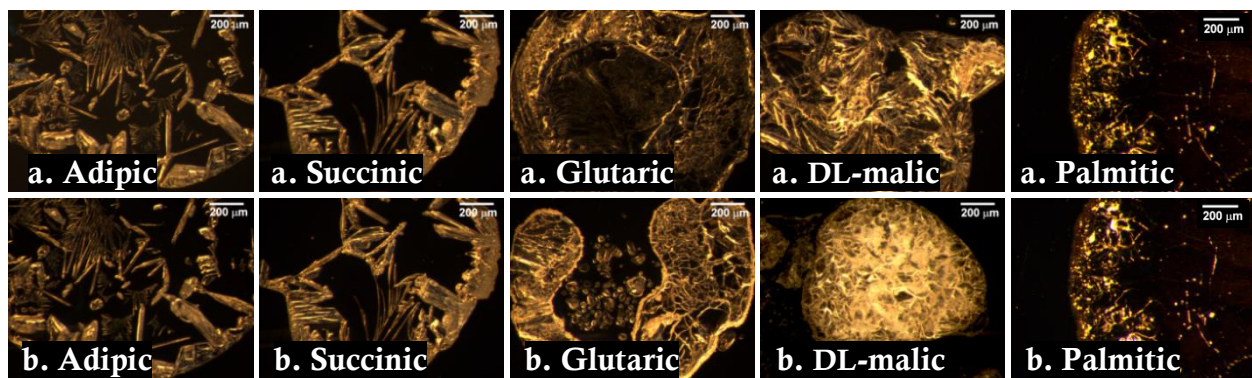
Figure 9.3: Appearance of WOA on a quartz crystal: a. before and b. after the exposure to 98 %RH at 25 °C

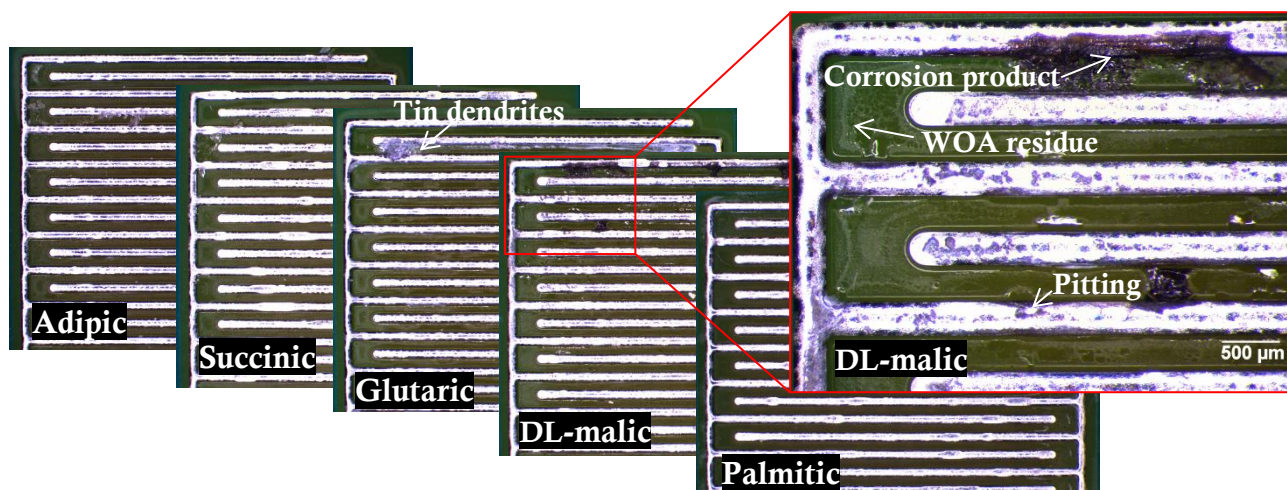
Figure 9.5: Overview of corroded SIR patterns showing important features (representative of leakage current measurements in Figure 9.4 a).

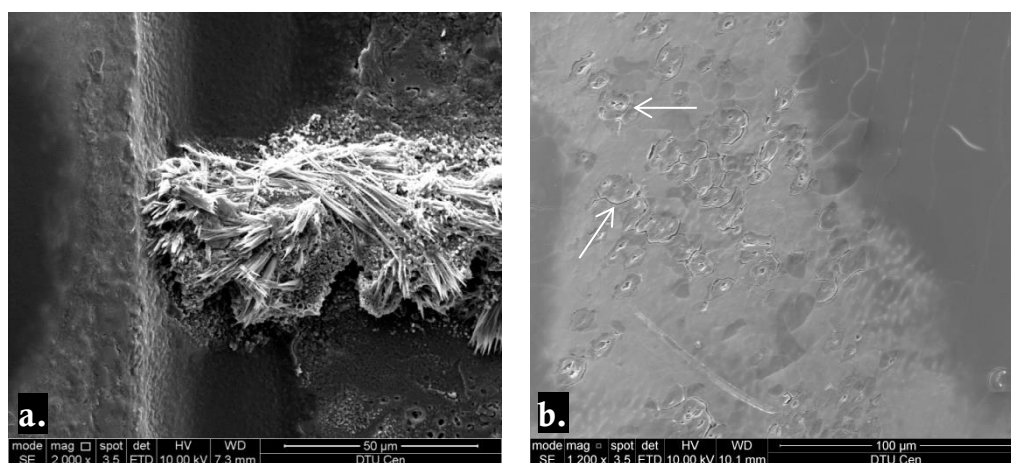
Figure 9.6: SEM images of corrosion features: a. bridging of anode and cathode electrodes of SIR pattern by dendrite formation due to electrochemical migration, and b. corrosion of anode electrode indicating pitting (related locations are indicated in Figure 9.5)

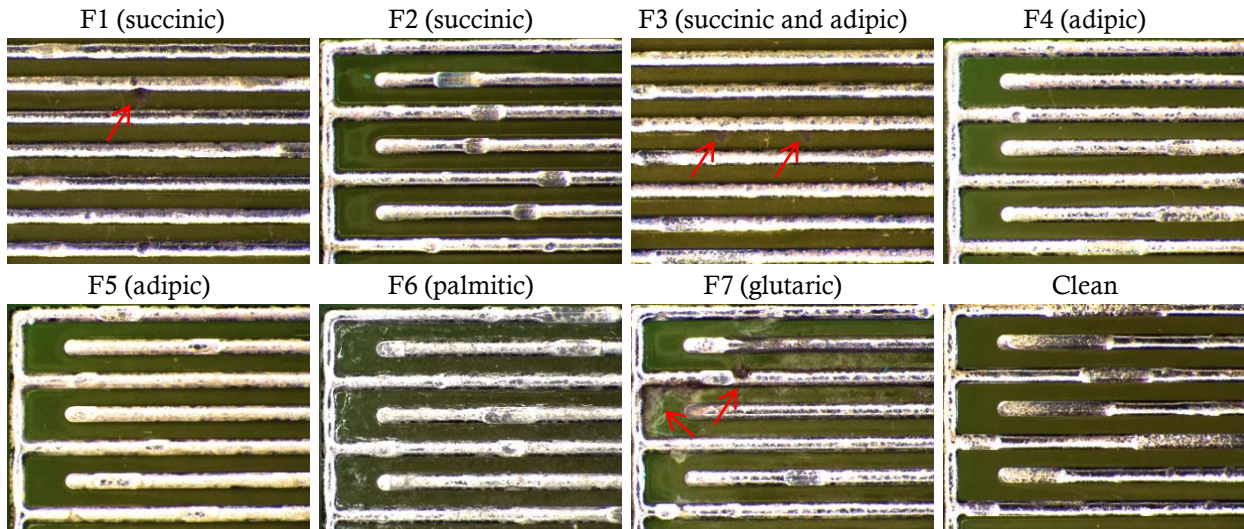
Figure 10.5: Optical micrographs of SIR pattern after climatic testing (test boards did not experience heating prior to humidity exposure)

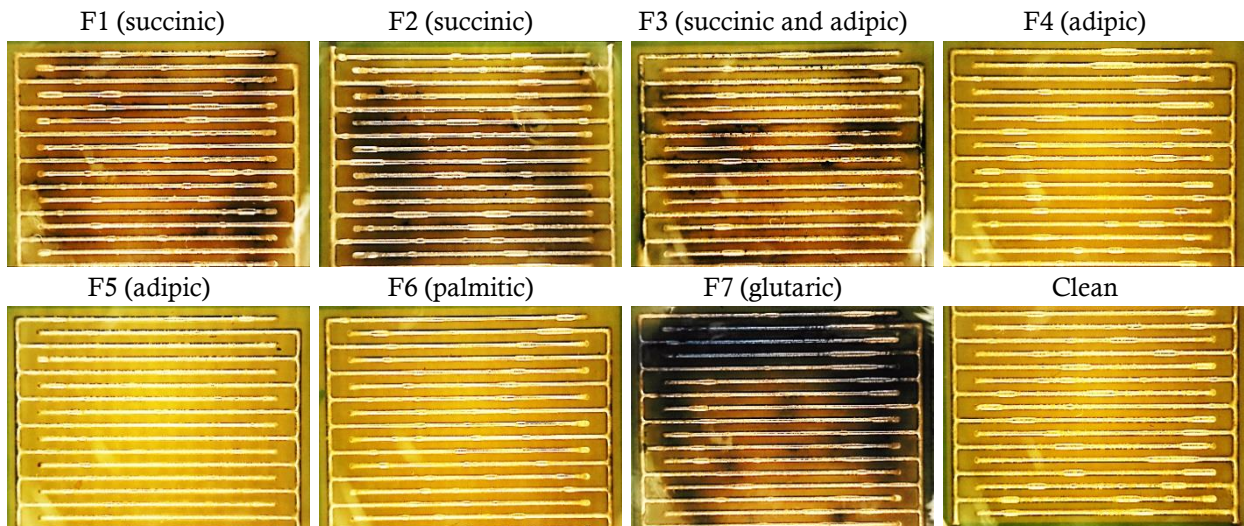
Figure 10.6: Optical micrographs of SIR patterns after climatic testing (corrosion of tin is indicated by blue coloration, while clear yellow colour indicates no corrosion of the SIR pattern)

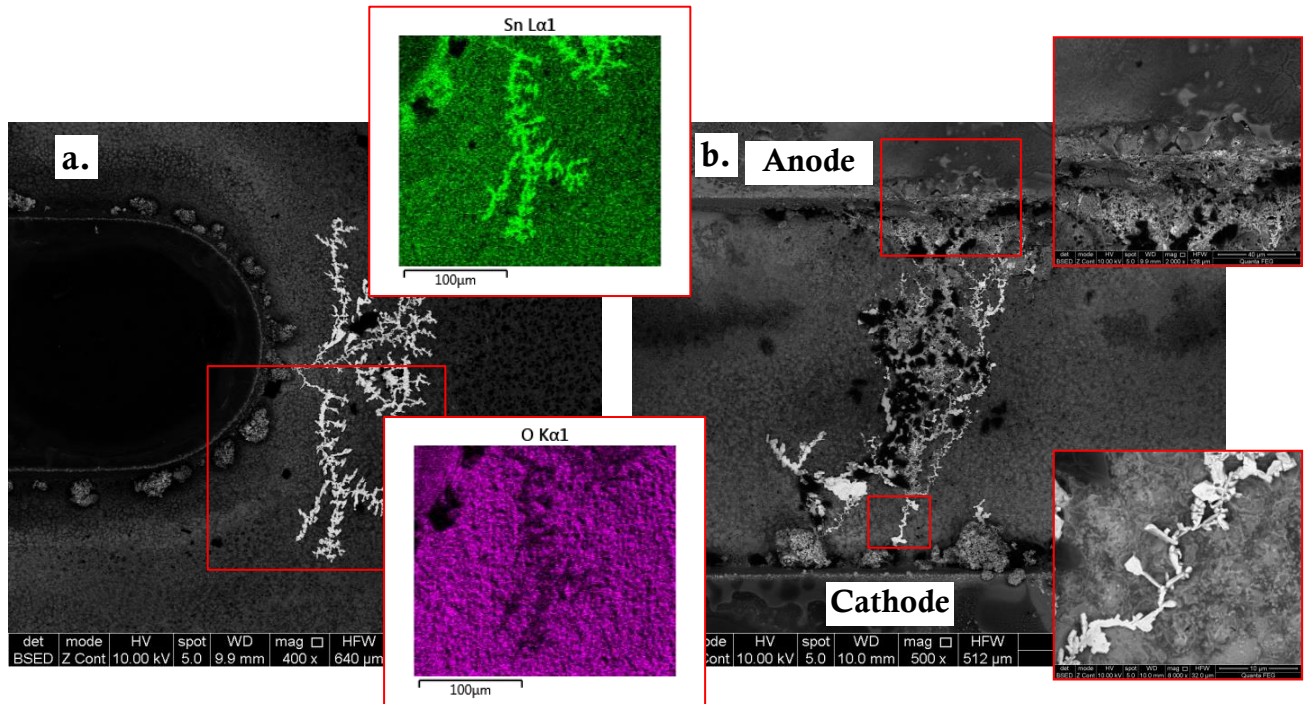
Figure 10.7: SEM image of dendrite on the SIR pattern (flux F7 heated at 220-245 °C for 45s): a. initiation and growth of tin dendrite, and magnified view of EDS map obtained on the tin dendrite, b. bridging of cathode and anode by dendrites and corrosion product

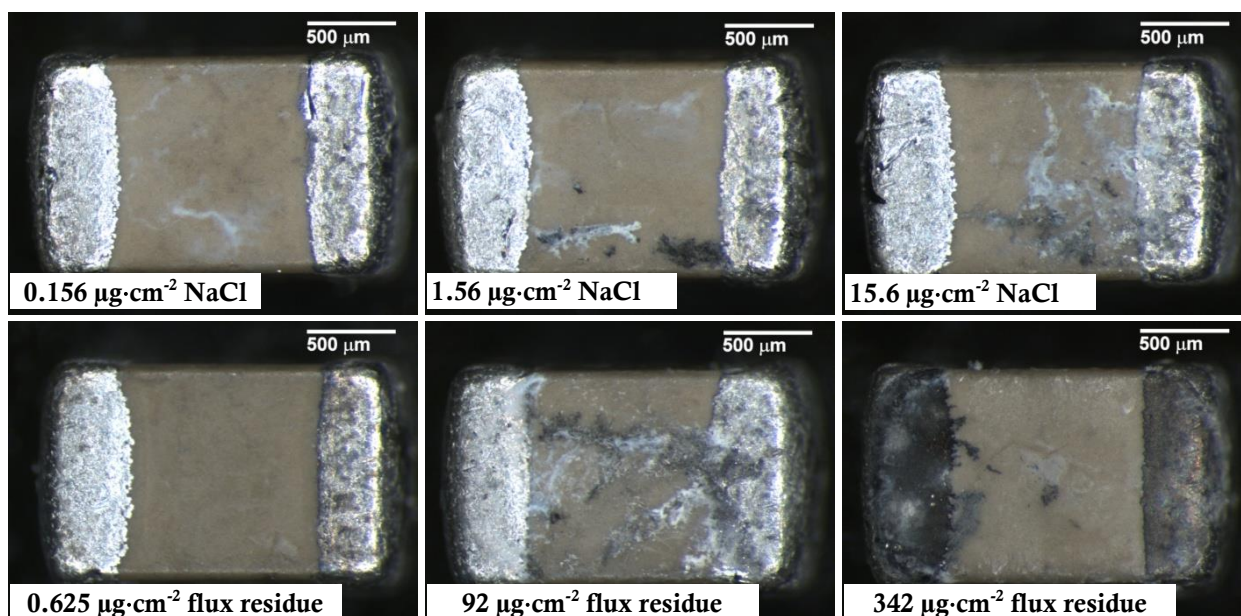
Figure 11.7: Size 0805 capacitors after ECM testing at 5 V DC (NaCl and solder flux residue concentrations are listed in images (anode: right terminal, cathode: left terminal))

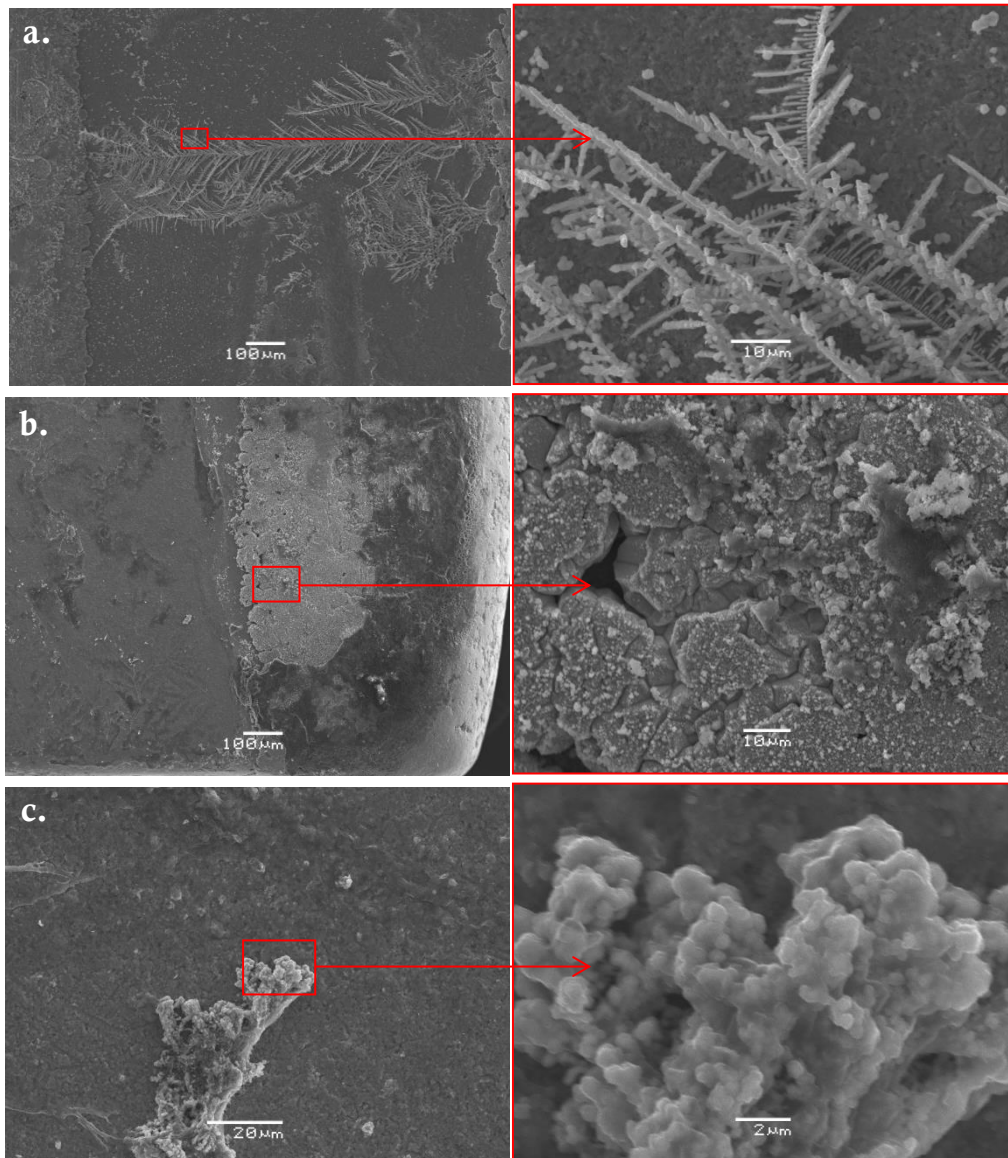
Figure 11.8: Typical SEM images of capacitor after ECM testing: a. tin dendrite on 0805 capacitor with flux residue level of $92 \mu\text{g}\cdot\text{cm}^{-2}$, b. corrosion of anode terminal, and c. deposition of corrosion product (black deposits) at nearby cathode terminal (b) and (c) are for $342 \mu\text{g}\cdot\text{cm}^{-2}$ of flux residue

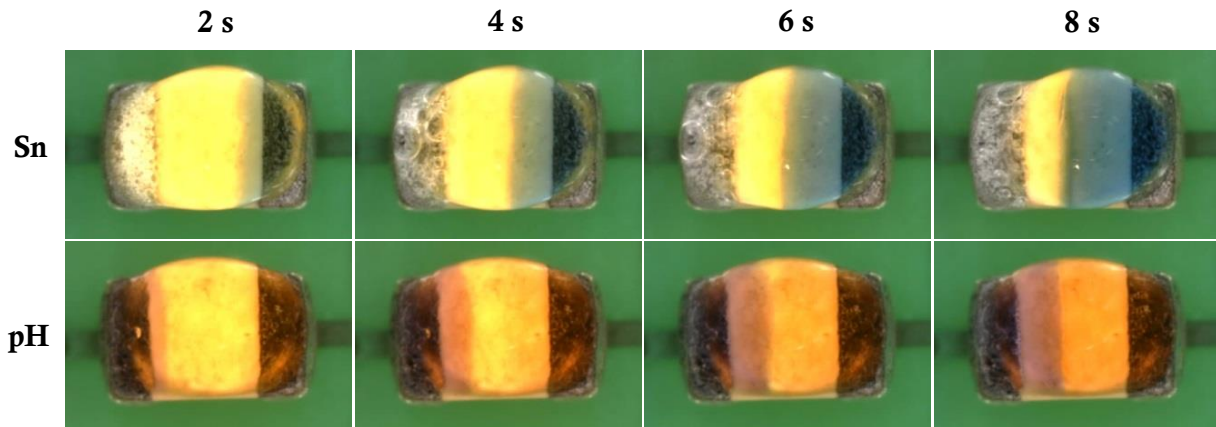
Figure 12.7: Dissolution of tin and local pH change observed on the component biased with 10 V DC (anode is on the right side)

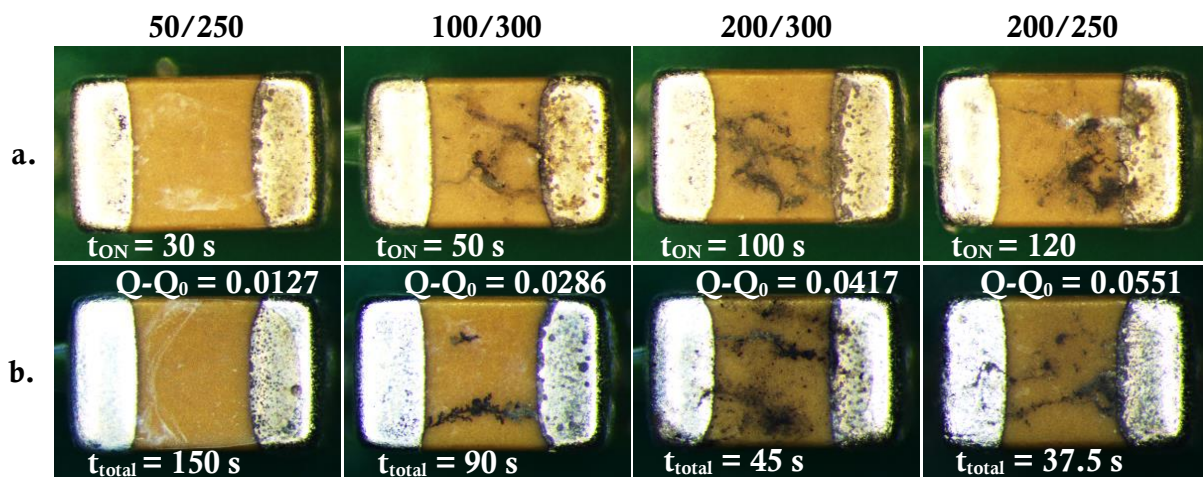
Figure 12.9: Optical appearance of ECM on the components after evaporation of electrolyte: a. effect of ON time (comparison after 150 s of test time) at $1.56\ \mu\text{g}\cdot\text{cm}^{-2}$ of NaCl, and b. effect of pulsed voltage (comparison after 30 s of ON time) at $15.6\ \mu\text{g}\cdot\text{cm}^{-2}$ of NaCl. ($Q-Q_0$ in the micrographs indicates average charge transferred, as readings from Figure 12.5)

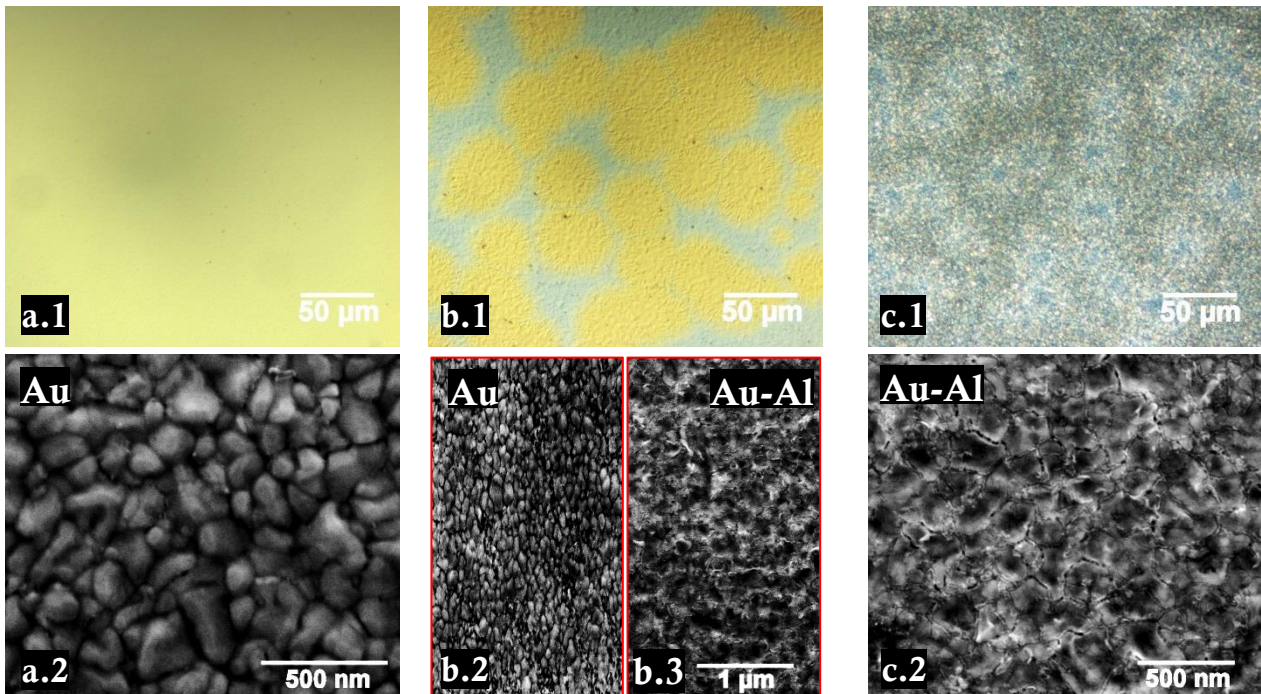
Figure 13.2: Optical and SEM micrographs showing the appearance of Au-Al multilayer after heat treatment at 175 °C: a. 0 h, b. 1 h and c. 4 h

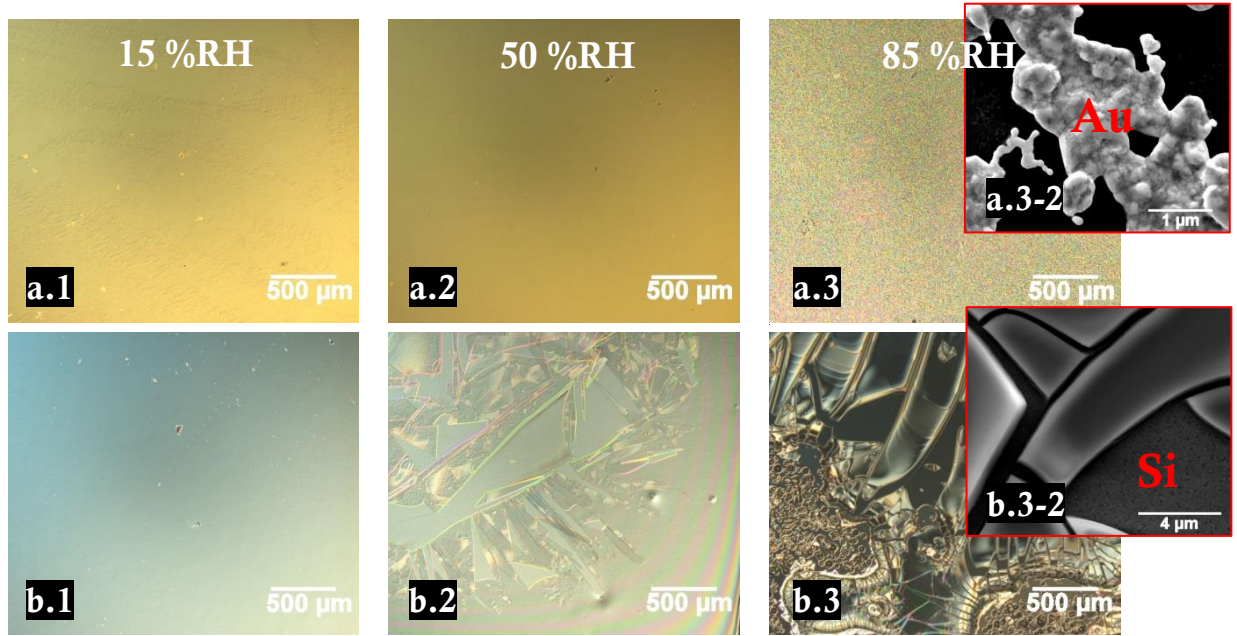
Figure 13.6: Corrosion of Au layer (a) and Al layer (b) after 24 h exposure to $1 \text{ mg}\cdot\text{L}^{-1}$ of iodine at 85°C and three levels of relative humidity: 1. 15 %RH, 2. 50 %RH, 3. 85 %RH

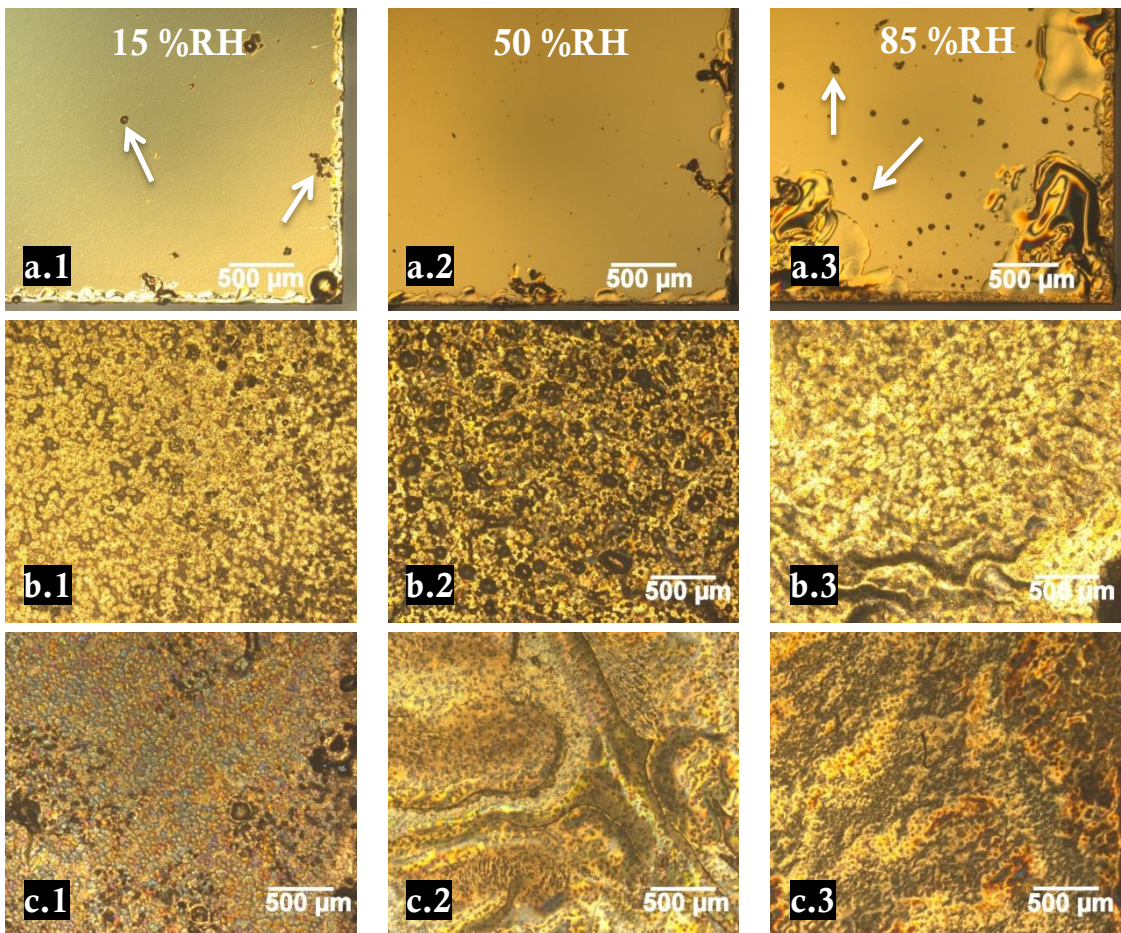
Figure 13.7: Corrosion of Au-Al multilayer heat treated at 175°C : a. 0 h, b. 1 h, and c. 4 h after 24 h exposure to $1 \text{ mg}\cdot\text{L}^{-1}$ of iodine at 85°C and three levels of relative humidity: 1. 15 %RH, 2. 50 %RH, 3. 85 %RH

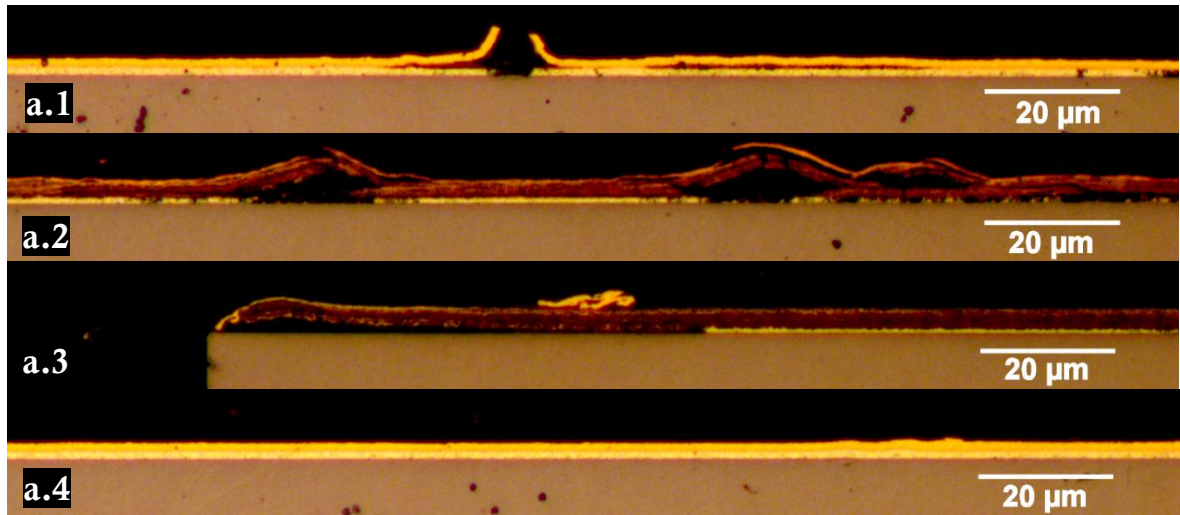
Figure 13.8: Cross section of Au-Al multilayers: after 24 h exposure to $1 \text{ mg}\cdot\text{L}^{-1}$ of iodine at $85^\circ\text{C}/85\%\text{RH}$: a.1 non-heated, a. 2 heat treated for 1 h a.3 heat treated for 4 h; b.3 reference sample (non-heat treated and unexposed to iodine)

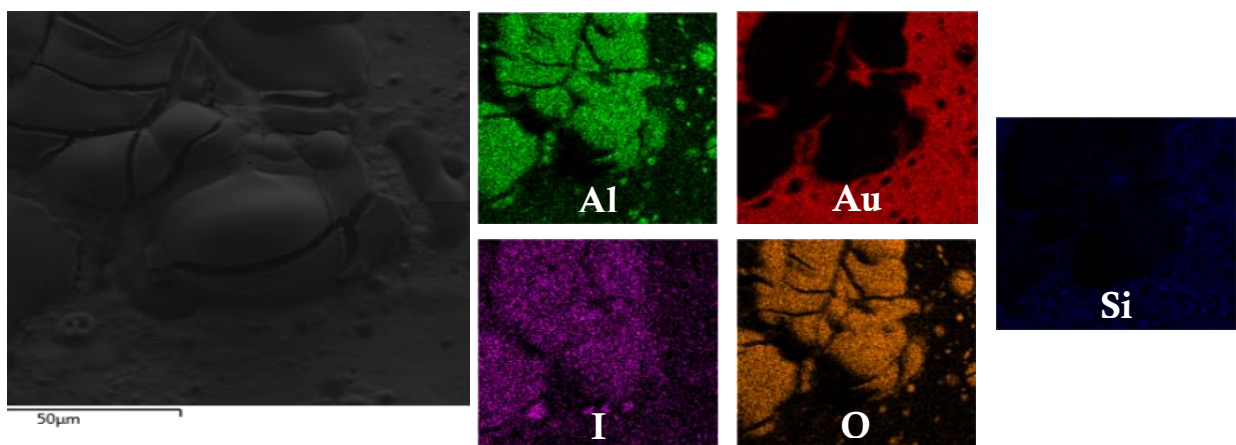
Figure 13.9: Corrosion of Au-Al multilayer heat treated for 1 h, after 24 h exposure to $1 \text{ mg}\cdot\text{L}^{-1}$ of iodine at $85^\circ\text{C}/85\%\text{RH}$

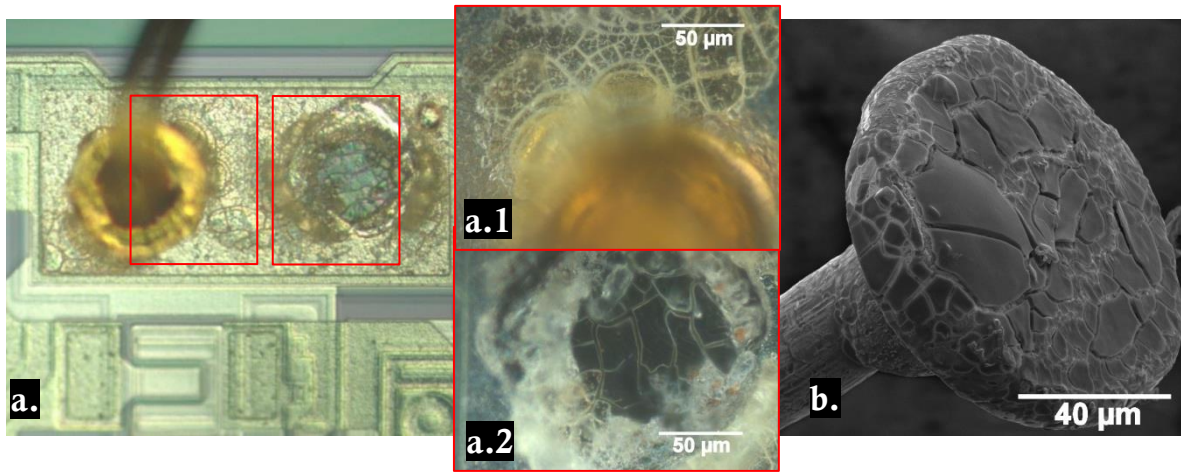
Figure 13.11: Micrographs of corrosion on Si dies after 24 h exposure to $1 \text{ mg}\cdot\text{L}^{-1}$ of iodine at $85^\circ\text{C}/85\%\text{RH}$: a. severe oxidation of the bond pad (a.1 and a.2 is close-up view), and b. lifted off wire bond (EDS map of the bond is provided in Figure 13.13)

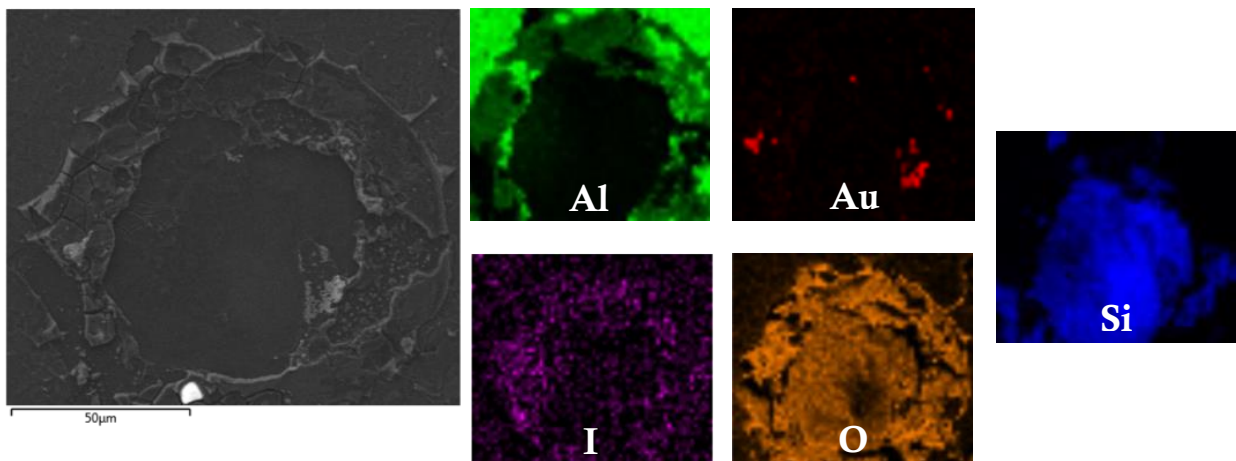
Figure 13.12: SEM EDS mapping of the bond pad after ball lift off (after 24 h exposure to $1 \text{ mg}\cdot\text{L}^{-1}$ of iodine at $85^\circ\text{C}/85\%\text{RH}$)

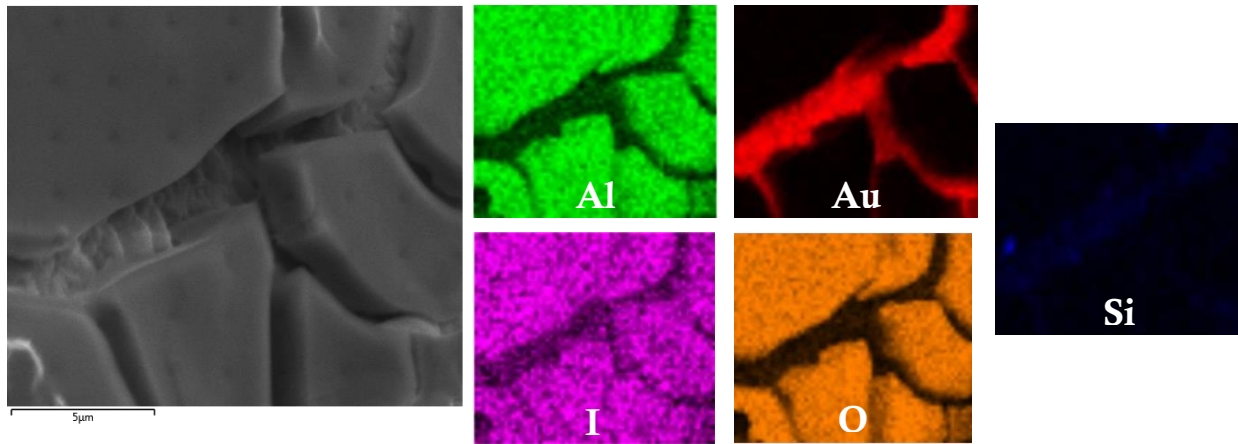
Figure 13.13: SEM EDS mapping of the wire bond after ball lift off (after 24 h exposure to $1 \text{ mg}\cdot\text{L}^{-1}$ of iodine at $85^\circ\text{C}/85\%\text{RH}$)

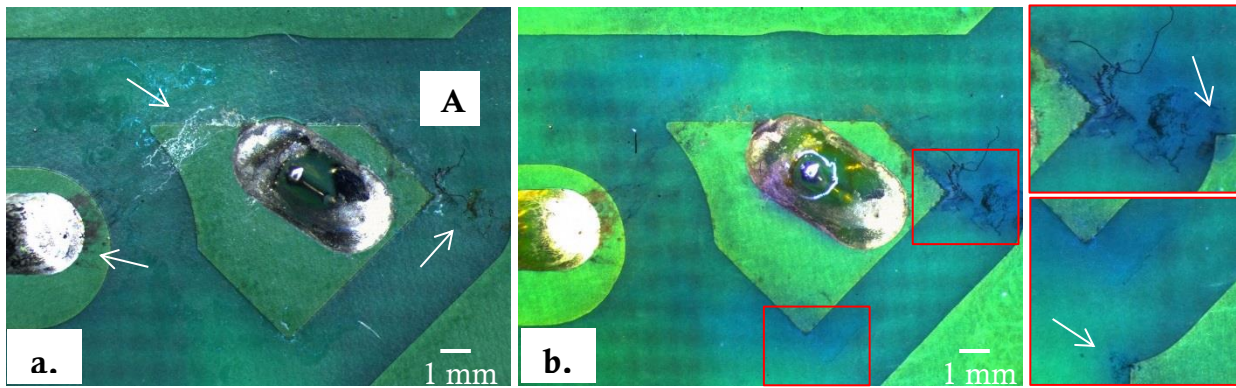
Figure 14.9: a. Corrosion between different bias points on the PCBA (DC+ and ground, and DC+ and AC phase; this area can be identified on bias voltage map in Figure 14.8), b. visualization of tin corrosion using tin ion indicator gel, with the magnified view of corrosion sites

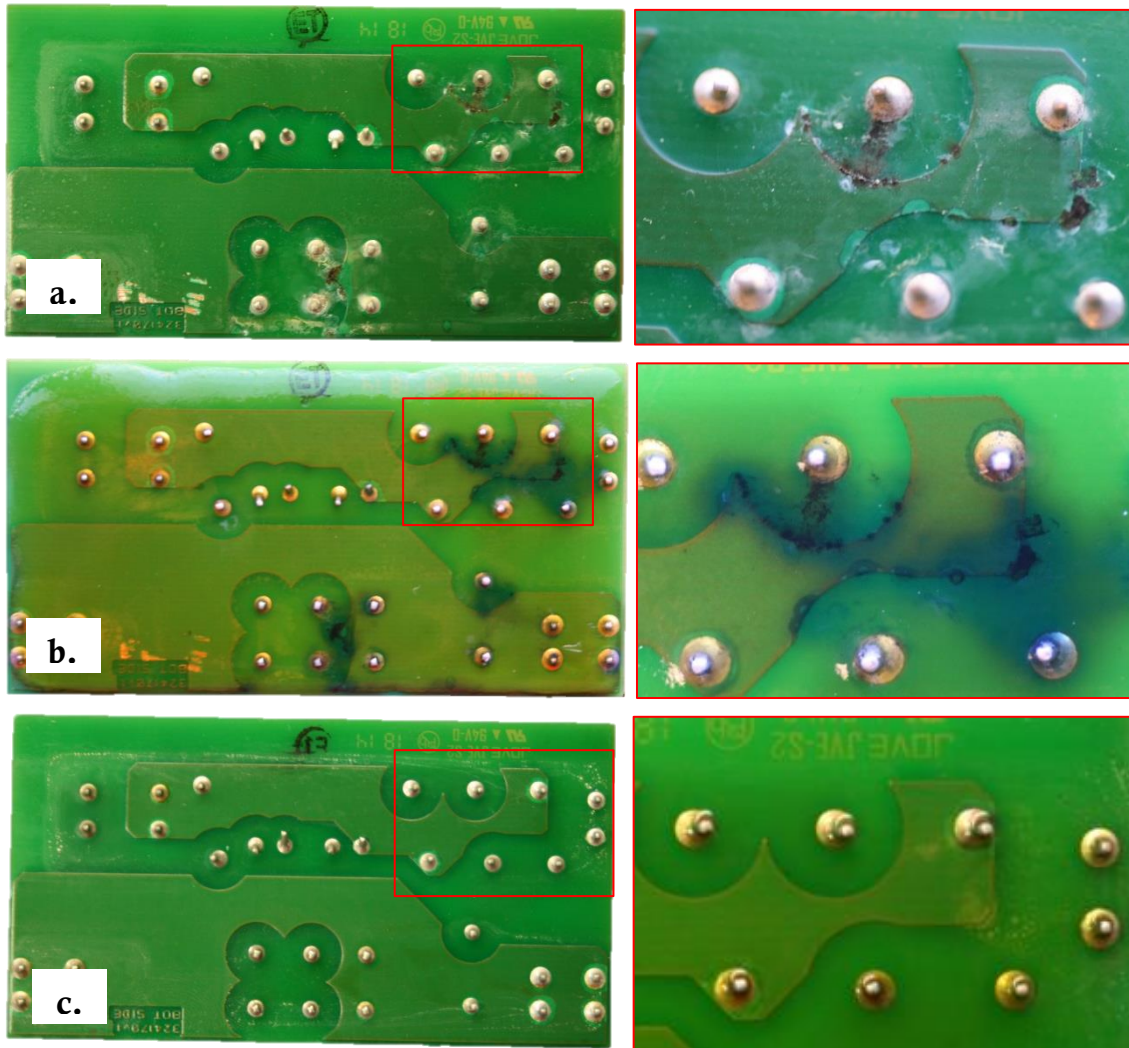
Figure 14.10: High AC voltage induced corrosion on the PCBA: a. original appearance of the PCBA, b. appearance after application of tin indicator, and c. PCBA with modified enclosure (white residues were seen after climatic testing, though no corrosion was identified)

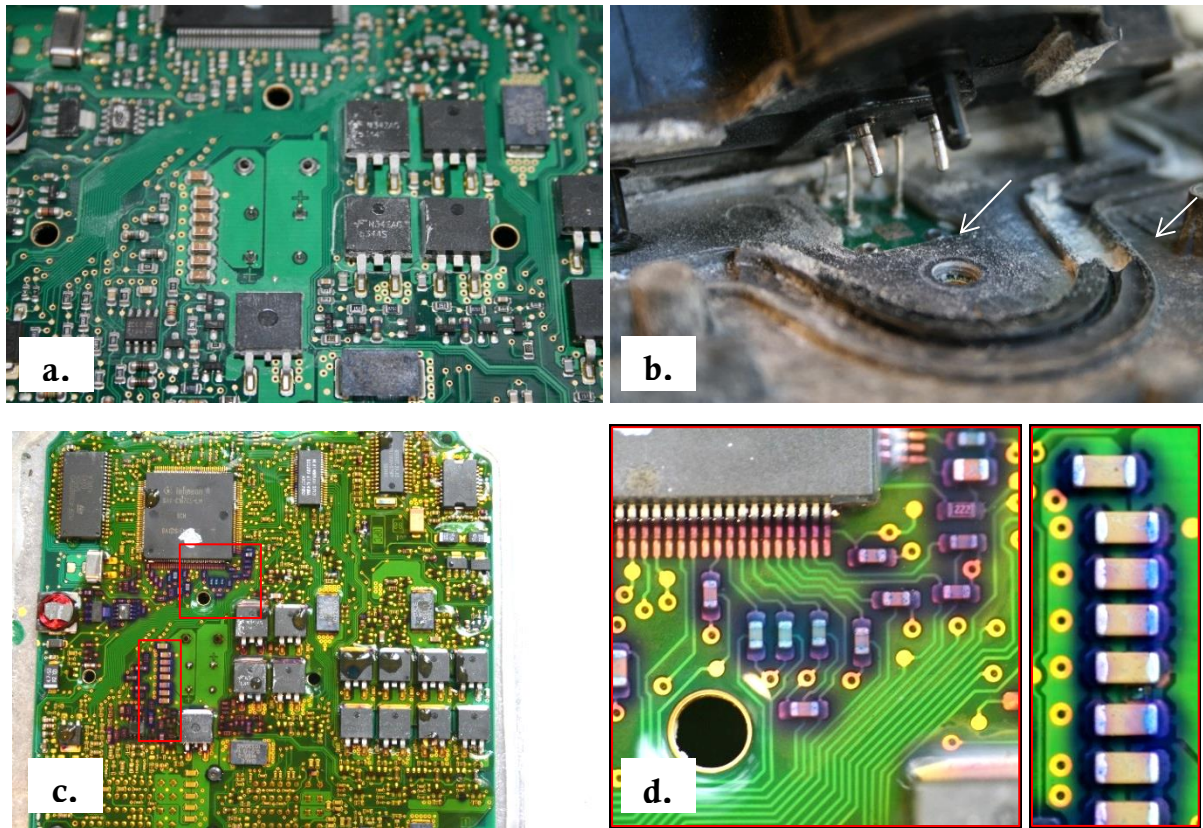
Figure 14.11 a. Visual inspection of the failed PCBA (top side) b. failed gasket and corrosion of aluminium enclosure served as entry point for humidity (bottom side), c. corrosion profile of the failed PCBA (top side), and d. close-up view of some of the components showing corrosion
