Durham E-Theses

Luminescence Dating of Medieval and Early Modern Brickwork

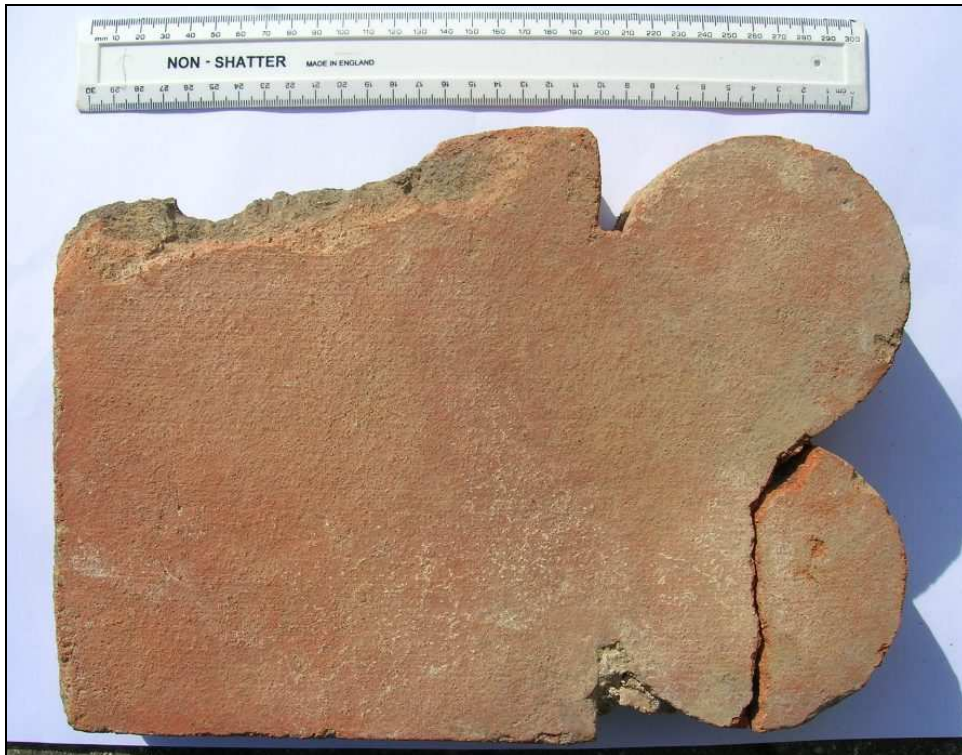
Fig. 2.2: Example of a moulded brick form used at Coggeshall Abbey (Pat Ryan, 2007).

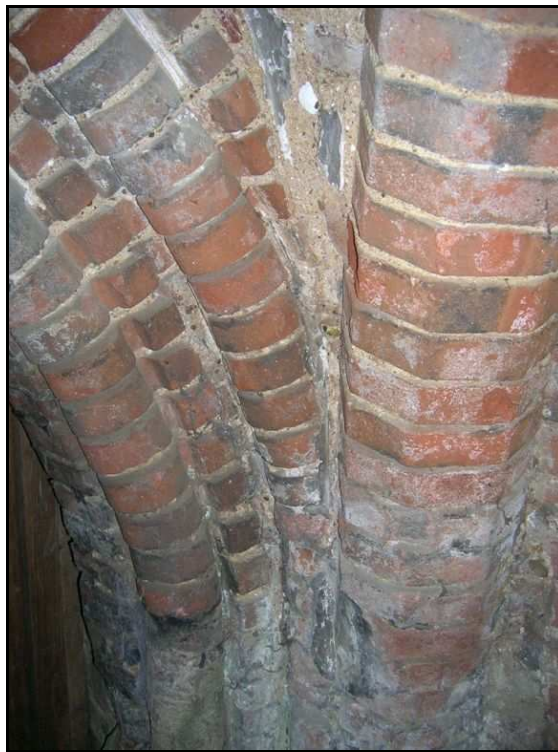
Fig. 2.3: Springing for a roll moulded doorway (left) and a chamfered vaulting rib (right) at Coggeshall Abbey.

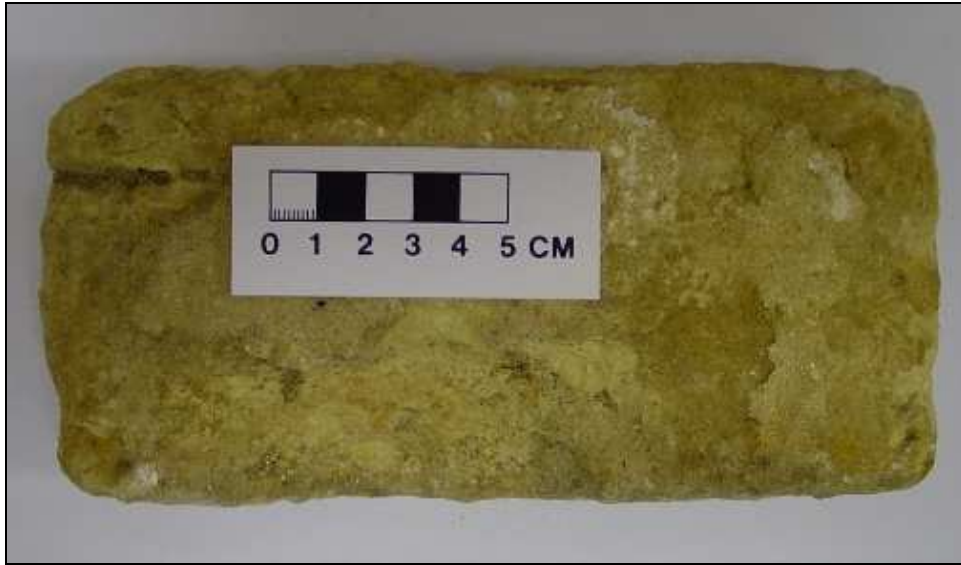
Fig. 2.5: An example of a 'Flemish' type brick.

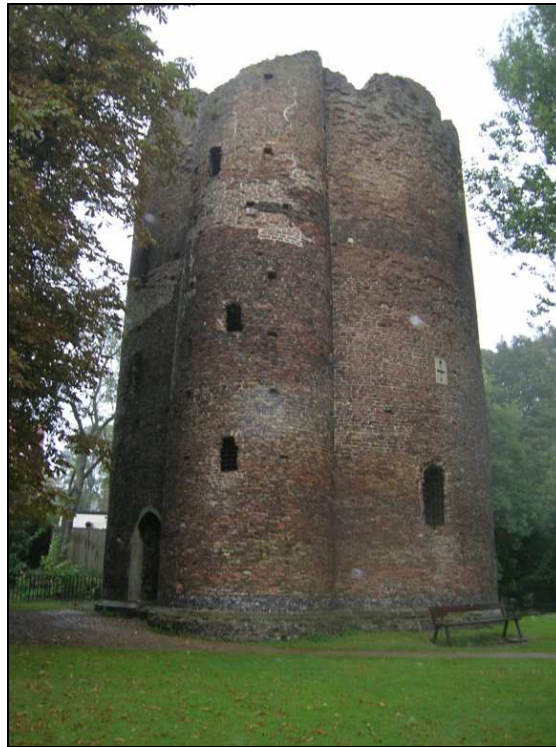
Fig. 2.6: The Cow Tower in Norwich, showing an early example of brick being used specifically as a dressing material.

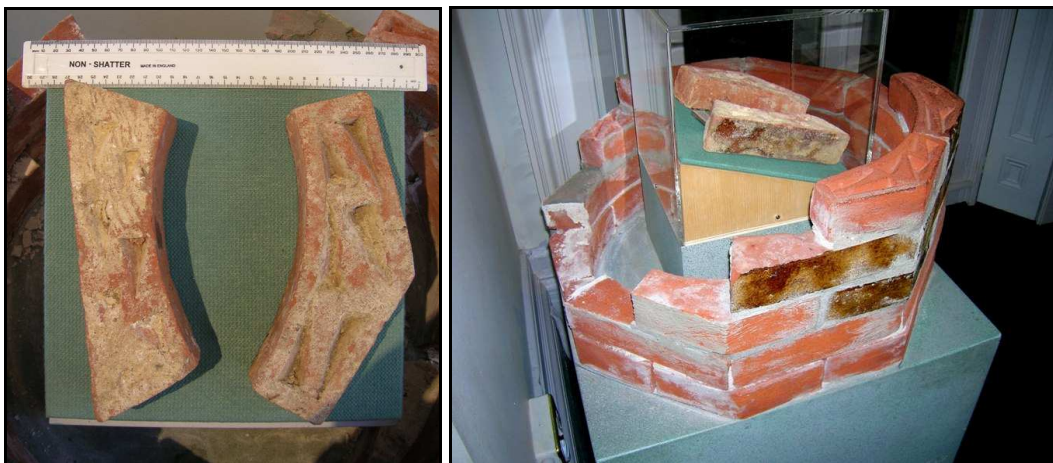
Fig. 2.14: Medieval chimney bricks. The left image shows the two different forms of brick needed to produce a chimney (the left brick is a ‘Type B’ brick whilst the right brick is a ‘Type A’ brick. Note the keying holes in the Type A brick). The image on the right demonstrates how alternating courses of the two types of brick produce a cylindrical shaft with an octagonal exterior.

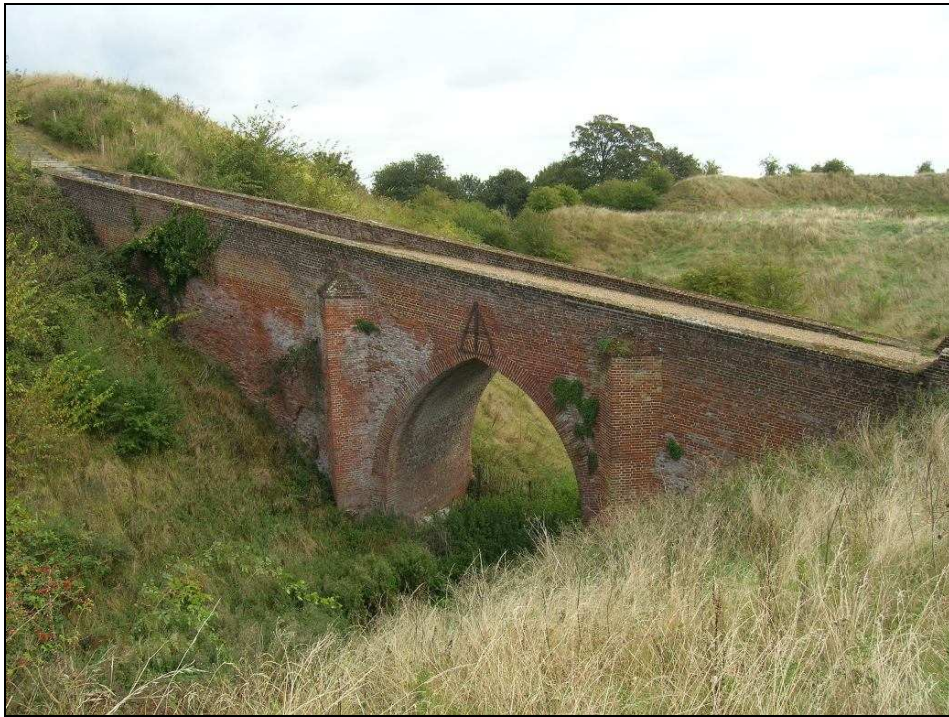
Fig. 2.15: Brick bridge at Pleshey Castle connecting the motte and inner bailey.

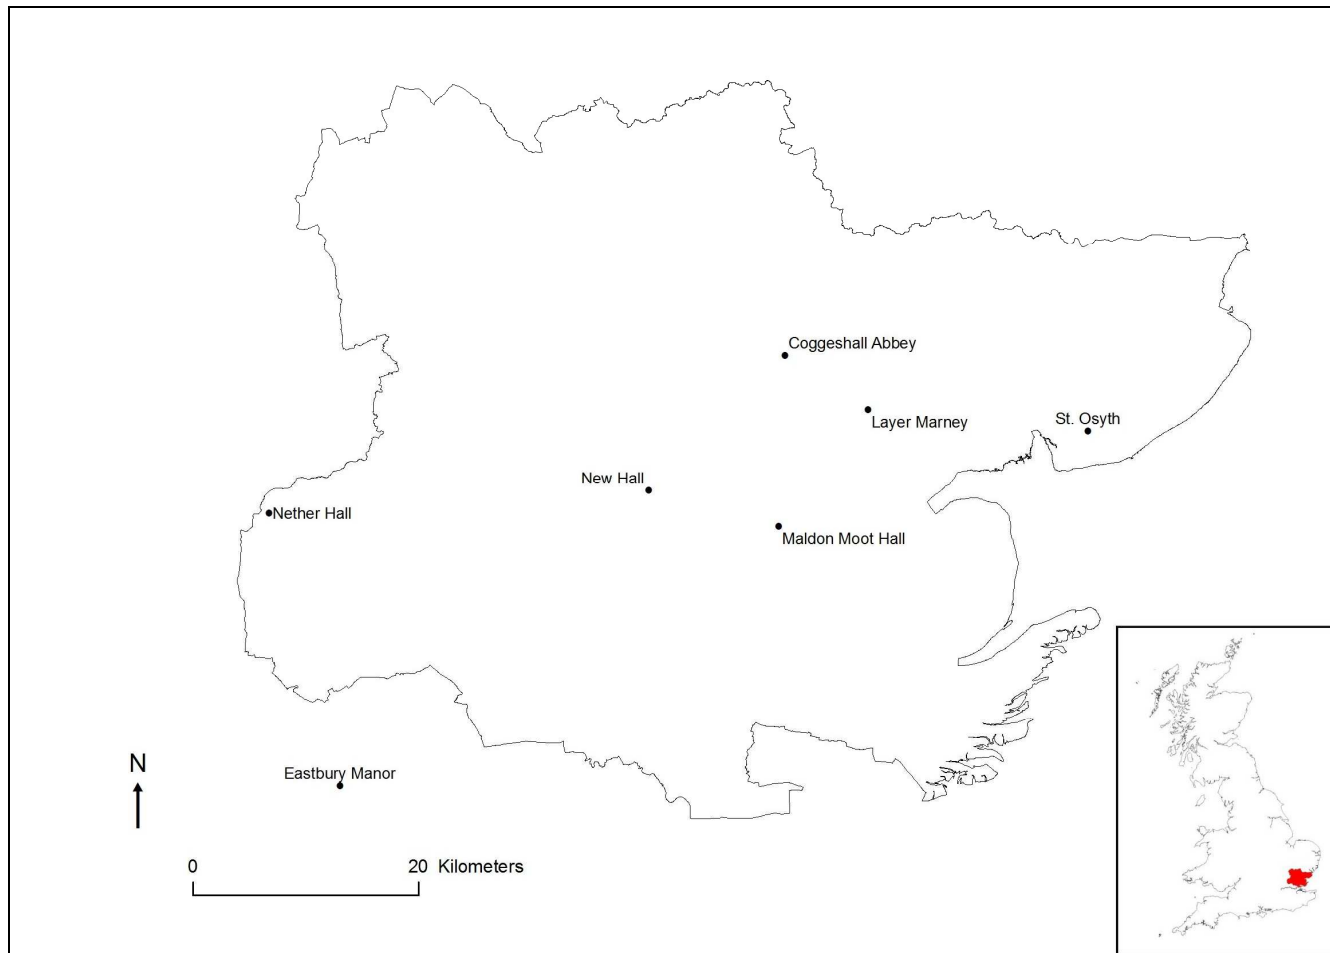
Fig. 3.1: Map of Essex showing the location of the different secular sites sampled for this project. Note that Eastbury now lies within Greater London following county boundary changes.

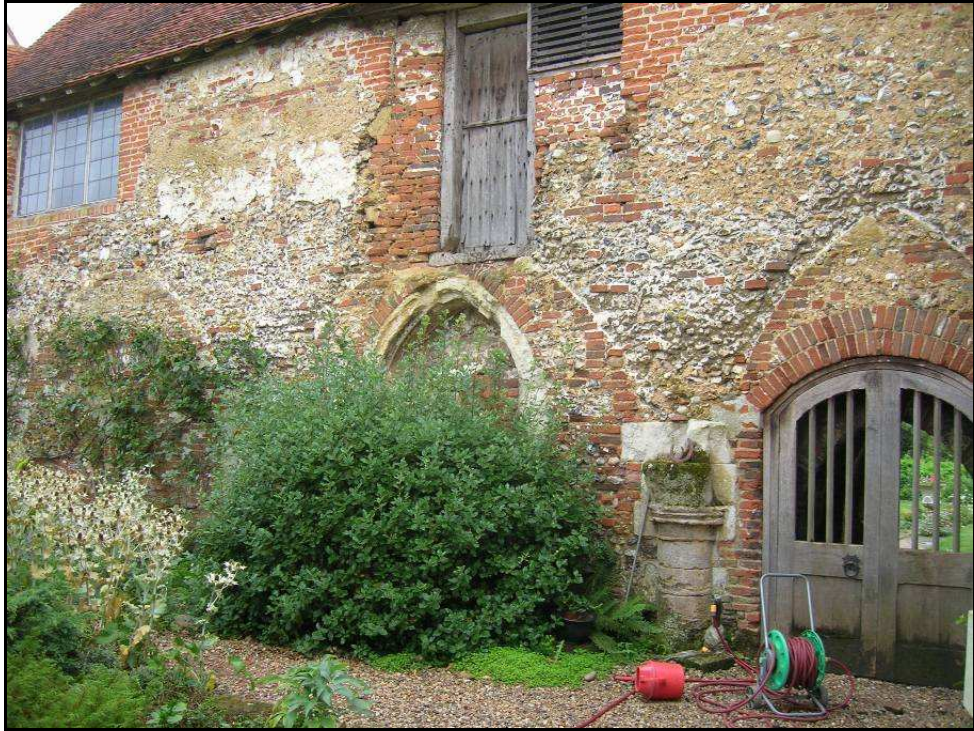
Fig. 3.4: Evidence of sub-dormitory vaulting at southern end of eastern cloister range. Note the wallshaft with moulded capital and keying marks for the quadripartite vaulting to the underside of the dormitory.

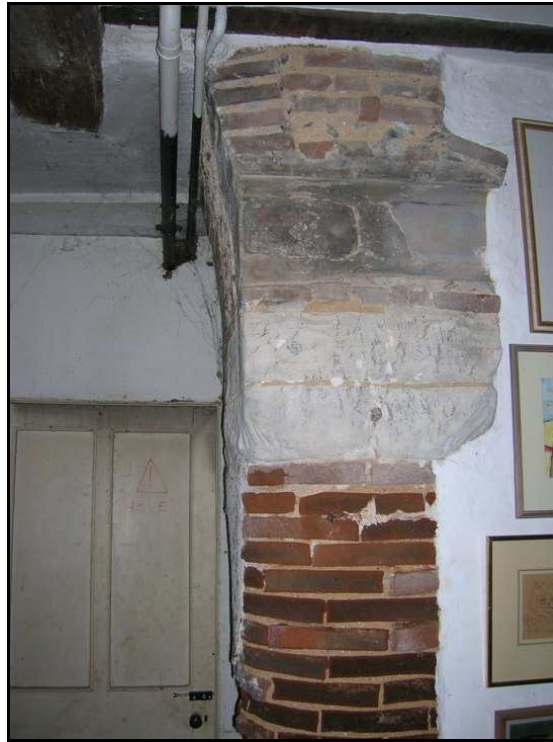
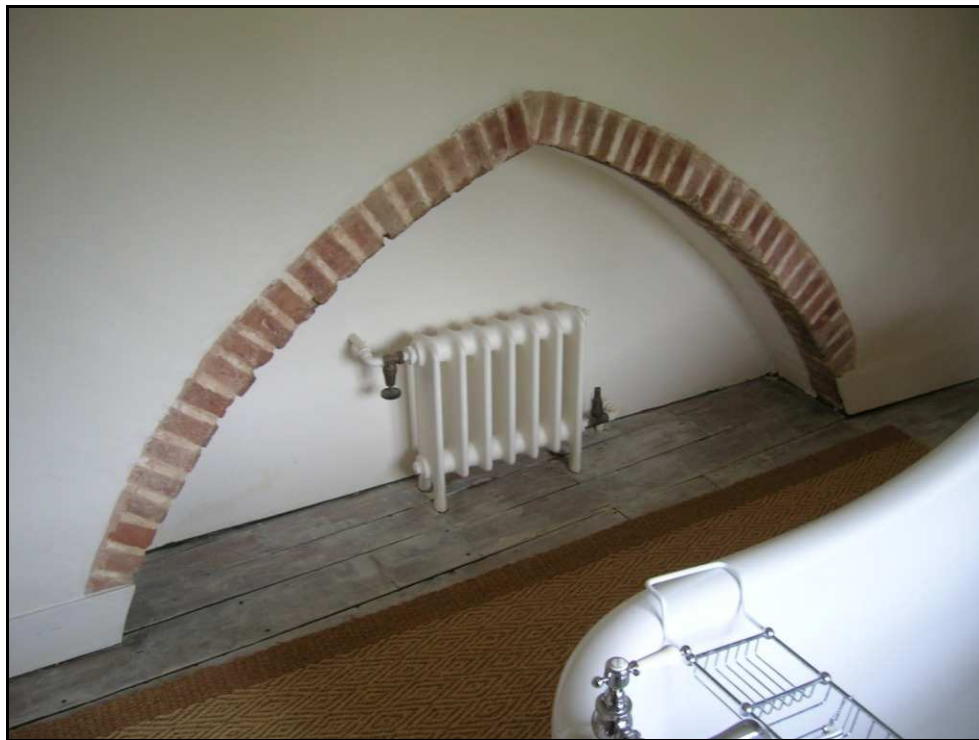
Fig. 3.8: The top image shows the Infirmary column with scalloped capital, now highly worn. The springing for the lancet arch can be seen above the capital whilst the crown of the arch is seen in the bottom image.

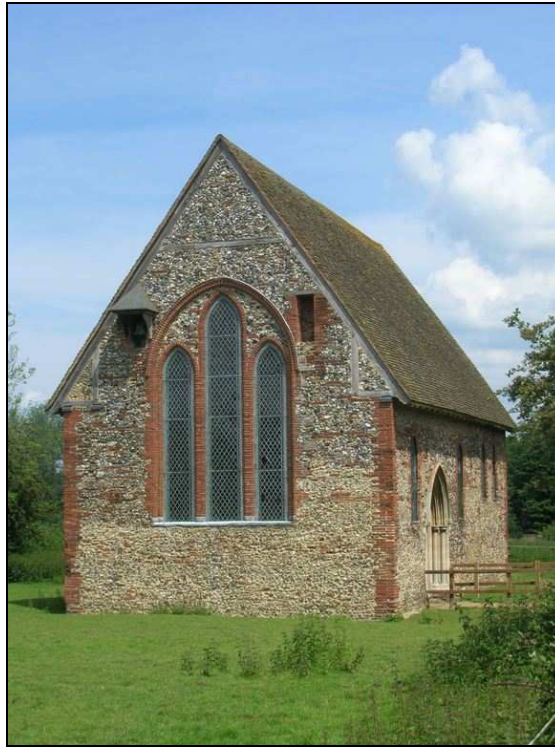
Fig. 3.9: St. Nicholas' Chapel. Originally this building acted as the capella extra portas to the abbey complex.

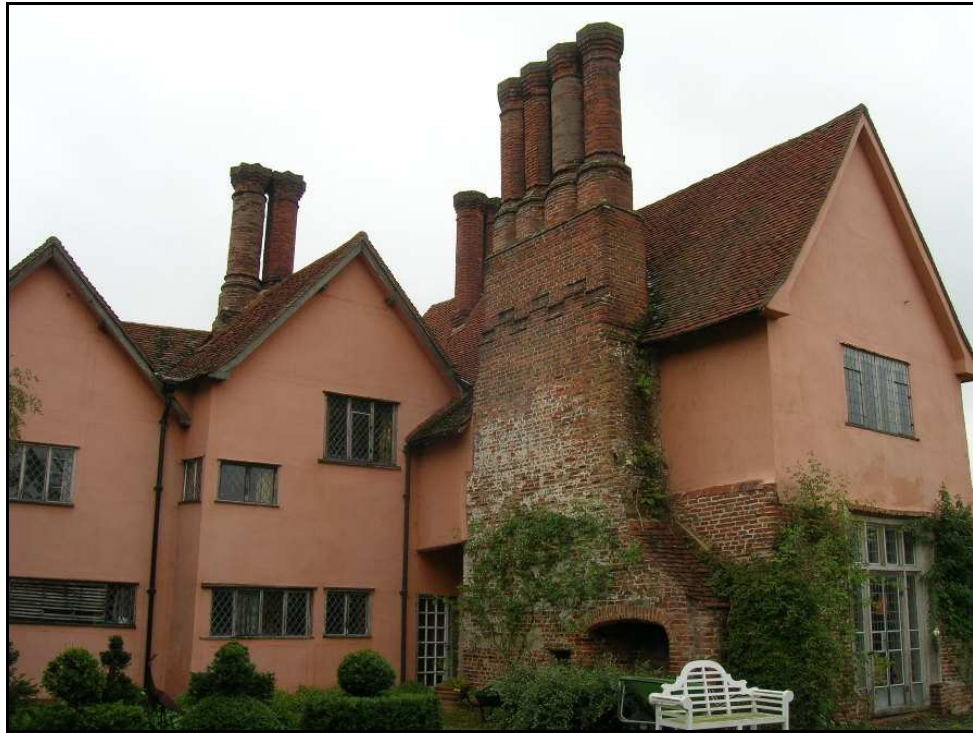
Fig. 3.10: The redundant fireplace attached to the eastern wall of the north range of the present building, suggesting a likely location for the first manor at Coggeshall Abbey.

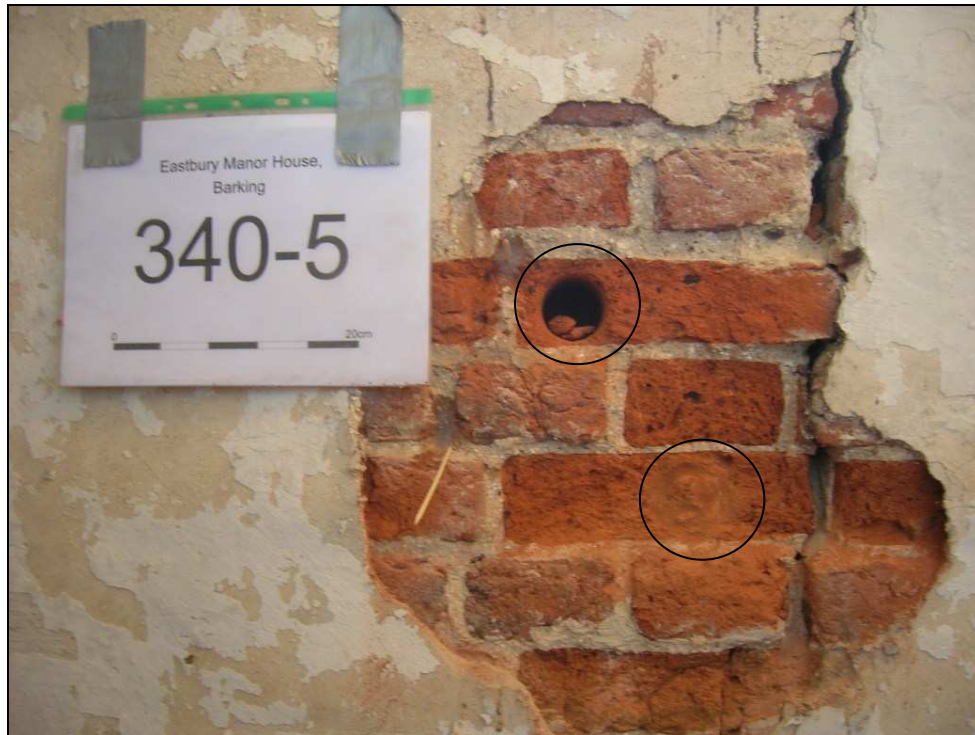
Fig. 3.20: The exposed fragment of brickwork in the western wall of the cupboard in the panelled room. The sampling locations have been circled. The scale bar is 20 cm in length. The image illustrates the aesthetic impact the sampling has on the brickwork since the lower of the two sample core holes in this image has been repaired and allowed to dry over the course of several months.

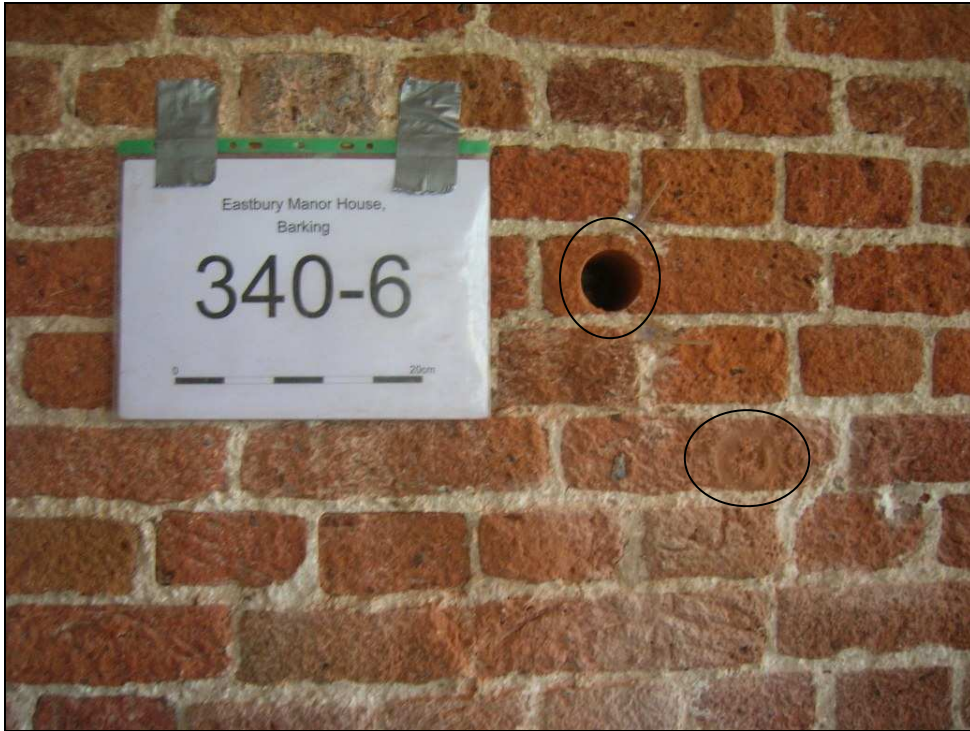
Fig. 3.21: The western wall of the summer parlour from which two samples were extracted. The sample points have been circled. The scale bar is 20 cm in length. As with Fig. 3.19, this image illustrates the aesthetic difference between a recent sample collection and a repaired sampling point.

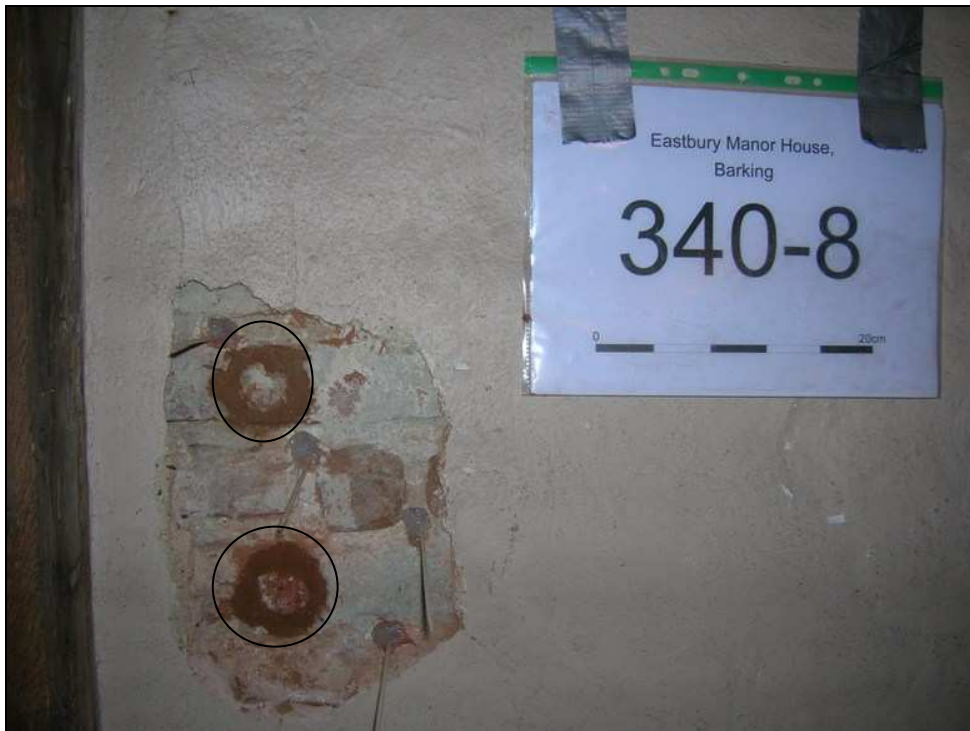
Fig. 3.22: The south western corner of the attic space where two samples were collected. The sample points have been circled. The scale bar is 20 cm in length. The image shows the wet mortar repair work shortly after sampling had taken place.

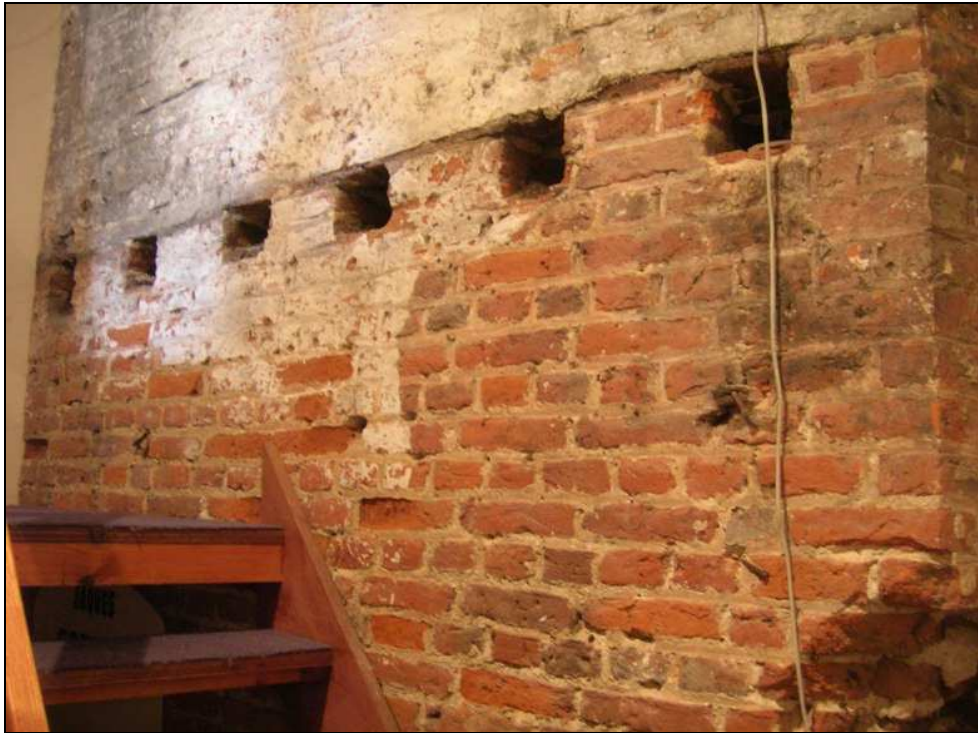
Fig. 3.31: Holes in the wall just above the modern first floor level. This wall extends eastwards from the Moot Hall and into the first floor of the adjacent building. It is thought that the holes may have held corbels to support the roof (see Fig. 3.34).

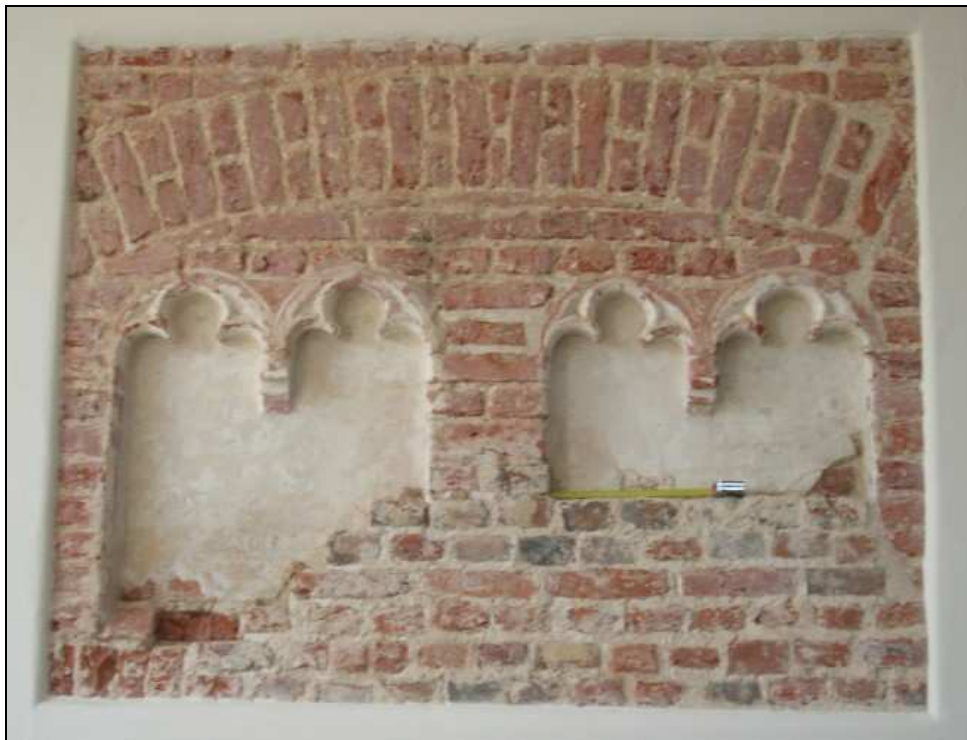
Fig. 3.36: Decorative trefoil corbelled niches made from carved, ruddled bricks above the fireplace within the Moot Hall.

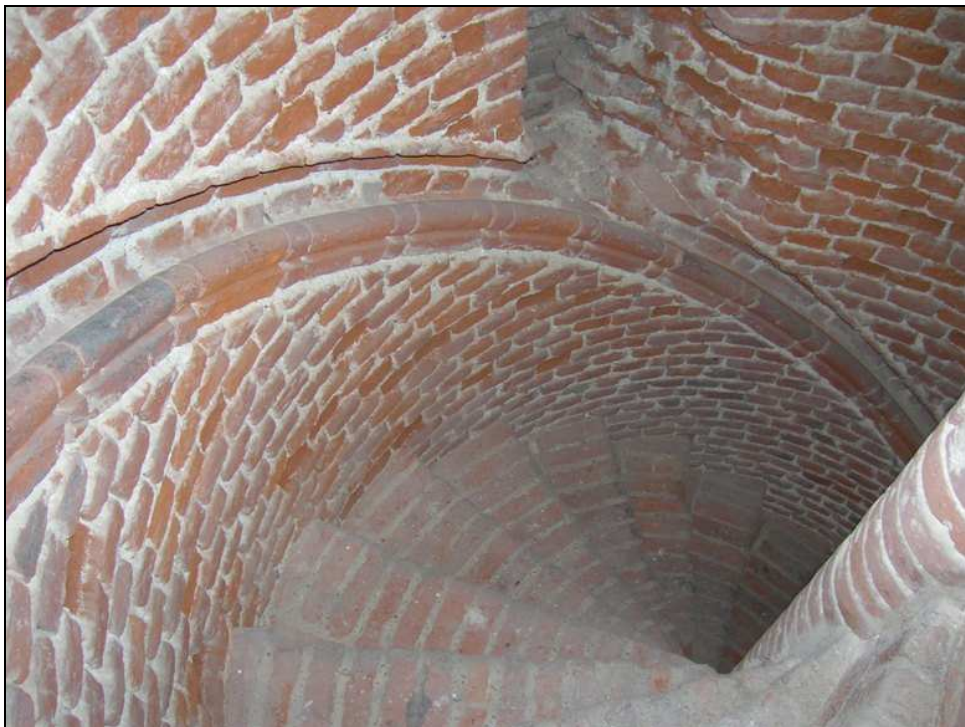
Fig. 3.38: The view down the brick newel staircase, illustrating the header bonded wall, the brick treads, the brick newel post and the alternating stretcher-header pattern of the moulded brick handrail.

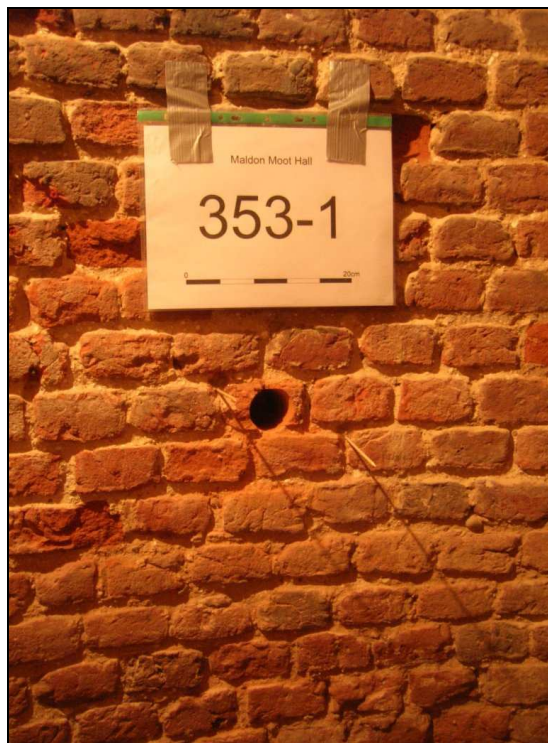
Fig. 3.40: The brickwork surrounding the sampling point at the base of the brick newel staircase in the Moot Hall, Maldon. The scale bar is 20 cm in length.

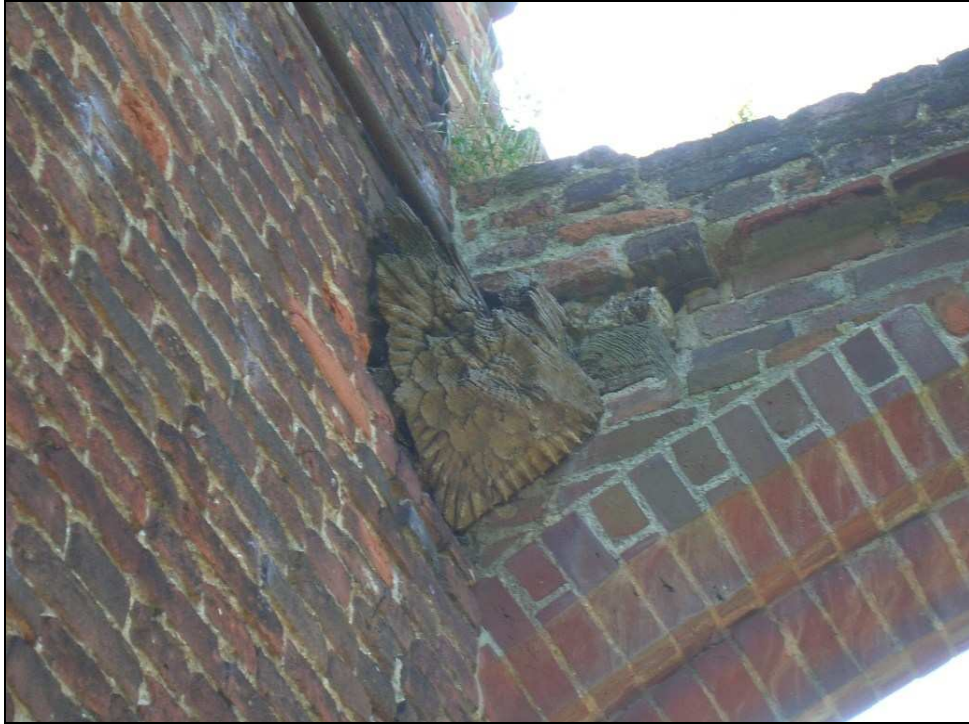
Fig. 3.45: Carved irradiated rose with a tun in the centre. This is the only carved decorative feature in the gatehouse complex that has survived largely intact.

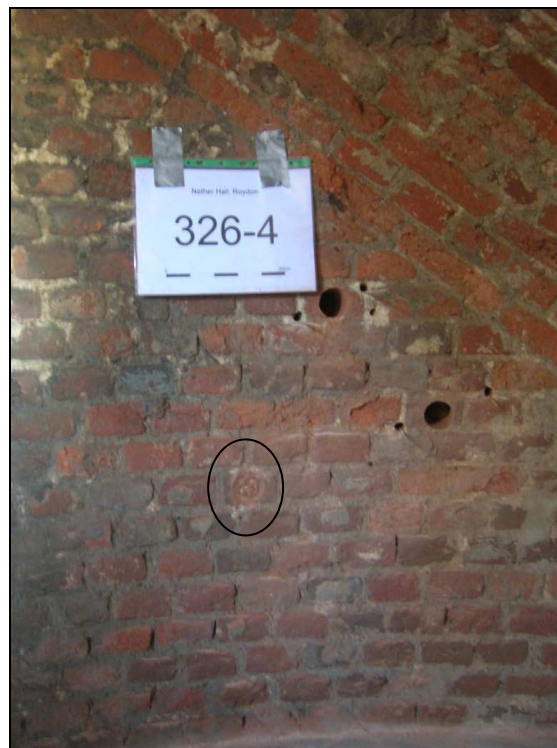
Fig. 3.48: The sampling points at the base of the brick newel stair. Note the change in the bonding pattern in the top right corner of the image. This change signifies the springing of the spiralling barrel vault upon which the lower part of the staircase sits. The scale in the image is 20 cm in length. There are three sampling points, two of which are shown open. The other sampling point is circled. This point was repaired and allowed to dry over the course of several months, illustrating the aesthetic effectiveness of the repair work undertaken.

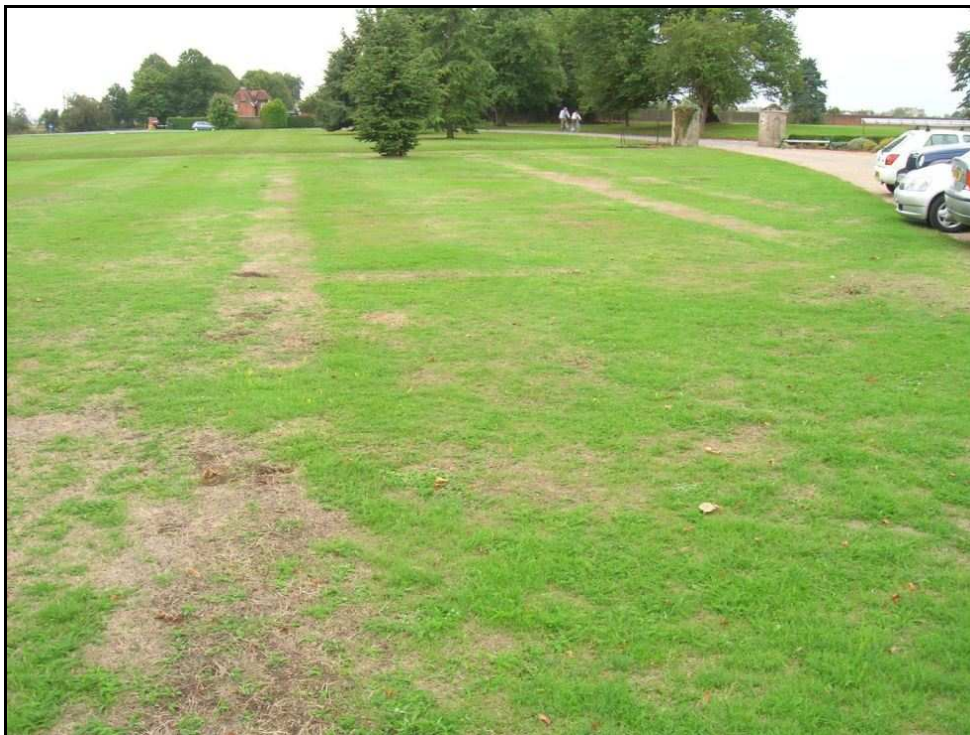
Fig. 3.50: Parch marks seen in the dry summer months. This southerly view shows the outline of the western range of the main courtyard.

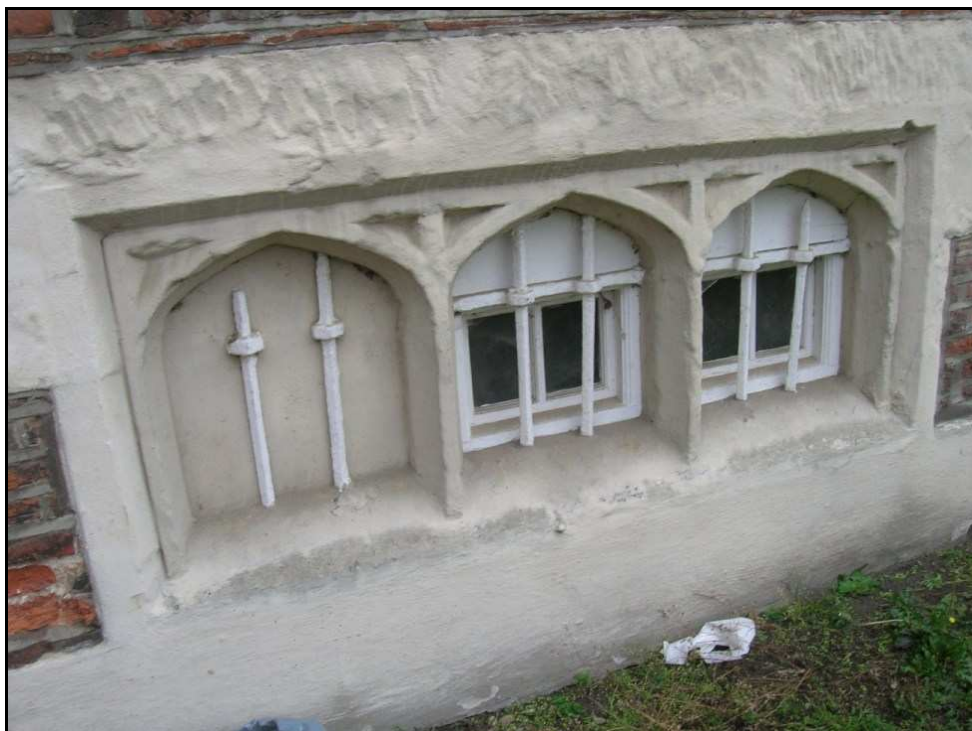
Fig. 3.54: Late perpendicular/early Tudor windows located in the eastern wall of the cellar.

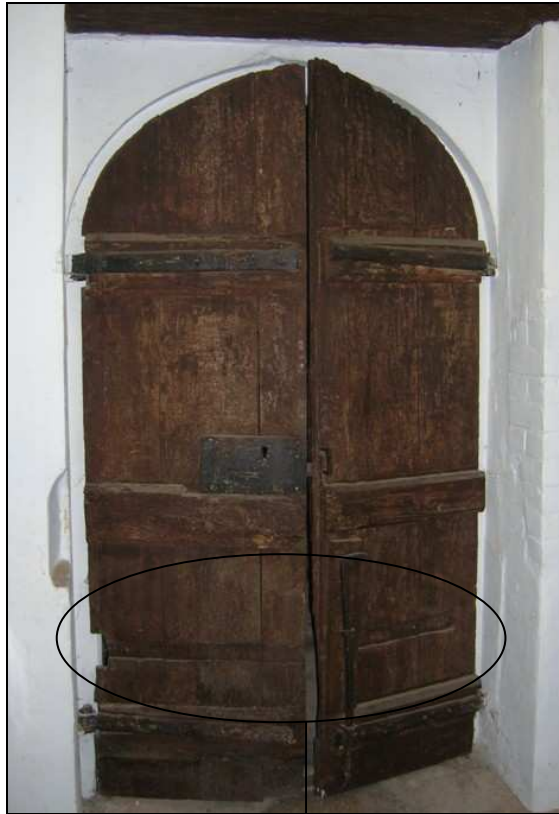
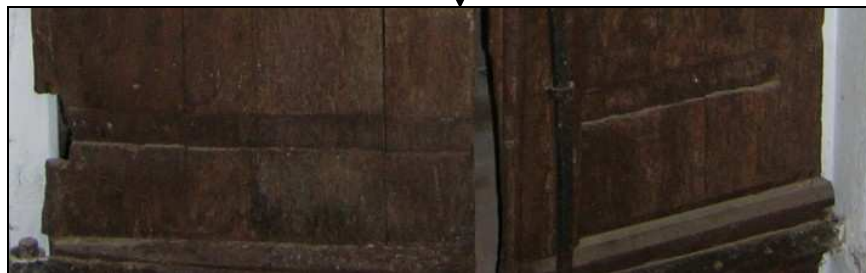
Fig. 3.56: The door and doorway between the north and south cellar chambers. The top image shows the north face of the door. Note that at the bottom of the present door there is a groove which runs across both leaves for an original hinge strap. There is also a niche on the left side of the image which was the location of the hinge loop to sit on the wall pintle.

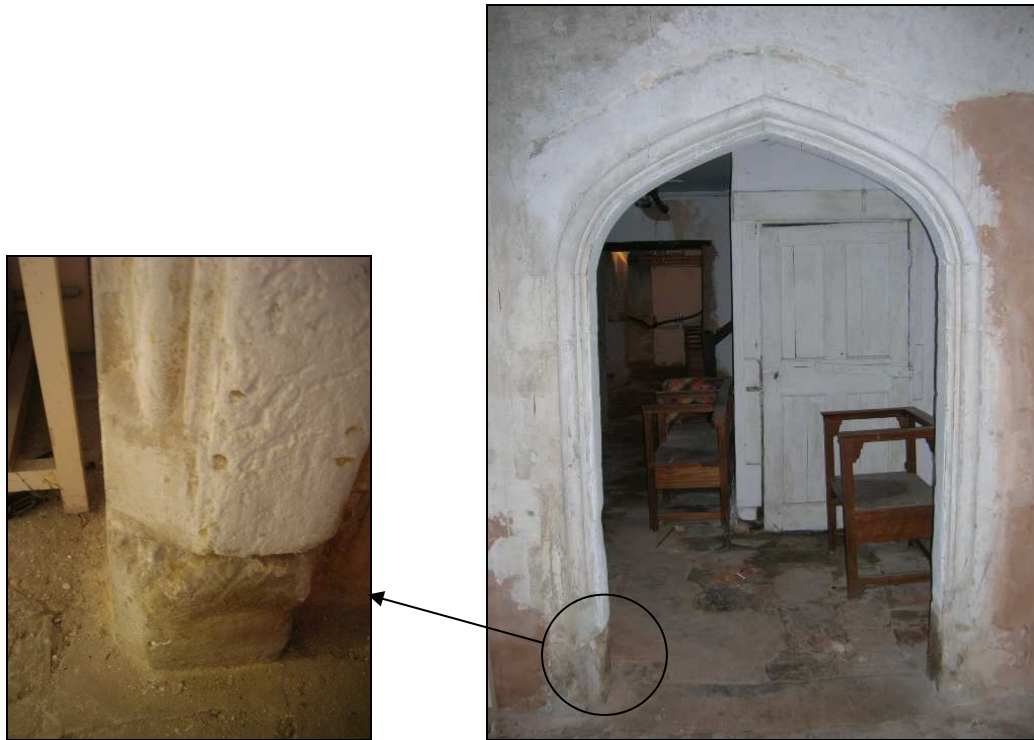
Fig. 3.57: The doorway in the southern chamber of the cellars, looking southwards. Note the roll mould decoration running around the doorway. At the bases of the jambs (the left image shows the eastern jamb) there appears to be a simple chamfer termination to the roll moulding and on the stone beneath a tapering to a second plain chamfer.

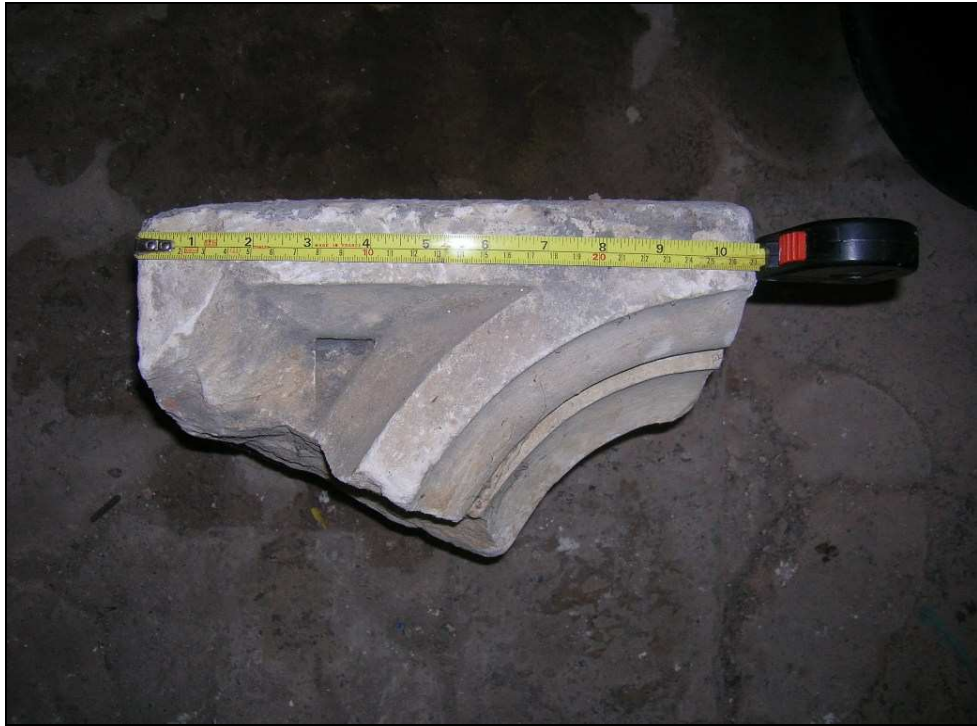
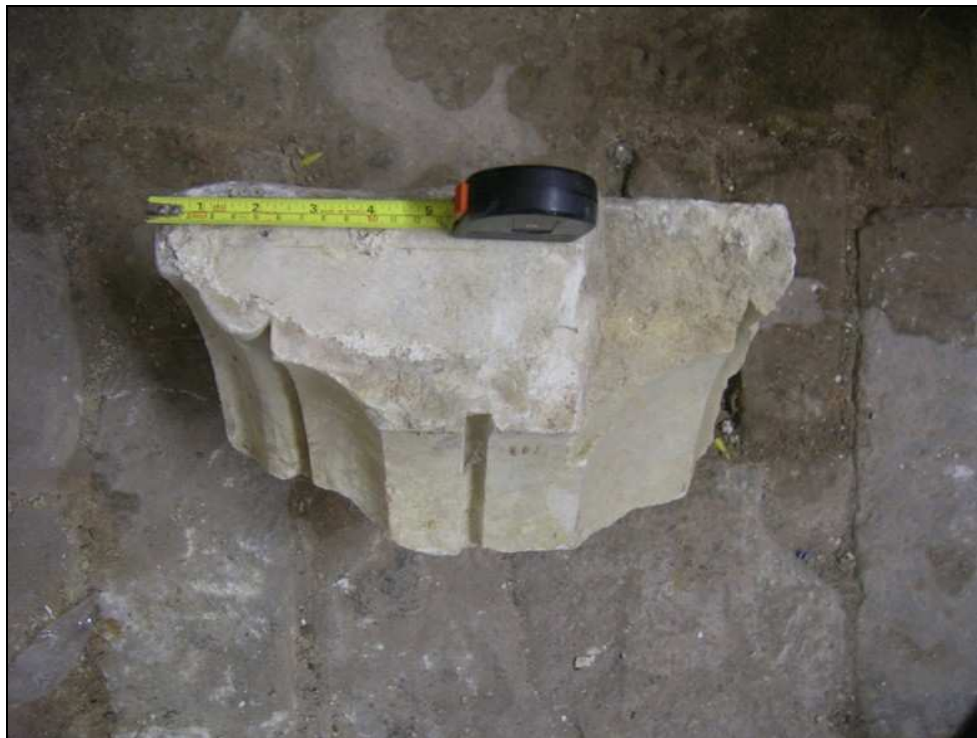
Fig. 3.59: Part of a window spandrel that had been re-used as a flag in the cellar floor. The top image shows the ogee and quarter circle moulding beneath the spandrel whilst the bottom image shows the cross sectional profile.

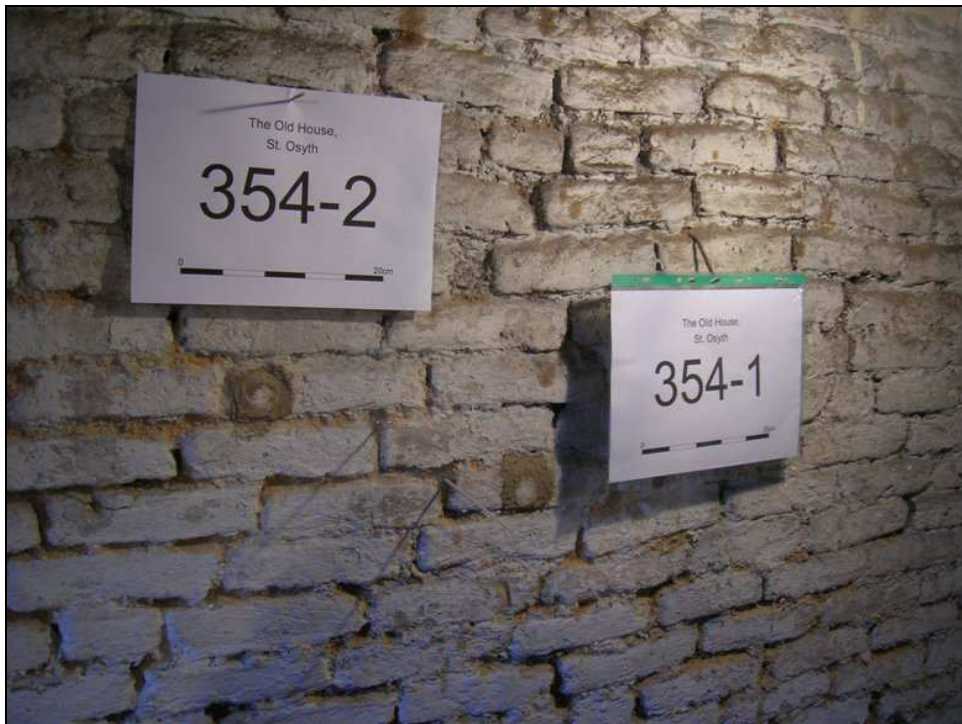
Fig. 3.66: The southern wall of the cellar at ‘The Old House’. The two sampling points had recently been repaired when this image was taken. Both of the scale bars are 20 cm in length. Note that whilst the brickwork of the wall is largely laid in stretcher bonding, there are irregularities. These include occasional header faces in the uneven courses.

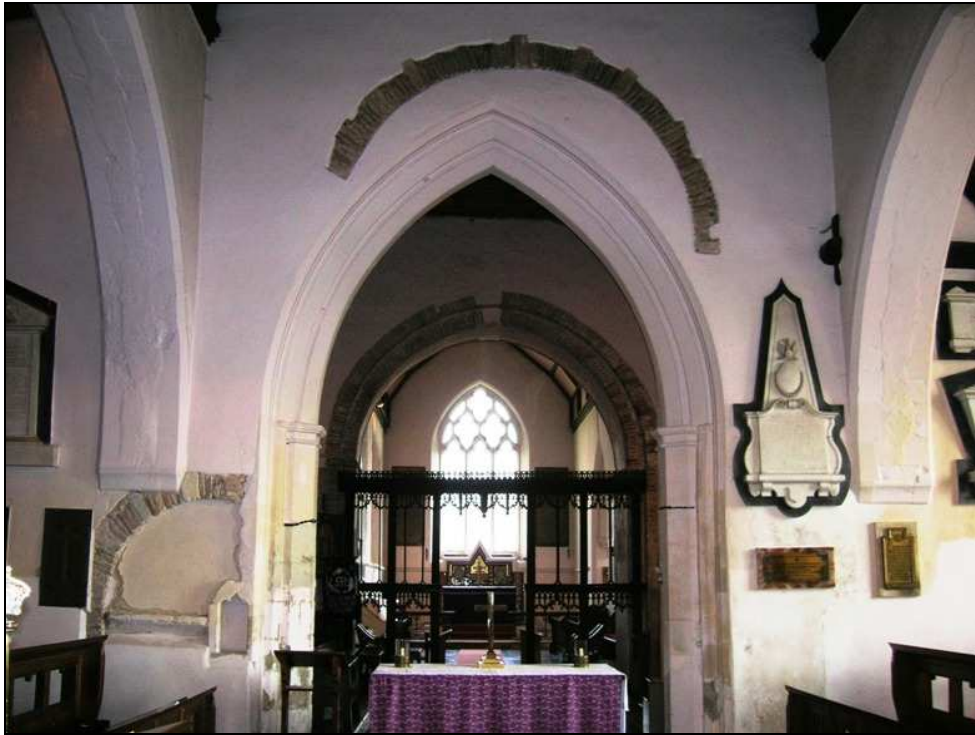
Fig. 3.71: The interior view of Boreham church from the nave looking through the tower into the east chancel. Note the Romanesque arch composed of brick and stone voussoirs above the later 14th century lancet arch and the quater-circular side niche to the left of the present lancet arch jamb.

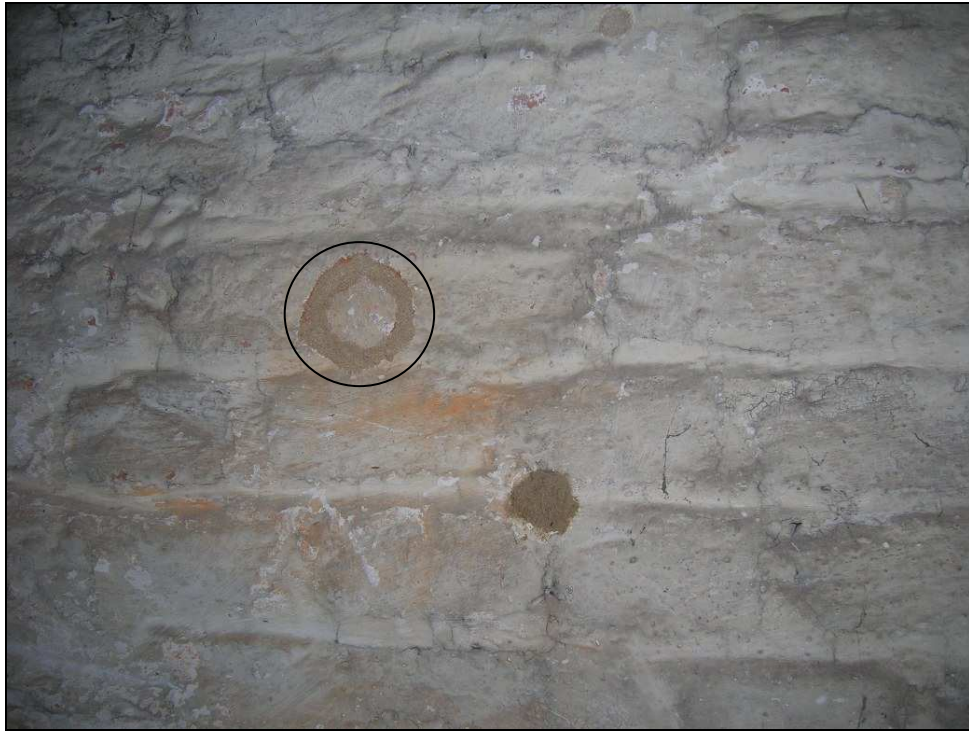
Fig. 3.83: The sampling point (circled) at St. Andrew's church. The sample and dose capsule hole (below and to the right of the sampling point) have both been filled with lime mortar.

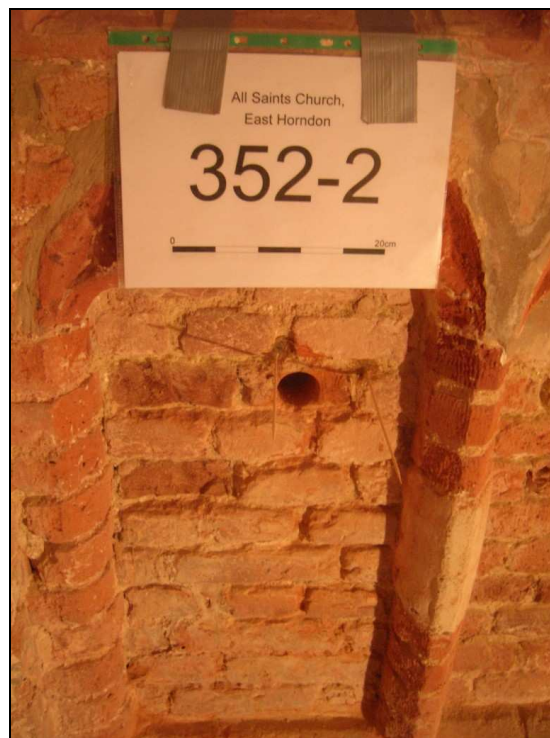
Fig. 3.87: The niche in the eastern wall of Thomas Tyrell's tomb niche. The label is covering the decorative cinquefoil corbelling located at the top of the niche. The irregularities of the bricks in this location contrast the modern replacement material located in other areas of the niche, suggesting this is authentic 'Tudor' type brick. The scale bar is 20 cm in length.

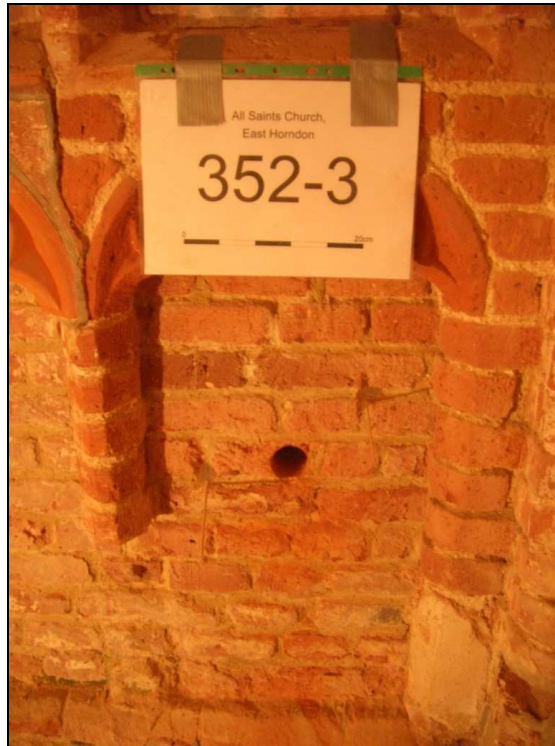
Fig. 3.88: The niche in the western wall of Thomas Tyrell's tomb niche. The label is covering the decorative cinquefoil corbelling located at the top of the niche. The irregularities of the bricks in this location contrast with the modern replacement material located in other areas of the niche, suggesting this is authentic 'Tudor' type brick. The scale bar is 20 cm in length.

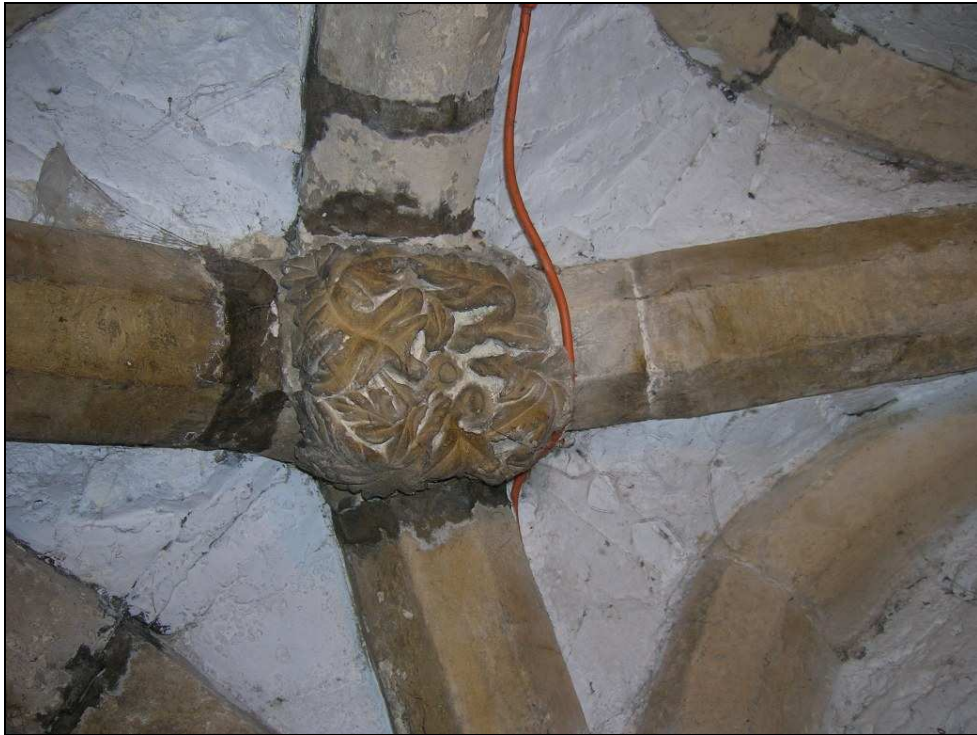
Fig. 3.91: The central boss carved with a foliage design located in the vaulting over the stairs leading down to the sunken chamber.
