Durham E-Theses

Luminescence Dating of Medieval and Early Modern Brickwork

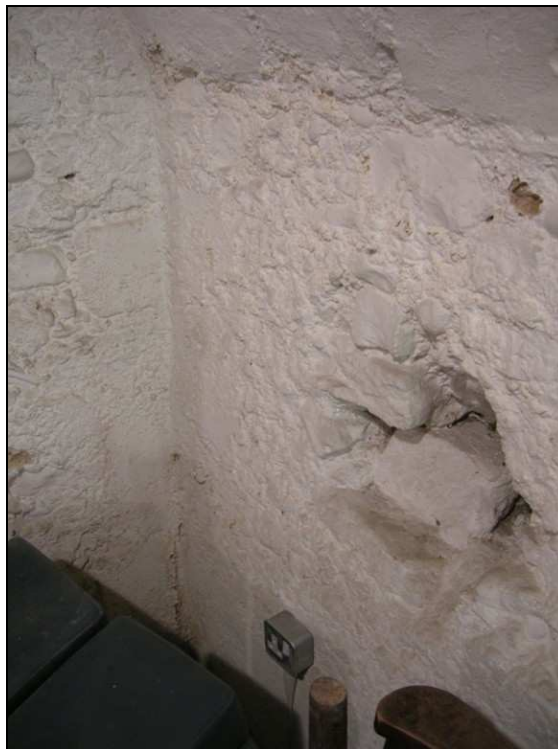
Fig. 3.95: Blocked indent at the eastern end of the southern wall of the sunken chamber. This feature might have been a piscina originally intended to serve an altar located at the east end of the chamber.

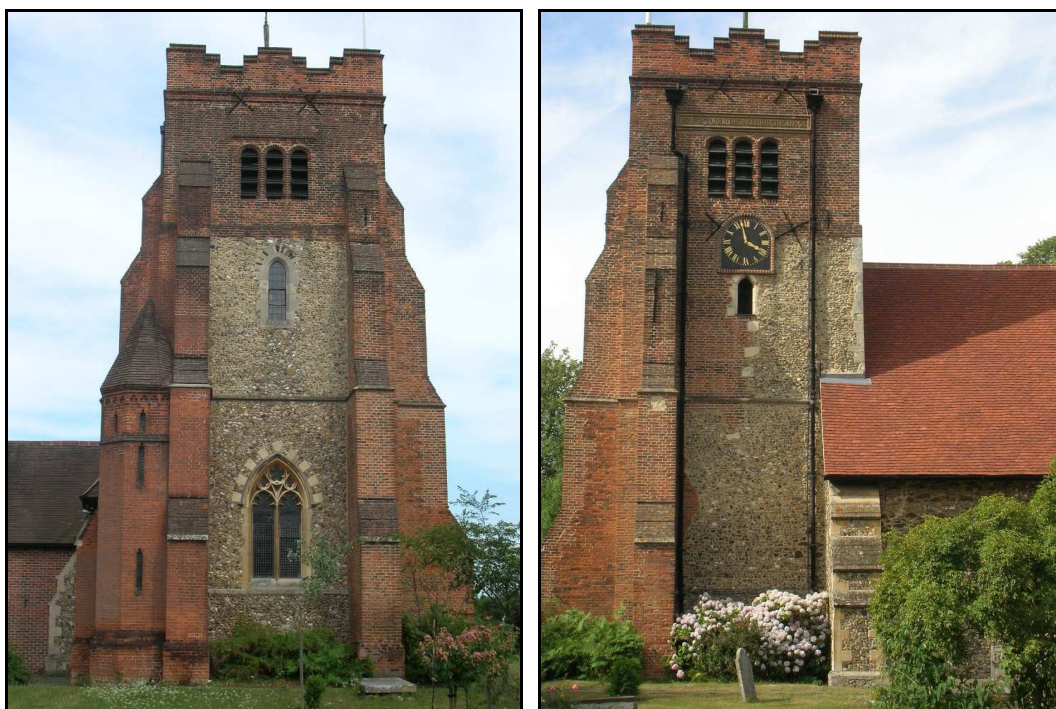
Fig. 3.98: The western tower at Springfield as seen from the west (left image) and the south (right image). Note the extensive use of brick for the third stage and the corner buttressing.

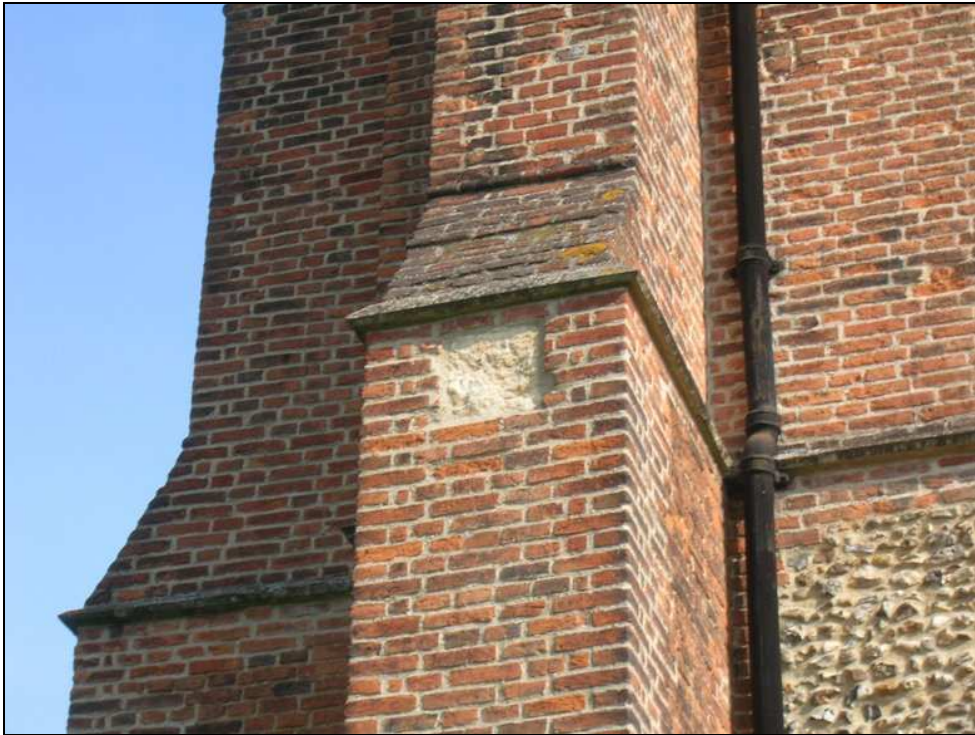
Fig. 3.100: Stone inset into the brick buttress on the southern face of the tower at the top of the first stage. Antiquarian accounts record that the Mildmay family arms and the date 1586 were originally inscribed in the stone.

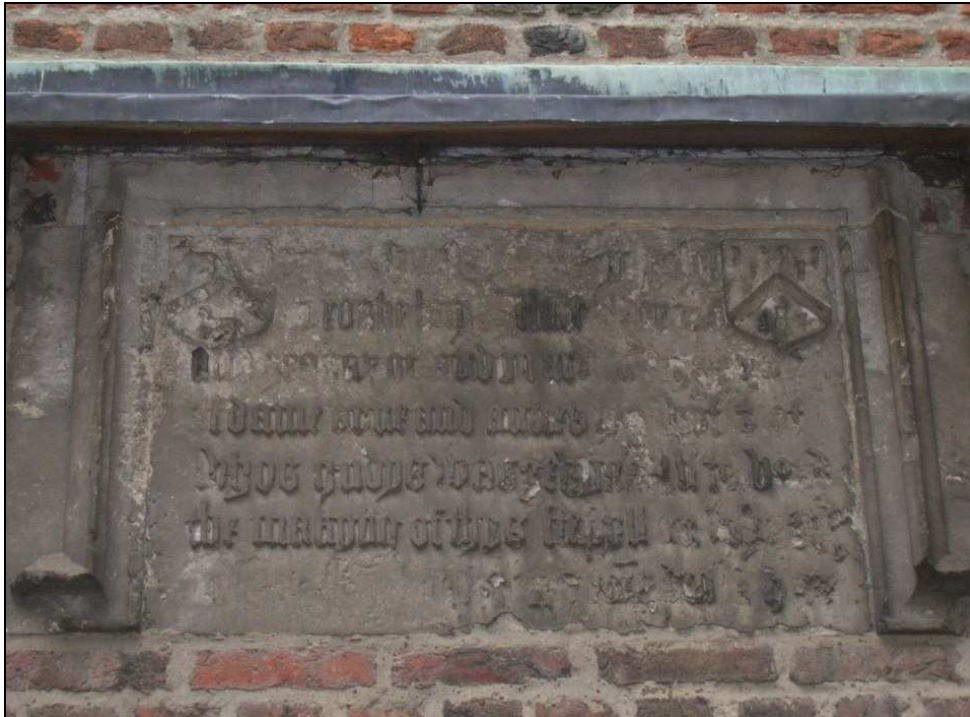
Fig. 3.104: The date plate on the southern side of the tower. Much of the inscription has been lost over time, some probably due to deliberate vandalism.

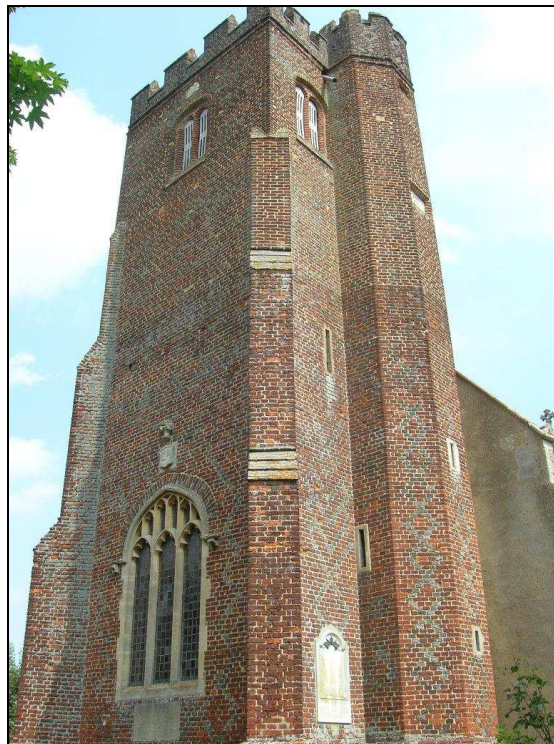
Fig. 3.108: The western brick tower of St. Margaret's church, Tilbury-juxta-Clare.

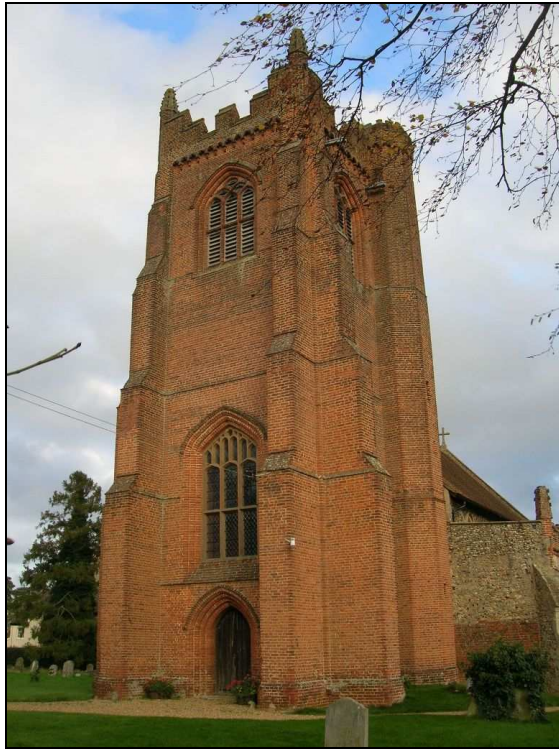
Fig. 3.110: Gestingthorpe church tower, thought to have been erected in the late 15th century.

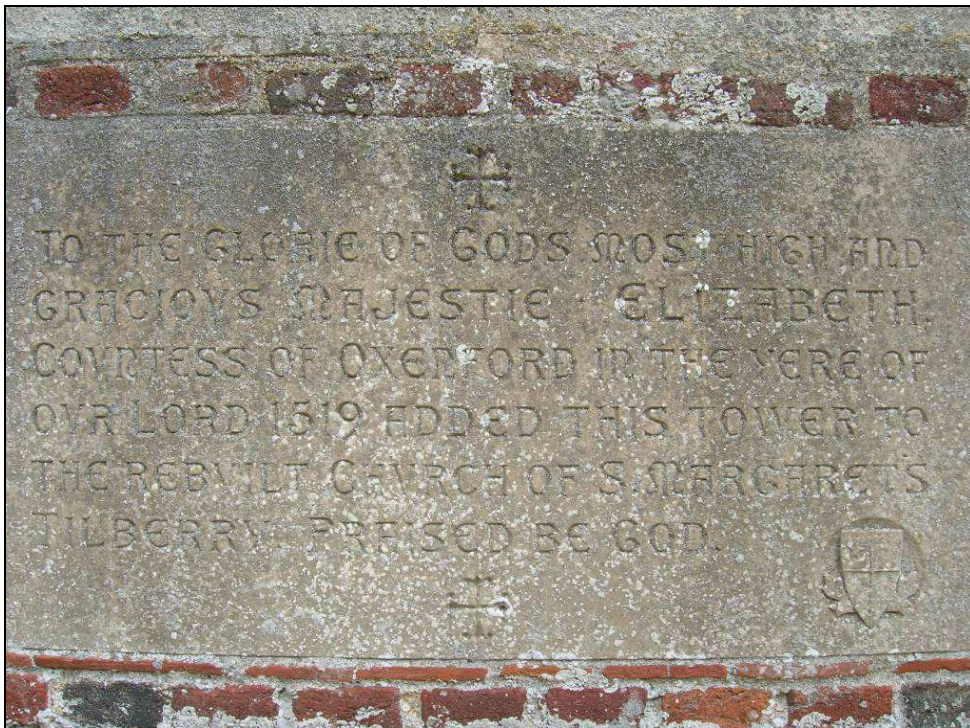
Fig. 3.111: The date plate located at the base of the western face of the tower.

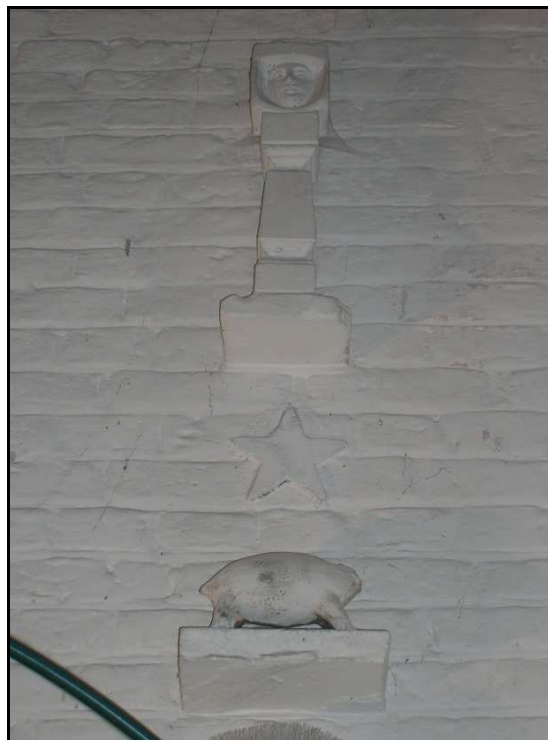
Fig. 3.112: Decorative fittings inside the church tower, probably added by Margaret Anna Brett. The lower two (the five pointed star and the headless boar) are emblems of the de Vere family.

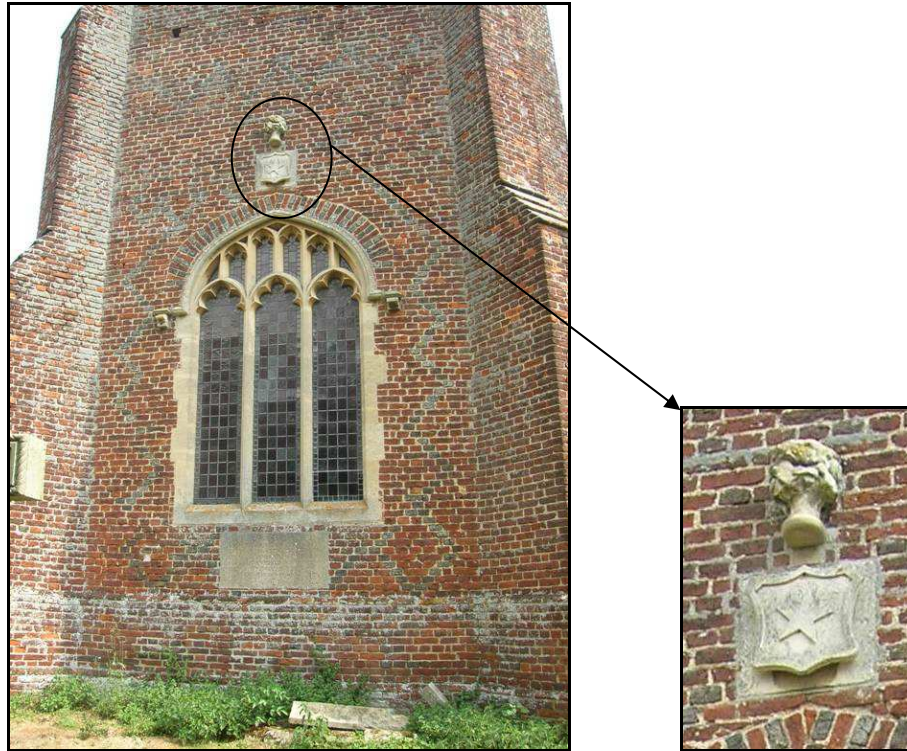
Fig. 3.113: The western face of the tower. Note the five pointed star, or mullet, located above the window, a heraldic emblem of the de Vere family. The western window, located directly above the date plate, is a modern replacement.

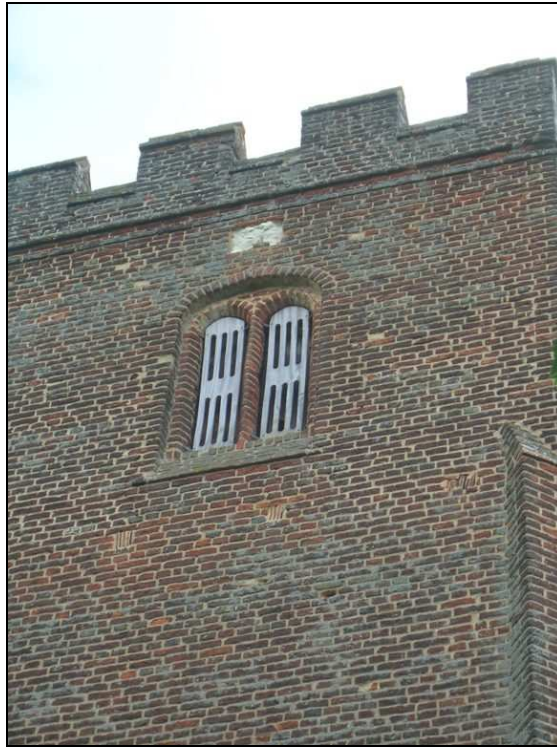
Fig. 3.114: The western face of the third stage of the tower. Note the weathered stone panel set immediately above the belfry window.

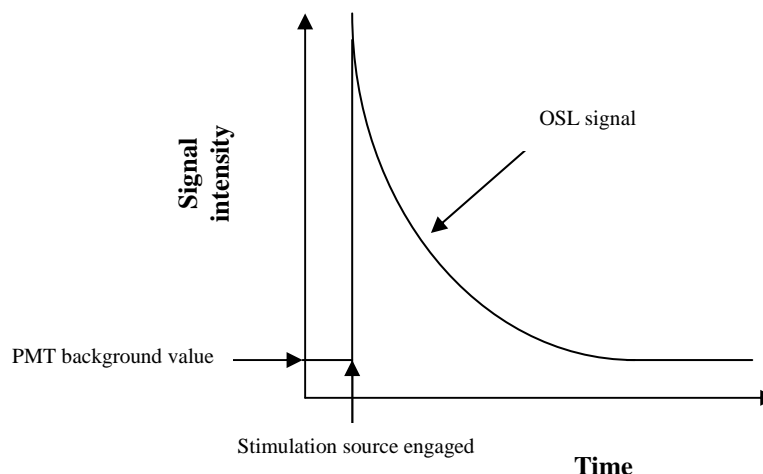
Fig. 4.2: A typical example of an OSL decay curve from quartz under constant stimulation from an optical source. The diagram shows the decrease in luminescence signal intensity due to the release of the trapped electron population over the course of time (typically, signal intensity returns to the PMT background value after a matter of seconds of stimulation) (after Aitken, 1998, 8).

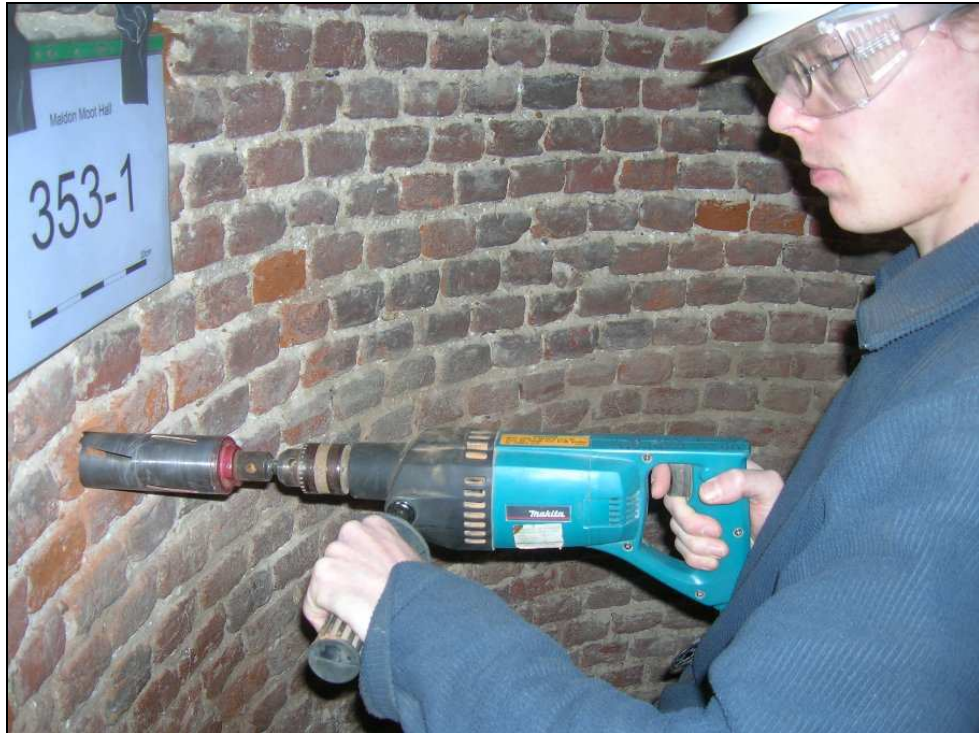
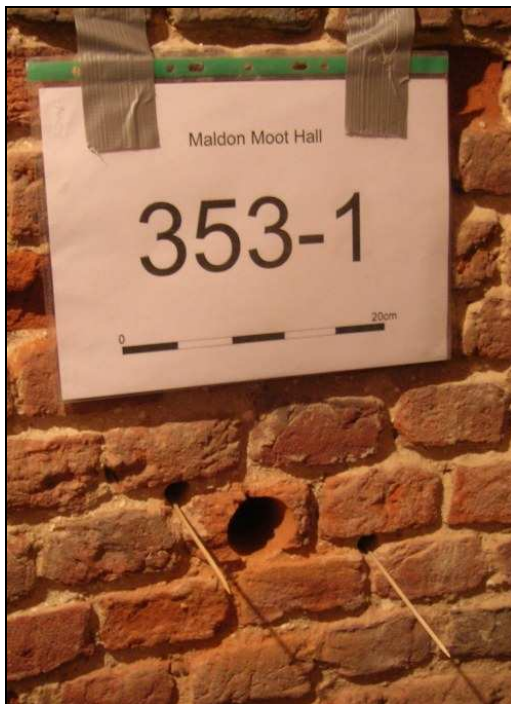
Fig. 4.4: Images illustrating the different stages in collecting a sample. The top image shows the brick selected for sampling being sampled with the electric core drill. The bottom left image shows the resulting hole after the core had been removed and the smaller holes in the mortar into which dose capsules have been inserted (the sticks to which the capsules are attached protrude from the wall face). The bottom right image shows the repair work done to the brick (circled) after sampling had been completed (the protruding parts of the dose capsule sticks were snapped off to prevent further disturbance to the capsules). The scale in the images is 20 cm in length.

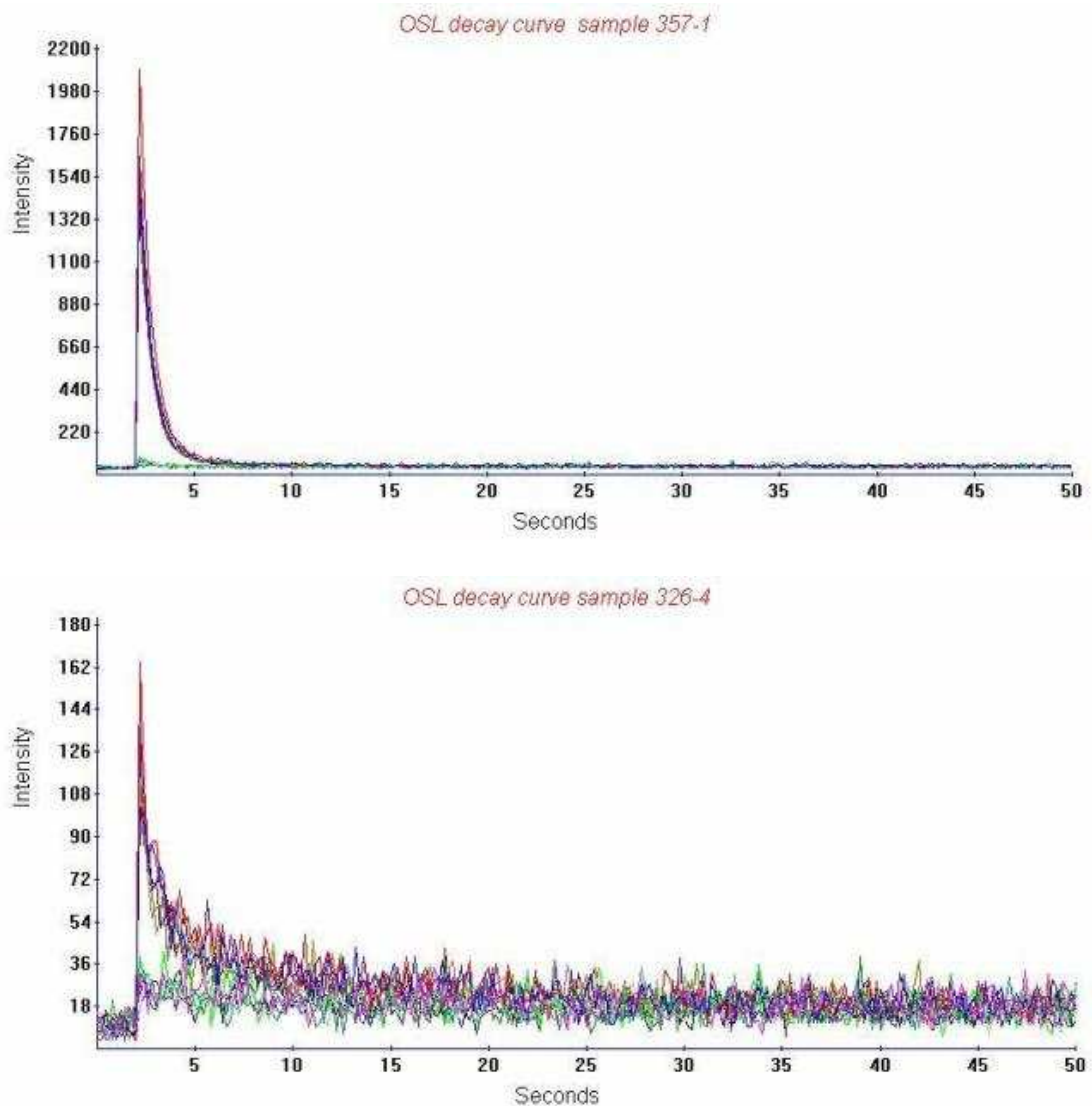
Fig. 4.7: OSL decay curves for two different samples. The top curve was for quartz extracted from sample 357-1 (Bradwell-juxta-Coggeshall) whilst the bottom curve was for quartz extracted from sample 326-4 (Nether Hall). Note the difference in the scale of signal intensity between the samples.

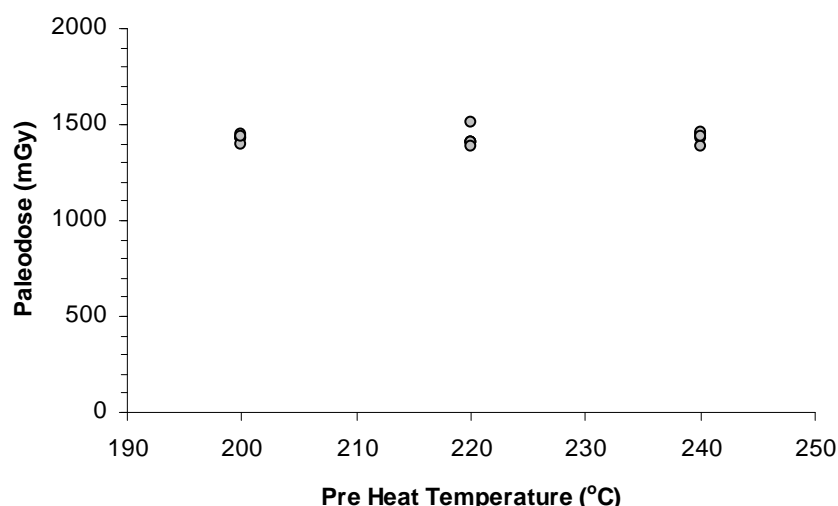
Fig. 4.9: Pre-heat plateau for sample 338-1 (Woodham Walter). Note the similarity of the paleodose values across the pre-heat temperature range. The mean paleodose derived for this sample was 1.4 Gy.

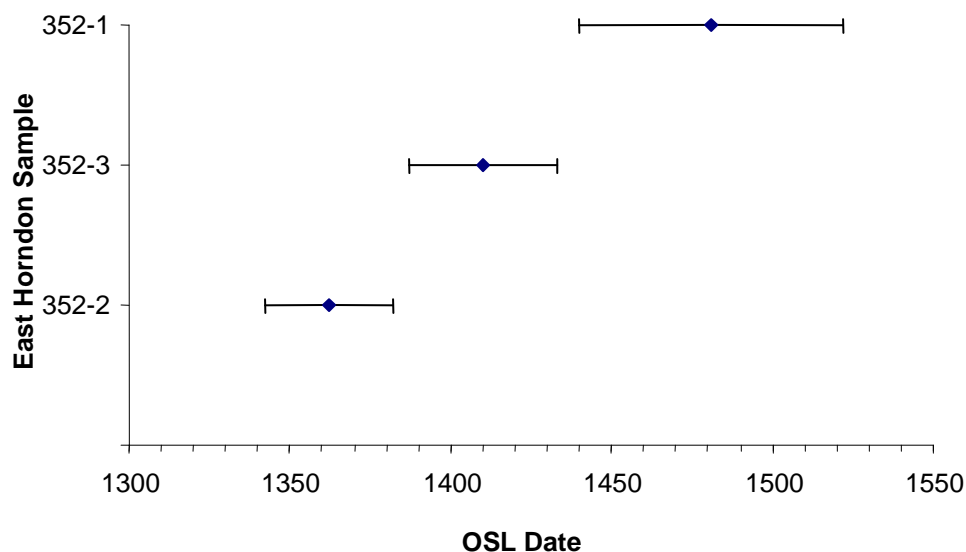
Fig. 5.5: Chronological comparison of the OSL dates derived for East Horndon (the error bars indicate $\pm 1\sigma_A$).

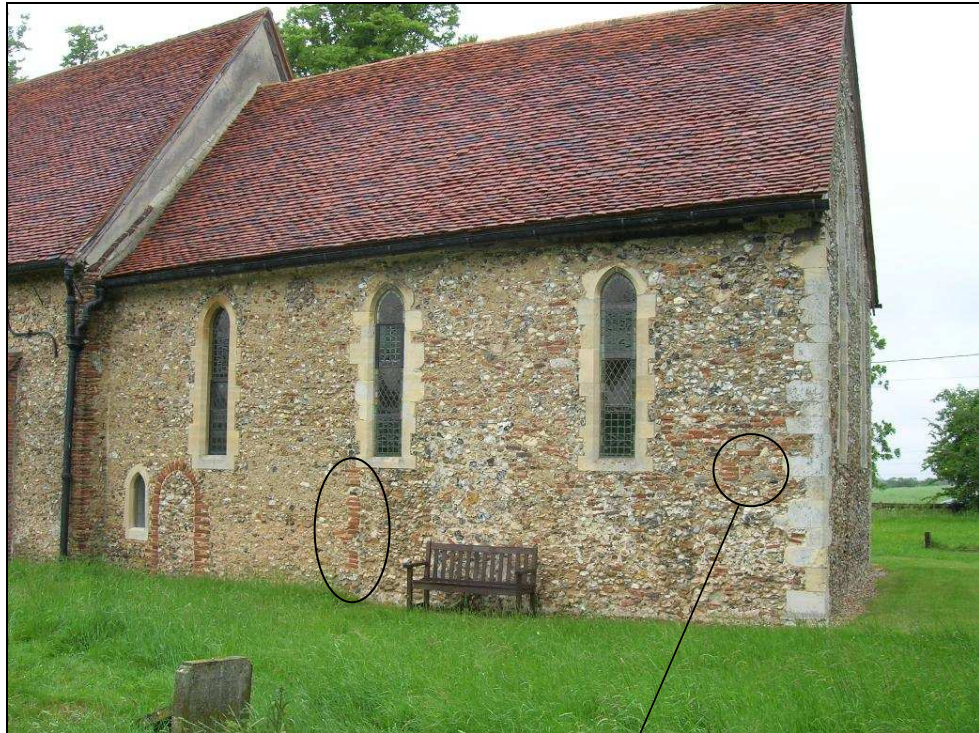
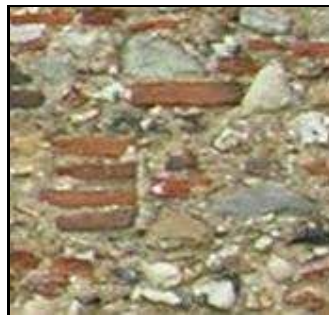
Fig. 6.1: Fairstead church chancel. The current chancel end is thought to have been extended in the 13th century, possibly replacing an earlier structure. The quoins that identify the eastern extent of the earlier structure are preserved in the wall fabric and are circled in the main image. Coggleshall type brick occurs randomly among the flint rubble walling of the 13th century square eastern end, an example of which is shown in the bottom image where Coggleshall type bricks have been used to form part of a put log hole. The occurrence of Coggleshall type bricks in the later 13th century chancel suggests re-use from an earlier context.
