DOCTORAT DE L'UNIVERSITÉ DE TOULOUSE

Degradation of the residual strength of concrete: Effect of fiber-reinforcement and of rubber aggregates - Application to thin bonded cement-based overlays

Laboratoire Matériaux et Durabilité des Constructions (LMDC) Toulouse

Key words: Repair, fiber-reinforcement, rubber aggregates, substrate surface preparation, durability, fatigue, interface debonding, digital image correlation

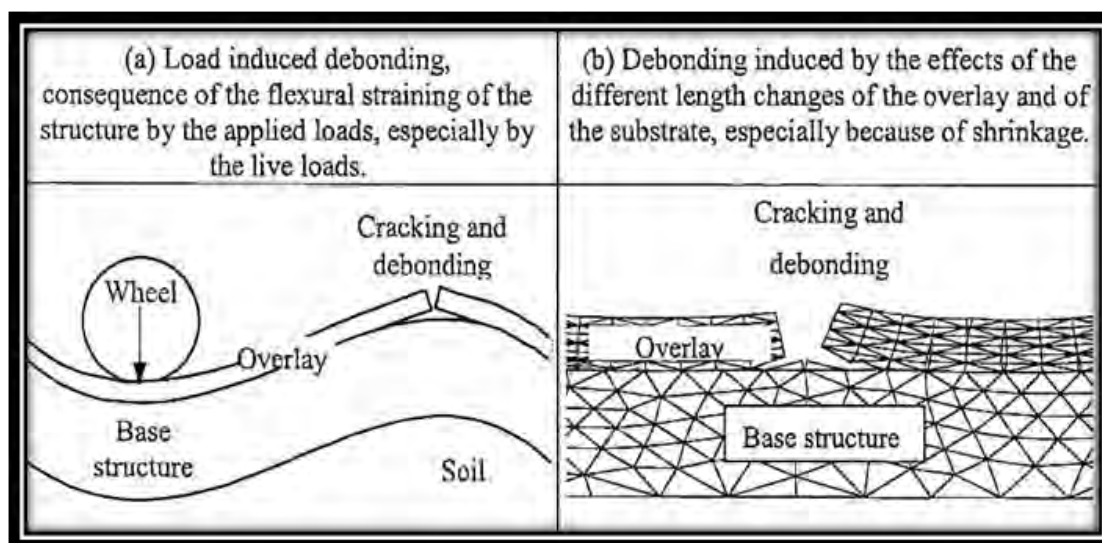
Figure I-1: Debonding induced by load and differential shrinkage (T-H. Nguyen et al., 2010)

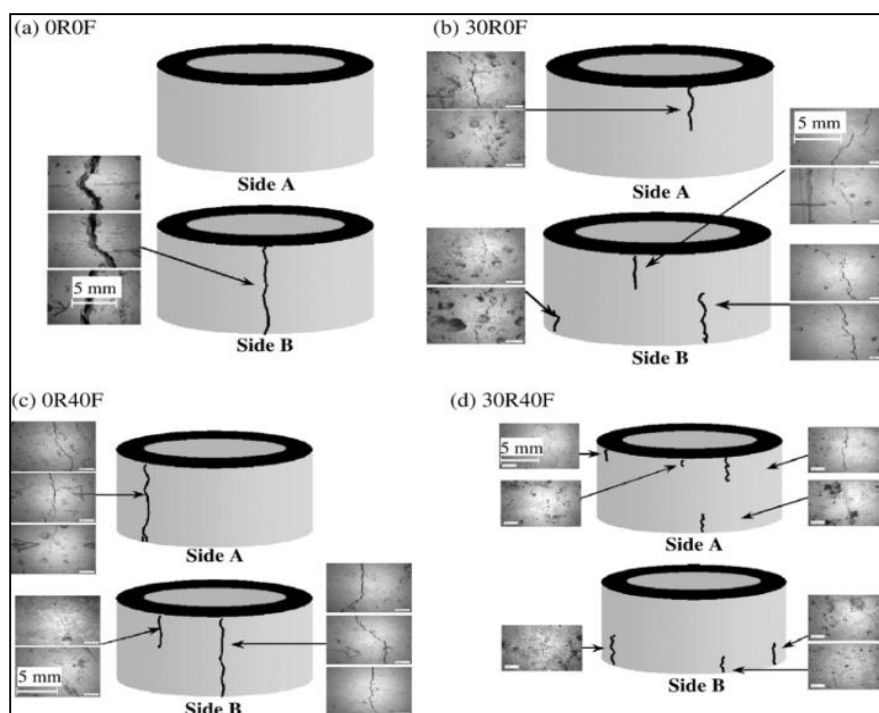
However, in case of specimens incorporating both rubber aggregates and metallic fibers (30R40F), multiple cracking with reduced crack length was observed. The opening of the crack is also limited in this type of mortar mix. So, this indicates the positive synergetic effect of the combine use of rubber aggregates and fibers.

Figure I-2: Shrinkage cracking pattern after 55 days (A. Turatsinze et al., 2006)

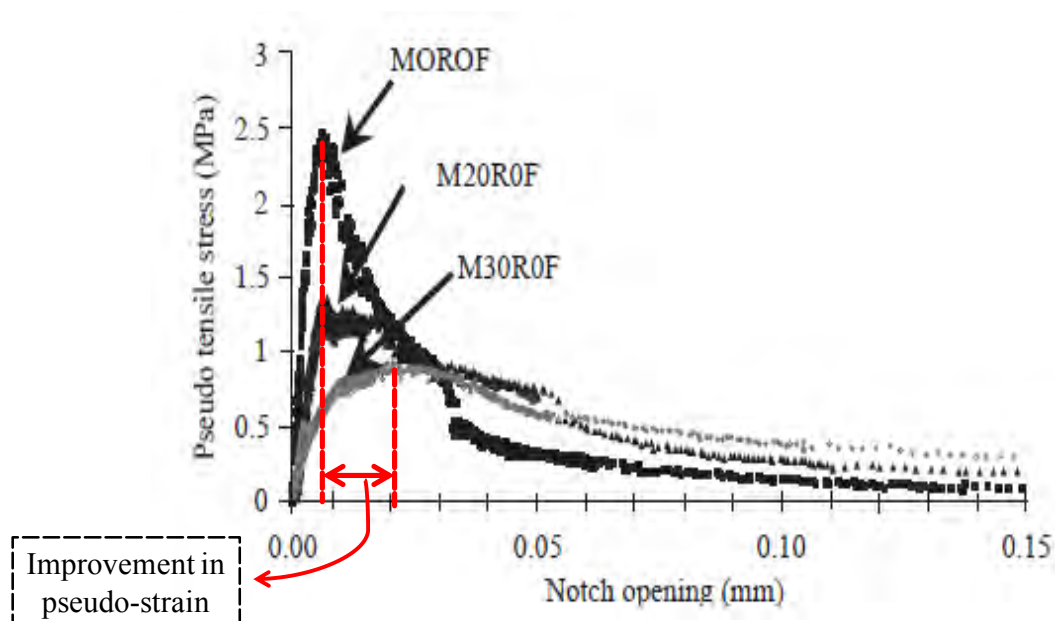
enhancing the strain capacity along with the post cracking residual strength. So, this proves that the benefits of rubber aggregates and fiber-reinforcement can be drawn simultaneously.

Figure I-3: Pseudo tensile Stress versus notch opening (A. Turatsinze et al., 2005)

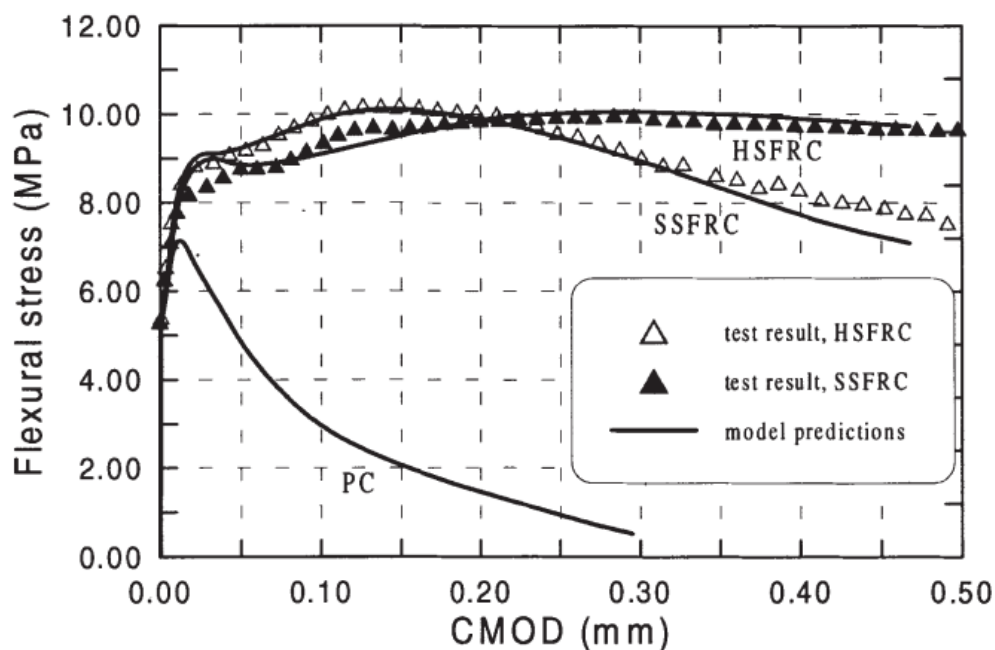
Figure I-8: Simulated flexure stress versus CMOD curves for plain concrete, SSFRC and HSFRC beams under three-point bending, shown together with experimental data (J. Zhang et al., 1999)

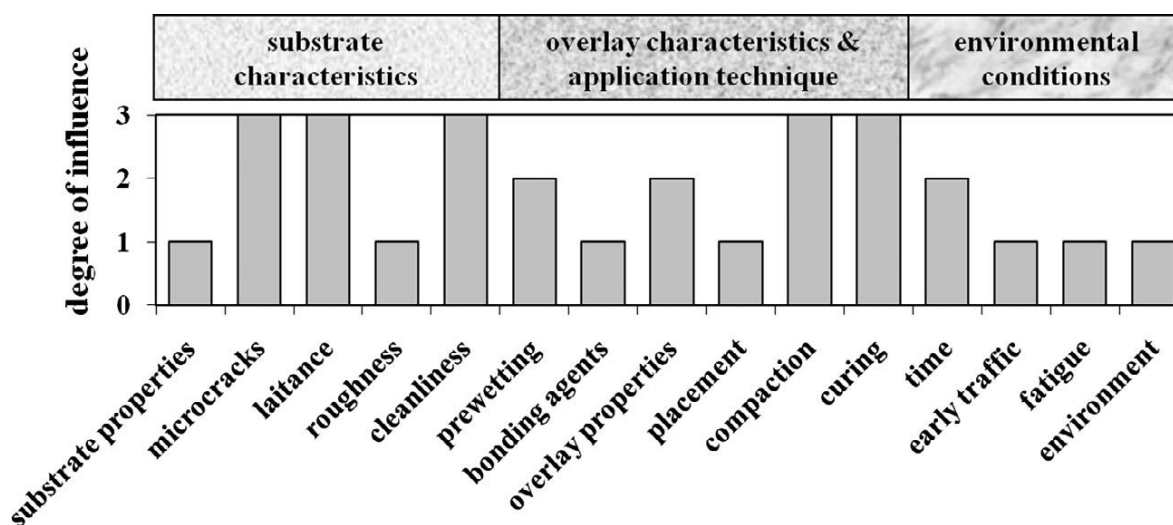
The first three parameters are directly related to the substrate characteristics and can be modified by substrate surface treatment. The substrate surface treatment is commonly done in order to improve surface roughness by removing the top weak laitance layer.

Figure I-15: Factors affecting bond between concrete substrate and repair material (J. Silfwerbrand., 1990)

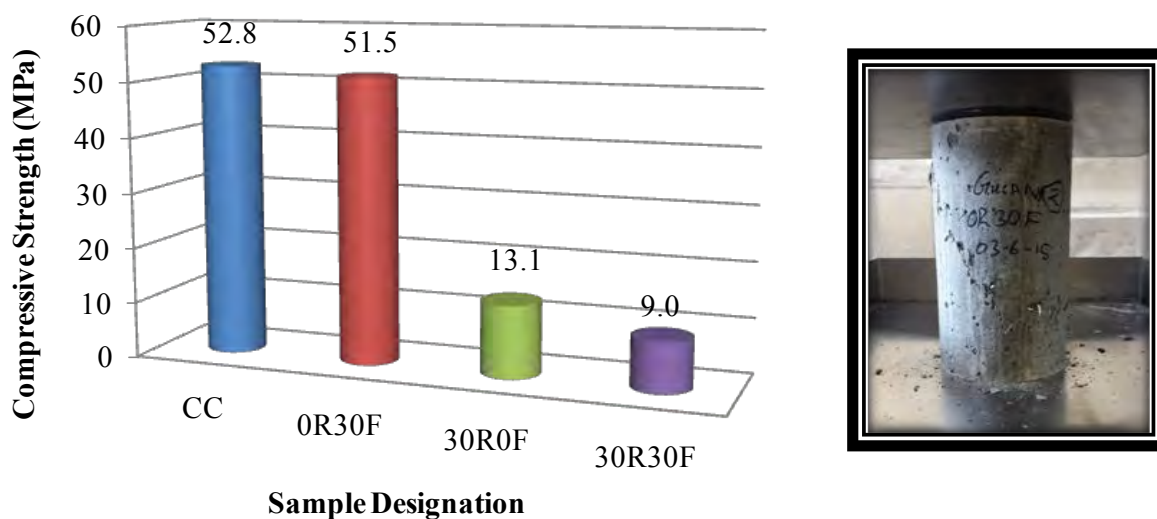
Compressive strength results of all mortar mixes containing rubber aggregates, fibers, combination of fibers and rubber aggregates and control mortar are presented in Figure II-4.

Figure II-4: Compressive strength of different mortar mixes

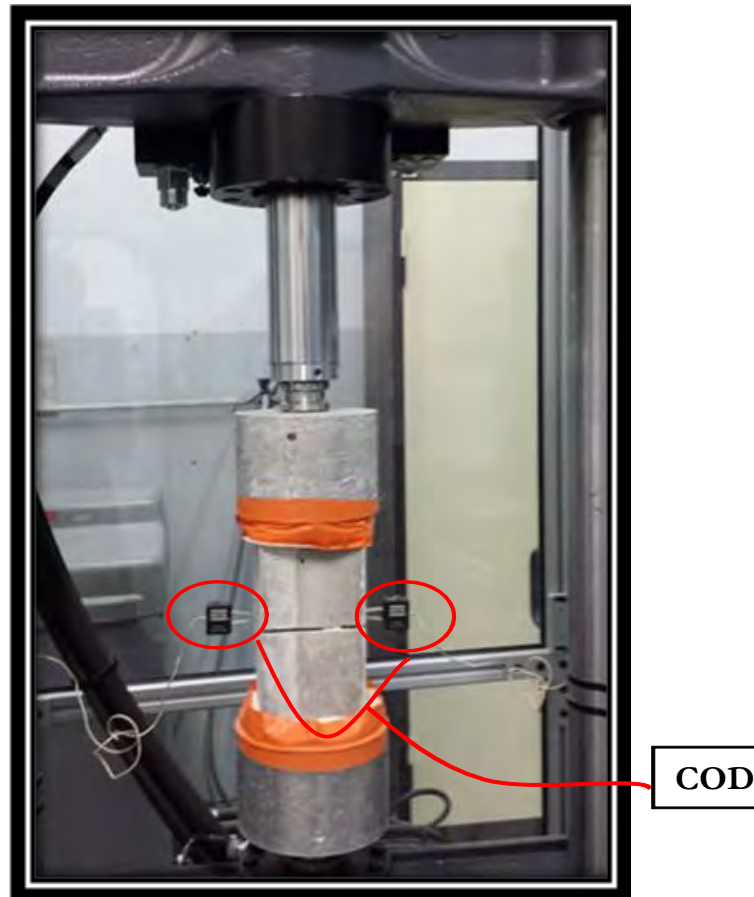
- ✚ 0 to 0.1 mm: speed equal to 5 microns / min,
- ✚ 0.1 to 1 mm: speed equal to 100 microns / min.

Figure II-8: Complete experimental testing set-up for tension test

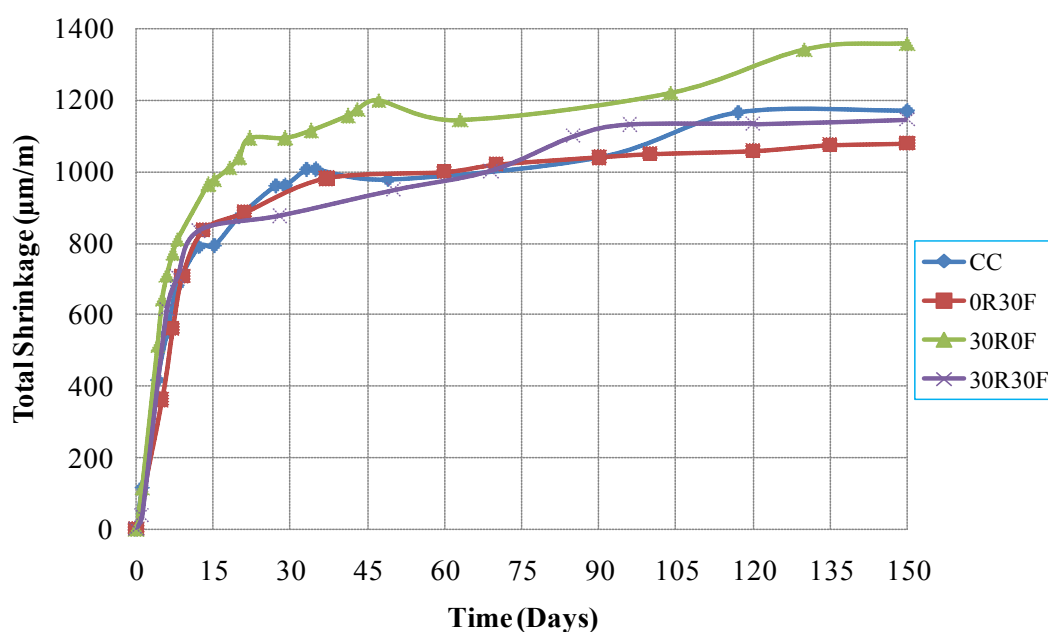
Results show that there is a significant increase in total shrinkage by incorporating rubber aggregates in mortar. The maximum total shrinkage was observed in a mortar mix with 30 percent rubber aggregates substitution (30R0F). These results are in good agreement with the previous researches (D.W. Hobbs., 1971; S. Bonnet., 2004; T-H. Nguyen., 2010), who also concluded that aggregate properties have significant impact on shrinkage of the cement-based matrix. Figure II-17 also shows that least total shrinkage was observed in a mix containing 30kg/m^3 of metallic fibers. Another noticeable thing is that the incorporation of these types of metallic fibers in mortar does not substantially reduce the shrinkage as compared to control mortar. Curves presented in Figure II-18 and Figure II-19 show that the mass loss due to water evaporation is an important factor in total shrinkage. But in case of rubberized mortar, along with the mass loss, low stiffness of rubber aggregates also play a vital role in order to enhance the shrinkage phenomena.

Figure II-17: Evolution of total shrinkage in different mortar mixes during period of 150 days

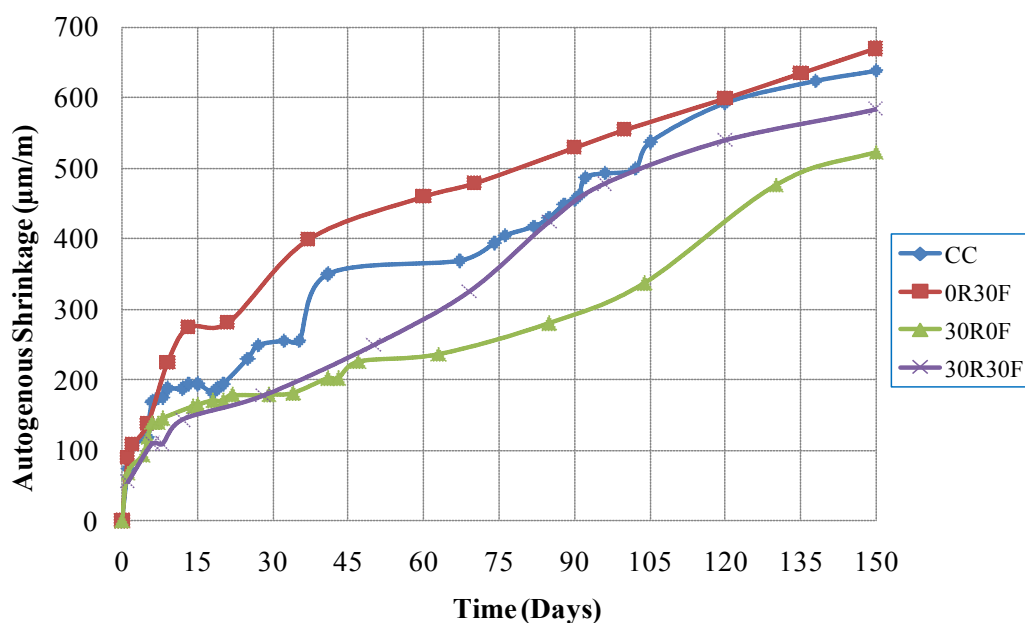
Results show that fiber-reinforcement of mortar does not reduce the autogenous shrinkage. On the contrary, fiber-reinforcement in mortar leads to a slight increase in autogenous shrinkage. A similar trend was found in some previous studies (F. Grandhaie., 1993; S. Bonnet., 2004). Also, some reduction in autogenous shrinkage was observed by rubber aggregates substitution in mortar. In rubberized mortar this early reduction in autogenous shrinkage is not because of rubber particles, but due to the high dosage of viscosity modifying agent (VMA). Since, it is necessary to add these VMAs in rubberized mortar for avoiding segregation of rubber particles. It was also reported in previous research (C. Ciobanu, et al., 2013) that by addition of these VMAs, small proportion of $\text{Ca}(\text{OH})_2$ produce which as a result delay the cement hydration process.

Figure II-20: Evolution of autogenous shrinkage in different mortar mixes during period of 150 days

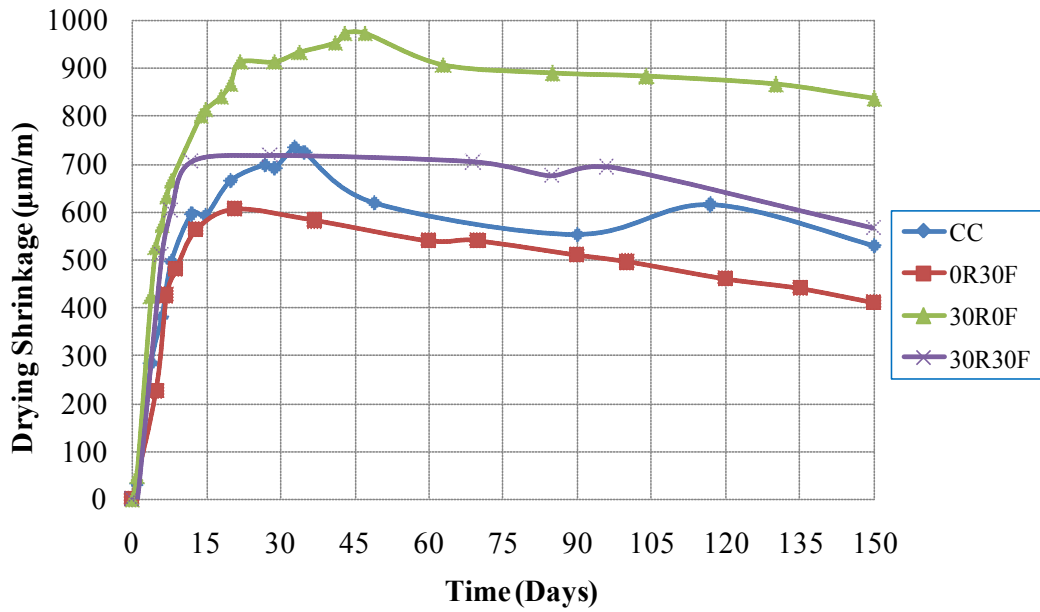
Figure II-21 shows the drying shrinkage values in the studied mortar mixes. The graphs show that there is a significant increase in drying shrinkage by incorporating rubber aggregates in mortar. In rubberized mortar almost 30% increase in drying shrinkage is observed as compared to control mortar. As far as the influence of fibers on drying shrinkage is concerned, results show some reduction in drying shrinkage as compared to control mortar. Also, it is evident from Figure II-21 and Figure II-22 that the combine use of rubber aggregates and fibers (30R30F) in a mortar is helpful to limit the shrinkage phenomena, especially the shrinkage induced due to low stiffness of rubber aggregates. And fiber-reinforcement of rubberized mortar try to counter balance the shrinkage additionally induced by the aggregates with low stiffness (rubber aggregates).

Figure II-21: Evolution of drying shrinkage in different mortar mixes during period of 150 days

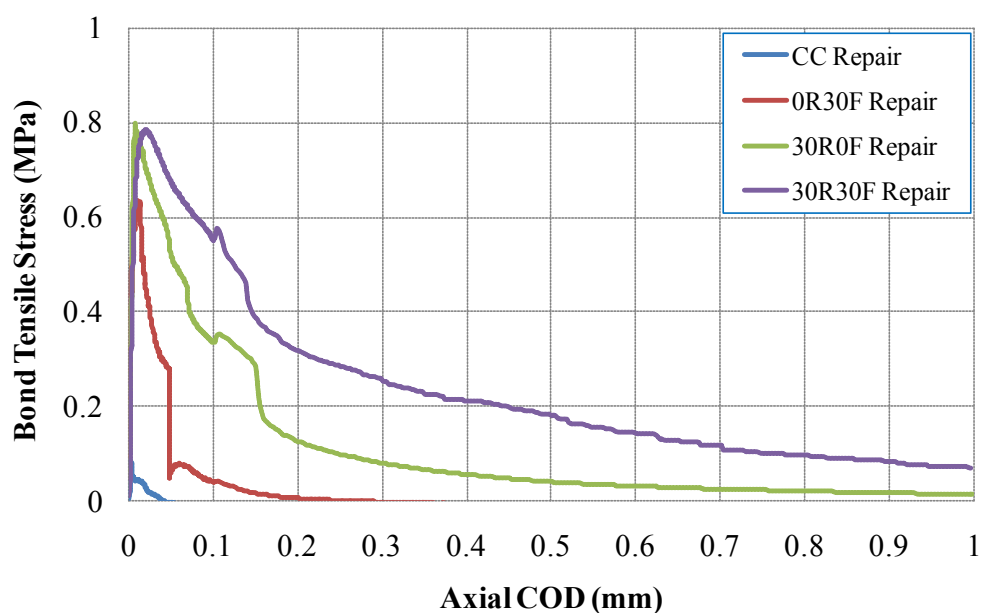
Figure III-15: Strain capacity behavior with different overlay repair materials

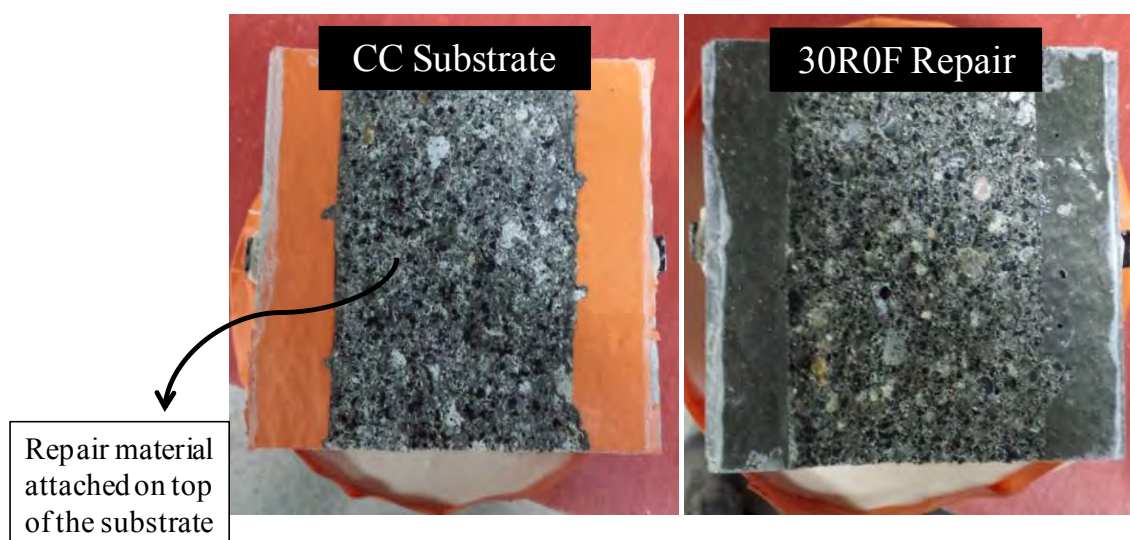
When tension tests were conducted on the specimens repaired with rubberized mortar (30R0F) or fiber-rubberized mortar (30R30F), it was noticed that failure started from interface location between repair and substrate, but the major damage occurs in the repair material as indicated in Figure III-16 and Figure III-20. This means that the bond tensile strength is more than the one of repair material. Results also show that the incorporation of metallic fibers along with the rubber aggregates in the repair material didn't significantly affect the bond tensile strength. Since, fibers didn't play their role effectively, because these fibers have no bond with the substrate mortar. The bond tensile strengths are almost same in specimens repaired with rubberized mortar (30R0F) and fiber-rubberized mortar (30R30F).

Figure III-16: View of broken sample with 30R0F repair, showing the fracture mainly occurred in the repair material

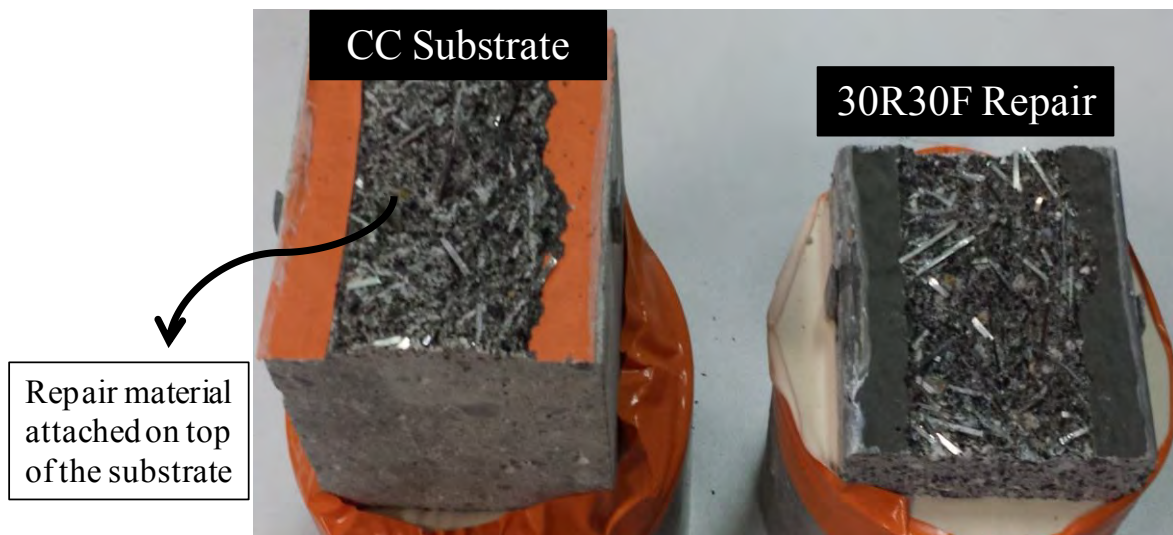
Figure III-20: View of broken sample with 30R30F repair, showing the fracture mainly occurred in the repair material

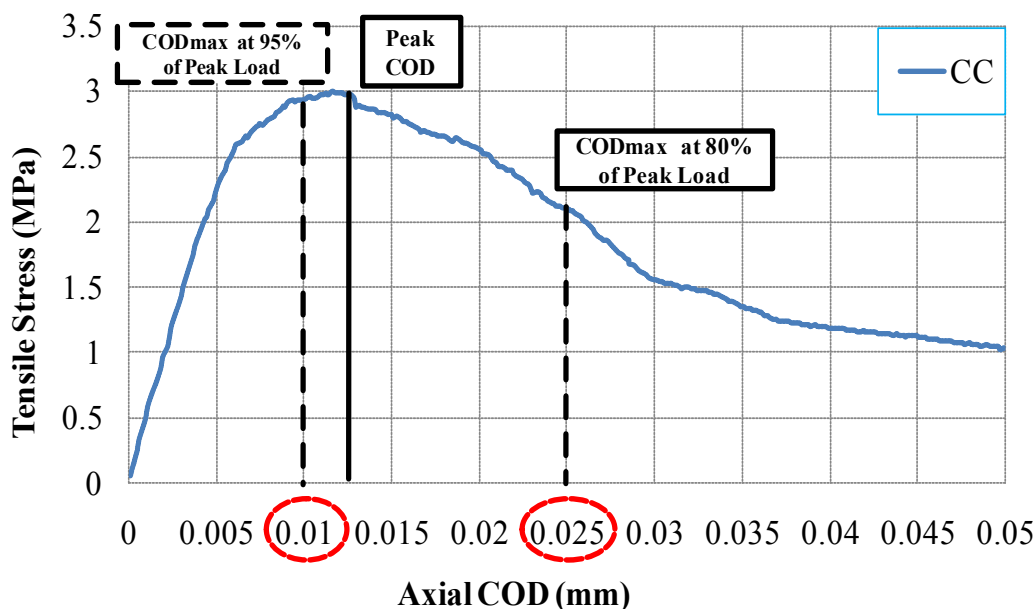
The uniaxial tensile fatigue tests were conducted on the prismatic pre-notched specimen shown in Figure IV-2. Similar procedure was adopted for sample fixation on interchangeable steel blocks by using fast curing glue as previously done in simple direct tension test. Firstly, the direct tension tests were conducted for each mix composition in order to access the peak load and the corresponding crack opening value. After that, control mortar (CC) is taken as a reference as shown in Figure IV-4. With reference to peak COD of control mortar, two COD values were selected as pre-cracked width (COD_{max}) for fatigue loading. One before peak COD and second after peak COD. A uniaxial tensile fatigue test was conducted between this maximum pre-cracked width (COD_{max}) and zero load. The above selected two COD_{max} values for control mortar (reference mortar) was used not only for control mortar but also for other mortar mixes in order to make comparison in degradation of bridging strength under tensile fatigue load. A fatigue loading with 5Hz frequency is conducted between this COD_{max} value and zero load.

Figure IV-4: Selection of COD_{max} for tensile fatigue loading corresponding to control mortar

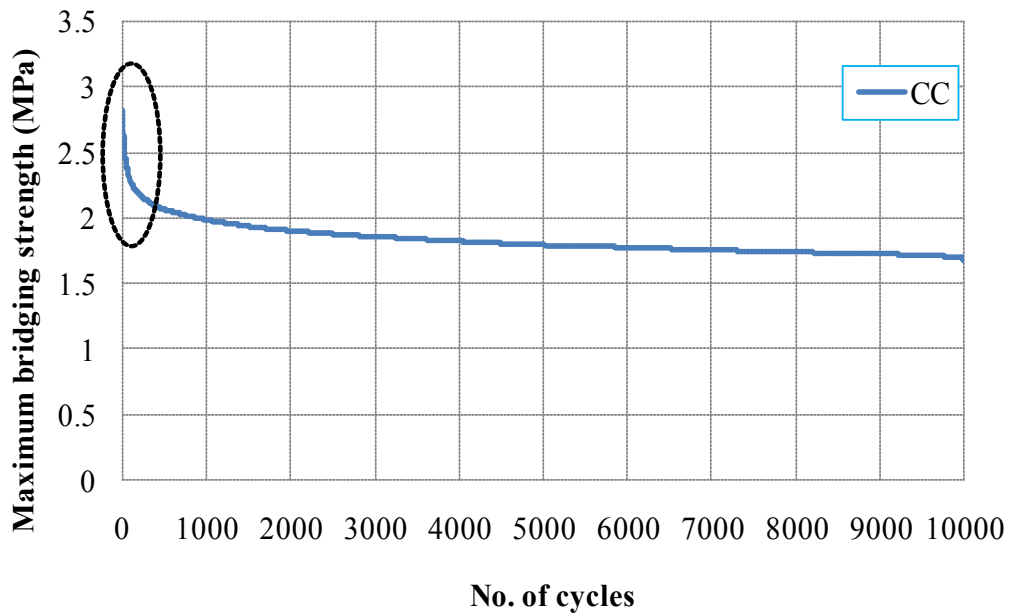
Figure IV-7: Test results of maximum bridging strength vs. number of cycles for control mortar corresponding to $COD_{max} = 0.025$ mm

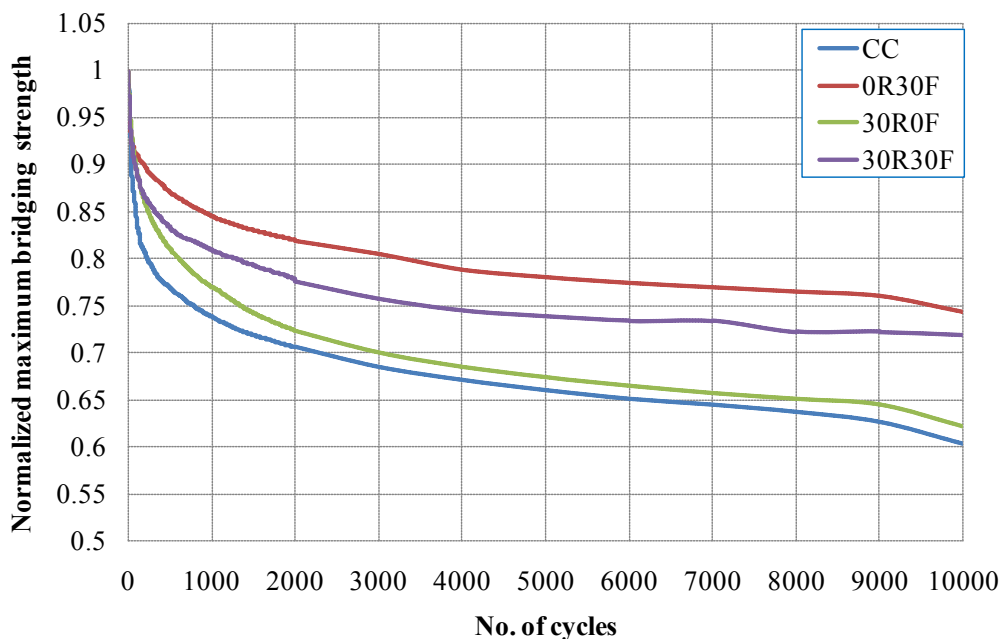
Moreover, a mortar mix incorporating both rubber aggregates and metallic fibers (30R30F) appeared as a suitable mix composite to limit the cyclic bridging strength degradation at a wide range of pre-cracked width values. This is due to the double bridging action provided by rubber aggregates as well as fibers. At less pre-cracked width value, rubber aggregates provide bridging and at large pre-cracked width value, fibers play their role. So, the composite matrix containing both rubber aggregates and fibers is found helpful to limit bridging strength degradation at different pre-cracked widths. Figure IV-11 and Figure IV-14 show the normalized maximum bridging strength degradation values in different mortar mixes at 10^4 cycles, corresponding to maximum crack widths of 0.010 mm and 0.025 mm respectively. Figure IV-10 and Figure IV-13 represent the relationship between normalized maximum bridging strength and number of fatigue load cycles on a logarithmic scale corresponding to the maximum crack width of 0.010 mm and 0.025 mm respectively. Figure IV-15 shows the comparison of normalized maximum bridging strength degradation values in different mortar mixes corresponding to different pre-cracked width values at 10^4 cycles.

Figure IV-9: Relationship between normalized maximum bridging strength and number of fatigue cycles corresponding to $COD_{max} = 0.025$ mm

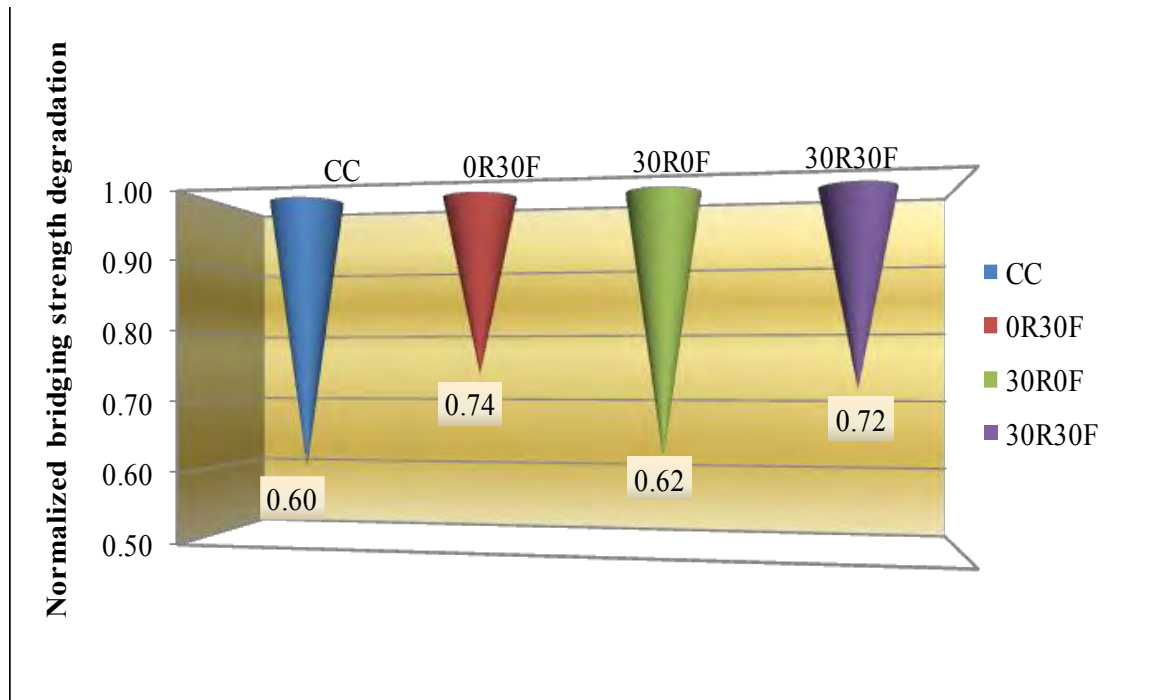
Figure IV-11: Normalized maximum bridging strength degradation values in different mortar mixes corresponding to $COD_{max} = 0.025$ mm at 10^4 cycles

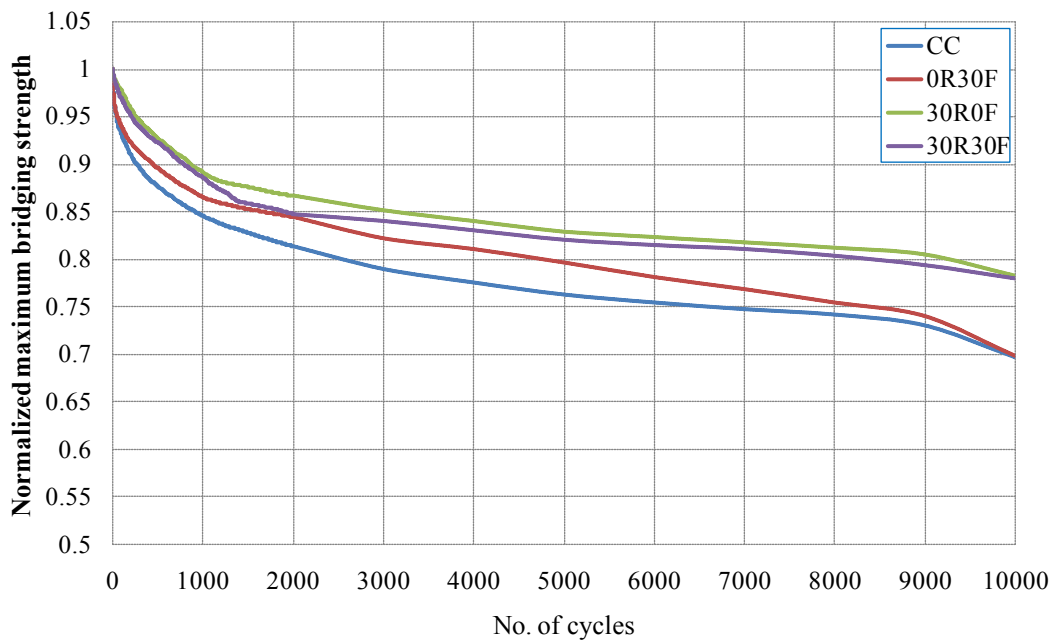
Figure IV-12: Relationship between normalized maximum bridging strength and number of fatigue cycles corresponding to $COD_{max} = 0.010$ mm

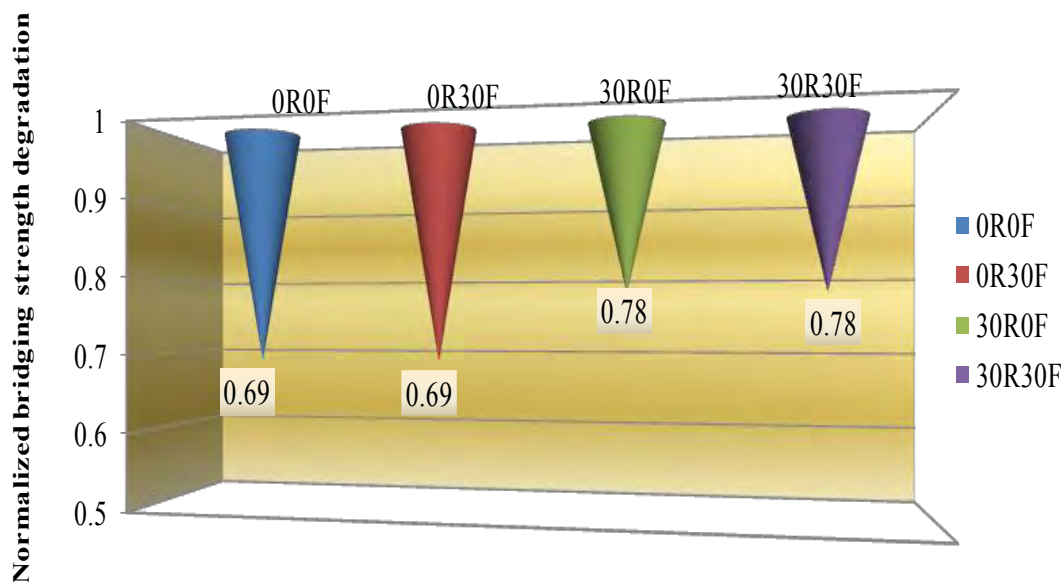
Figure IV-14: Normalized maximum bridging strength degradation values in different mortar mixes corresponding to $COD_{max} = 0.010$ mm at 10^4 cycles

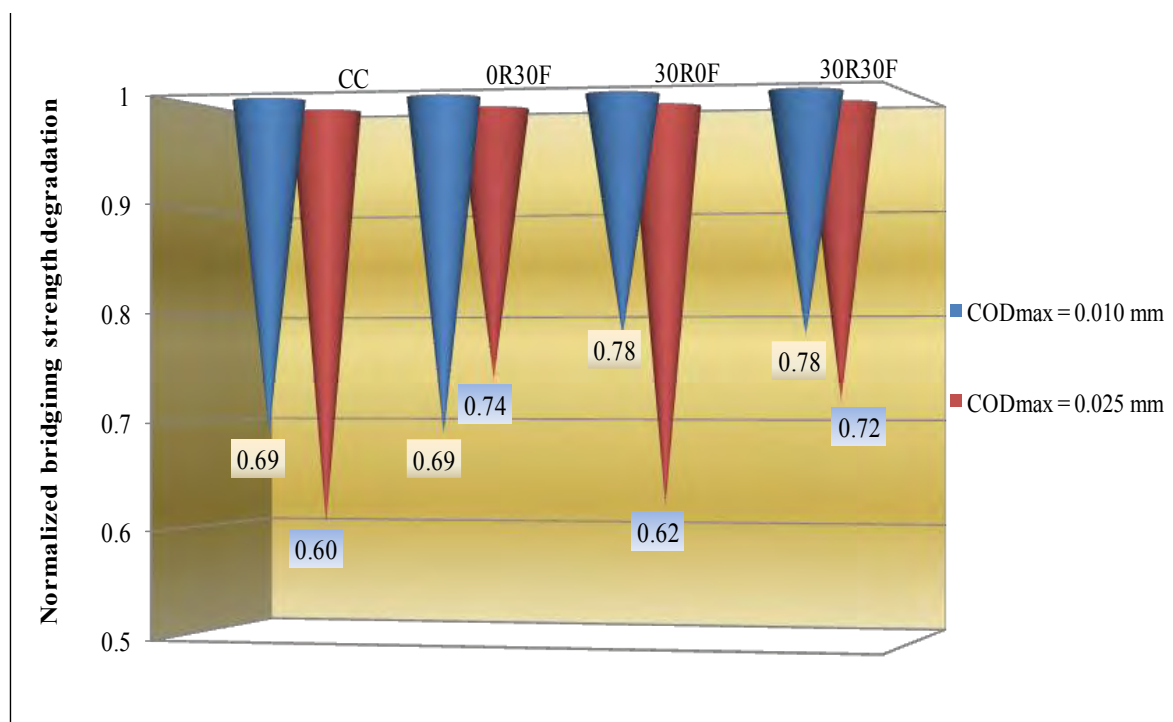
Figure IV-15: Comparison of normalized maximum bridging strength degradation values in different mortar mixes, corresponding to different pre-cracked widths (COD_{max}) at 10^4 cycles

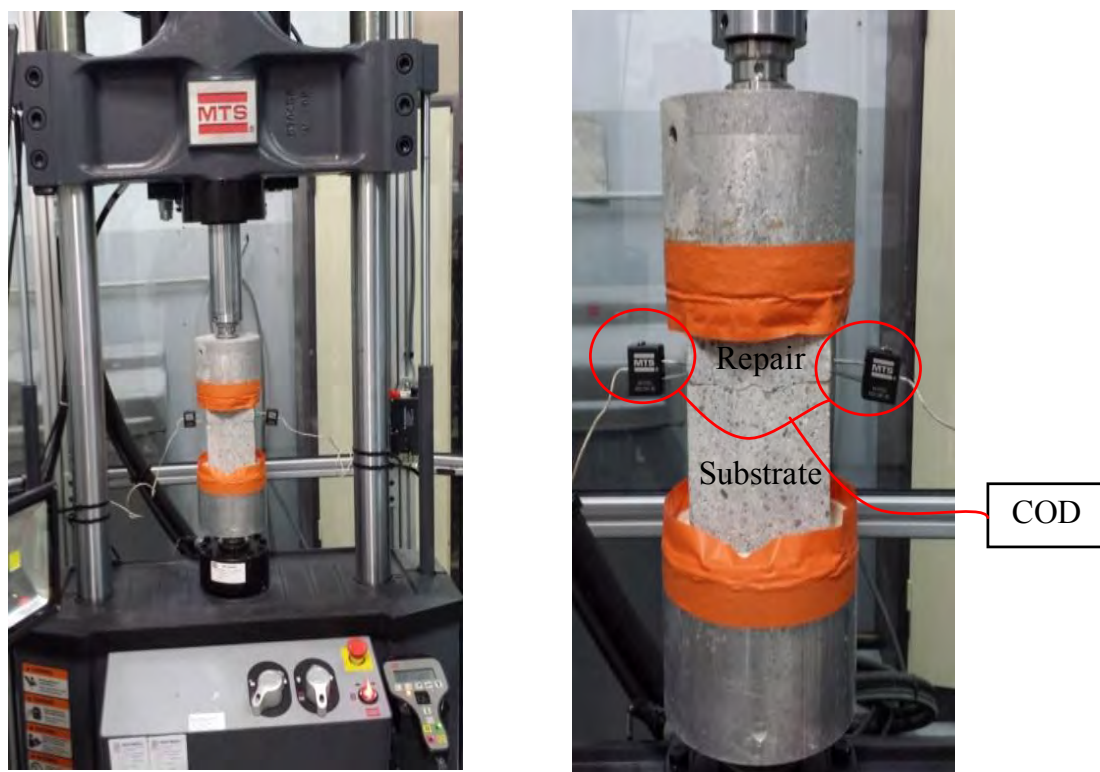
Figure IV-18: Complete experimental testing set-up for determining interfacial bond strength degradation

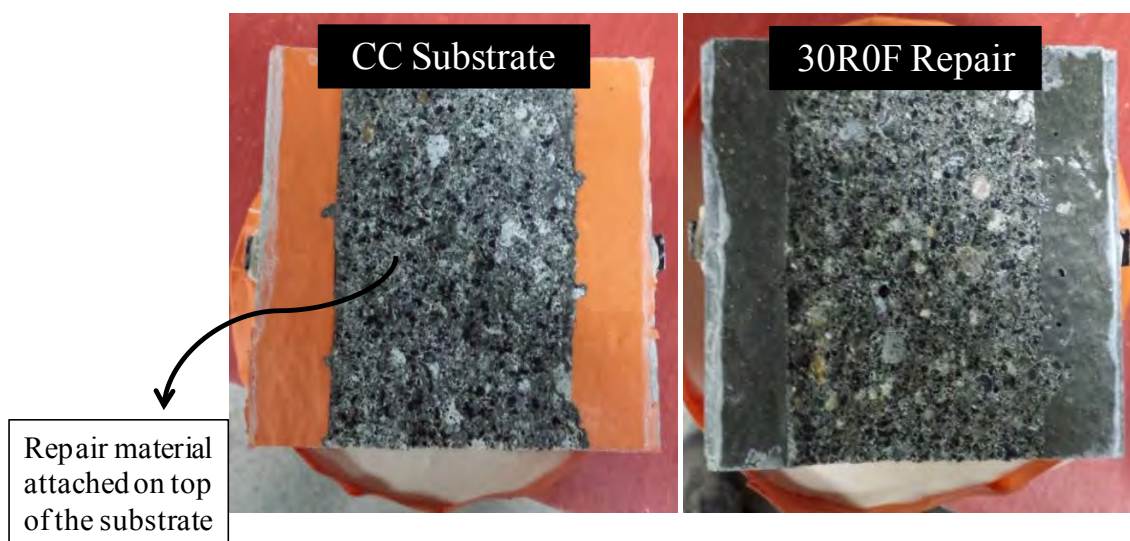
Figure IV-20: View of broken sample with 30R0F repair after conducting bond tension test

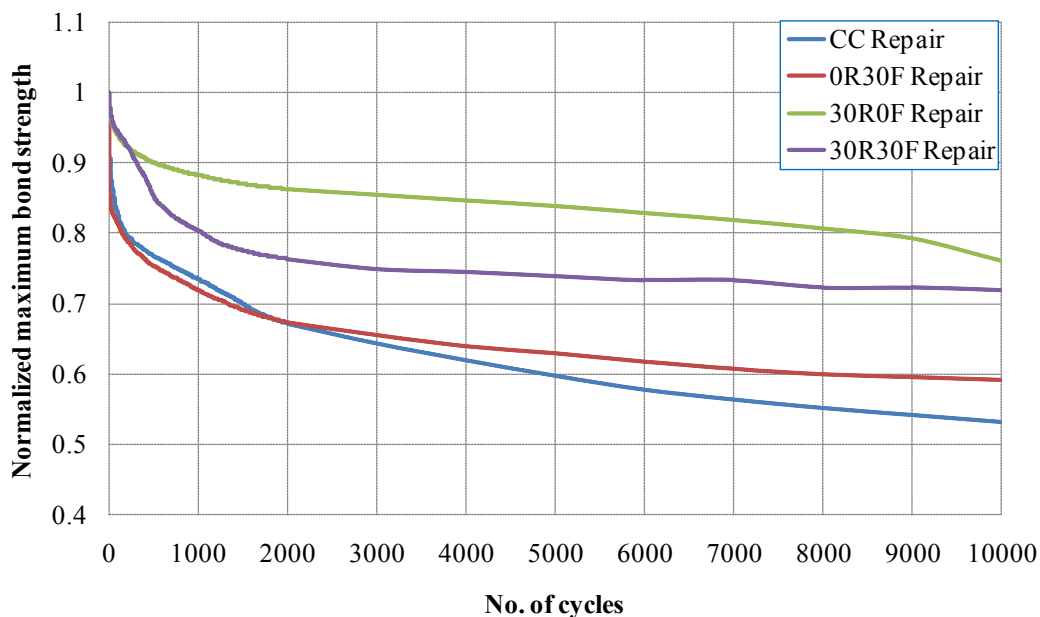
Figure IV-21: Relationship between normalized maximum bond strength and number of fatigue cycles corresponding to $COD_{max} = 0.010$ mm

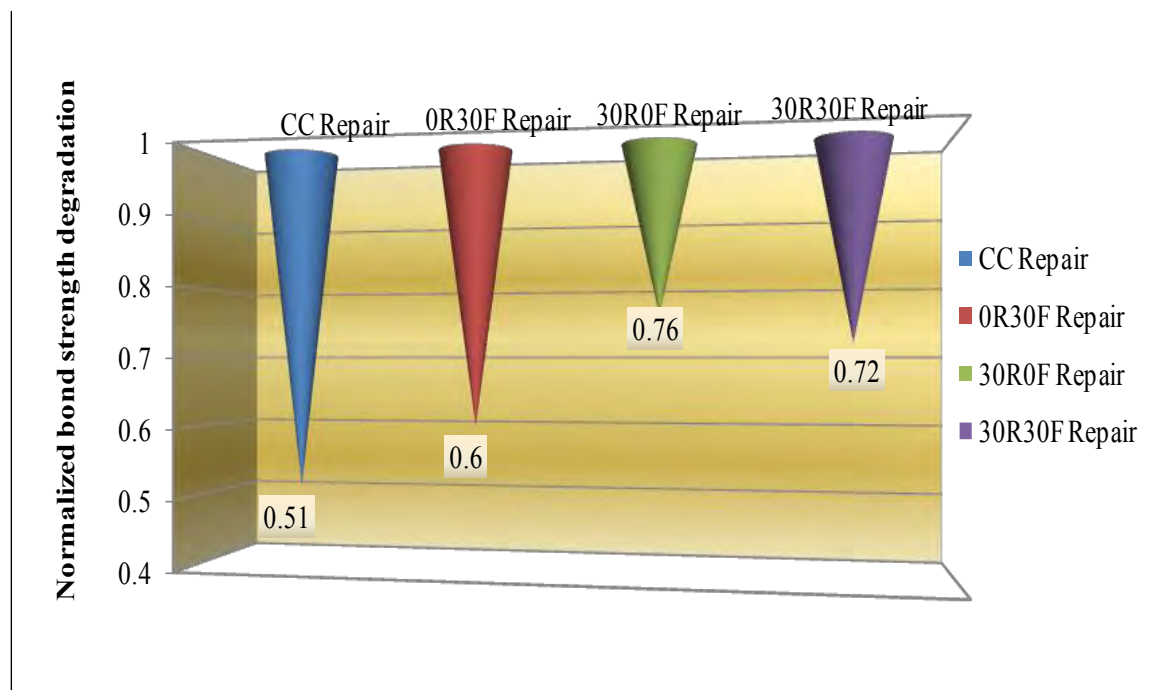
Figure IV-23: Normalized maximum bond strength degradation with different repair mortar mixes corresponding to $COD_{max} = 0.010$ mm at 10^4 cycles

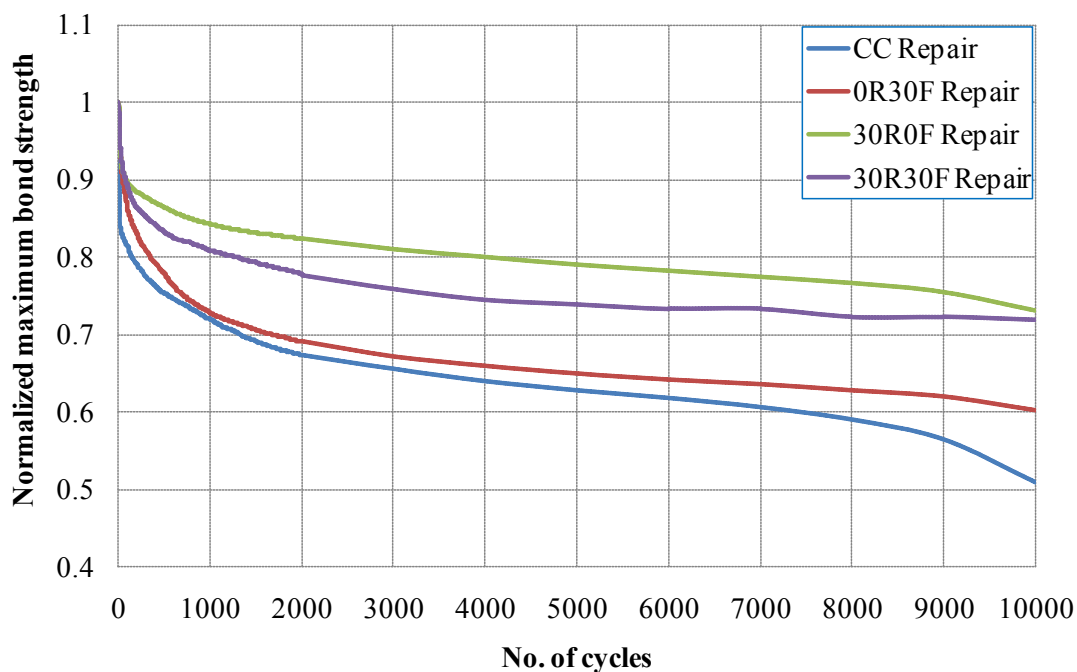
Figure IV-24: Relationship between normalized maximum bond strength and number of fatigue cycles corresponding to $COD_{max} = 0.020$ mm

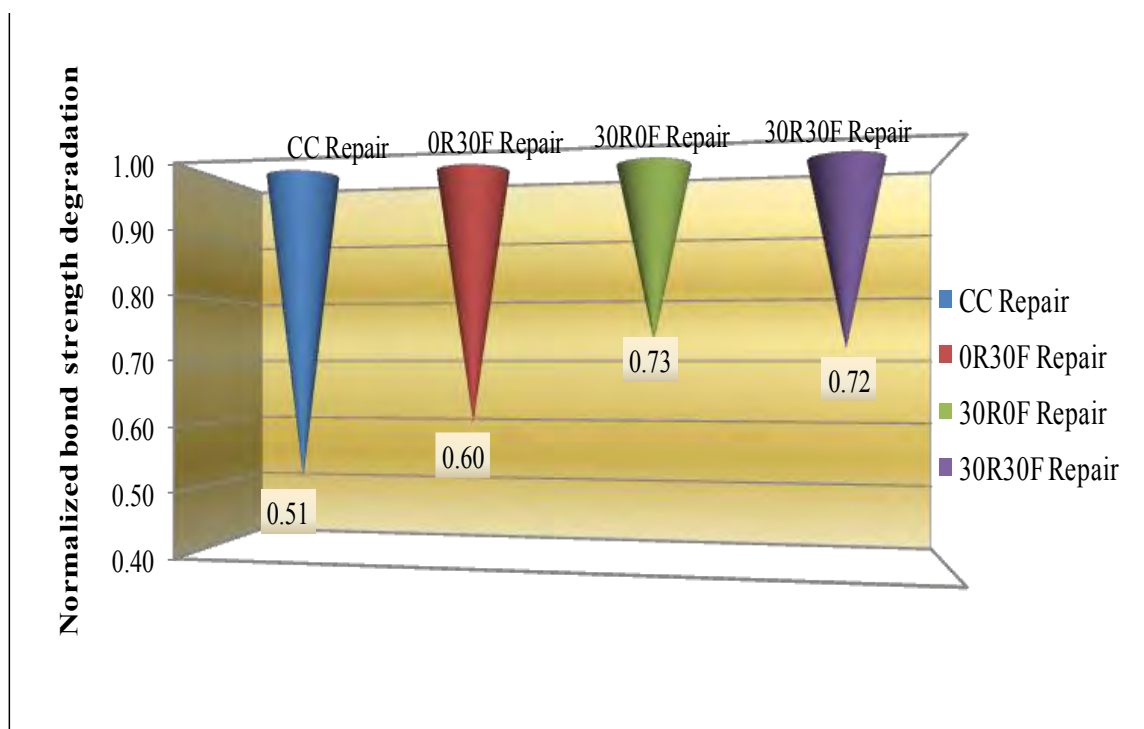
Figure IV-26: Normalized maximum bond strength degradation with different repair mortar mixes corresponding to $COD_{max} = 0.020$ mm at 10^4 cycles

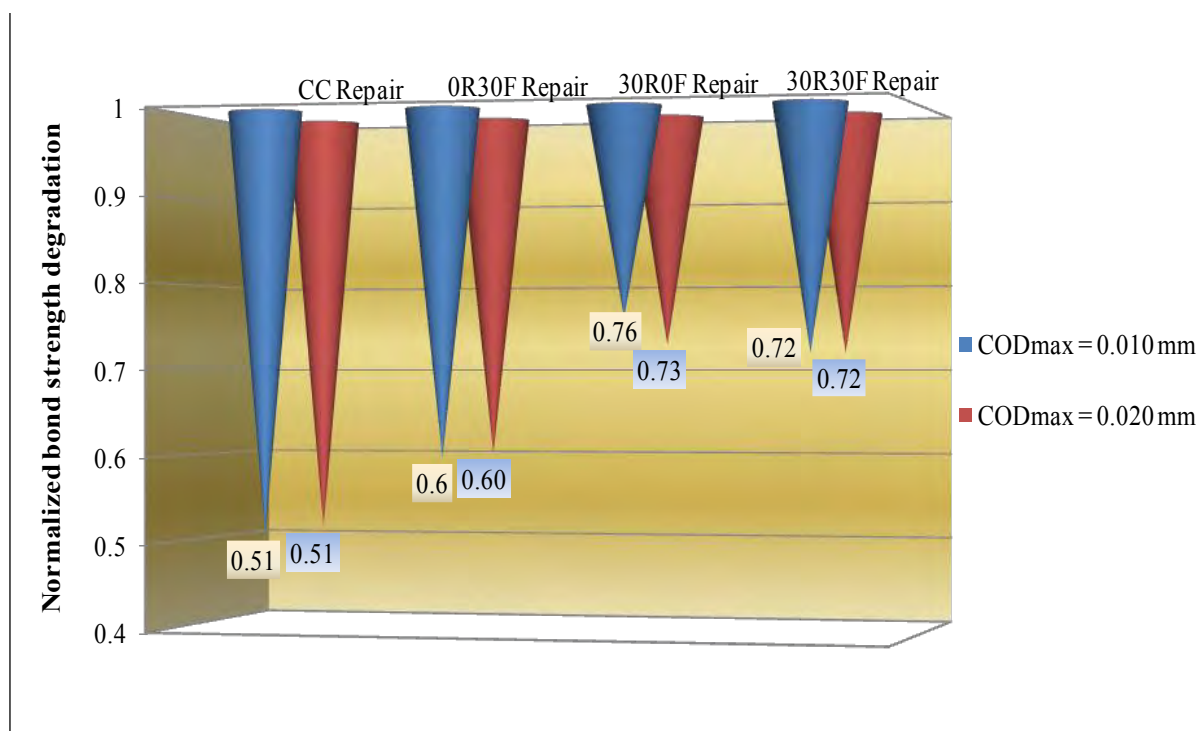
Figure IV-27: Comparison of normalized maximum bond strength degradation for different repair material, corresponding to different pre-cracked widths (COD_{max}) at 10^4 cycles

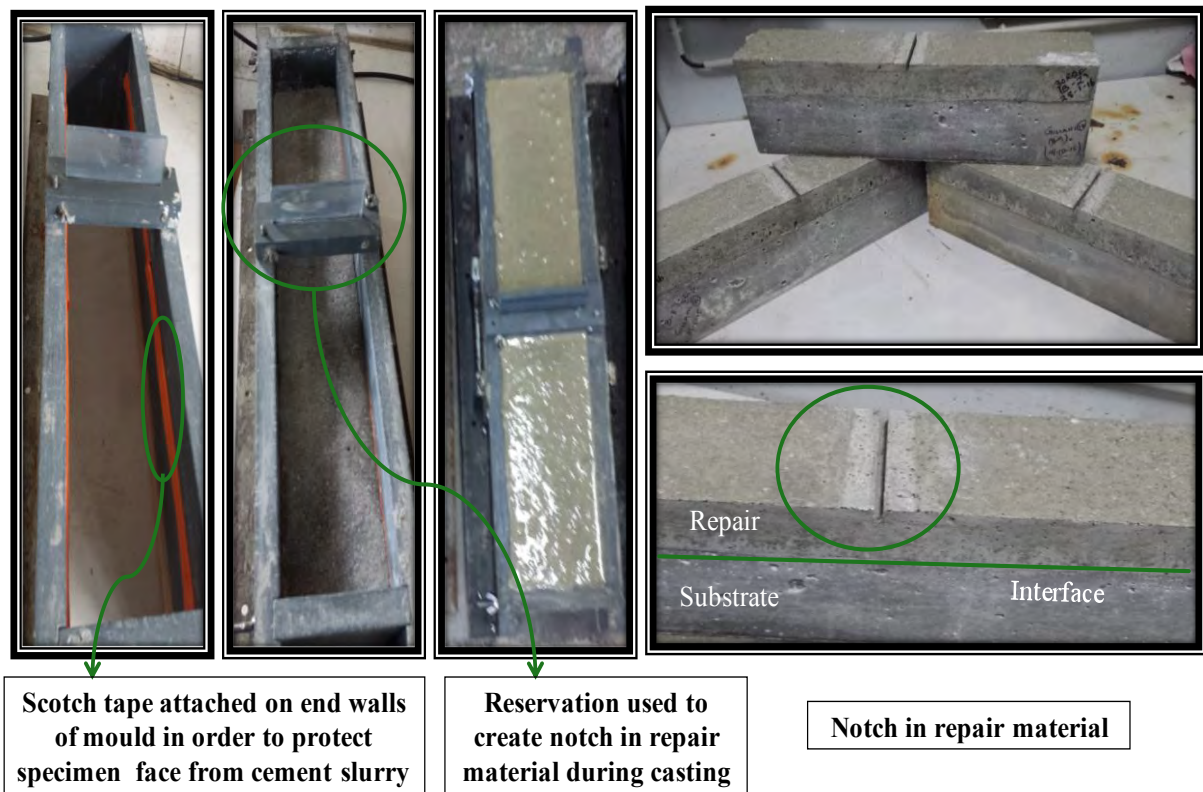
Figure V-1: Casting of repair on top of substrate

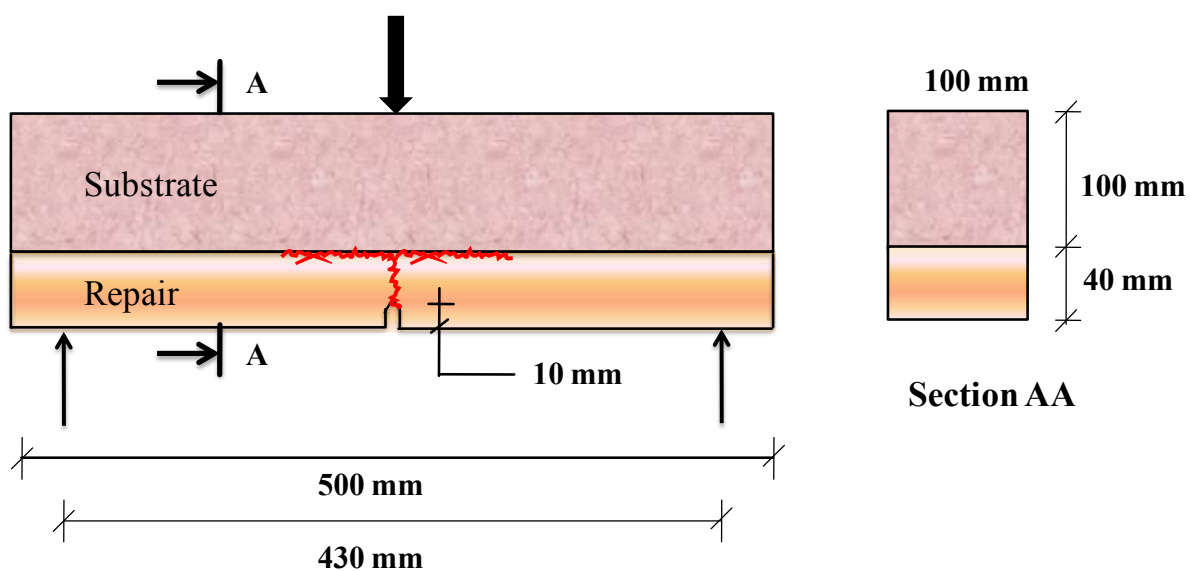
Figure V-4: Schematic diagram of a composite specimen under three point bending test
