DOCTORAT DE L'UNIVERSITÉ DE TOULOUSE

Degradation of the residual strength of concrete: Effect of fiber-reinforcement and of rubber aggregates - Application to thin bonded cement-based overlays

Laboratoire Matériaux et Durabilité des Constructions (LMDC) Toulouse

Key words: Repair, fiber-reinforcement, rubber aggregates, substrate surface preparation, durability, fatigue, interface debonding, digital image correlation

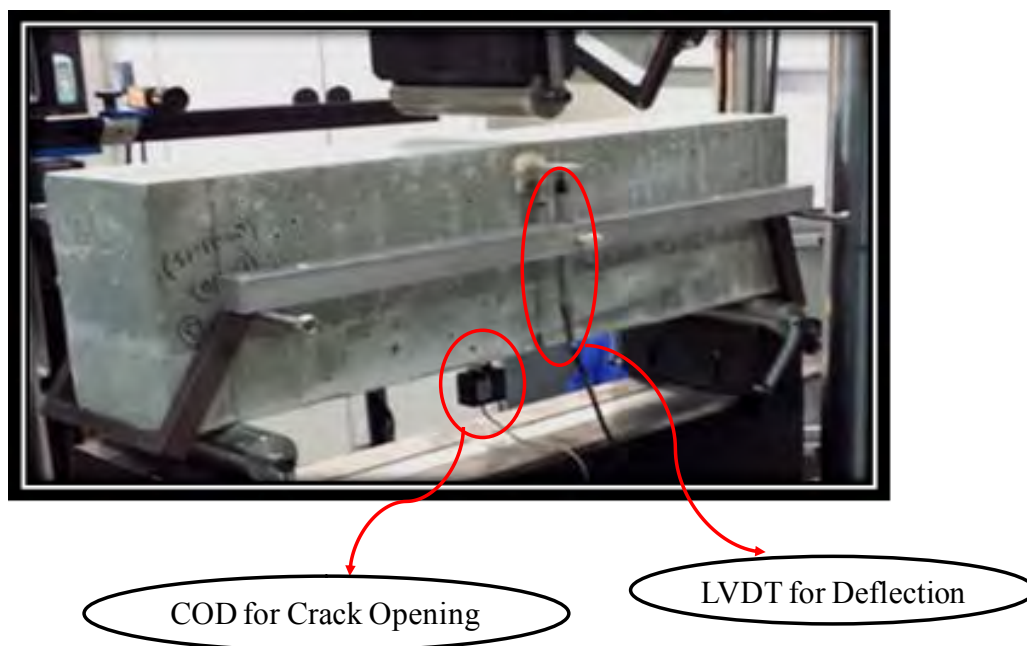
Figure V-5: Complete testing setup for three point bending test

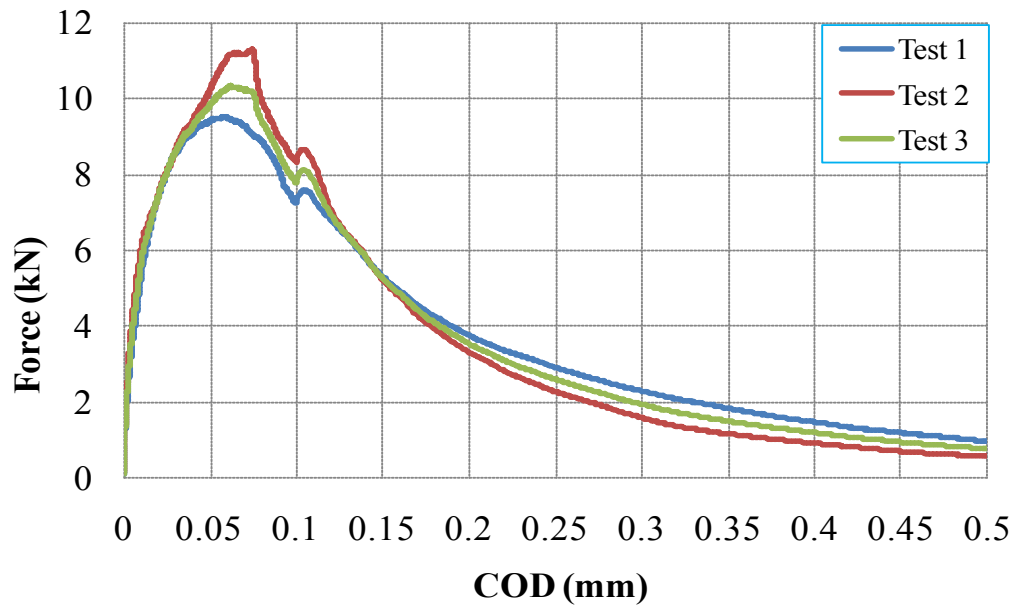
Figure V-6: Load versus opening of notch (COD) curves for 0R0F (CC) repair

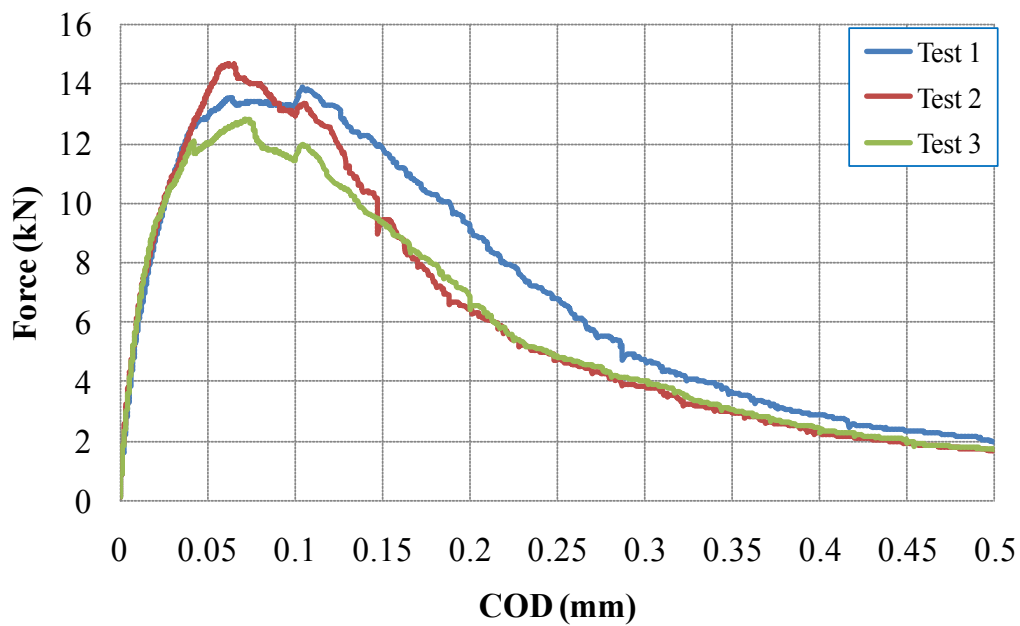
Figure V-7: Load versus opening of notch (COD) curves for 0R30F repair

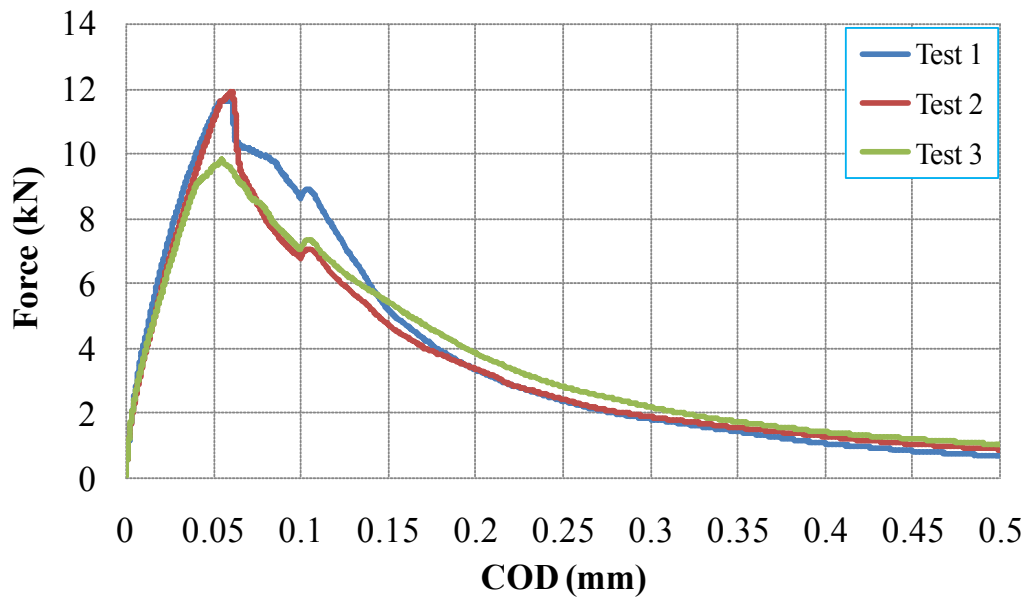
Figure V-8: Load versus opening of notch (COD) curves for 30R0F repair

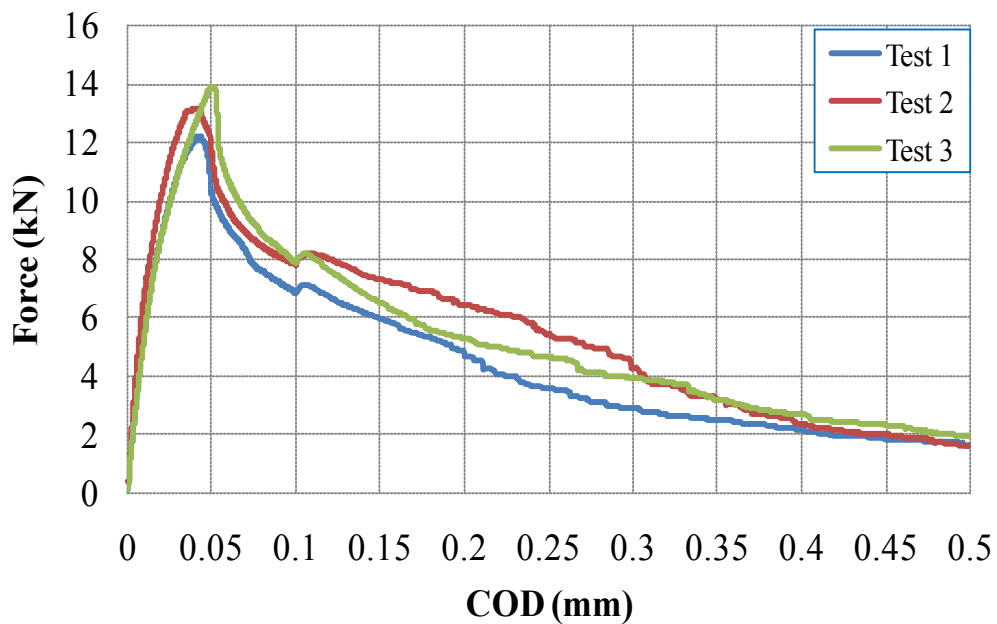
Figure V-9: Load versus opening of notch (COD) curves for 30R30F repair

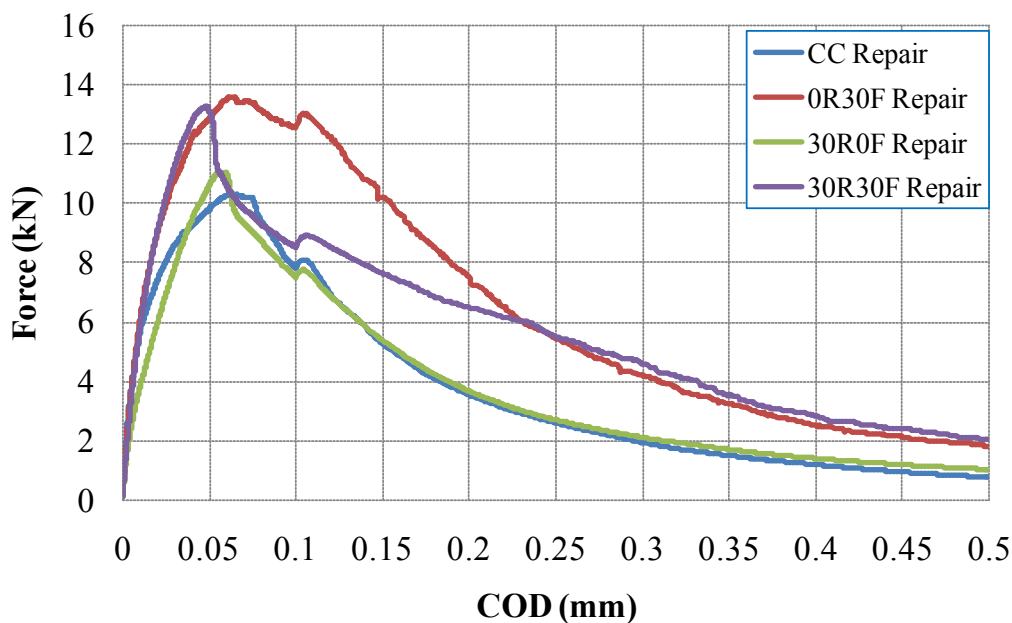
Figure V-10: Load versus opening of notch (COD) curves for composite repaired beams with different repair mix compositions

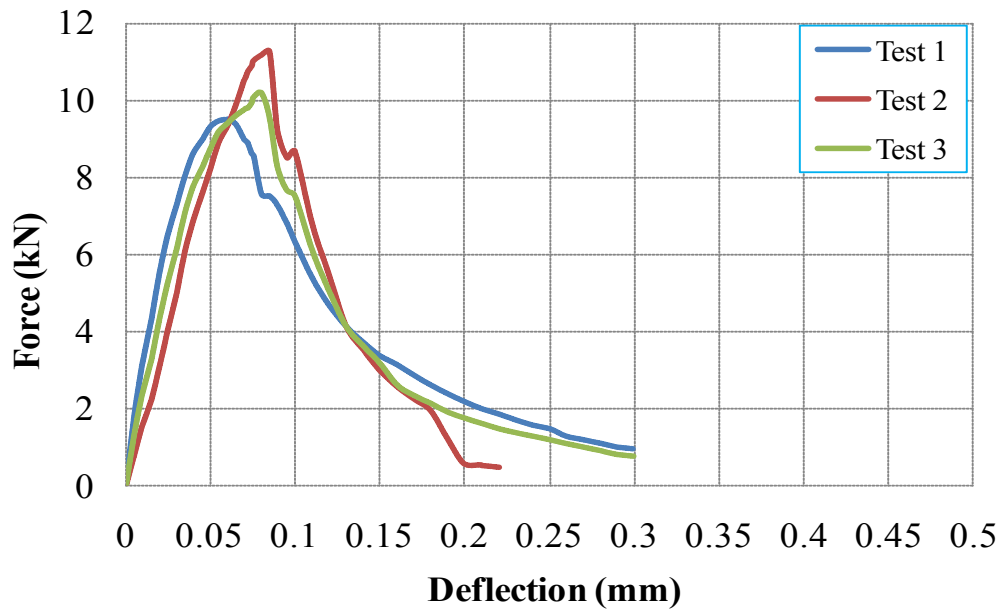
Figure V-11: Load versus deflection curves for CC repair

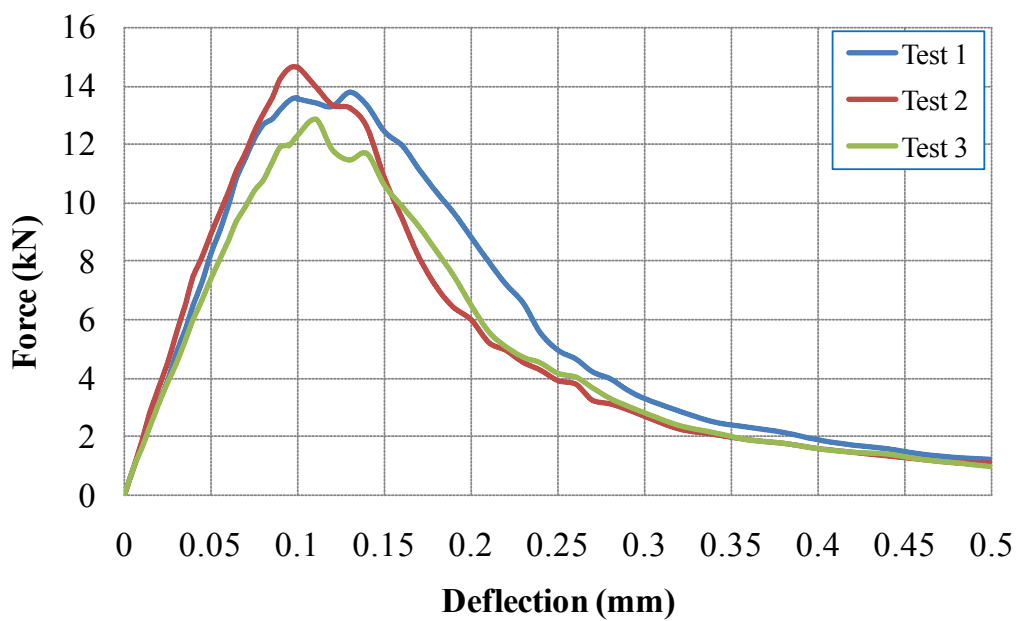
Figure V-12: Load versus deflection curves for OR30F repair

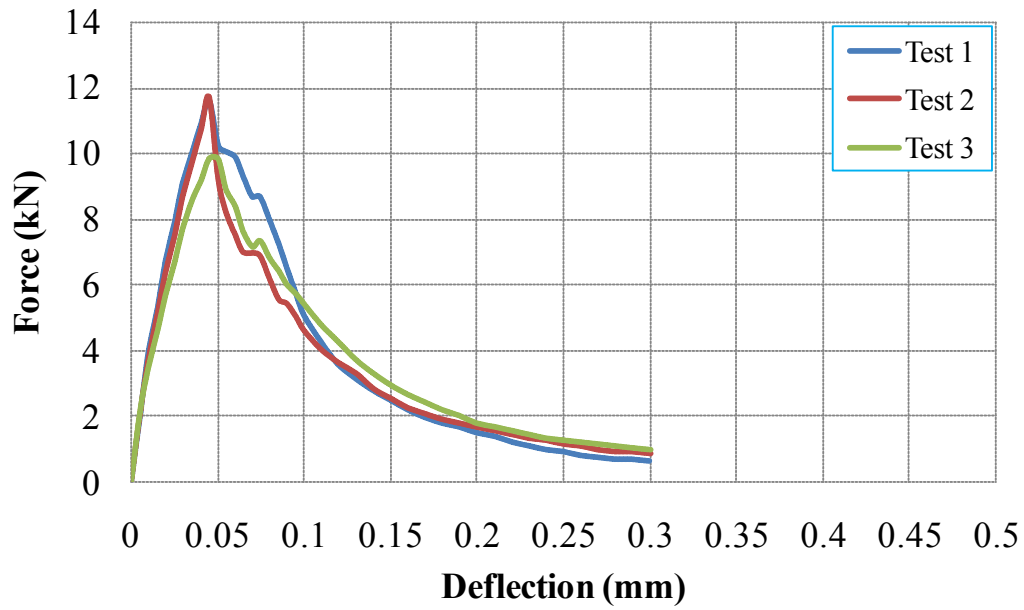
Figure V-13: Load versus deflection curves for 30R0F repair

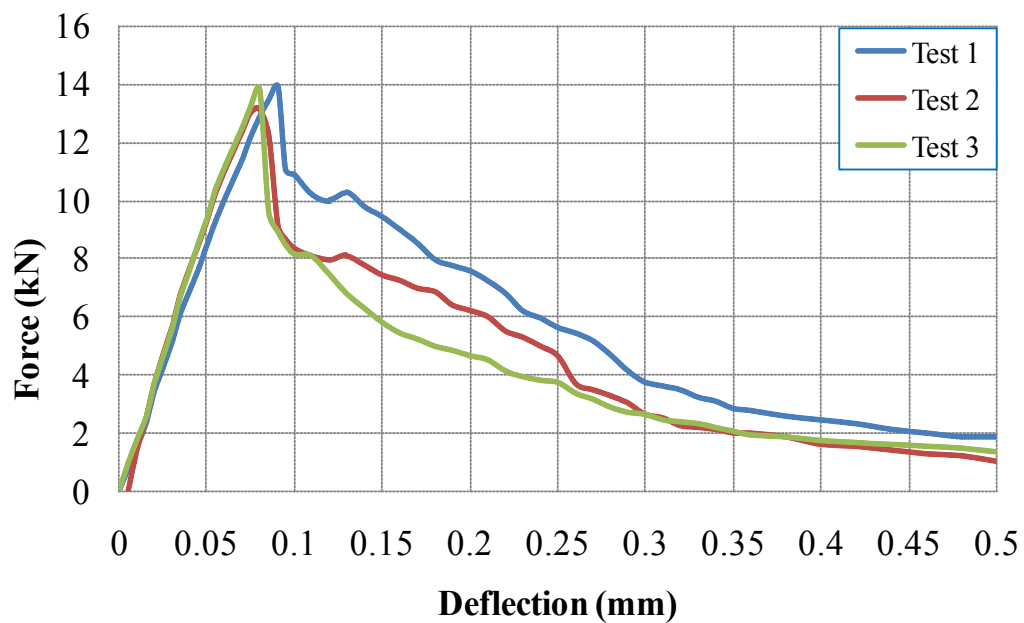
Figure V-14: Load versus deflection curves for 30R30F repair

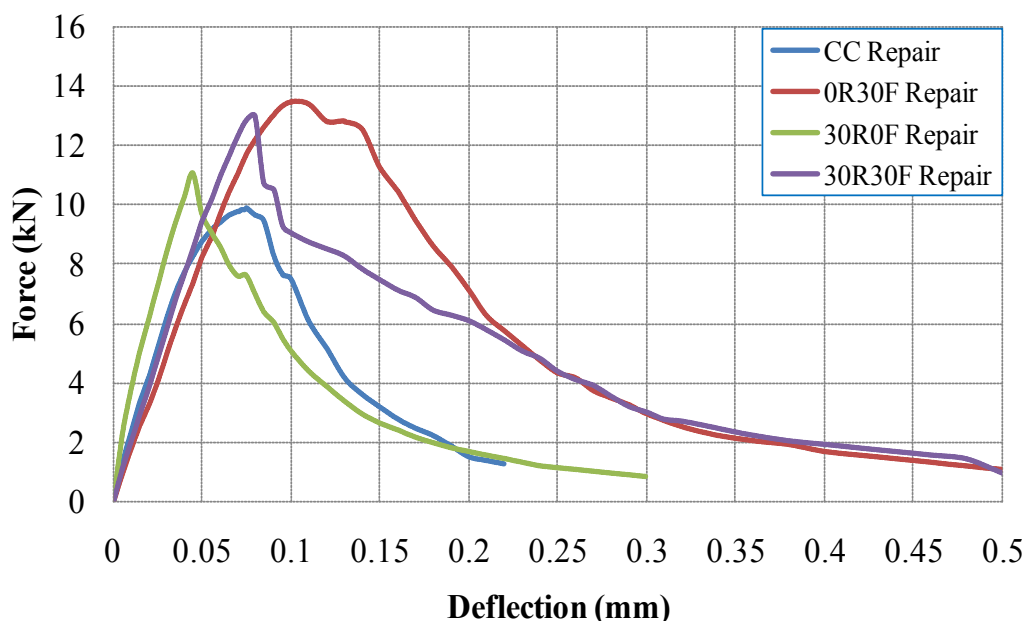
Figure V-15: Load versus deflection curves for composite repaired beams with different repair mix compositions

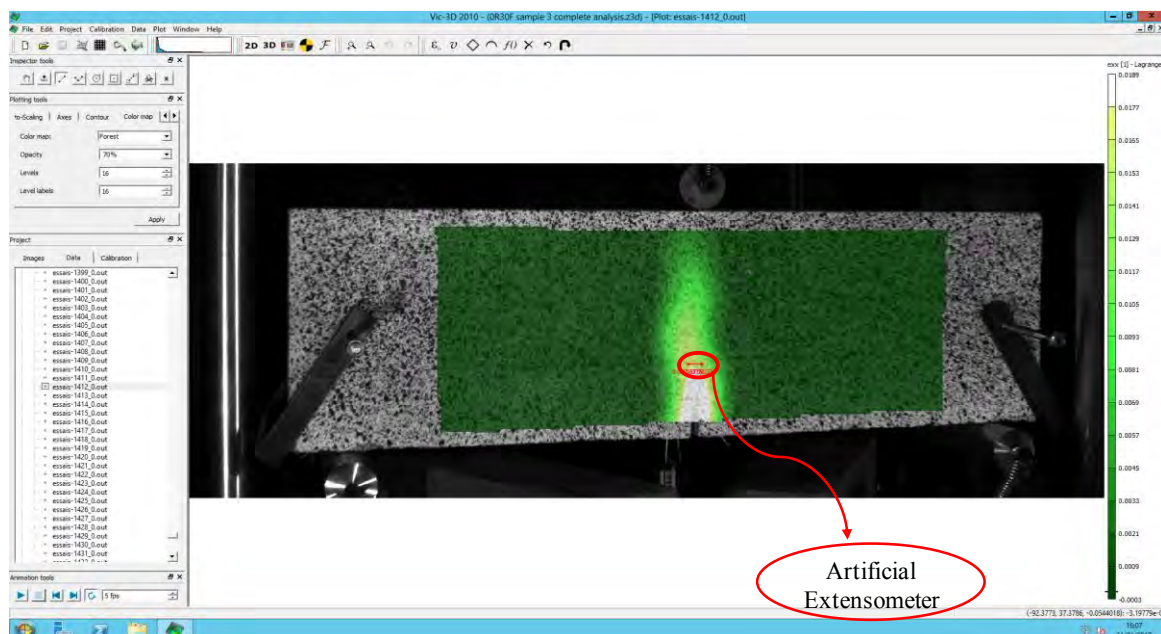
Figure V-18: Selected strain visualizations for crack observation and use of artificial extensometer for detecting the load at which crack reach at interface location

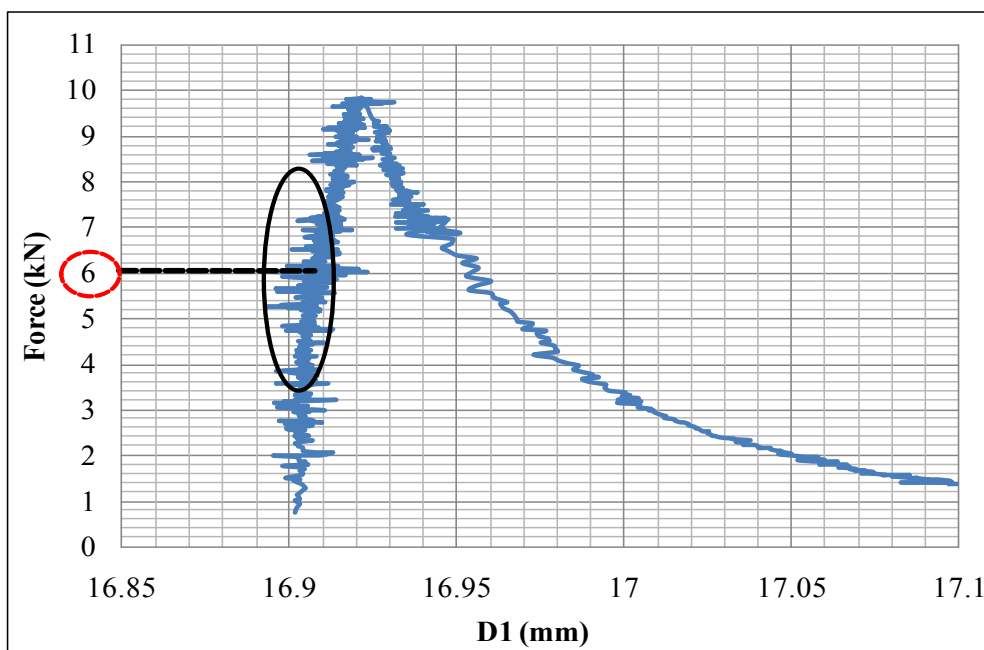
Figure V-19: Force vs. opening of artificial extensometer (D1): detection of load at which crack reach at interface location and debonding initiated

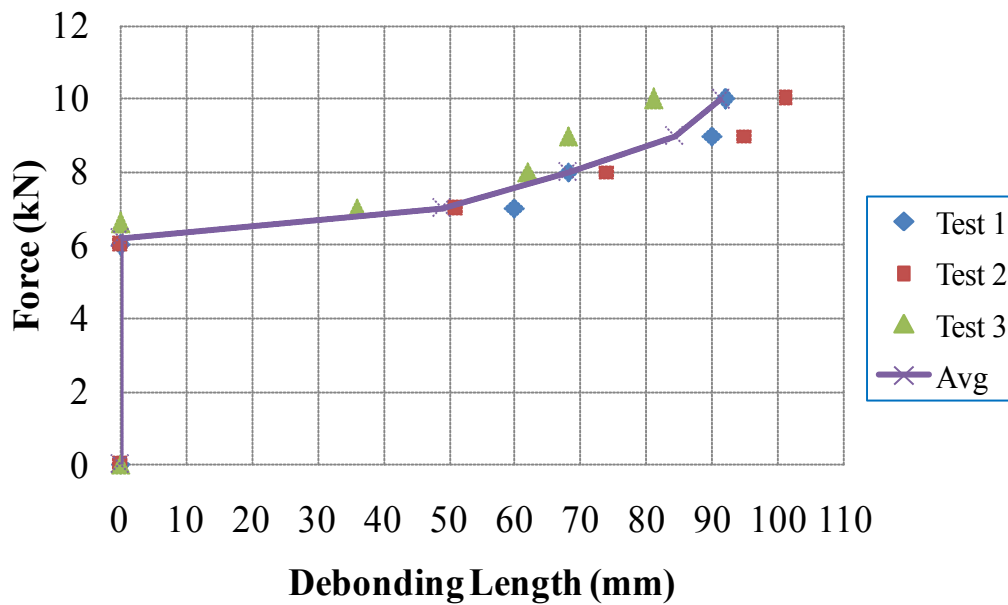
Figure V-20: Force vs. debonding length at interface for 0R0F (CC) repair

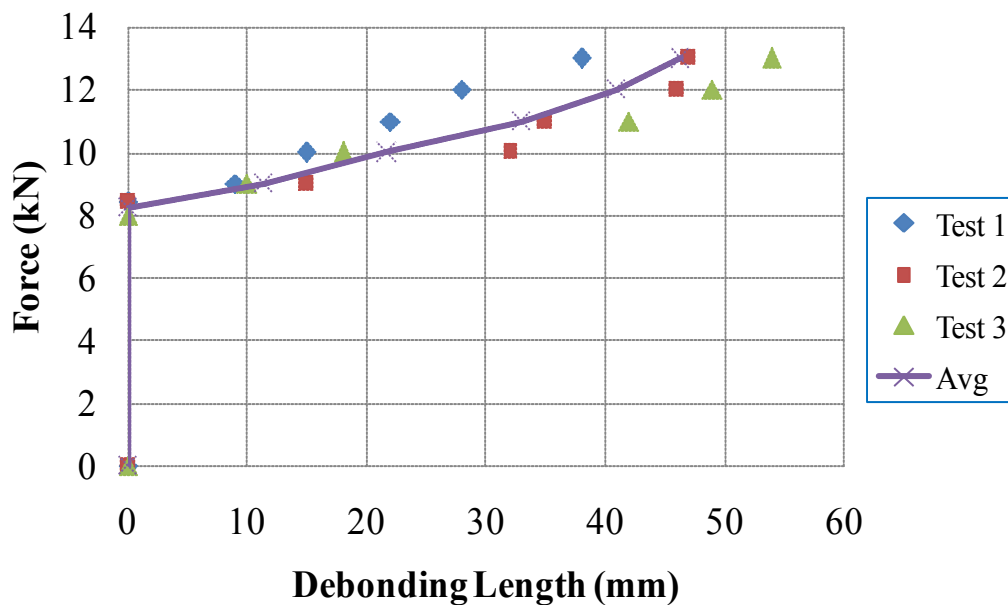
Figure V-21: Force vs. debonding length at interface for 0R30F repair

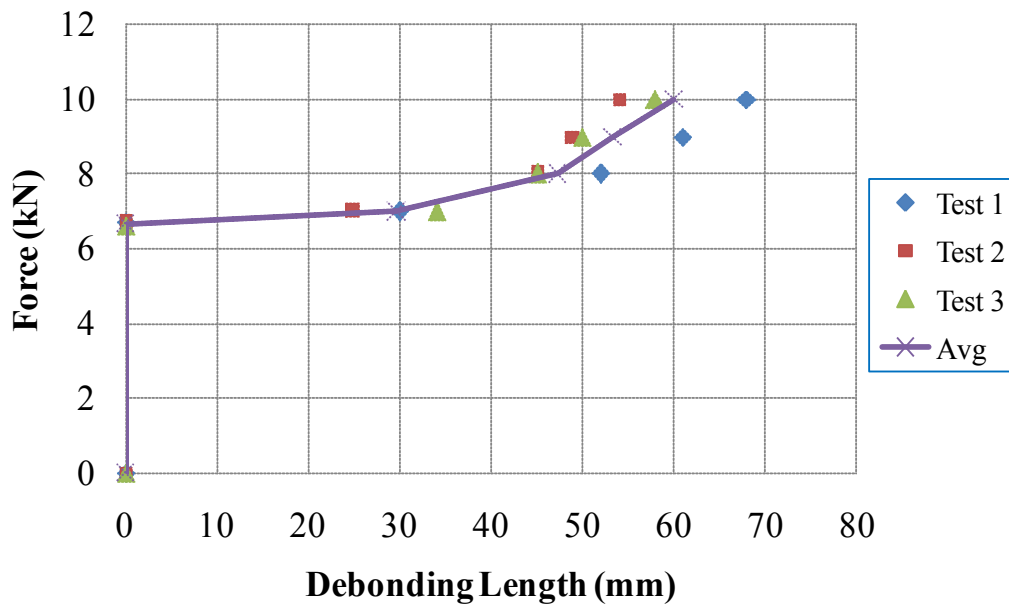
Figure V-22: Force vs. debonding length at interface for 30R0F repair

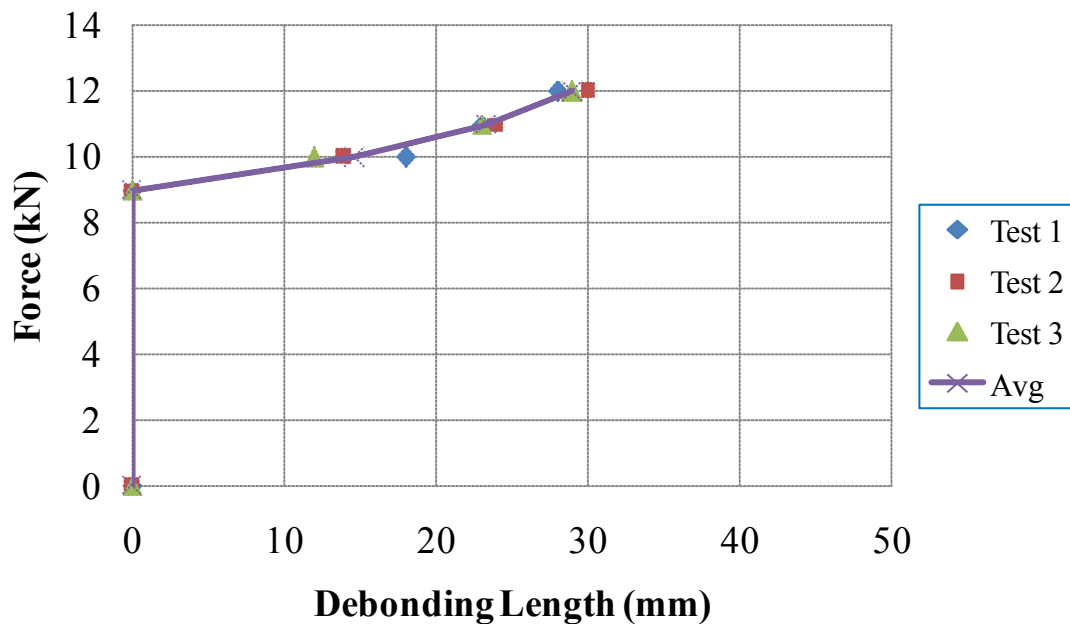
Figure V-23: Force vs. debonding length at interface for 30R30F repair

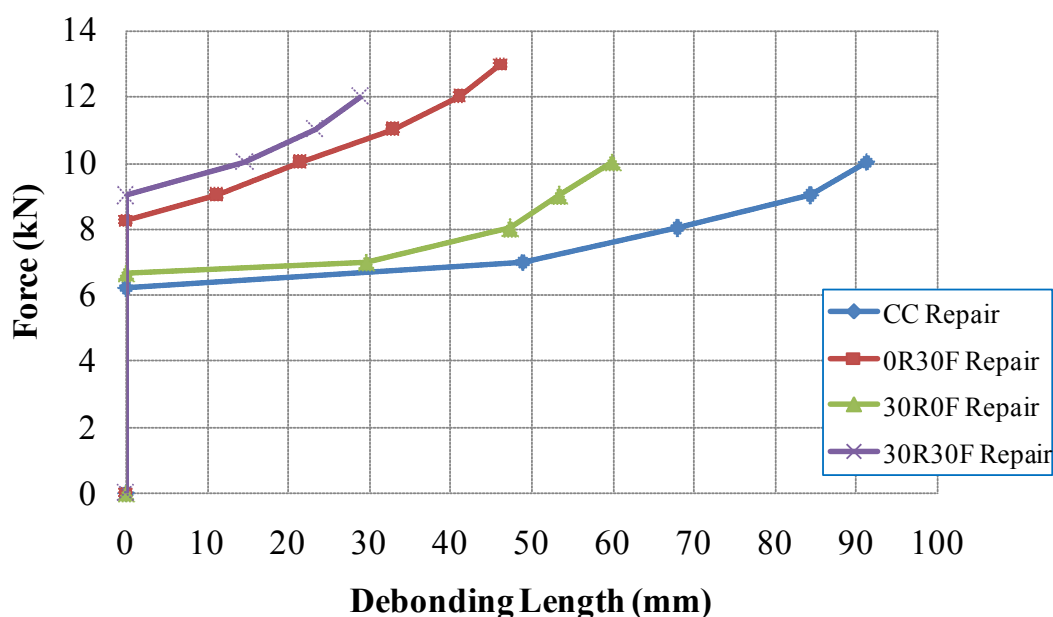
Figure V-24: Force vs. debonding length at interface for different repair layers

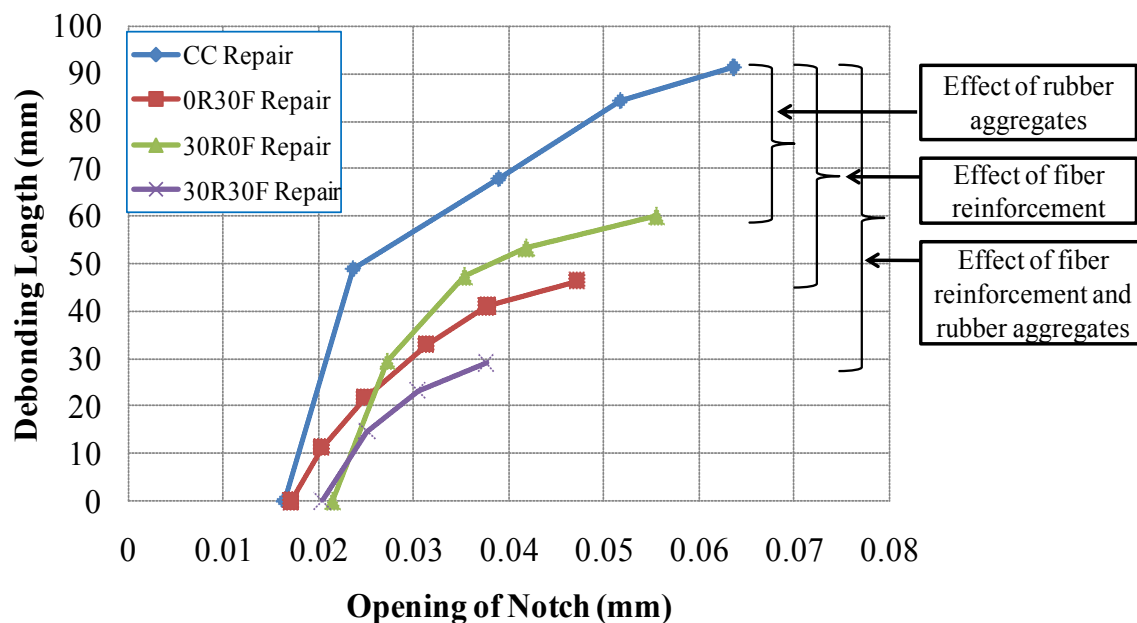
Figure V-25: Debonding length vs. opening of notch for different repair layers under monotonic loading

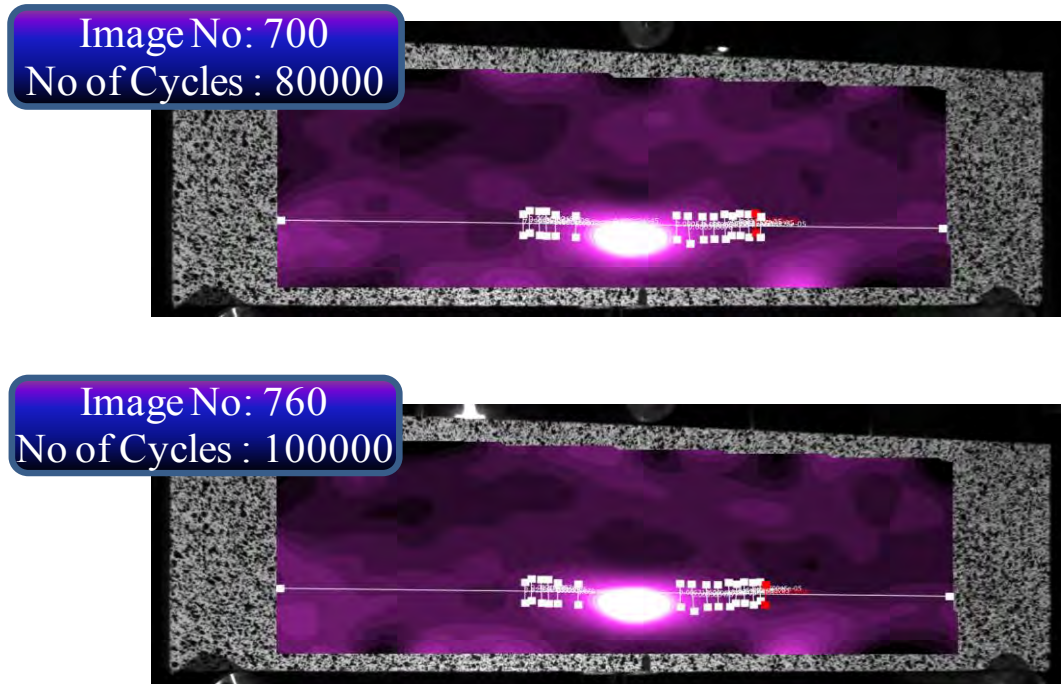
Figure V-29: Seven Strain fields showing interface debonding propagation with number of cycles and using artificial extensometer to determine the debonding length for 30R0F repair

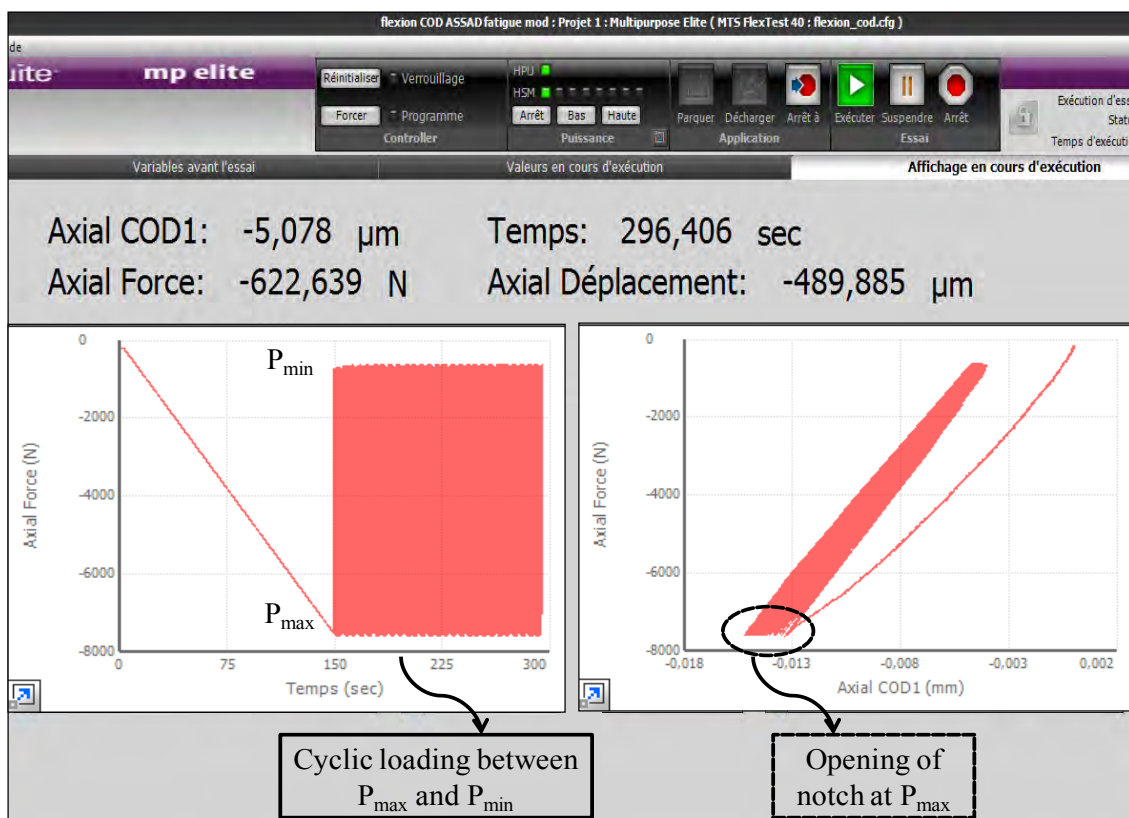
Figure V-30: Snapshot of MTS acquisition during fatigue test, showing opening of notch (COD) due to the application of cyclic loading between P_{max} and P_{min}

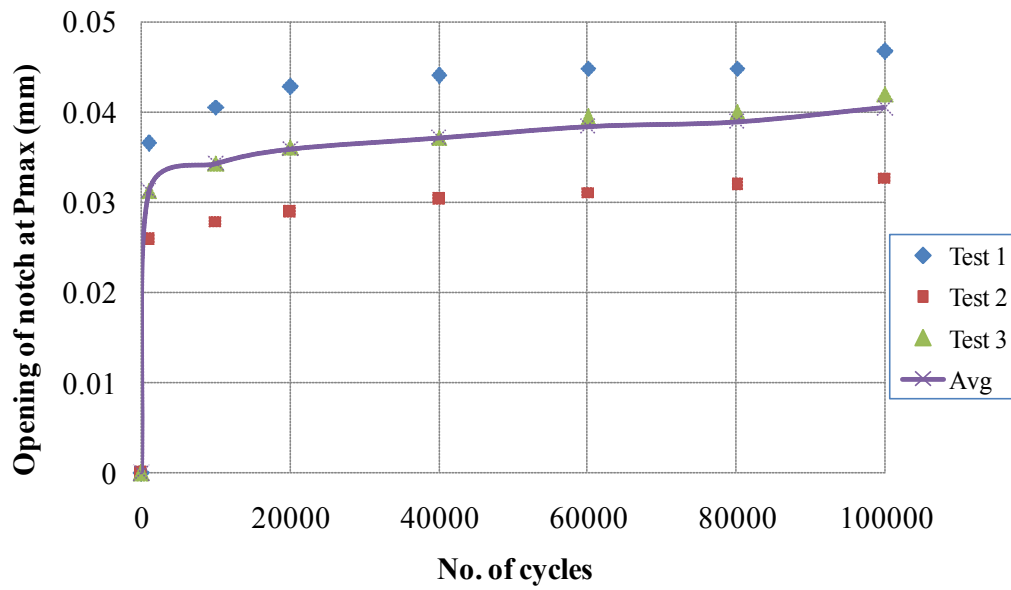
Figure V-33: Opening of notch at P_{\max} with number of cycles for 30R0F repair

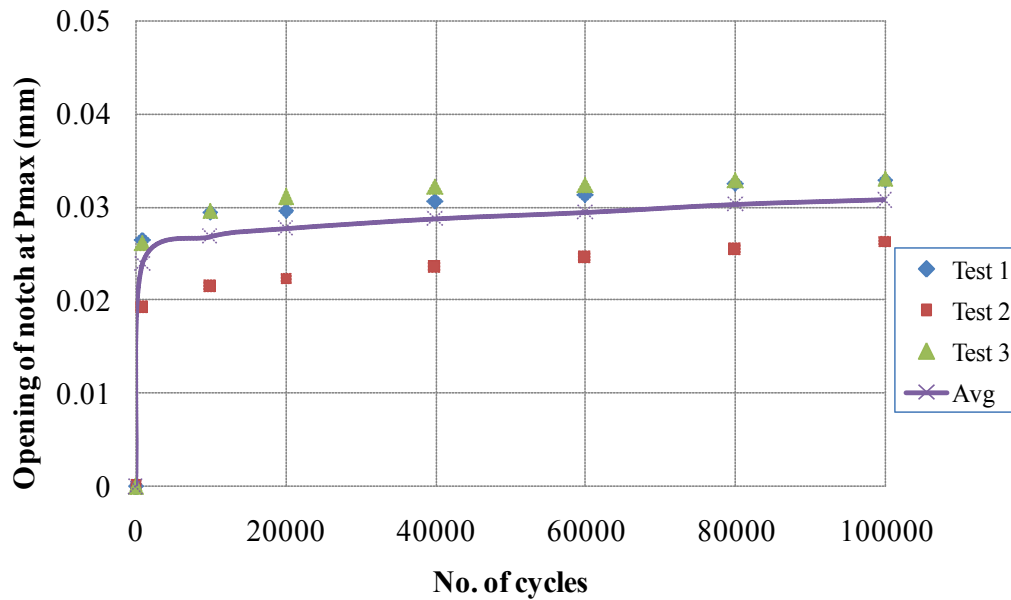
Figure V-34: Opening of notch at P_{\max} with number of cycles for 30R30F repair

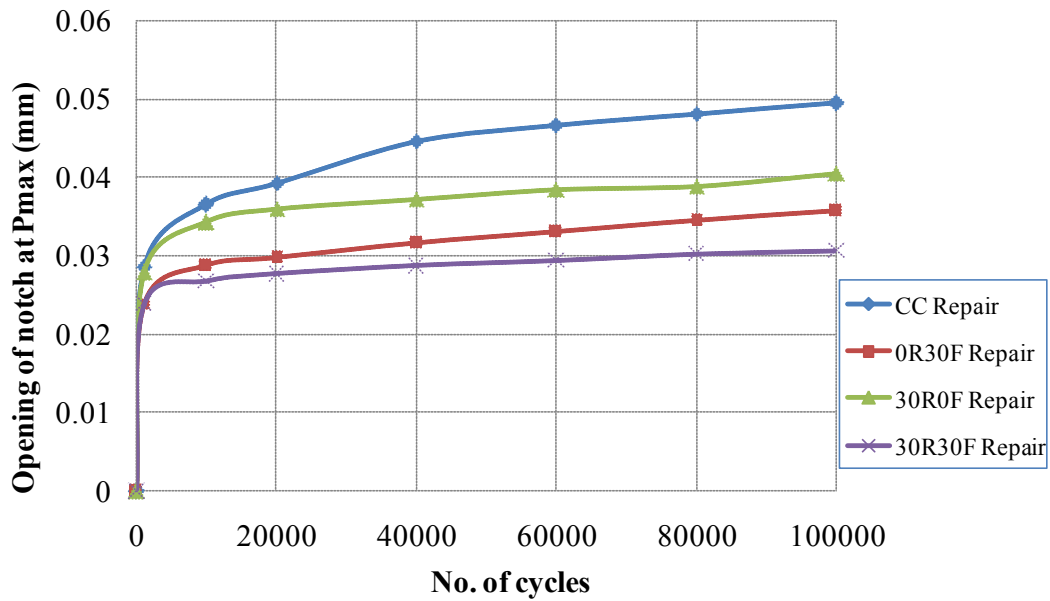
Figure V-35: Opening of notch at P_{max} with number of cycles for different repair mortar mixes

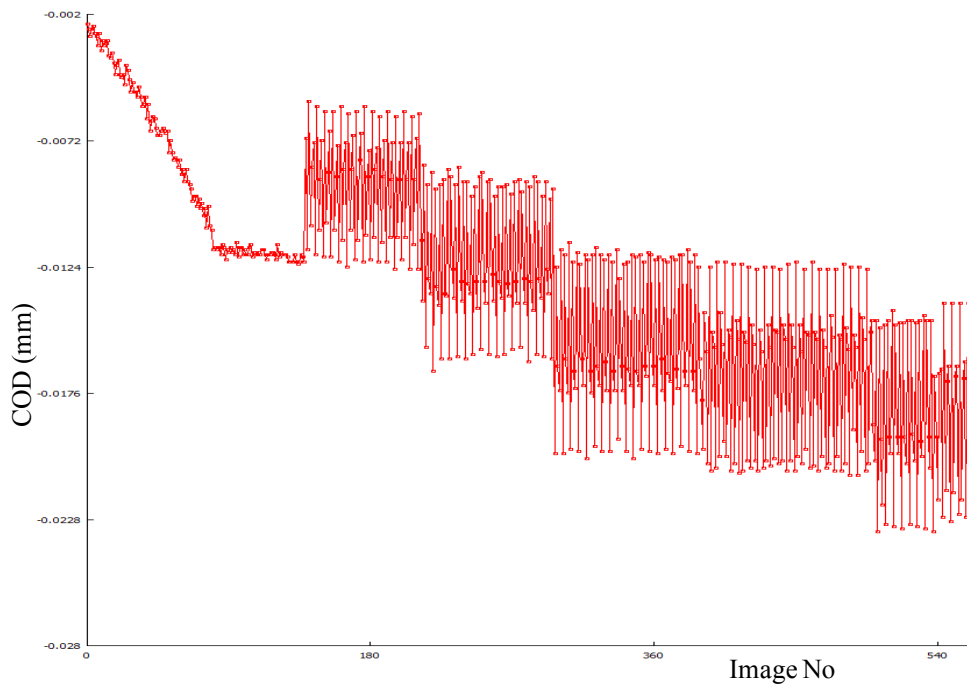
Figure V-36: Curve between COD and image number (recorded at every 20000 cycles), showing evolution of notch opening with number of cycles

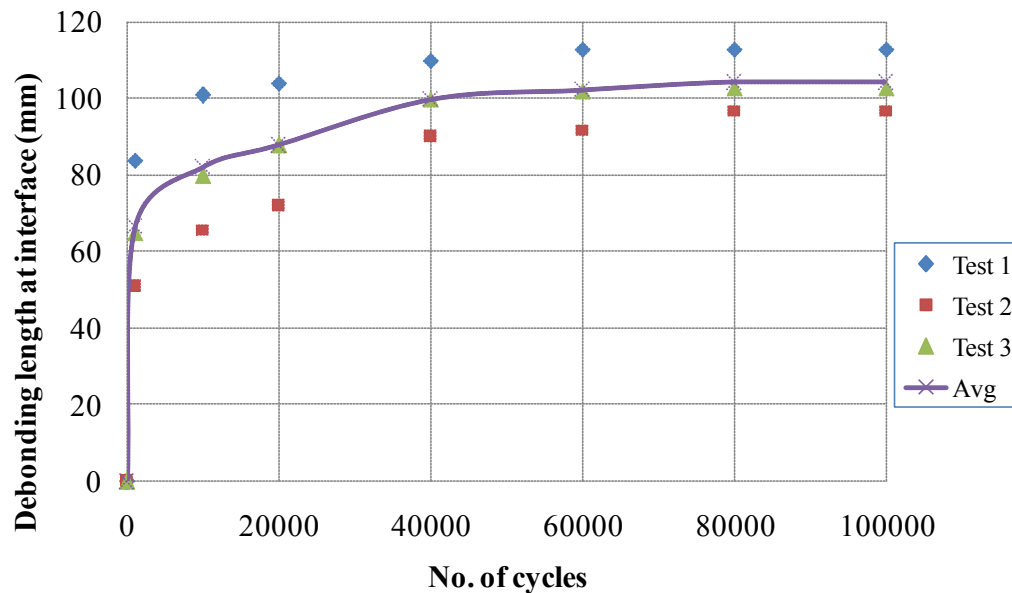
Figure V-39: Propagation of debonding length at interface with number of cycles for 30R0F repair

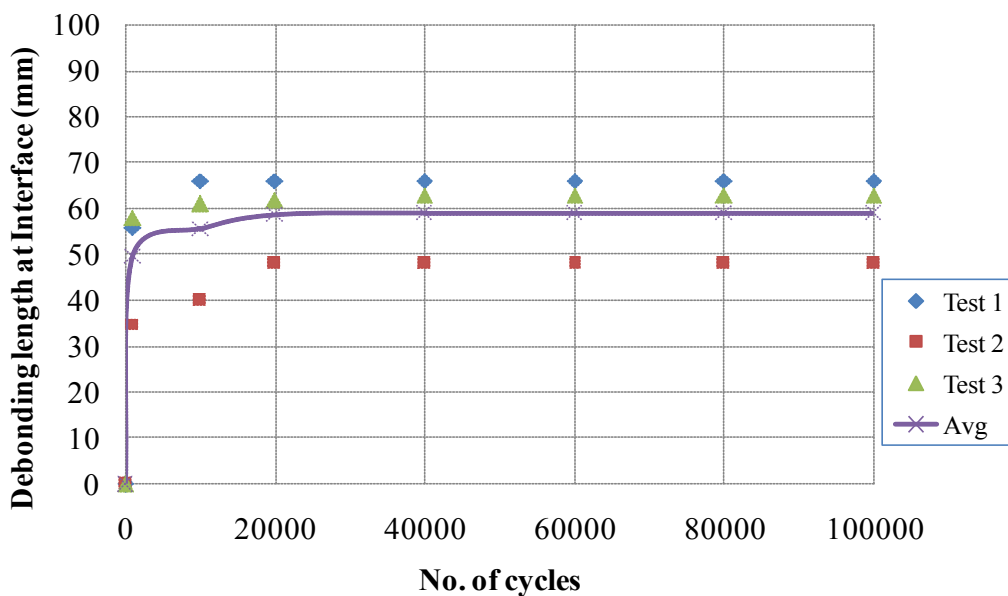
Figure V-40: Propagation of debonding length at interface with number of cycles for 30R30F repair

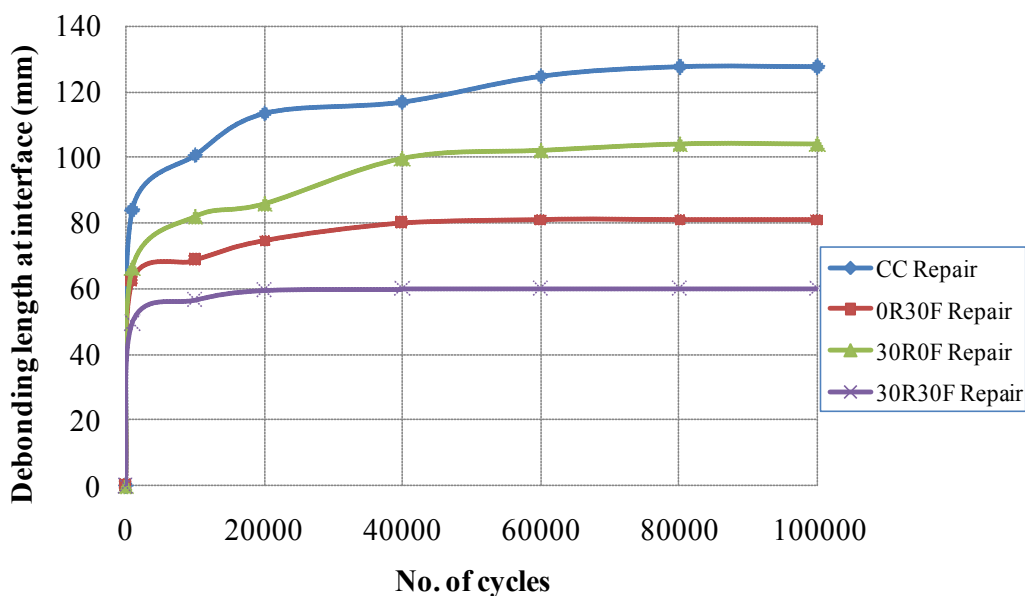
Figure V-41: Propagation of debonding length at interface with number of cycles for different repair mortar mixes

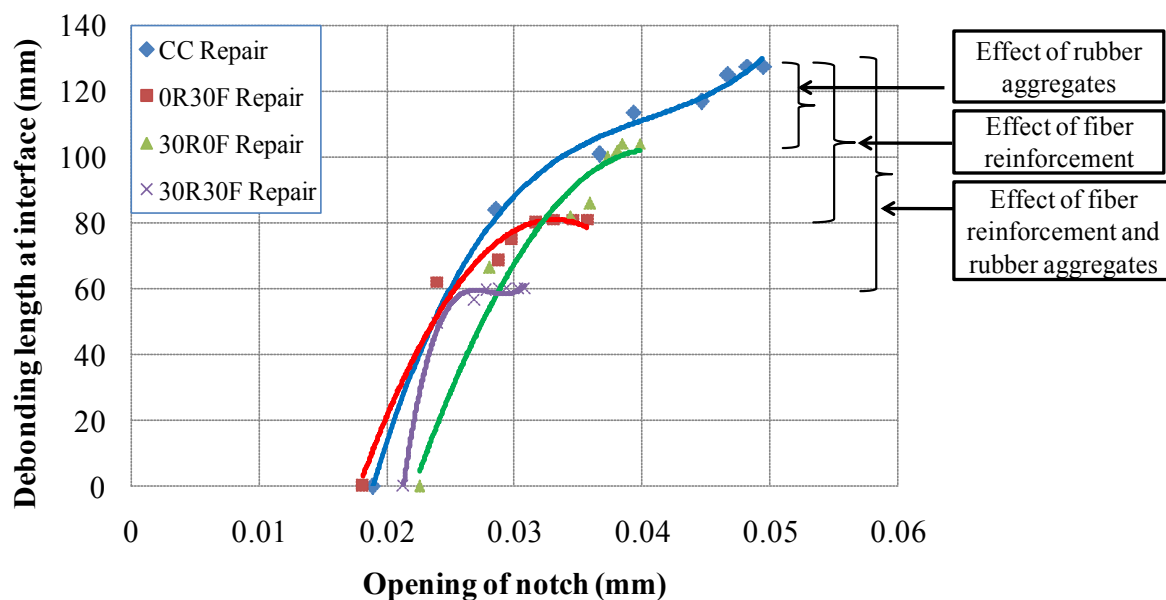
Figure V-42: Debonding length at interface vs. opening of notch for different repair mortar mixes

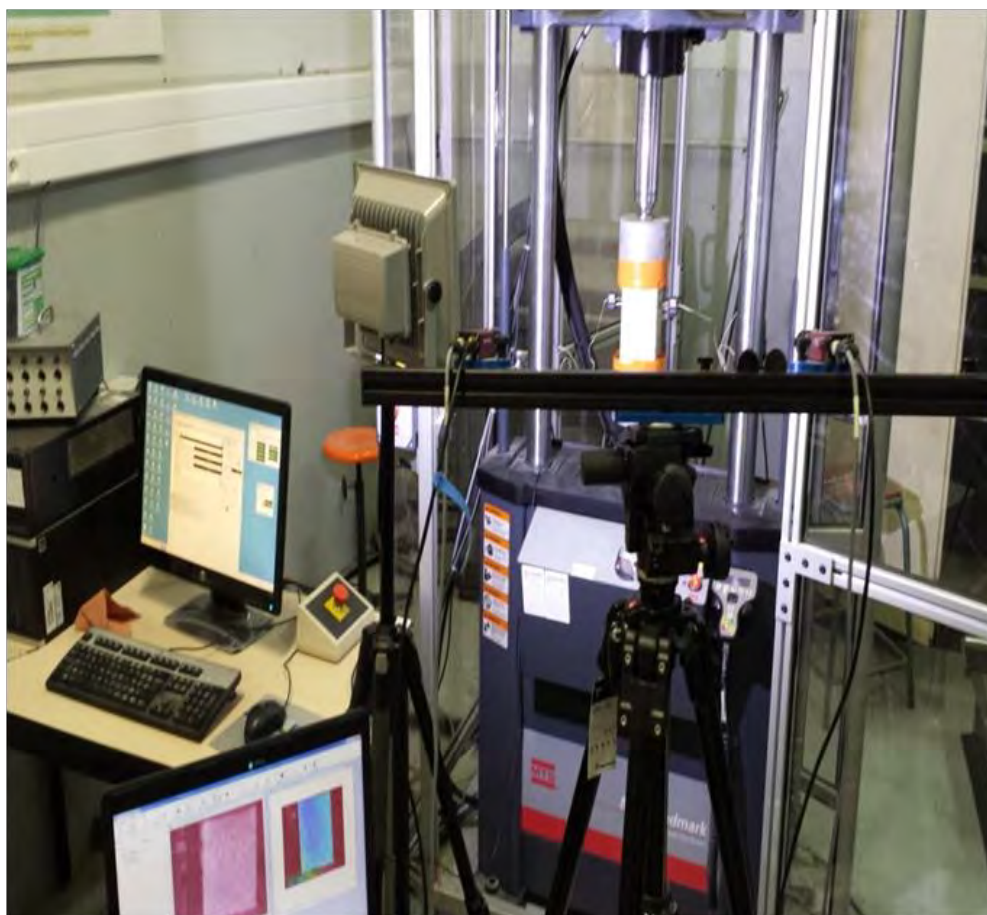
Figure C-2: Testing arrangements for using Digital 3D Image Correlation Technique

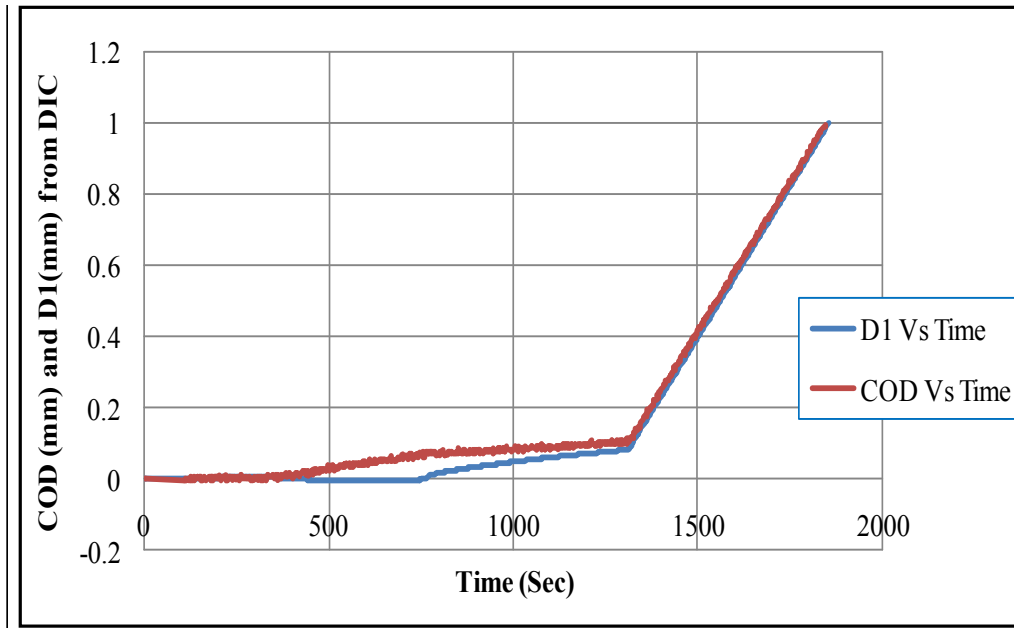
Figure C-3: Crack opening at interface under direct tension measured by COD and by using extensometer D1 in post treatment through DIC Technique

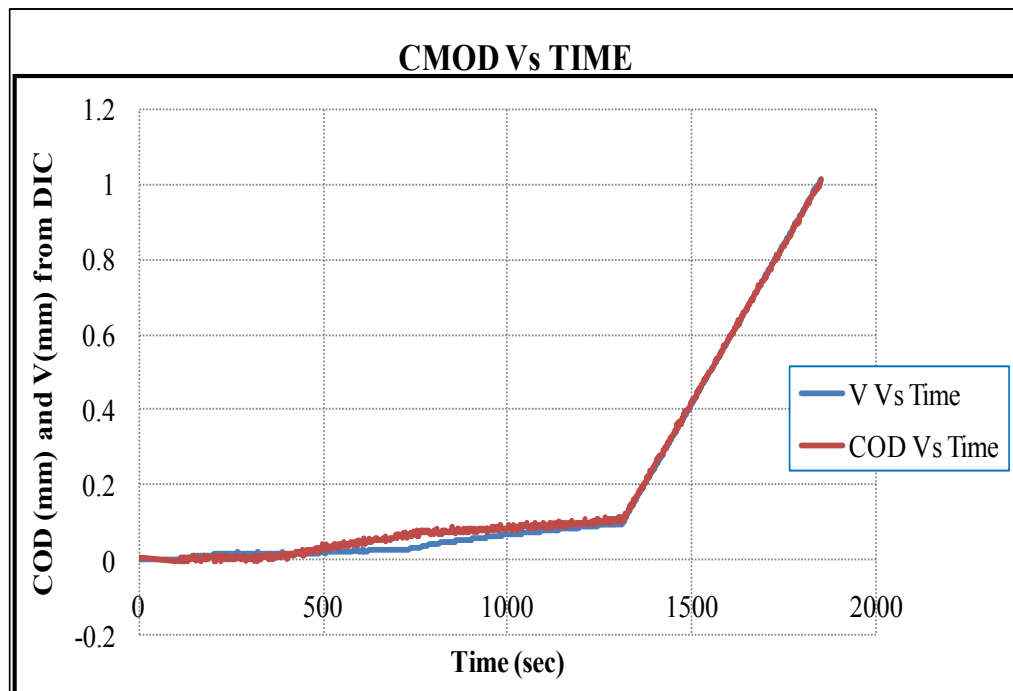
Figure C-4: Crack opening at interface under direct tension measured by COD and vertical displacement V from DIC Technique
