Analysis of Groundwater Quality in a Nigerian Community

Department of Civil Engineering, Covenant University, P.M.B. 1023, Ota, Ogun State, Nigeria

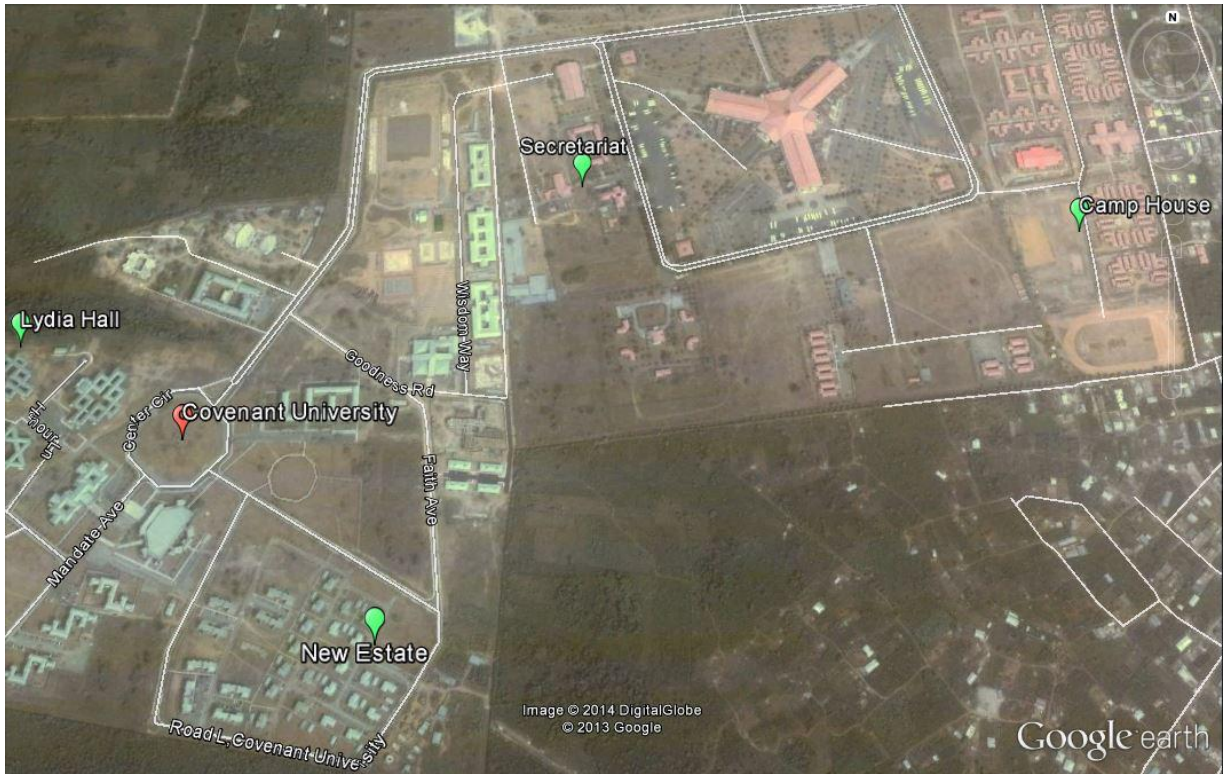
Fig. 1 Satellite image of the study area showing the layout of the church area, university campus, and the four sampled boreholes (green markers)

The study area is Canaanland in Ota, Ogun State, Nigeria (Fig. 1). It is located between Longitude 3°10' 3" E and Latitude 6°40' 35" N and it is the administrative seat and international headquarters of the Living Faith Church Worldwide (Winners' Chapel), an evangelical mega church located at km 10, Idi-Iroko Road, Ota, Ogun State in the South-Western Nigeria. Canaanland is a 560-acre (2.3 km²) facility that was opened in 1999, and it has since expanded to almost 5,000 acres (20 m²). The rapidly growing city houses the Faith Tabernacle (a 50, 000 seating capacity church building), Covenant University (a full residential tertiary institution with a populace of over 8, 000 students), Faith Academy Secondary School, FA (a full-boarding secondary school), Kingdom Heritage Nursery/Primary School (KHMS) and Covenant University Day Secondary School (CUDSS). A number of business ventures operated by the church are situated within Canaanland including a bottled-water processing plant, a publishing house, bakery, various restaurants, four banks, petrol station, gas-turbine powered electricity generation station, and several residential estates that provide accommodation for over 3,000 church employees. The campus has about 30 boreholes. However, due to constant pumping to meet demand, about half of the total number of wells has failed (Fig. 2). The campus reticulation system was designed in such a way that water pumped from a particular borehole can be channeled to supply different elevated tanks. Similarly, a single elevated tank can be supplied by three to four boreholes. This design was done to ensure water can reach different parts of the campus in case any well fails or in case any elevated tank requires servicing or cleaning. Most of the elevated tanks are one hundred thousand- litre (or 100 m³) capacity steel tanks set up on 16 m high steel stanchions (Fig. 2). Each of these 100 m³ capacity elevated water tanks are strategically placed to serve high population residential areas (Fig. 3).

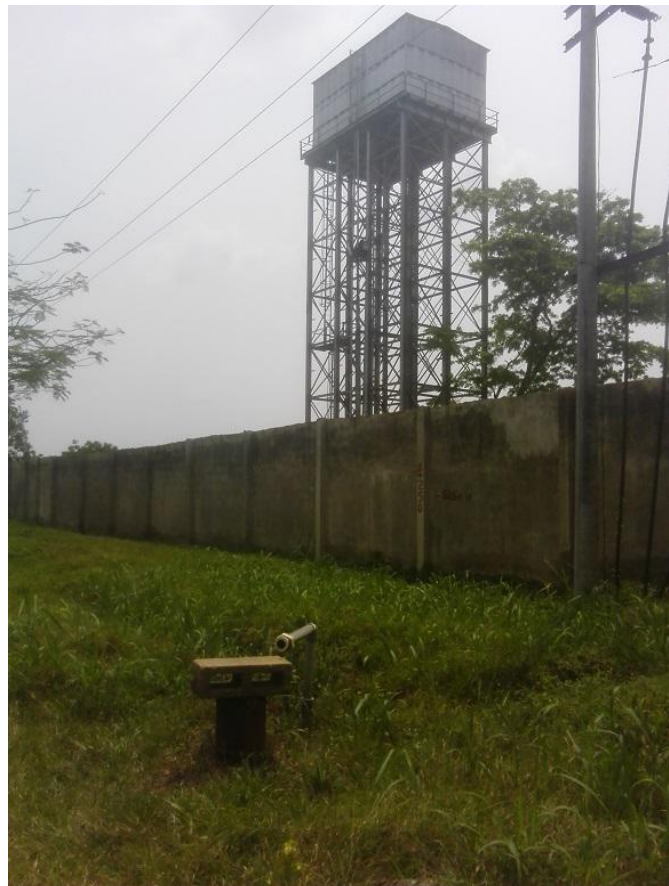
Fig. 2 A dysfunctional borehole close to an elevated water tank

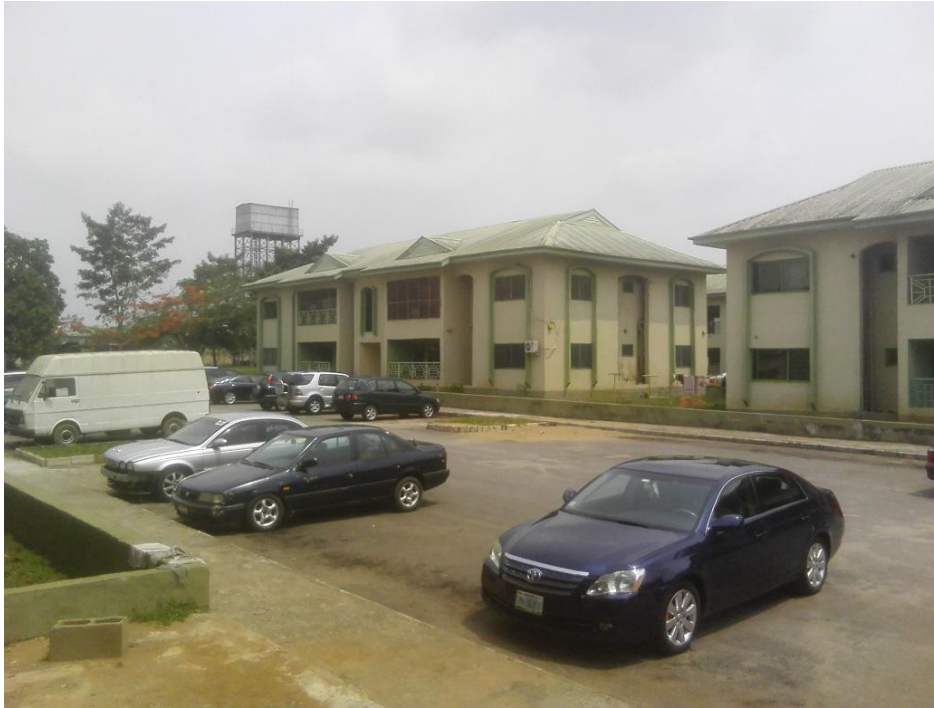
Fig. 3 A view of some residential quarters which is serviced by one elevated tank (shown in the background)
