Reconstructing the damage field of the 1855 earthquake in Switzerland: historical investigations on a well-documented event

Stefan Fritsche, Donat Fäh, Monika Gisler and Domenico Giardini

Swiss Seismological Service, Institute of Geophysics, ETH-Hoenggerberg, HPP L4, 8093 Zurich, Switzerland. E-mail: stefan.fritsche@sed.ethz.ch

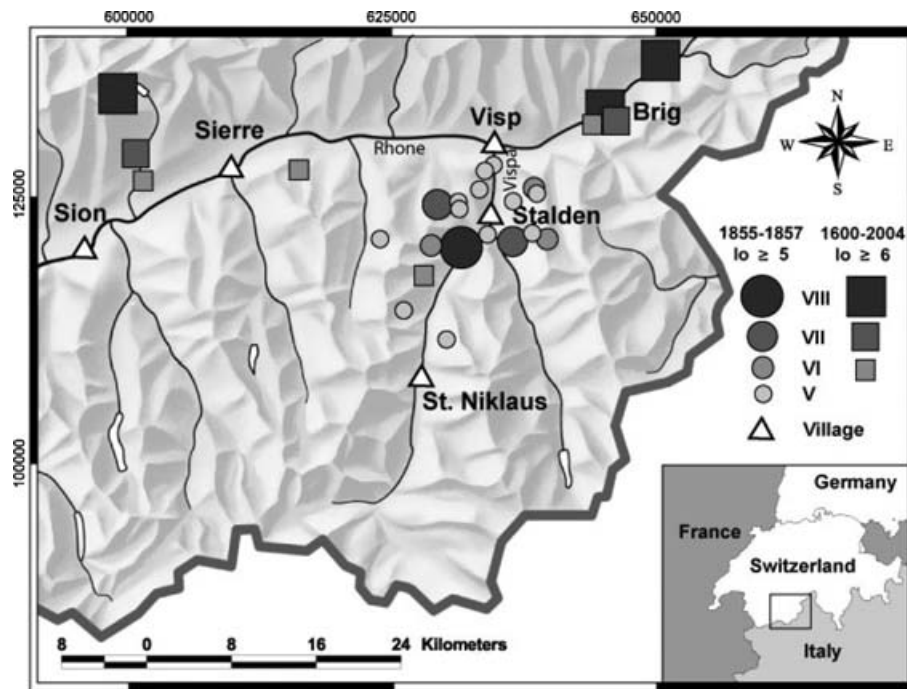
Figure 1. Historical seismicity of the investigated region in the middle Valais.

nation but also in other parts of Europe. The extent of damage was remarkable and is still unsurpassed in the Valais. The large quantity of available contemporary source material such as newspaper and scientific journal articles, travel diaries and entries in chronicles is, therefore, not surprising. Most known of these sources is the diary of Pastor Moritz Tscheinen (1857). Tscheinen was an eyewitness living in Törbel, a small village in the epicentral area. With high accuracy, Tscheinen listed the series of main and aftershocks by notifying the date, time, strength and manner of the felt events (Table 1 and Fig. 1).

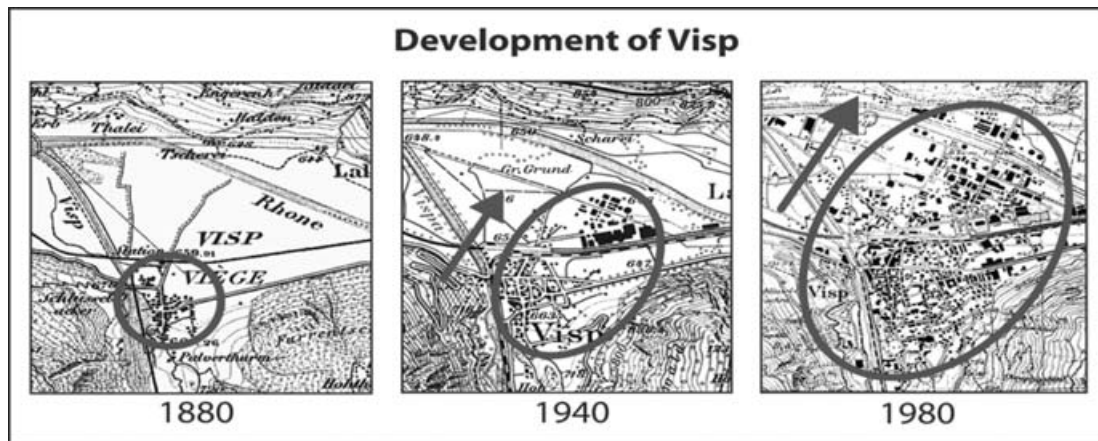
Figure 2. Development of Visp from 1880 to 1980.

attractive places for expanded settlement in the last two centuries: river regulations allowed many villages and cities to grow extensively on these wide plains, as they do in the Rhine Valley or the Valais (Fig. 2). The risk to settlements is therefore increasing. Further research into the relation between damage and possible site effects is definitely merited.

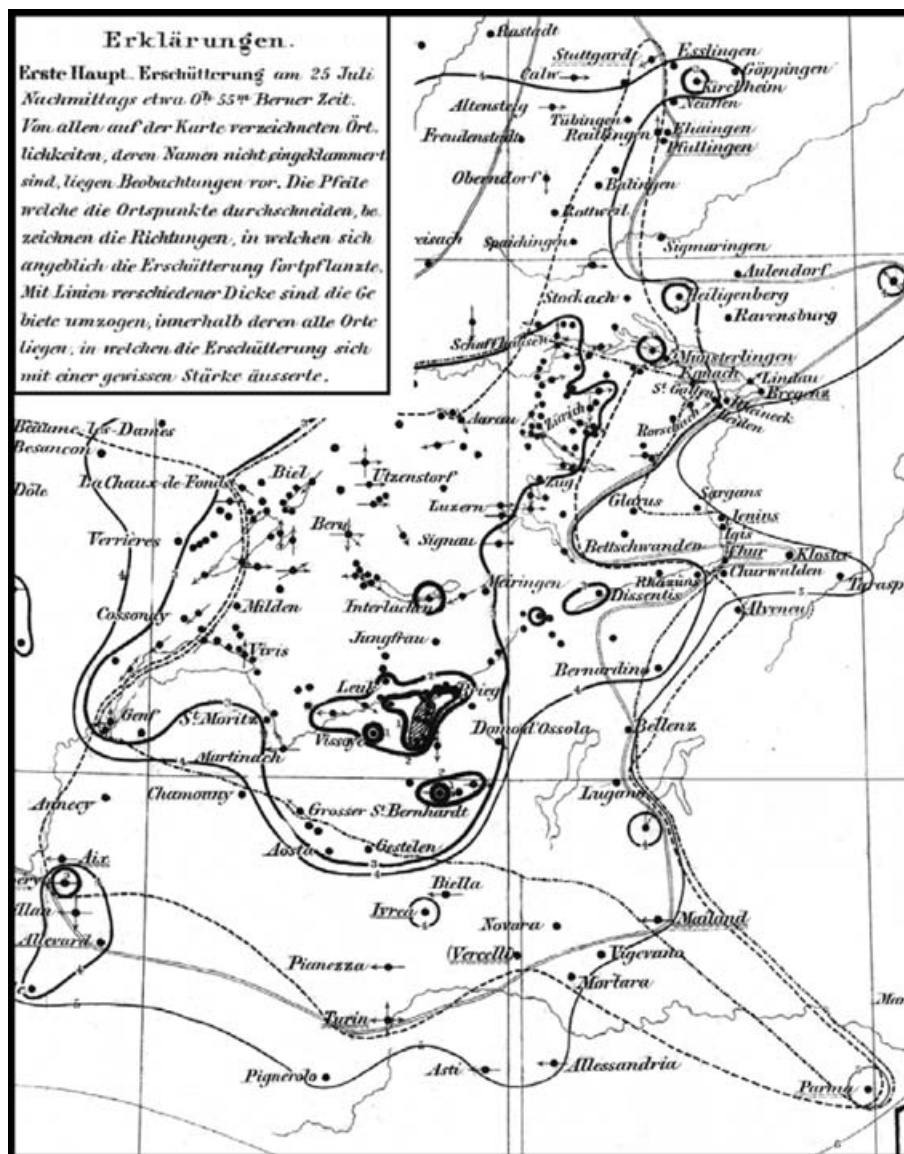
Figure 3. Part of the isoseismic map of Volger with a scale from 1 (heavy destruction) to 6 (felt). (Volger 1856).

In a few cases he noted information about the damage. Another well-known and important source is the work of the German mineralogist and geologist Otto Volger (Volger 1856). Volger (1822–1897) worked several years on historical earthquakes in Switzerland. A comprehensive publication in 1857 dealt with earthquake phenomena in Switzerland in general (Volger 1857), another publication with the 1855 earthquake in particular (Volger 1856). Remarkable for example is his ‘macroseismic map’ of the 1855 event: an early form of an isoseismic map (Fig. 3).

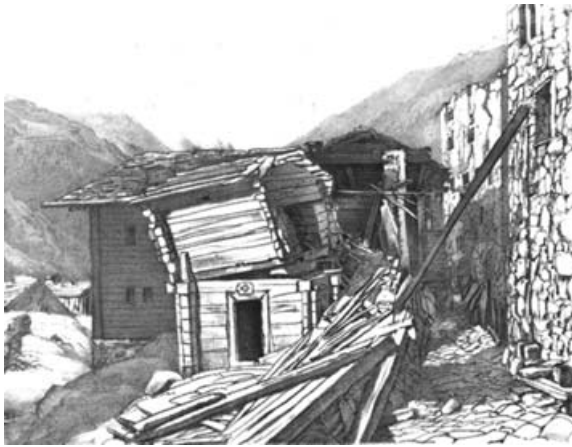
Figure 4. St. Niklaus after the mainshock of 1855 July 25 (Heusser 1856).

The next village they visited was St. Niklaus, a small spot of about 30 houses and 70 farm buildings. Like other authors describing the damage to this village, Nöggerath pointed out that the stone buildings suffered heavy destruction: ‘... all of them are either already collapsed or disrupted in a way, that hardly one of them can be repaired.’ (Nöggerath 1855, 24). While Heusser’s report contains no further information on St. Niklaus—with the exception of a meaningful illustration (Fig. 4)—Walter de la Rive’s description is remarkable. Similar to Nöggerath and Heusser, De la Rive pointed out that damage is more apparent than in Visp or Stalden. ‘[...] there is no semi-devastation, the ruins are complete, the houses are not only disrupted but the debris covers the street [...] one of the hotels has quasi disappeared, its façades do not exist anymore [...]’ (De la Rive 1855, 95/96). However, if one believes De la Rive’s report, the disaster could have been much worse. According to him, the meadow above the village was littered with boulders of a rock fall stopped only by the soft soil. This circumstance protected the village from a catastrophe: ‘[...] if the terrain would have been frozen [...] nothing of St. Niklaus would have remained [...]’ (De la Rive 1855, 95/96) (Fig. 7).

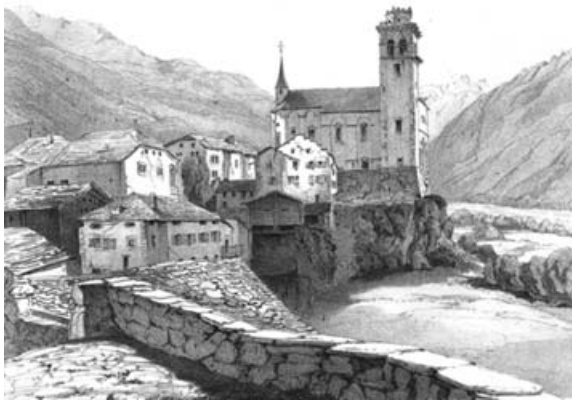
Figure 5. Visp and the Martinkirche with the damaged tower (Heusser 1856).

heavy destruction. Both were large stone buildings. Martinskirche lost its famous pinnacle while the rest of the tower remained upright with many large cracks in the walls (Fig. 5). In both churches the well-constructed vaults (Nöggerath 1855, 12) collapsed. Nöggerath commented: 'If already these structural collapses [the collapse of the vaults] require strong motion of the lateral walls, an even better proof [for this strong motion] is the fact, that in the Martinskirche the con-rods, tightening the lateral walls below the vault [...], partly broke, partly had been pulled out of the walls.' (Nöggerath 1855, *ibid.*). Heusser was particularly shocked by the heavy devastation inside the churches: 'The walls of both churches are disrupted in many cases, and furthermore the interior of both of them form a veritable heap of rubble, as the organ, pieces of masonry and images were all jumbled together.' (Heusser 1856, 6). Both visitors also noted cracks in the ground of the village. Heusser gave an account of a particularly large crack with a width 'of about one half to one foot' in the eastern part of Visp (Heusser 1856, 6). Nöggerath mentioned several cracks in the alluvial ground in and near Visp (App. II). Nöggerath as well as Heusser reported recent clefts in the

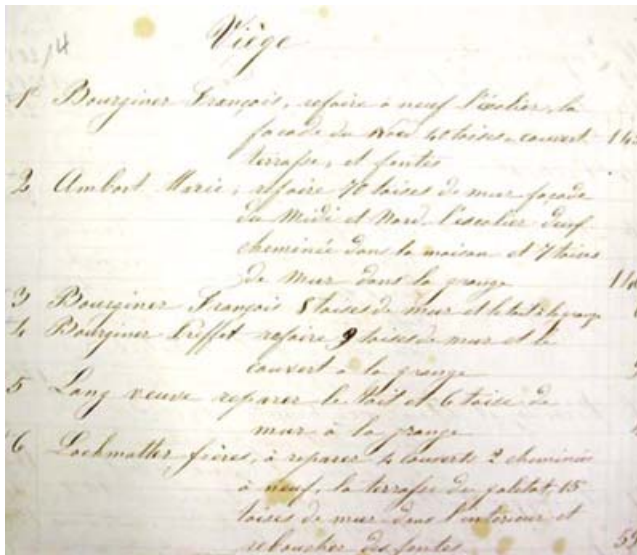
Figure 6. First page of the damage list of Visp. The columns contain from the left to the right: consecutive numbers, the name of the owner, a short description of the damage and an amount of money in CHF. (Staatsarchiv Wallis 27.3.3: Ancien fonds du département de l'intérieur. Tremblement de terre de juillet 1855. Revision de la taxe, distribution des secours.)

a quantitative analysis and thereby a precise reconstruction of the damage field. Immediately after the mainshock of 1855 July 25, the government of the State of Valais, domiciled in Sion, became aware of serious consequences. In its meeting of July 27, the government decided to send a commission of experts into the affected region (Staatsarchiv Wallis 1101: Protocoles des séances du Conseil d’État 1855-57, séance du 27. juillet 1855). This commission had orders to assess damage and consider reparations (Ibid.). During the following weeks, the commission members travelled from village to village to survey damage. Their descriptive lists usually consist of four columns and, depending on the extent of damage, up to 150 descriptions of cases of loss per township. The first column contains consecutive numbers, the second the name of the owner, the third a short description of the recognized damage and the fourth an estimation of the repair costs in Swiss Francs (Fig. 6).

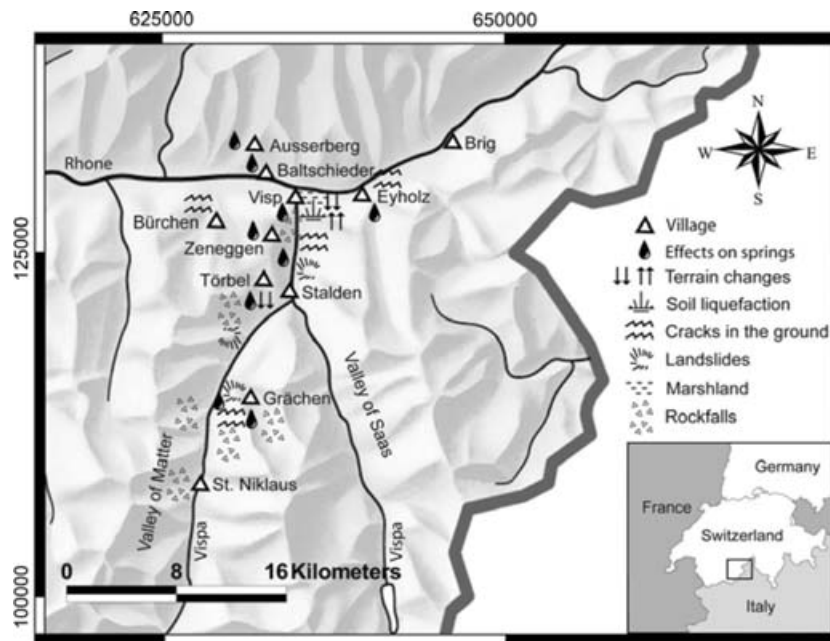
Figure 7. Seismogeological effects in the Valley of Visp.

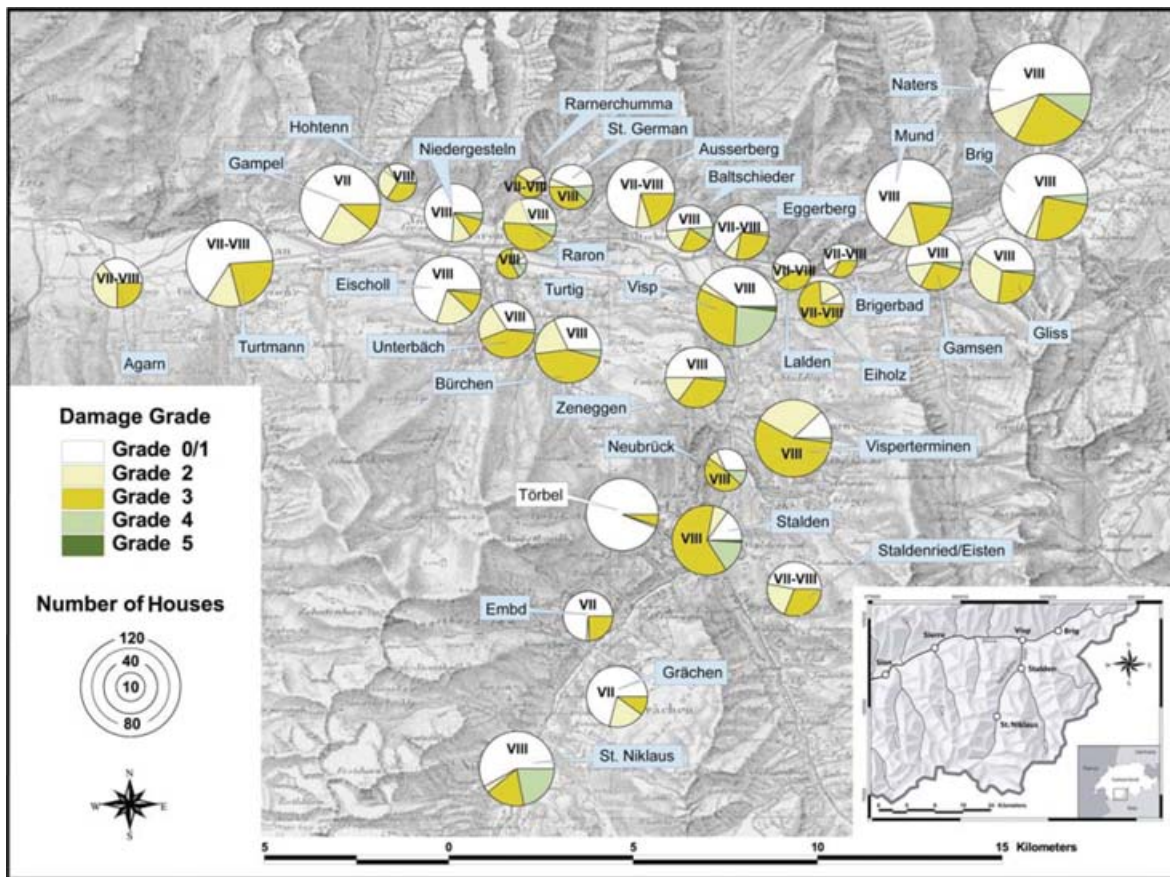
Figure 8. Damage grades and intensities assigned on the basis of the damage lists. For locations with intensity degrees in the form of VII–VIII, it was not possible to decide which value is appropriate. They contain elements of intensity degrees VII and VIII. (Grünthal 1998, p. 57).

Fig. 8 summarizes the results of the assessed damage field on the background of a reproduced map (1:100 000) first published in 1854 (Bundesamt für Landestopographie 1988). The investigated regions are plotted as pie charts. Their size is proportional to the total number of existing houses at that time. The coloured segments indicate the different damage grades. As mentioned, damage of levels 1 and some of 2 were not assessed and are, therefore, included in the white coloured segment representing the undamaged buildings. The assigned intensity degrees are represented by roman numerals. Before going into detail, we will compare this figure with the descriptions and comments in paragraph 4 (an overall description of the damage field pp. 11–17). Two differences are obvious. While the highest intensities in Fig. 8 are of grade VIII (heavily damaging), an assignment of intensities on the basis of the quotations in paragraph 4 would instead produce intensities of up to grade IX (destructive).

After a closer look at Fig. 8, the following deserves attention. According to EMS 98 damage occurs in the range of intensity VI and higher (Grünthal 1998, 18–20). However, our damage field shows no intensities of degree VI, not even on its borders. This is due to the fact that intensity VI is defined by damage of grades 1 and 2, which did not (or only partly) match the criteria to obtain compensation payments. Thus, we have to assume that outside the figure border localities showing intensities of degree VI were present in 1855. Fig. 9 is based on several earthquake catalogues and confirms this assumption, showing the investigated region as part of the entire macroseismic field.

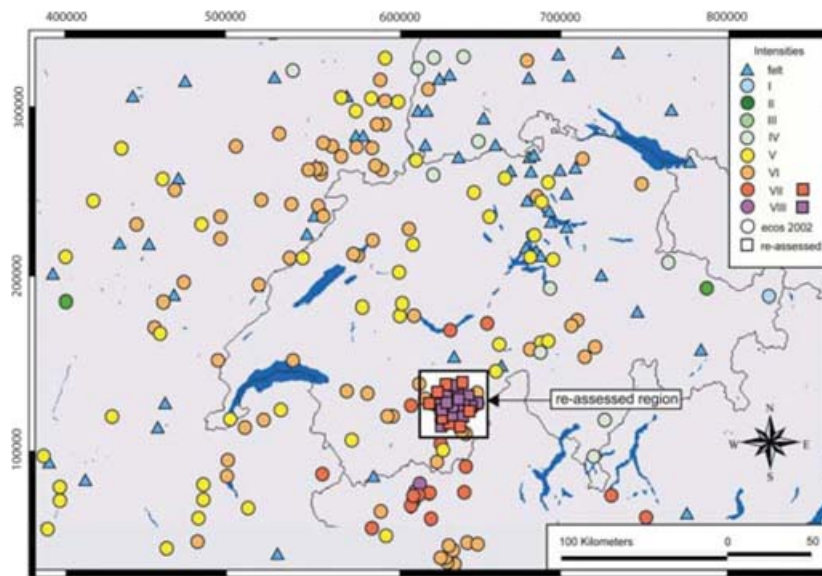
Figure 9. Investigated region as part of the entire macroseismic field of 1855. The data for this analysis derive from the revised Earthquake Catalogue of Switzerland (ECOS) (Swiss Seismological Service 2002), from the Italian Catalogo parametrico dei terremoti italiani (Istituto Nazionale di Geofisica 2005) and from the French catalogue SisFrance (BRGM *et al.* 2005).

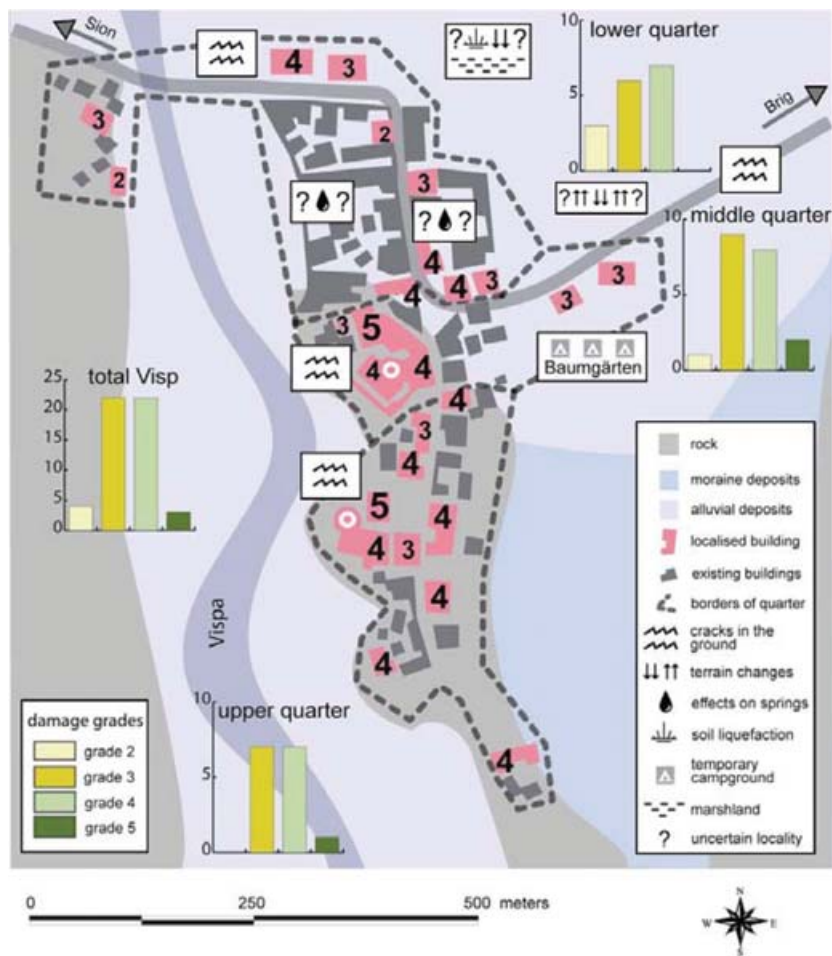
Figure 10. Geology, localized buildings, dispersion of damage and approximate position of seismogeological effects in Visp.

ble to identify their former position. We were able to locate exactly about 50 per cent of the houses mentioned in the damage lists. Approximately 20 per cent could be assigned to one of three parts of the township (see Fig. 10). This detective work was based upon comparing the damage lists to the original documents of the 1850 population census (Eidgenössische Volkszählung 1850, Gemeinde Visp) and 1870 (Eidgenössische Volkszählung 1870, Gemeinde Visp). However, even more important than these documents was the help of the local historian, Christian Fux. His profound knowledge of Visp, its history, and families was indispensable to the completion of this work.

Fig. 10 summarizes the results of this historical investigation against the geological background. Exactly located buildings are marked in red. The corresponding number specifies the assigned damage grade. In contrast to this, the black coloured houses do not represent the exact situation as it was in the 1850s, but indicate the area of the historical village. The dotted line represents the borders of the historical quarters, as they could be reproduced on the basis of the 1870 census documents. Finally, the bar charts summarize the damage per quarter including that to houses whose location is not exact. All the still existing houses are built in simple stone masonry and belong to vulnerability class B. We assume as well that most buildings no longer existing fit into this category. Indications for this assumption can be found in the photograph of Visp (Fig. 11) published by Fux (1996).

The bar charts show that the distribution of damage grades is very similar in all three parts of Visp. This is astonishing when we consider that the geological situations of the upper quarter (built on rock) and the lower (built on the large deposits of the main valley) differ significantly. Because of amplification effects, we had expected that more serious damage would have occurred on the deposits than on the rock. The assumption that a site effect played a major role in the damage distribution in Visp is thus not yet verifiable. A possible explanation for the equal distribution of the damage is a source effect. This thesis would agree with the fault postulated by (Crealp 1999) and Joris (2005). However, to understand better what really happened in the Visp of 1855, we plan to further investigate

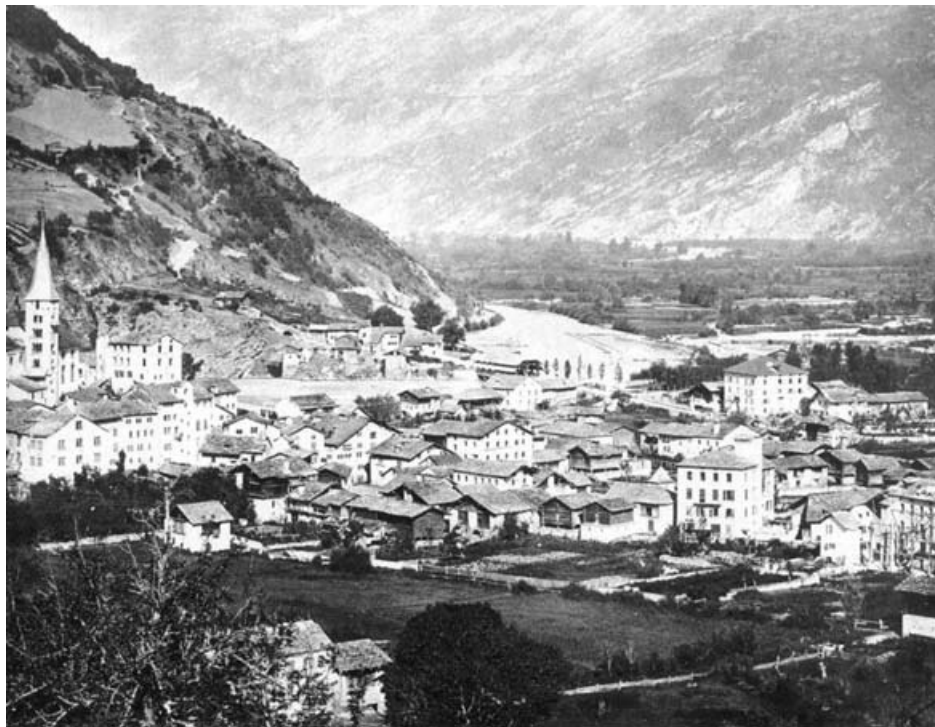
Figure 11. Photograph of Visp in 1856 (Fux 1996, no. 195). Some of the buildings still show damage caused by the earthquake or are under reconstruction.
