Proceedings of the Forty First Turbomachinery Symposium
September 24 – 27, 2012, Houston, Texas

BABBITTED BEARING HEALTH ASSESSMENT

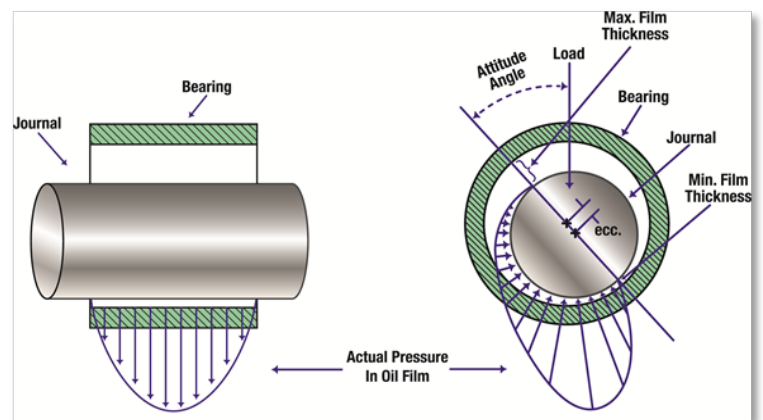
Figure 1 Hydrodynamic film generation

Figure 1 is a sketch of a journal in a bearing (with greatly exaggerated clearances). This figure also contains some terms that will be used throughout this presentation.

There is a journal rotating (CCW) inside a journal bearing and the rotation of this journal drags oil into a converging space. Since oil is incompressible, all of the oil cannot be pulled through this space so a pressure is generated that forces the oil out the axial ends of the bearing. This pressure is depicted by the pressure profiles as shown.

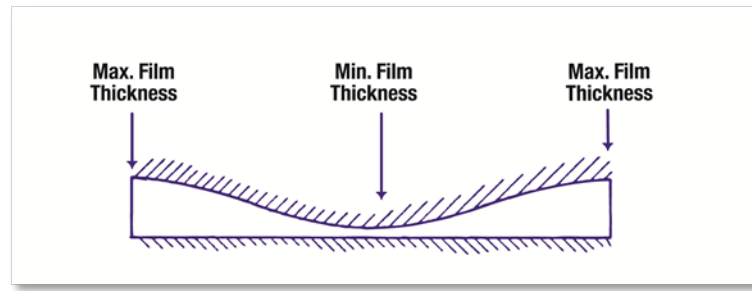
Figure 2 Unwrapped Clearance Space

The "minimum oil film thickness" lies on the line of centers and can be defined by the eccentricity ratio and bearing radial clearance. Figure 2 is a drawing of the clearance space

unwrapped – starting at the point of maximum oil film thickness (opposite the minimum) and continuing 360 degrees though the minimum and back to the maximum. Here the converging and diverging wedges can be more clearly seen.

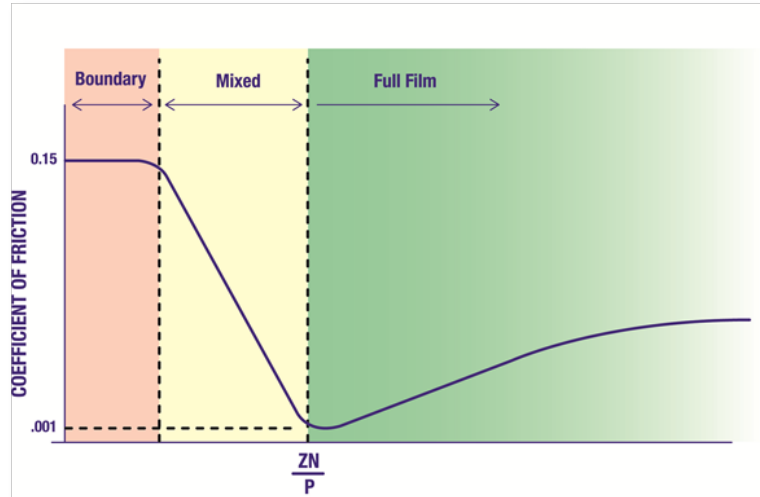
Figure 3 Stribeck curve

As a machine is brought up from zero speed to full speed it goes through three hydrodynamic lubrication regimes. The Stribeck curve contains these regimes and is presented in Figure 3. The curve plots the coefficient of friction on the vertical axis and ZN/P on the horizontal. In this plot Z is viscosity, N is speed and P is the unit load on the bearing. The best way to first study this curve is to envision a machine coming up in speed, where the viscosity and load are constant.

At zero speed and at very low speeds there is boundary lubrication; here the two surfaces are in contact with a relatively low coefficient of friction (~0.15) thanks to the presence of oil and two very good surfaces (babbitt and typically a ground journal). Once the speed is sufficient to pull oil into the wedge hydrodynamic pressure begins to develop and the surfaces begin to separate; hence the drop in friction as speed increases, this regime is referred to as mixed film lubrication. Once the surfaces are fully separated we have a minimum friction (depicted as .001 in the figure) and as speed

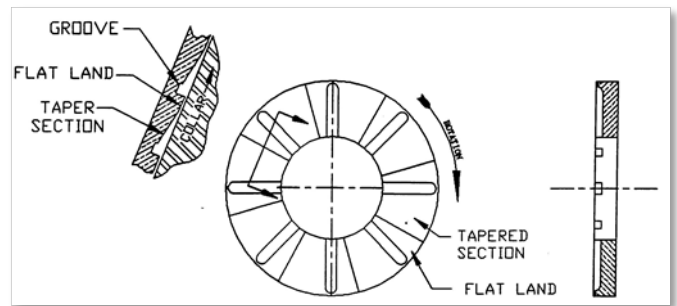
Figure 4 Taper Land Thrust Plate

The hydrodynamic principle is the same since the face of the babbitted bearings must have a converging wedge to support the load. Figure 4 contains a drawing of a taper land thrust plate. In this design the wedge (or taper) is machined into the face of the bearing as noted in the section on the left. The rotation of the thrust collar pulls oil into this converging space and hydrodynamic pressure is generated.

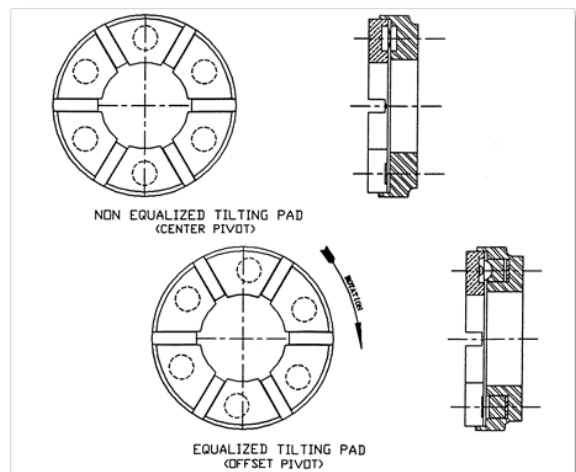
Figure 5 Tilting Pad Thrust Bearings

Figure 5 shows two variations of tilting pad thrust bearings. On top is the non-equalized bearing with pad pivots in the circumferential center of the pad and on the bottom is a fully equalized tilting pad thrust bearing. The equalized bearing

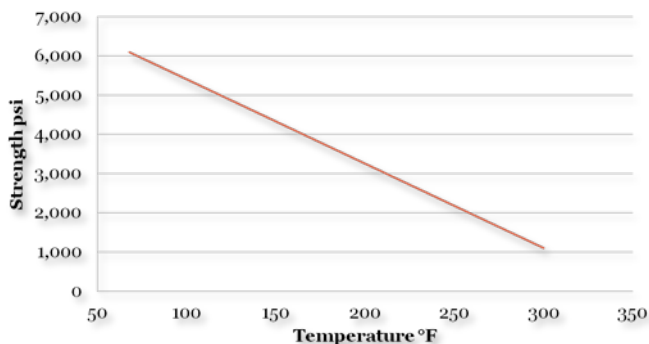
Figure 6 ASTM B23 Alloy 2 Yield Strength

A plot of babbitt yield strength vs. temperature is presented in Figure 6. This data comes from ASTM B23 and has been extrapolated to 300 °F. The yield strength is also presented based upon a 0.125% offset (0.125% deformation of gage length). Yield data is presented at a 0.2% offset from time to time and of course that results in higher values for the yield strength (i.e. 0.125% offset values are more conservative).

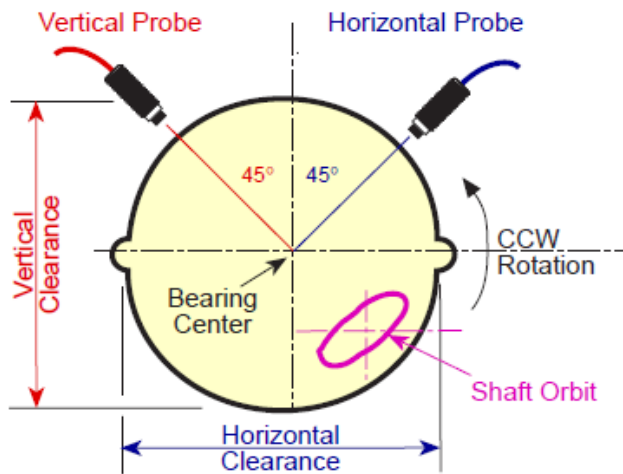
When the shaft begins to rotate, it is lifted by the oil wedge and is displaced laterally in the direction of rotation (see Figure 7). Other influences, such as misalignment and gear tangential and separation forces can also cause movement of the shaft in the bearing clearance.

Figure 7 – Illustration of Proximity Probe Layout and Shaft Movement for a Counterclockwise Rotating Shaft (Eisenmann and Eisenmann, 1997)

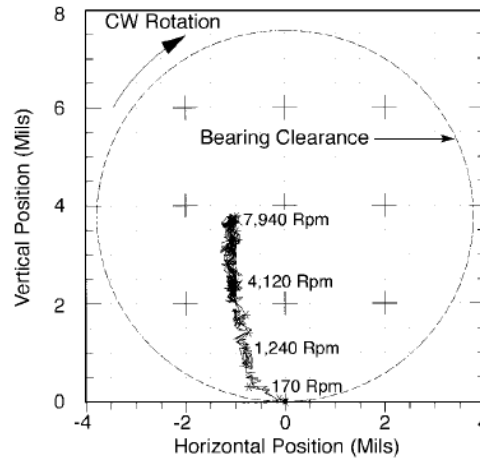
High speed data acquisition systems can record the probe DC components and show changes in shaft position in some detail. Figure 8 is a plot of continuous sampling of DC gap voltages and resultant shaft movement during a start up for a machine with clockwise rotation. The initial point is with the shaft resting on the bottom of the bearing and all the changes in position are relative to that shut down condition. This machine was equipped with tilt pad bearings, and this direction and magnitude change in shaft position is considered normal for this type and size bearing. (Eisenmann and Eisenmann 1997)

Figure 8 – Shaft Position Change during Start Up for a Machine with Clockwise Rotation (Eisenmann and Eisenmann, 1997)

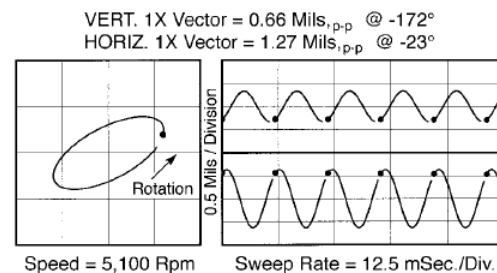
The timebase signals from orthogonal proximity probes used to measure radial vibration can be combined with a once-per-turn phase reference to produce an orbit plot, which provides a graphical representation of the shaft motion in the bearing (see Figure 9). Alarm and shutdown limits for radial shaft vibration are sometimes established as a percentage of bearing clearance in order to avoid bearing damage from excessive shaft radial movement. Orbit shape is often elliptical rather than round, so it is advisable to set the alarm and shutdown using the amplitude of the major axis of the ellipse (S_{max}), since that is the highest amplitude motion that could cause bearing damage. The S_{max} calculation is available as a standard function on many modern monitoring systems.

Figure 9 – 1X Filtered Orbit (Eisenmann and Eisenmann, 1997)

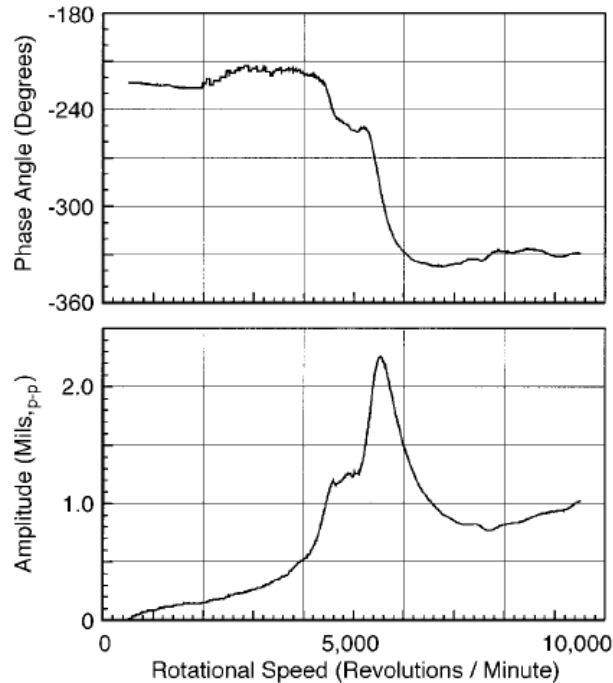
Vibration data acquired during machine start up and shut down (“transient” data) can also be an indicator of radial bearing condition. The Bode plot (see Figure 10) is a representation of synchronous rotational speed (1X) vibration amplitude and phase angle plotted as a function of machine speed. The polar plot (see Figure 11) is the same data presented in a Nyquist format. The Bode plot is helpful in detecting changes with respect to speed, the polar plot shows the change in phase angle and physical orientation in a more easily interpreted format. Cascade plots (see Figure 12) are a data format where spectrum plots acquired at speed intervals during start up or shut down are plotted on the same graph.

Figure 10 – Bode Plot (Eisenmann and Eisenmann, 1997)

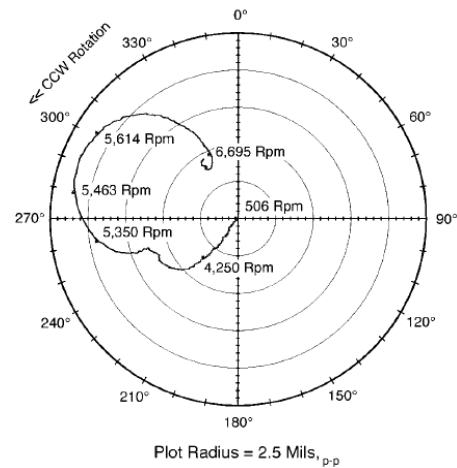
Figure 11 – Polar Plot (Eisenmann and Eisenmann, 1997)

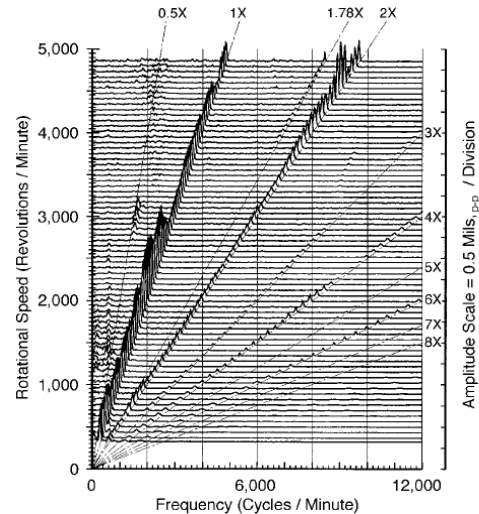
Figure 12 – Cascade Plot (Eisenmann and Eisenmann, 1997)

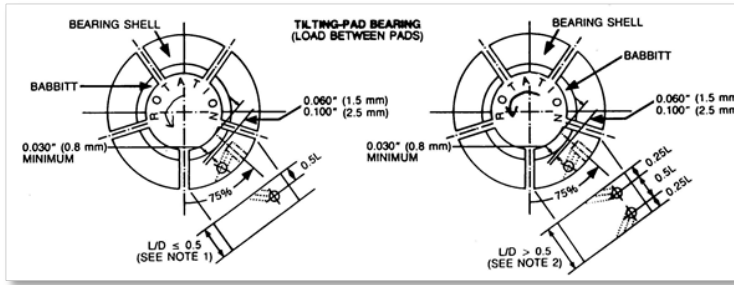
Figure 13 API 670 Figure for TPJ Instrumentation

Proper thermocouple or RTD placement in a 5 pad tilting pad journal bearing oriented in a load between pad (LBP) configuration is denoted in Figure 13. Note the instrument is located very close to the babbitt bond line and 75% in circumferentially from the pad leading edge. The 75% location may not represent the hottest portion of the pad surface but it does closely represent the most distressed location taking into consideration temperature and film pressure. Also note the instrument should not compromise the bond line as dimpling of the babbitt surface is possible.

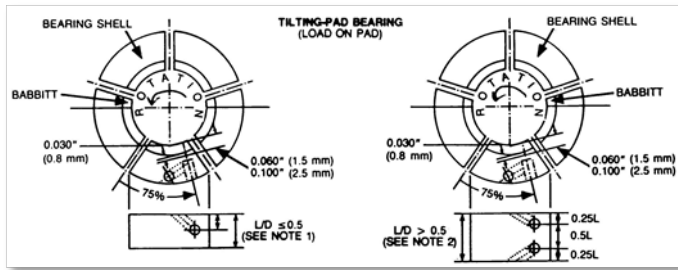
Figure 14 API 670 figure for LOP instrumentation

Figure 14 is for Load on Pad (LOP) configurations. There is also a similar figure for sleeve bearings. Figure 15, also from API 670, denotes the proper location of temperature instrumentation in tilting pad thrust bearings.

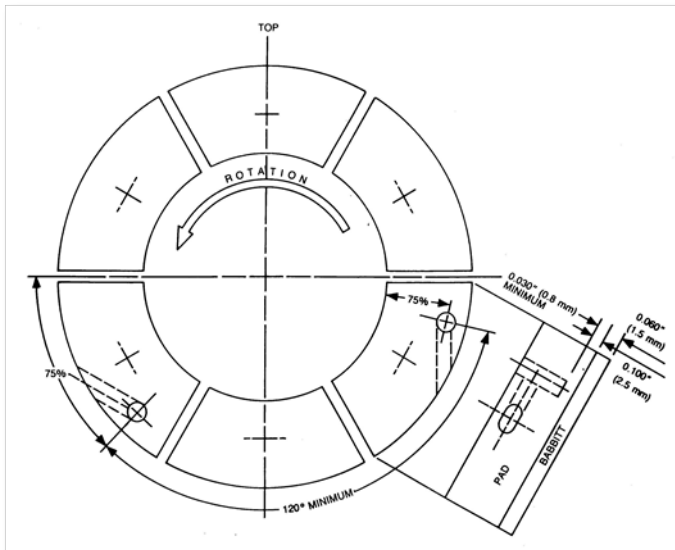
Figure 15 Temperature sensor placement in thrust bearings

Note that these are very good standard locations for sensor placement. They closely represent the most distressed location in the bearing and the standardization allows one to effectively analyze the condition of the bearing. For instance if there was a sensor placed at the center of the pad there would need to be some of correlation required to estimate the temperature at the API location.

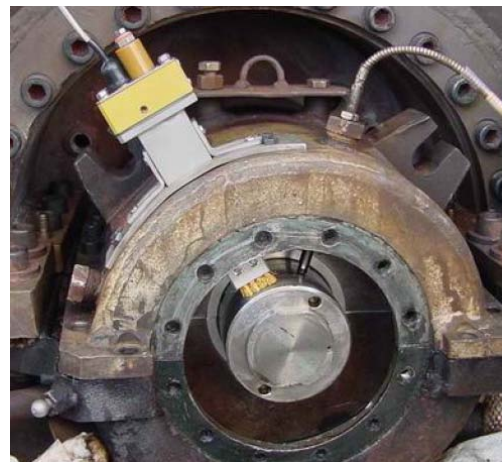
Shaft grounding brushes serve two purposes. The brushes are able to transmit modest amounts of stray current to ground for prevention of arc damage through parts of the machine (especially the bearings). The brushes also permit measurement of the shaft voltage and current, which allows assessment of the electromagnetic condition of the machine.

Figure 16- Typical Grounding Brush Installation (Sohre, 2010)

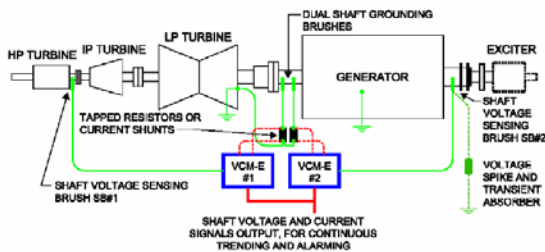
Monitoring to determine shaft current level and changes is performed using a shaft voltage current monitor (VCM). The VCM measures voltage and current through the grounding brushes. Ideally, the output of the VCM should be connected to a recording device or plant data historian so that trends of the voltage and current can be used to detect changes in shaft electrical properties. If readings increase slowly, it could be an indication of deterioration of the electrical machinery (motor, generator, or exciter) or possible progressive self-magnetization of the machine. Sudden increases in current may indicate that self-magnetization has occurred, possibly due to the reasons previously mentioned.

Figure 17 – Shaft Voltage Current Monitor Installation on a Turbine Generator (Nippes and Galano)

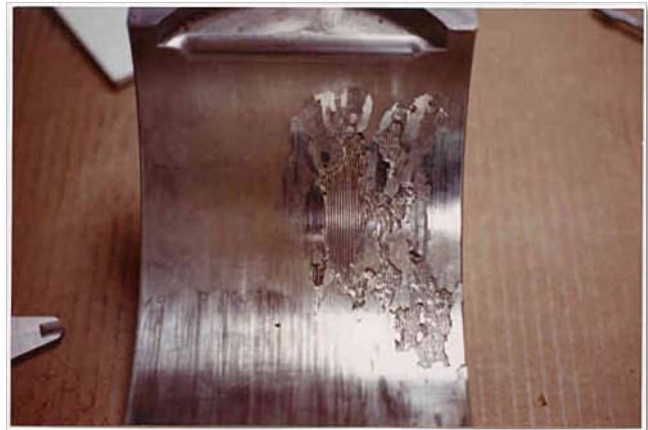
Figure 18 Wiping and fatigue/misalignment

Figure 18 is a photograph of a bearing that exhibits slight low speed wiping coupled with at-speed fatigue damage, brought on by bearing to journal misalignment.

Here we see that the bottom portion of this bearing shows an even wipe (or polish) pattern from low speed operation (operating in the boundary lubrication regime). We also see fatigue damage; however this is presenting itself only on the right side of the bearing – indicating that the bearing became misaligned once up to speed.

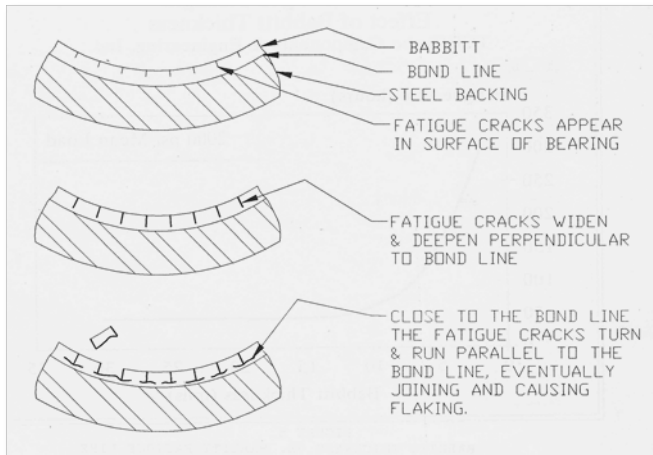
Figure 19 Fatigue crack propagation

circumferentially, meeting with other cracks and dislodging pieces of babbitt. This is conceptually illustrated in Figure 19.

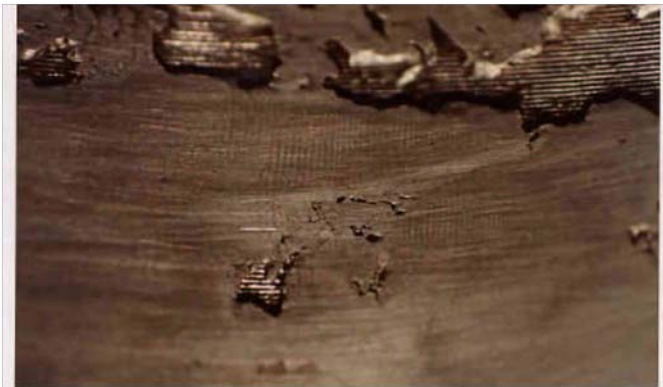
Figure 20 Close up of fatigue damage

A close up of the babbitt surface (Figure 20) shows portions of babbitt missing and a section showing only surface cracks.

Babbitt fatigue strength can be increased by utilizing thinner babbitt (to take advantage of the backing material strength) and by keeping the babbitt temperature low.

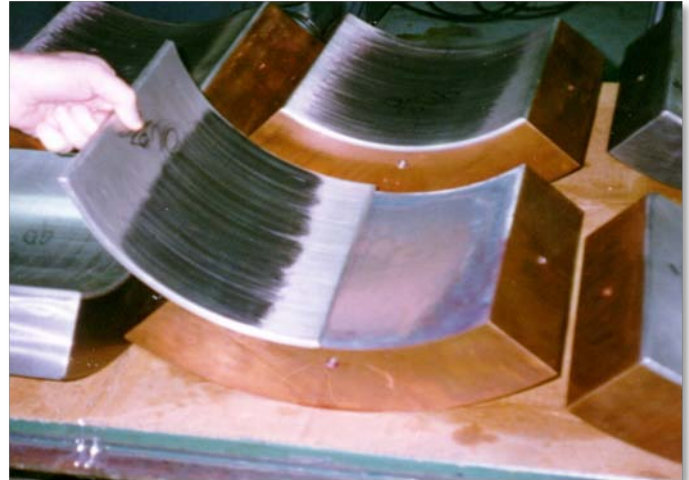
Figure 23 Loss of bond with copper pads

This is most common when babbitt is applied to copper alloy. Copper is used extensively to reduce bearing operating temperatures by allowing a significantly increased heat transfer coefficient. Most bearing companies use a copper alloy that has good stiffness and strength while still having good heat transfer properties. Figure 23 is a photograph of a sheet of babbitt that came off of a 16" journal pad.

It has been discovered that copper has a strong affinity for tin and this is magnified at elevated temperatures. When babbitt is applied to bearings the process includes a tinning operation so the tin adheres to the base metal and then the babbitt bonds to the tin. Should the tin diffuse into the copper the bond will become weaker and weaker, and brittle. Oddly enough this is often times not discovered during normal NDT inspection (such as visual, PT or UT) since the bond is intact, it is just compromised and measures of bond strength are destructive.

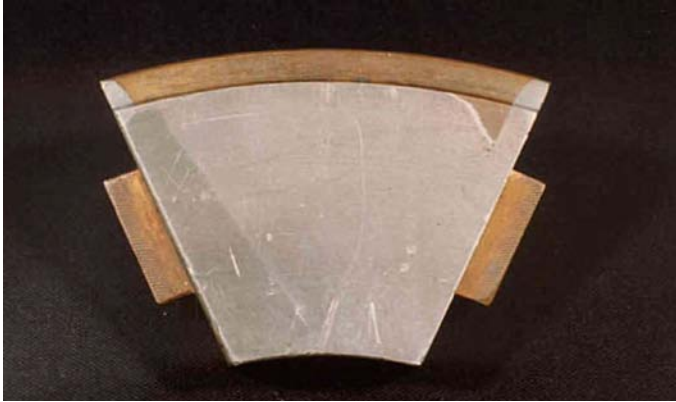
Figure 24 Thrust pad with electrostatic discharge damage

A pad exhibiting signs of electrostatic discharge is shown in Figure 24. Note that with a bearing like this the point of minimum film thickness is typically on the upper trailing edge as shown. Note that the babbitt has been spark eroded away starting in the minimum film thickness corner and working its way down the pad, as the pad shape changes.

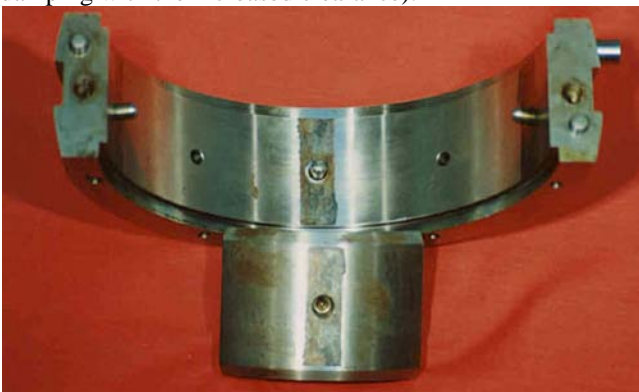
Figure 25 Pivot wear

One way to detect the possibility of this happening is by monitoring the shaft centerline position for journal bearings and axial position for thrust. If moves are detected and there is no tin found in the oil then one may conclude there is a possibility of pivot wear. For journal bearings this could also be accompanied with increased vibration (due to loss of stiffness and damping with the increased clearance).

This damage can be avoided with a lower stress pivot design and/or control of vibration levels.

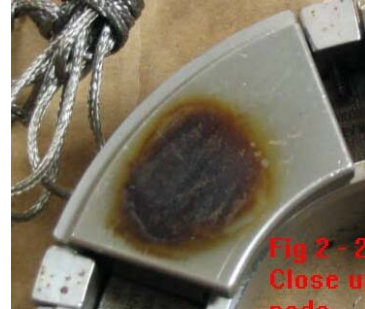
Figure 26 Oil coking

Figure 26 illustrates this phenomena. Note that the presence of this “coke” is typically located in the area of the bearing exposed to high film pressure coupled with high operating temperatures; also note that the 75-75 location does seem to represent the most distressed portion of the pad.

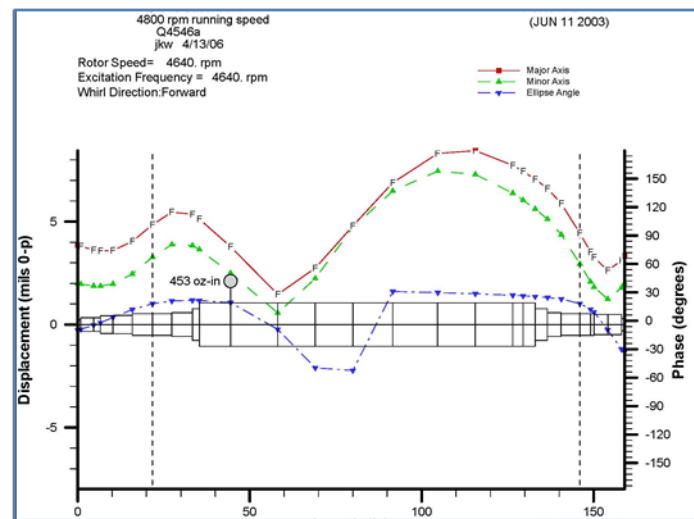
Figure 29 Rotor deflection due to imbalance

The rotor model the rotor deflection shape from an unbalance at the first wheel are presented in Figure 29. Note that this is a drive through machine so there is a coupling on each end. Also note that the analysis predicts that for this unbalance the vibration at each bearing should be about the

same. However the actual machine had 5 mils vibration on one bearing and 1 mil on the other. It was determined that an unbalance between bearings could not duplicate the vibration spread observed.

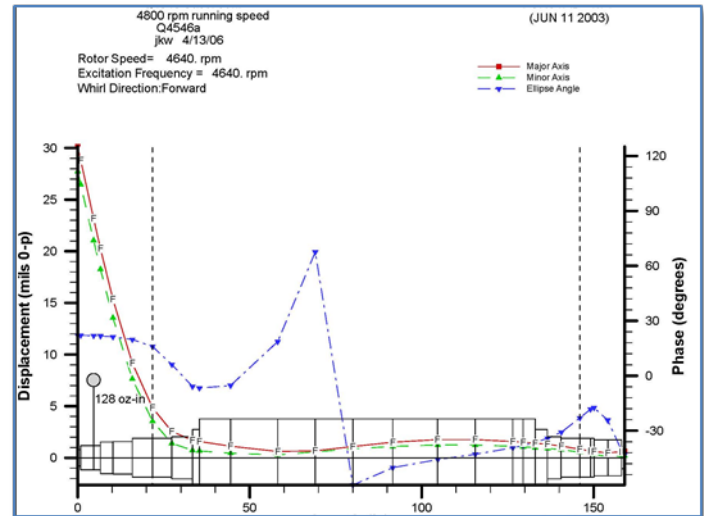
Figure 30 Rotor deflection shaft with coupling unbalance

As shown in Figure 30 when applying an unbalance to the coupling we find the roughly 5 to 1 variation in vibration as observed from one end of the rotor to the other. It was determined that somehow the coupling became unbalanced – even though the vibration on the other side of the coupling remained low. This analysis also replicated the speed dependency found in the actual machine.

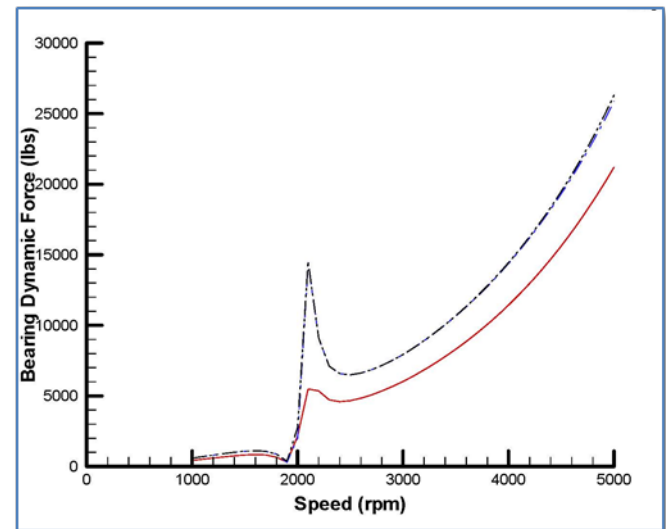
Figure 31 Bearing force due to coupling unbalance

The dynamic force imparted on the bearing due to a coupling unbalance sufficient to raise the vibration to 5 mils is depicted in Figure 31. Note the significant dynamic load (which is zero to peak). The bearing had (roughly) a static load (journal

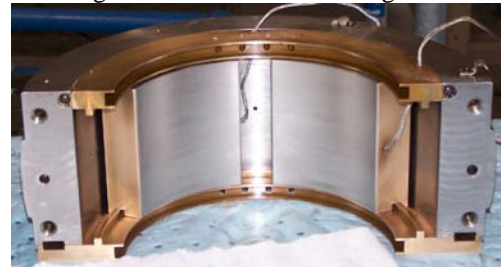
Figure 37 201 compressor after 9 years operation

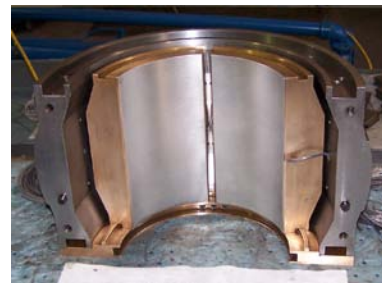
Figure 28 601 bearing after 9 years in operation

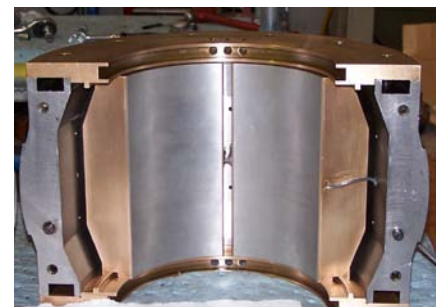
Figure 39 201A Bearing after 9 years in service

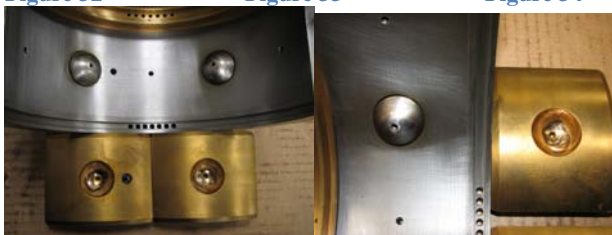
to some pivot wear and babbitt loss. Figure 32 is a photo of the bearing assembly; Figure 33 shows the bottom two pads; Figure 34 the top pads; Figure 35 the lower pad pivots and Figure 36 is a close up of the pivot wear. The bearing on the other end had the same bore as when it shipped 11 years earlier.
