Diagnosis and Solution of High Noise and Vibration Issues After a Propylene Refrigeration Compressor Re-rate

Zheji Liu

Dresser-Rand

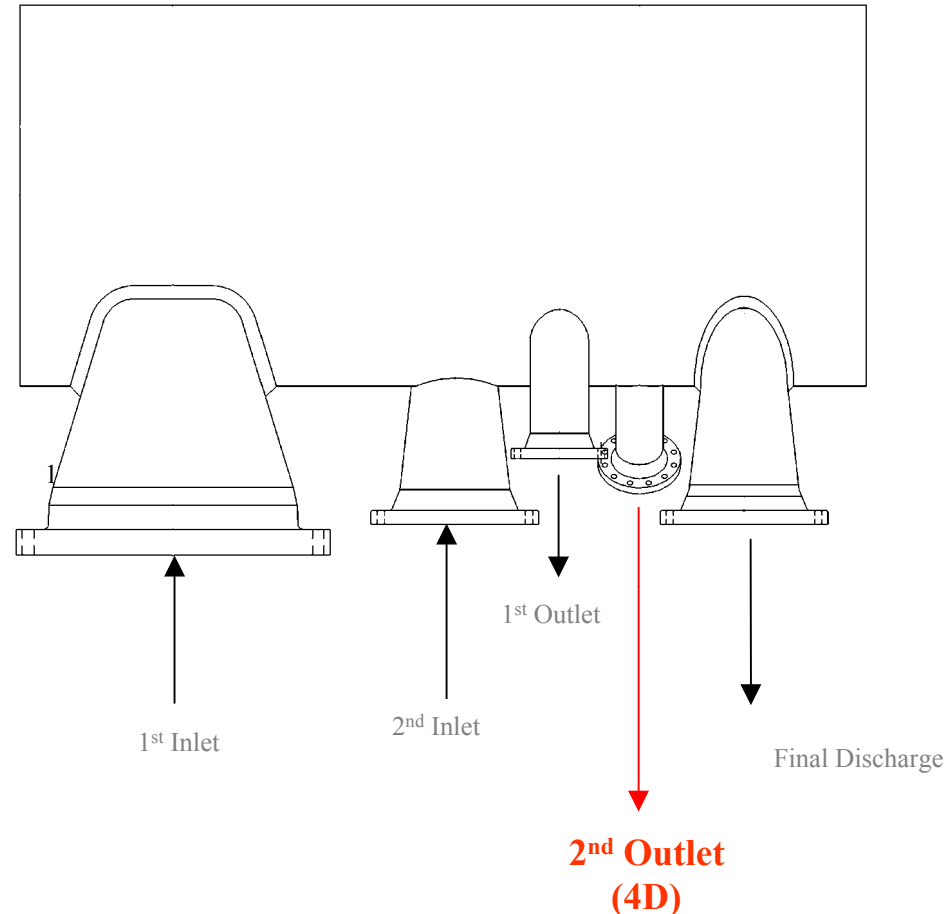
- ◆ The subject compressor draws gas from two process pipes and discharges gas through three discharge pipes.
- ◆ Main inlet 1: 42-inch-diameter .
- ◆ 2nd inlet: a 20-inch nozzle (2) to bring in additional gas.
- ◆ 1st outlet: a 10-inch nozzle (3) to take gas out of compressor.
- ◆ 2nd outlet: an 8-inch nozzle (4) (This impeller/nozzle/discharge pipe is the focus of this study). The 8-inch nozzle is then transitioned into a 12-inch-diameter discharge pipe (4D).
- ◆ Final discharge: 20-inch-diameter final discharge nozzle (5).

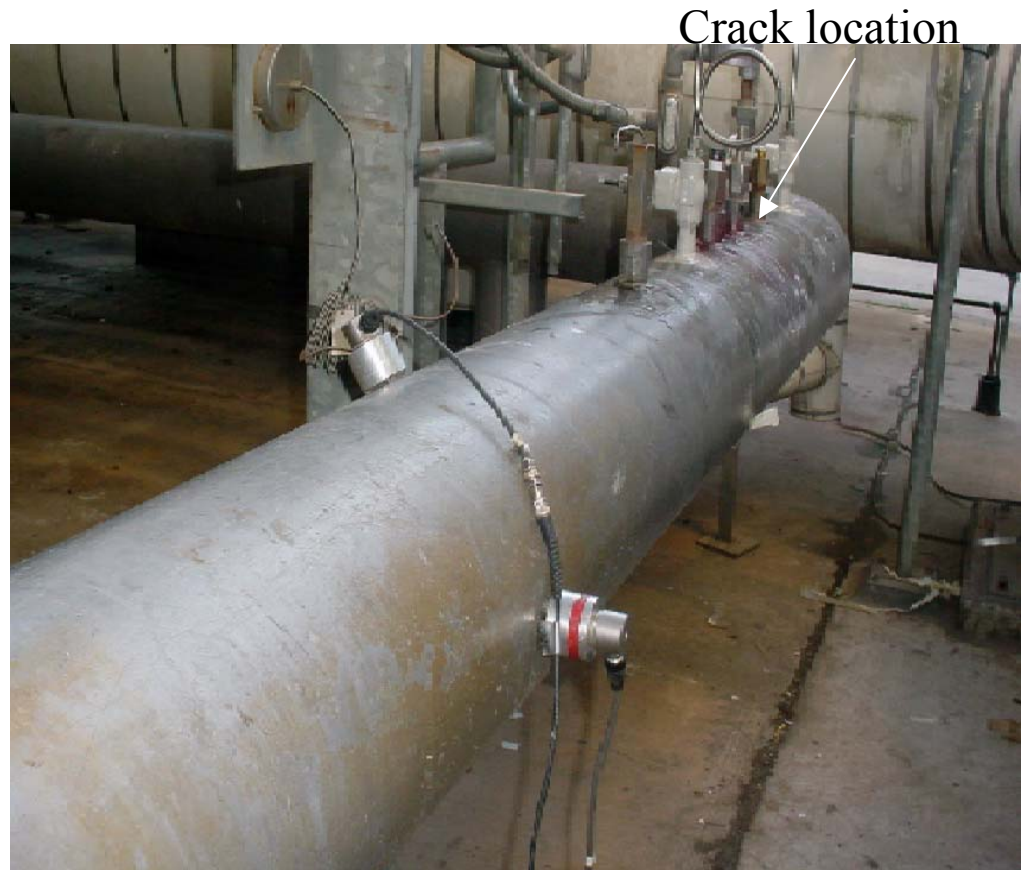
- ◆ High noise and vibration was observed only on the 4D pipe.
- ◆ It caused external piping connections on the 4D pipe to develop cracks.

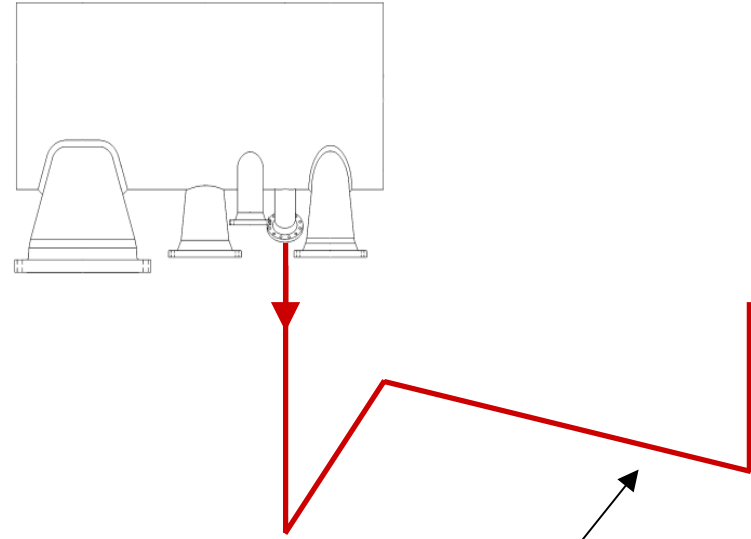
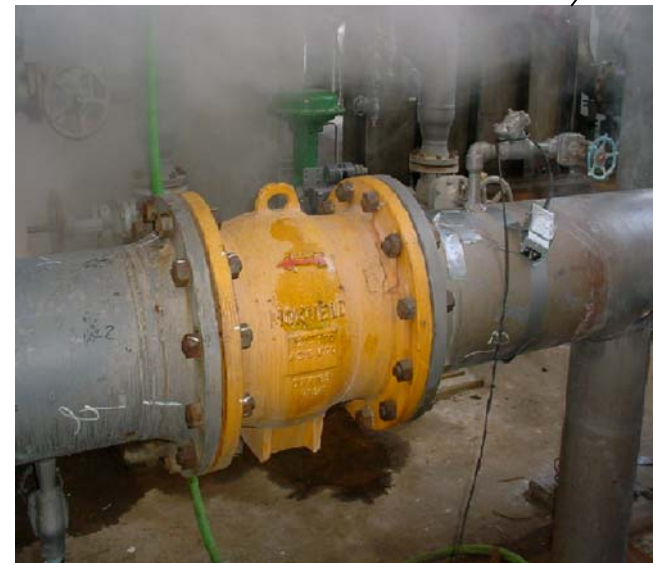
- ◆ Plant engineering resources initially contacted an outside firm to assist in determining the cause of the high levels of vibration and noise.
- ◆ Pressure pulsations, piping vibration and dynamic strain were measured on the 4D pipe.
- ◆ The conclusion from the first consultant was that the “Mokveld” check valve located downstream of the compressor was inducing an “acoustic” vibration resonance on the piping. Vortex shedding was claimed as the root cause of the high noise and vibration.

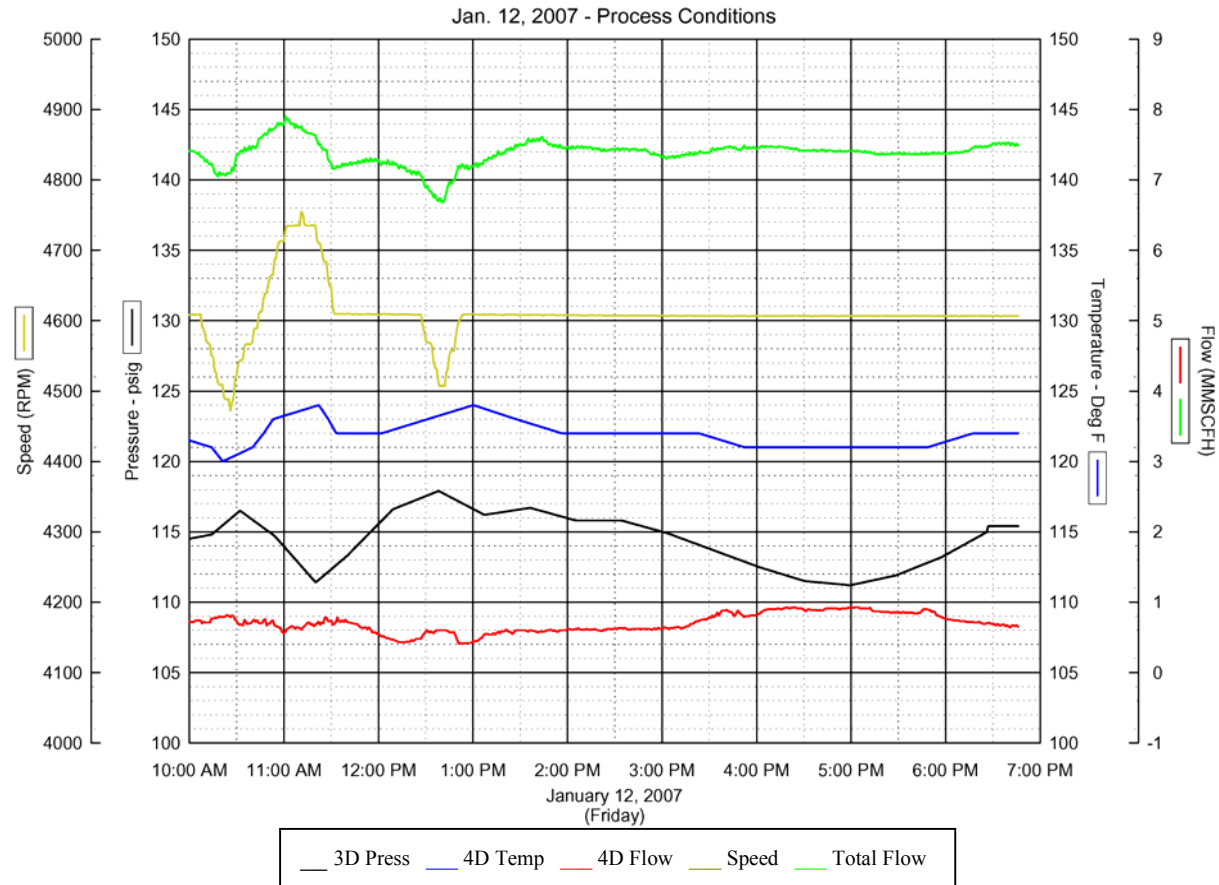
- ◆ Test lasted about 9 hours, dynamic signals (pulsation, vibration, strain and noise) were continuously recorded.
- ◆ Speed, flow rate, pressure, and temperature were varied during the test.

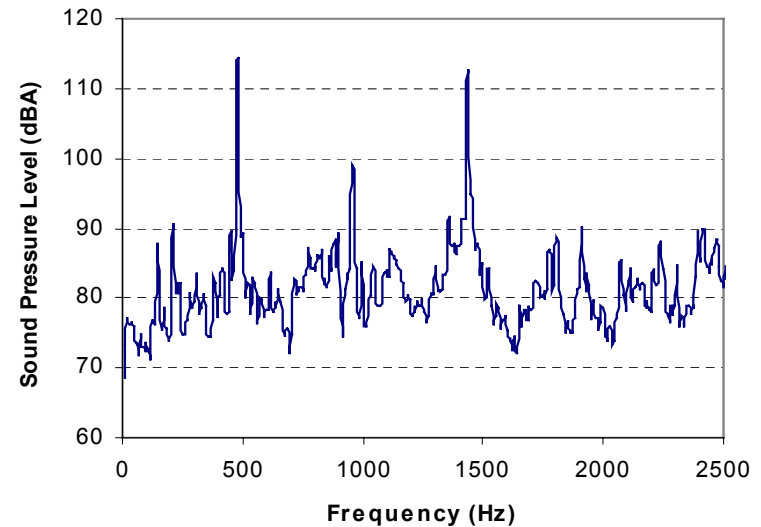
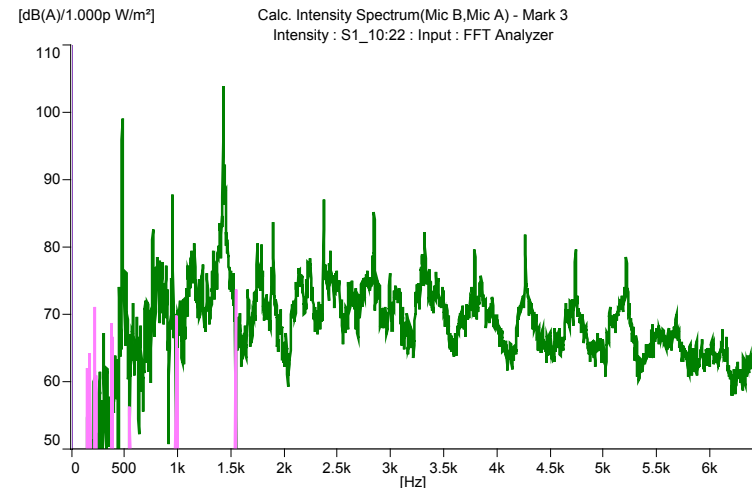
- ◆ Both sound pressure level and sound intensity level were acquired in narrow band (FFT).
- ◆ Noise source is discrete in nature with strong tonal components - fundamental at 480 Hz, and integer multiples at 960 Hz and 1440 Hz.
- ◆ This type of noise signature is not likely from a Vortex shedding phenomenon.
- ◆ It can not be a sole result of either acoustical or structural resonance of the 4D pipe.
- ◆ The excitation source is not likely within the 4D pipe.

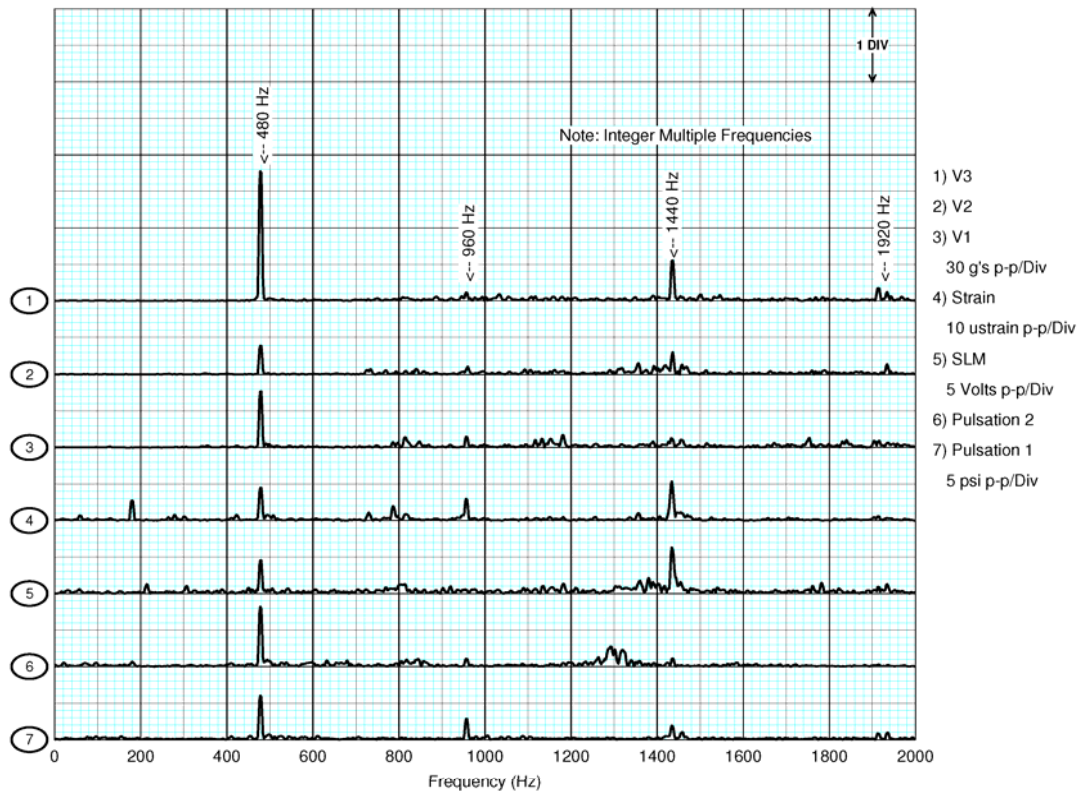
- ◆ Pulsations, vibration, and dynamic strain data show strong coherence among them.
- ◆ All have peaks at 480 Hz (fundamental); 960 Hz (2nd harmonic), and 1440 (3rd harmonics).

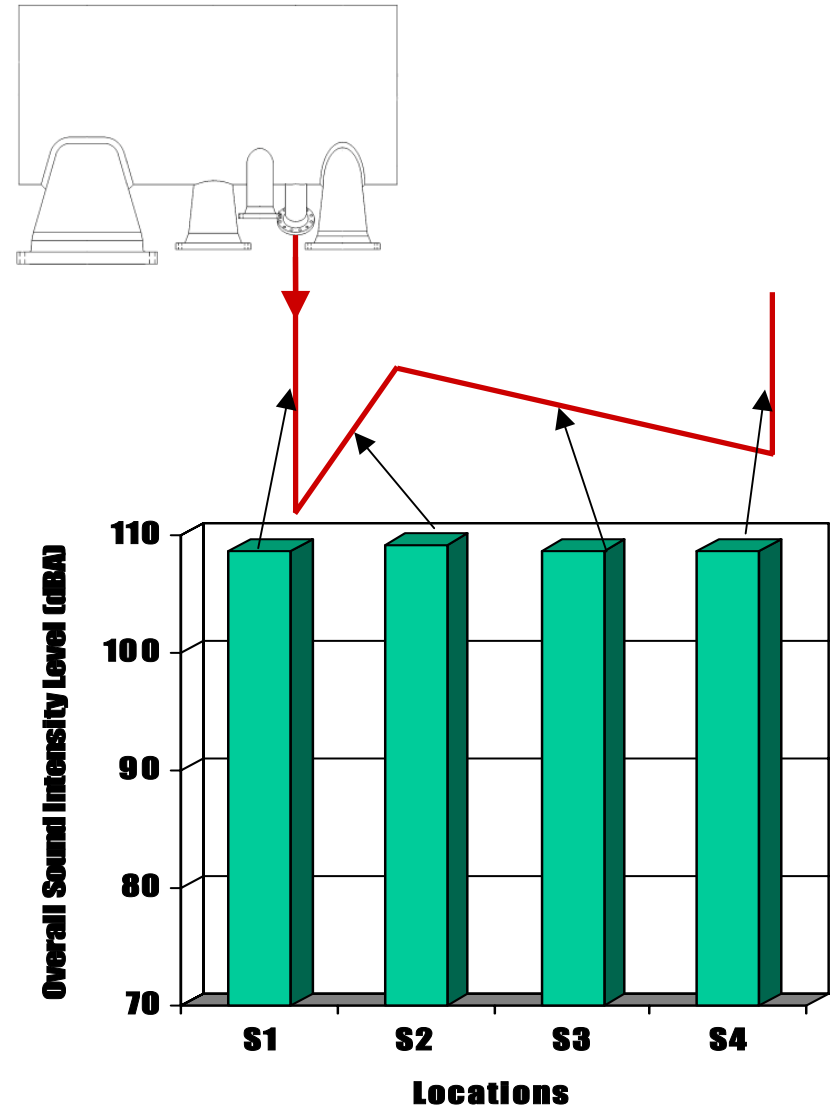
- ◆ Measuring noise spatial variation, sound intensity scanning is an excellent technique for noise source identification.
- ◆ Uniform intensity levels along the 4D pipe indicates the excitation source is from upstream of the 4D pipe - the compressor.

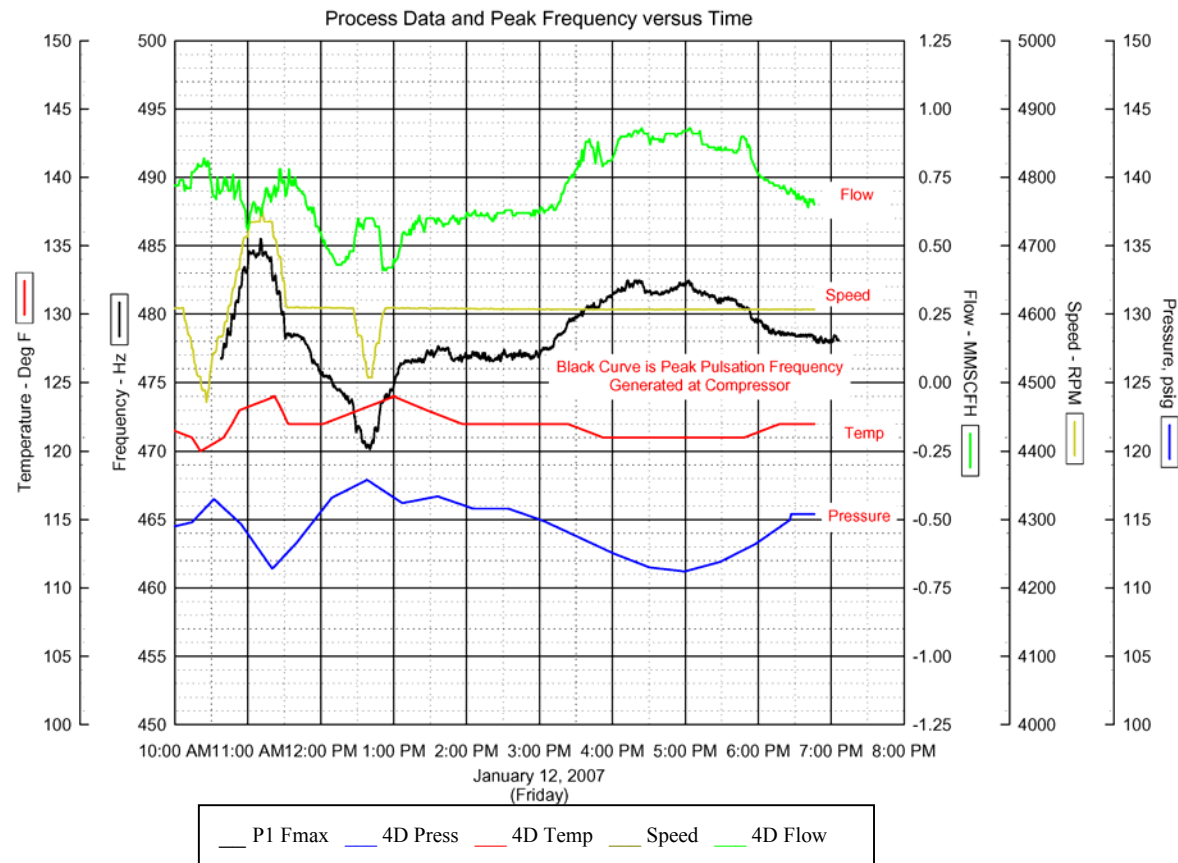
- ◆ Peak pulsation frequency does not track to speed - not a rotational source.
- ◆ It also does not correlate to flow rate - not a vortex shedding source.

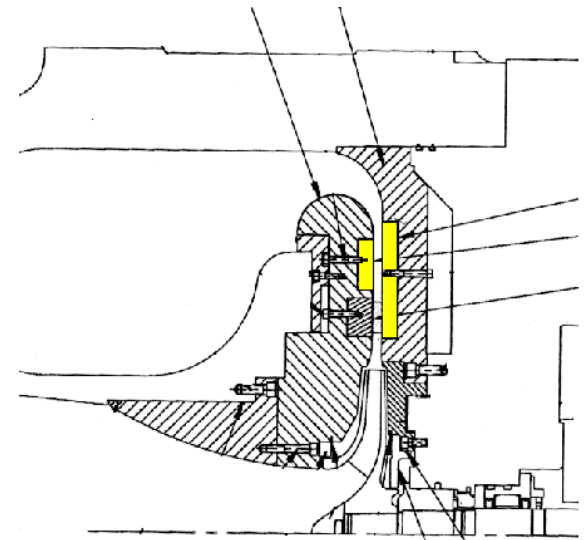
- ◆ Using Duct Resonator array to reduce the compressor noise source internally by lowering
 - Pressure Pulsations
 - Dynamic Excitations
 - Structural Vibration
 - Noise Radiation.
- ◆ Benefits include
 - Reduce unsteady aerodynamic load on impeller blades and diffuser vanes.
 - Reduce piping vibration and improve structure integrity and instrumentation life.
 - Reduce compressor noise level.

Require machine
internal
modification

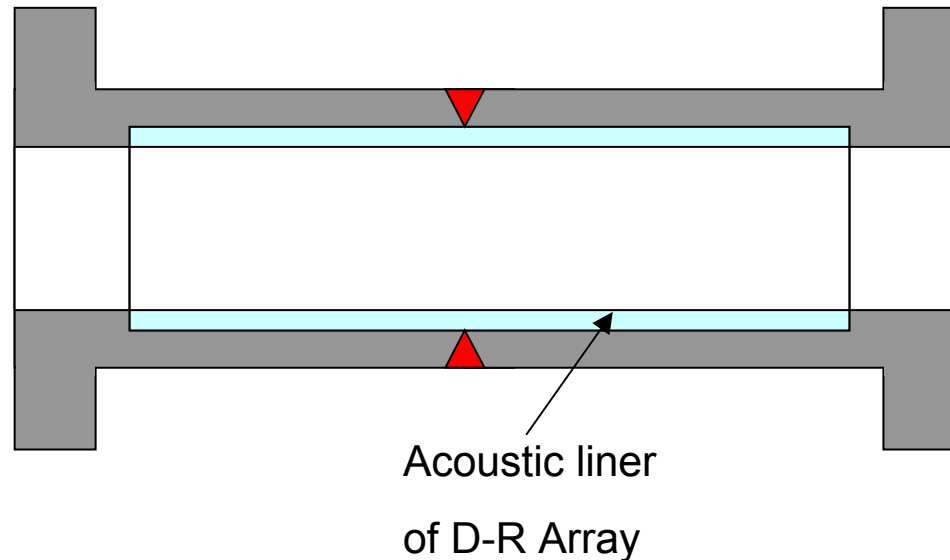
- ◆ Applying the duct resonator array technology to the compressor inlet and discharge pipe.
- ◆ Lining the inner wall of the inlet/discharge pipe (spool piece) with duct resonator array.
- ◆ No need to disassemble compressor.

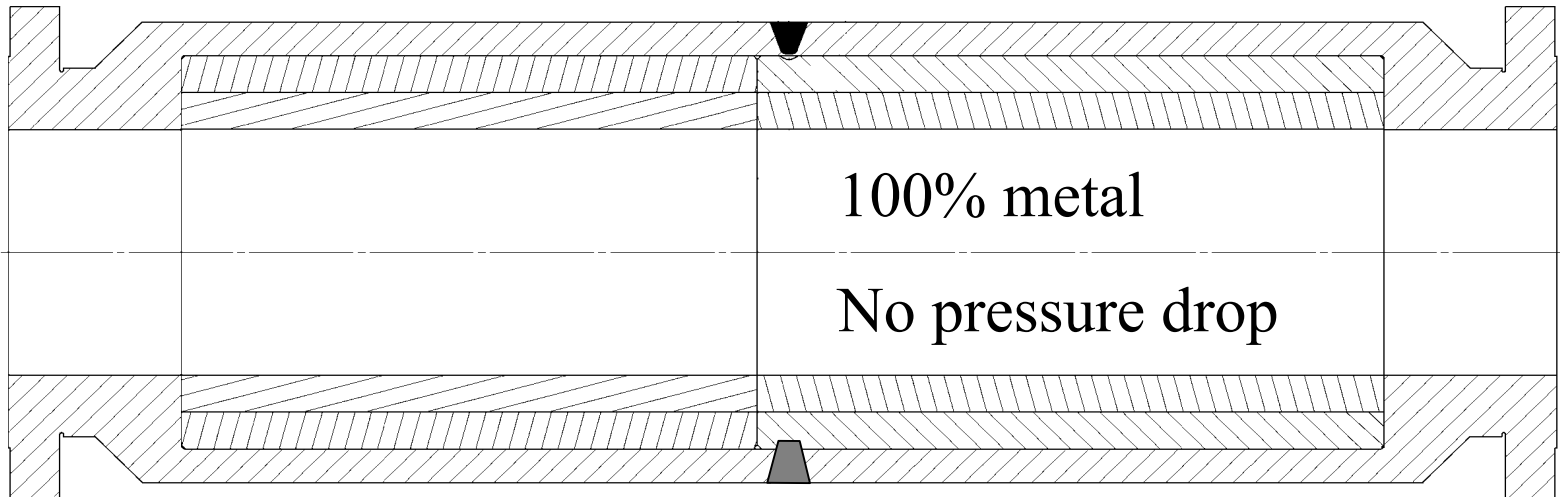
- ◆ A two DoF pipe array was designed to reduce noise and vibration at 480 Hz and 1440 Hz.
- ◆ It requires no compressor internal modification and provides quick turnaround.
- ◆ As it is mounted on the 4D nozzle, the pipe array minimizes the excitation energy entering the 4D pipe.

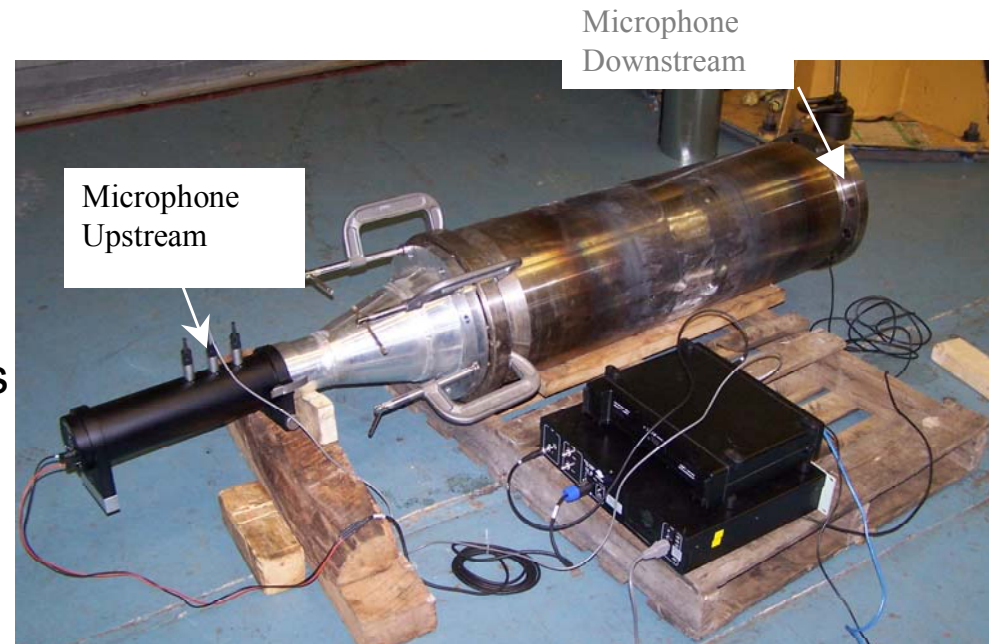
- ◆ An impedance tube with an acoustic driver was used to test the pipe array via a transition cone.
- ◆ Microphones positioned upstream and downstream of the array to measure the sound pressure level difference across the array.
- ◆ A PC driven B&K Pulse Front End was used for
 - Generating noise signal
 - Measuring noise

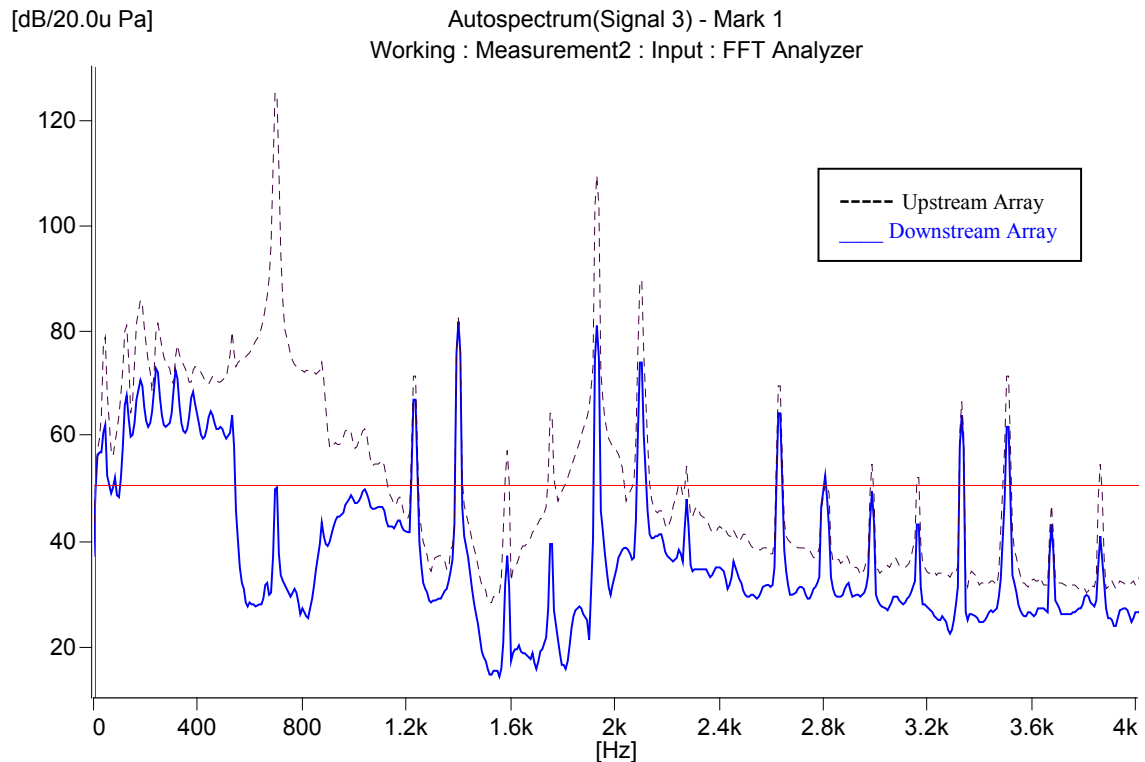
- ◆ Discrete noise source with tones at 700 Hz and 1900 Hz was applied.
- ◆ This is to emulate the 480 Hz and 1440 Hz dominant noise components at site.
- ◆ This frequency shift is due to change in sonic velocity of the gas (Propylene vs. Air).

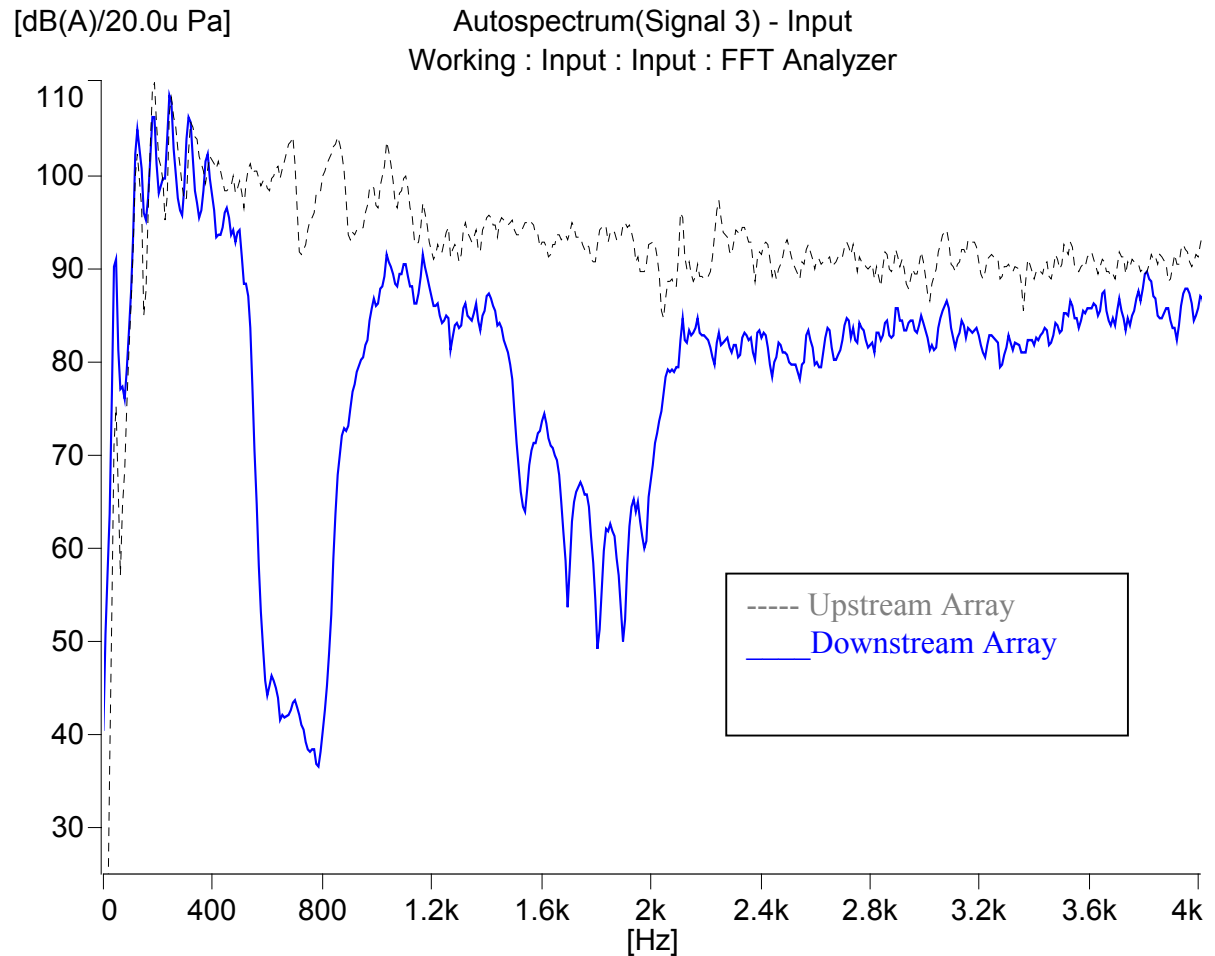
- ◆ Broadband noise source was also fed into the pipe array.
- ◆ This comparison demonstrates the noise attenuation bandwidth(s) of the array.

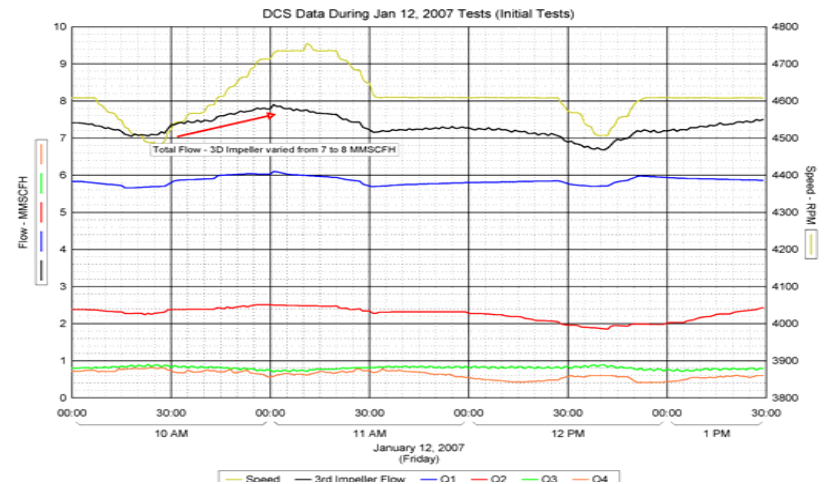
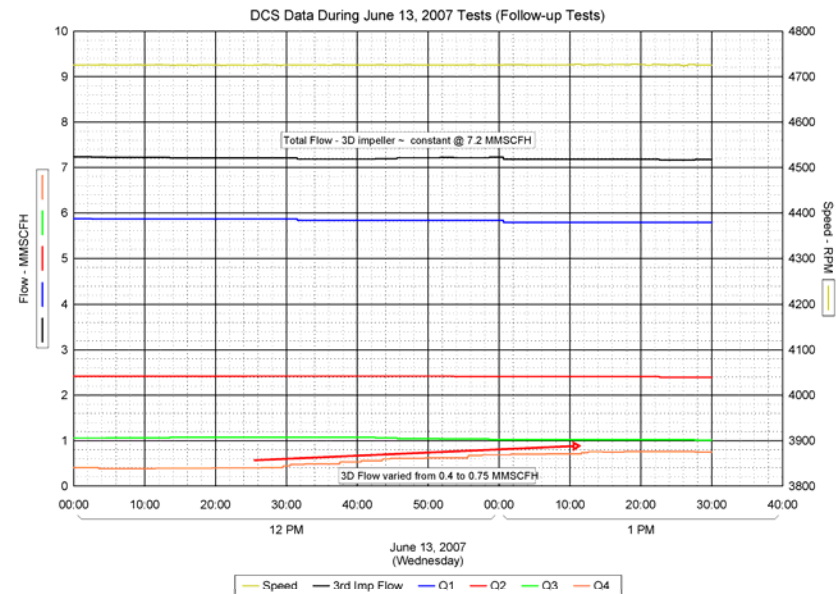
- ◆ After the pipe array was inserted between the compressor 2nd outlet (nozzle 4) and the 4D discharge pipe, follow-up testing was conducted to verify the results.
- ◆ The test procedure was to install pressure transducers upstream and downstream of the pipe array and record pulsation data at process conditions similar to those that resulted in excessive pulsation, vibration, and noise levels during the initial testing in January 2007.

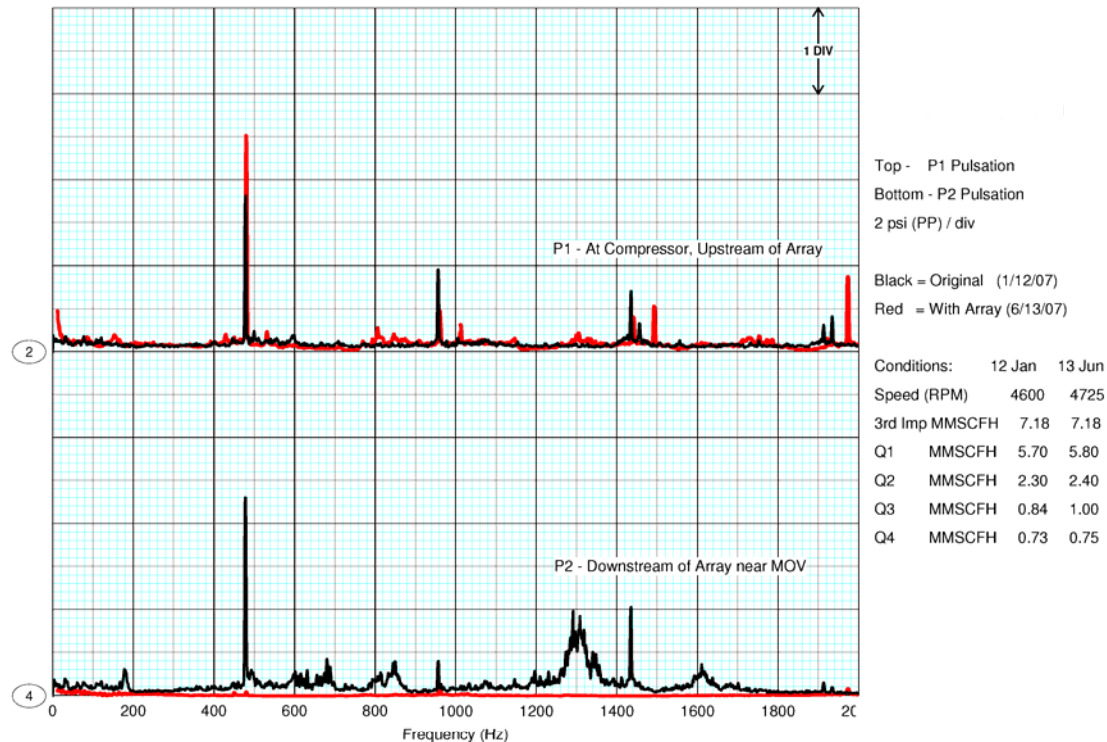
- ◆ The final test shows virtually no pulsation near 480 Hz (red curve), whereas this location had about 2.3 psi pk-pk during the initial test on January 12, 2007.
- ◆ The pressure pulsation at 1440 Hz was also completely eliminated by the introduction of the resonator array.
- ◆ Adding the pipe array corrected the problem.

- ◆ After the pipe array was installed in the discharge piping, a second site test was performed to confirm the effectiveness of the array. Pressure pulsation data were measured upstream and downstream of the array, which indicated that the pressure peaks at 480 Hz and 1440 Hz were both eliminated.
