Turbomachinery Symposium – Case Study

Practical root cause analysis of connecting rod bushing failures in a new reciprocating compressor and the theory behind the failure mechanism

Case Study Overview

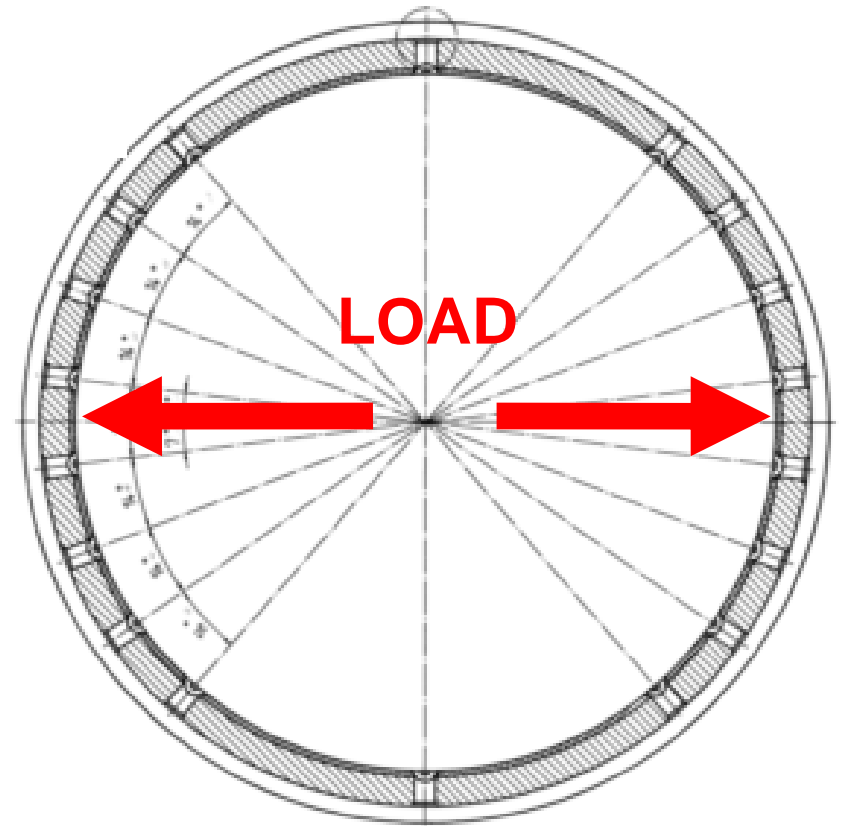
Connecting Rod Bushing

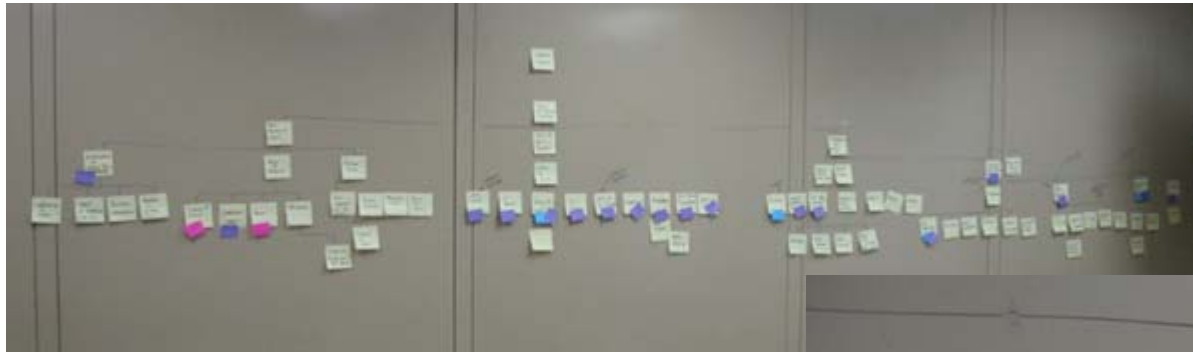
Root Cause Analysis

Identify all potential failure modes and causes

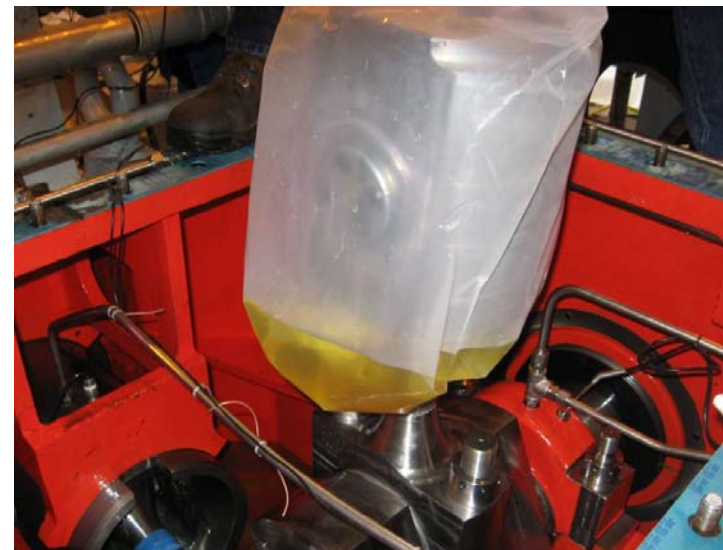
- PV Analysis and Strain Gage Analysis to measure / confirm rod loads and check for torsional resonance
- Operating Deflection Shape (ODS) to identify any structural resonance
- Confirm actual oil flow

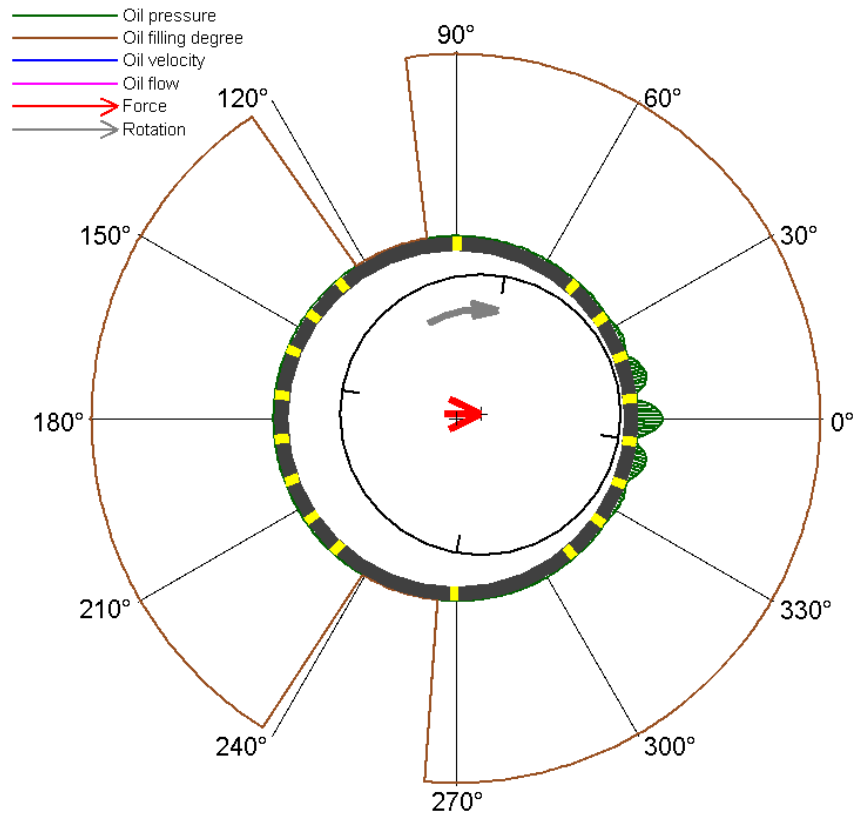
Bushing with original groove geometry and ISO 100 Mineral Oil

Peak Pressure = 1.0 (normalized)

Min Oil Film Thickness = 1.0 (normalized)

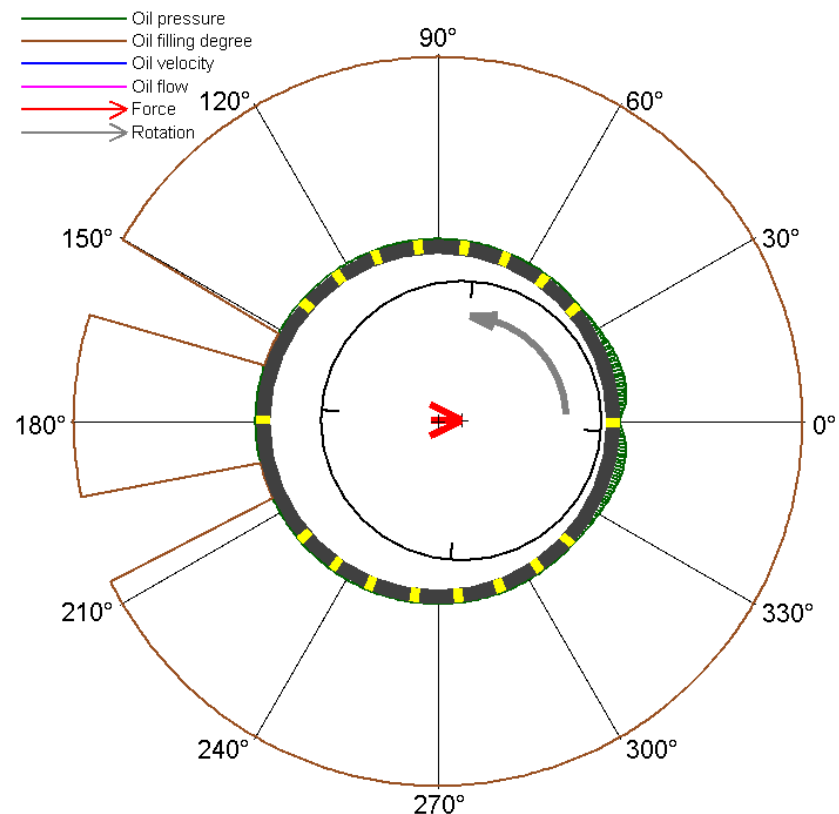
Bushing with modified groove geometry and ISO 150 Synthetic Oil

Peak Pressure = 0.23 (normalized)

Min Oil Film Thickness = 4.7 (normalized)
