AN ASSESSMENT OF THE FORCES ACTING UPON A CENTRIFUGAL IMPELLER USING FULL LOAD, FULL PRESSURE HYDROCARBON TESTING

The test program and results described herein represent an OEMs and end user's efforts to identify the cause of repeated impeller failures in an offshore gas reinjection compressor. A machine identical to the field units was fully instrumented with aerodynamic and mechanical instrumentation (including radial and axial vibration probes, dynamic and static strain gauges, dynamic pressure transducers, and other interstage pressure and temperature instrumentation). The compressor was then tested at full load and full pressure on hydrocarbon gas at the OEMs facility. Descriptions of the instrumentation and test procedure are provided.

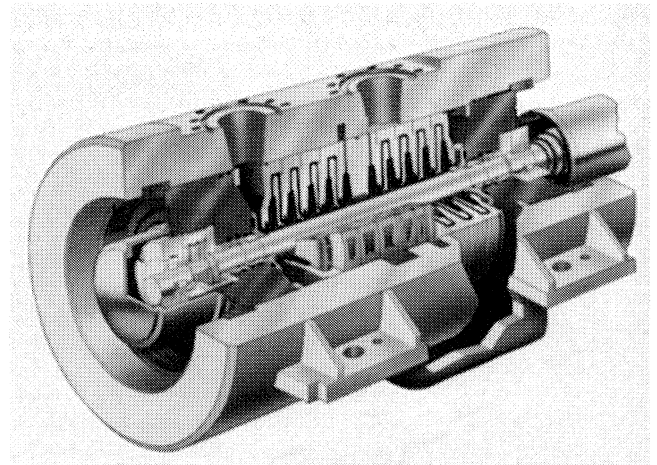
Figure 1. Back-to-Back Compressor—Conceptual Schematic.

The fifth section compressor is a six stage back-to-back design with an internal crossover, i.e., no intercooling between sections. To illustrate the back-to-back concept, a cutaway view of a 10 stage compressor is given in Figure 1. In the design pictured, flow enters the main inlet, passes through five centrifugal stages, and is collected in a volute. It then passes through the crossover (at the bottom of the figure), the second section inlet, through five more centrifugal stages before being collected in a volute and exiting the final discharge.

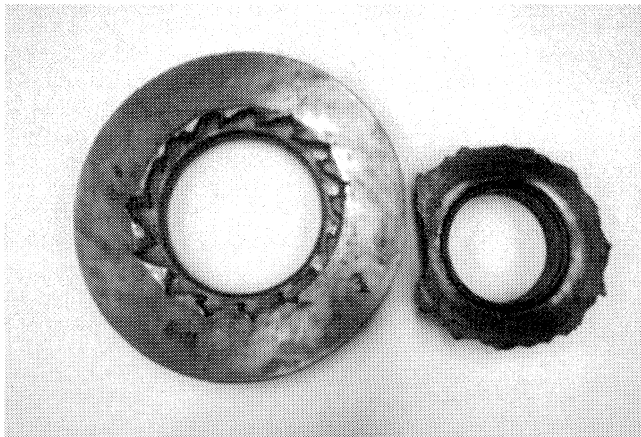
Figure 2. Photograph of Failed Impeller.

Within a few hours after bringing the compressors online at full load, one of the trains shut down due to excessively high vibrations in the high pressure compressor. Upon opening the machine, inspection discovered a catastrophic impeller failure in the third stage. The inner portion of the disk had separated from the remainder of the impeller as shown in Figure 2. Initial theories focused on surge as the most likely cause for the failure as:

Metallurgical analyses of the original and redesigned third stage impellers were performed by the OEM and by an outside consultant. These analyses indicated that cracks on the original design initiated simultaneously at all 15 blade noses at the juncture of the slot weld to the blade. The cracks started at nucleations of about eight mils. Both parties judged that the indications served as nucleators to the cracks but were not the cause of the cracks. The external consultant judged that the weld profile was very good and that all welds were acceptable. Typically, three or four initiation sites were found on both sides of each blade (suction and pressure sides) very close to the nose. The failures were definitively categorized as fatigue. They were not environmentally assisted; all chemical and physical properties being within specification. The redesigned impeller showed cracks initiating at eight of 13 blades. These were at the slot weld to disc juncture, about 0.5 in to 1.0 in from the leading edge on the suction side only. Like the original impeller, the cracks started at indications with typically three or four initiation sites at each of the eight blades.

Accordingly, a new, more robust impeller was developed. Since the exciting mechanism remained a mystery, there was no means to assess the new design's ability to tolerate the field conditions. Lacking any more proven approach, the existing configuration was modified to achieve a substantial change in impeller natural frequency. All wall and blade thicknesses were increased and the number of blades in the impeller was reduced from 15 to 13. This more robust design was later shown analytically (based on an assumed dynamic load) to have both a significant increase in natural frequencies and a significant decrease in stress in the critical location.

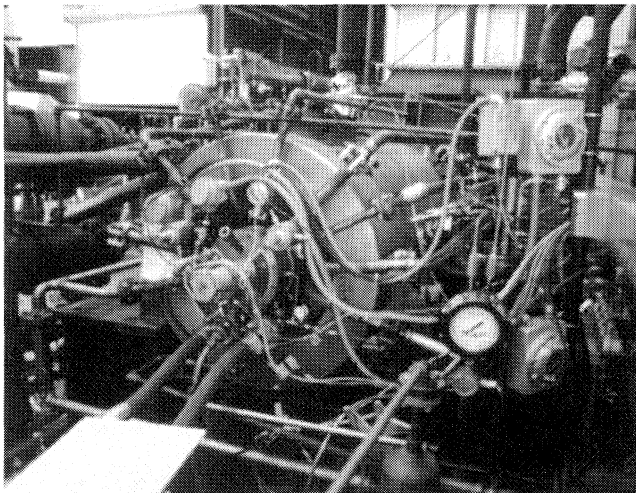
Figure 3. Photograph of Compressor—Shop Test Setup.

A duplicate compressor was assembled and outfitted with unique instrumentation for test. The rotor for this machine was configured with a third stage impeller of the original design. This compressor was installed in a closed loop system on the hydrocarbon test bed at the test facility (Figure 3). The compressor was driven through a speed increasing gear by a steam turbine. An auxiliary boost compressor was employed to maintain inlet pressure.

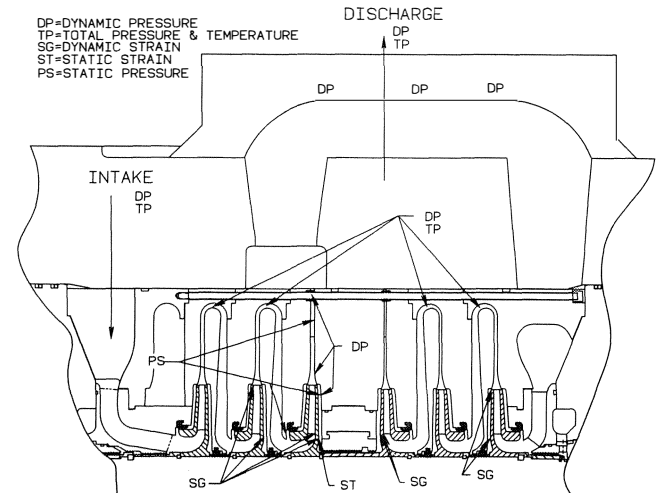
Figure 4. Compressor Cross Section Showing Instrumentation Location.

pronounced and replicated failures. Instruments were also installed throughout the machine, as conditions leading to the failures may arise upstream (or downstream) of the problem stage (Figure 4).

Dynamic strain gauges were applied to stage two, three, four, and six impellers during the different phases of testing (Figure 4). Gauges were applied to external (to the primary flowpath) disc and cover surfaces and on the impeller blade leading edge as close as possible to the failure site. Lead wires entered the shaft through a tight clearance plug inserted into a radial hole, which intersected with a central $\frac{3}{4}$ in bore (Figure 5). These lead wires terminated at junctions bonded to the outer diameter of this bore at the nondrive end of the shaft. From these junctions, a short section of Teflon[®] insulated multistrand lead was joined to a final section of Kapton[®] insulated single strand lead. The Teflon[®] lead was required for flexibility during assembly and strain relief during operation. The Kapton[®] insulated wire was used for its compatibility with the compression seal at exit to atmosphere. This seal was contained within the slip ring drive hub, which was bolted to the compressor

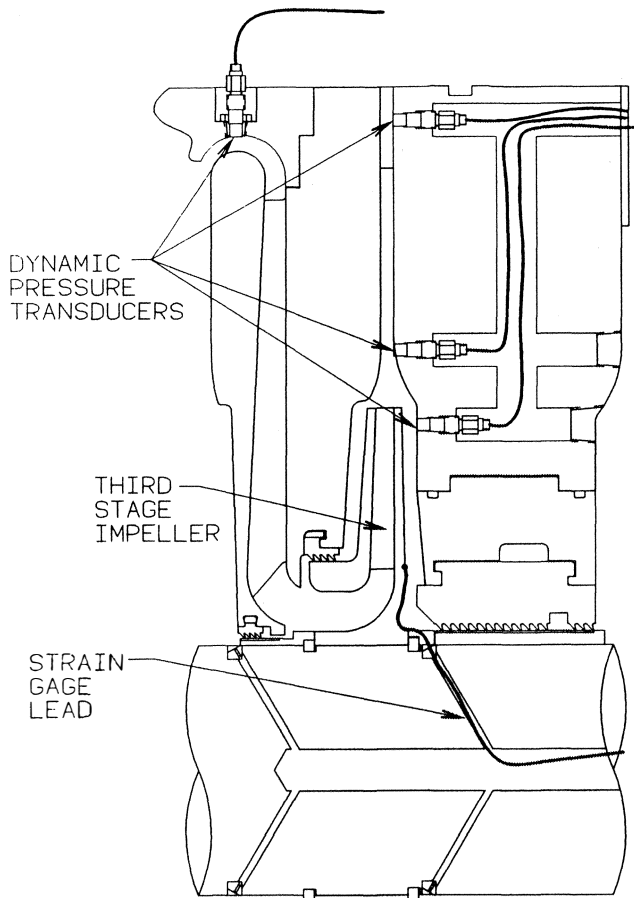
Figure 5. Location of Dynamic Pressure Transducers.

- Internal, behind impeller disc, quantity of two (Figure 5)
- Internal, diffuser wall, quantity of three (Figure 5)
- Internal, return bend, one each for stage one, two, four, and five (Figure 5)
- External, crossover channel, quantity of three
- External, inlet and discharge spool piece, one each

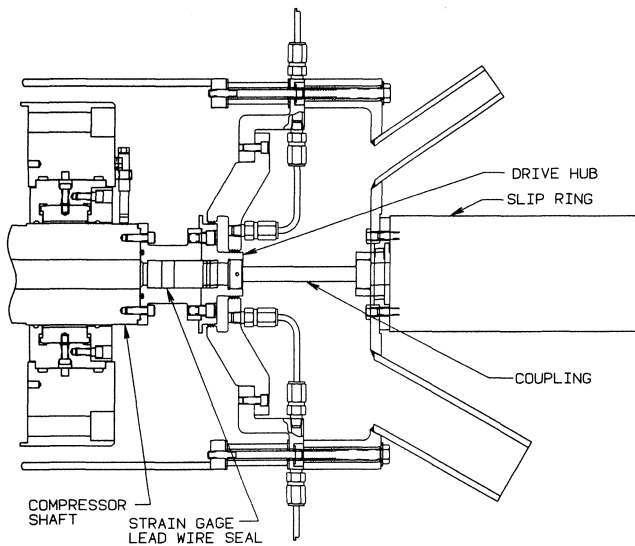
Figure 6. Slip Ring Schematic.

shaft end. A 60 ring mechanical slip-ring coupled to this hub by means of a hollow flexible drive shaft was employed to convert the rotating strain gage signal to a stationary output (Figure 6). Signal conditioning was accomplished by using a constructed dynamic stress console consisting of 30 channels of isolated potentiometric strain gage bridge completion.

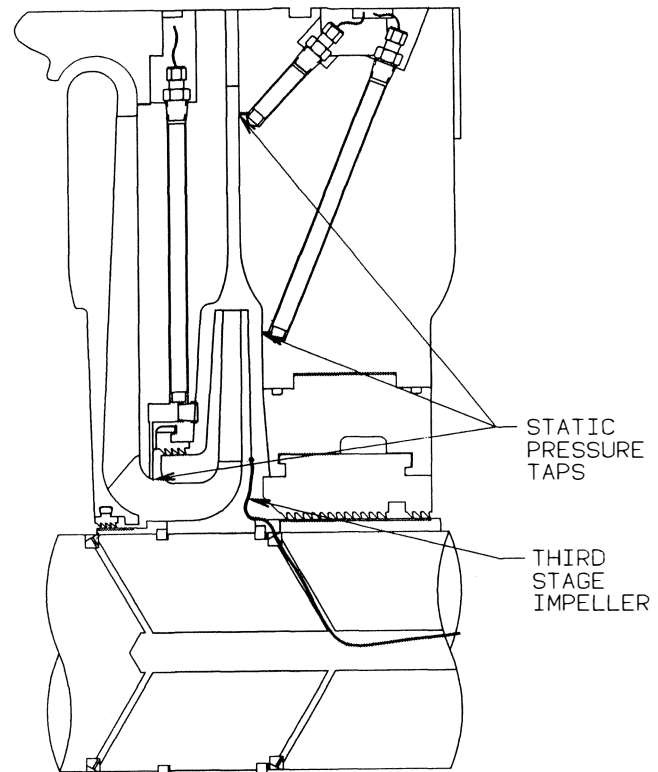
Figure 7. Location of Static Pressure Taps.

- The inlet
- Near the impeller exit
- Near the diffuser exit

of the third stage impeller (Figure 7). Steel tubing sealed by a compression gland was used to conduct the static pressures to a bank of 18 pressure transmitters.

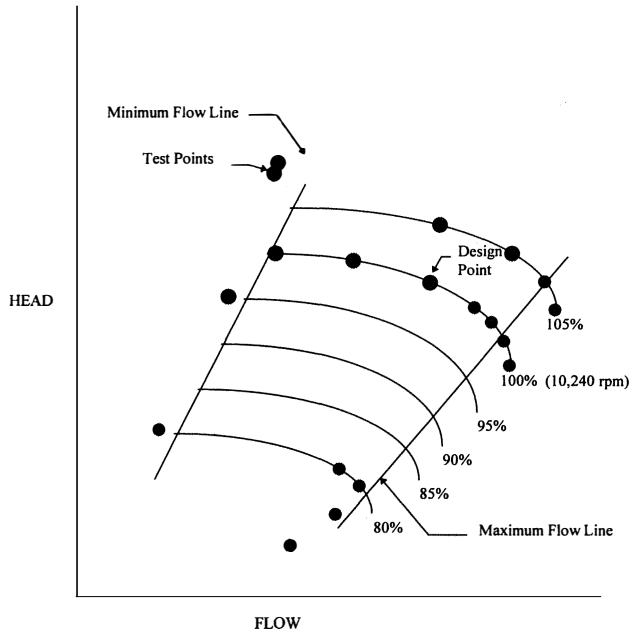
Figure 8. Compressor Performance Map Showing Test Points.

The compressor was operated on and outside of its projected flow map (Figure 8). Discharge pressures as high as 6250 psia were achieved during testing at 10,750 rpm. The compressor was intentionally put into stall at four different speeds (data points four, six, seven, and eight) to investigate stall as a failure cause. The machine was also operated extensively at very high flowrates, including a 20 hour endurance run to assess the effects of operation in deep overload.

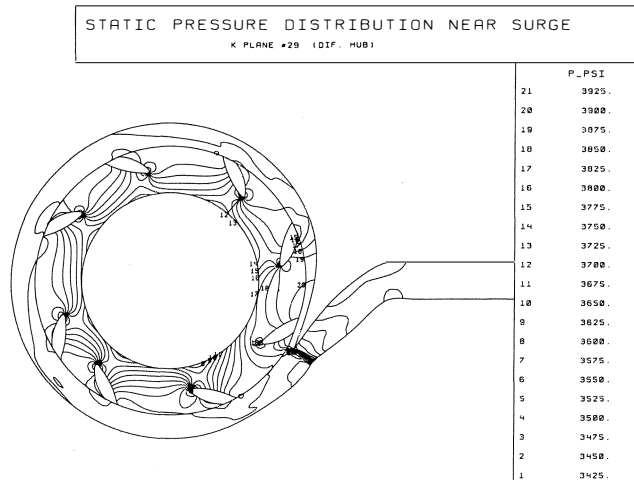
Figure 9. Diffuser/Volute Pressure Distribution at Near Surge Operation—CFD Result.

The CFD results for the diffuser and volute analyses proved to be extremely interesting as they showed that a nonuniform pressure field was being created around the circumference of the machine. This finding is consistent with those of Flathers and Baché [1], which clearly showed that flow within the volute and around its “tongue” or “cutwater” was causing a nonuniform static pressure field, and that this field would cause an unbalanced force at the exit of the impeller. These CFD analyses also showed that as the flowrate was increased from near surge to overload, the magnitude of the pressure variation increased. For illustration, the results provided in Figure 9 are the pressure field in the volute when the stages are running near surge. The “near surge” analyses indicate that the pressure varies by approximately 400 psi. In Figure 10 the overload condition, the ΔP , has increased to in excess of 900 psi. Clearly, the nonuniformity is more severe in overload than at surge.

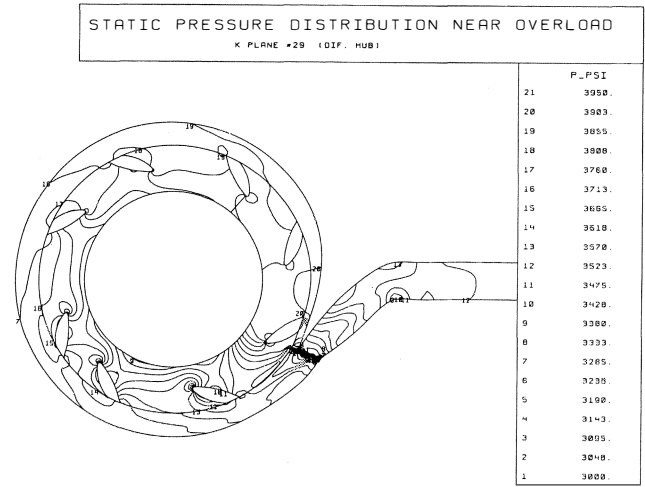
Figure 10. Diffuser/Volute Pressure Distribution at Overload Operation—CFD Result.

Also of significant interest, the CFD results suggest that the direction of the net force acting upon the impeller would rotate relative to the volute tongue as the flowrate increased from near surge to overload. Note the location of the minimum vs maximum static pressure in the contour plots given in Figures 9 (near surge) and 10 (overload). The direction of the net force has rotated relative to the volute tongue.

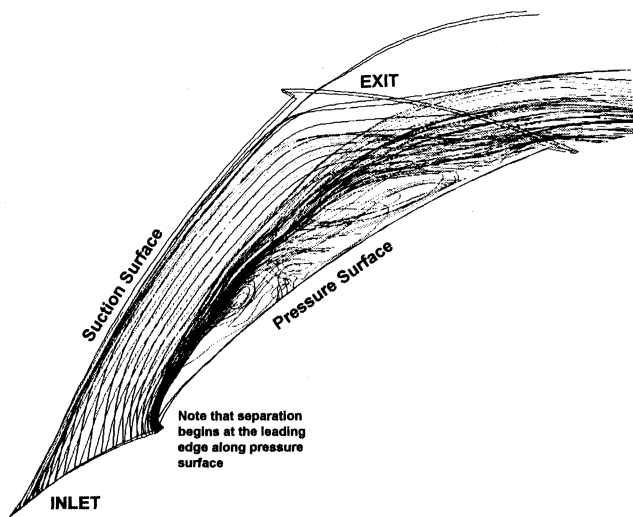
Figure 11. Streakline Plot of Impeller Flowfield—Overload Operation.

Results for flowrates at or below the BEP mass flow were, for the most part, uninteresting and, therefore, will not be discussed. However, at progressively higher flowrates and the associated increase in negative incidence on the impeller leading edge, a notable trend began to emerge. At near 160 percent to 170 percent of BEP flow, the flow begins to separate from the pressure surface of the impeller blading, as illustrated in the streakline plot given in Figure 11. The stagnation point (maximum static pressure) had moved to the suction surface side of the leading edge (concave side of blade). There was also a region of depressed static pressure on the pressure side of the blade (convex side) caused by the separation bubble (Figure 12). In short, the difference in static pressure level was increasing. Further increases in flowrate yielded even higher ΔP s between the suction and pressure surfaces. In short, the force across the blade leading edge intensified substantially with increased incidence.

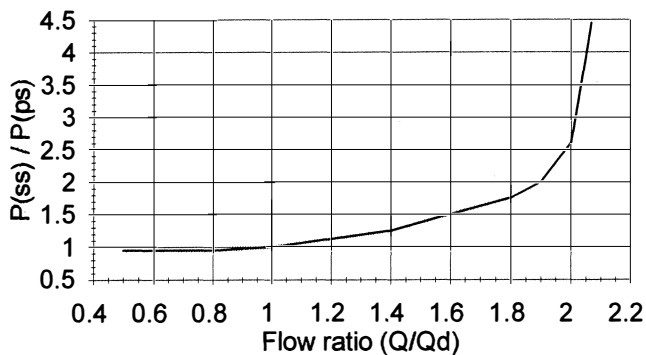
Figure 13. Variation of Leading Edge Pressure Differential with Flow.

The general trend in pressure differential suction surface to pressure surface is shown in Figure 13. Note the exponential increase in the pressure ratio for flowrates above 180 percent of BEP flow. Should the impeller be operating at high negative incidence and elevated inlet pressures, the pressure load across the blade leading edges could become extreme. For example, in reviewing the case of the impeller operating at 185 percent BEP flow with an inlet pressure of 3000 psi, the pressure variation across the leading edge would be in excess of 1200 psia!

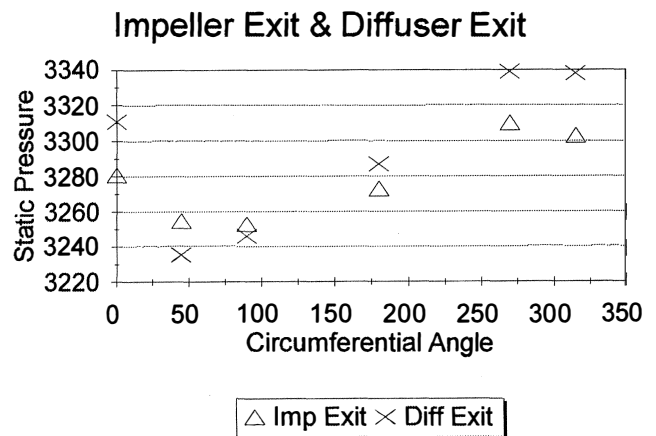
Figure 14. Static Pressure Gradient—Impeller and Diffuser Exit—Overload Operation.

In the case of the third and sixth stage, the impeller discharges against a nonuniform field caused by the volute. This fact is suggested by the CFD work and confirmed by the static pressure taps located at the diffuser and impeller exit (Figure 14).

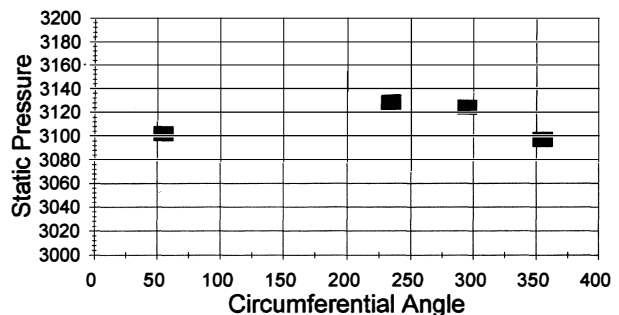
Figure 15. Static Pressure Gradient—Impeller Inlet—Overload Operation.

Of even more importance, the impeller inlet pressure distribution showed evidence of the nonuniformity. The taps in the inlet guidevane upstream of the third stage impeller clearly showed a pressure variation around the circumference of the machine (Figure 15). Clearly, the nonuniform field is enveloping the impeller. (This should not be too surprising. If a compressor discharges into a downstream vessel whose pressure fluctuates in time, the compressor inlet conditions will adjust in reaction to the change in downstream pressure. Similarly, the individual flow passages within the impeller will react to a nonuniform downstream pressure. The variation in the individual passages then influences the inlet pressure field upstream of the impeller.)

It follows then that as the impeller rotates within this field, the leading edge of each blade passes through the nonuniform field once per revolution. The result will be fluctuations in the velocities, Mach numbers, flow angles, pressure profiles, etc., within the various passages. Recalling the impeller CFD analyses, which suggest a large leading edge ΔP caused by the high negative incidence, and coupling that with fluctuating inlet conditions caused by the volute, it is not difficult to hypothesize a fairly high dynamic pressure load near the impeller failure location.

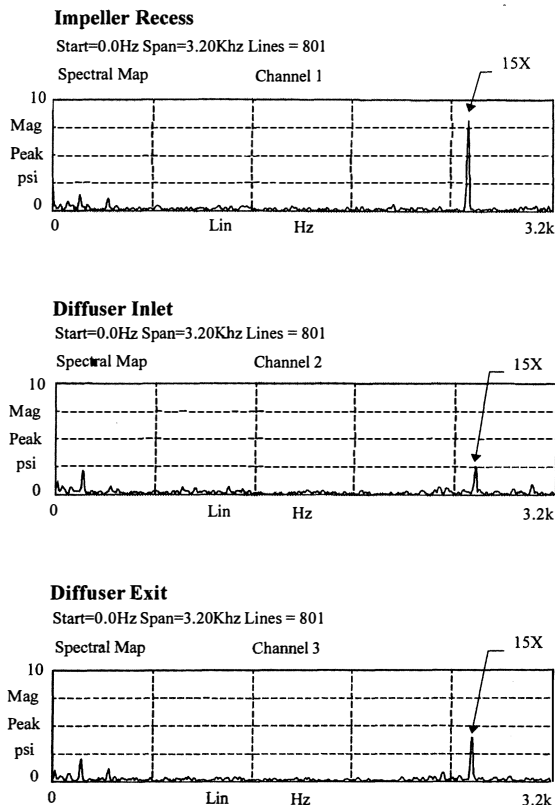
Figure 16. Spectra from Dynamic Pressure Probes—Impeller Recess, Diffuser Entrance, Diffuser Exit.

A review of the data obtained from the dynamic pressure probes yielded some interesting observations. There was a clear response at $15\times$ the compressor running speed in all probes in the third stage. Somewhat surprising, the highest response was in the dynamic pressure probes mounted in the recess behind the impeller hub (Figure 16). In addition, the response was highest when the compressor was running toward the overload end of the performance map and decreased as the flow was reduced toward surge/stall.

The third stage impeller does have 15 blades, so it was hypothesized that the pressure pulsations were a consequence of the normal wakes shed by impellers. Classic jet/wake theory suggests that the wakes should be larger at low flows. That is, blade wakes, which are the accumulation of secondary flow within an impeller, are always larger at low flowrates and smaller at high. However, at higher flowrates, the throughflow velocity exiting the impeller would be greater. The higher velocity results in a larger dynamic pressure and, therefore, a higher differential between the total pressure in the main flow and static pressure in the blade wakes. In short, the higher pulsation amplitudes in overload are simply a reflection of a higher total to static pressure ratio.

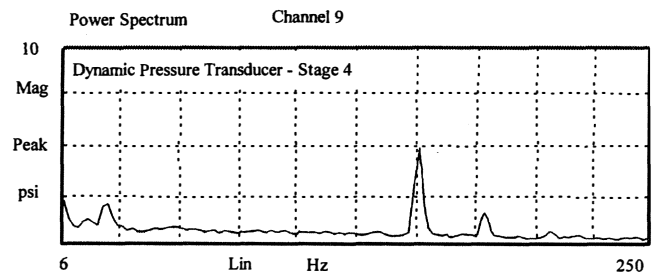
Figure 17. Dynamic Pressure Transducer Spectra—Stage Four.

At 90 percent, 100 percent, and 105 percent speeds, the compressor tripped offline due to a sudden, sharp increase in radial vibrations. As such, there were only momentary data available on the response of the machine to the onset of the stall mode. A review of the dynamic pressure probes showed that the latter stages (four, five, and six) were in stall. A frequency spectra obtained from the dynamic pressure probes for the fourth stage is shown in Figure 17, while the spectra from a radial vibration probe is given in Figure 18. Note the near alignment of the dynamic pressure and radial vibration amplitudes near 23 Hz and 152 Hz. This subsynchronous frequency near 85 percent of running speed is consistent with an impeller stall, while the response at 16 percent of running is more characteristic of diffuser stall.

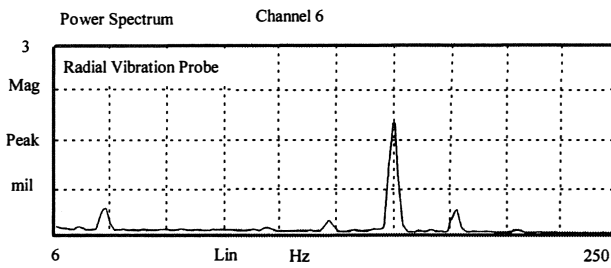
Figure 18. Radial Vibration Probe Spectra.

At the 80 percent speedline, the vibration levels did not cause a trip. Therefore, it was possible to move the compressor in and out of stall mode repeatedly. During these excursions, the output of the dynamic pressure probes and radial vibration probes were closely monitored to determine how the rotor was responding to the pressure disturbances caused by stall. At the reduced speed, it appeared that the first and, possibly, second stage were in stall. A

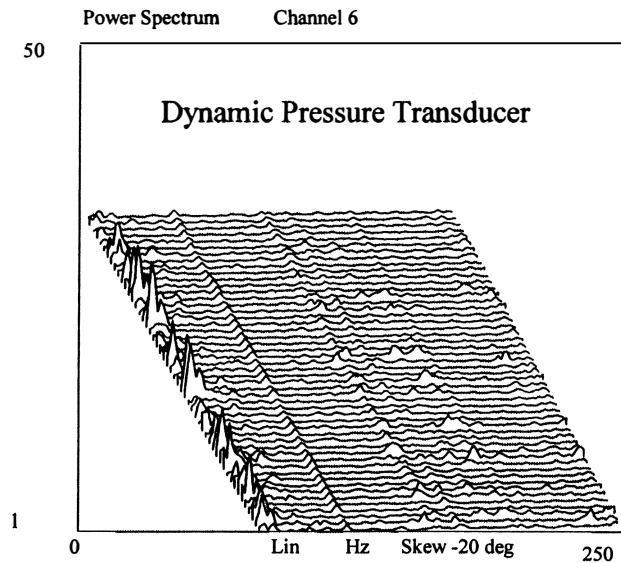
Figure 19. Waterfall Diagram—Dynamic Pressure Transducer Stage One.

waterfall plot from the first stage diffuser dynamic pressure probe is shown in Figure 19, while the corresponding radial vibration is given in Figure 20. The spectra show frequencies that are consistent with both diffuser and impeller stall. As in the higher speed runs, it is possible that both the impeller and diffuser move into stall simultaneously, or that the time between onset of impeller and onset of diffuser stall is so short that it was not discernible, given the response time of the probes and monitoring equipment.

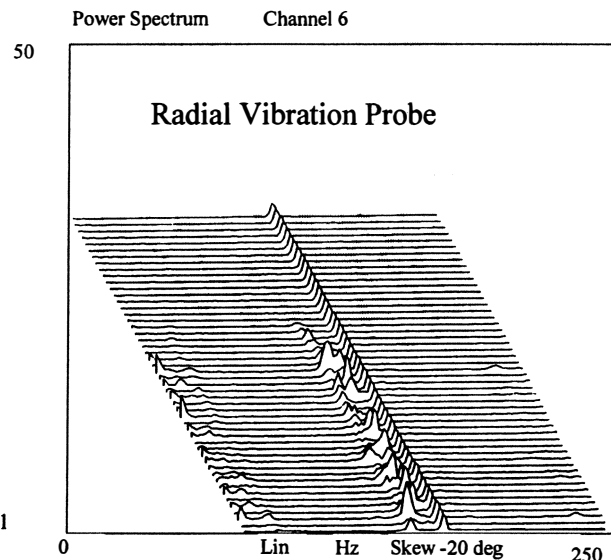
Figure 20. Waterfall Diagram—Radial Vibration Probe.

Though the radial vibration probes indicated a substantial force acting upon the rotor, the dynamic straingauges did not show a significant increase in activity in the impellers during the repeated stall excursions at 80 percent speed.

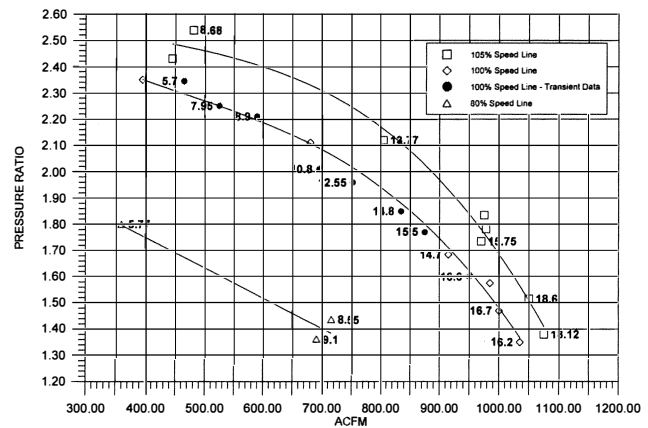
Figure 21. Pressure Ratio vs ACFM—Test Points Labeled with Dynamic Strain in ksi.

In general, stresses increase as operation is moved from surge to overload. A plot of the dynamic stress in ksi on the blade leading edge vs test point location is illustrated in Figure 21. Dynamic stresses at overload are about four times those near the surge for the third stage impeller. Dynamic stresses on the sixth stage impeller in overload are only 1.4 times those near surge. Therefore, the sixth stage impeller does not appear to experience the dramatic increase in stress in moving from surge to overload as does the third stage impeller. The only exception to the increase in stress when moving toward overload is a slight decrease in stress (average of six percent) when moving from the site system resistance line to areas further into overload. Dynamic stresses are a function of pressure variation and they do appear to increase proportionally to the square of the speed. This is expected when considering that head is proportional to the square of the speed.

The highest stresses consistently occurred at the site system resistance line at 10,750 rpm. At this point, the third stage axial blade stresses averaged 18.6 ksi and disc backside radial stresses averaged 6.7 ksi (these are mean to peak stresses). Backside tangential stresses were much lower at about 0.5 ksi.

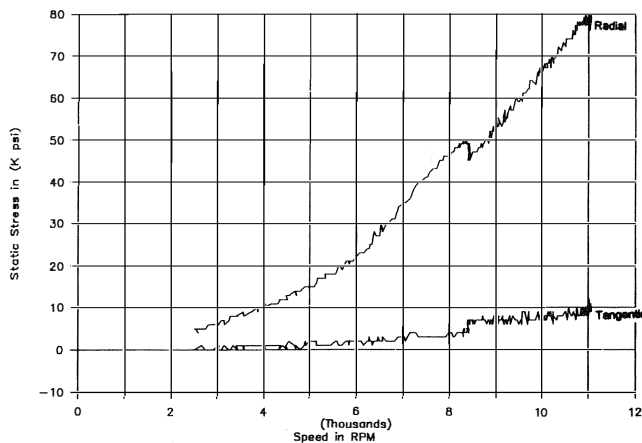
Figure 22. Variation in Static Stresses with Speed.

Static stress results from static strain gauge measurement in the radial and axial directions are plotted in Figure 22. They increased with the square of the speed as expected. However, they were about twice as high as the steady state stresses calculated using finite element analysis (FEA). The reason for this is being investigated through further review of the steady state pressures imposed on the FEA model and by conducting an instrumented push test on the third stage impeller. This will aid in correlating strain gauge results to FEA results for a known load.
