RETROFIT INSTALLATION OF A BOILER FEED PUMP HYDRAULIC COUPLING

ABSTRACT

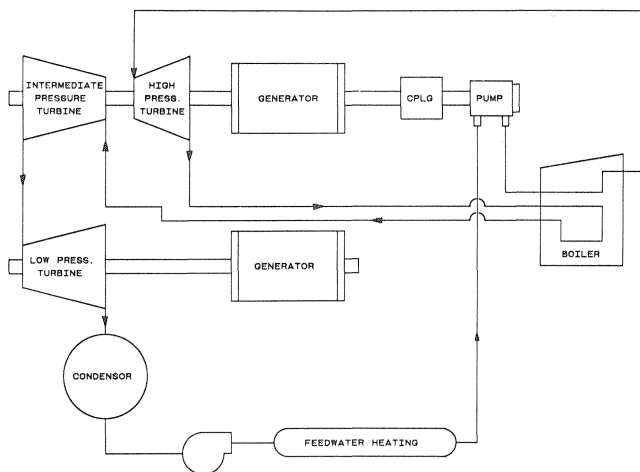
Figure 1. Simplified Flow Diagram.

The main boiler feed pump is connected to the outboard (collector) end of the high pressure/intermediate pressure (H.P./I.P.) turbine-generator via a variable speed coupling. The original variable speed coupling used for this application was an electromagnetic coupling which was selected for its high efficiency and low slip. This coupling was directly coupled to the generator shaft. Each unit also has a high speed (7200 cpm) auxiliary boiler feed pump and turbine driver to provide for easier startup and to supply feedwater when the main pump is out of service.

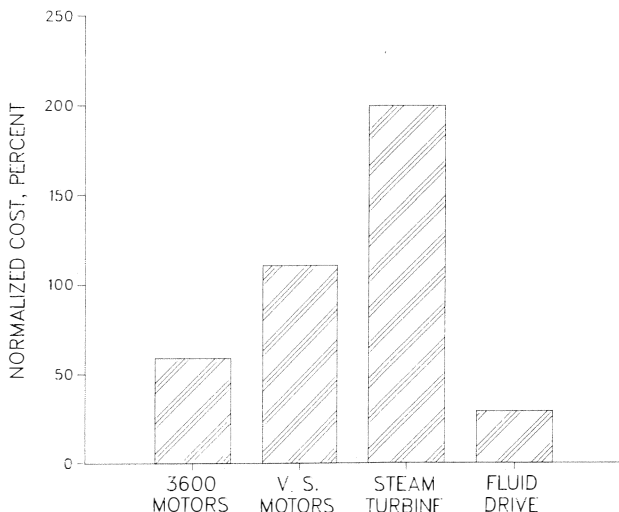
Figure 2. Installed Cost Comparison of Replacement Options.

The costs of the various options are illustrated in Figure 2. This chart compares the costs of each option to the average cost of all options. This chart shows only the capital cost of the installation without engineering and corporate overheads. The evaluated costs of the different options, when energy costs are included, are shown in Figure 3. Some points of interest are the fact that the constant and variable speed motors were so close in evaluated cost, and the fact that the steam turbine evaluated cost was so high. The primary reason for the steam turbine high cost was that a significant amount of piping, both steam and feedwater, would need to be rerouted and a new foundation installed. The hydraulic coupling could use existing foundations, fit in the existing location, and would require no modifications to the boiler feed pump or piping.

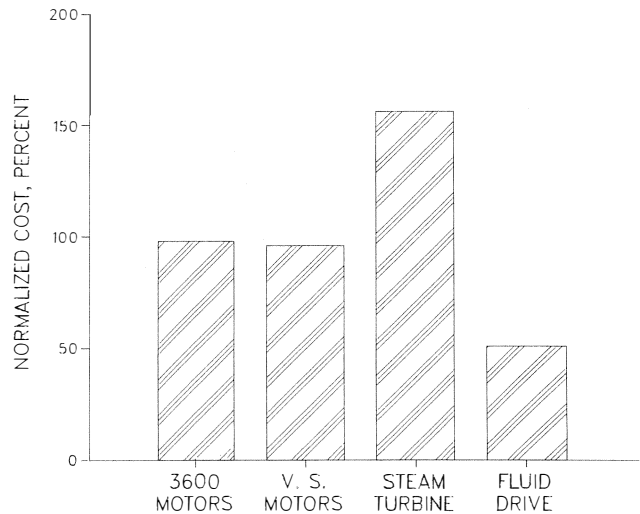
Figure 3. Evaluated Cost Comparison of Replacement Options.

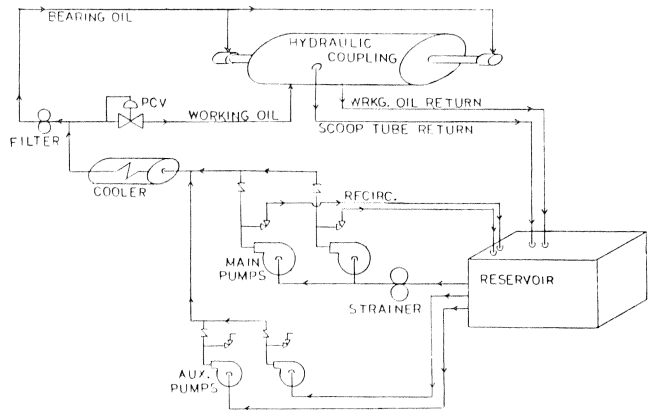
Figure 4. Hydraulic Coupling Oil Circuit Flow Diagram.

draws oil from an external reservoir through a duplex strainer, then passes it through an oil cooler. After the cooler, a portion of this oil passes through a filter then on to the bearings, while the rest of the oil is directed through a pressure control valve. After the valve, this working oil is passed through an orifice plate into the working chamber of the coupling primary wheel (impeller).

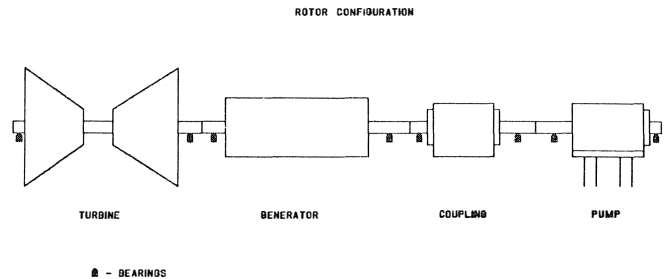
Figure 5. Generalized Rotor Arrangement.

The analysis was performed using a somewhat typical computer model of the shaft and bearing system (Figures 5 and 6). At the utility's direction, the model was also tuned to match vibration data taken during a startup. This data identified two critical speeds which the generator passed through, one at 1000 cpm and a second at 2700 cpm. The orbit and sine wave data is shown in Figure 7. A waterfall plot of the shaft end during a startup is shown in Figure 8.

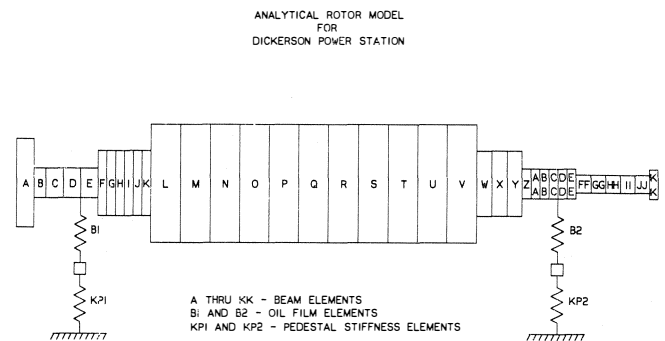
Figure 6. Generator Shaft Model.

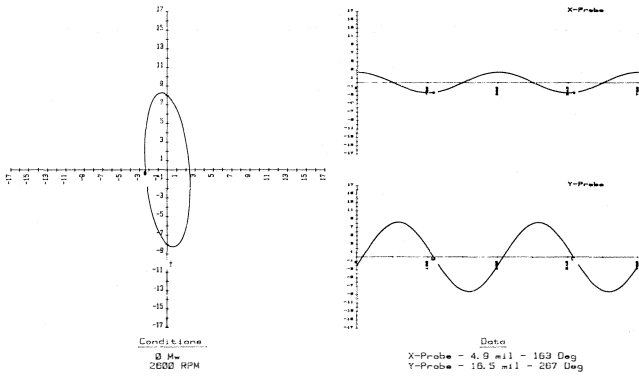
Figure 7. Orbit and Sine Wave Data for the Generator Shaft End, Uncoupled Condition.

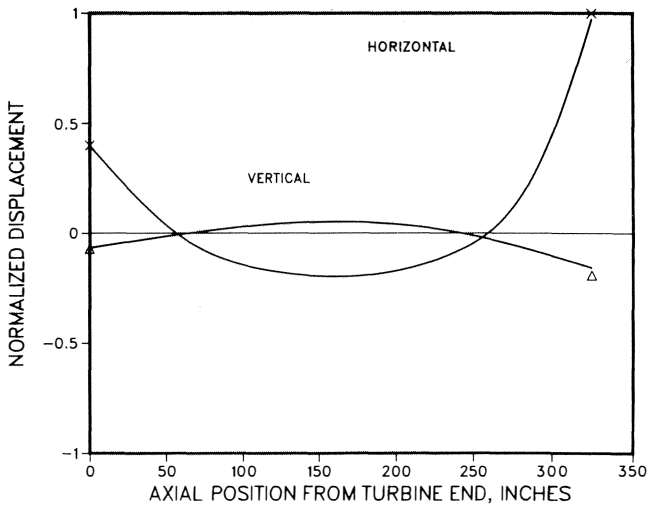
Figure 10. Undamped Mode Shape at 2579 cpm. (Note the high deflection at the shaft end.)

In order to calibrate the model to reflect actual data, an undamped critical speed map was made first (Figure 9). The critical speeds plotted were for the first and second vertical and horizontal modes. A pedestal stiffness was then chosen to correlate with the measured critical speeds. Although not exact, a value of three million lb/in was used as the best correlation between the measured values for the first and second critical. Mode shapes were also plotted as a means of identifying which modes could cause large amplitudes at the shaft end. One example of the mode shapes at 2579 cpm is shown in Figure 10. This example shows the high amplitude at the end of the generator shaft in the vertical direction. Similar modes exist at slightly different speeds in the horizontal direction. The mode shapes were also used to identify which critical speeds correspond to the measured data. For example, the undamped analysis indicates a second critical at approximately 1600 cpm. However, the mode shape indicates large displacements at the bearings. These frequencies are probably critically damped.

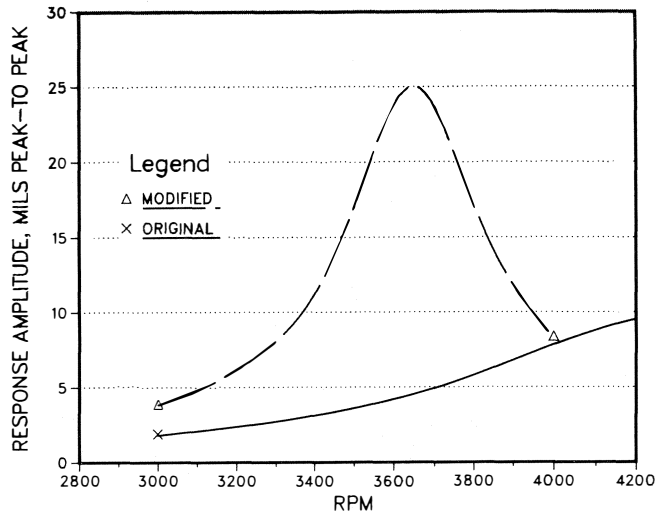
Figure 11. Predicted Unbalance Response of Generator Shaft.

Once a model for the existing configuration was established, the model was modified to reflect the effect of a flexible coupling. The major effects of the modification were to reduce the third critical speed to near that of the operating speed and to create a greater response to any unbalance force. A graph of the response to an assumed unbalance of one inch-pound is shown in Figure 11. As can be seen from the diagram, the response is

approximately six times greater than the original at 3600 cpm. The critical speed now occurred near running speed, instead of several hundred cpm higher.

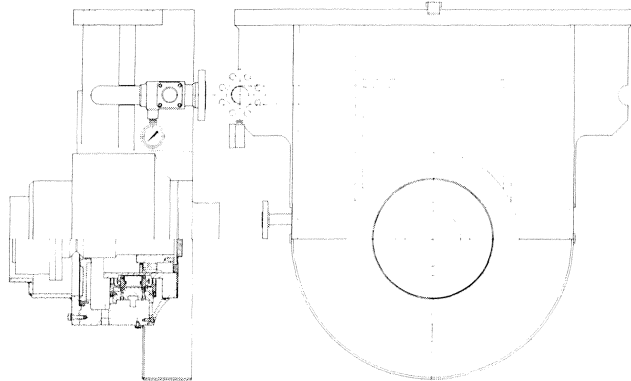
Figure 12. Steady Bearing Outline and Section.

Since the axial thermal expansion of the outboard end of the collector overhang has been measured to be over 5/8 in, a gear type flexible coupling was selected as the type to use for the mechanical link to the hydraulic coupling as shown on Figure 12.

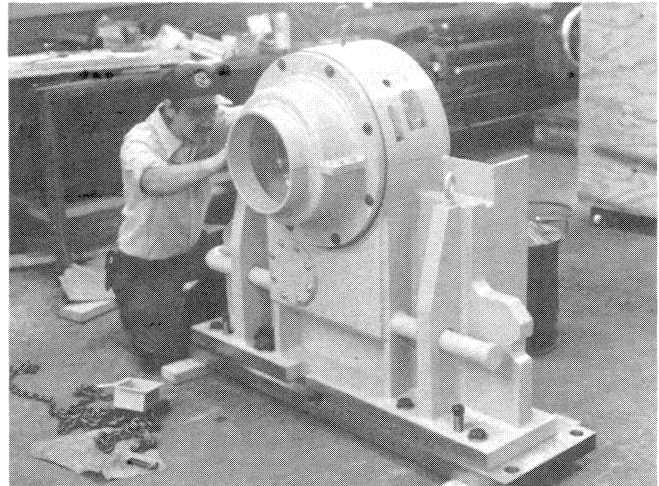
Figure 13. Steady Bearing, Assembled.

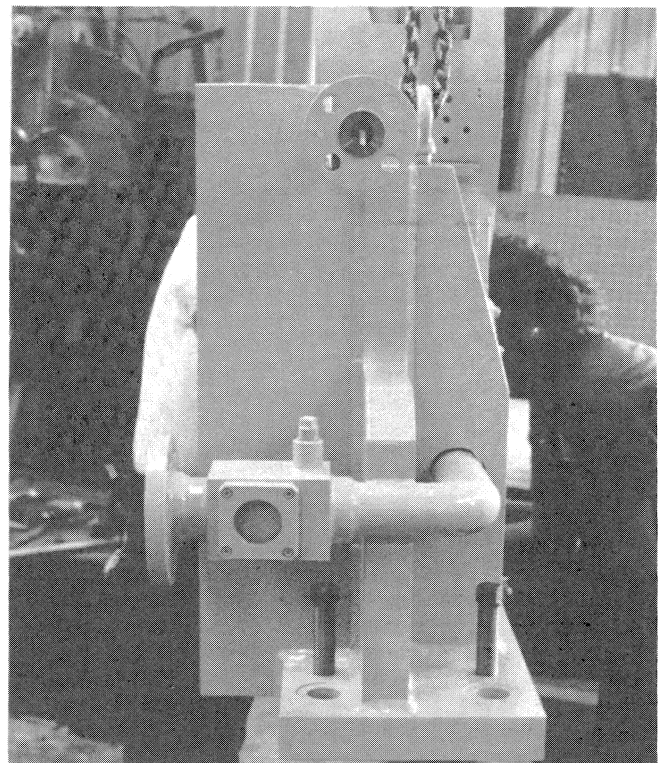
Figure 14. Side View of Steady Bearing.

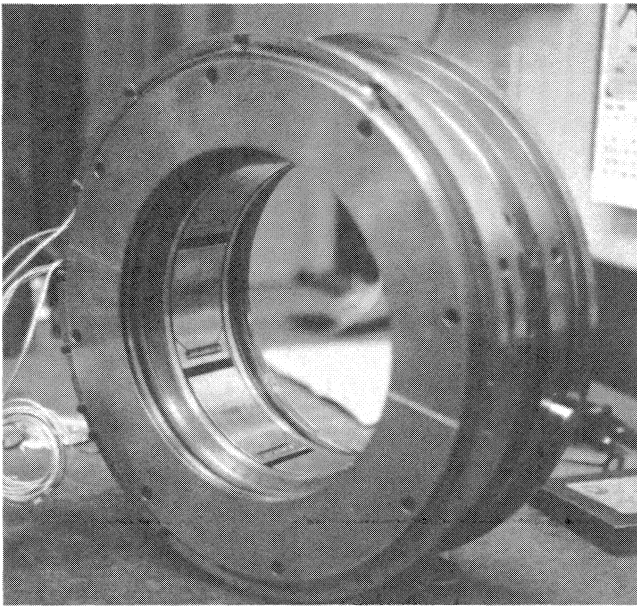
Figure 15. Tilting Pad Bearing.

have operated successfully. The complete assembled bearing is shown in Figure 15, ready for clean up and shipping.

Drawings and photographs of the tilt pad steady bearing and the support pedestal are featured in Figures 15, 16, 17, 18, and 19. Typically, in a situation such as this, it is prudent to provide the optimum bearing available to avoid potential problems of misalignment, high unbalance forces, fatigue failure, oil leakage, etc. Design features of this bearing include:

- A seven pad design was used to get a good length to width ratio of one. The seven pad design also can carry load in any direction with equal efficiency. Referring to Figure 15 and to Figure 16: pad orientation is load between pad, with a vertical down load.

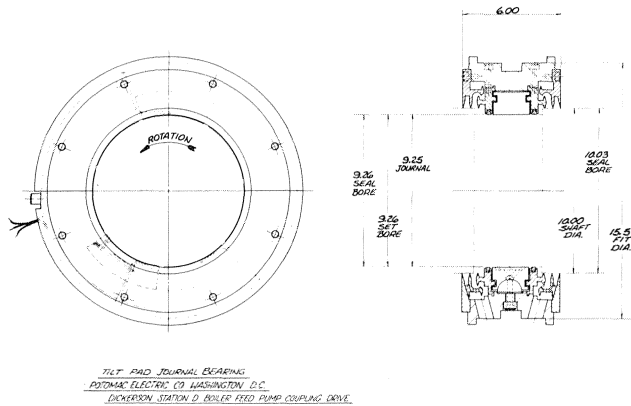
Figure 16. Tilting Pad Outline and Cross-Section.

- An offset pivot design is used for optimum load carrying ability. This feature, which assures positive preload action of the unloaded pads, is shown in Figure 16.

- Journal pad pivots on ball supports (Figure 16) result in low pivot stresses helping maintain original running clearances even under severe operating conditions.

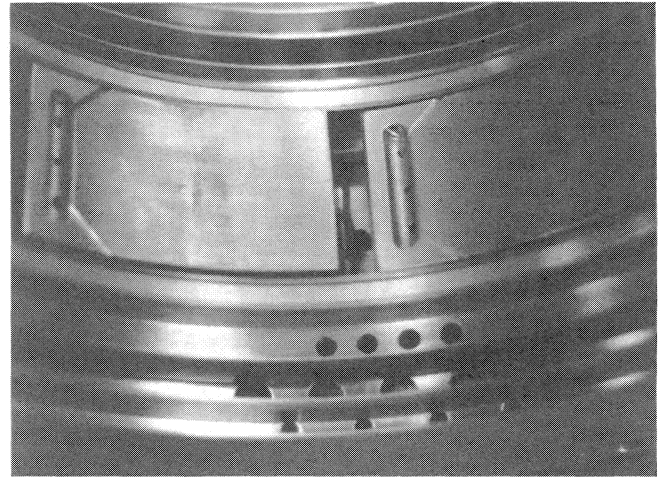
Figure 17. Oil Feed Grooves to Pads.

- Oil lubrication is to the leading edge of each pad through each spherical pad support. In addition to the grooves in Figure 17, a small amount of oil is circulated around the pad area.

- Thin babbitt (0.005 in to 0.007 in) centrifugally cast to the bearing bronze backing material was used as the journal pad material for greater load carrying ability and fatigue resistance. By looking closely in the groove area of Figure 17, this thin babbitt can be seen.

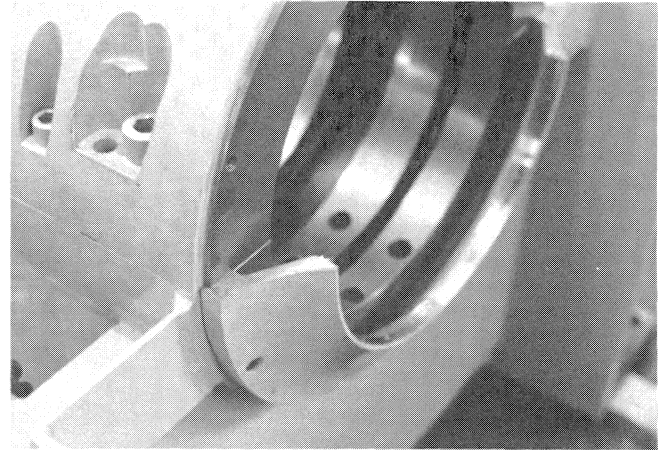
Figure 18. Bearing Housing and Seals.

- A contoured seal between the steady bearing support and the collector (Figure 18) directs cooling air away from the shaft mounted fan through an opening in the pedestal base, which must also act as a duct leading to the basement. This ducting is a requirement that surfaced after the initial design was submitted for review. Sides of the ducting acted as stiffeners for the pedestal lower half, while a circular lagging fitted at assembly was provided for the upper half.

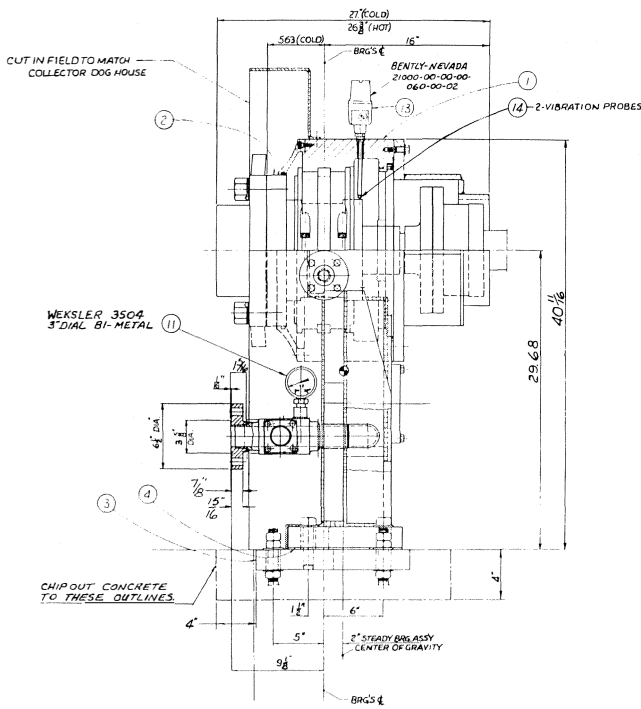
Figure 19. Final Outline—Side View.

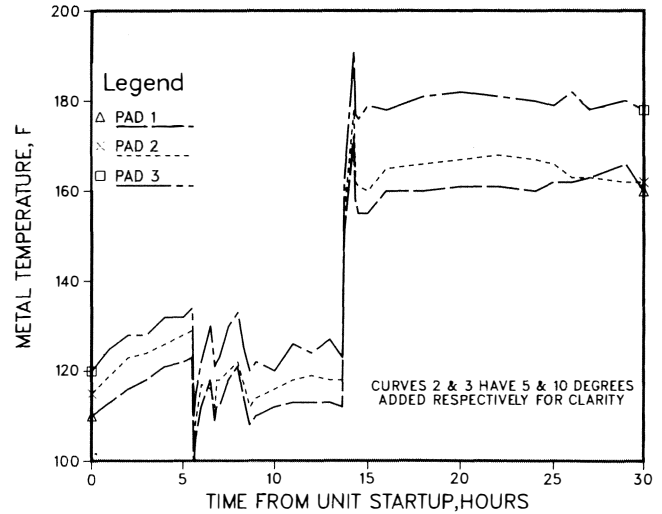
Figure 20. Bearing Temperatures at Unit Startup.

At startup, temperatures of the steady bearing pads were monitored to determine the relative load on the pads. Three pads, two lower and one upper, were monitored for any anomalies. The results are shown in Figure 20. Although the turbine was started at time 0, the hydraulic coupling was not loaded until about 14 hours later. The results did not show any significant change in temperatures relative to each other. The reason for this became very clear when the shaft centerline position was plotted. The plot (Figure 21) showed that the shaft position only moved about seven mils which implies that the housing of the steady bearing grew perhaps 12 mils. Further checks have indicated the growth of the steady bearing tracks the generator growth through the load range. Oil temperature leaving the bearing is approximately 130°F.

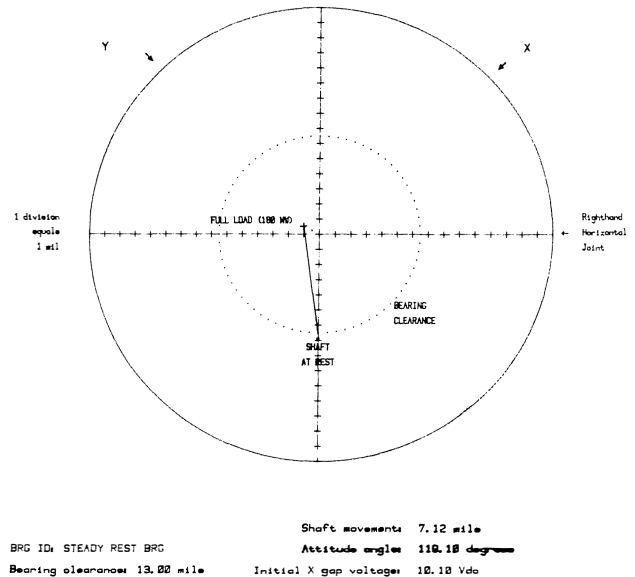
Figure 21. Shaft Position Plot.

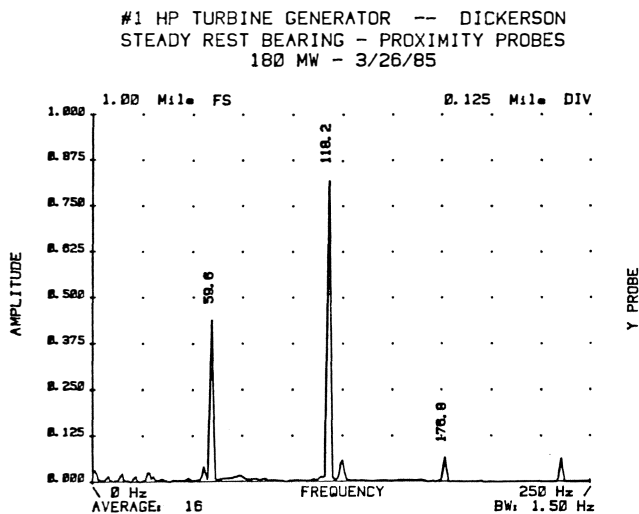
Figure 22. Vibration Spectrum—Steady Bearing Stub Shaft.

The unit presently operates at a normal full load of 185 MW. This load occurs at 72 percent scoop tube position and a pump speed of 3453 cpm, with four percent slip. At this load, vibration of the coupling input and output shafts is only 1.4 mils. Steady bearing vibration (i.e., the generator shaft) is only 1.8 mils. These vibration levels include mechanical and electrical runout of approximately 0.5 mils for an actual vibration level of 0.9 mils and 1.3 mils, respectively. Vibration spectra shortly after startup are shown in Figures 22 and 23.

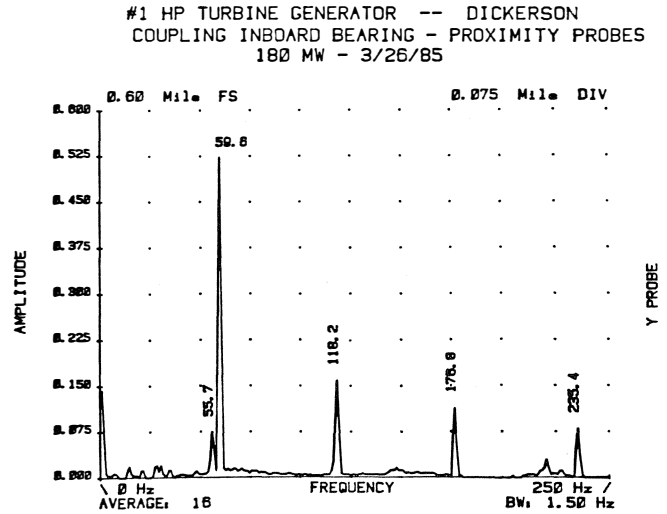
Figure 23. Vibration Spectrum—Hydraulic Coupling Input Shaft.

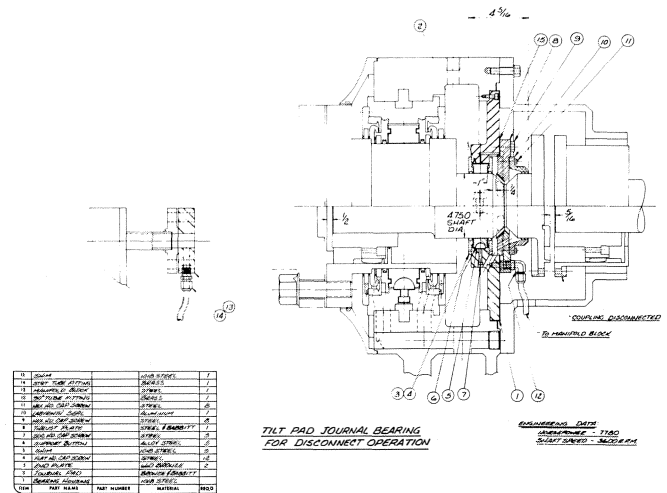
Figure 24. Auxiliary Support Bearing.

First, it was determined that the hydraulic coupling could not be uncoupled from the main turbine-generator and disassembled, unless the steady bearing was also disassembled. The input shaft of the coupling was supported by two journal bearings, and was bolted to the floating element of the steady bearing. This element floats (via gear teeth) inside an outer hub which was the journal surface of the steady bearing. Consequently, the outboard end of this element had no support when it was disconnected from the hydraulic coupling input shaft. To alleviate this, the bearing manufacturer designed an auxiliary support bearing which could be temporarily attached to the coupling outboard end of the floating element; the coupling can then be unbolted and the turbine-generator operated without needing to disassemble the steady bearing. A cross-section diagram is shown Figure 24.

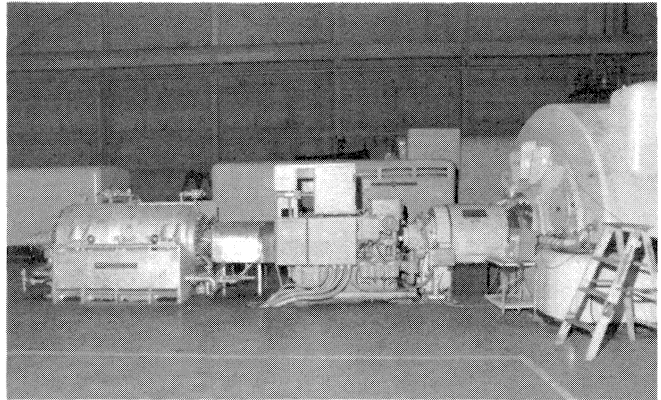
Figure 25. Completed Installation.

To date, the operation of hydraulic couplings for boiler feed pump drive service has proven to be reliable and the increased efficiency of variable speed shaft drive provides significant economic advantages over alternate drive systems. A view of the completed installation is shown in Figure 25.
