ANALYSIS OF SERVICE FAILURES

Paul S. Gupton

Monsanto Company

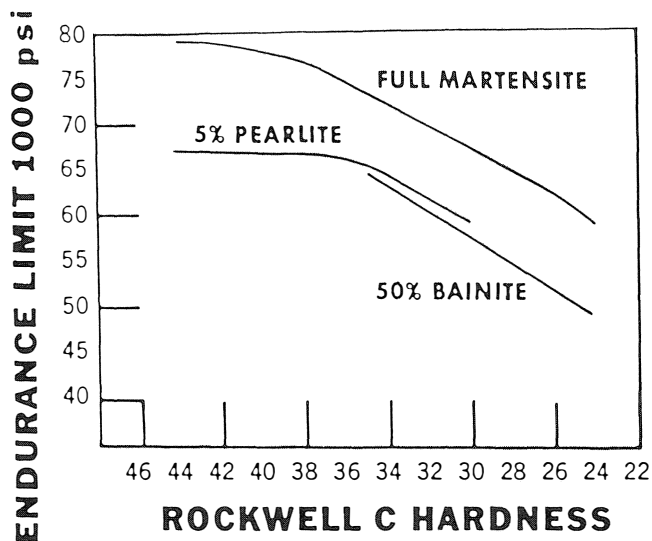
Figure 3. Effect of Non-Martensitic Transformation Products on the Rotating Beam Endurance Limit of an AISI-4340 Low Alloy Steel.

structure produces the highest fatigue strength. Deviation from this with increased mixtures of pearlite, free ferrite and retained austenite result in inherent metallurgical notches. This effect on the endurance limit of American Iron and Steel Institute (AISI) 4340 at various hardness levels is shown in Figure 3.

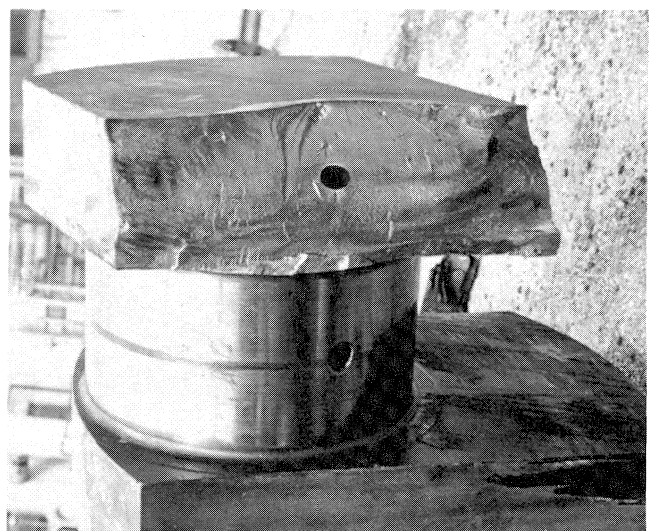
Figure 5. Failure of a Large 12 Inch Diameter Journal Reciprocating Engine/Compressor Crankshaft. The failure mode was fatigue in bending caused by main bearing misalignment.

• Manufacturing techniques can greatly influence the fatigue performance of a component. For instance, large multi-throw crankshafts are fabricated by twisting their individual crank sections at the main journals. Two methods of laying out forged slabs prior to rough machining and twisting are shown in Figure 4. The old technique placed the web section, containing the crank pin to main overlap, on the center line of the slab, which inherently contains the maximum shrinkage, segregation and nonmetallic inclusions. This is also the section that is subjected to the highest bending stress during operation. A typical bending fatigue failure of a large crankshaft is shown in Figure 5. An improved method places the less

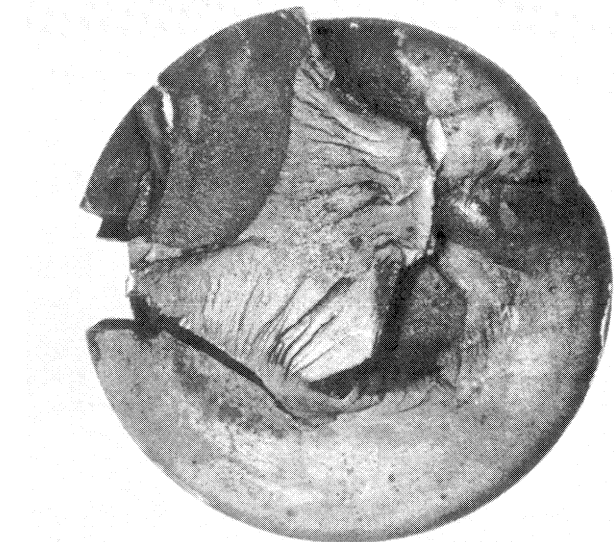
Figure 10. Combination Torsional and Bending Fatigue Failure of a Zirconium Alloy 705 Pump Shaft Due to a Loose Impeller.

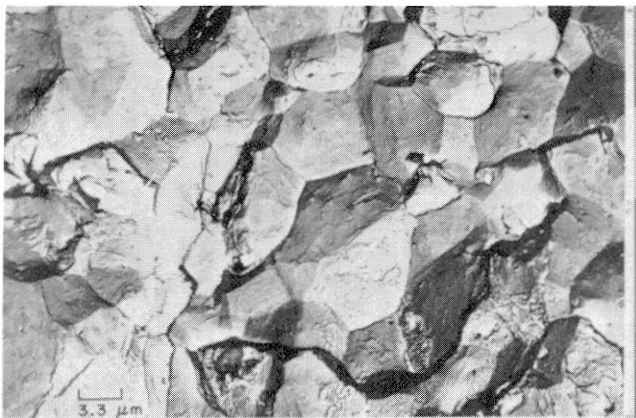
Figure 25. TEM Fractograph of an Intergranular Failure from Stress Corrosion Cracking.

Stress corrosion cracking is brittle appearing failure which can occur in ductile materials and exhibits no plastic deformation in or near the cracking. Stress corrosion results when a metal is subjected to electrochemical corrosion while being stressed. This mode of failure can be either transgranular, intergranular, or a combination of both. The intergranular mode is shown in Figure 25. The fracture type is a function of

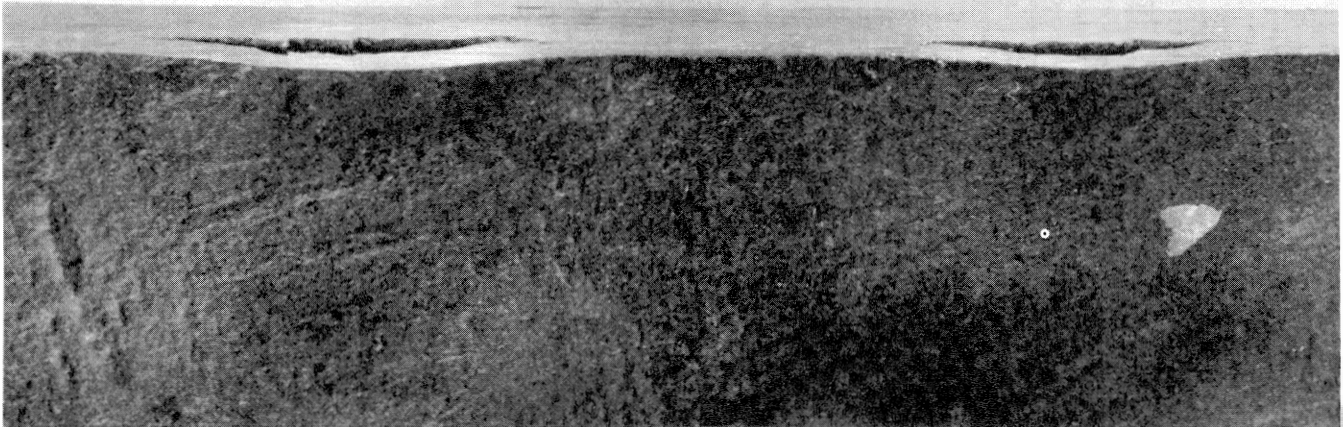
Figure 27. Cross Section of Plate in Figure 26 through Blisters Showing Delamination of Plate at Defects from Hydrogen Diffusion Combining to Molecular Form and Expanding.

The presence of atomic hydrogen can affect metals, namely steels, in two primary ways. The first is by concentrating at sites, primarily non-metallic inclusions, causing the equilibrium pressure between the molecular hydrogen in the voids and the atomic hydrogen surrounding microstructure to be sufficient to cause delamination and blistering. This mode of failure is shown in a section of ¼ in steel plate from a pressure vessel in Figures 26 and 27.

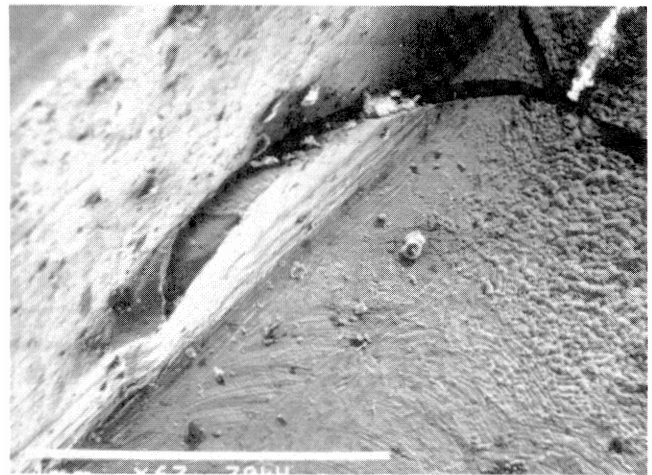
Figure 34. SEM Fractograph of the Dynamometer Wheel in Figure 33 Showing Cavitation Pitting Nucleation for Fatigue Failure of the Blading.

Erosion-corrosion—or velocity accelerated corrosion, occurs due to the relative motion between the fluid and the metal surface. This condition may occur in the absence of abrasive particles. Most metal attacking environments have critical maximum velocities in which erosion-corrosion will not occur. An example of erosion-corrosion involving abrasive practices is shown in Figure 32. This closure flange was grooved by the action of catalyst particles and gas leakage. Cavitation is a special form of this failure mode. A cavitation induced fatigue failure of a high speed rotor due to incorrect material selection and hardness is shown in Figures 33 and 34.
