Diagnosis of Centrifugal Pump Faults Using Vibration Methods

Albraik, A., Althobiani, Faisal, Gu, Fengshou and Ball, Andrew (2012) Diagnosis of Centrifugal Pump Faults Using Vibration Methods. *Journal of Physics: Conference Series*, 364. 012139. ISSN 1742-6596

# Diagnosis of Centrifugal Pump Faults Using Vibration Methods

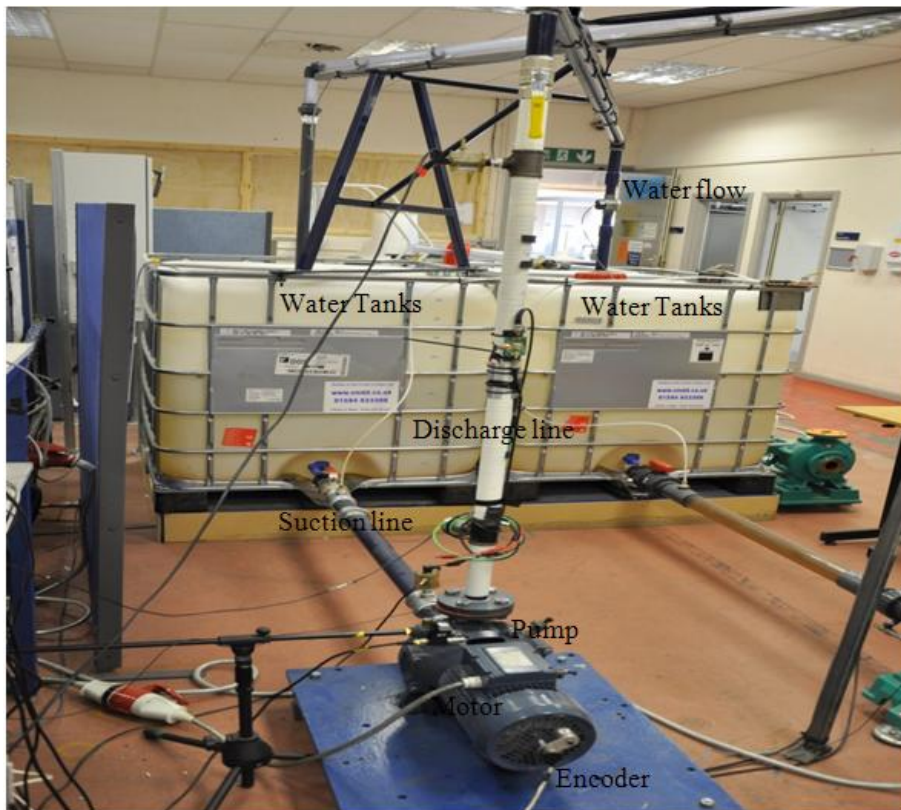
**Figure 3.1.** Photograph of the test-rig.

The test rig consists of a centrifugal pump, variable speed motor and the closed-loop water piping system for water circulation. A photograph of the finished test-rig is shown in figure 3.1.

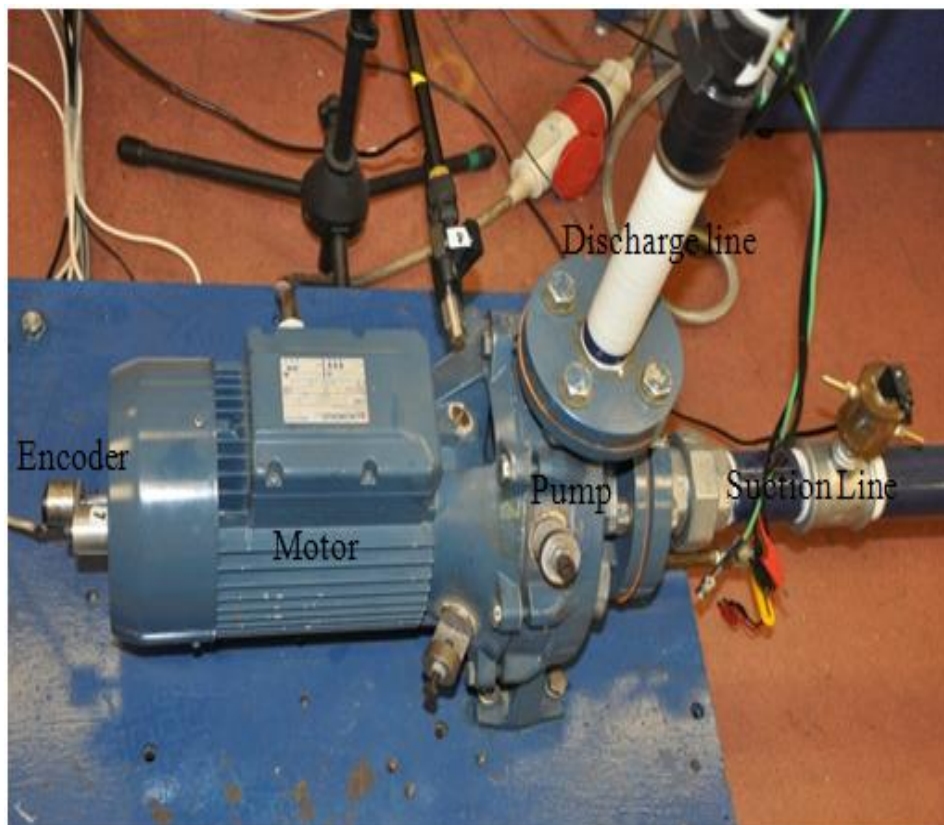
**Figure 3.2.** The test-rig pump.

The pump model is a F32/200A series centrifugal pump standardised to DIN 24255. The centrifugal pump was used in the test-rig shown in Fig. 3.2. It was a single suction, single stage, end/top discharge, closed impeller and closed-coupled centrifugal pump, which can deliver water at a rate of up to 30m<sup>3</sup>h<sup>-1</sup> (500l/min) at a head of up to 55m. It is driven by a three-phase electric motor running at 2900rpm on 9.5A at 380-400V (nominal 4kW/5.5hp). The capacity of the tank is based on the maximum flow rate.

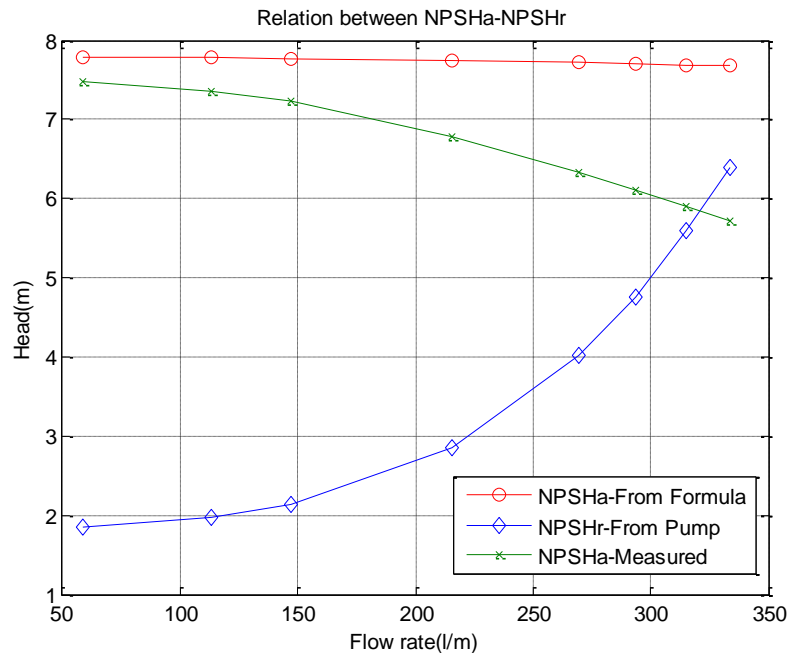
**Figure 3.3.** Pump performance.

The predicted characteristics between the NPSHa and NPSHr for this system were obtained by throttling the valve in the discharge line progressively while the pump speed is at 2900rpm and the valve in the suction line was fully open (100%) as suggested in ISO 3555. Figure 3.3 shows the relation between NPSHa, NPSHr and flow rate. NPSHr (from pump head) increases with flow rate and increases rapidly above 220 l/m. The measured NPSHa decreases with flow rate and the NPSHa-NPSHr intersection occurs at a flow rate of approximately 320 l/m and head 5.75(m).

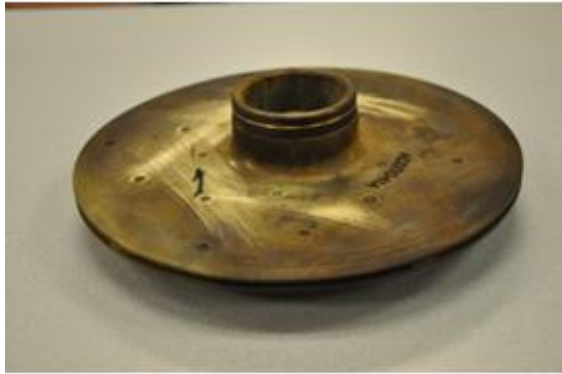
**Figure 4.1.** Impeller 1 In good condition.

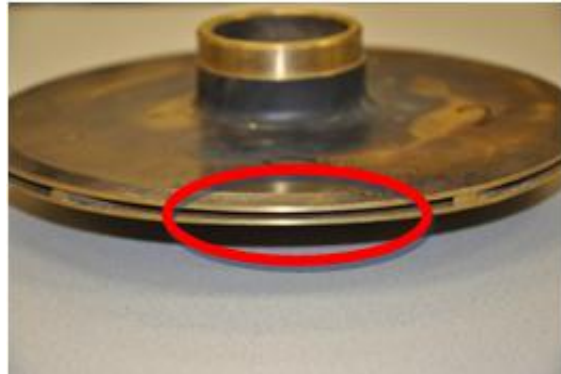
**Figure 4.2.** Impeller 2 with gap between two plates.

Figure 4.3 (a) compares flow rate against head the impeller in good condition (blue line) with defective impeller 2: a hammer blow on its edge reduced the gap between two plates at that point to 2.4mm (red line). The healthy impeller had a gap of 3.2mm. Impellers 1 and 2 are the same geometry. The red line shows a higher head compared to the blue line and the deviation is greater at higher flow rates. In Figure 4.3 (b) the red line shows that the faulty condition consumes more voltage than the healthy condition. The current consumption is almost the same for both conditions. Power consumption is higher for the faulty condition particularly for flow rates higher than 250 l/m. Vibration acceleration is generally greater for the faulty condition for flow rates between 100 l/m and 320 l/m, as can be seen from the blue and red lines in Figure 4.3 (c). Above a flow rate of 320 l/m the situation is reversed and the measured vibration acceleration is greater for the healthy pump. The vibration acceleration for the faulty pump is almost linearly proportional to flow between 50 to 220 l/m and then increases rapidly up to 320 l/m flow rate after which it decreases rapidly. The vibration acceleration for the healthy pump increases almost linearly between flow rates of 50 and 275 l/m then increases rapidly.

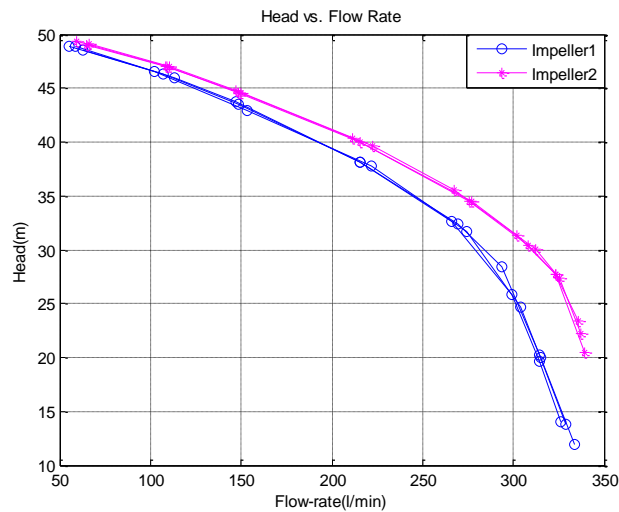
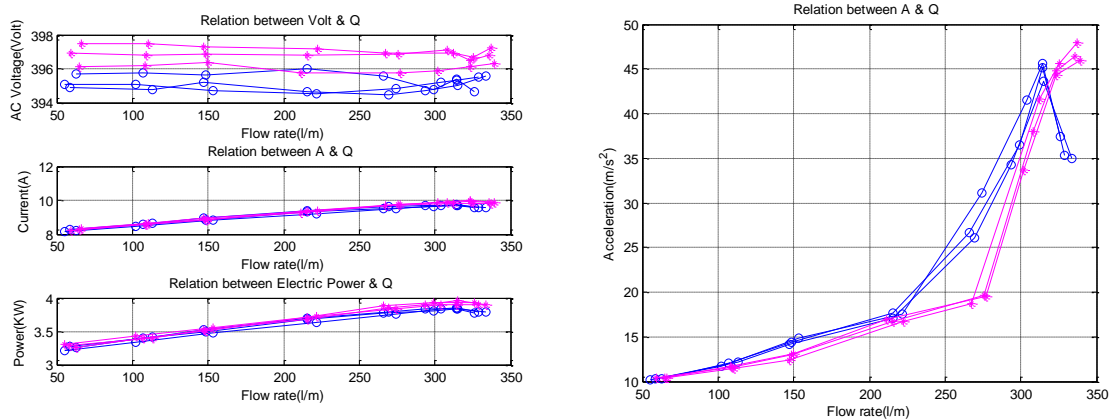
(a) Head vs flow rate.

(b) Voltage, current, power vs flow rate. (c) Vibration acceleration vs flow rate.  
**Figure 4.3.** Collected data at different flow rates ( impeller 1 vs impeller 2).

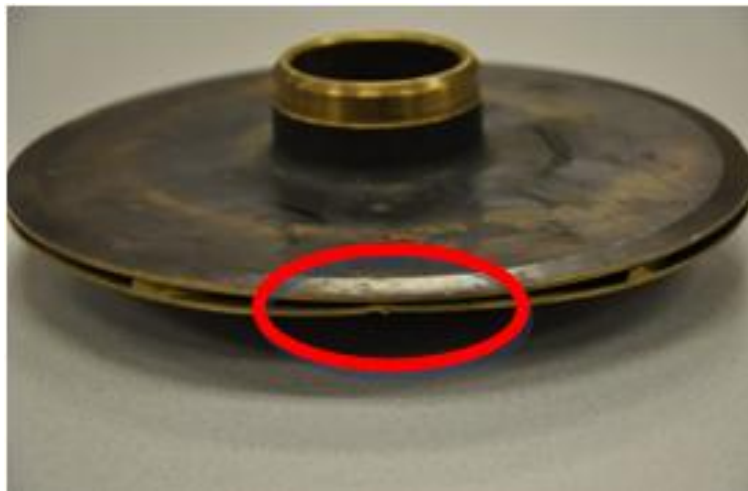
**Figure 4.4.** Impeller 3 with gap between two plates reduced to 0.7mm at a single point by a hammer blow.

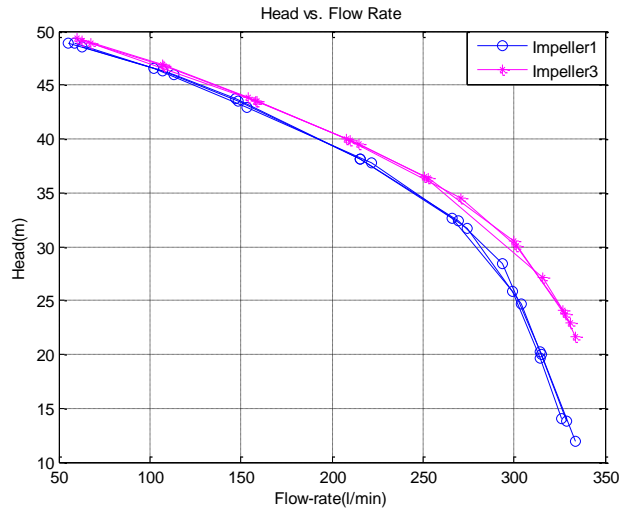
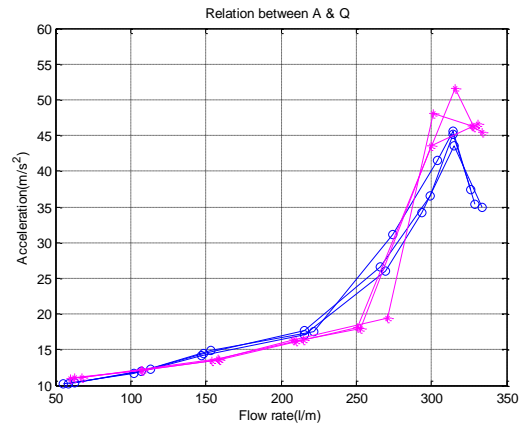
(a) Head vs flow rate.

(b) Voltage, current and power vs flow rate.

(c) Vibration acceleration vs flow rate.

**Figure 4.5.** Collected data at different flow rates (impeller 1 vs impeller 3).

Figure 4.5 (a) compares flow rate against head for the impeller in good condition (blue line) with defective impeller 3: a hammer blow on its edge reduced the gap between two plates at that point to 0.7mm (red line). Impellers 1 and 3 have the same geometry. Figure 4.5 (a) compares the healthy impeller (blue line) with the defective impeller (dented and with reduced gap between two plates) (red line). Once again, the faulty impeller had a higher head than the healthy impeller at all flow rates, but particularly above about 300 l/m. Figure 4.5 (b) shows that the voltage remains almost the same across flow rates from 50 to 325 l/m, but current and power increase slightly with flow rate. Figure 4.5 (c) shows that the vibration acceleration is almost the same in both healthy and faulty impeller for flow rates up to about 220 l/m; for flow rates 220 to 275 l/m the vibration acceleration is greater for the healthy condition, but above 275 l/m the defective impeller produced a greater level of vibration. The vibration acceleration for the defective impeller is almost linearly proportional to flow rate between 50 to 220 l/m, then increases rapidly up to 320 l/m and then decreases.

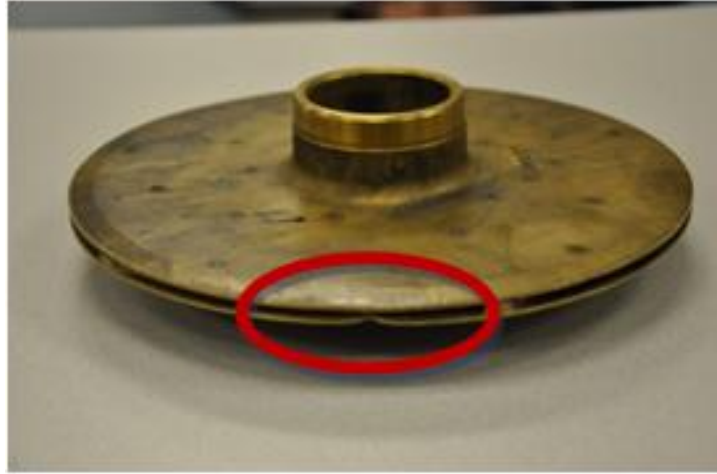
**Figure 4.6.** Impeller 4 with gap between two plates reduced to 0.3mm at a single point by a hammer blow.

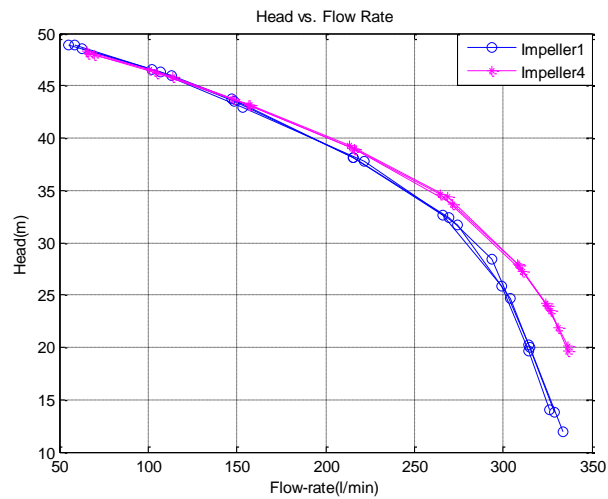
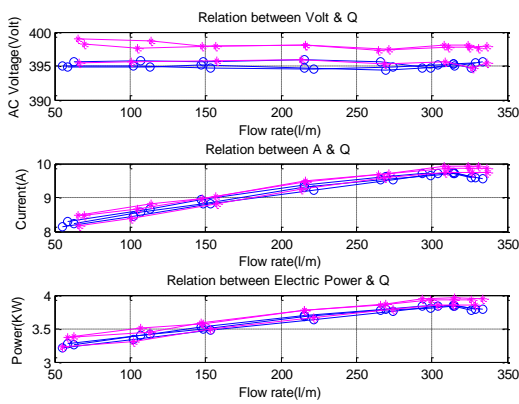
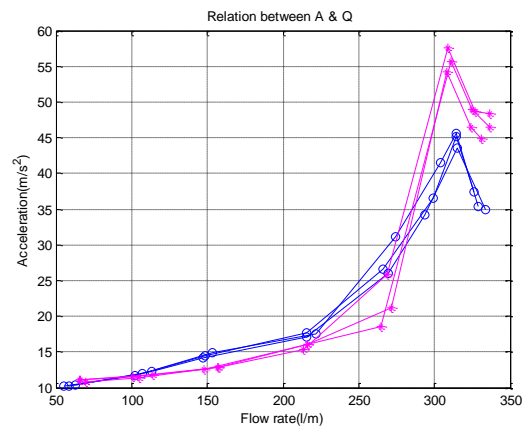
(a) Head vs flow rate.

(b) Voltage, current and power vs flow rate.

(c) Vibration acceleration vs flow rate.

**Figure 4.7.** Collected data at different flow rates (impeller 1 vs impeller 4).

Figure 4.7 (a) compares flow rate against head for the healthy impeller (blue line) with defective impeller 4: a hammer blow on its edge reduced the gap between two plates at that point to 0.3mm (red line). Impellers 1 and 4 are the same geometry. As previously, the faulty impeller provides a higher head compare to the healthy impeller on flow rate above about 150 l/m, the difference is very marked at flow rates above 300 l/m. Red consumes more AC volt compared to blue in Figure 4.7 (b), where current consumption is slightly higher in Red compared to Blue. Power consumption is high in Red compared to blue. In figure 4.7 (c), acceleration is found to be more in blue compared to red for the flow rate 100-275 (m/l). Above 275 (m/l) flow rate, acceleration is more in red compared to Blue. Acceleration in blue is almost linearly proportional between 50 to 220 (m/l) flow rate then, increases rapidly up to 320 (m/l) flow rate and after that decreases rapidly. Acceleration in red is almost linearly proportional between 50 to 275 (m/l) flow rate then, increases rapidly up to 315 (m/l) flow rate and then increases rapidly.

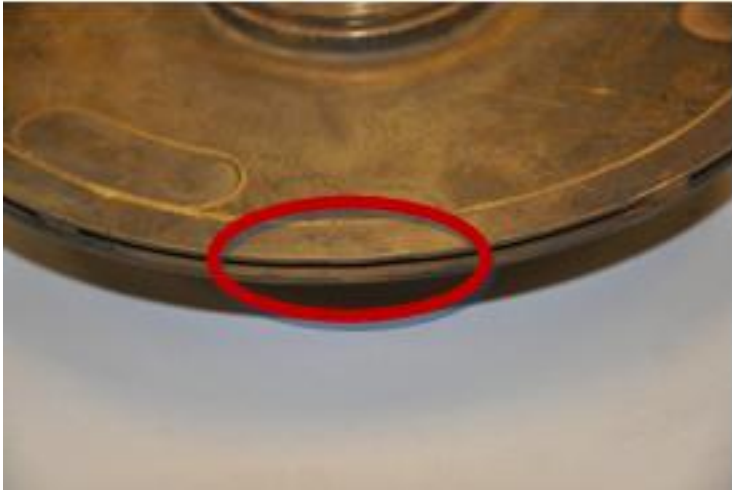
Figure 4.8. Impeller 5 with gap between two plates reduced by a hammer blow at three equally spaced points.

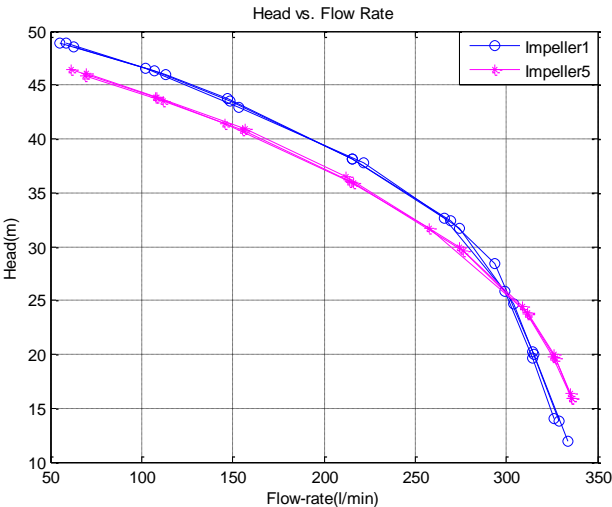
(a) Head vs flow rate.

(b) Voltage, current and power vs flow rate.

(c) Vibration acceleration vs flow rate.

**Figure 4.9.** Collected data at different flow rates (impeller 1 vs impeller 5).

Figure 4.9 (a) compares flow rate against head for the healthy impeller (blue line) with defective impeller 5: three equally spaced hammer blows around the circumference reduced the spacing to 2.6mm, 2.9mm and 3.0mm, respectively, as shown. Impellers 1 and 5 are the same geometry. Unlike the previous results, the healthy impeller produces a greater head up to about 300 l/m, for flows above this the defective impeller produced a higher head. Figure 4.9 (b) shows that the pump containing the faulty impeller consumes more power, requiring a higher AC voltage and current than the healthy pump. Figure 4.9 (c) shows that vibration acceleration is much greater in the pump with defective impeller for flow rates up to about 280 l/m between about 300 l/m and 325 l/m the vibration acceleration is greater for the healthy pump, but above 325 l/m the acceleration is much the same for both pumps.
