Transactions of the VŠB – Technical University of Ostrava, Mechanical Series

No. 2, 2010, vol. LVI

TOOL LIFE TESTS OF CERAMIC CUTTING TOOLS AT SLIDE TURNING

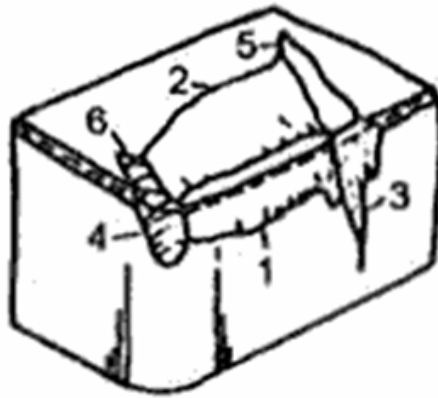
Fig. 1 The external signs of tool wear [2]

1 – flank tool wear of cutting tool, 2 – cratered tool wear, 3 – tothing tool wear, 4 – tool wear of point, 5 – external tool wear of the front surface of cutting tools, 6 – internal tothing formed by chip.

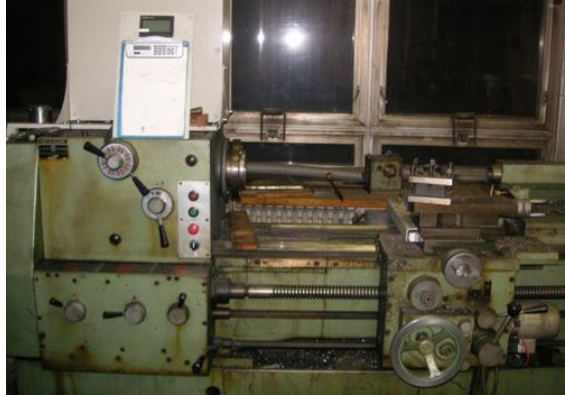
Fig. 2 Machine tool CMM SLIVEN

The machine tool CMM SLIVEN (Fig. 2) was used for machining. The machine tool has rigid structure that provides a sufficient clamping. The machine tool reaches a maximum of 2000min^{-1} and the engine power is 6kW.

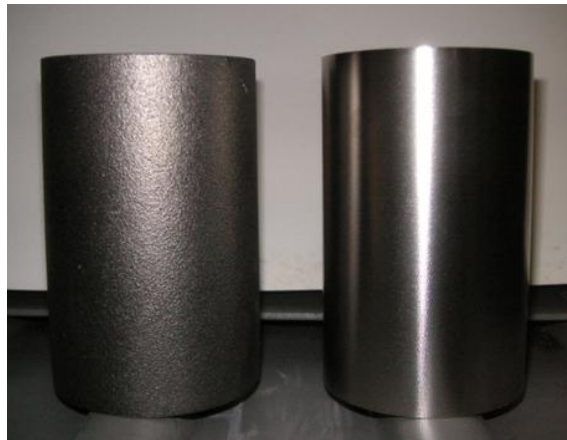
Fig. 3 Machined semi-product (sleeve car engine)

As the machining material were used sleeves for car engines (Fig. 3) which were supplied by the contracting authority. It is a 25P class of material. Because sleeves had a conical shape it was necessary to machined cylindrical surface and the same diameter (Fig. 3). If we did not do, a constant depth of cut a_p should not be maintained during tests.

The workpiece before machining (left) and after machining (right).

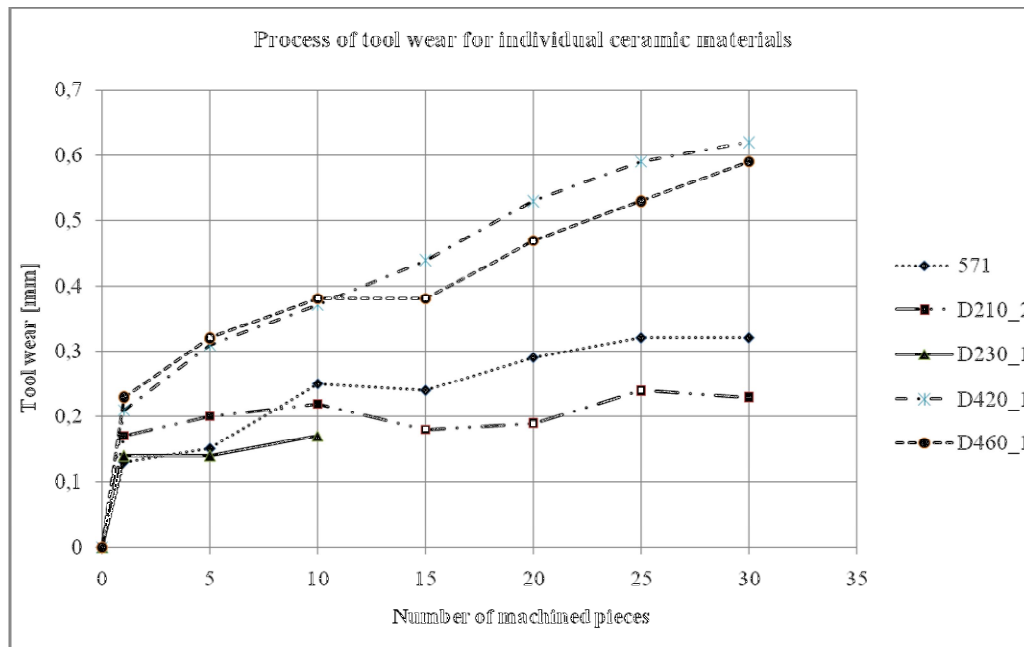
Fig. 4 Dependence of tool wear (growth) on the number of machined pieces

Dependence of tool wear on the number of machined pieces (cutting inserts) is shown in Figure 4. We cut off two layers with 2 mm depth of cut (on the each sleeve). The polynomial approximations third procedures for materials that have not reached the criterion of tool wear are on the following graph (Fig. 5).

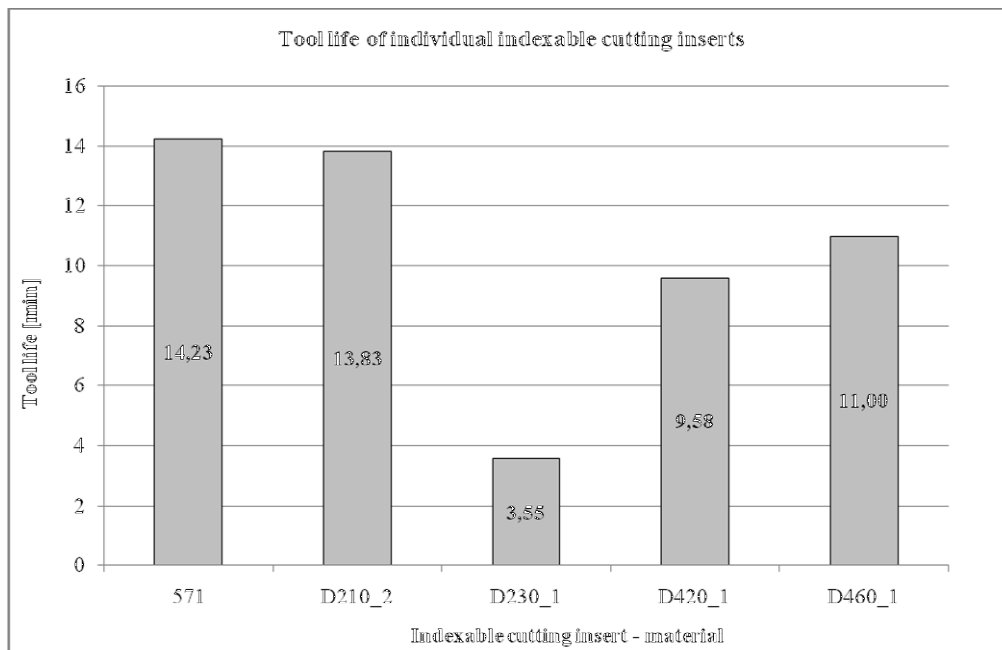
Fig. 6 Tool life of individual indexable cutting inserts

Tool life of individual indexable cutting inserts (Fig. 6) and the number of machined pieces (Fig. 7) is shown in the following charts.

The 571 materials achieved the best results (tool life - 14,23 min and the number of machined pieces – 44 after approximation), D210_2 (tool life – 13,83 min and 39 pcs.). Other materials in the order D460_1 (11 min, 31 pcs.) and D420_1 (9,58 min, 27 pcs.). The D230_1 material is at the end of the order (3,55 min and 10 pcs.).

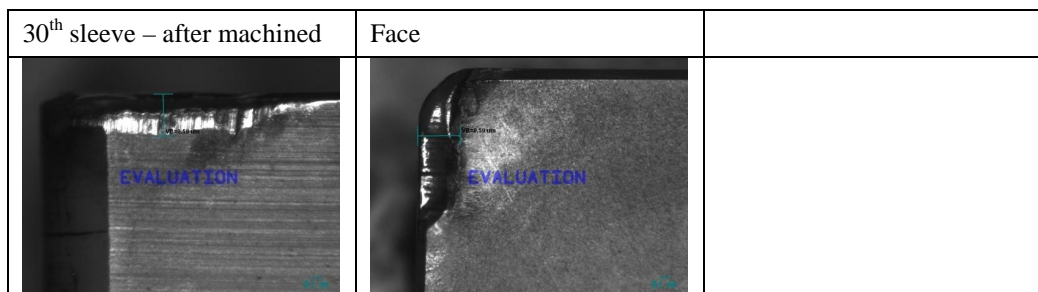
Tab. 6 Picture (tool wear) – D460_1 material

1 st sleeve – after machined	5 th sleeve – after machined	10 th sleeve – after machined

15 th sleeve – after machined	20 th sleeve – after machined	25 th sleeve – after machined
