MONITORING WOOD DECAY IN POLES BY THE VIBRO-ACOUSTIC RESPONSE METHOD.

Ian A. Craighead^a, Steve Thackery^b, Martin Redstall^b, Matthew R. Thomas^b

^a Dept. of Mechanical Engineering, Univ. of Strathclyde, Glasgow, Scotland G1 1XJ

^b BT Research Laboratories, Martlesham Heath, Ipswich, IP5 7RE, UK.

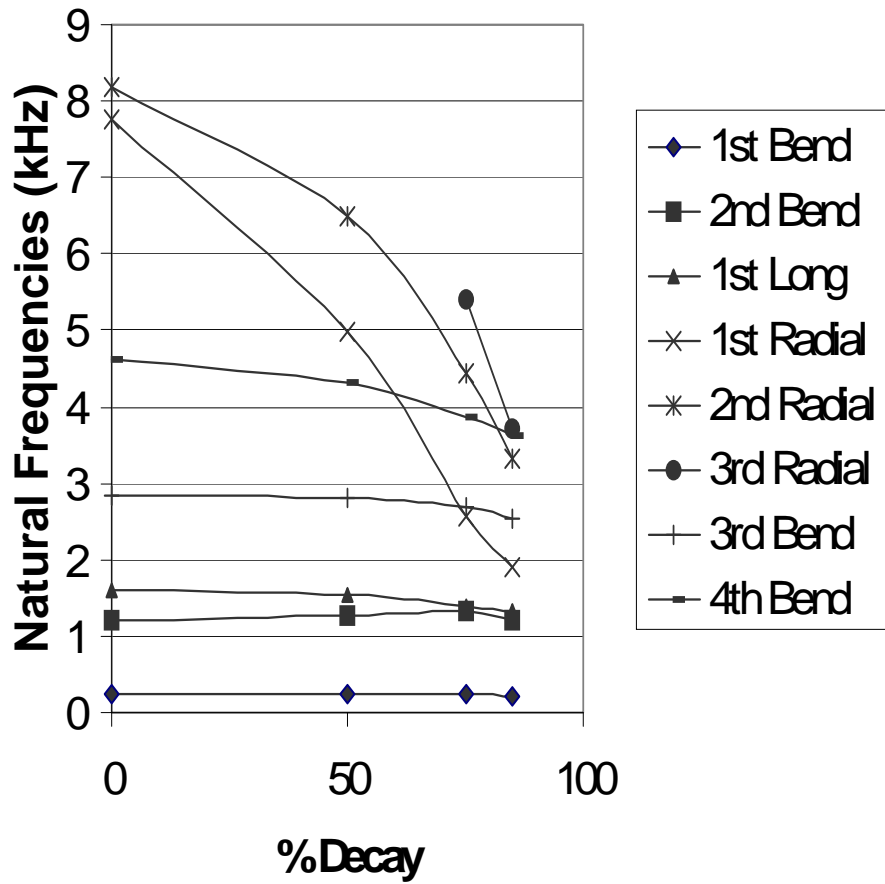
Figure 2 Natural frequencies of Isotropic FE model showing influence of decay.

The results from the model are presented in Figure 2 and plots of the various radial mode shapes are included in Appendix 1 .

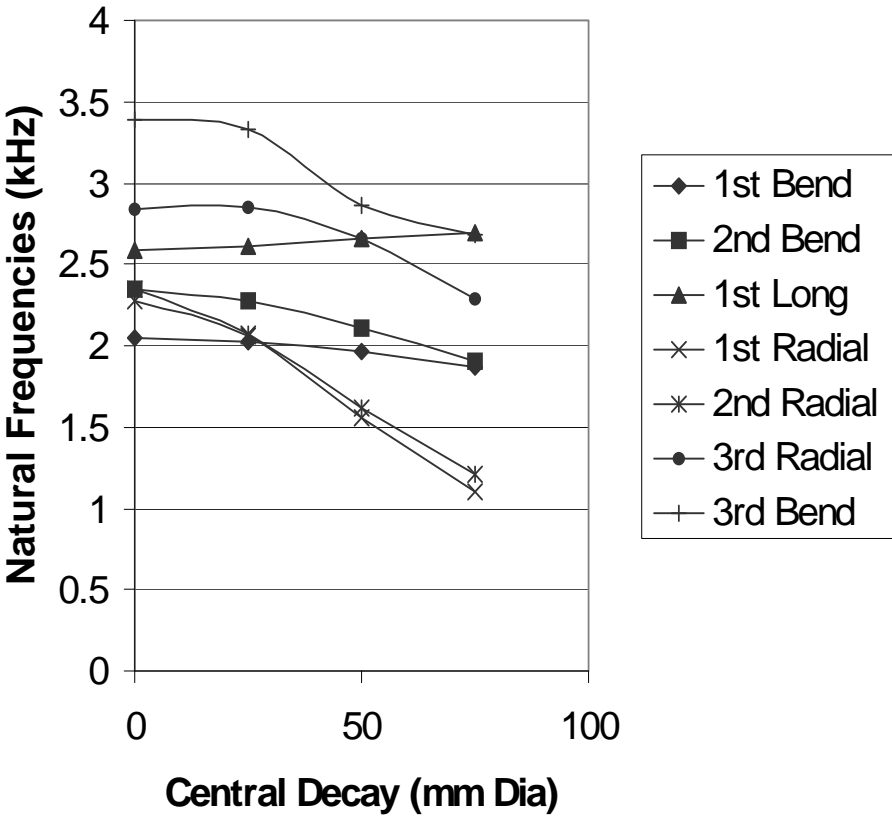
Figure 5 Natural frequencies of orthotropic FE model of short pole freely suspended.

The natural frequencies of the short pole were obtained for the various amounts of decay and the results are summarised in Figure 5.

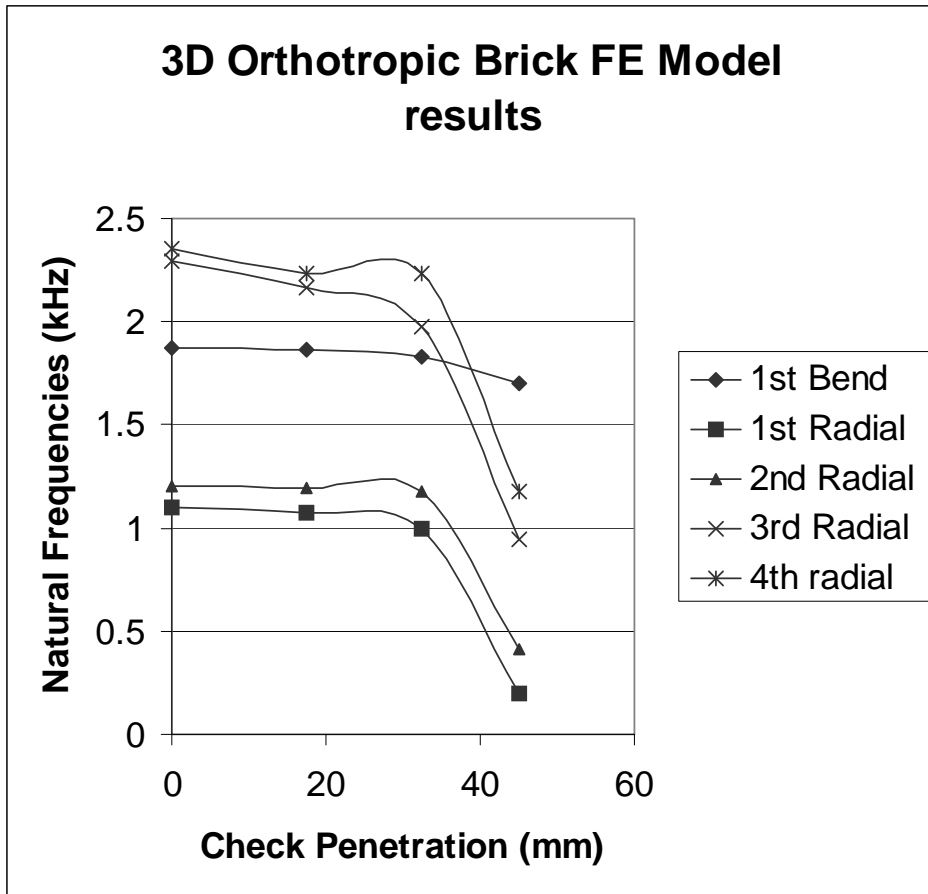
Figure 6 Natural frequencies of orthotropic FE model of short pole showing effect of check penetration.

To investigate the effect of a check in the pole, the short pole model with a 75 mm diameter central hole was used and the freedom constraints were removed gradually from the outer radius through to the inner radius. The results are included in Figure 6.

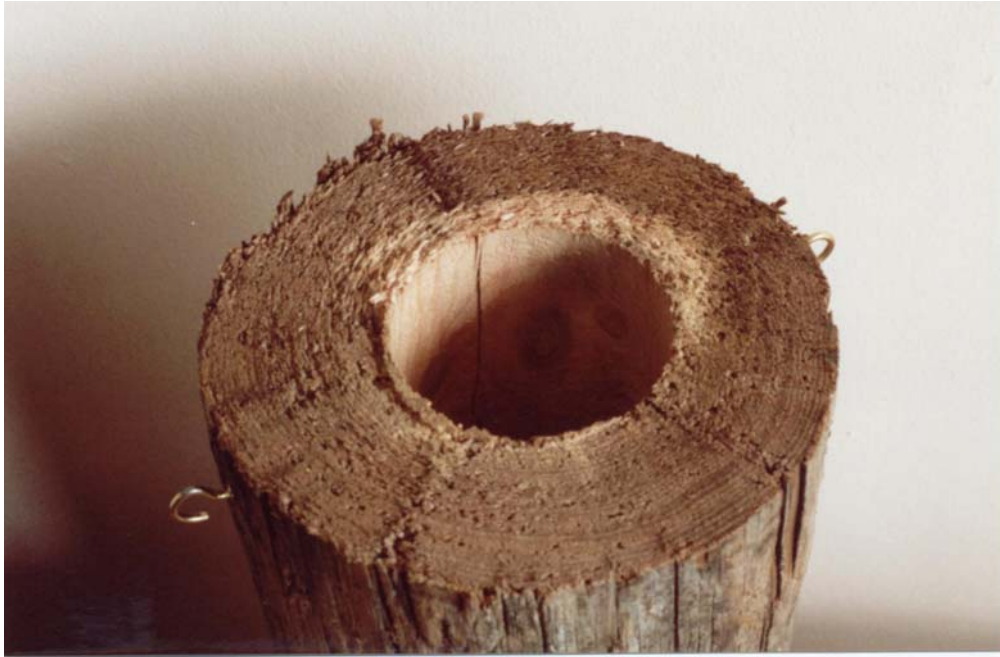
Figure 7 Short pole section showing cup hooks and 75 mm central “decay” hole.

A 300 mm section of telegraph pole was obtained from a pole, which had been condemned. There was found to be no sign of decay in the pole when it was sectioned and the section tested appeared to be sound wood. Two “cup” hooks were screwed into the pole near the top surface 180° apart as shown in Figure 7. The section of pole was suspended in an anechoic chamber and 4 positions marked on the mid-plane at 90° spacing as shown in Figure 8.

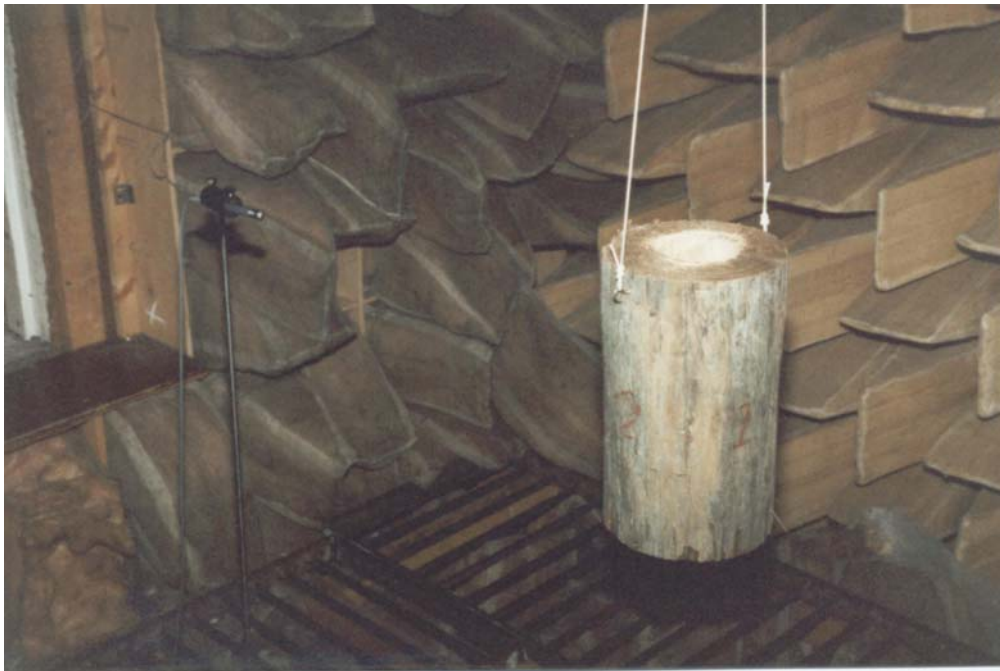
Figure 8 Short pole section in anechoic chamber and microphone location.

A microphone was positioned approximately 0.5 m away from the suspended pole at the mid-plane level. The pole was tapped with a hammer at each of the 4 positions and the sound analysed using an Ono-Sokki FFT analyser. Figure 9 shows a typical spectrum obtained from the acoustic signal.

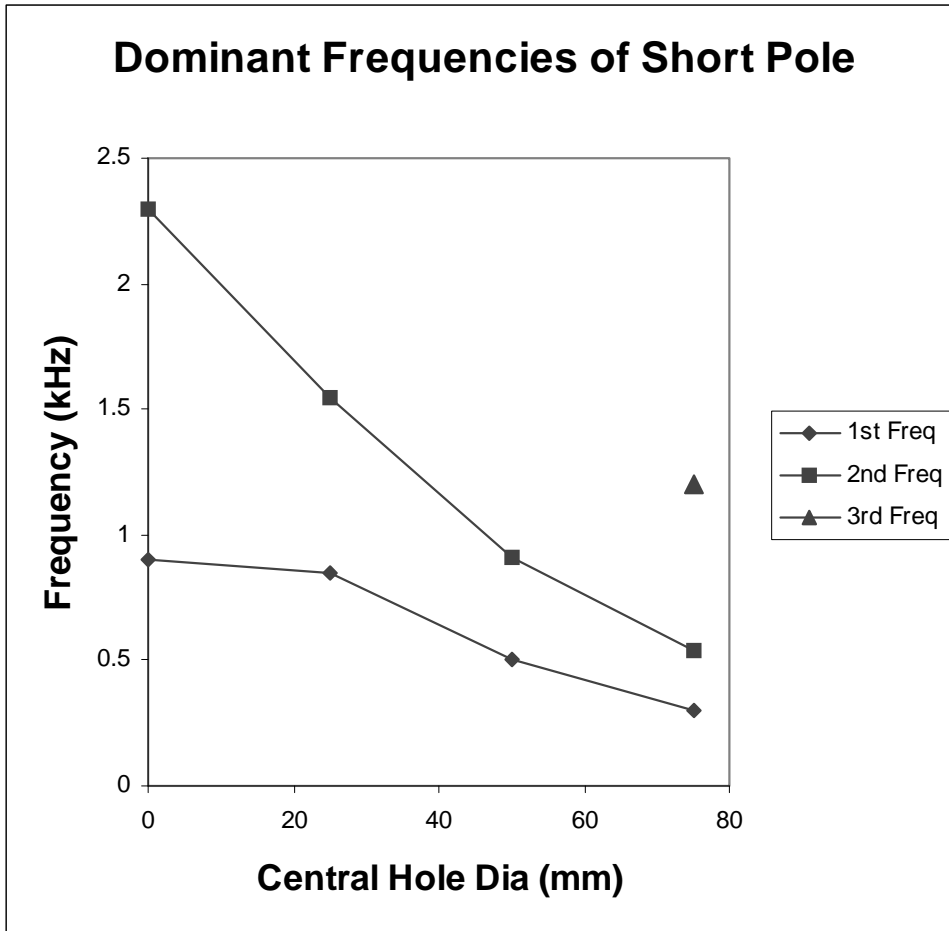
Figure 10 Dominant frequencies of short pole section.

A 25mm hole was drilled axially through the centre of the pole to represent decay and the measurements repeated. A 50 mm hole and then a 75mm diameter hole were also tested. Any further enlargement of the hole would have been difficult due to the presence of checks, which would have resulted in the hollowed pole breaking apart. The checks can be clearly seen to penetrate to the inner radius of the pole in Figure 7. Dominant frequencies were identified from the acoustic spectra and are presented in Figure 10.

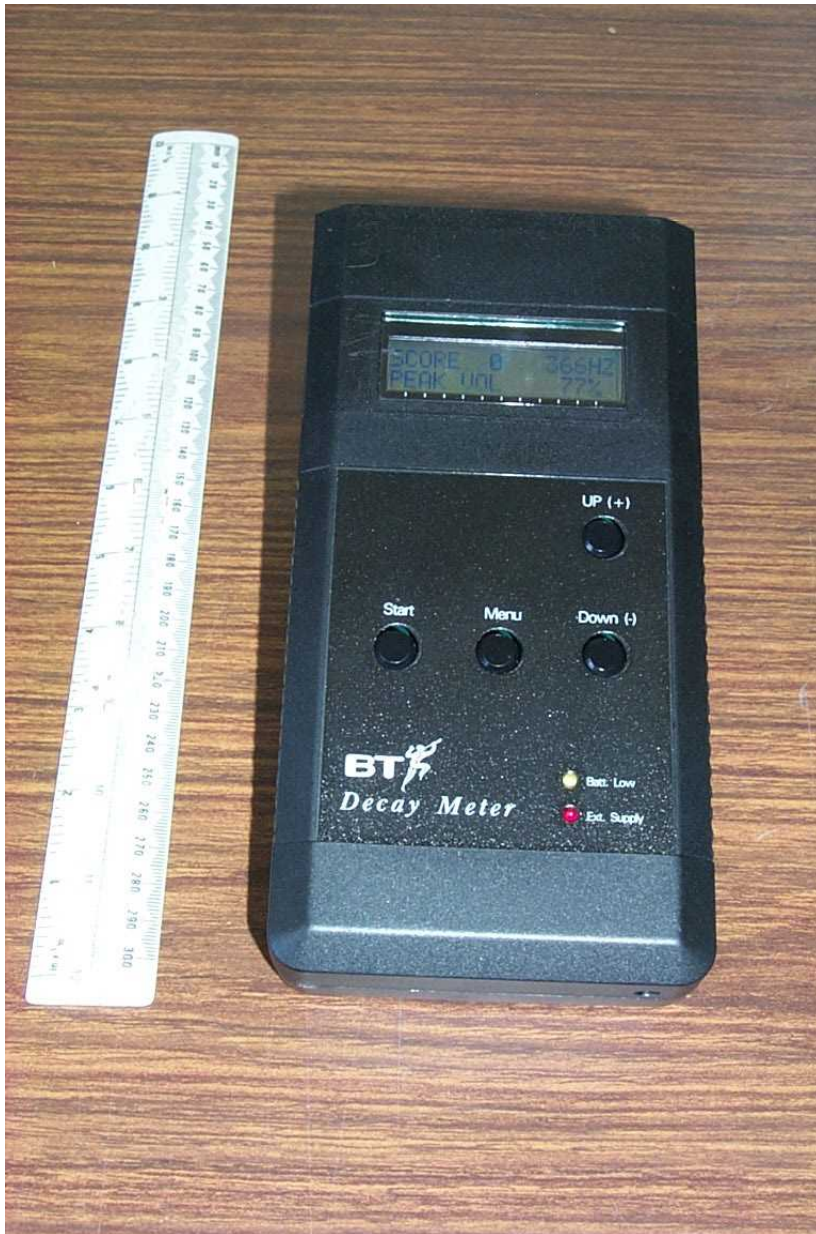
Figure 13 The pole decay meter.

Based on the algorithms identified a small number of prototype meters were developed. The general appearance is shown in Figure 13. The sound is captured by a microphone and then digitised for signal processing. The display provides an indication of the score as calculated by the algorithms and the meter is capable of providing further information to aid future algorithm development. Field trials are currently being carried out.
