David-West, O.S. and Nash, D.H. and Banks, W.M. (2009) *Impact characterisation of doubly curved composite structure*. In: 17th International Conference on Composite Materials, ICCM17, 2009-07-27 - 2009-07-31, Edinburgh, UK. (Unpublished)

IMPACT CHARACTERISATION OF DOUBLY CURVED COMPOSITE STRUCTURE

O S David-West¹, D H Nash² and W M Banks^{2*}

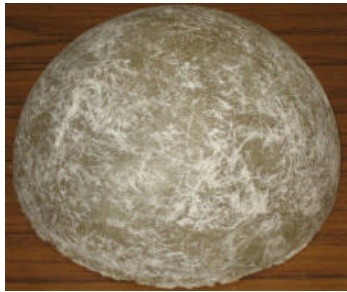
Figure 1. Photograph of manufactured 150mm diameter composite.

A solution of silicone is spread on the surface of the moulds with a spray. These operations help the removal of the samples from the moulds. The matrix was made of the mixture of resin and catalyst (where the catalyst is just 2% by mass of the resin). Each ply is applied in the mould and impregnated of resin with a brush. A particular care is taken to not have bubbles, which cause discontinuity in the composite. When all the plies are laid, the moulds are placed 24 hours under an extractor hood. *Figures 1 & 2* are the photographs of samples manufactured.

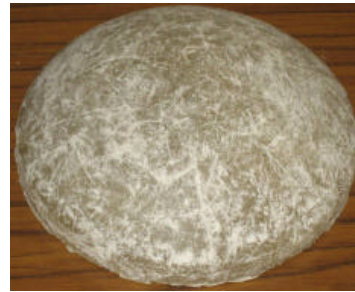
Figure 2. Photograph of manufactured 200mm diameter composite

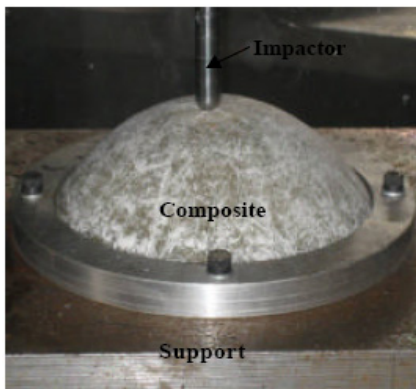
Figure 4. Impacted composite dome.

The samples were simply supported in the instrumented drop tester [*Figure 3*] and impacted with a cross-head mass of 30kg. Transient response of the composite was measured and stored. The impact parameters obtained include load, energy, velocity and displacement as a function of time. The system measures the load – time response through the load cells. The other parameters were calculated by the application of the laws of motion. The energy that goes into the composite is calculated based on conservation of energy principles and is calculated based on the potential energy of the impactor, initial kinetic energy of the impactor at the time of impact and instantaneous kinetic energy. *Figure 4* is a photograph of the composite on the support and schematic set-up for testing shown in *Figure 5*.

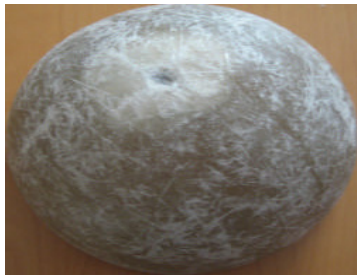
Figure 7. Damaged 150mm diameter composite dome due to repeated impact.

Figures 7 & 8 are top view photographs of the composite domes after the repeated drop impact tests. The localized damaged boundary has an irregular shape that is difficult to predict. Some of the features seen include indentation and cracking. Also the specimens were sectioned through the impact zone, the cut surface ground with 800, 1200 and 2400 grit silicon carbide papers with water; and macro photographs (*Figure 9.*) obtained with Sony digital still camera DKC-CM30. The image revealed failure modes such as debonding, matrix crack and fibre pull-out.

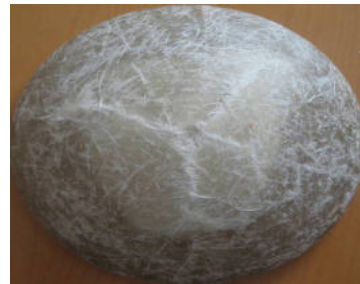
Figure 8. Damaged 200mm diameter composite dome due to impact.

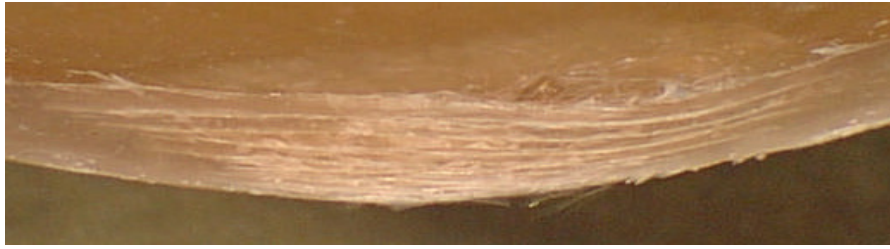
Figure 9. Through the impact point sectioned macro-photograph damaged composite dome.

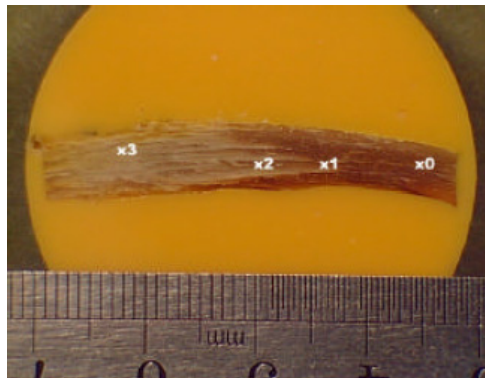
Figure 10. Sectioned composite impregnated in a resin for micro-photographs.

The micro-structural photos were taken with a Nikon Epihot metallurgical microscope at x 50 magnification. In preparing of samples for these photos, they were (in addition to being sectioning through the impact point of the composite with an abrasive cutting disc and cooling water) mounted on Struers Durofix-2 cold mounting acrylic resin [Figure 10]. Then ground with 220grit SiC paper with cooling water at 300rpm, followed with 800, 1200, 2400 grit papers to reduce scratch pattern. Finally, they were polished with 3 micron diamond suspension with DP blue lubricant on DP-Dur polishing pad at 150rpm. The micro-photographs were taken at four locations on the surface as marked in Fig. 10. The Figures 11 to 14 are the micro-images taken from location x0 to x3 respectively, revealing damage modes such as the cracking of the matrix material and delamination. The inter-laminar delamination seems to dominate and might have taken a greater percentage of the absorbed energy because of the inter-laminar stresses and moments generated by the actions of the impact event.

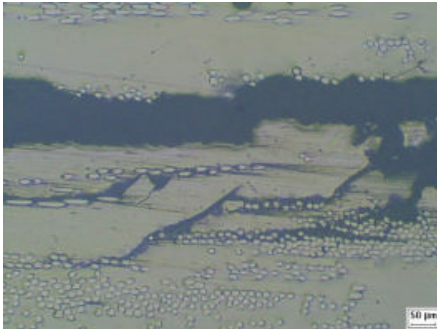
Figure 13. Micro-photograph at point X2 in Fig. 10 Figure 14. Micro-photograph at point X3 in Fig. 10

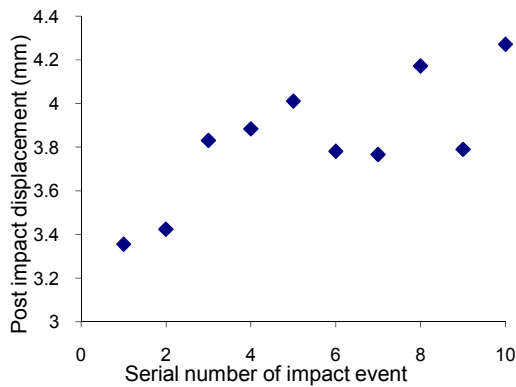
Figure 17. After each impact displacement for the 150mm diameter dome.

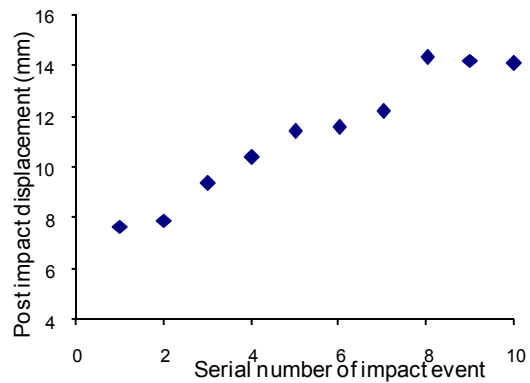
Figure 18. After each impact displacement for the 200mm diameter dome.

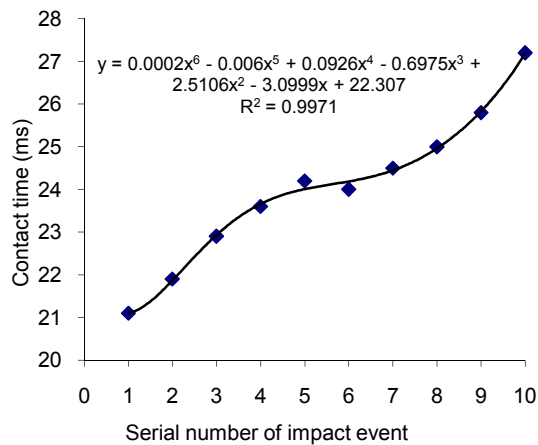
Figure 19. Contact time for the 150mm diameter dome.

The contact time between the specimen and the striker was obtained when the contact force returns to zero. Figures 19 & 20, are plots of the contact time observed during the test and the increase in time can be associated with the formation of indentation, compression of the composite and the effect of the moments generated by the impact process. The 150mm dome composite shows a monotonic increase in the contact time, while the 200mm dome showed almost stable contact time from the eighth impact. This implies that, the dome diameter affects the contact time and the saturation value for α [shown in Figure 6].

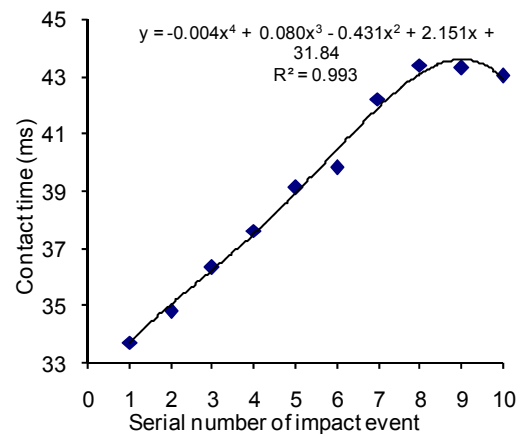
Figure 20. Contact time for the 200mm diameter dome.
