**Settlement Rehabilitation of a 35 Year Old Building:  
A Case Study Integrated with Analysis and Implementation**

This paper presents a rehabilitation project concerning the settlement of a 35 year old building. The foundation system of the northwest wing of the building consists of strip footings and slab-on-grade. Differential settlement results in significant cracking of the masonry partition walls located on the footing and hence rehabilitation of the footing is required to stabilize the foundation system. Geotechnical and structural investigations are conducted, including site borings and analytical modeling based on one-dimensional consolidation theory that is incorporated into a finite element analysis. The predictive model exhibits that the differential settlement does not cause noticeable distress for the primary structural members, whereas the continued settlement affects use of the building. Site implementation is performed with the push-pile method to terminate the continuous settlement of the foundation.

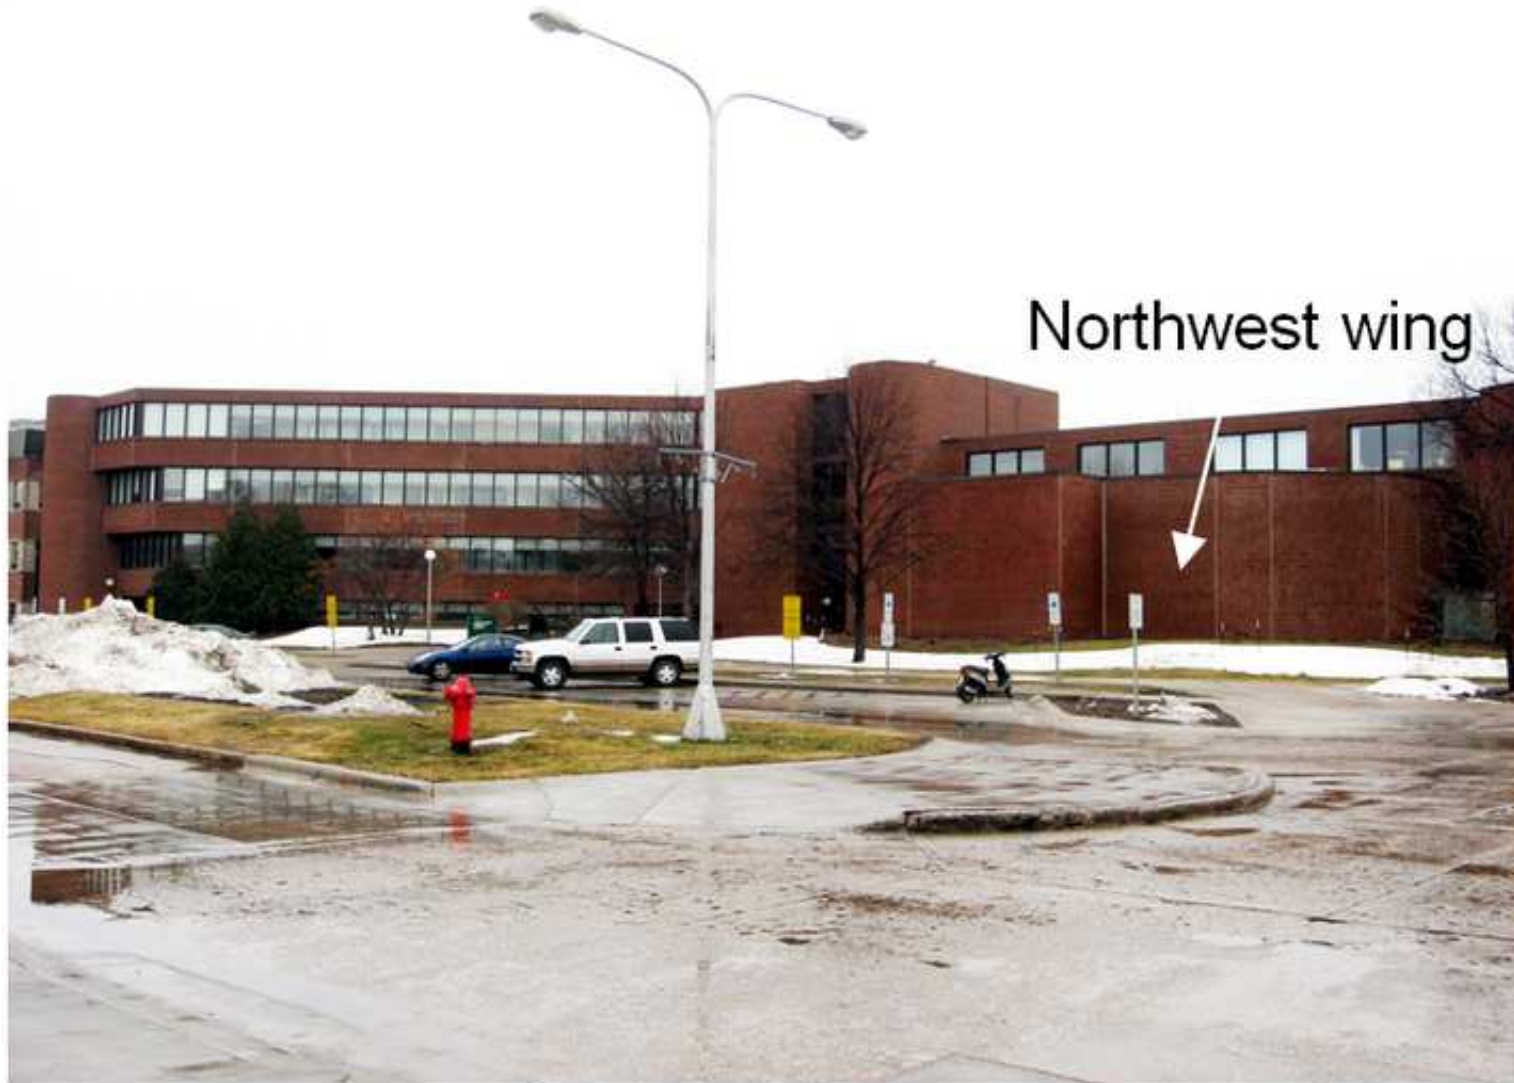
**Figure 1b**

**Fig. 1.** Details of the FLC building [unit in mm; 1 mm = 0.0394 in]: (a) site view; (b) plan view of the building; (c) overview of the foundation and slab of northwest wing

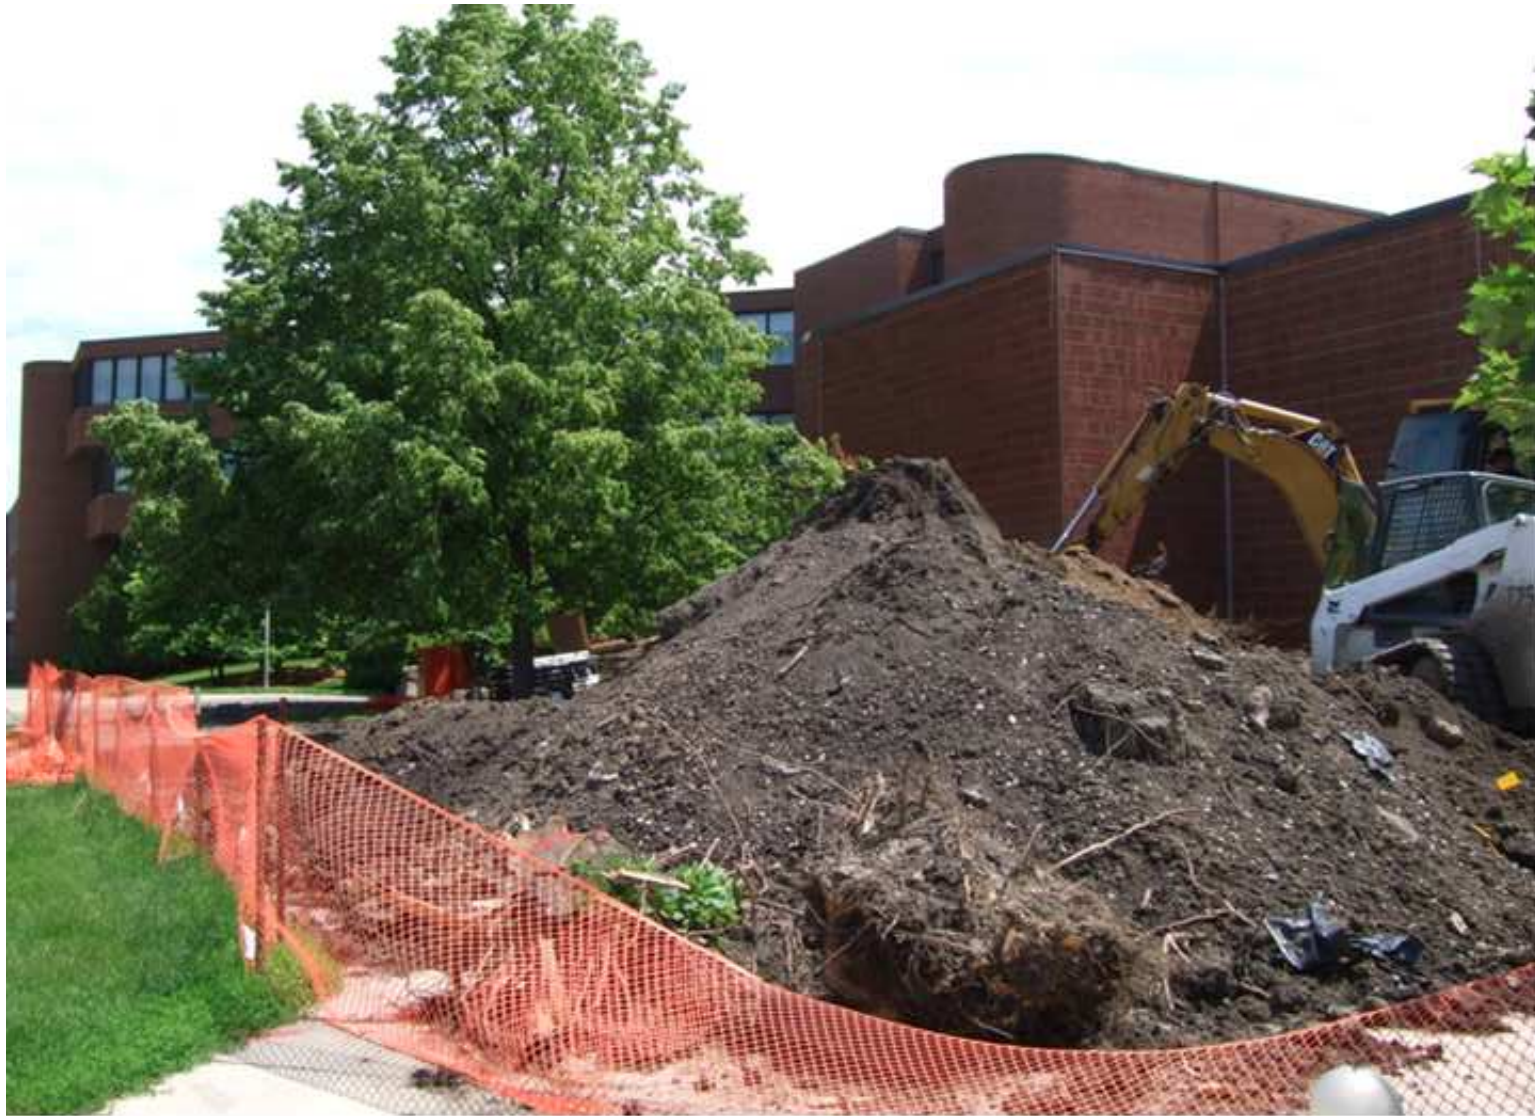
**Fig. 8.** Rehabilitation of the foundation: (a) excavation of the site; (b) exposed existing foundation; (c) installing steel casing; (d) completed foundation piles; (e) concrete grouting and overlay; (f) recovered site

Figure 8 shows the site implementation to stabilize the continuous settlement of the building. To install the push-piles, the site was excavated until the existing footing was exposed [Fig. 8 (a),(b)]. The push-pile system used here included a high-strength steel casing ( $\Phi = 150$  mm [6 in]) and a load transfer bracket tucked under the foundation pile cap that was designed to lift up the existing foundation during a jacking operation, as shown in Fig. 8(c). The foundation bracket was bolted to the existing footing and the pile was driven hydraulically into the soil. The steel casing, a spacing of 1.2 m [4 ft] on center, was continuously driven until a suitable load-bearing stratum was achieved (about 7.0 m [23 ft] below the foundation level) and the initial elevation of the foundation was restored. The pile was cut and the hydraulic jack was removed, as shown in Fig. 8(d). The loads of the building were then transferred to the rigid foundation through the push-pile system. The loads were partially resisted by the skin friction between the piles and clay

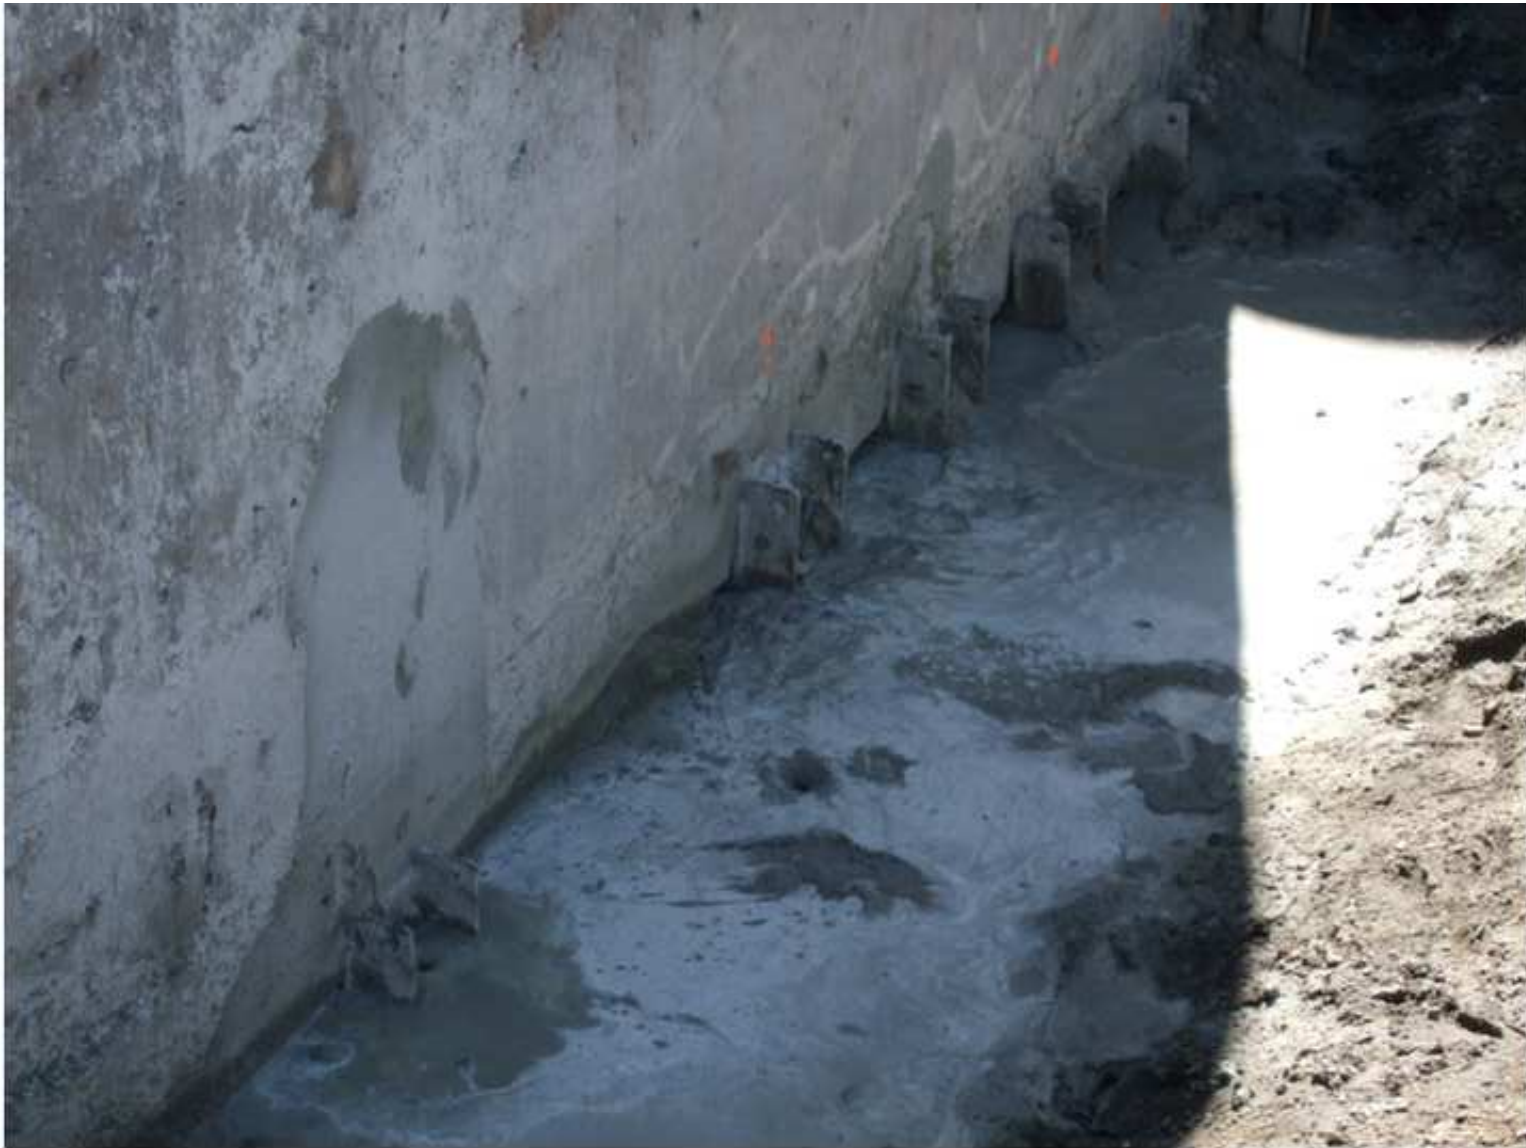
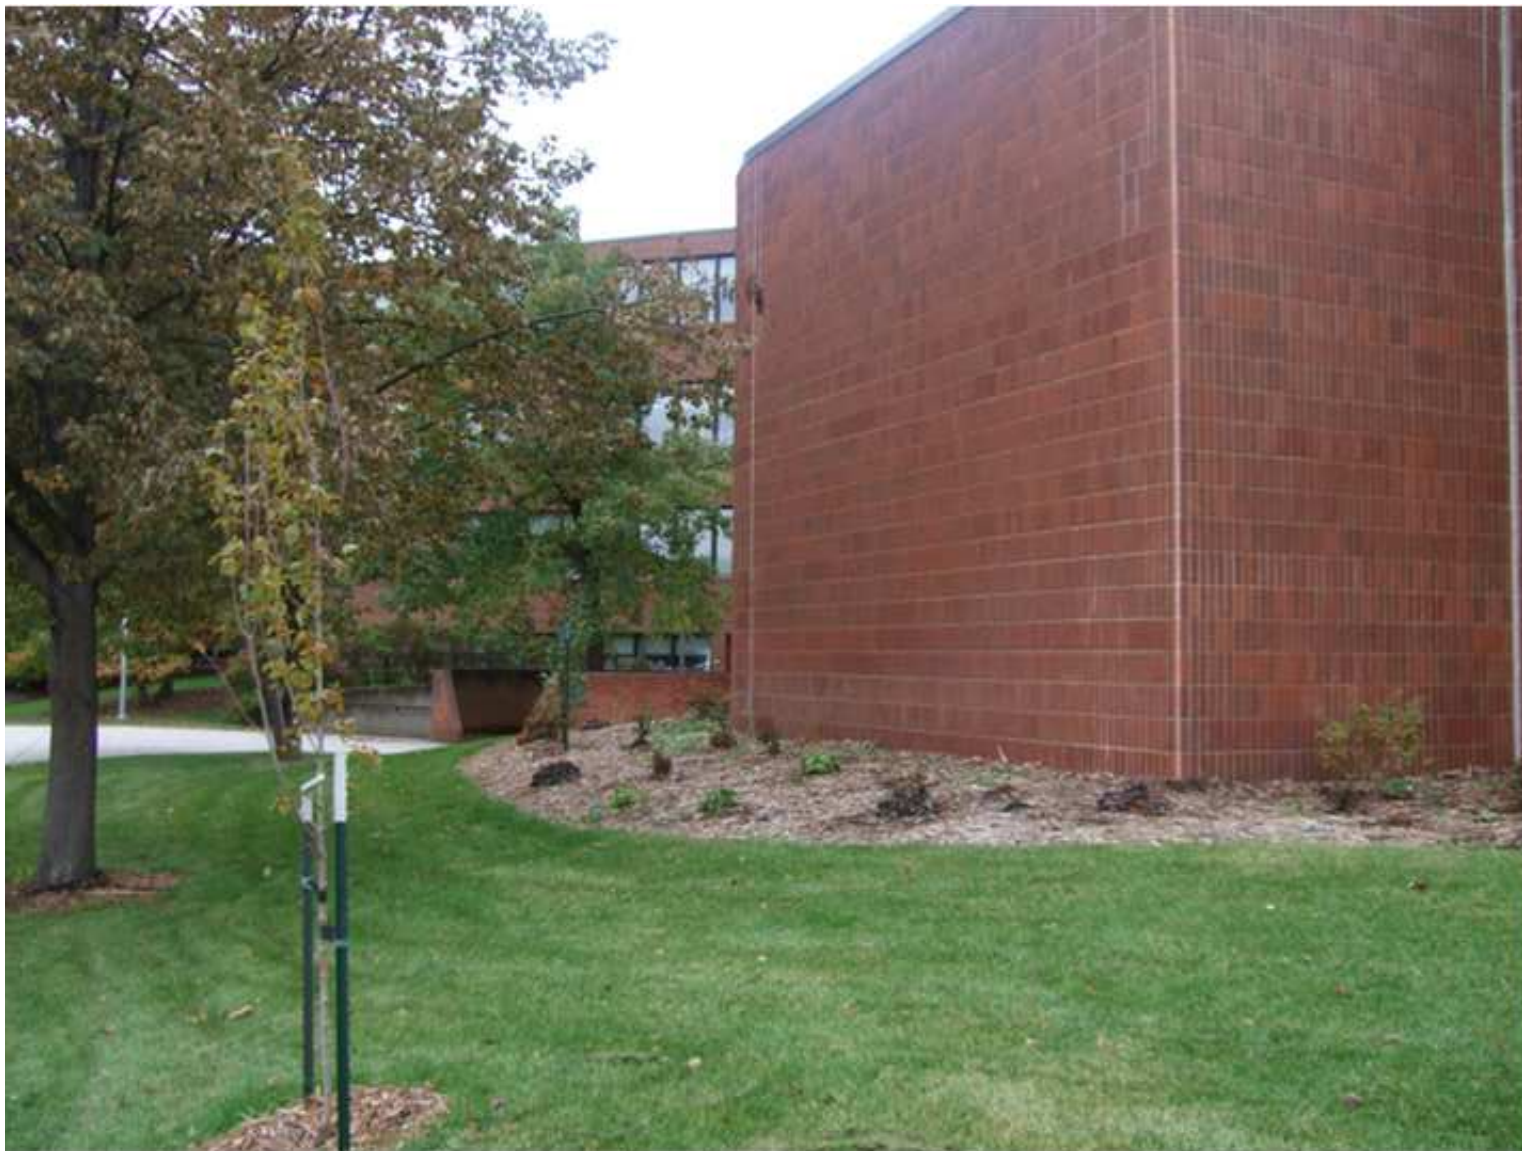
Bolted  
bracket

Embedded steel  
casing

(Fig. 2), given that the clay had already been consolidated to the applied stress level and the base resistance from the stiff clay layer was located beneath the Fat Clay layer. The piles were grouted to fill the void [Fig. 8(e)]. Upon completion of the push-pile system, the site was recovered, as shown in Fig. 8(f). After the rehabilitation work, the structural movement of the FLC building was terminated.
