AN ECONOMIC ANALYSIS OF STREAM RESTORATION IN AN URBAN
WATERSHED: AUSTIN, TEXAS

A Thesis

Major Subject: Water Management and Hydrological Science

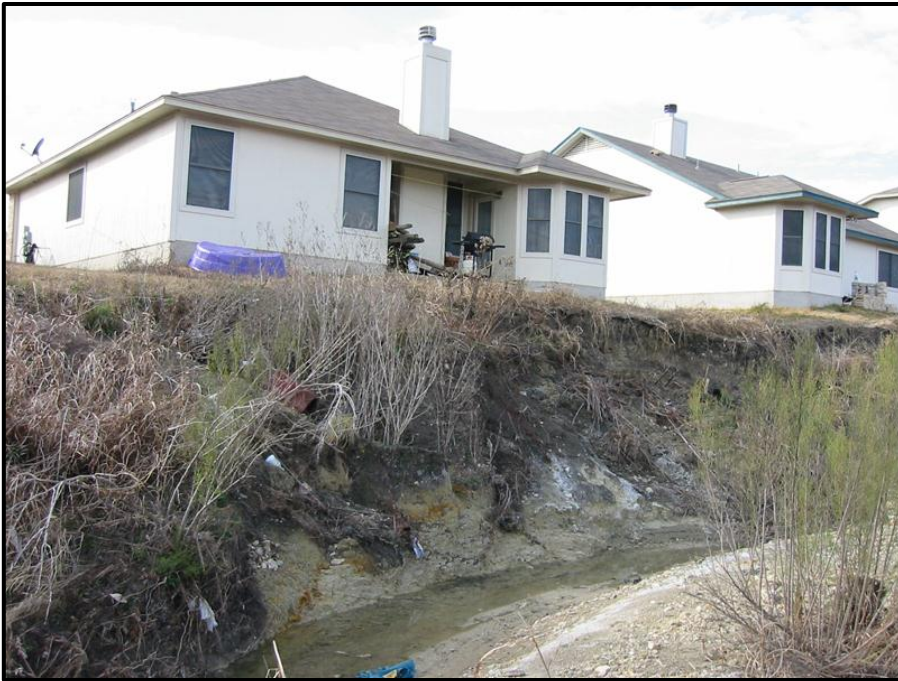
Figure 4. Houses adjacent to the eroded bank before restoration in 2003 (City of Austin).

The restoration project of the Walnut Creek tributary at Ritchie Drive took five months to complete. The goal of the restoration project was to protect residential properties adjacent to eroded stream banks (Figure 4). After the restoration (Figure 5), the banks were stabilized for a length of 300 feet along the stream channel with limestone blocks, vegetative soil layers, and vinyl netting to minimize erosion (Figure 6 and Figure 7, City of Austin, 2004).

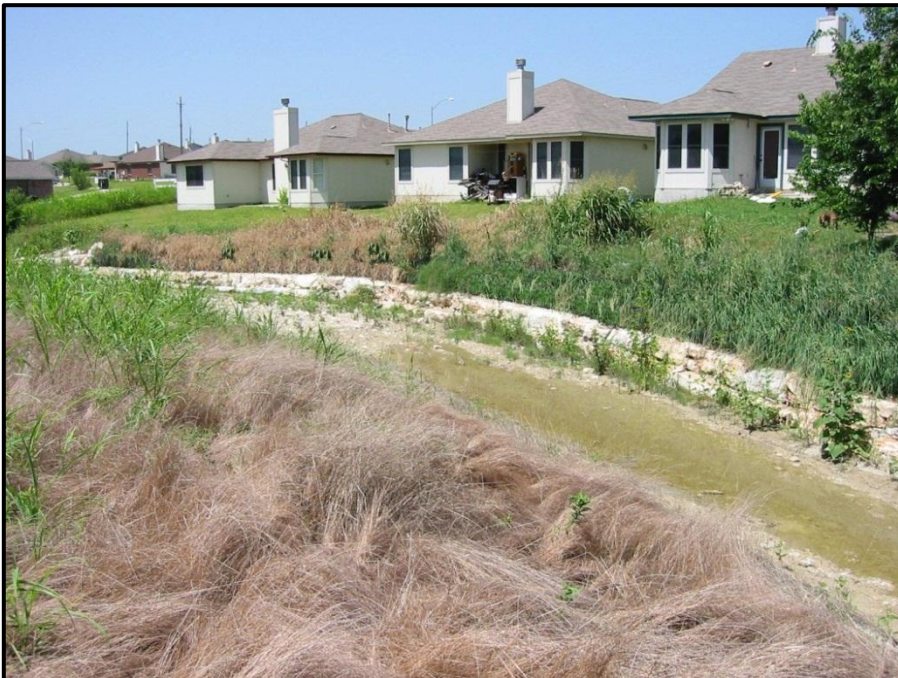
Figure 5. After stream restoration in 2008 (City of Austin).

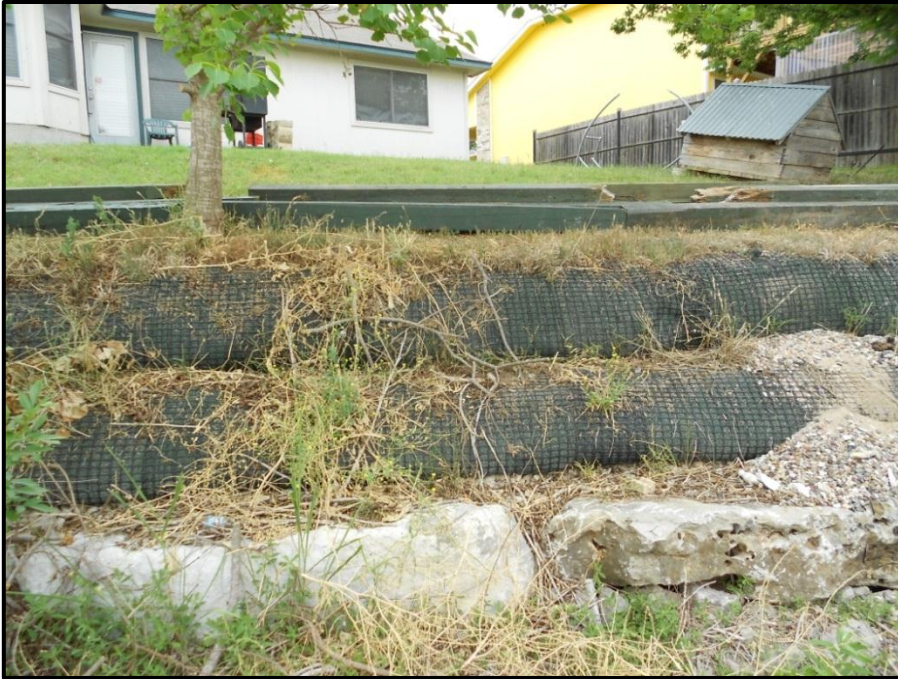
Figure 6. The bank was stabilized with rocks, vegetative layers, and soils.

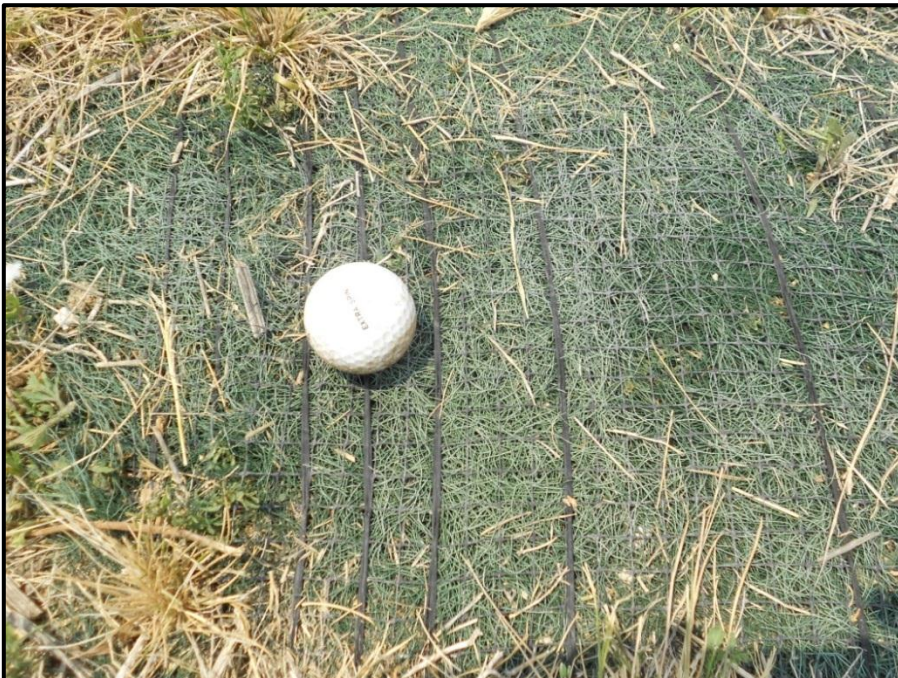
Figure 7. Vinyl netting to minimize erosion problem.

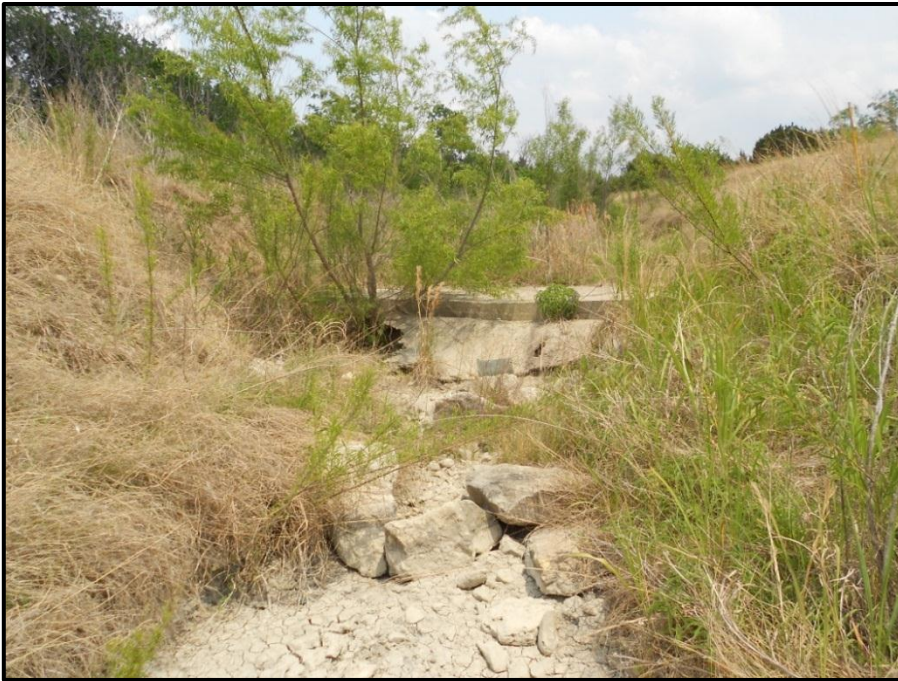
Figure 8. Front view of limestone rock riffle covered the petroleum pipeline, after restoration, 2011.

Furthermore, the bank opposite the houses was graded to a stable slope and revegetated with native grasses (City of Austin, 2004). In addition to bank stabilization and channel grade control, a natural thalweg was constructed along the channel and with portions of the stream bed being filled (City of Austin, 2004). Lastly, an exposed petroleum pipeline in the area was covered with a limestone rock riffle both for protection of the pipeline as well as an attempt to enhance the aesthetics of the stream beauty (Figure 8 and Figure 9).

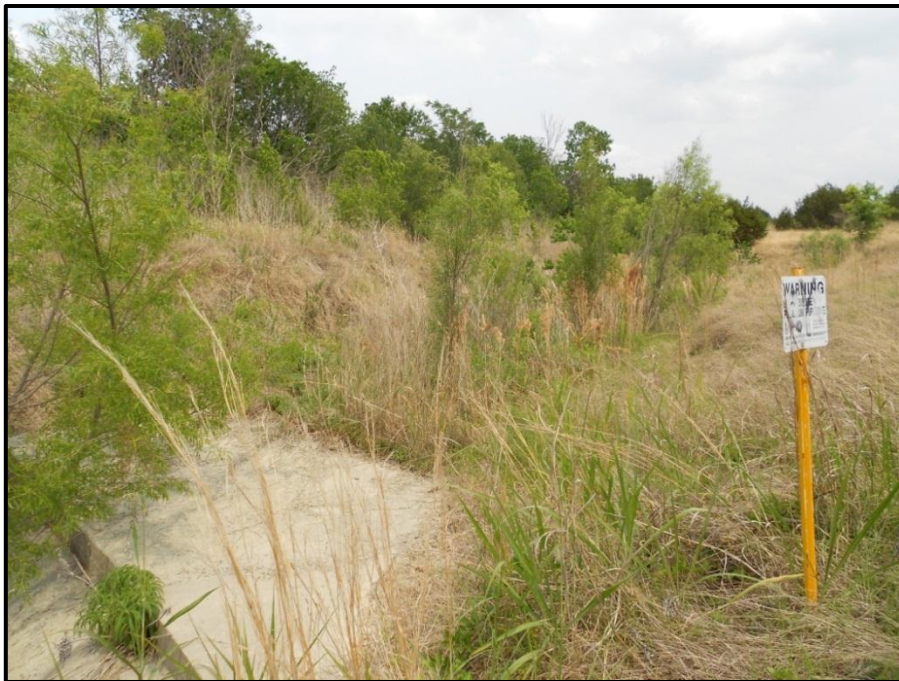
Figure 9. Side view of limestone rock riffle covered the petroleum pipeline, after restoration, 2011.

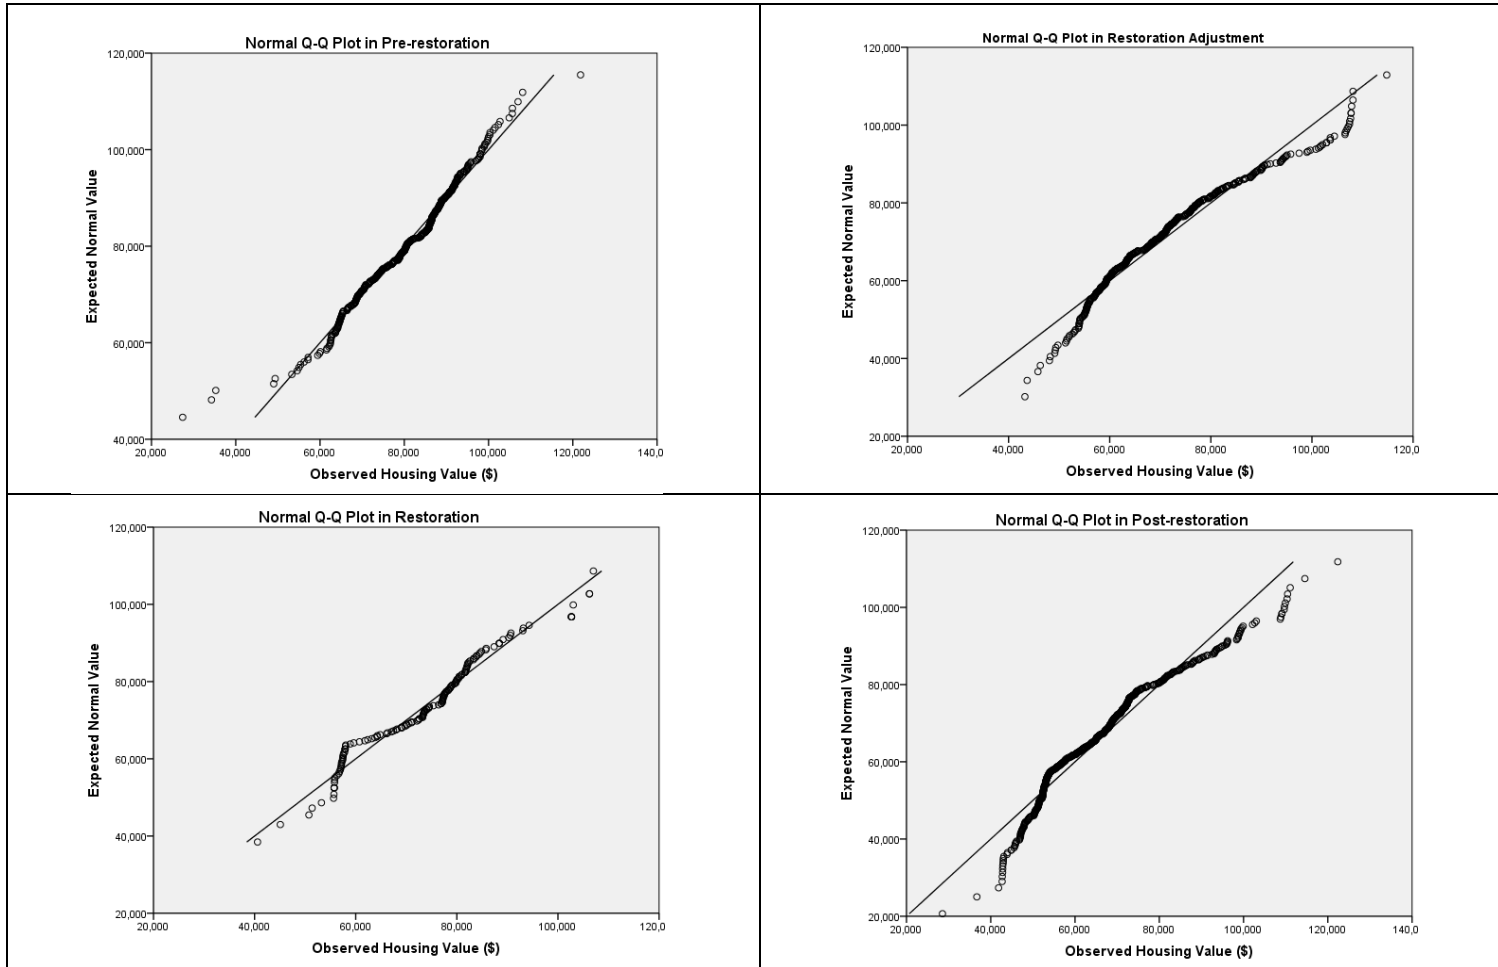
Figure 11. QQ-plots of housing values from pre-restoration to post-restoration.

- (1) The dependent variables of housing values were normally distributed. We checked for the normal distribution with a Q-Q plot from pre-restoration to post-restoration (See Figure 11).
- (2) Equal or unequal variances of the two groups were determined by the Levene's test. The results were presented in section 5.3.
- (3) The two groups of houses were independent of one another.

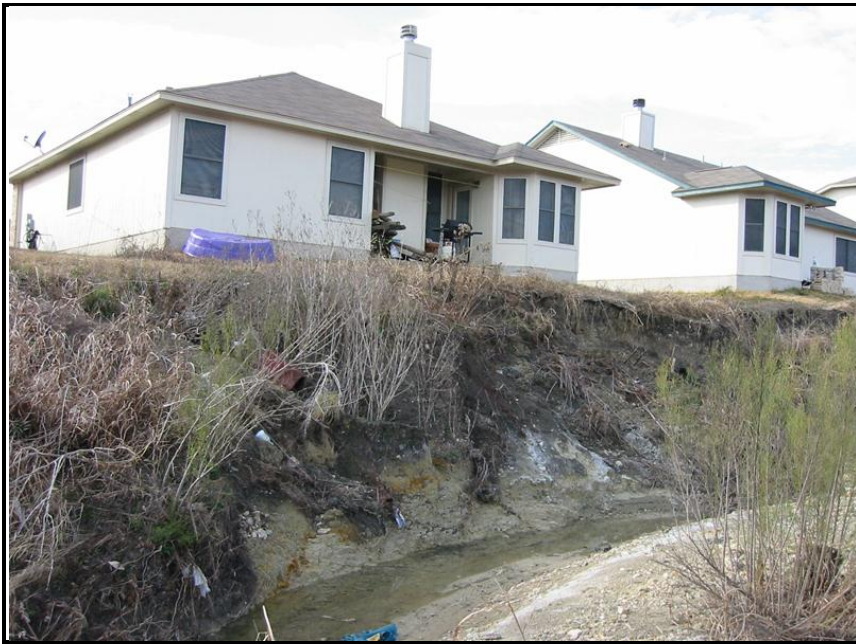
Figure A-1. Walnut Creek at 7315 Ritchie Drive before restoration in February 2003 (City of Austin, 2003).

To assess the stream conditions along the eroded banks during the periods of pre-restoration and post-restoration, repeat ground photography was used to study the visual changes of restored stream banks of the Walnut Creek tributary. Repeat ground photography can document temporal and spatial changes of stream conditions (Rasmussen and Voth, 2001). Meier (2008) applied repeat ground photography to analyze and evaluate stream stability of Waller Creek and Tannehill Branch in Austin, Texas. To show the current condition of the restored stream in this study, photographs were taken based on the techniques of repeat ground photography. Photography taken before the restoration was obtained from the City of Austin. Photographs from before and to after the restoration were presented in the Appendix A.
