**POST-IRRADIATION EXAMINATION
OF THE FUEL ROD CART-C1 N° 4**

A. FRIGO, R. KLERSY, K.H. SCHRADER, A. SCHÜRENKÄMPER
(EURATOM)
A. BENVENUTI, G. CAMONA and F. MANTEGA
(CISE)

Joint Nuclear Research Centre
Ispra Establishment - Italy

POST-IRRADIATION EXAMINATION
OF THE FUEL ROD CART-C1 N° 4

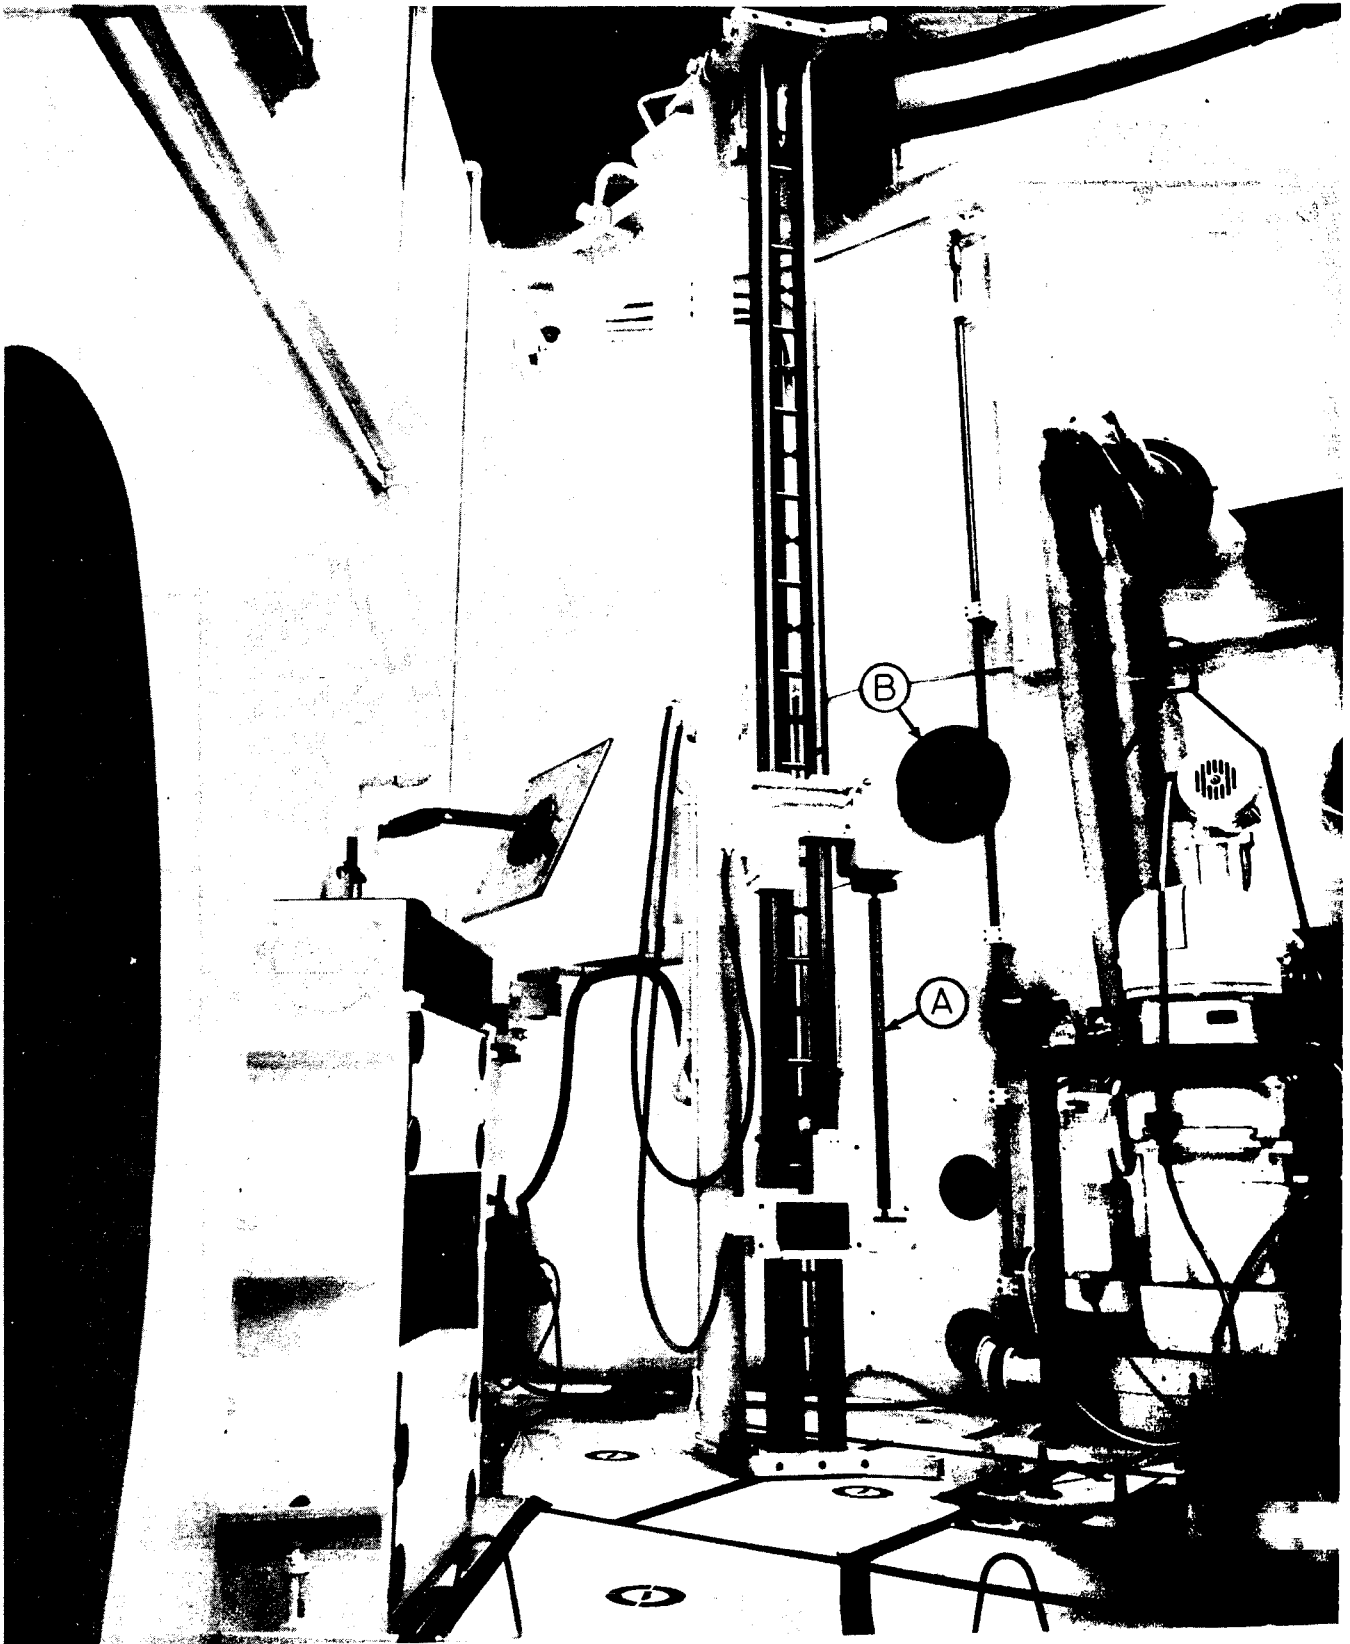
Fig.1 - Gamma-scanning equipment

A : fuel element

B : collimator

The used apparatus consists of a mechanical part installed inside the hot cell (Fig. 1), a collimator system mounted in the concrete wall of the cell and the equipment for gamma-ray analysis outside the cell. An electronic control unit allows to run measurements automatically following a preselected program for the displacement of the fuel rod and for counting time. In the described experiments the fuel rod was rotating during counting but in a fixed position with regard to the axial direction. A cylindrical collimator with a diameter of 1 mm was used. The total gamma-activity in the energy range from 100 to 2.500 KeV has been measured in steps of 0.5 mm using a NaI-crystal. The gamma-spectre have been measured each 20 mm using a Ge-Li crystal.

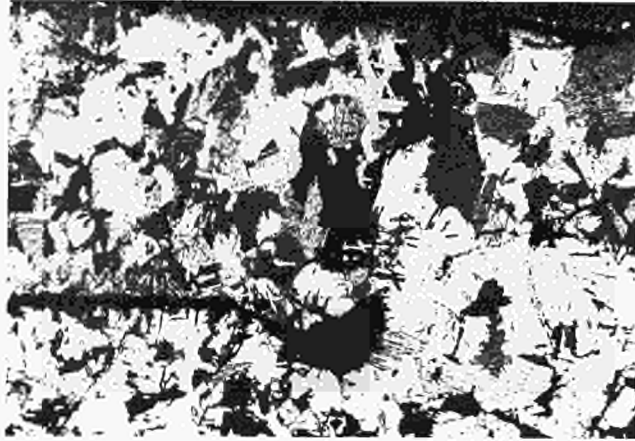
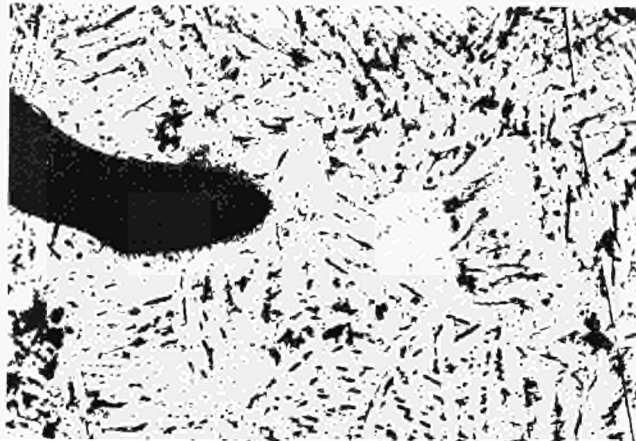
FIG. 18 - Welding zone of the plug.

a : polarized light

b : bright field

Fig. 18a shows the welding zone of the plug in polarized light. The junction appears perfect. The interface of the two original pieces can be recognized due to the presence of small needle shaped grains. In bright field observation no interface at all could be detected (fig. 18b).
