## Application of Rosgen's BANCS model for NE Kansas and the development of predictive streambank erosion curves

Christopher K. Sass, Tim D. Keane

**Citation:** Sass, C. K., & Keane, T. D. (2012). Application of Rosgen's BANCS model for NE Kansas and the development of predictive streambank erosion curves. *Journal of the American Water Resources Association*, 48(4), 774-787.

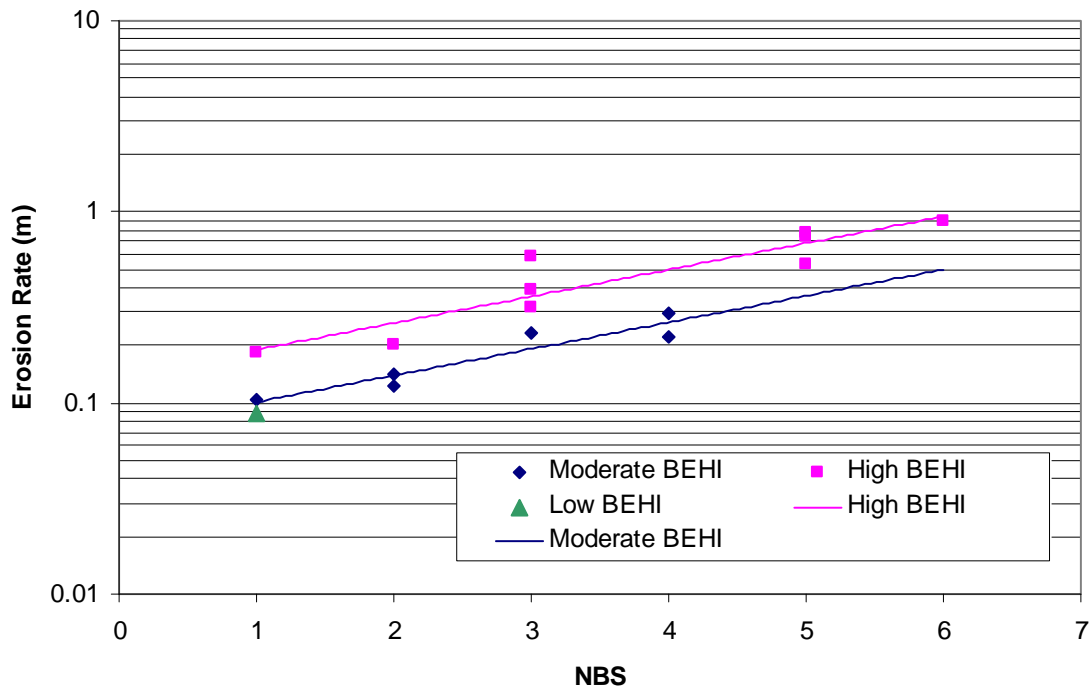
**Figure 13. Adjusted BEHI-NBS erosoin prediction curves for Northeast Kansas. Vegetation modification of 2.5 or 8.5 is included in this edition of curves. Moderate BEHI (Blue) R<sup>2</sup> 0.88 (6 data points) while High BEHI (Magenta) R<sup>2</sup> 0.84 (9 data points) Low (1 data point).**

Note: High BEHI slope :  $y=0.1378e^{0.3213x}$  ; Moderate BEHI slope :  $y=0.0736e^{0.3195x}$  .

As noted in Table 8, 13 of the 18 study banks changed BEHI ratings. Of those, 11 adjective ratings decreased while two increased in erosion hazard. Figure 13 illustrates the changes to the predictive erosion curves utilizing the new BEHI ratings according to vegetation adjacent to the streambank.
