MEASUREMENT THE THERMAL PROFILE OF STEELMAKING LADLE WITH SUBSEQUENT EVALUATION THE REASONS OF LINING DAMAGE

Based on the operational measurement, of which content was to determine ladle thermal profile, there were analysed causes of possible damage of lining in steel ladles by steel breakout through the ladle shell. There exists connection between thermal state of ladle lining during the operation and its lifetime. There were reached to the conclusion that the cause of failure in the lining of ladle is except for high temperature of bath, also wide interval of temperature change during the tap operation, in consequence with possible insufficient pre-heating of ladle, discontinuous operation of aggregate and damage of insulating lining layer, respectively deformation of ladles shell.

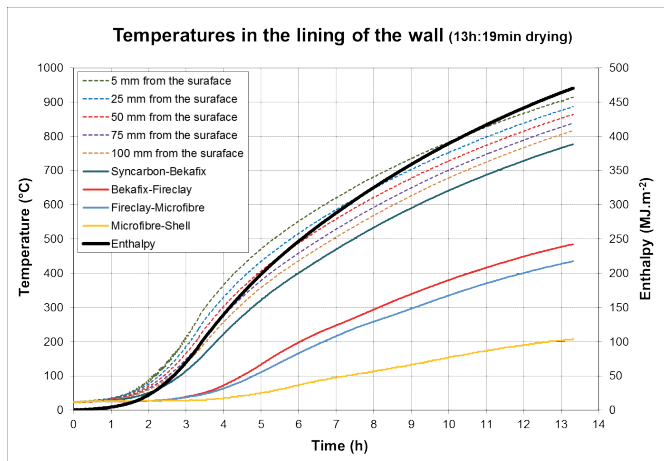
Fig. 1. Temperatures inside the ladle lining during the drying process

Temperature course of ladle lining was plotted into a several graphs. In Fig. 1, there are presented temperatures inside of lining during the drying process of ladle lining before the 1st tapping. Fig. 2 shows detailed view of the 1st melting.

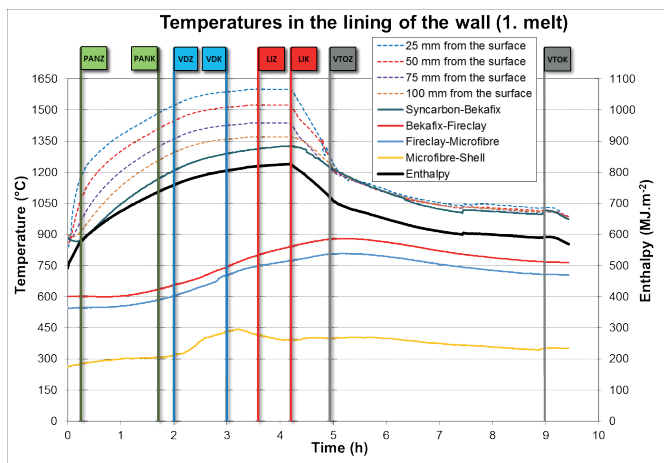
Fig. 2. Detailed view on 1st melt

Explanation of particular abbreviations from Fig. 2:

- PANZ (PANK) - start (end) of steel processing in ladle furnace
- VDZ (VDK) - start (end) of steel processing in cofferdam
- LIZ (LIK) - start (end) of casting
- VTOZ (VTOK) - start (end) of ladle high-temperature heating

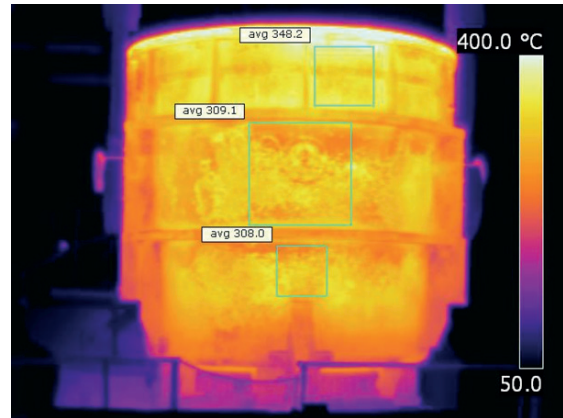
Fig. 3. Thermovision view of ladle

Afterwards the measurement of surface temperatures of ladle took place by the thermovision camera FLIR ThermaCAM P25 with adjustable emissivity on value 0.95. The measurement of surface temperatures is insufficient for the purposes of calculation the thermal losses realized by furnaces wall and for calculation of steel cooling speed during

the tap age. Measurement by thermovision camera was focused on evaluation the shells temperature in dependence on ladle working time.

Fig. 3 presents thermovision view to ladle immediately after its taking out of the vacuum station cofferdam.

Temperature at ladle shell inner side was measured during first 5 circulation cycles by thermocouple, outer side was measured by pyrometer. There was measured maximum temperature of shell inner side 485.5°C and outer side 351°C (no measured during vacuum process, when the shell temperature will be much higher, because of ladle closing in cofferdam) during the monitored period. The highest shell temperatures in the ladle are recorded in the course of vacuum
