BORE POLISHING OF DIESEL ENGINE CYLINDER LINERS

A Thesis submitted as partial fulfilment
of the requirement for the degree of

DOCTOR OF PHILOSOPHY
Brunel University, West London

G.F. AL-KHALIDI, B.Sc., M.Phil.

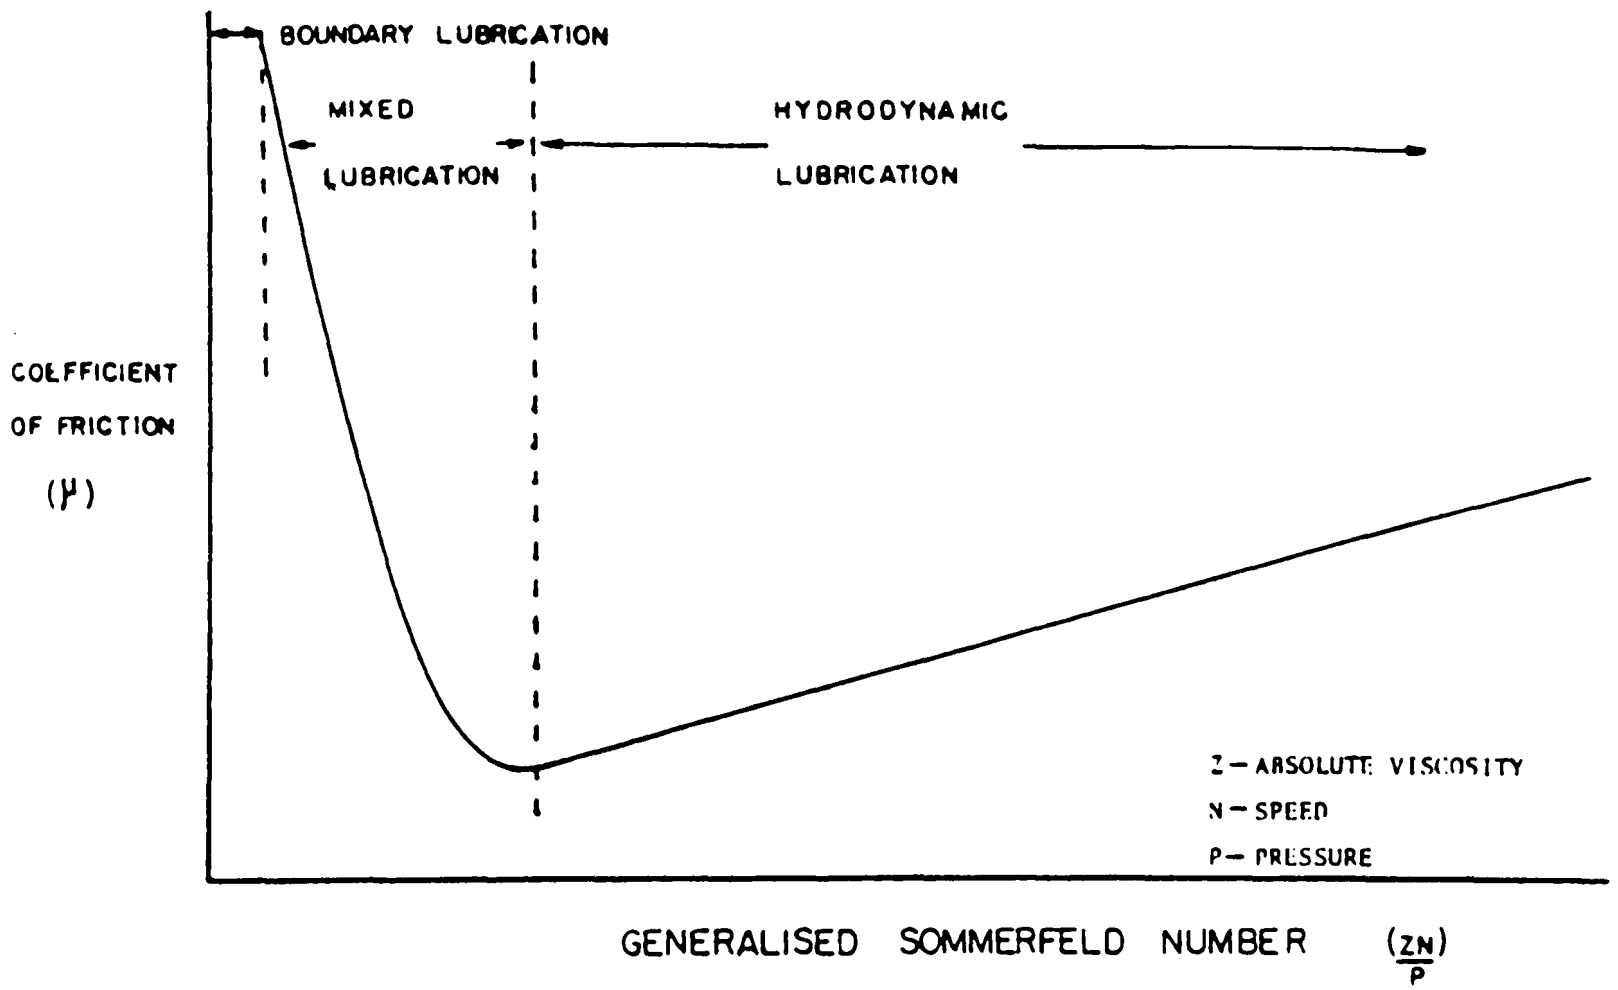
Fig.4 Stribeck curve. (Reference 34)

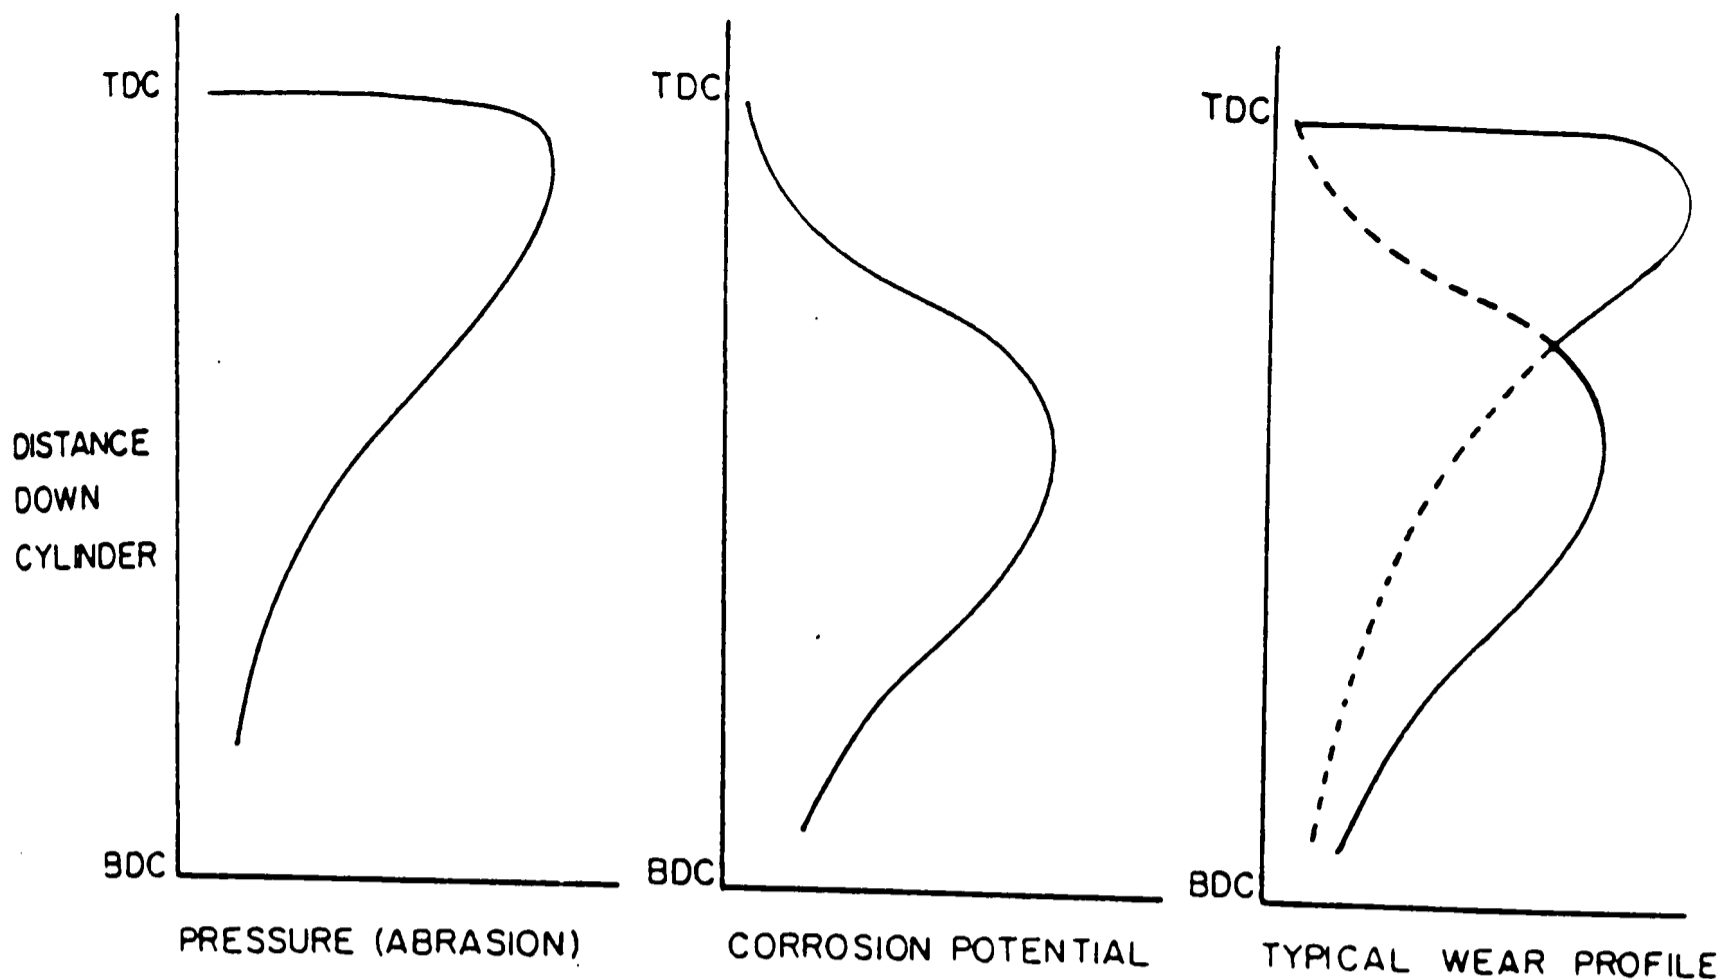
Fig.10 Liner wear profile down the engine stroke resulting from abrasion and corrosion. (Reference 61)

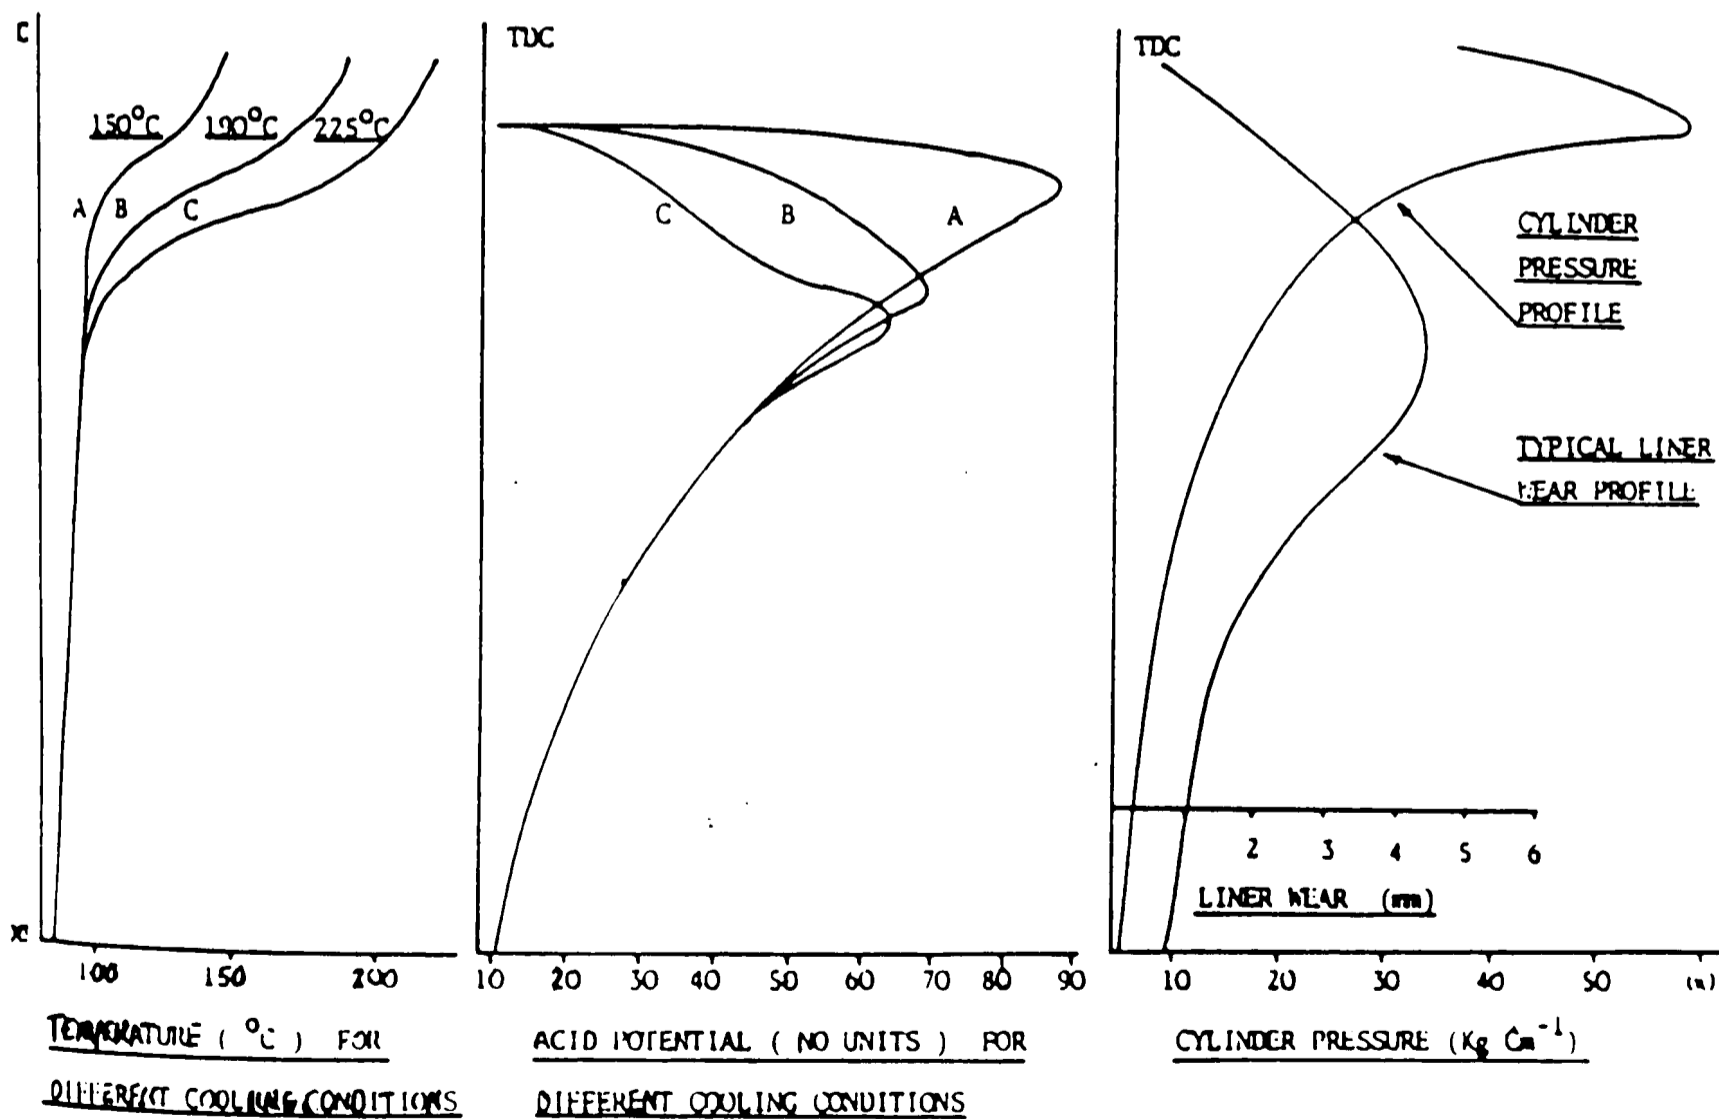
Fig.11 Temperature, corrosion potential, gas pressure and liner wear profile for an engine running on a 3.0% sulphur residual fuel. (Reference 63)

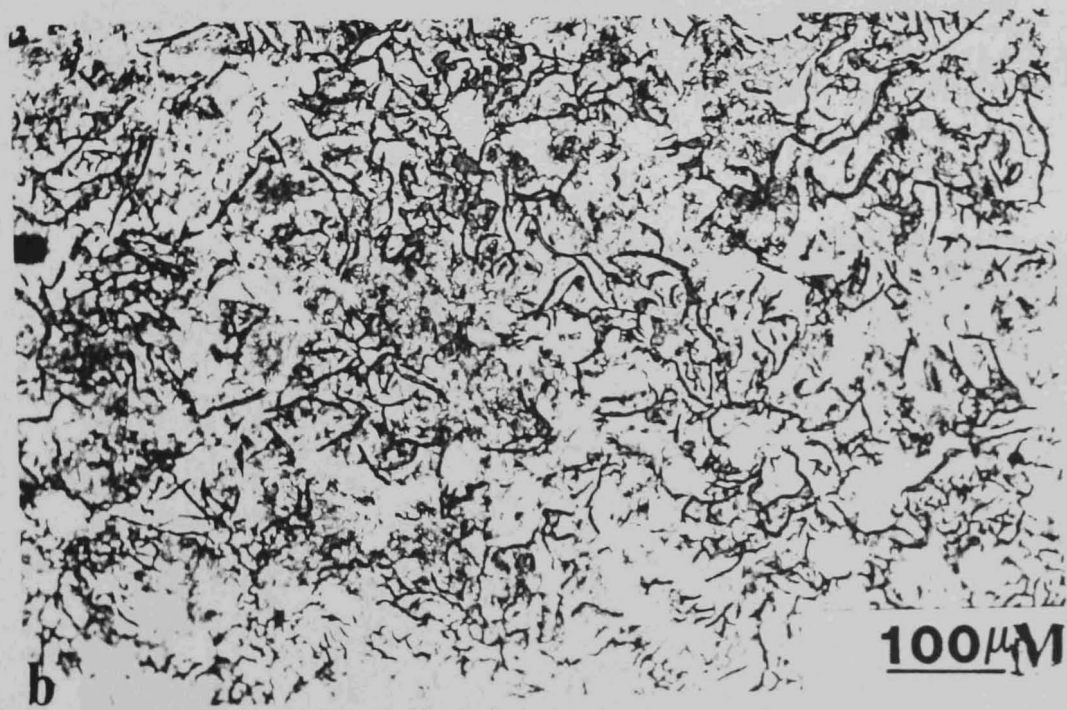
Fig. 29 Microstructure of the liner:
a) Unetched
b) Etched

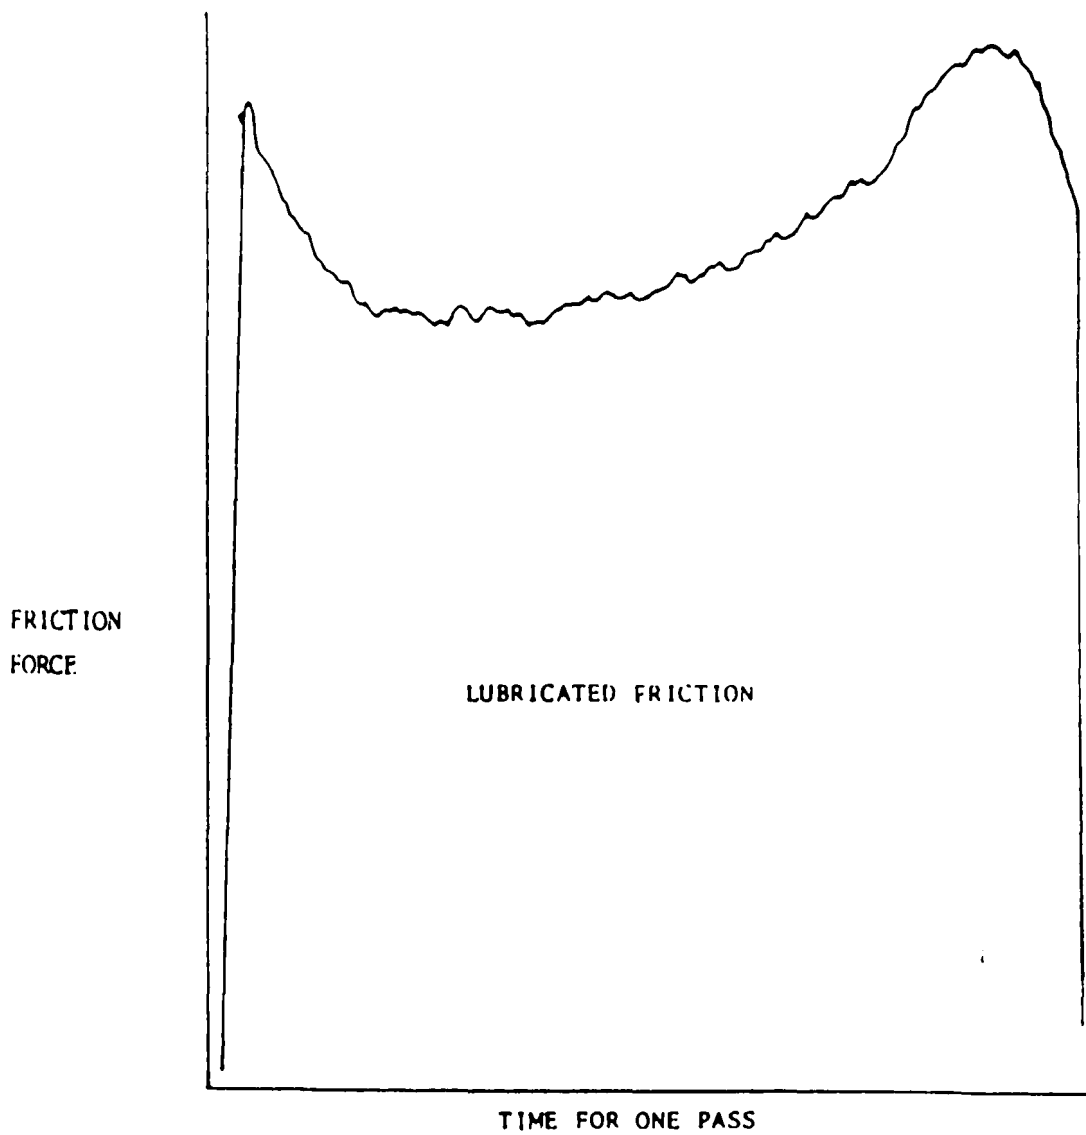
Fig.44 Oscilloscope trace of friction force over one pass during equilibrium wear (load = 900N).

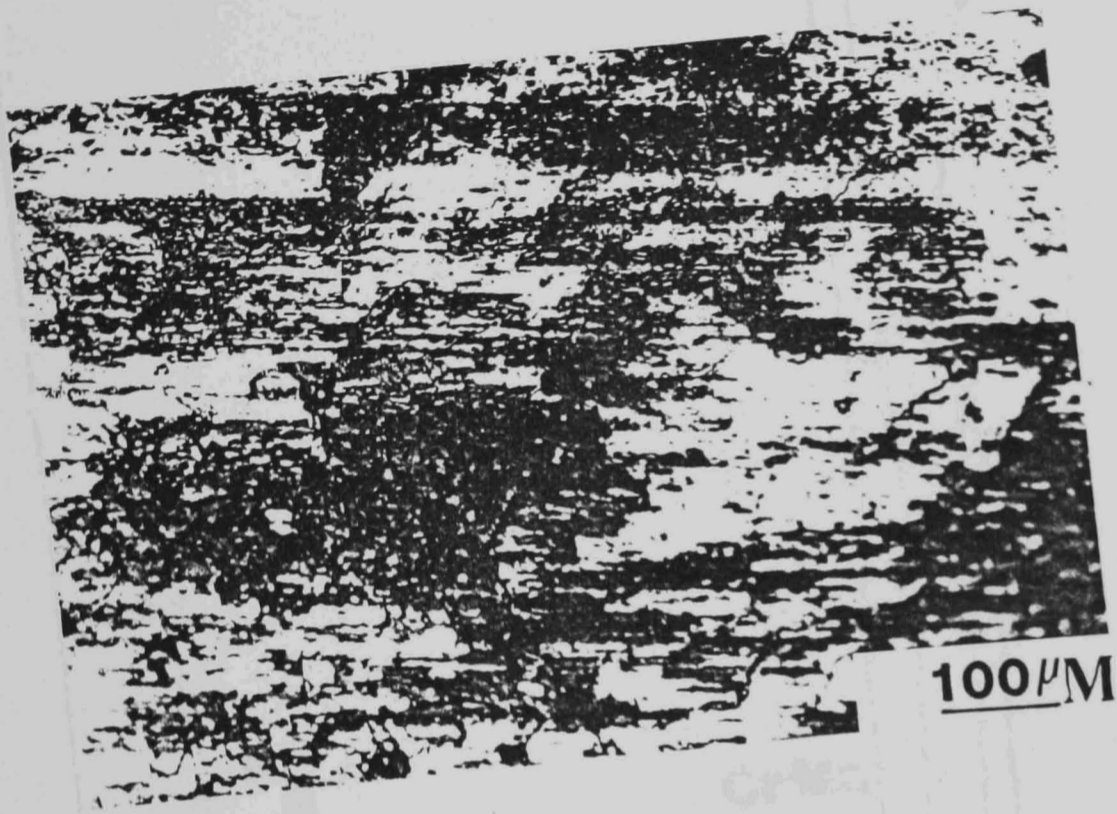
Fig.70 Deposit on the wear track for the worn flat.
