Does a micro-grooved trunnion stem surface finish improve fixation and reduce fretting wear at the taper junction of total hip replacements? A finite element evaluation

Ariyan Ashkanfar, David J. Langton, Thomas J. Joyce

To appear in: *Journal of Biomechanics*

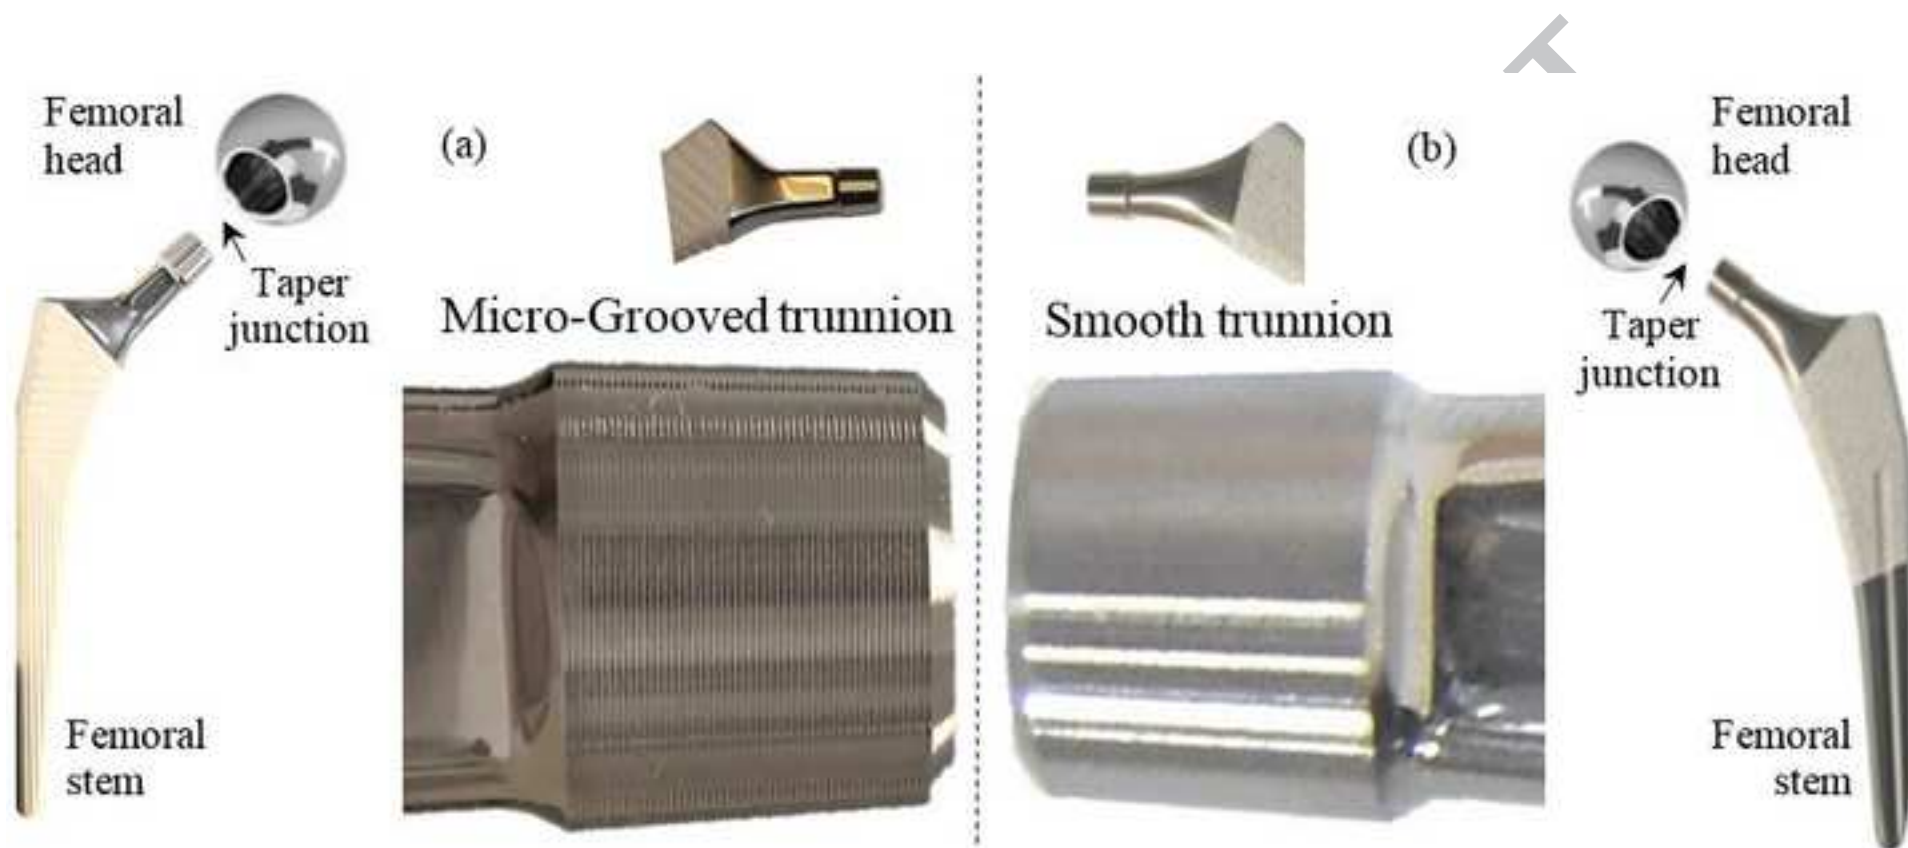
Figure 1: CoCr femoral head and Ti femoral stem of THRs; 36mm femoral head with smooth taper surface finish mated with femoral stems with (a) micro-grooved trunnion stem and (b) smooth surface finish.

The use of separate components (modularity) in total hip replacements (THR) is very common, allowing flexibility intra-operatively to facilitate optimum prosthetic functionality and anatomical fit for individual patients. In addition, modularity allows the use of different materials for different components – e.g. cobalt-chromium (CoCr) for femoral heads due to good wear properties, and titanium (Ti) for femoral stems in order to encourage bone ingrowth. On the femoral side of a THR, the modular connection involves a taper junction between the femoral stem (trunnion) and the internal taper of the femoral head (see Figure 1).

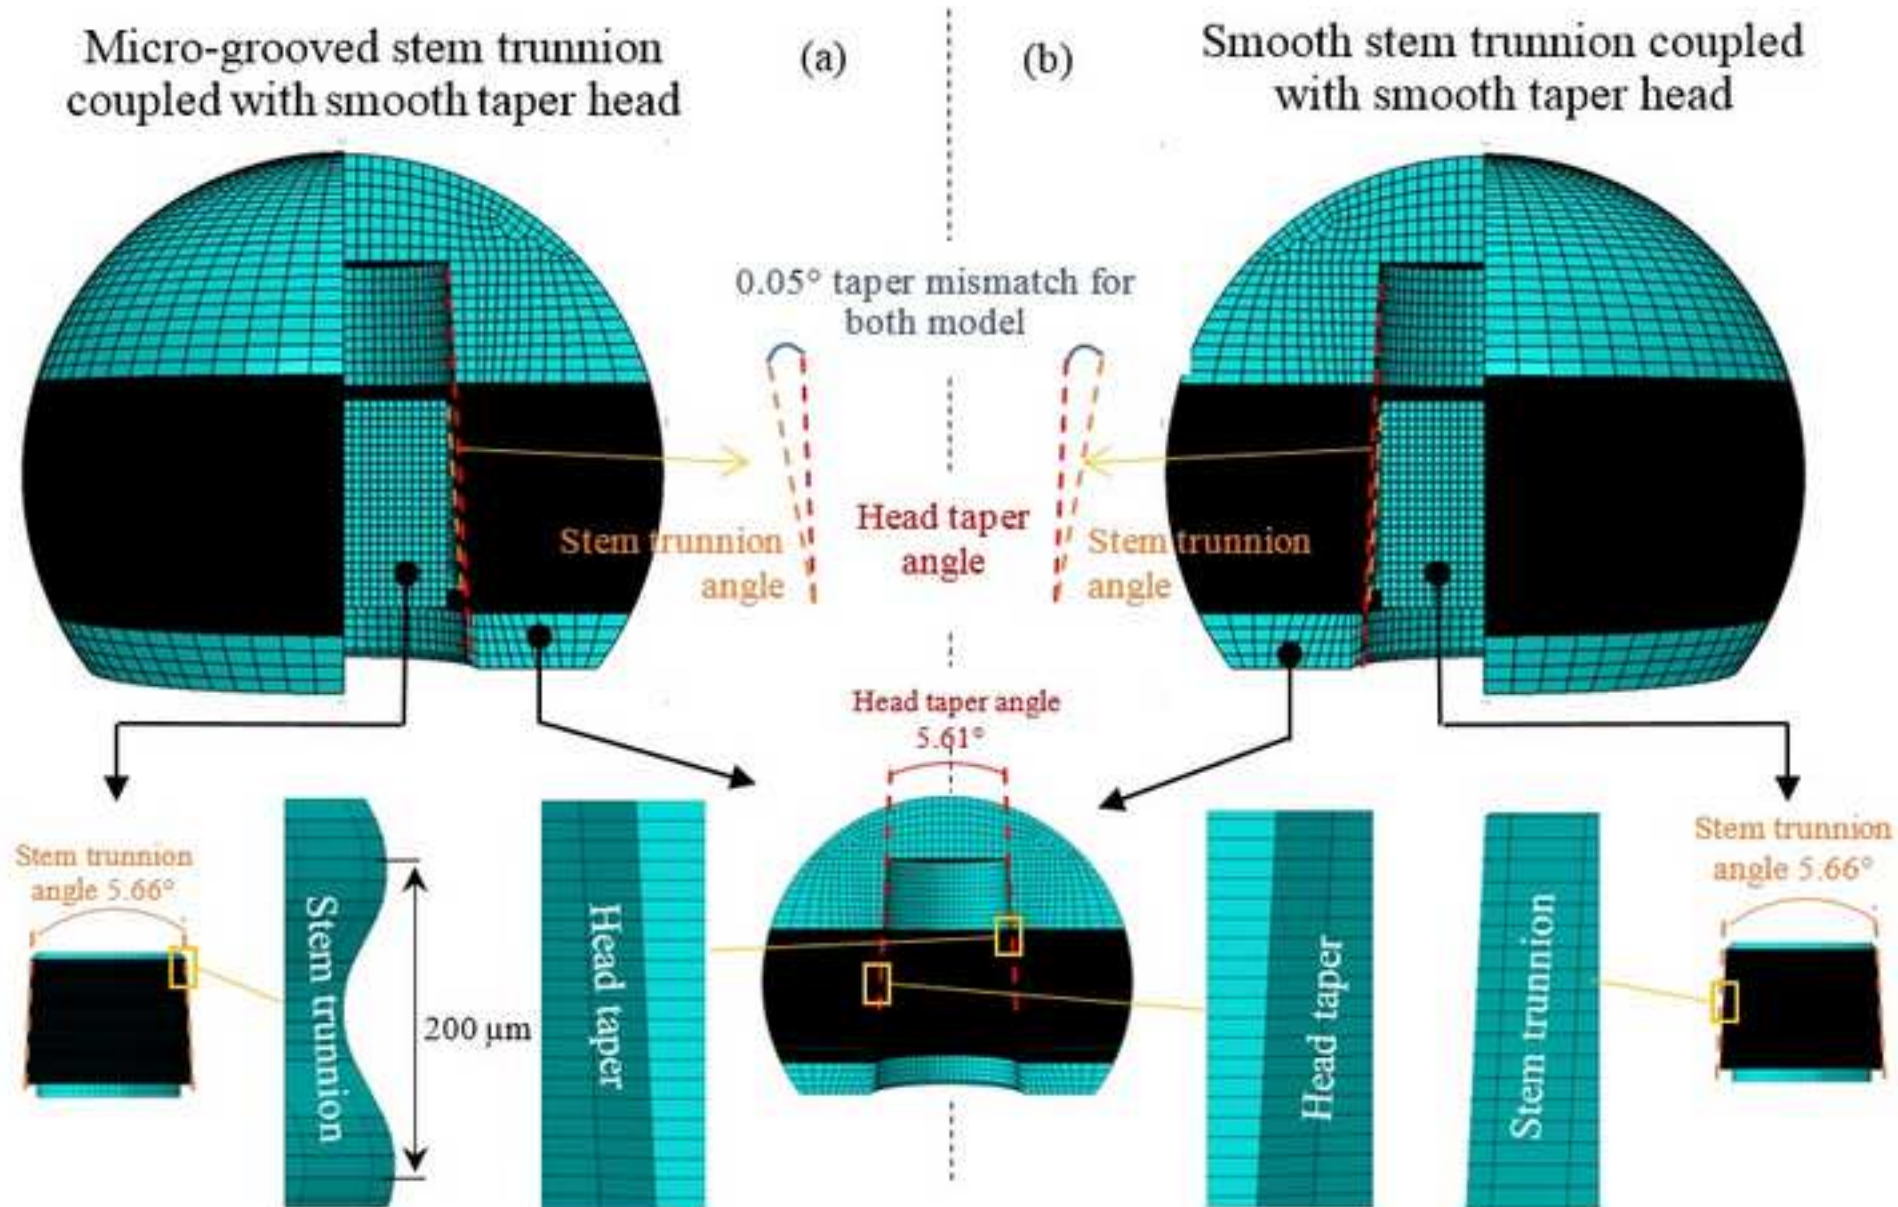
Figure 2: FE model and mesh distribution of the head and stem of THRs; smooth femoral head taper mated (a) with micro-grooved trunnion stem with 200 μ m spacing (Munir et al., 2015) and (b) with smooth trunnion stem; 5°36' head taper angle (in red) and 5°39' stem trunnion angle (in orange) (Brock et al., 2015) produced 3' base-locked taper mismatches for both models.

Two femoral stem FE models, one with machined micro-grooves and the other with a smooth trunnion surface finish, both coupled with a 36 mm diameter CoCr femoral head with a smooth taper surface finish, were modelled in ABAQUS (6.14-3 ABAQUS Inc) (see Figure 2). A base-locked taper mismatch – where the taper and trunnion surfaces engaged at the base of the interface – of 3' between taper and trunnion was selected (see Figure 2) (Ashkanfar et al., 2017). The key difference between the models was the trunnion surface roughness as shown in

Figure 2.

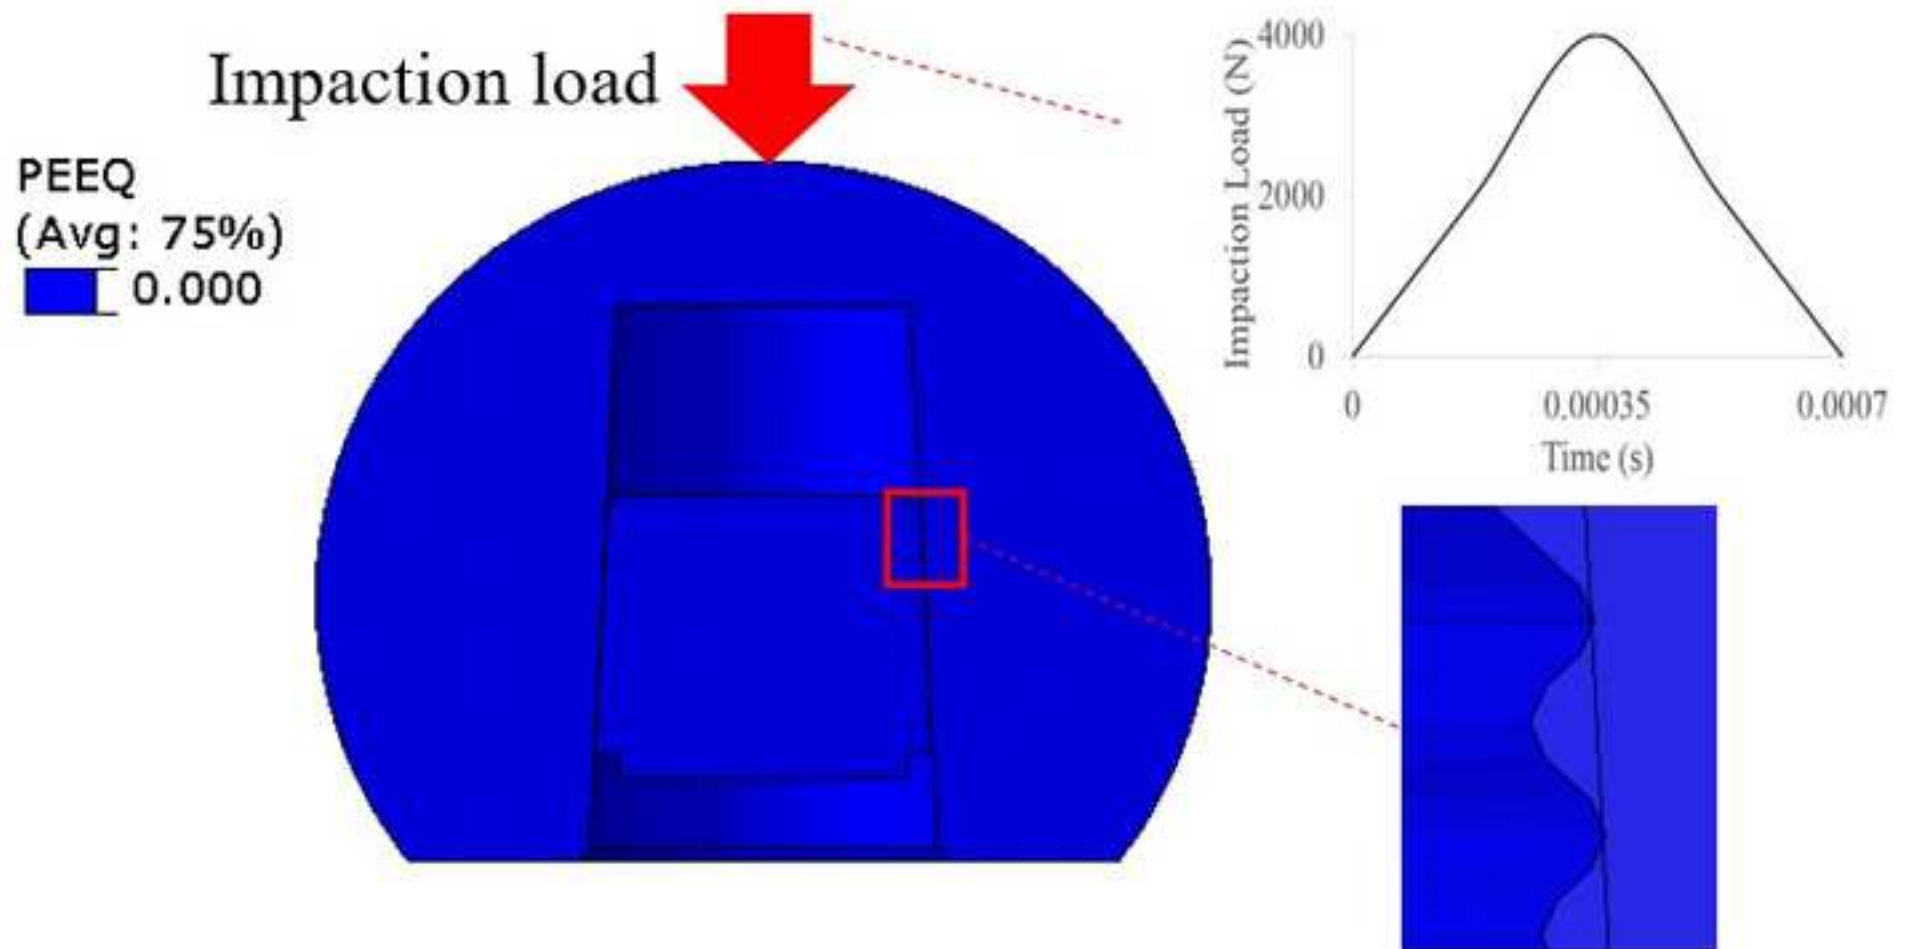
Figure 3: Equivalent Plastic Strain (PEEQ) showed no plastic deformation at the grooves of the femoral trunnion stem associated with FE initial impactation Elastic-Perfectly Plastic analysis

The impaction analysis was executed as a dynamic implicit analysis (see (English et al., 2016) and Figure 3 for full details). Furthermore, in this study, the plasticity included in the FE impaction analysis and simulated as an FE Elastic-Perfectly Plastic analysis, was undertaken to investigate whether any plastic deformation of the micro-grooves would occur due to the initial assembly force.

During the impact analysis, 4kN impact load with the load time history as shown in Figure 3 was applied on the top of the femoral head. The overall aim of machining grooves onto the stem trunnion stem is said to be that the grooves enhance the fixation at the taper junction (Munir et al., 2015). However, in this study, the result showed no Equivalent Plastic Strain (PEEQ, ABAQUS field output) as illustrated in Figure 3. Figure 6 details the contact pressure distributions along the trunnion surfaces. As expected, the maximum contact pressure was localised at the distal edge of the models due to the base-locked taper mismatches. The maximum contact pressures were approximately 196 and 385 MPa for smooth and micro-grooved trunnion surfaces respectively. These stresses illustrate that no plastic deformation could possibly occur based on the initial impact assembly load for CoCr/Ti material combination.

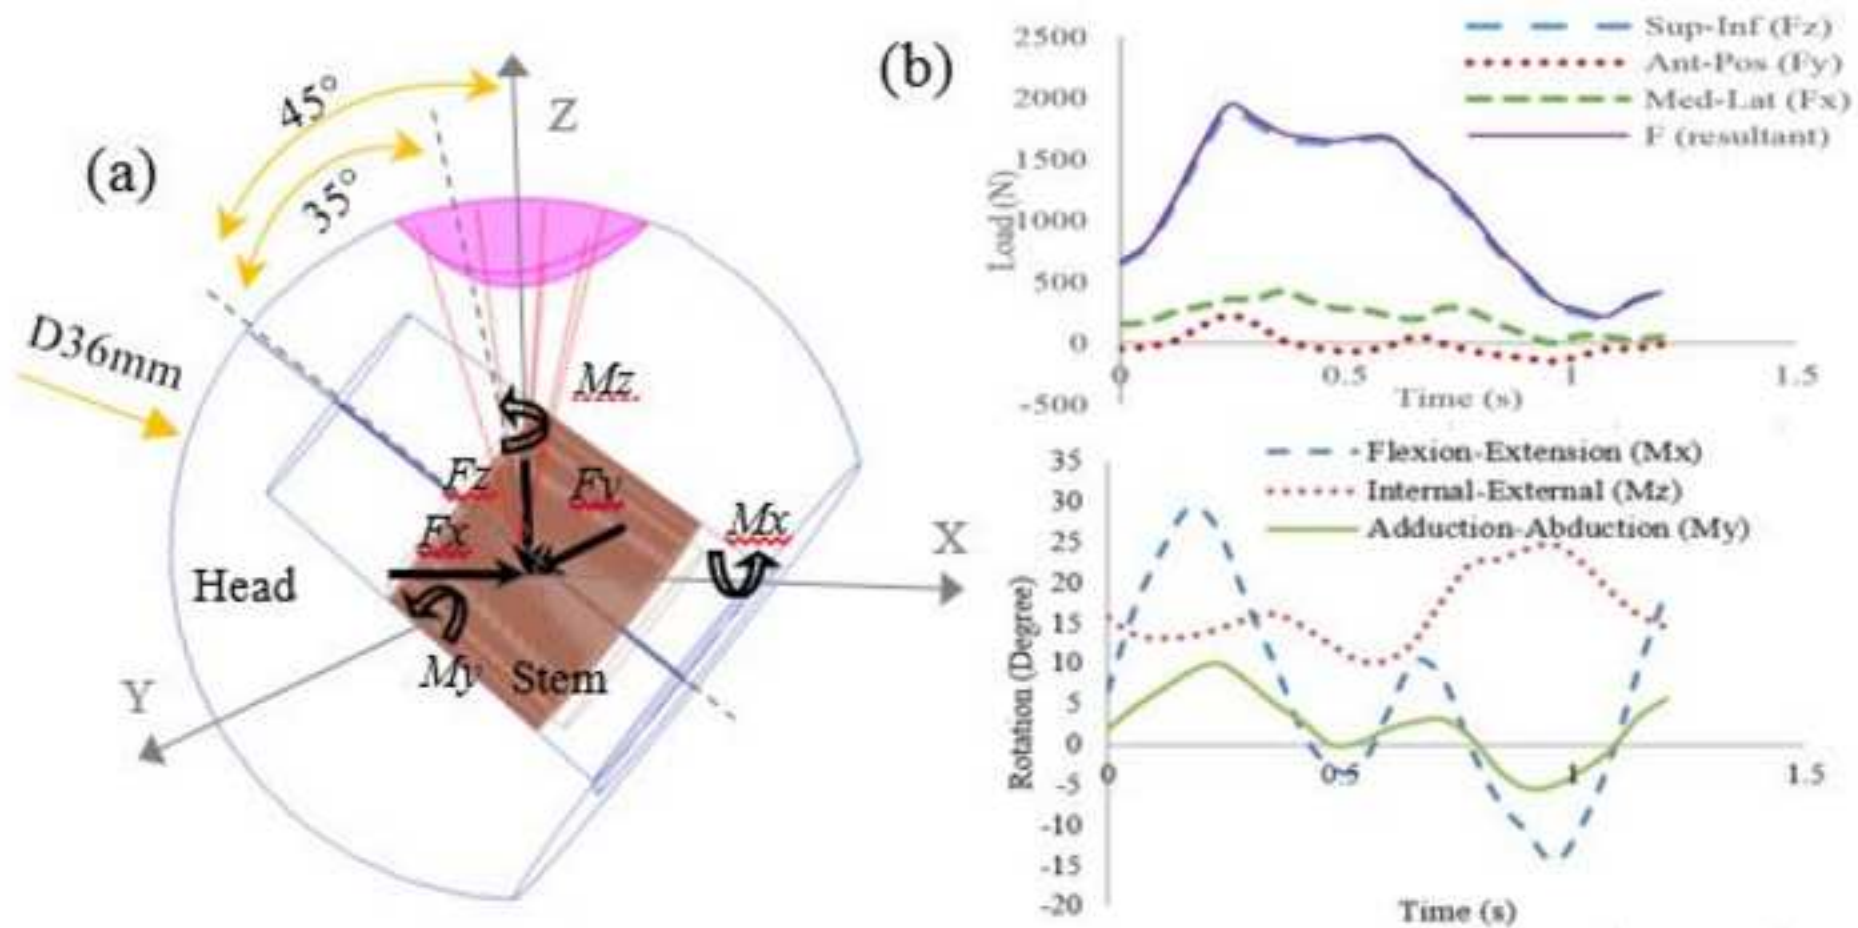
Figure 4: Schematic presentation of the finite element loading

The loads and rotations of a walking step were assigned on the models as shown in Figure 4 and described earlier in detail in (Ashkanfar et al., 2017). These loading and boundary conditions create an efficient and realistic walking simulation which was applied to a dynamic implicit analysis step discretised into 10 equal time intervals over a 1.2 s period.

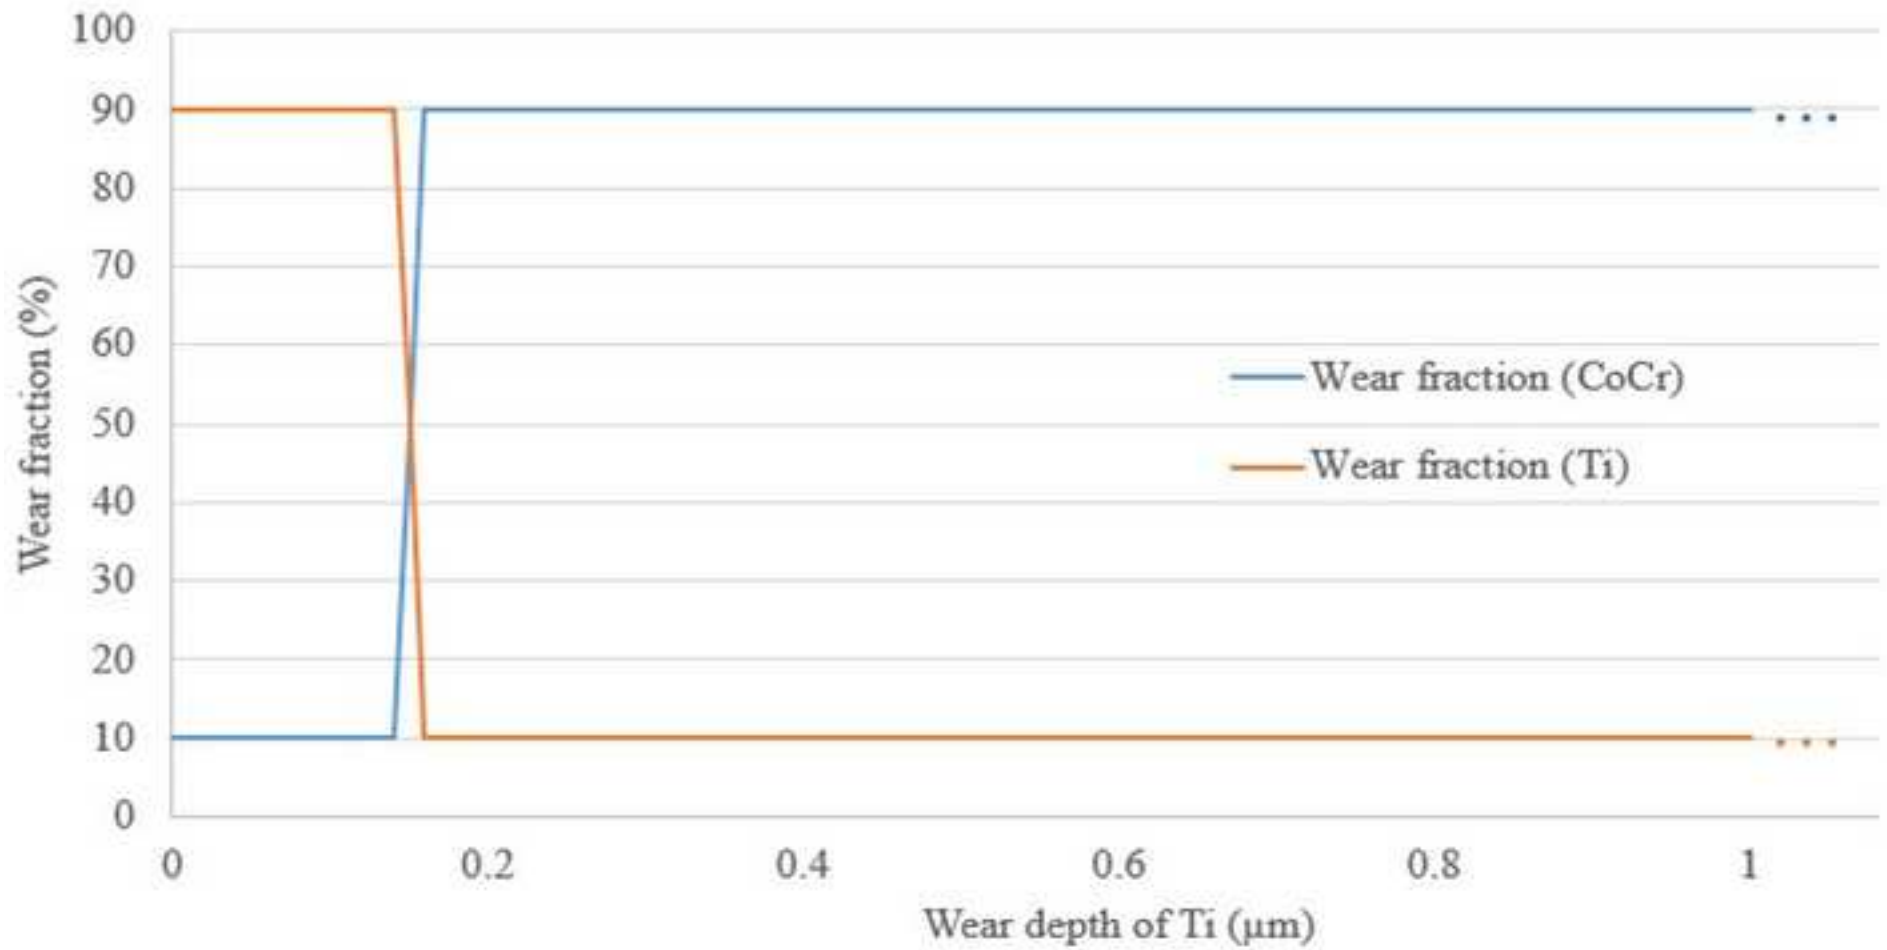
Figure 5: wear fraction between CoCr and Ti material combination over developed wear depths during the wearing procedure

“wear fraction” (English et al., 2015), depends on the specific materials being considered. The wear fraction for a CoCr femoral head and Ti trunnion material combination is mainly based on the theory of Ti hardening in-vivo (Moharrami et al., 2013). Put simply, at first, the Ti trunnion is worn by the harder CoCr head. However, over time an increasingly thick Ti oxide layer builds up. Once it reaches around 150 microns in depth, it has sufficient hardness at sufficient depth to begin to wear the CoCr alloy. This change in hardness, and thus wear, has been modelled computationally by varying the wear fraction during the wearing analysis as shown in Figure 5. While the concept of an apparently softer material wearing a harder material may seem counterintuitive, under fretting conditions (as would be the case in a taper-trunnion junction) such an effect has been seen in multiple tribological studies (Elleuch and Fouvry, 2005; Kayaba and Iwabuchi, 1981; Lemm et al., 2015; Varenberg et al., 2002). In such cases the differential wear has been attributed to “the formation of oxide debris which then became trapped in the contact area and embedded in the softer surface; the hard, embedded particles then abraded the harder” material (Lemm et al., 2015).

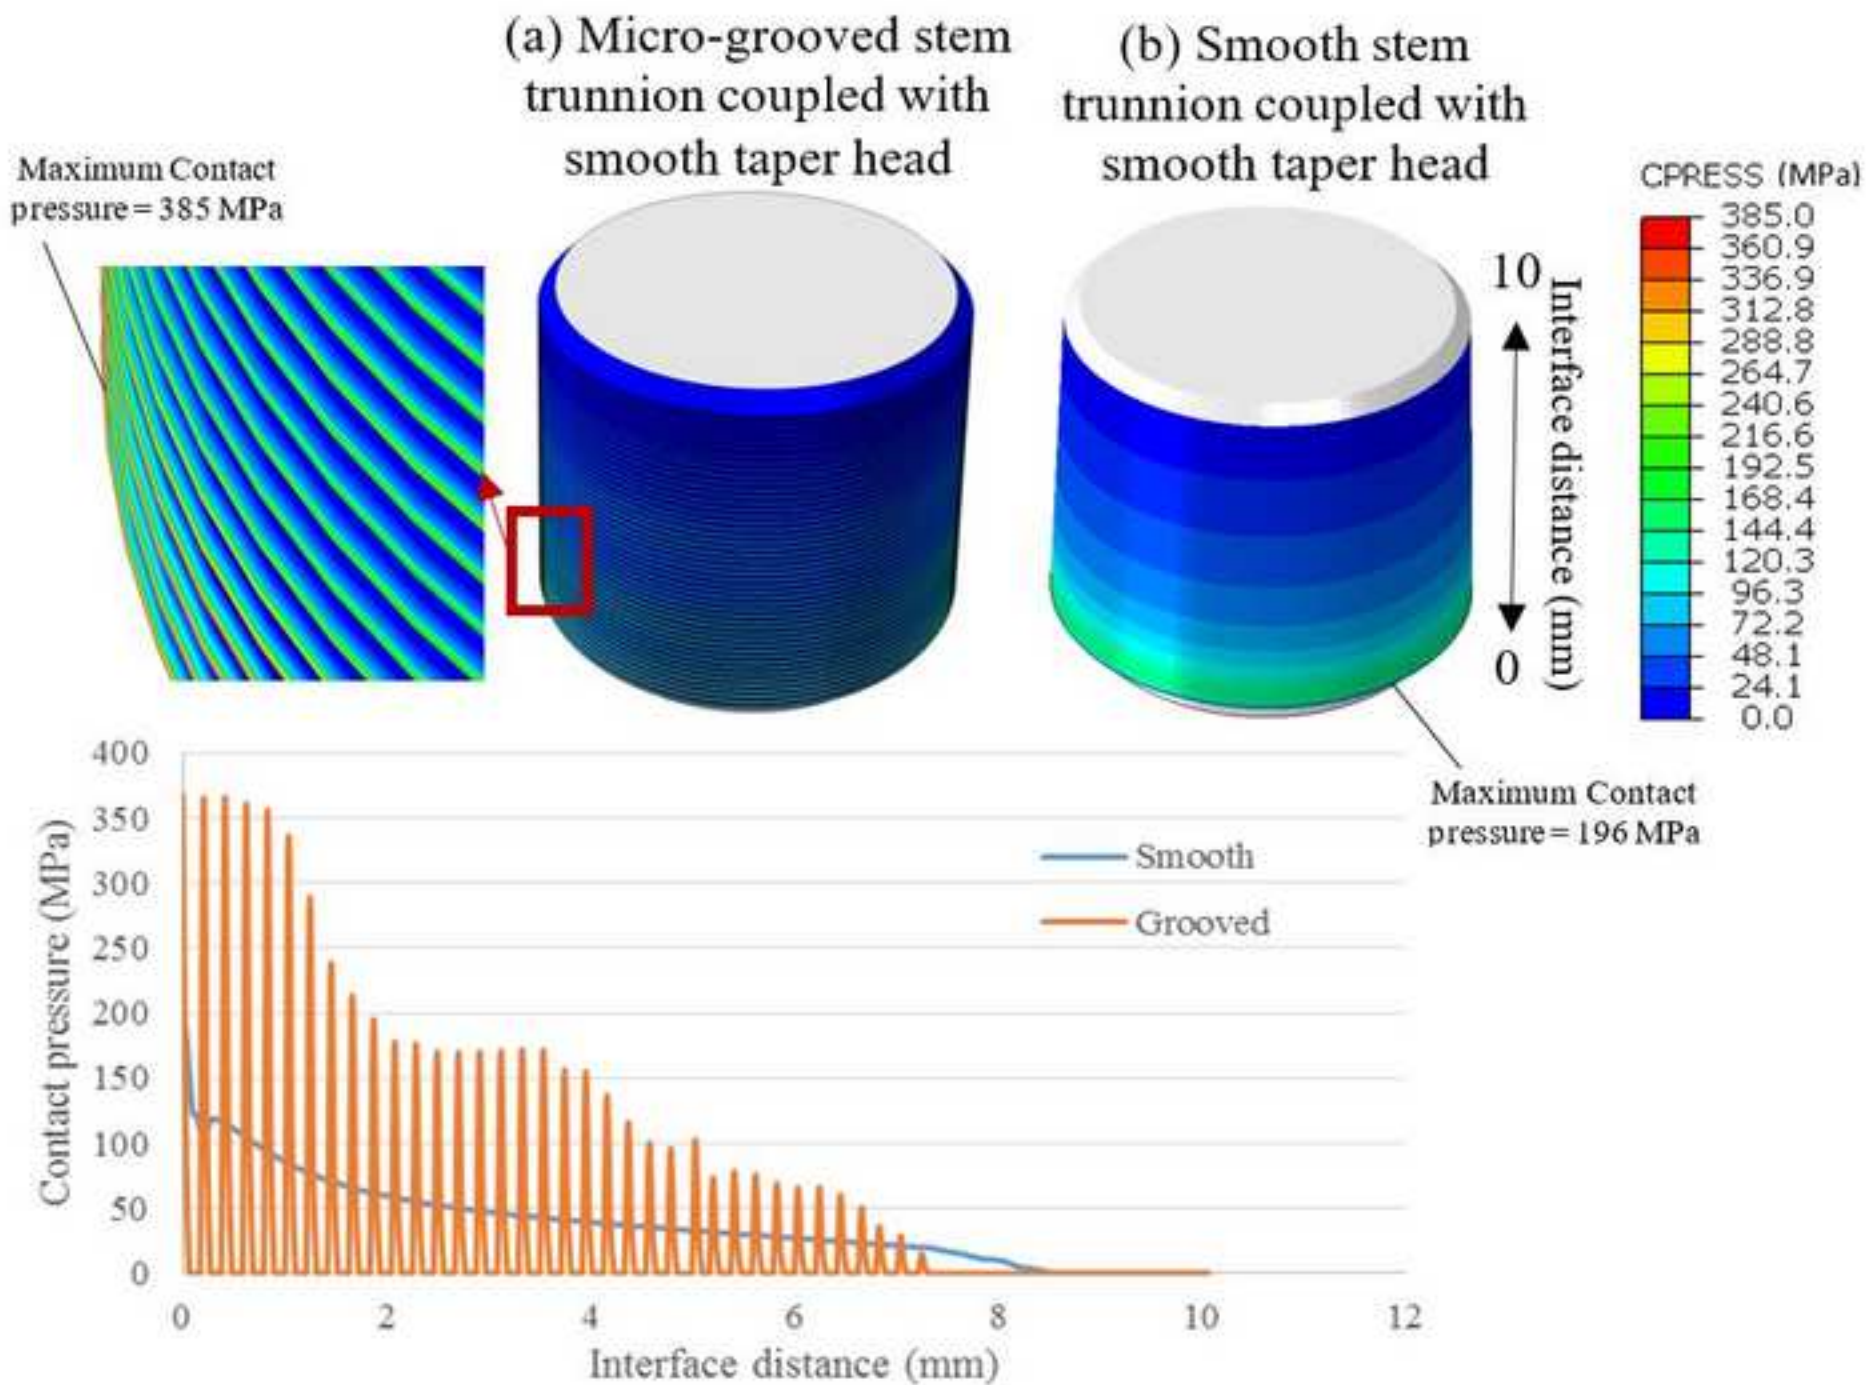
Figure 6: Contact pressure (CPRESS) distribution over the interface of the trunnion stem associated with the initial assembly impactation (4kN) for (a) micro-grooved and (b) smooth trunnion surfaces

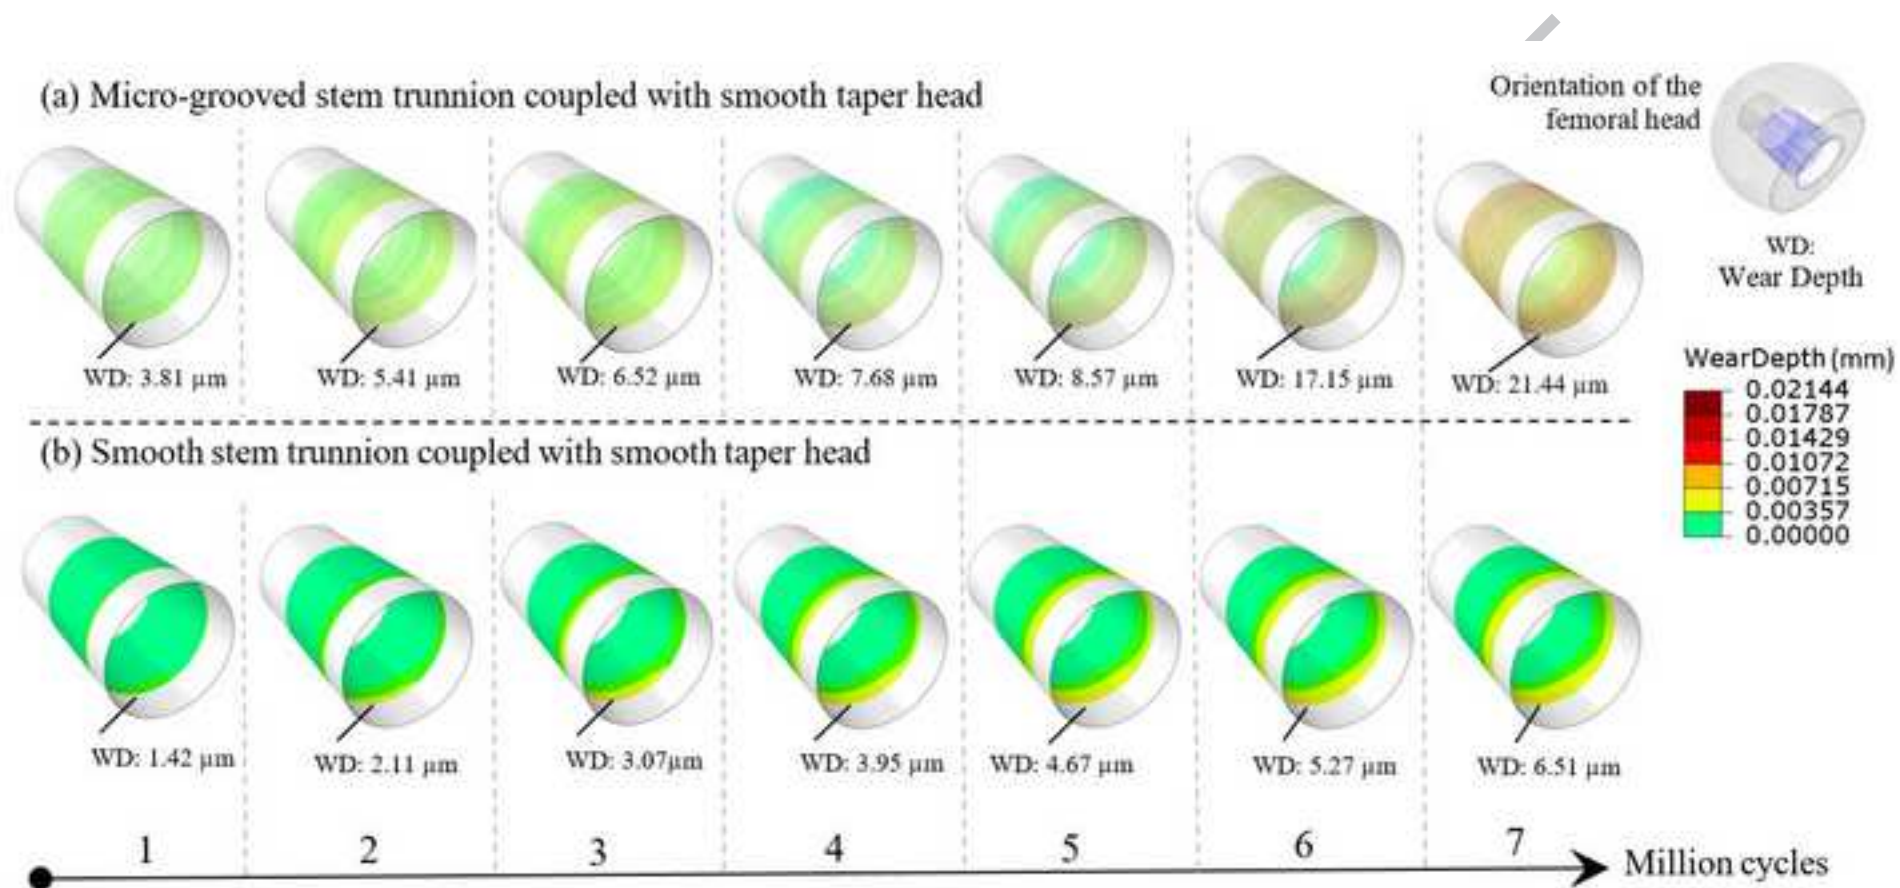
Figure 7: Evaluation of the wear pattern on the smooth head taper surfaces mated (a) with a micro-grooved and (b) with the smooth trunnion surface finish. Note that the specific wear depth (WD) values on the figure show the maximum wear depth at each stage of the analysis.

The evaluation of the wear damage over a 7 million load cycle period is shown in Figure 7, comparing the smooth femoral head taper surface coupled with micro-grooved (Figure 7a) and smooth (Figure 7b) trunnions. As expected the wear depth evolves for both cases as the wear analysis progresses.

Accelerated increases in the wear depth can be seen for the femoral head taper which was coupled with a micro-grooved trunnion after 5 million load cycles where the relative micromotion at the interface starts increasing rapidly. This increase in the micromotion continues until the femoral head starts rotating on the femoral stem with a much larger scale than fretting relative micromotion at 6.8 million load cycles. The maximum wear depth increases from a value around $8.57 \mu\text{m}$ at 5 million load cycles to $21.44 \mu\text{m}$ at 7 million load cycles (see Figure 7a). It should be noted that, as the sophisticated FEA model focussed on wear at the micro grooves with a resolution of 0.012 mm , so when the entire taper (approximately 10 mm long) is shown as an image, as in Figure 7, areas of red (maximum wear depth) become difficult to discern on this macro scale. For the femoral head coupled with a smooth trunnion (Figure 7b), however, the wear depth increases at the distal edge of the contact interface to approximately $6.51 \mu\text{m}$ at 7 million load cycles. The wear damage at the interface is distributed more uniformly and circumferentially at the femoral head taper (see Figure 7b). This lower wear depth, compared with the femoral head coupled with micro-grooved trunnion stem, is mainly due to having more area in contact and subsequently a larger interface. The larger interface allows better fixation which could maintain the relatively small amounts of micromotion for a larger number of load cycles.

As discussed, due to the Ti hardening *in-vivo*, which increases its hardness over the CoCr alloy, the CoCr alloy wears significantly more (Moharrami et al., 2013). In this study, the algorithm is able to consider the hardening of the Ti during the wearing analysis. As such, the harder micro-grooved trunnion stem imprints into the femoral surface as shown in Figure 7. Although this hardening happens for the smooth Ti trunnion stem as well, the surface damage is less extensive (see Figure 7).

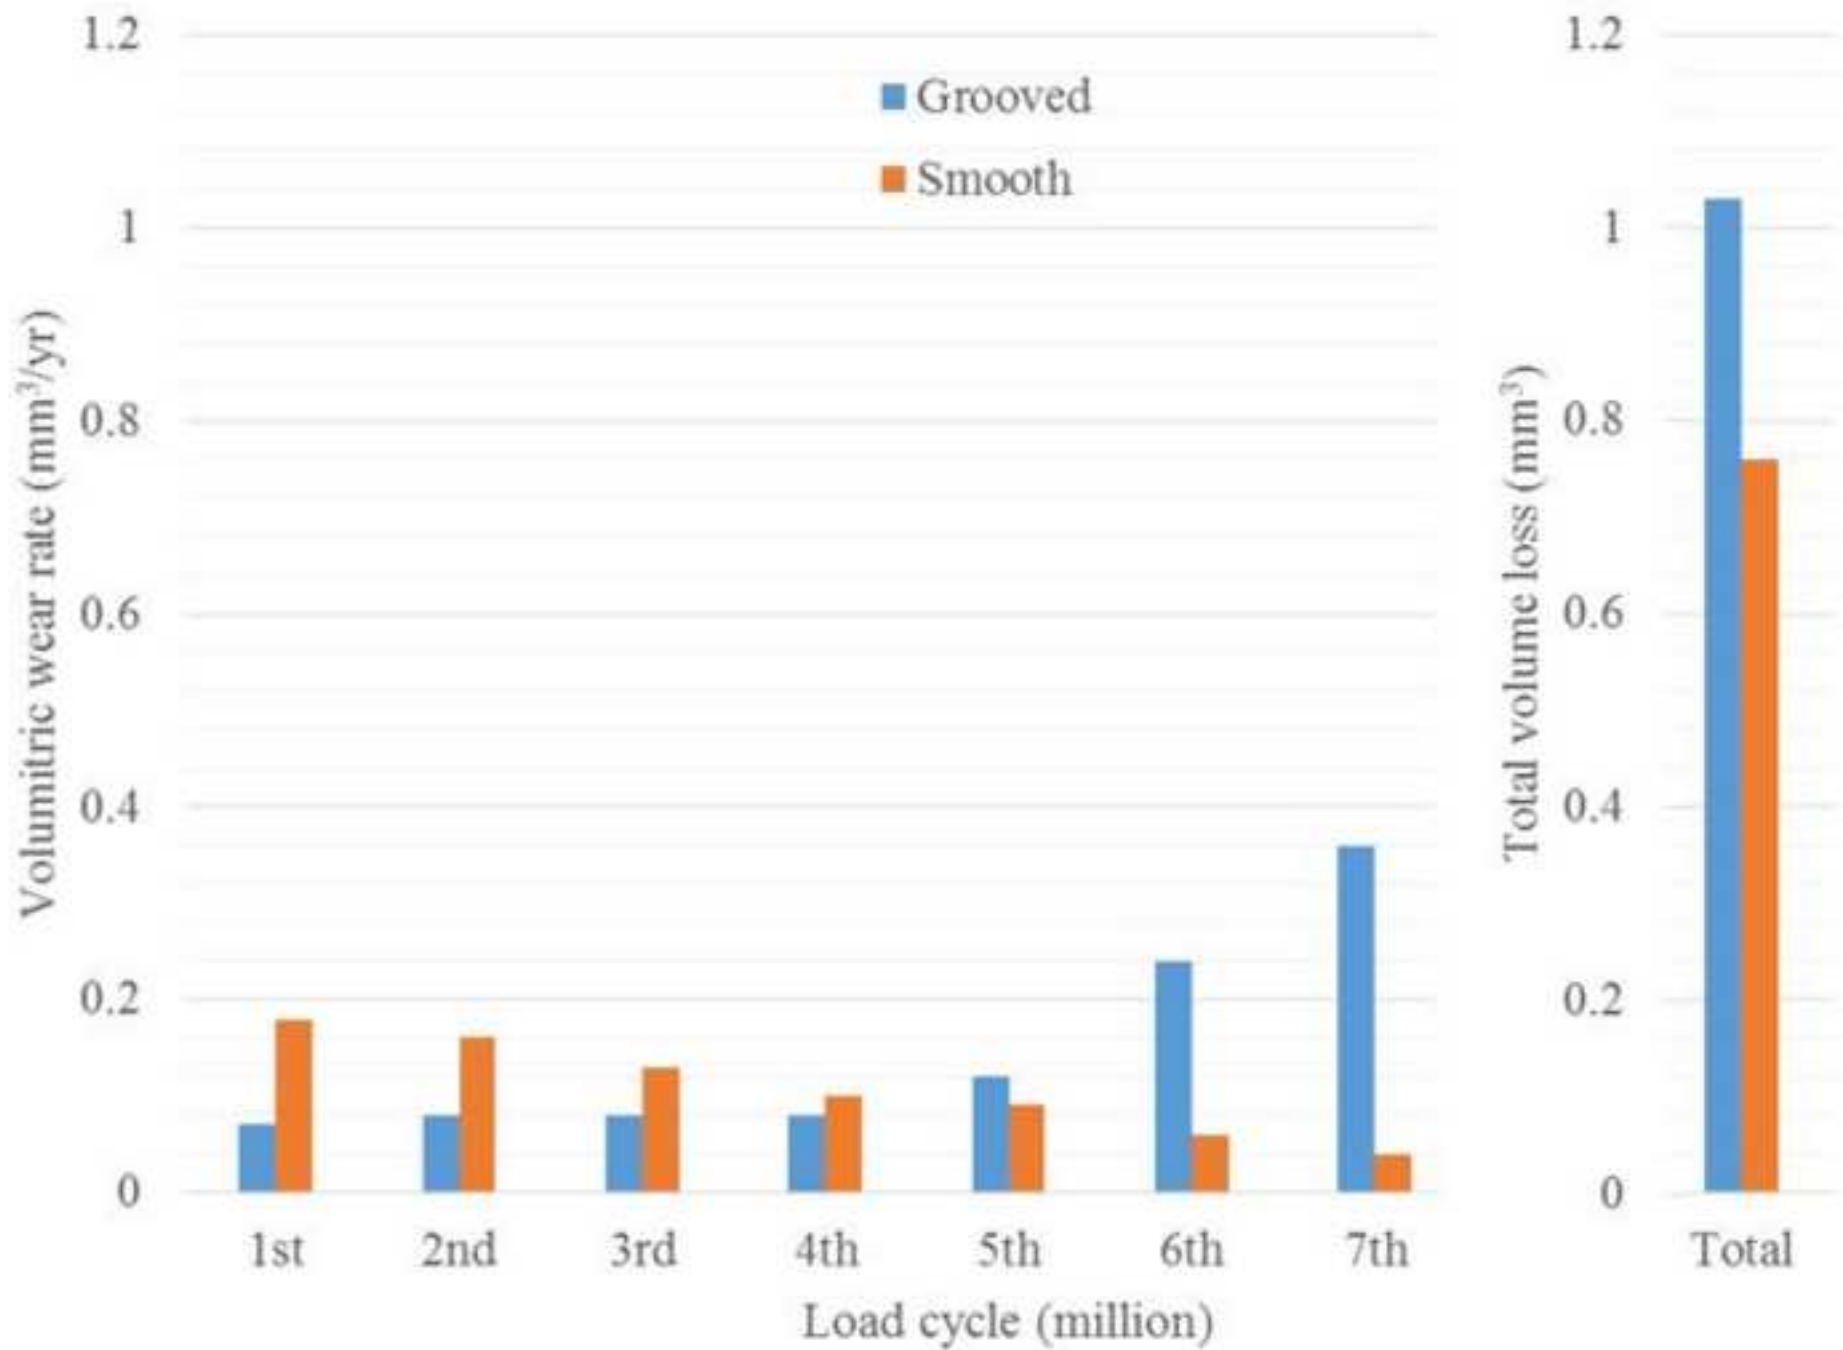
Figure 8: Volumetric wear rates and total volume loss over and after 7 million load cycles respectively

The volumetric wear rate over 7 million load cycles and the total volume loss are compared for both cases and are shown in Figure 8. For the head coupled with a micro-grooved stem trunnion, the volumetric wear rate is relatively constant over 4 million load cycles (approximately $0.08 \text{ mm}^3/\text{yr}$) and then rapidly increases to 0.12 , 0.24 and $0.36 \text{ mm}^3/\text{yr}$ over years 5, 6 and 7 respectively. This increase in the volumetric wear rate is due to the effect of loss of fixation which leads to a rapid increase in the relative micromotion and thus the material loss. The total volume loss is around 1.03 mm^3 over 7 million load cycles. It can be seen in Figure 8 that the initial wear rates for the head coupled with a smooth trunnion surface are slightly higher than the head coupled with a micro-grooved trunnion surface ($0.19 \text{ mm}^3/\text{yr}$) as a smooth taper-trunnion coupling provides a greater surface contact area. Although these initial wear rates are higher, the fixation is better maintained over time at the

taper junction. As the micromotion is maintained at its lower extent over a longer period of time the contact stress at the interface reduces slightly and this causes a reduction in the wear rates gradually over time (to around $0.04 \text{ mm}^3/\text{yr}$ at 7 million load cycle). The total volume loss over 7 million load cycle is 0.76 mm^3 .

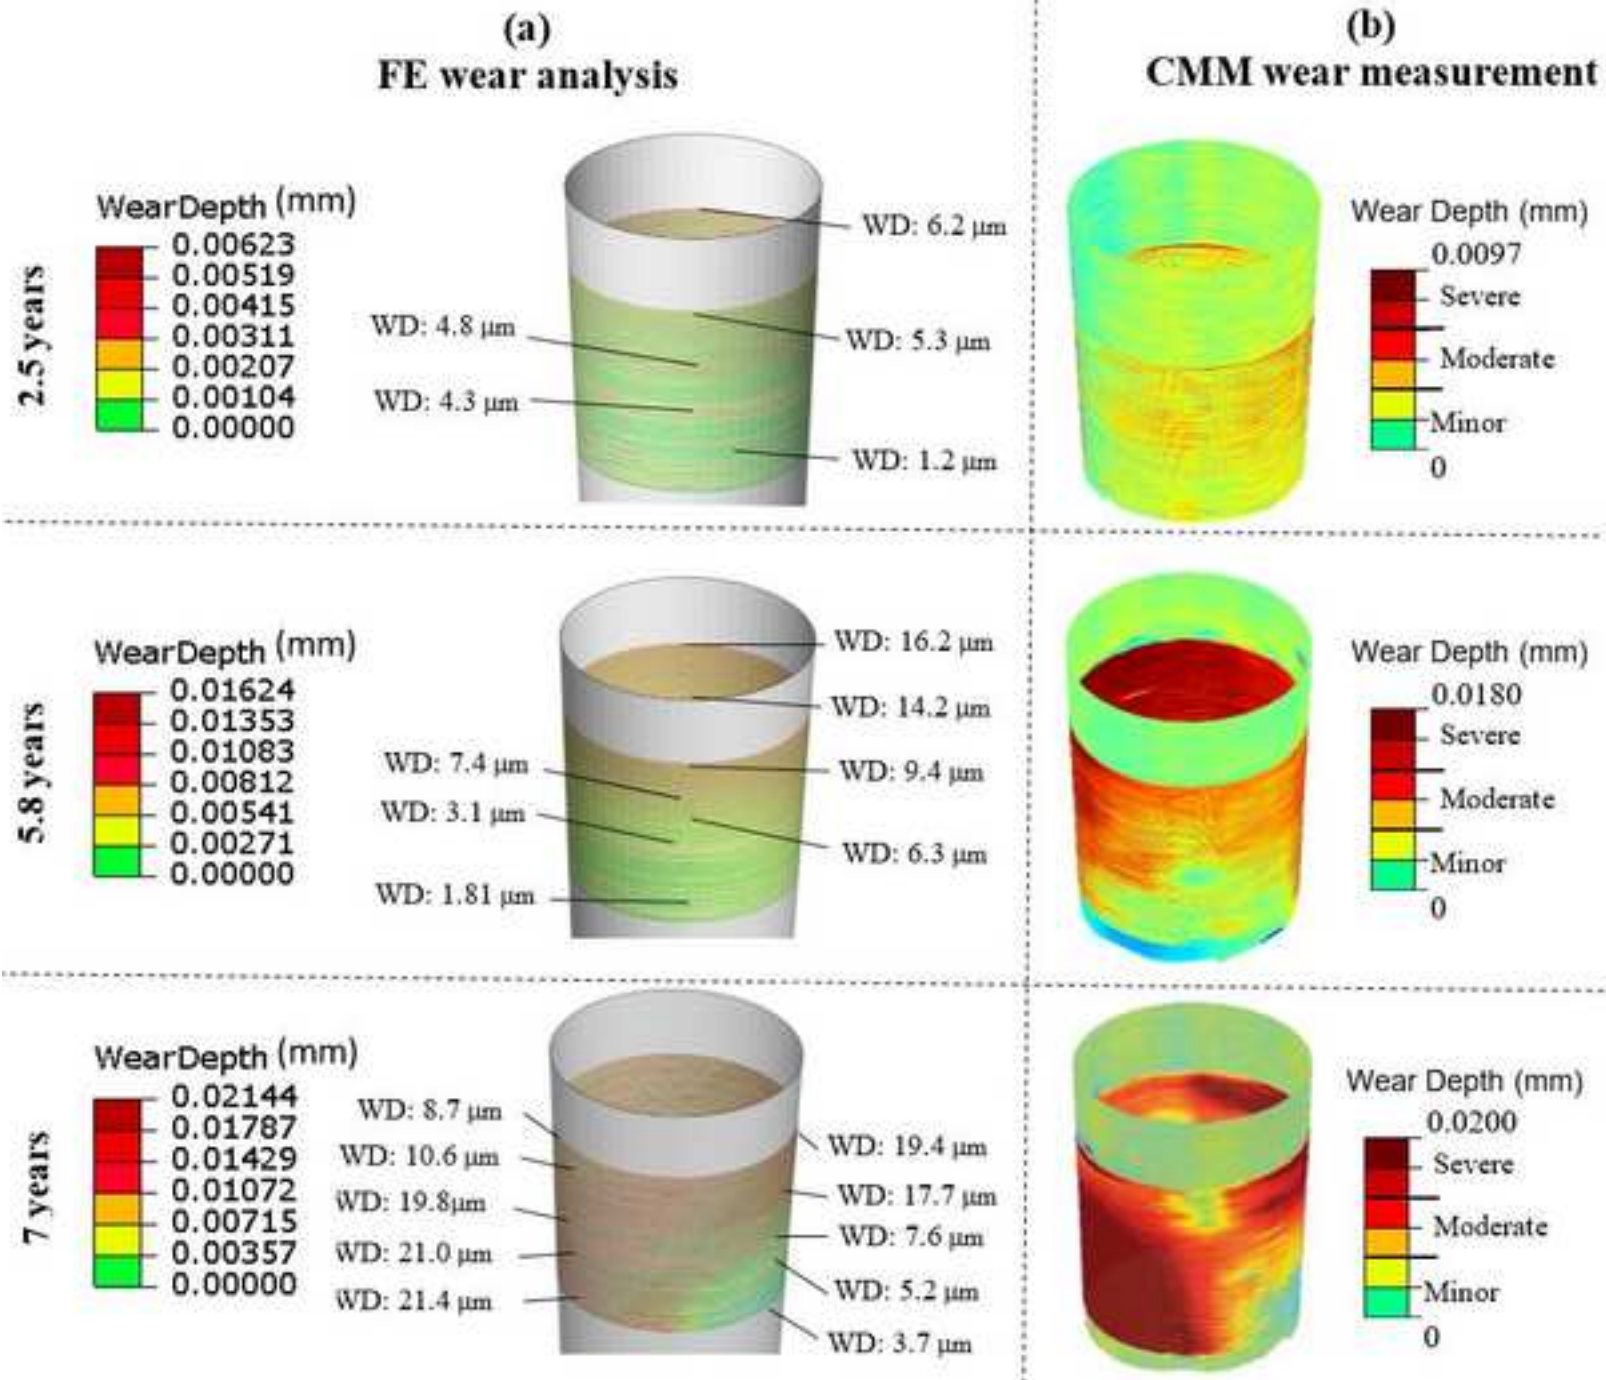
Figure 9: 36mm CoCr femoral head taper mated with Corail micro-grooved stem trunnion; (a) Finite Element analysis and (b) CMM wear measurement. Note that, the specific wear depth (WD) values have been added to help show the similarity in wear results between the FEA and CMM analyses.

Figure 9 compares the computational FE wear pattern damage obtained in this study with CMM measurements of wear damage at the retrieved femoral taper surfaces. The FE wear model could be analysed at specific points (i.e. 2.5 million cycles) to allow a direct comparison with a specific hip implant's time *in vivo* (i.e. 2.5 years). It can be seen in Figure 9 that the wear depths obtained computationally compare favourably with the CMM measurements for explants retrieved at 2.5, 5.8 and 7.0 years. Once again, note that due to the fine mesh size (0.012mm) of the FEA model, and the localised material removal from microgrooves, once the image is scaled up to show an entire taper, so areas of red (maximum wear depth) become difficult to discern on the FEA image. The average volumetric wear rate for the hip explants obtained from the CMM was $0.28 \text{ mm}^3/\text{yr}$, (range 0.04 to $1.67 \text{ mm}^3/\text{yr}$), while that from the FEA model was $0.26 \text{ mm}^3/\text{million cycles}$ (figure 8). The close similarities shown between the numerical analysis and measured wear damage of retrieved prostheses

demonstrates the effectiveness of the 3D FE wear model, the chosen loading and boundary conditions, and the wear algorithm; therefore, the computational analysis is validated.
