# Concrete Sewer Pipe Corrosion Induced by Sulphuric Acid Environment

Anna Romanova, Mojtaba Mahmoodian, Upul Chandrasekara, Morteza A. Alani

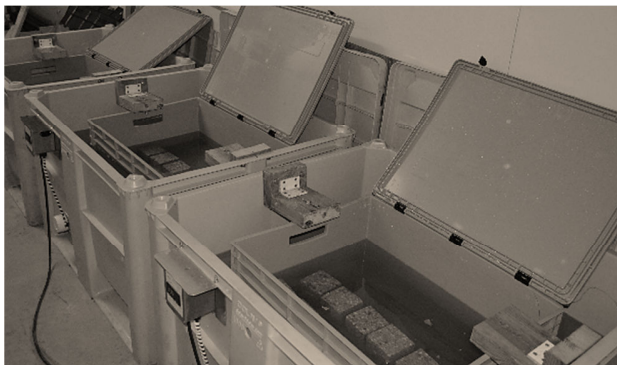
Fig. 1 Experimental set up of cubes being submerged into diluted sulphuric acid

The chamber hosted three 500L HDPE tanks where two of them were curing tanks and could autonomously control the fluid temperature inside them. Each of the tanks had a further 120L HDPE container, which was submerged by 2/3 into the fluid contained by 500L tank. This was done to create a thermal bath type effect and control a constant temperature of the solution in 120L containers. To avoid any fluctuation or displacement of the containers they were attached to the sides of the tanks by the use of L-type brackets. Three tanks: Tank 1, Tank 2 and Tank 3 maintained a constant temperature of solution located in containers of 10°C, 20°C and 30°C, respectively. The temperatures were chosen to represent the common range of effluent temperatures found in sewer pipes at different climate conditions. The temperature of Tank 1 was controlled by the environmental chamber which was set to deliver 10°C at a humidity level of 70%. Tank 2 and 3 temperatures were controlled autonomously by heating elements.

A total number of 45 cubes, cut out from brand-new circular concrete pipe were used in these experiments. Each cube had a measurement of 100x100x100mm and was cut with diamond-blade rotating saw, however as the process of cutting a circular pipe is very challenging and labour consuming a tolerance of 10% in each side measurement of the cube was allowed for. A number of 15 cubes were fully submerged into 0.5 pH solution of sulphuric acid in each of the containers in Tanks 1, 2 and 3. Further they were extracted at different points in time and assessed using different techniques to account for the corrosion level. Fig. 1 demonstrates a setup of tanks, containers and cubes located in the environmental chamber.

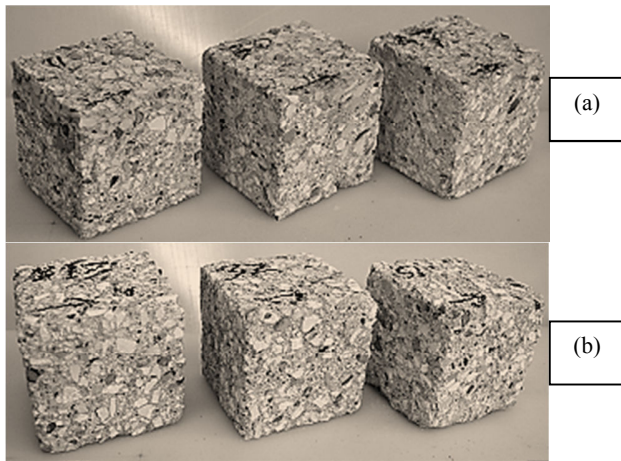
Fig. 5 Cube samples 11, 30 and 47 (left to right) after 42 days immersion into 0.5 pH sulphuric acid solution and temperatures of 10°C, 20°C and 30°C, respectively (a) and cube samples 13, 32 and 51 (left to right) after 56 days immersion into 0.5 pH sulphuric acid solution and temperatures of 10°C, 20°C and 30°C, respectively (b)

Interestingly that the leap between the cubes corrosion depth doubled in periods from 28 days to 42 days and then further between 42 days to 56 days which could be visibly assessed. Examples of such can we seen in Fig. 5.
