The Effect of Continuous Flight Auger Pile Installation on the Soil-Pile Interface in the Mercia Mudstone Group

Linda Seward

A dissertation submitted for the
Degree of Doctor of Philosophy

City University London
Department of Civil Engineering
Geotechnical Engineering Research Centre

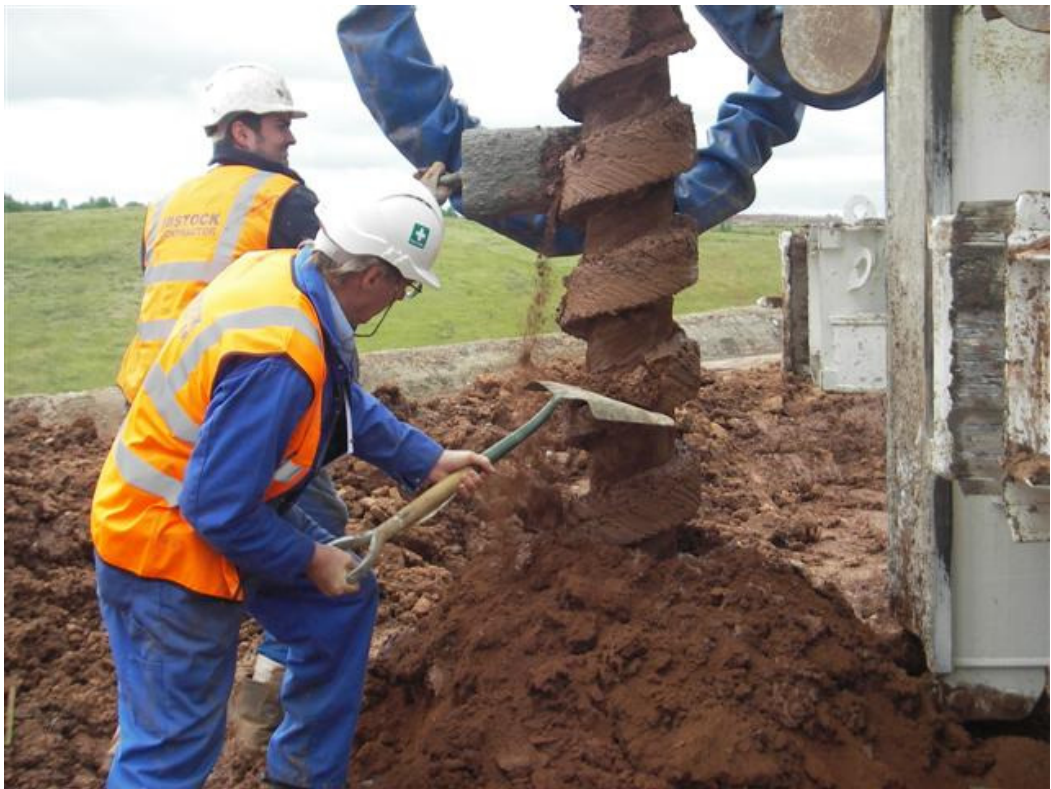
Figure 4.6 The relationship between the auger and the wet soil around pile MR3. Clear markings can be seen on the inner surface of the shaft, along with the hose used to pour water down the shaft

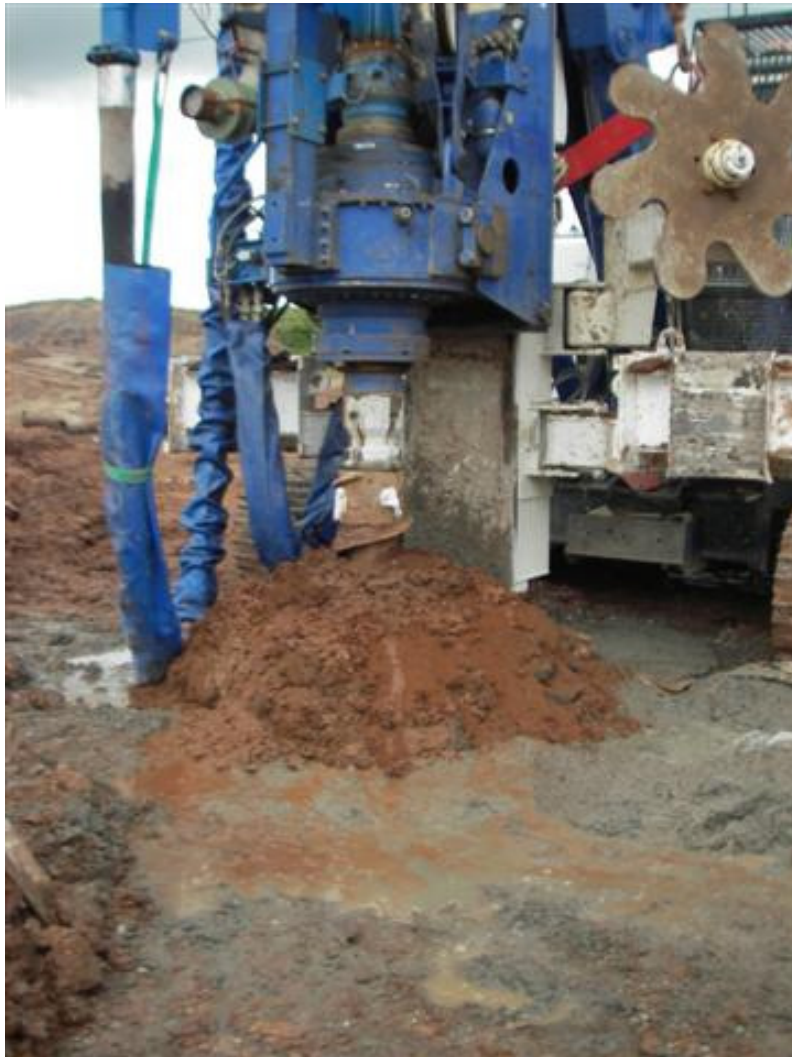
Figure 4.7 The removal of the auger from pile MR3

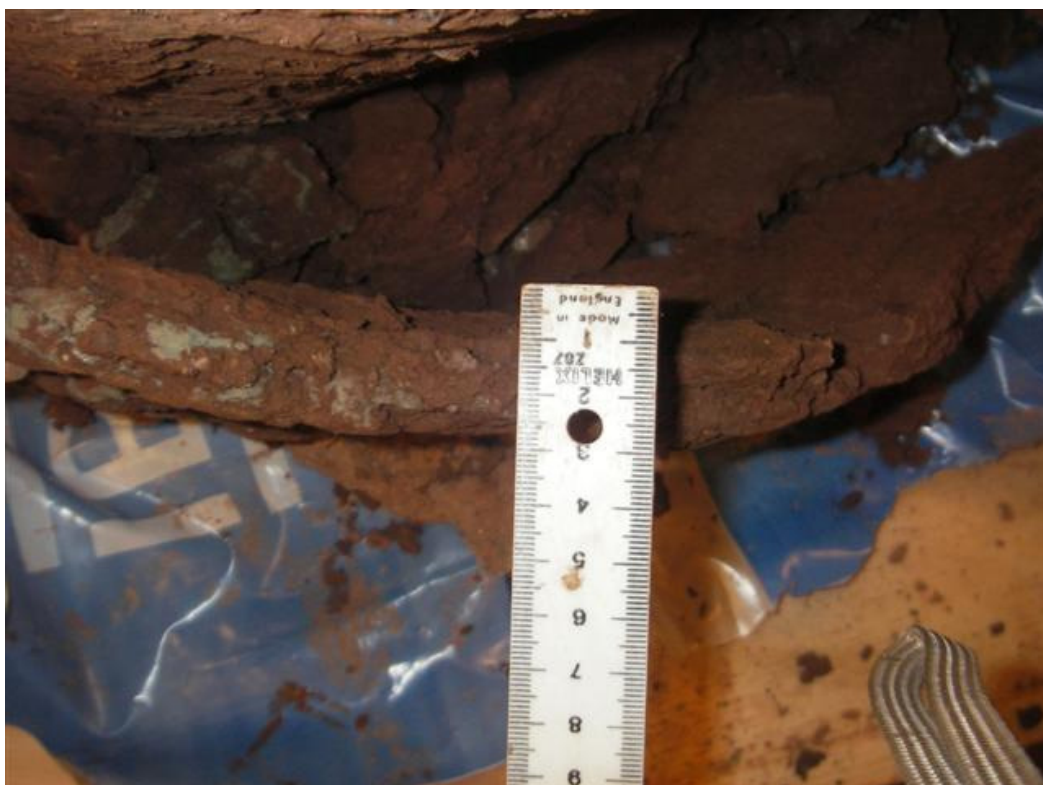
Figure 4.13 Sketch drawing and photograph of remoulded material around pile MR1, 0-495mm below ground level. The photograph is taken looking downwards, with the pile at the top of the picture

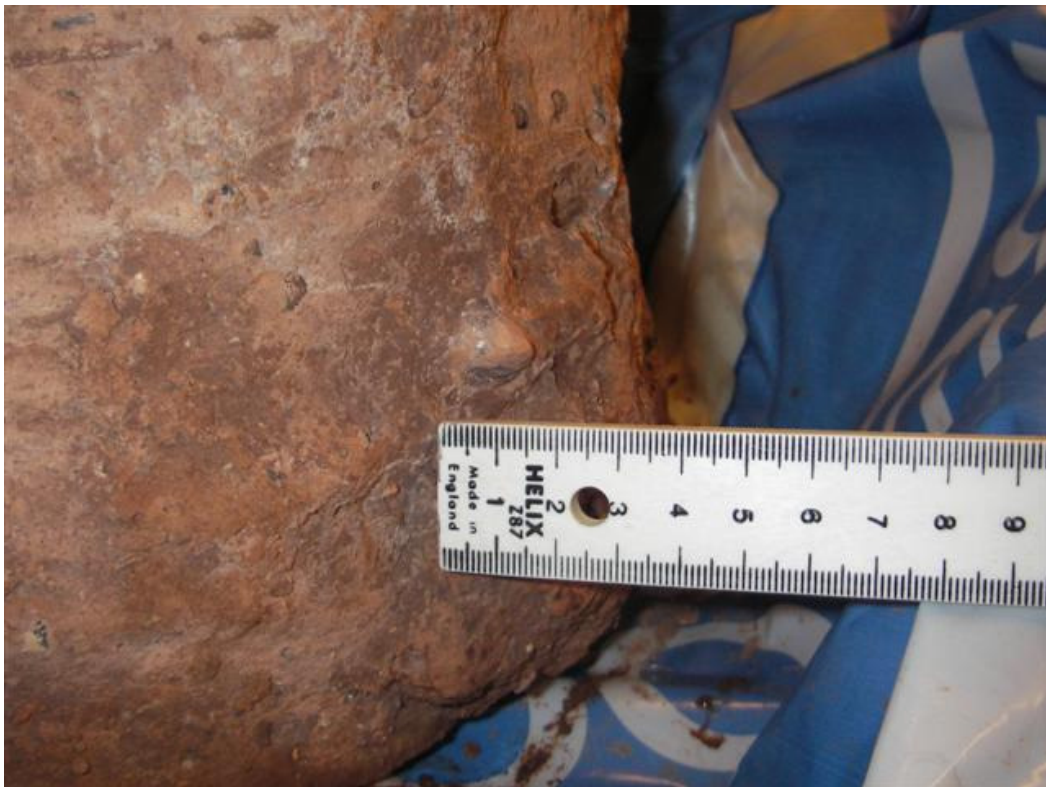
Figure 4.15 Aggregates from concrete of the pile coming out from the surface of the pile shaft. Pile MR1, 0-495mm below ground level.

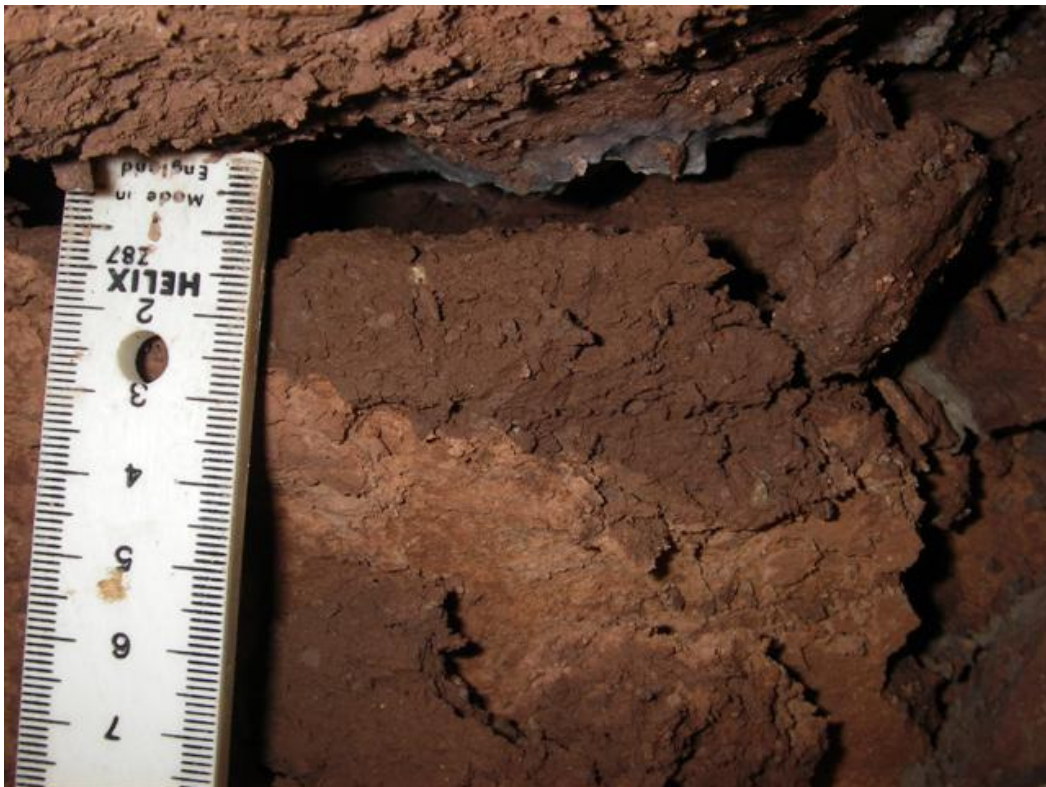
Figure 4.16 The boundary between the host soil and remoulded soil around pile MR1, 819-1277mm below ground level

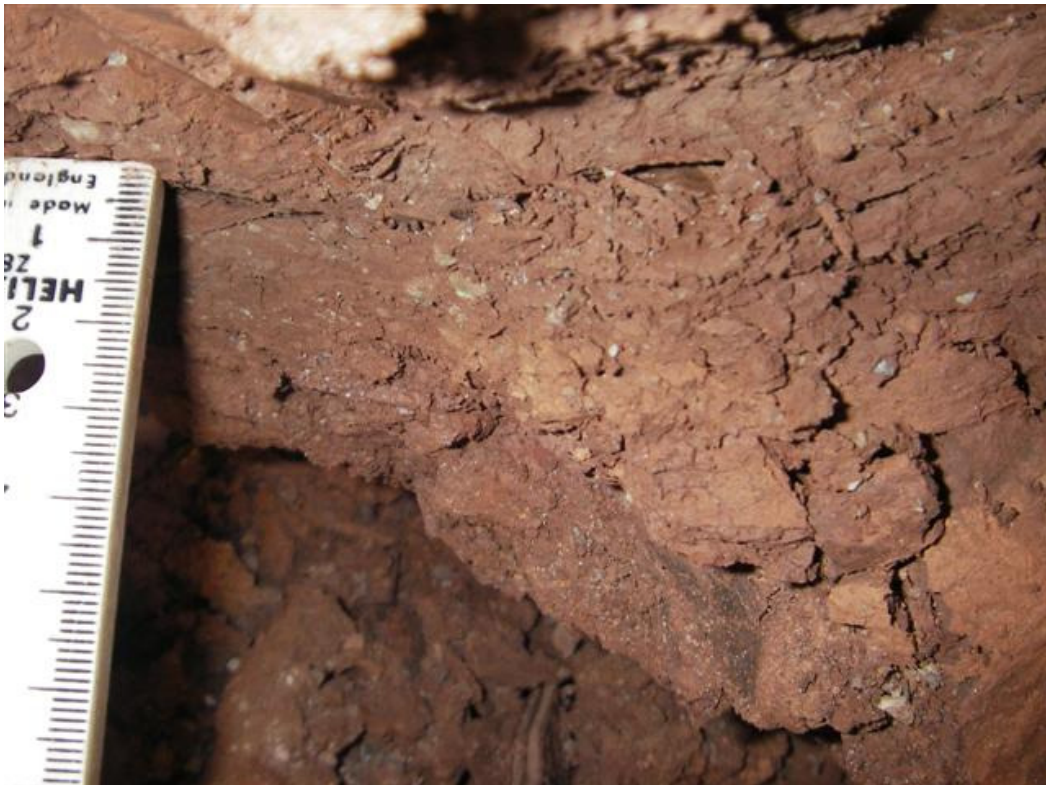
Figure 4.20 The remoulded zone of pile MR2 at 0-1000mm below ground level. Shows silt aggregations within the remoulded layer. Photo was taken horizontally against the vertical pile shaft

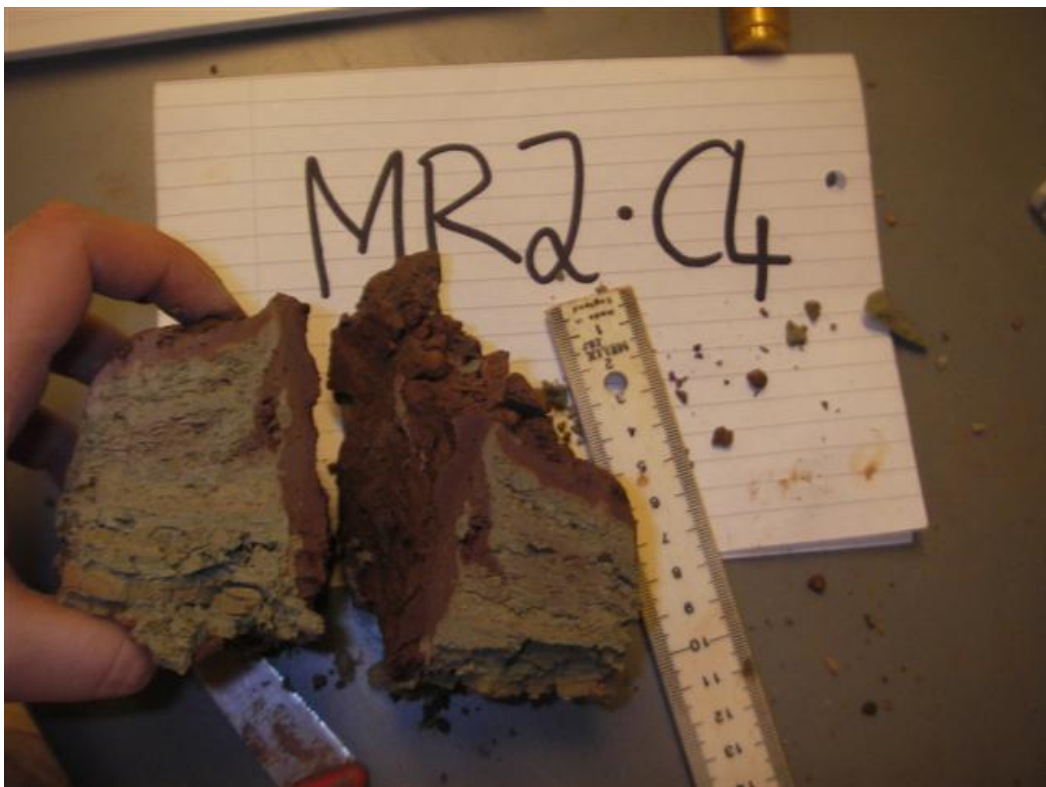
Figure 4.25 The colour change between remoulded and undisturbed material from around pile MR2 at a depth of 1457-1979mm below ground level

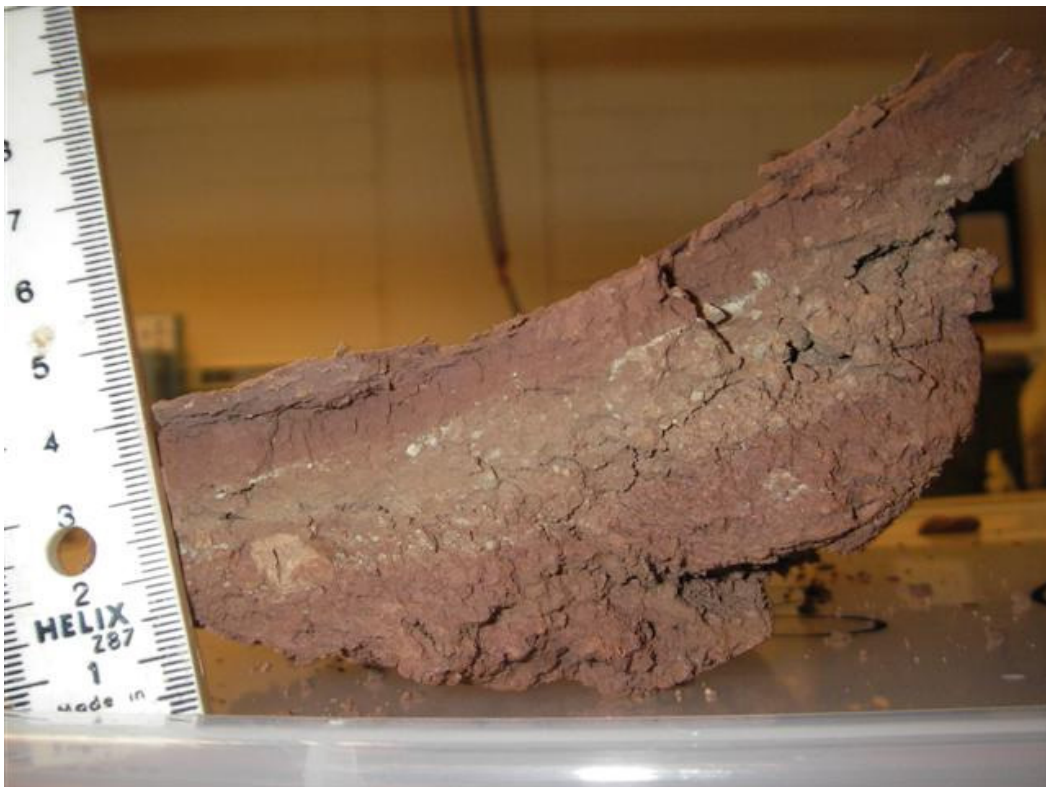
Figure 4.33 Zoning of remoulding with the soil surrounding pile MR3 860-1210mm below ground level. Then soils is viewed from above, and the pile would have been at the top of this picture

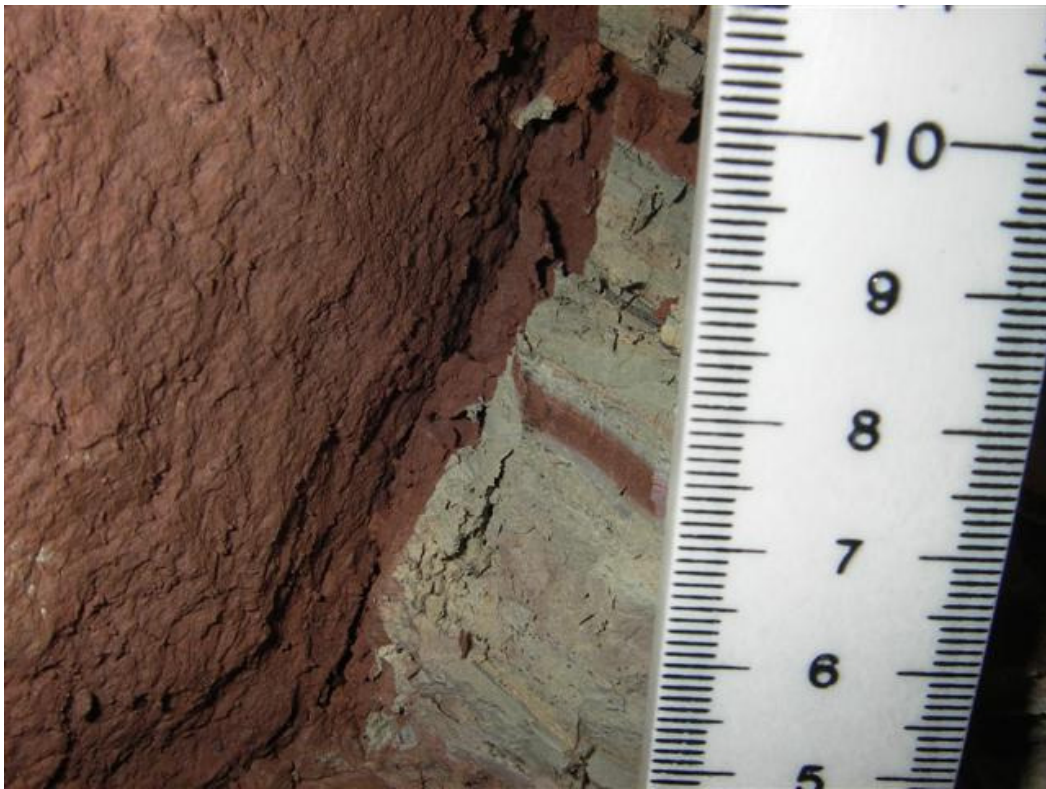
Figure 4.43 The remoulded material from 1600mm below ground level showing the distinct colour and texture differences between the remoulded and host soils

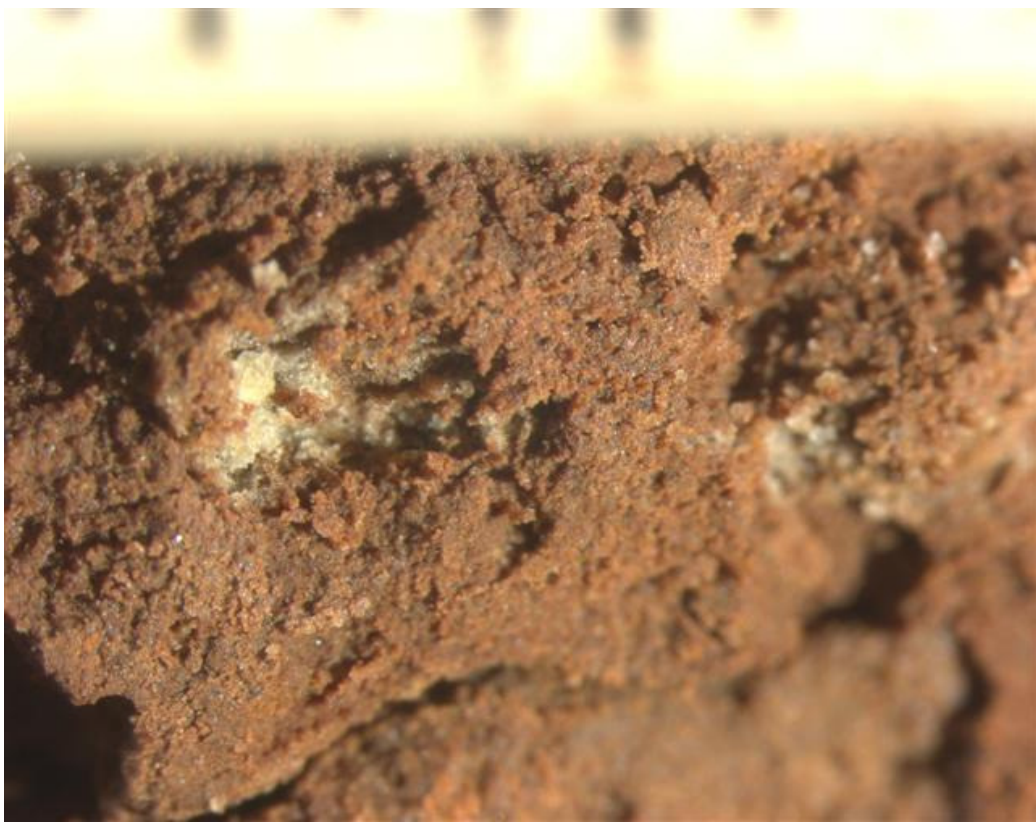
Figure 4.54 The remoulded zone surrounding pile MR4 at 922mm below ground level. Quartz aggregations are seen within this layer. Ruler is in the position of the pile.

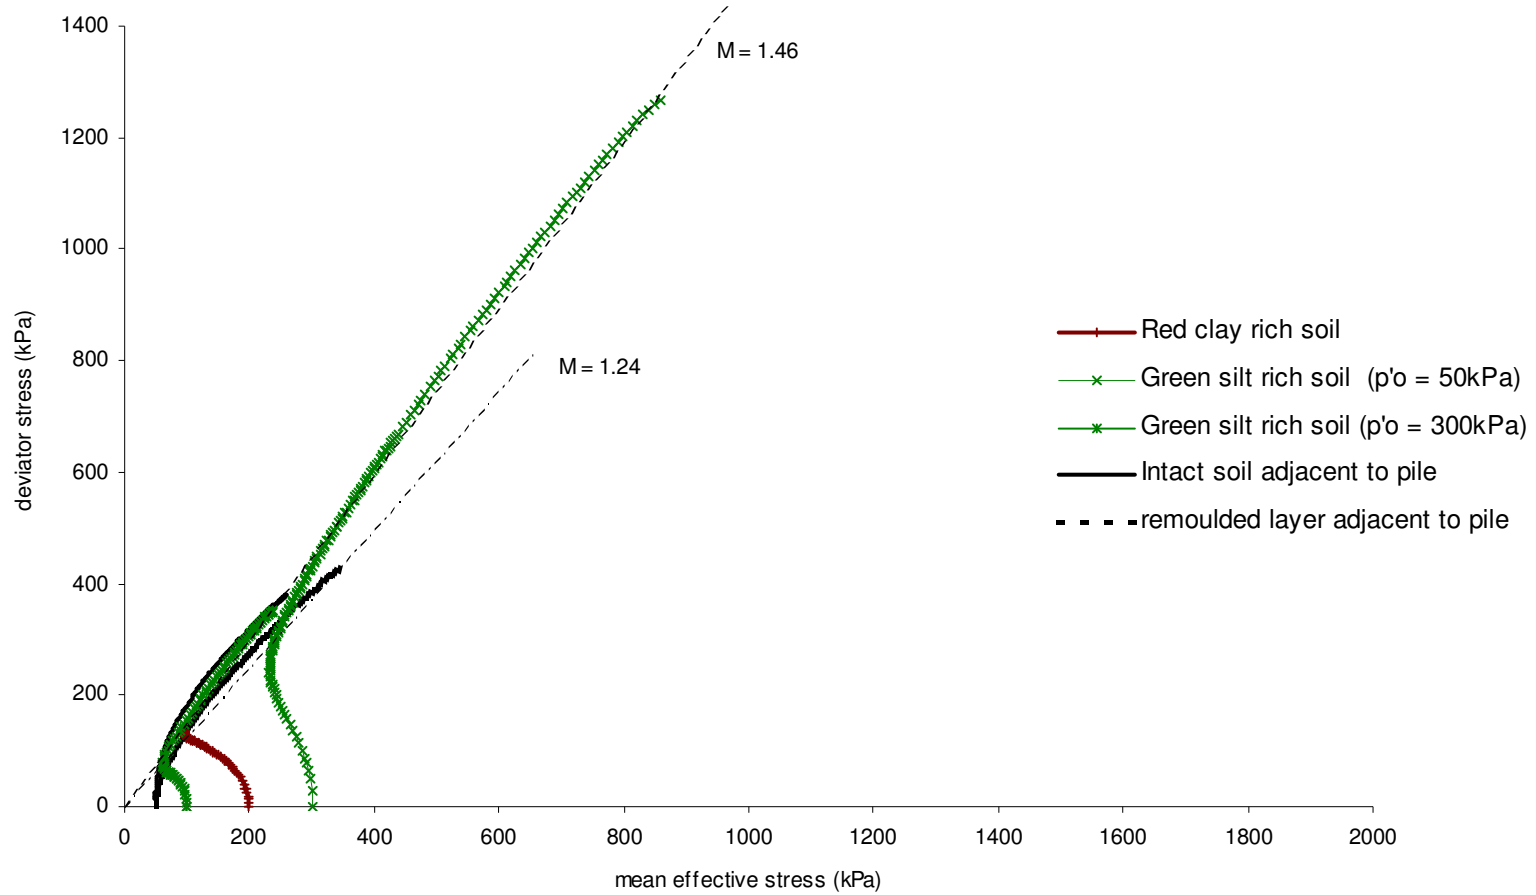
Figure 4.91 Mean effective stress plotted against the deviator stress for all triaxial tests
