Restoring The Past Experience Of Stone Masonry In Burkina Faso For Fostering The Use Of Local Materials

**Proceedings of the 13th International Congress on the
Deterioration and Conservation of Stone – Volume II**

RESTORING THE PAST EXPERIENCE OF STONE MASONRY IN BURKINA FASO FOR FOSTERING THE USE OF LOCAL MATERIALS

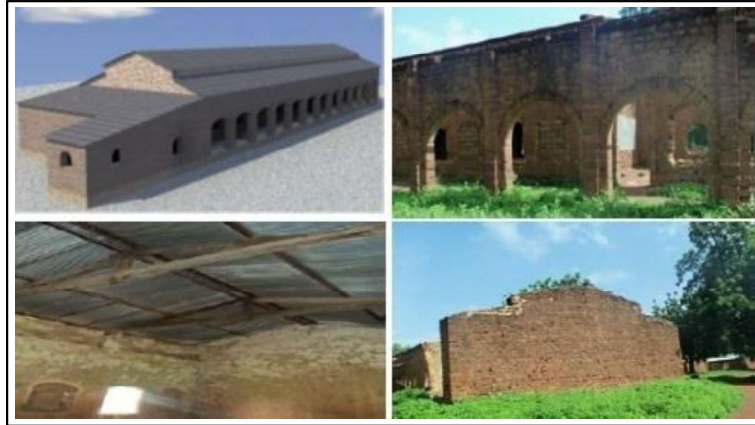
Fig. 3: Views of the school and CAD representation.

The construction (see Fig. 3) is composed by thick masonry walls (double walls) built with adobe with lime mortar and coated with plaster (clay and cement), whereas the top layers, which are exposed to rain and wind, are made with LDS. The load-bearing walls are made with a mixed masonry of adobe and stone blocks locally quarried. Stone units are connected together by means of a weak lime and sand mortar. The cohesion between the mortar and the stone is weak. All different types of masonry in the structure can be defined as solid masonry.

A layer of lime plaster and one of lime wash paint were applied to create smooth surface. Masonry blocks have small to medium size (L: 20 cm, h: 15 cm, w: 10 cm) with rough surface, rectangular or square shape. Some of them show a flattened surface. Blocks were used according to their strength, being the weaker used for filling or for coating, whereas the stronger were used for structural purposes. A virtual reconstruction view has been obtained with a CAD application as shown above left in Fig. 3.

On site visual inspection revealed severe damages. The roof structure of the school was dismantled and partly destroyed. As a result, the vault of the north wall collapsed, and the building was no longer in an operational state. Bricks from demolition were reused for foundations, but also as aggregates in concrete. However, the integrity of the existing arches appears still satisfactory and not affected by the general conditions. No deformation and collapse of gable walls was observed, although these were built as a single layer. There is no evidence that the building collapsed because under dimensioned, or because of insufficient bearing capacity of the construction material or due to any overload on the structure.

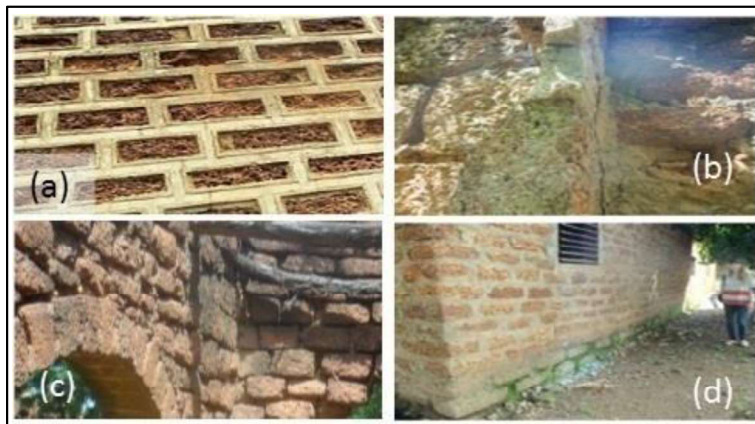
Fig. 4: Views of the most usual defects observed in LDS structures.

Masonry defects can be associated with several reasons, from a wrong choice of materials to an insufficient quality of the workmanship (Bromblet and Association MEDISTONE, 2010). The local climatic impact can also have a role. Main categories of defects and related causes were defined by direct observations on the surveyed LDS building (the old school and the houses) in Fig. 4:

- Deterioration of the structure of LDS, by atmospheric agents, such as sandy wind and rain, affecting surface stone (a). The block can also be damaged by the cracking associated with the action of water and temperature variation, which facilitates rock degradation and failure (b),
- Disintegration of lime and sand mortar joints, due to the moisture transfer or water runoff action and also because the excessive mortar width between the layers and loss adherence (c),
- Organic deterioration from musk and other plants growth on the lowermost layer of masonry elements, due lack of drained or ventilated space in the basements (d),
- Cracks due to uneven distribution of the loads.

Some of the above mentioned defects can be avoided by controlling the block production. Good ashlar with rough, parallel surfaces are to be preferred, since these features improve the joint strength, contribute to an even distribution of the loads and reduce the potential accumulation of organic material on joints. The quality of the laying of the block is also an important factor for preventing structure failures. The width of the joints should be kept at a minimum, and in some cases the laying should be carried out even without joint. The quality of the LDS is another key point. Top quality LDS seem to be subject to hardening upon exposure to alternate wetting and drying, but poor to medium quality are not, since granular morphologies are disintegrated by drying and wetting cycles. Masons must be careful when choosing the blocks during construction, trying to use them according to their quality in different places of the structure.
