## Determination of transfer stress from ruptured pre-load galvanised tendons in tanks and bund walls

O'FLAHERTY, Fin, LAMBERT, Paul, MANGAT, Pal and STARINIERI, Vincenzo (2017). Determination of transfer stress from ruptured pre-load galvanised tendons in tanks and bund walls. *Materials and structures*, 50 (5), p. 228.

**Determination of transfer stress from ruptured pre-load galvanised tendons in tanks and bund walls**

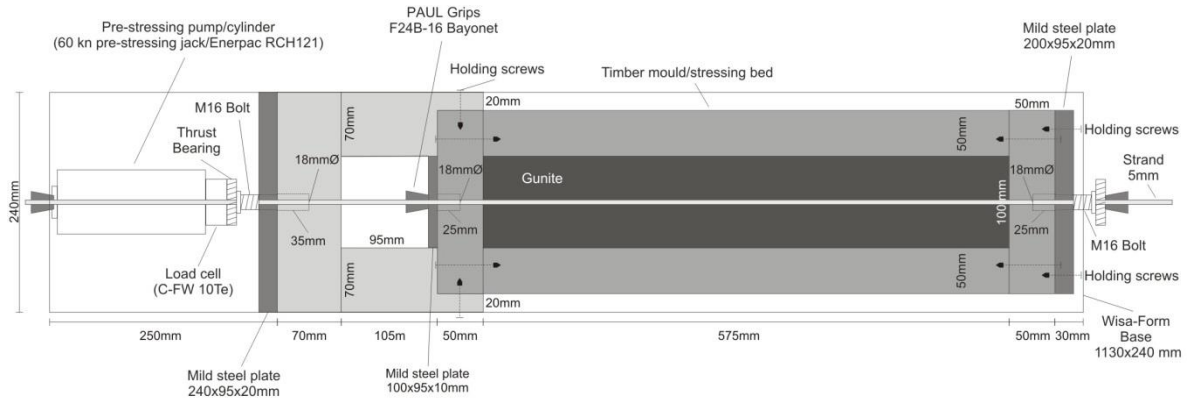
Figure 1 Timber mould and stressing bed

A number of timber moulds/pre-stressing beds (Figure 1) were designed and developed to (i) pre-load the tendon; (ii) provide formwork for the 100 mm x 100 mm mortar formulated to represent gunite in composition and strength (hereafter referred to as gunite) and (iii) enable the magnitude of pre-stress transfer to the gunite to be determined at rupture. The main components of the test system are given in Figure 1.

The mould and stressing bed shown in Figure 1 was used to determine the transfer of pre-stress to the gunite. The mould was securely fastened to the bed of a test frame and the pre-load was quickly released at one end by turning the mild steel bolt to relieve the stress in the tendon. The wedge was held with a vice-grip during stress release to prevent rotational bond failure of the tendon in the gunite. The contraction of the tendon was accurately measured via a linear variable displacement transducer (LVDT, accuracy calibrated using slip gauges) to give the 'shrink-length' upon release from which the transfer stress could be calculated.

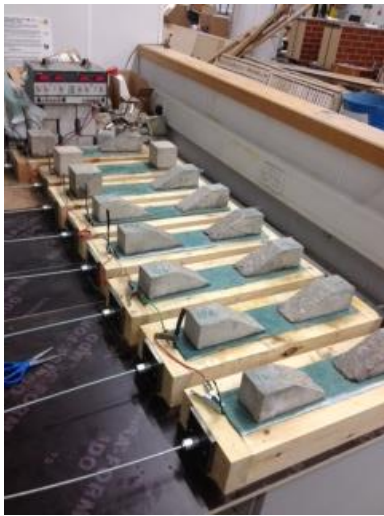
Figure 2 Accelerated corrosion of tendons via power supply (top left)

Eight specimens were laid side-by-side in the laboratory for accelerated corrosion (Figure 2) and current applied in parallel via a power supply. The polarity of the current was such that the tendon served as the anode and strips of mixed-metal oxide (titanium) placed on top of the specimens and weighed down to ensure full contact with the gunite served as the cathode. The specimens were covered with a green landscaping fabric which was continuously moistened to maintain an electrolytic connection. For each batch of eight specimens, the applied current was fixed (48.8 mA x 8, Equation 4) and corrosion period was adjusted (Equation 2) to give the required target degree of corrosion (e.g. 121.8 hours for 3 %, 243.6 hours for 6%).

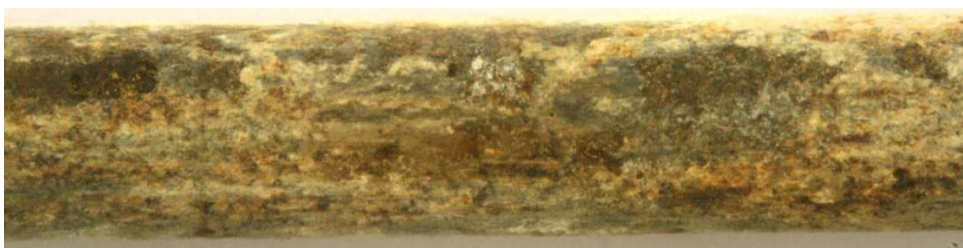
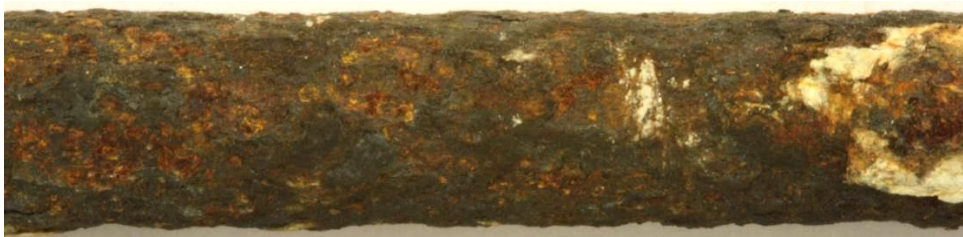
Figure 3 (a) Medium corroded Sample A5 (~3 %) and (b) High corroded Sample A11 (~6 %)

A visual representation of two different corrosion levels are given in Figure 3. Referring to Figure 3 (a), Sample A5 is considered as a Medium level of corrosion (~3 %) whereas Sample A11 in Figure 3 (b) represents a High level of corrosion (~6 %).

Both conditions represent the appearance of galvanized wires observed in pre-load structures. The Medium level of corrosion shows a significant proportion of white corrosion product from the galvanizing layer, with relatively little brown corrosion product from the underlying steel, Figure 3 (a). At the Medium level, the loss of steel cross-section is minimal and the strength of the tendon relatively unaffected. The High level of corrosion represents the condition where corrosion of the steel substrate dominates, resulting in both higher volume corrosion products and reduction in the cross-section of the wire and is a precursor to the disruption of the gunite and possible failure of the wire, Figure 3 (b).

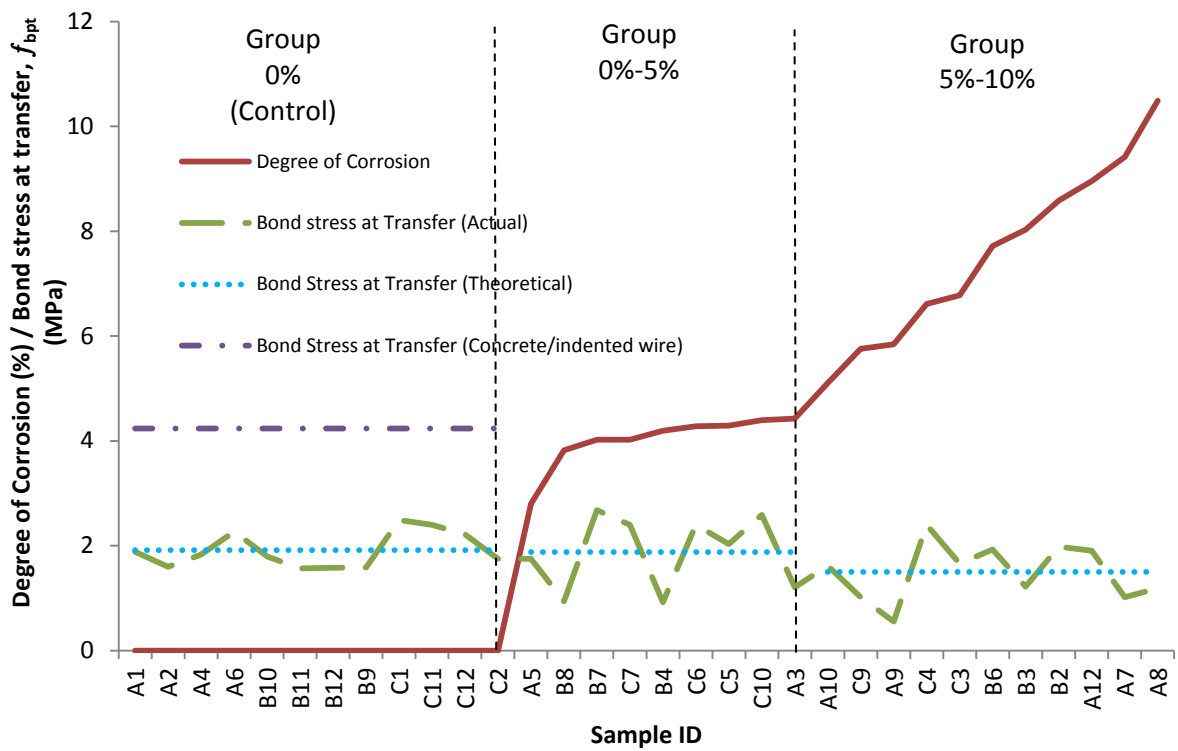
Figure 4 Relationship between degree of corrosion and bond stress at transfer

The data presented in Cols. 2 and 6 in Table 1 is shown graphically in Figure 4. The degree of corrosion is zero for the first twelve control samples but increases to a maximum of 10.49 % for Sample A8. Referring to Table 1, the average bond stress at transfer for Groups 0 % and 0-5 % corrosion are quite similar, 1.91 and 1.88 N/mm<sup>2</sup> respectively, hence low levels of corrosion have not significantly influenced pre-stress transfer. However, this decreases to 1.50 N/mm<sup>2</sup> for corrosion Group 5-10 % as the higher levels of corrosion has a greater influence on bond stress. For comparison, the design bond stress at transfer for a Grade 35 concrete and indented wire using the same parameters as used in the gunite example is also shown in Figure 4 (0 % corrosion,  $f_{bpt} = 4.23$  N/mm<sup>2</sup>, also unfactored). This is significantly higher than the average bond stress for the pre-load tendon/gunite found in these tests (1.91 N/mm<sup>2</sup> at 0 % corrosion, 1.88 N/mm<sup>2</sup> at 0-5 % corrosion and 1.50 N/mm<sup>2</sup> at 5-10 %).

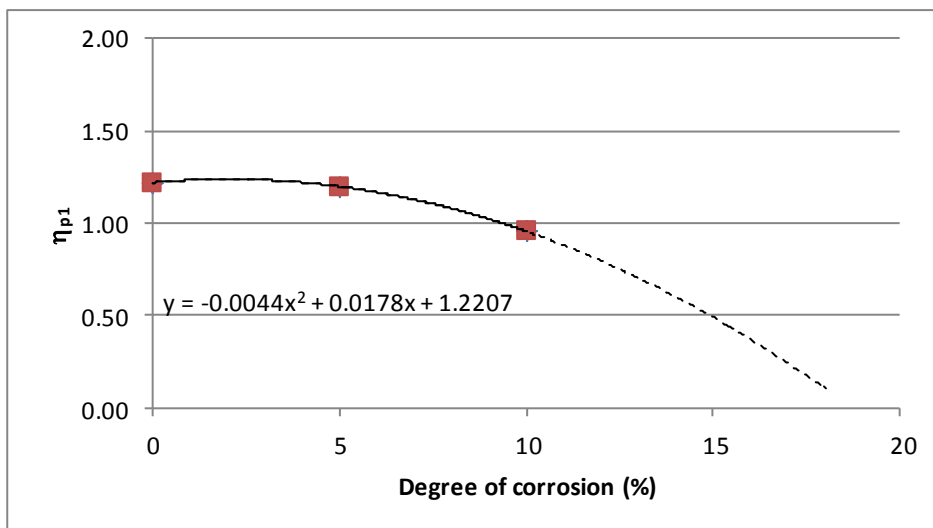
Figure 5 Reduction in  $\eta_{p1}$  with increasing corrosion (unfactored)

Referring to Table 1, the average bond stress at pre-stress transfer,  $f_{bpt}$  (rupture of the tendons) is 1.91 N/mm<sup>2</sup> at 0% corrosion, 1.88 N/mm<sup>2</sup> at 0-5 % corrosion and 1.50 N/mm<sup>2</sup> at 5-10 %. Substituting these values for  $f_{bpt}$  into Equation 8 gives empirical values for  $\eta_{p1}$  as

shown graphically in Figure 5. Referring to Figure 5, once an estimate of the degree of corrosion is obtained from a field investigation,  $\eta_{p1}$  can be obtained from Figure 5.

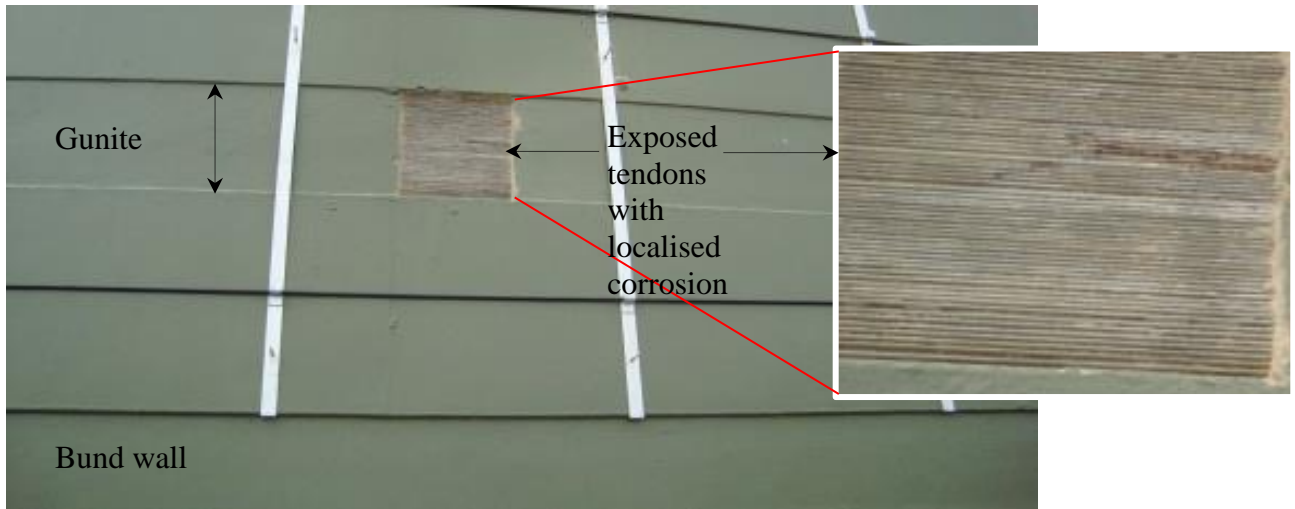
Figure 6 Typical bund wall with exposed tendons

The tendon recess (Figure 6) is shown idealised in Figure 8 where a number of vertical layers of tendons with gunite cover between them is shown. The depth and length of the recess can vary from structure to structure, but in the bunds inspected by the authors', the number of tendons varied from about 240 to 370 for a depth of 80 mm and height around 500 mm (bund wall thickness was 500 mm). A tendon in the outermost layer is assumed to rupture as this will be a worst case scenario (an explosive failure is more likely at this location as inner tendons will have more confinement, corrosion is also more likely on the outer layer).

Since corrosion can be very localised (see Figure 6), it is possible for two or more adjacent tendons to suffer damage at a similar point along their circumference, hence there is a possibility of overstressing the gunite due to double (or more) pre-stress transfer. Referring to Figure 12, the gunite area of influence overlaps for two adjacent tendons. It is assumed that both tendons do not rupture at exactly the same time, it is more likely that one will rupture first followed by the second sometime later, hence the concept of pre-stress transfer influencing a zone around the single tendon as analysed in Section 5.3 also applies here. Referring to Equation 15, the area of gunite required for equilibrium for a single tendon rupture in this example is 935 mm<sup>2</sup> ( $A_{zone}$ ), hence this will be doubled to 1870mm<sup>2</sup> at double

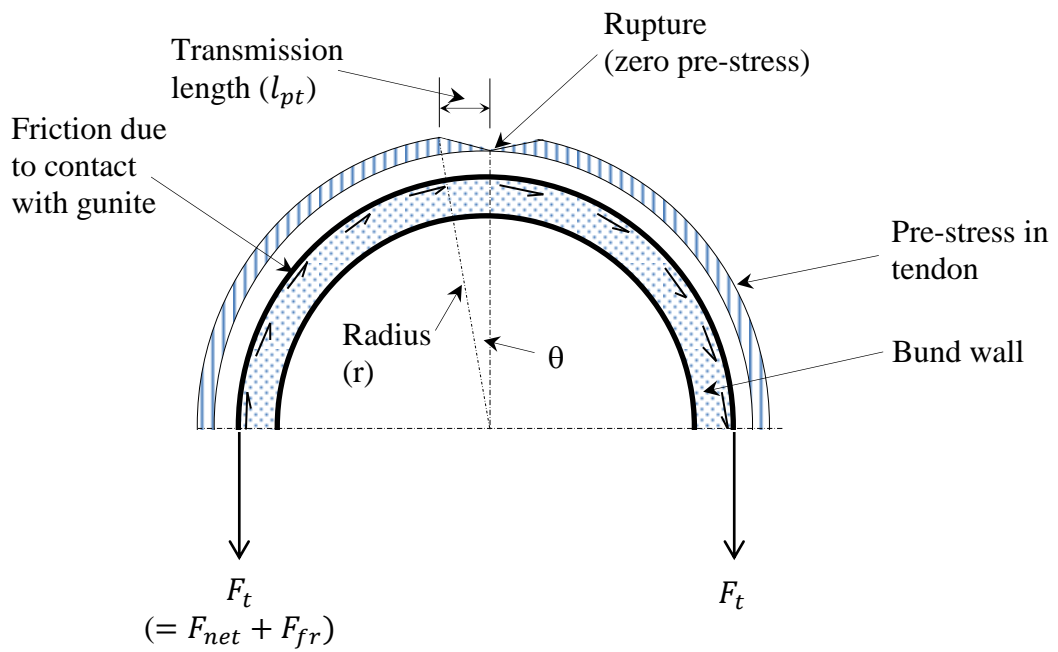
Figure 7 Plan of half bund wall with pre-stressed single tendon

When the tendon ruptures, the pre-stress becomes zero at the point of failure but gradually increases along the transmission length ( $l_{pt}$ , Figure 7 and Figure 8). The pre-stressing force ( $F_t$ ) is fully mobilised beyond  $l_{pt}$  and transmitted to the gunite via bond. This is shown in Figure 8 where a single tendon is isolated to clarify the transmission length,  $l_{pt}$ , and increasing stress from point of rupture (zero stress) to full pre-stress at a distance  $l_{pt}$ . From EC 2 [14], the transmission length,  $l_{pt}$ , is given by:

Referring to Figure 7 and Figure 8, the zero stress at point of rupture will increase gradually along the tendon until full pre-load is transferred to the gunite at the end of the transmission length ( $l_{pt}$ ). At this point, the force in the gunite ( $F_g$ ) equals the force in the tendon ( $F_t$ ) due to equilibrium and since force equals stress times area, it follows that:

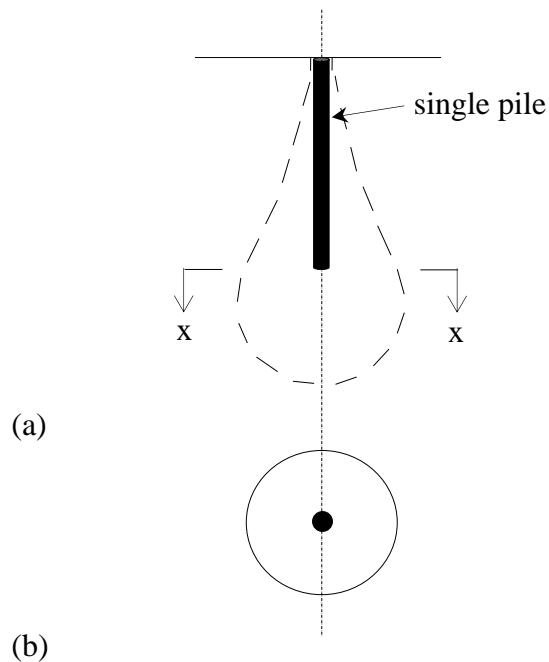
Figure 9 (a) Vertical section through pile pressure bulb, horizontal section x-x through pile pressure bulb

In order to estimate the area of gunite in the idealised section that is influenced by the ruptured tendon, an analogy is made with the pressure exerted on adjacent soil through a loaded single pile. Referring to Figure 9 (a), the adjacent soil is stressed in the shape of a bulb if a vertical section is taken along its depth. However, if a horizontal section (x-x, Figure 9 (b)) is taken, the stress is distributed uniformly around the pile in a circular shape. Therefore, it will be assumed that when a tendon ruptures, the zone of the influenced gunite can also be assumed as circular in the vertical plane commencing at a distance  $l_{pt}$  (Figure 8).

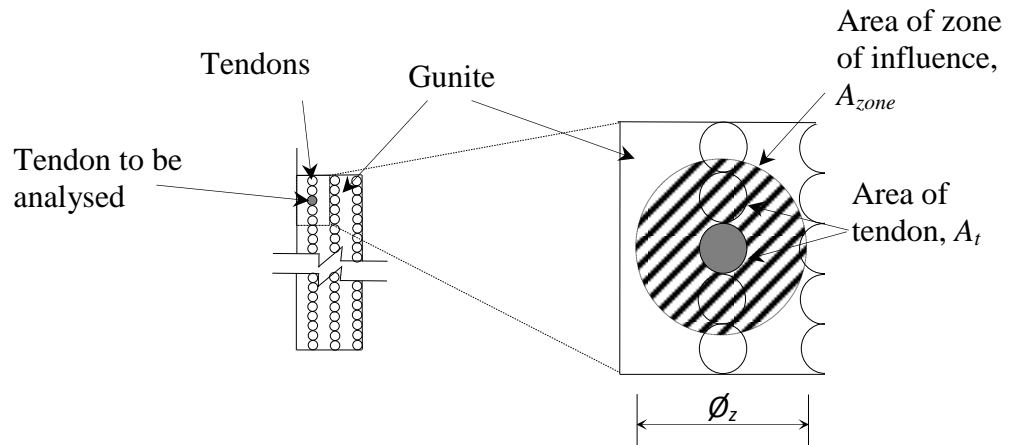
Figure 10 Idealised area of zone of influence due to single tendon rupture

Referring to Figure 10, a section through the recess is given which highlights the zone of influence,  $A_{zone}$ , as a result of the ruptured tendon. This circular area will overlap and/or intersect adjacent tendons above and below the ruptured tendon under consideration which will contribute to carrying the compressive force in the gunite. The area of the zone of influence,  $A_{zone}$ , is calculated from:

and solving gives the positive root as 2.4, meaning the number of tendons in the zone of influence,  $n$ , is 2.4 (or 3.4 if the ruptured tendon is included). Inserting  $n = 2.4$  back into Equation 19 (or Equation 20) gives  $\phi_z = 17$ mm, the diameter of the zone of influence (Figure 10). The cover,  $C_t$ , to the ruptured tendon can now be checked from:

In addition, rupture of tendons at other levels of pre-stress will also influence the diameter of the zone of influence,  $\phi_z$ , Figure 10. This is also modelled in Figure 11 where the number of tendons,  $n$  (secondary y-axis) contributing to absorbing the pre-stress transfer in the gunite

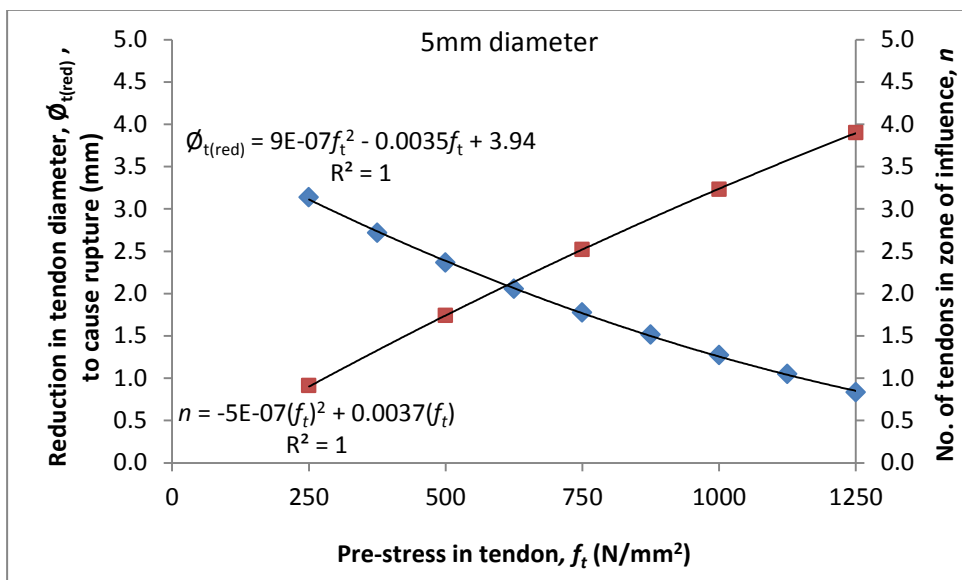
Figure 11 Determination of: (primary y-axis) loss in ruptured tendon diameter for different levels of pre-stress transfer; (secondary y-axis) number of 5 mm  $\phi$  tendons in zone of influence for other levels of pre-stress transfer

The example presented here focuses of a pre-load of 1.5 metric tonnes on the tendon (giving a pre-stress,  $f_t$ , of 750 N/mm<sup>2</sup>). However, if the design pre-stress varies in the ruptured tendon, the loss in diameter to cause failure also varies. This is considered in Figure 11 where  $F_t$  is varied in Equation 26 to give different levels of pre-load in the tendon (converted to pre-stress,  $f_t$ , in Figure 11). The reduction in tendon diameter,  $\phi_{t(red)}$  (primary y-axis in Figure 11) can be related to the pre-stress in the tendon by:

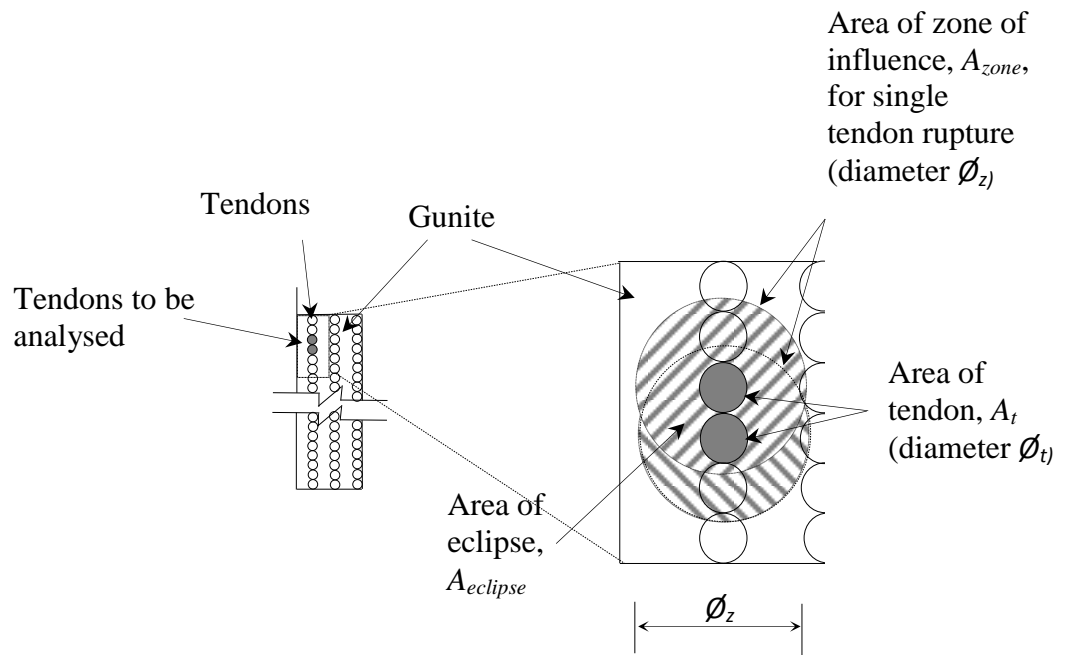
Figure 12 Idealised area of zones of influence due to double tendon rupture

tendon failure ( $2A_{zone}$ ). However, the zone of influence from two ruptured adjacent tendons will overlap (Figure 12) meaning the eclipsed area will be subjected to two pre-stress transfers and possible over stressing. Using  $\phi_z = 17$  mm from Equation 19 or Equation 20, the eclipsed area ( $A_{eclipse}$ ) is  $143 \text{ mm}^2$  from [24]. However, this area will include tendons which will also help carry the pre-stress transfer and by inspection of Figure 12, the adjacent zone of influence due to the second tendon rupture has moved downwards by one tendon diameter. It was established above (Equation 24 or Equation 29) that  $n$  equals 2.4 tendons in a single zone of influence, hence  $n$  in the eclipsed area will be one tendon diameter less or 1.4 (this includes the tendon which ruptured first as this will now support the pre-stress transfer to the gunite). Since the area of the eclipsed zone of influence ( $A_{eclipse}$ ) equals  $143 \text{ mm}^2$  from above, the net area of gunite in the eclipsed zone ( $A_{g(eclipse)}$ ) will be  $A_{eclipse}$  minus the area of the tendons within this zone i.e.  $nA_t$  or  $1.4A_t$ . As shown in Section 5.3, these tendons will contribute to carrying the pre-stress so an equivalent area of gunite ( $A_{g(equiv)} = nmA_t$ ) can be obtained to give:
