1 **Engineering Geology and Tunnelling in the Limmo**

2 **Peninsula, East London**

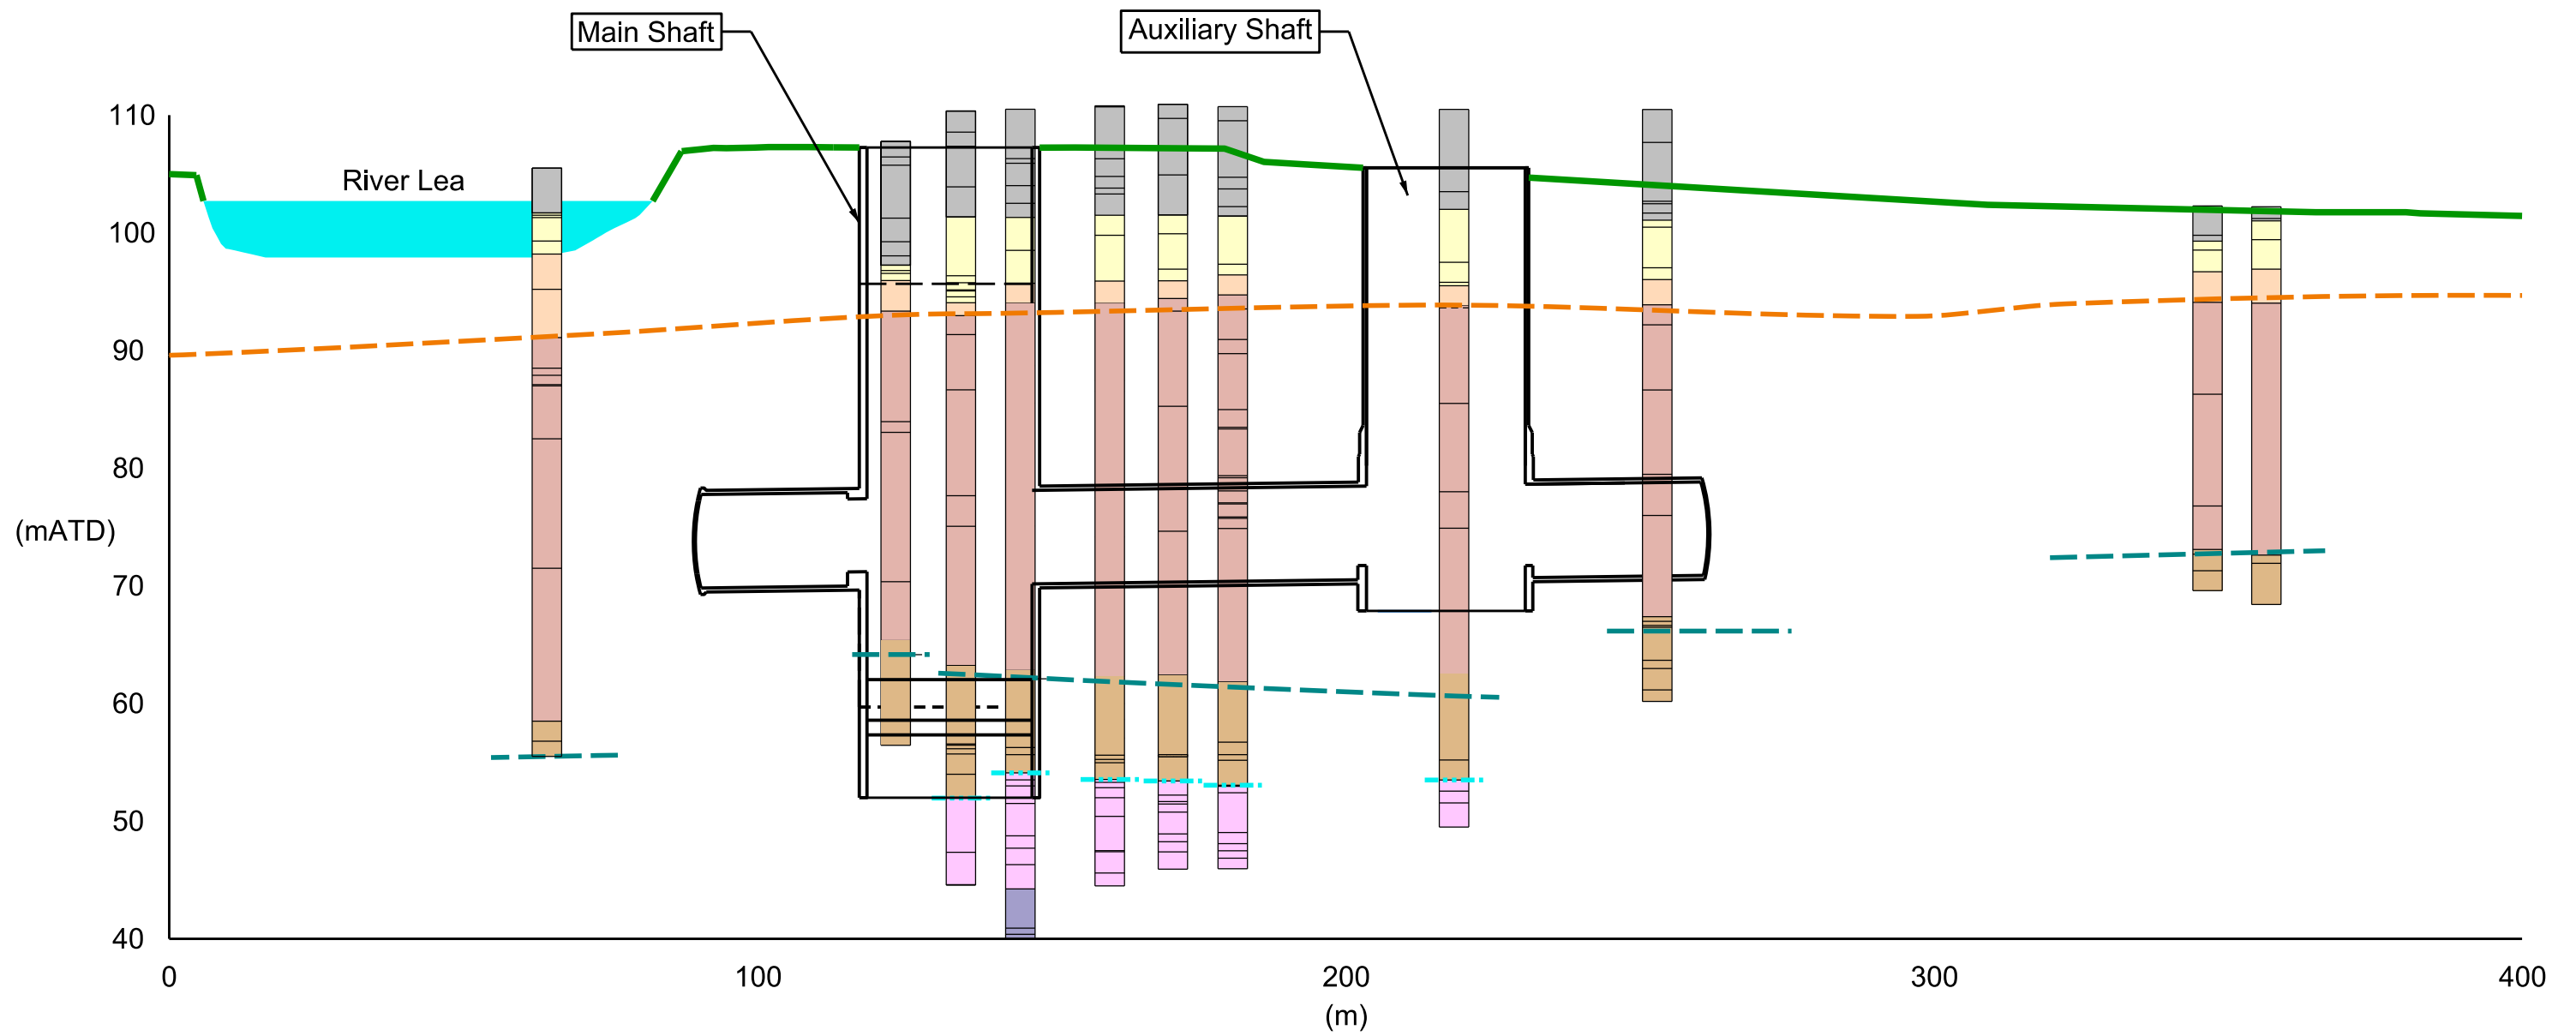
365 Figure 4. Geological cross section in Limmo site.

95 Figure 4 shows a schematic geological cross section based on the ground investigation.

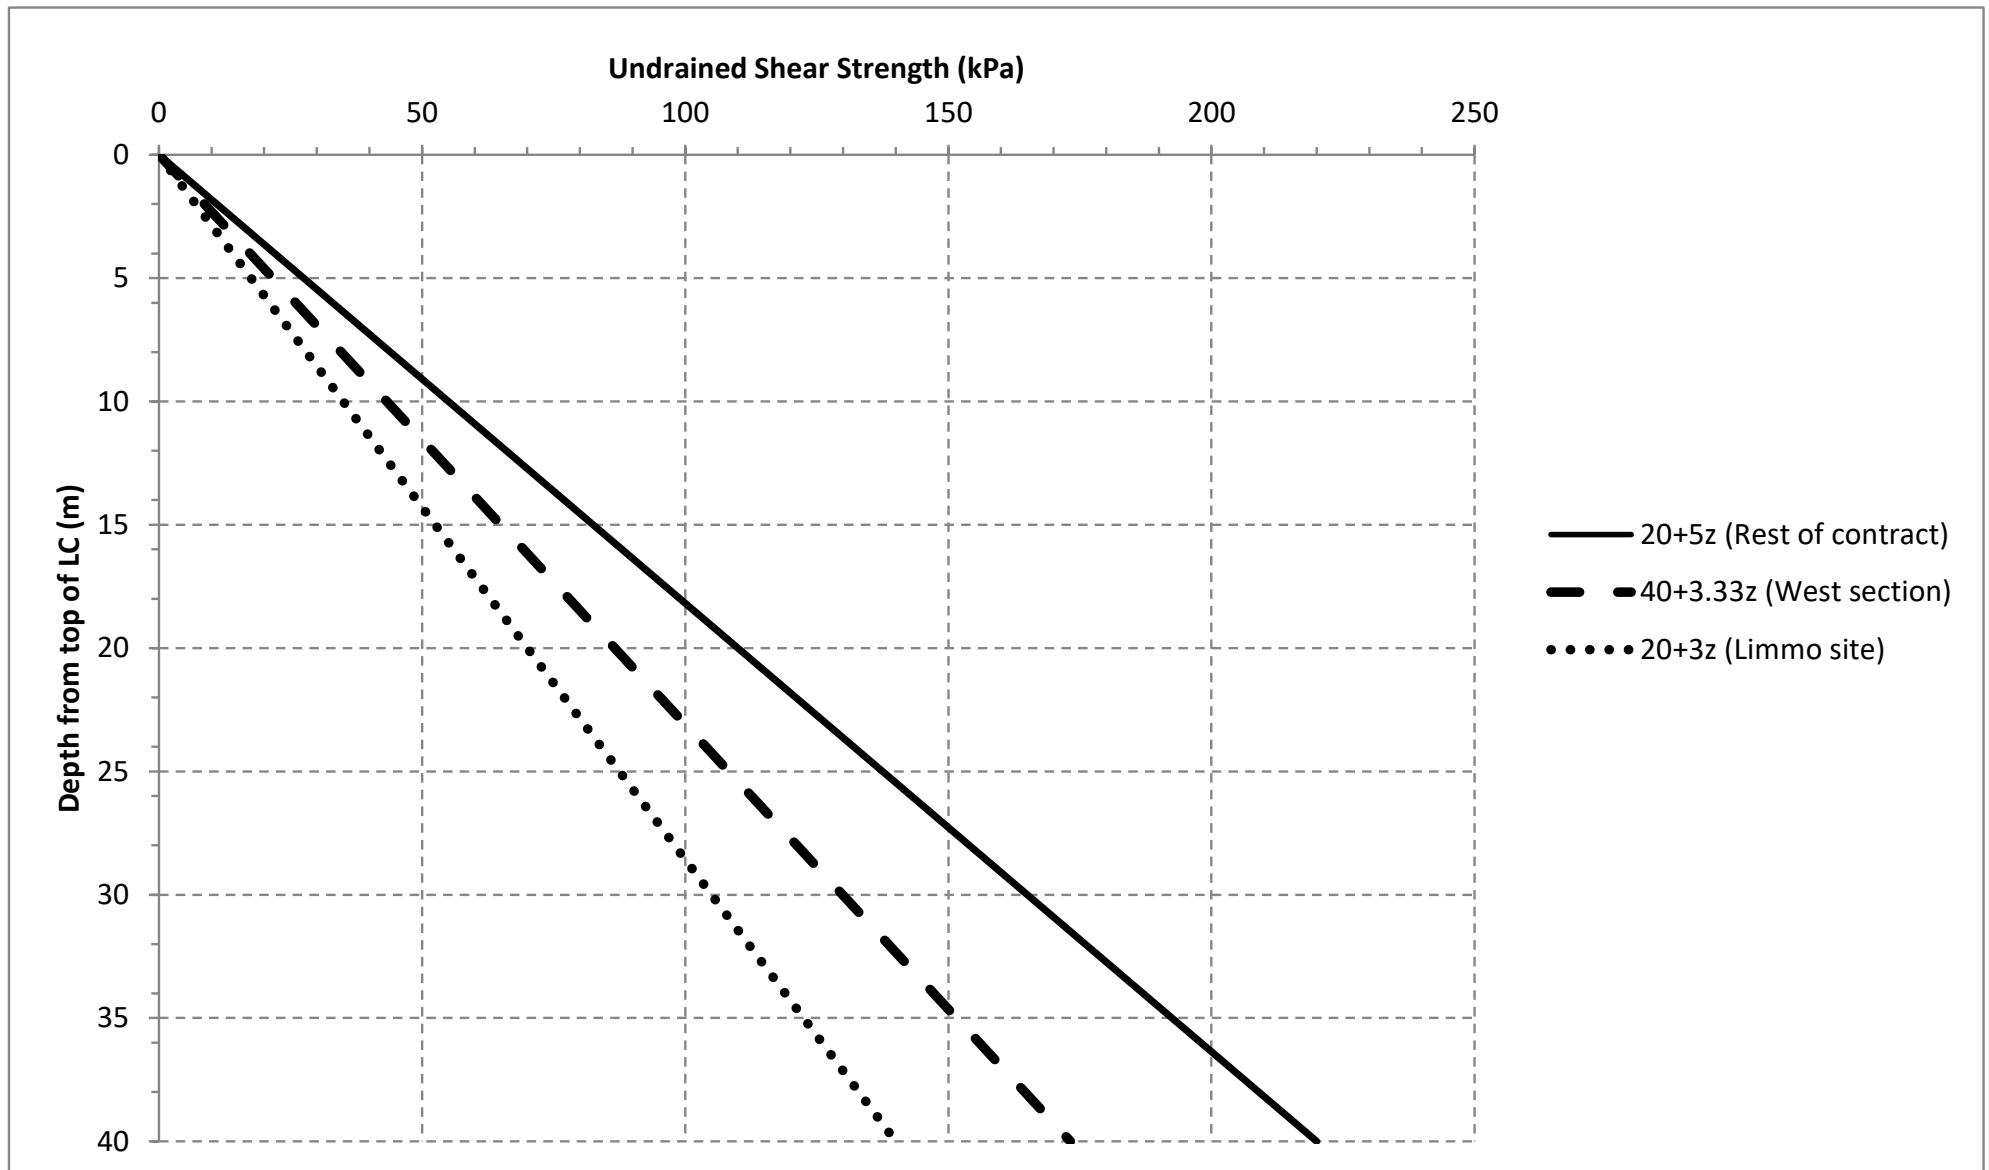
366 Figure 5. London Clay lower bound values of the undrained shear strength obtained with
367 for Limmo and for all other Crossrail sites.

130 Routine laboratory testing was performed on fine and coarse grained soil samples obtained from the
131 boreholes, including classification and index tests, and routine strength tests. In all the units the index
132 test results were typical for the London area. An exception to this was that at Limmo, the undrained
133 shear strength (s_u) measurements were lower than those at other Crossrail sites, especially the
134 minimum values. Figure 5 shows a comparison of the lower bound values for Limmo site with the rest
135 of the East section of the Crossrail tunnel (Liverpool St-Pudding Mill Lane) and the West section
136 (Royal Oak – Liverpool St.).

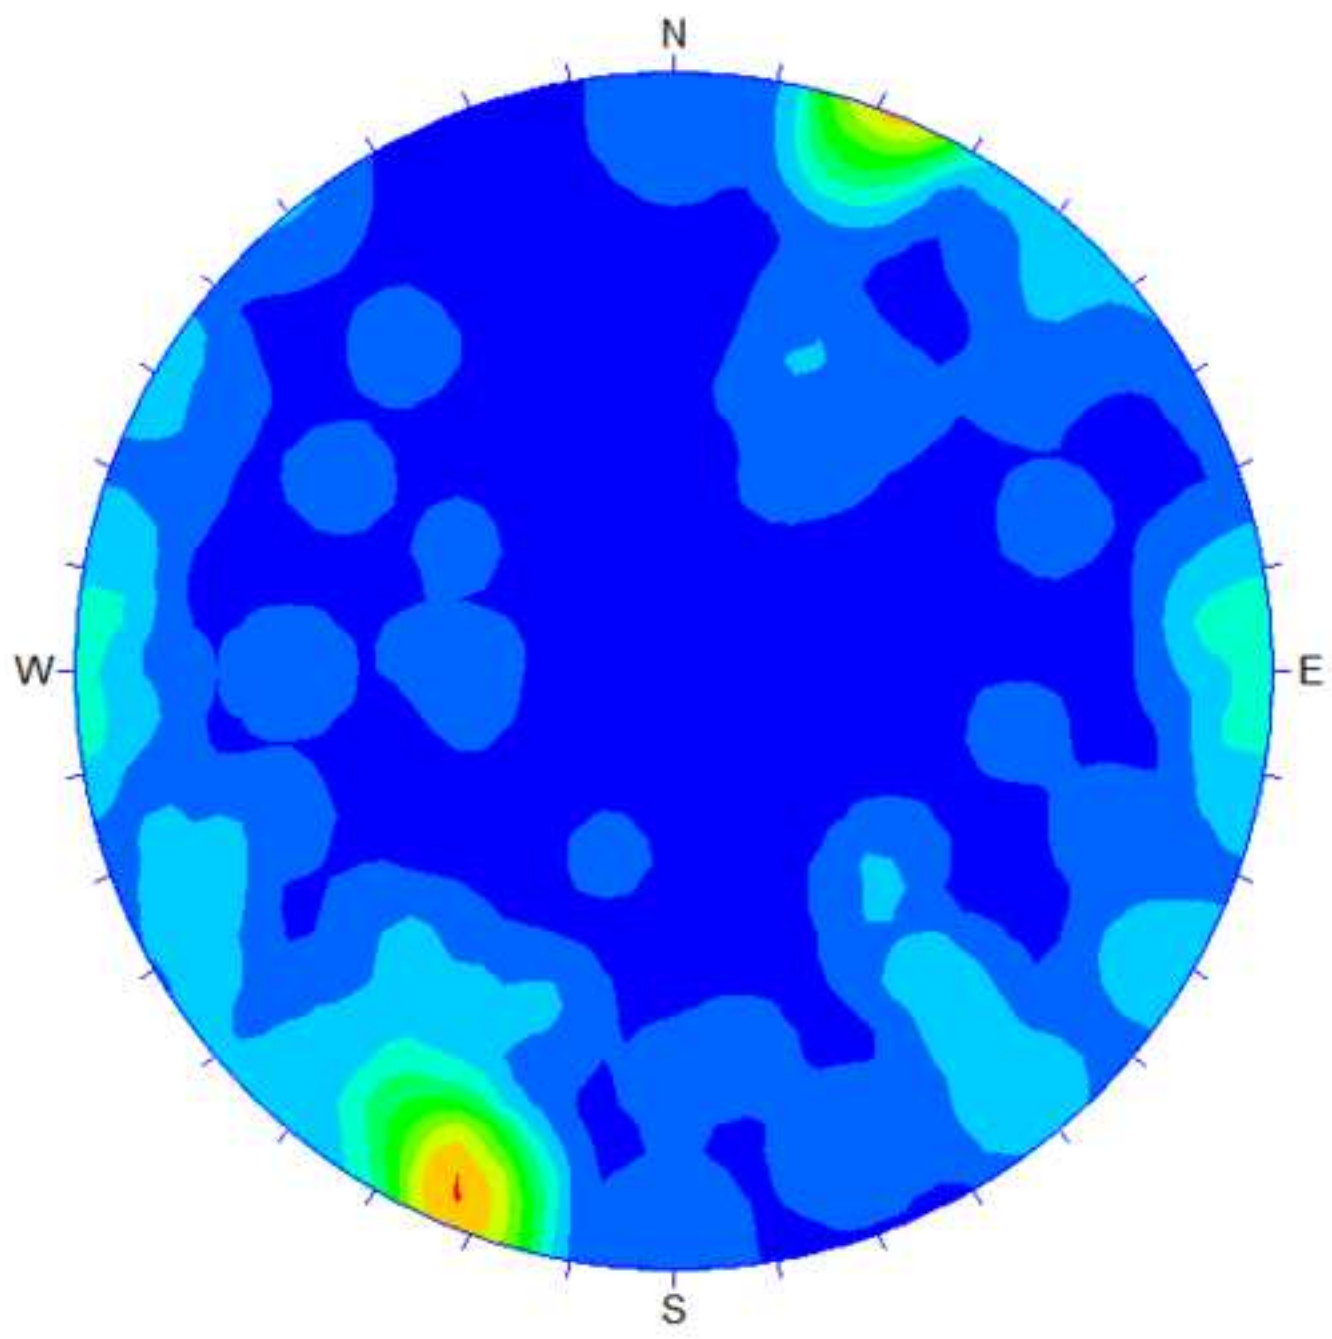
368 Figure 6. Stereogram polar density plot of discontinuity orientation

167 Fissures are a common feature in the London Clay formation. Usually, they are regarded as of
168 synsedimentary or lithogenic origin. In the Limmo area the spacing is quite small, ranging from
169 medium to extremely closely spaced. Polished and slickensided surfaces (commonly known as
170 'greasybacks') were encountered but no trend in the orientation was identified.

171 Joints, defined as discontinuities longer than 1 m and probably tectonic in origin, are also very
172 frequent. They are usually planar and polished, occasionally slickensided. Apertures range between
173 0.1mm and 1 mm, and are sometimes filled with a soft clay. Joints are typically spaced at 100 mm to
174 2m intervals. Discontinuity orientations were recorded during excavation of the main shaft (Figure 6).
175 The primary set is sub-vertical, striking WNW-ESE, with a second set striking N-S. However,
176 discontinuities may strike in any direction with dips as low as 40° to 60°.

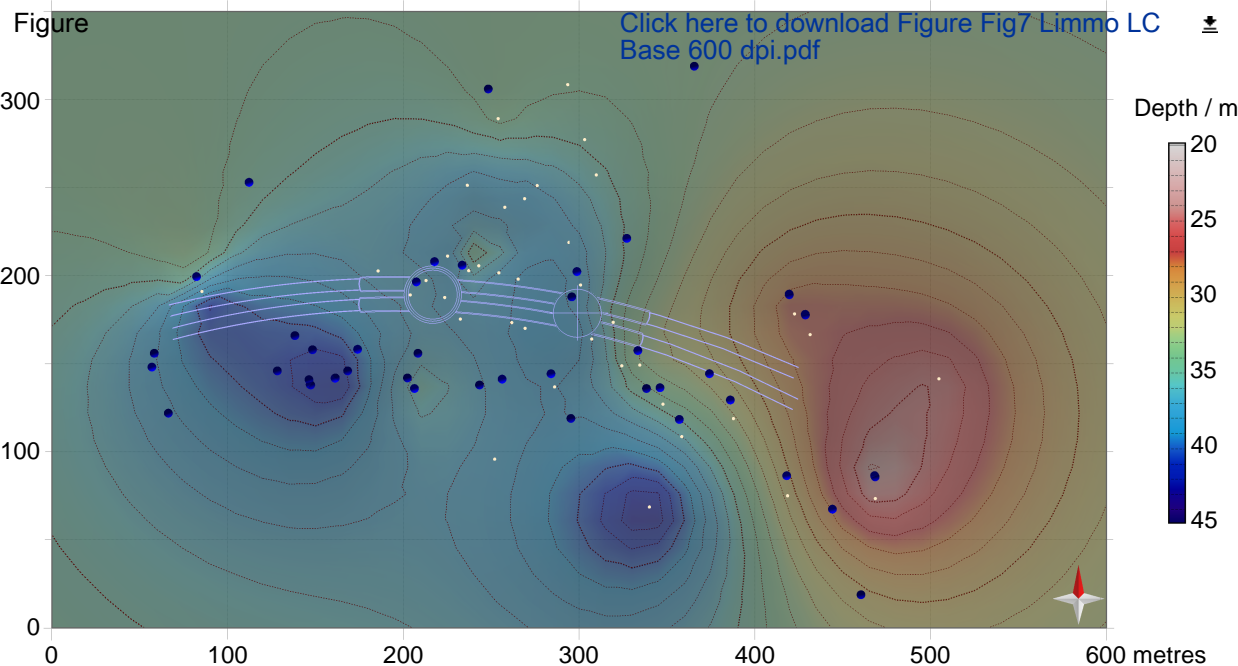
369 Figure 7. Estimated contours of the base of the London Clay formation across the Limmo site

191 Desk studies and ground investigation data meant that faulting was anticipated at the Limmo site: the
192 variation in the elevation of the boundaries between different strata is a clear indicator. Figure 7
193 shows an estimation of the contours of the base of the London Clay formation using the boreholes,
194 that suggest the presence of faults especially to the south of the shafts.

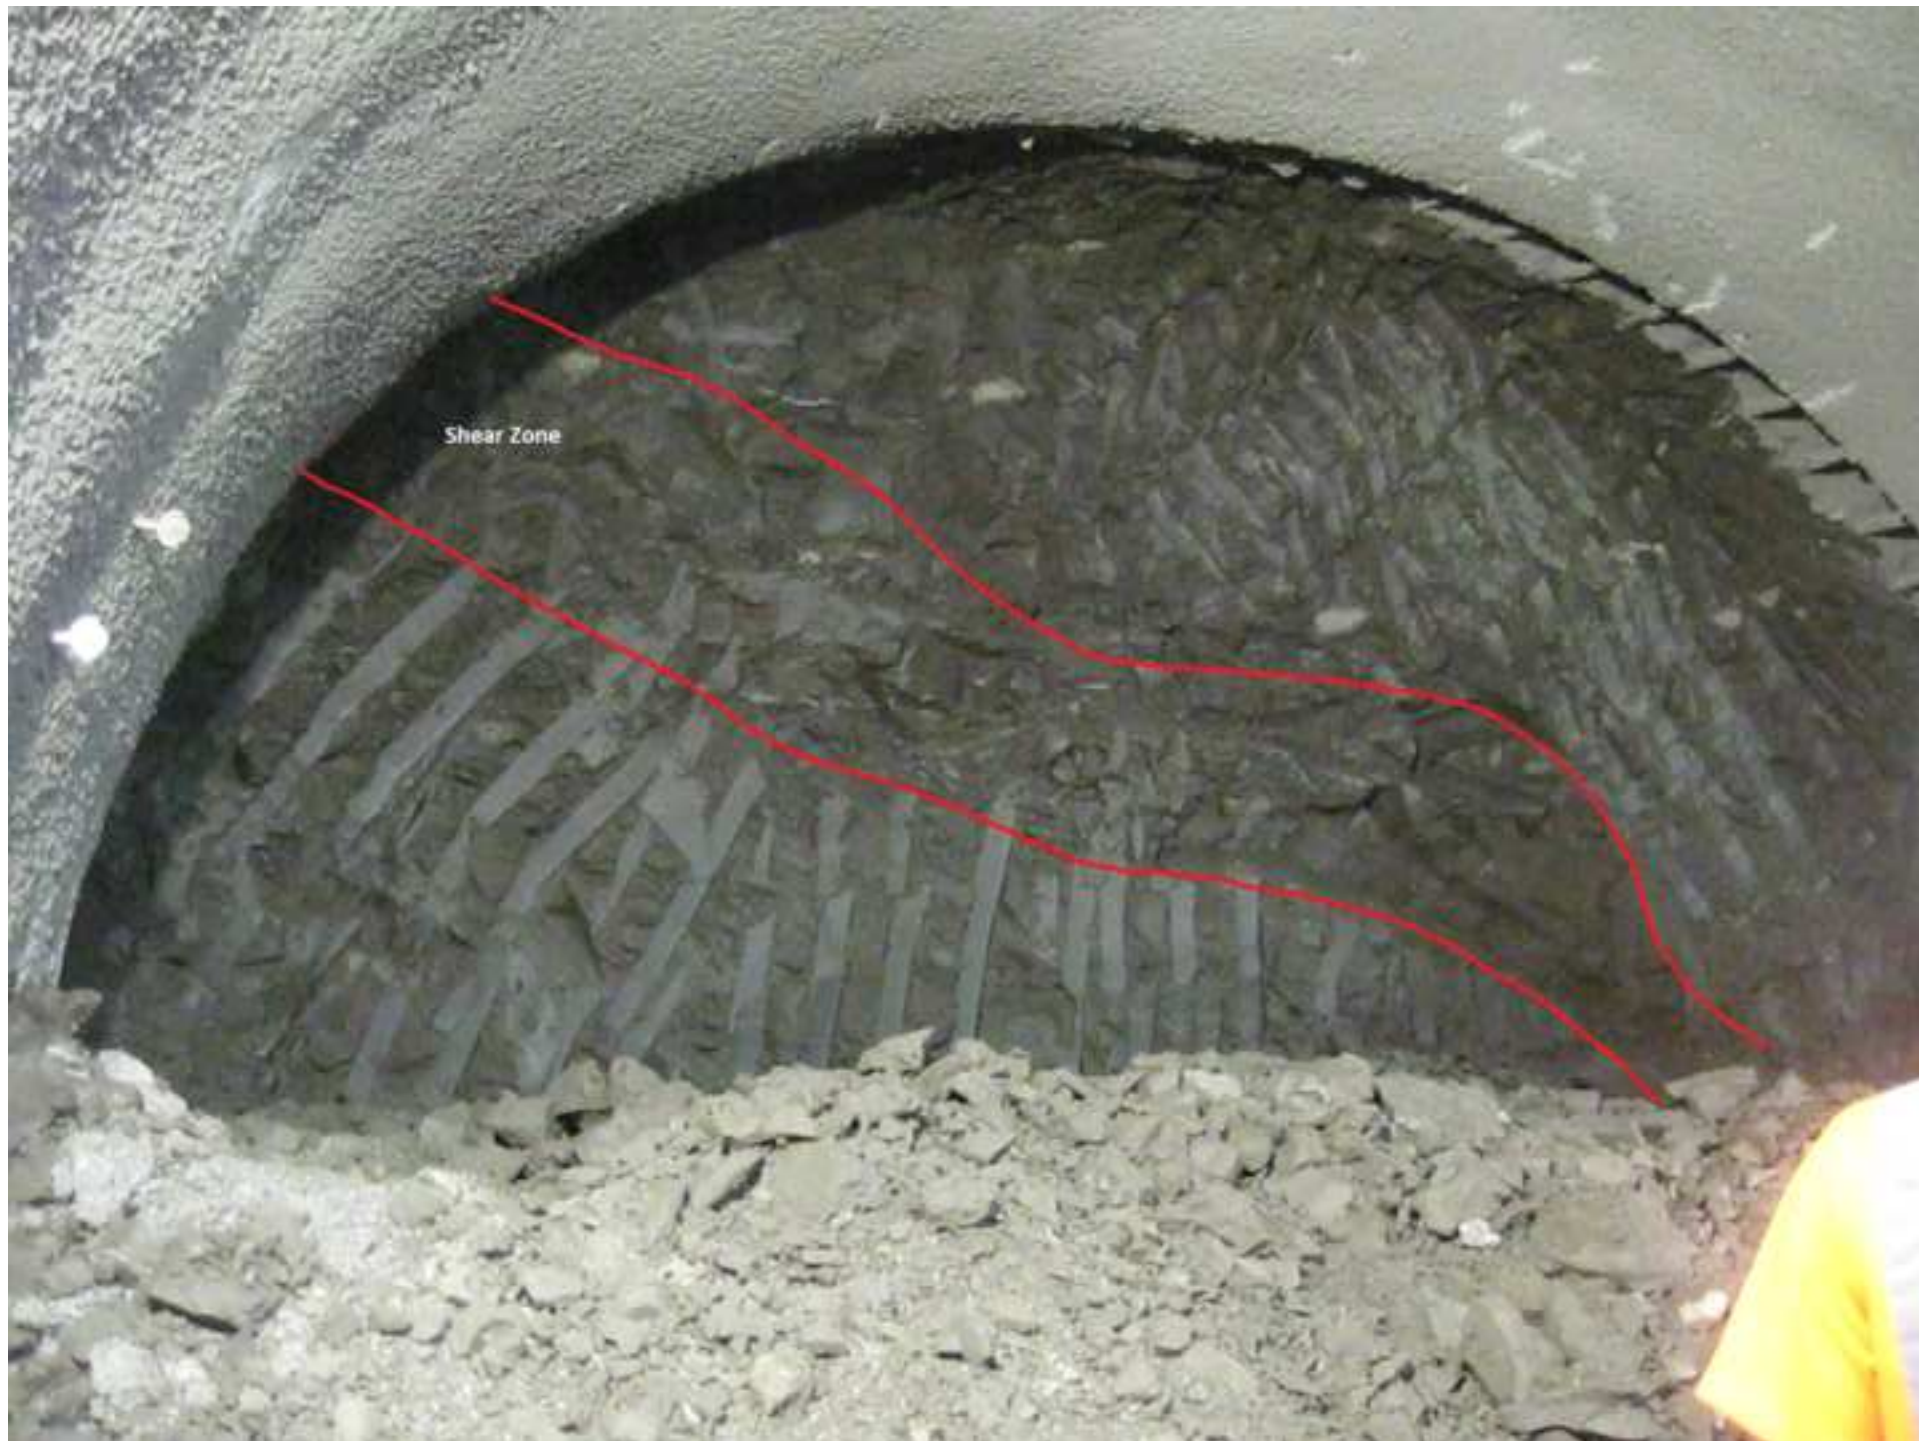
370 Figure 8. Shear zone encountered between Chainages 9 to 12.

203 Between Chainages 9 to 12 a ~1 m band of highly fractured clay was encountered (Figure 8), with an
204 orientation of approximately 70/150 (dip/azimuth). It was assumed to be a fault, but its slip direction
205 could not be estimated.

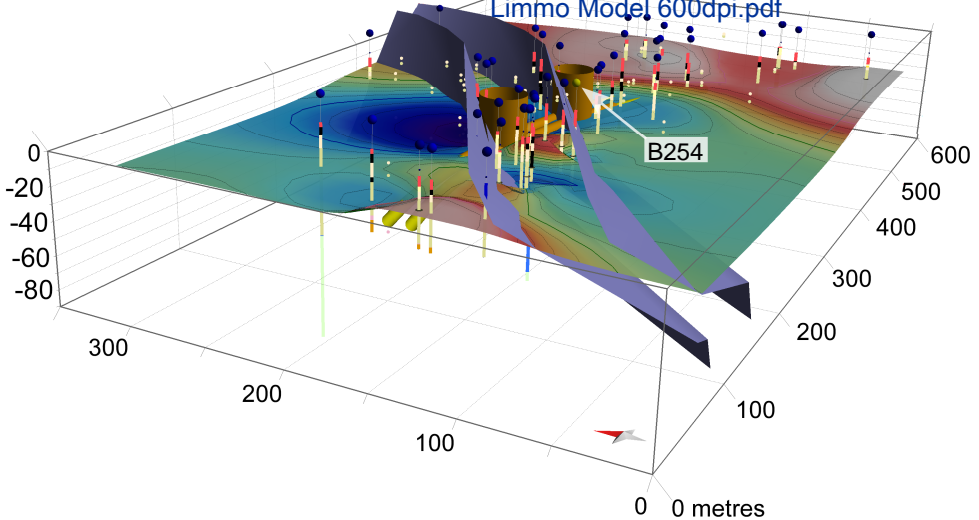
384 Figure 10 Idealised section and block diagram illustrating the propagation of fractures associated with
385 a bend on a strike-slip fault, through younger sediments. A bend (A) on a basement strike-slip fault
386 causes a releasing bend pull-apart basin (idealised at B) in the Chalk, probably during early Tertiary
387 extension. This is reversed by recent inversion (shortening) aligned slightly obliquely to the basement

388 fault (note that the straight part of the blue and red fractures is oriented differently to the straight line
389 part of the green fracture), and generates new restraining bend push-up structure (C and D) in the
390 Tertiary sediments (Lambeth Group and London Clay Formation), one new push-up structure for each
391 fracture in the Chalk pull-apart structure. Note the complexity this generates at (D); in reality, many
392 fractures would have formed in the pull-apart basin (B), each generating a push-up structure
393 themselves contain many fractures. Hence the ground in these areas becomes intensely fractured and
394 weakened.

236 Figure 10 represents an idealised block of this structure for clarity

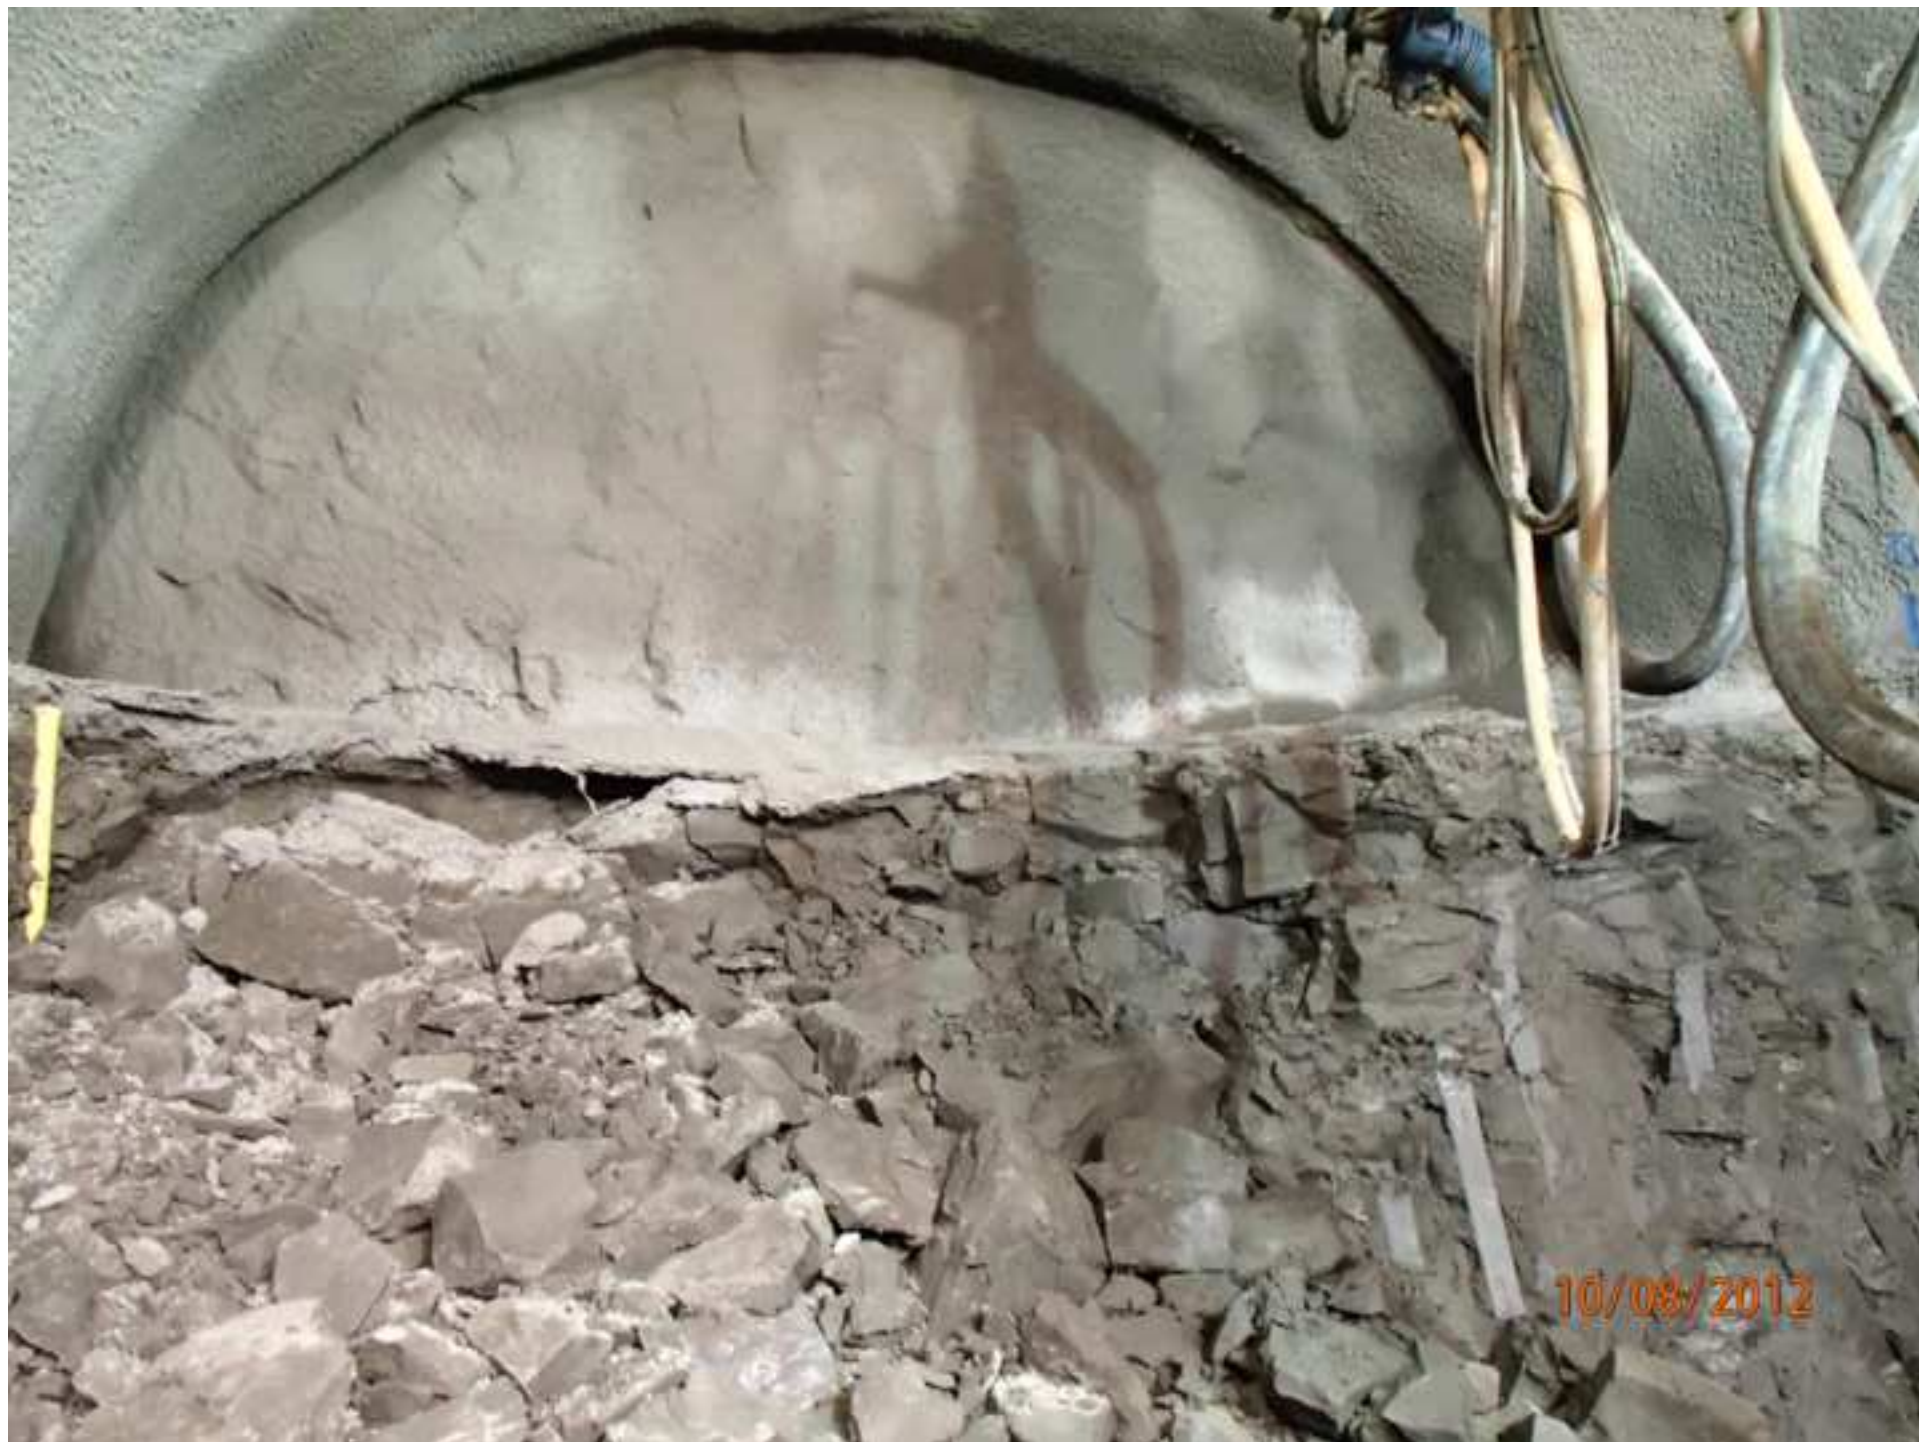
399 Figure 13. Circular failure during bench stage

278 In another instance, a local increase in the frequency of joints and fissures led to a rotational failure.
279 As a consequence, the clay behaved similarly to a blocky rock mass (Figure 13).

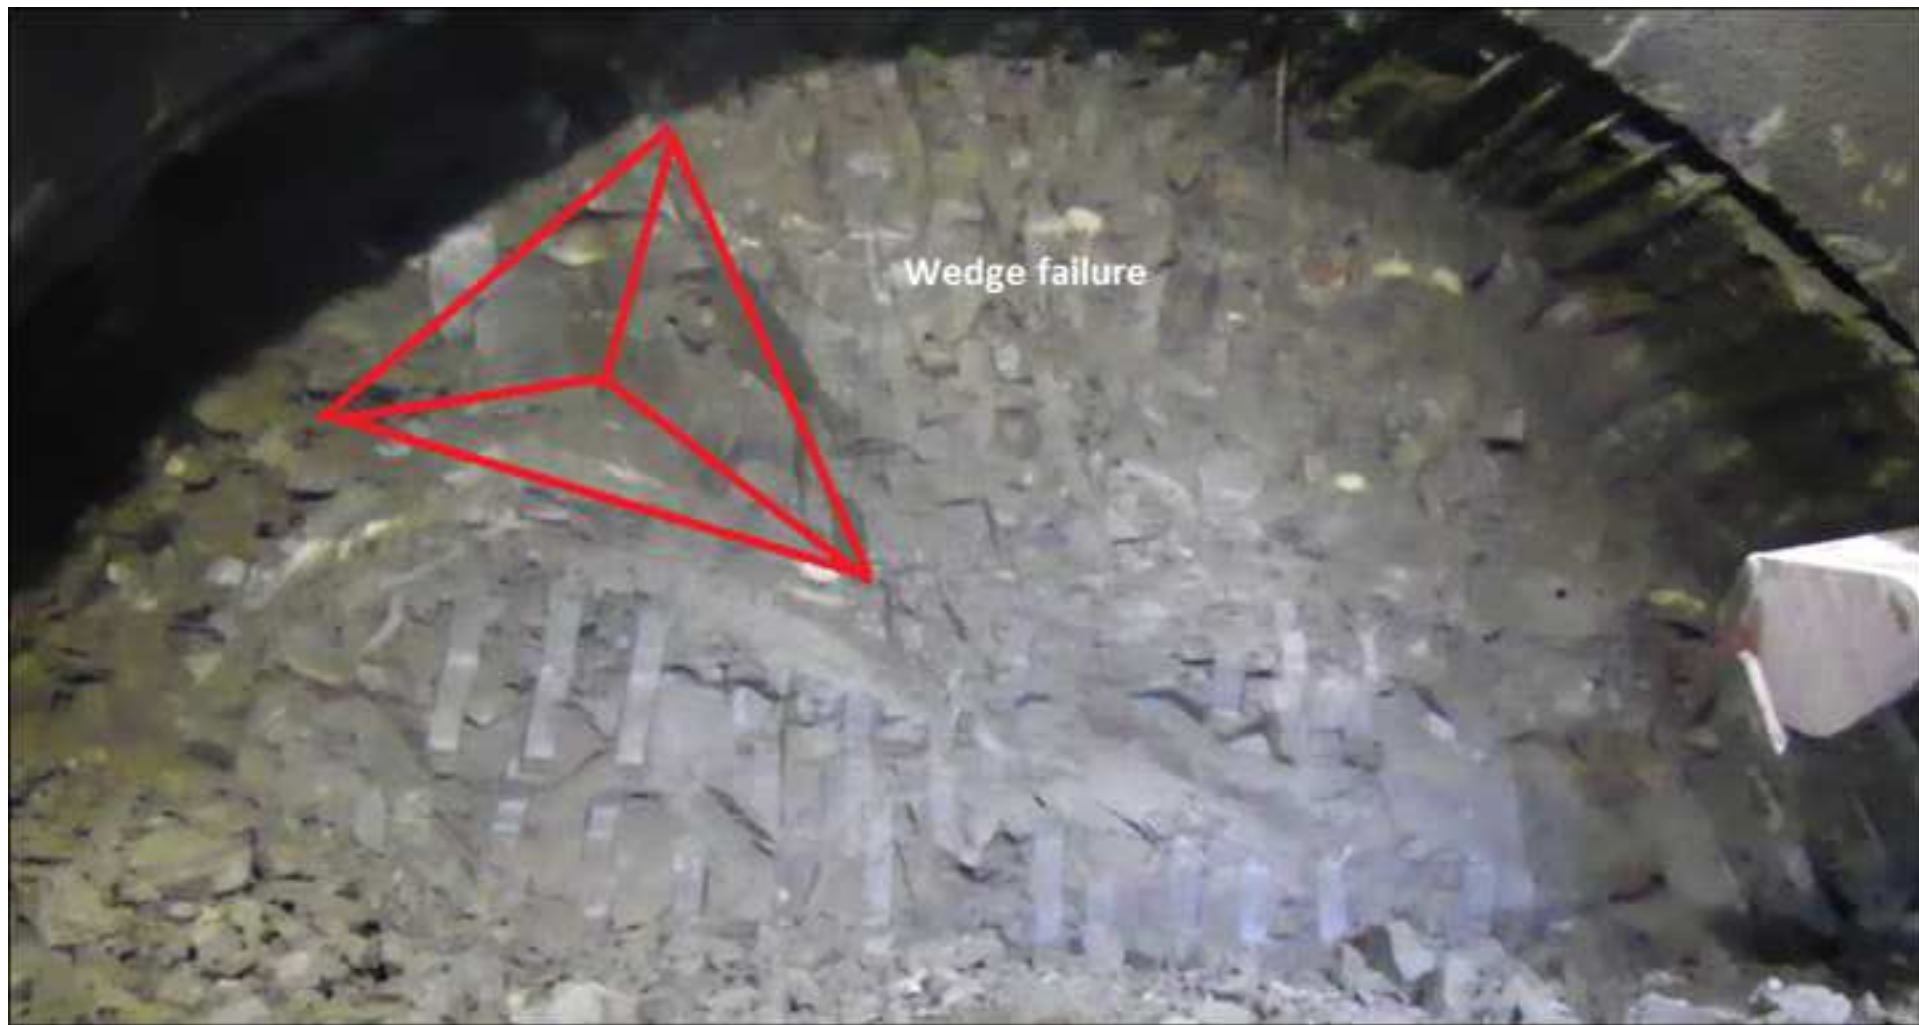
400 Figure 14. Wedge failure during top heading stage

283 The presence of discontinuities also impacted the stability of top headings. There were numerous
284 examples of wedge failures during the excavation. Figure 14 shows an example of a localised wedge
285 fall from the top heading face that occurred as a result of the intersection of three discontinuities.
