Research & Consultancy Report No. 58

Reliability Case Notes No. 4

Autosub6000 and Autosub3 actuator potentiometer
failure analysis and testing report

M E Furlong and M P Brito

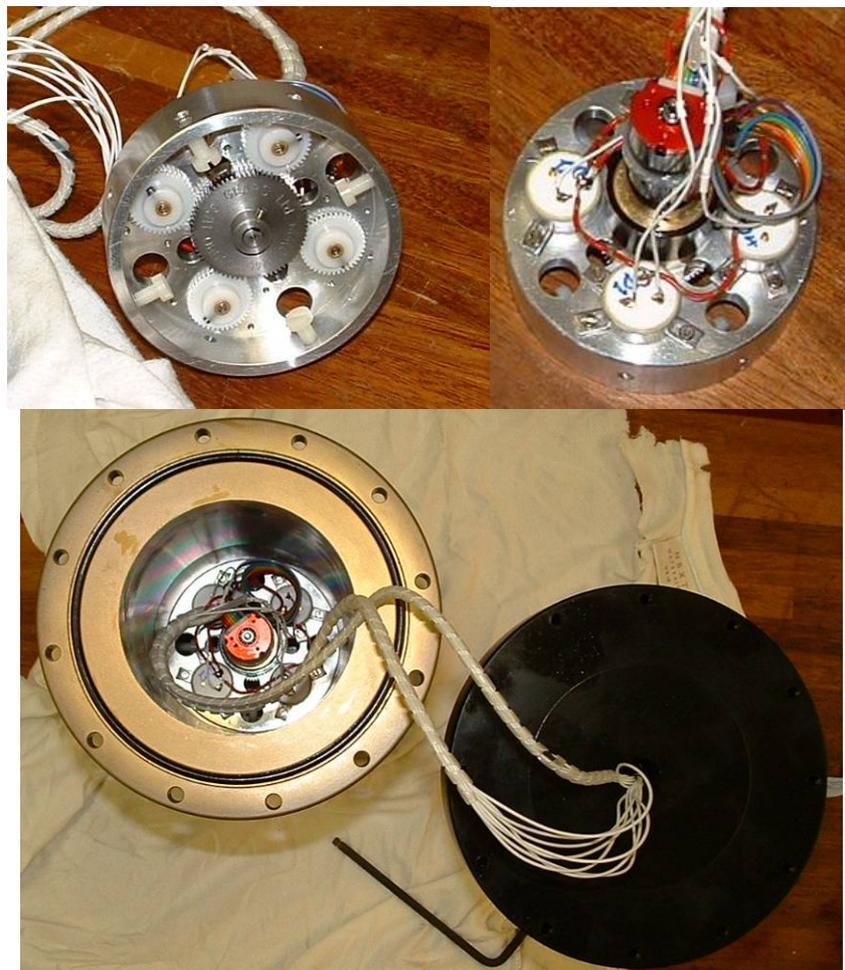
The final hypothesis was that the pressure would cause the breakdown in the track. This was tested by simulating running conditions of the potentiometer in an accelerated aging test in the pressure pots within NOCS. To speed up the testing a rig was built that could test four potentiometers together. The rig is shown in Figure 5 and Figure 6.

Figure 5 – Internal arrangement of the potentiometer tester

The potentiometers were driven using a Maxon brushless dc motor powered by the Autosub6000 actuator test rig. This in turn was controlled using Labview to control the potentiometer oscillations. One of the potentiometers was used for feedback to the rig. During testing the Labview software logged the resistance of the potentiometer tracks as well as the input voltage and orientation of the potentiometers.

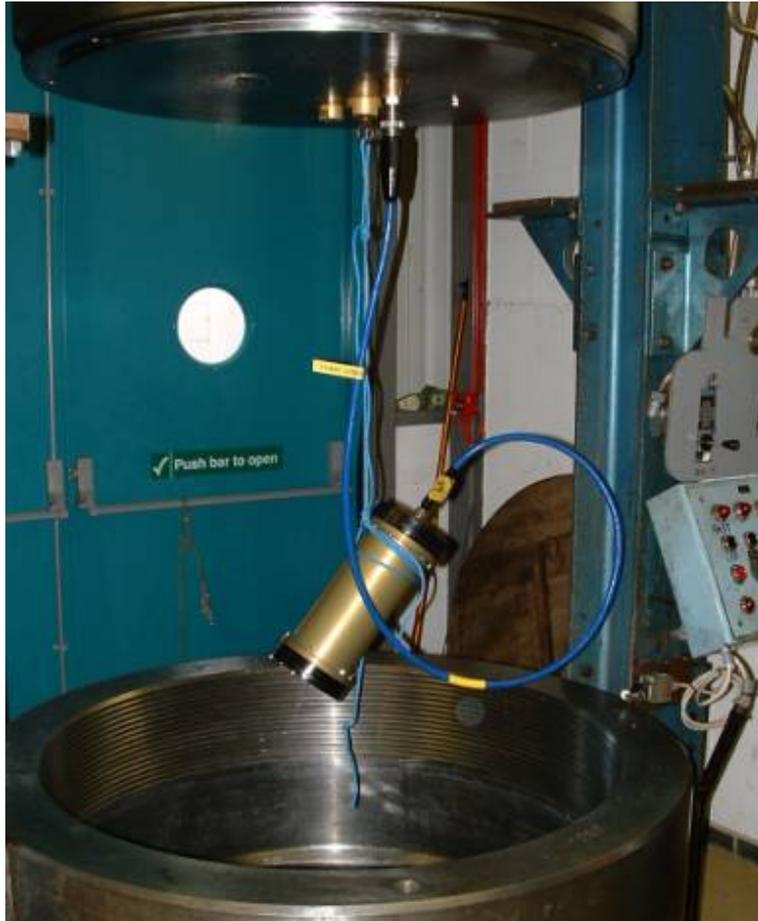
Figure 6 – The potentiometer tester in the large pressure pot
