The Source of Building Stone for Westown Kirk, Perthshire: a geological and architectural investigation

BUILDING STONE ASSESSMENT GEOREPORT GR_200779/1

The source of building stone for Westown Kirk, Perthshire: a geological and architectural investigation

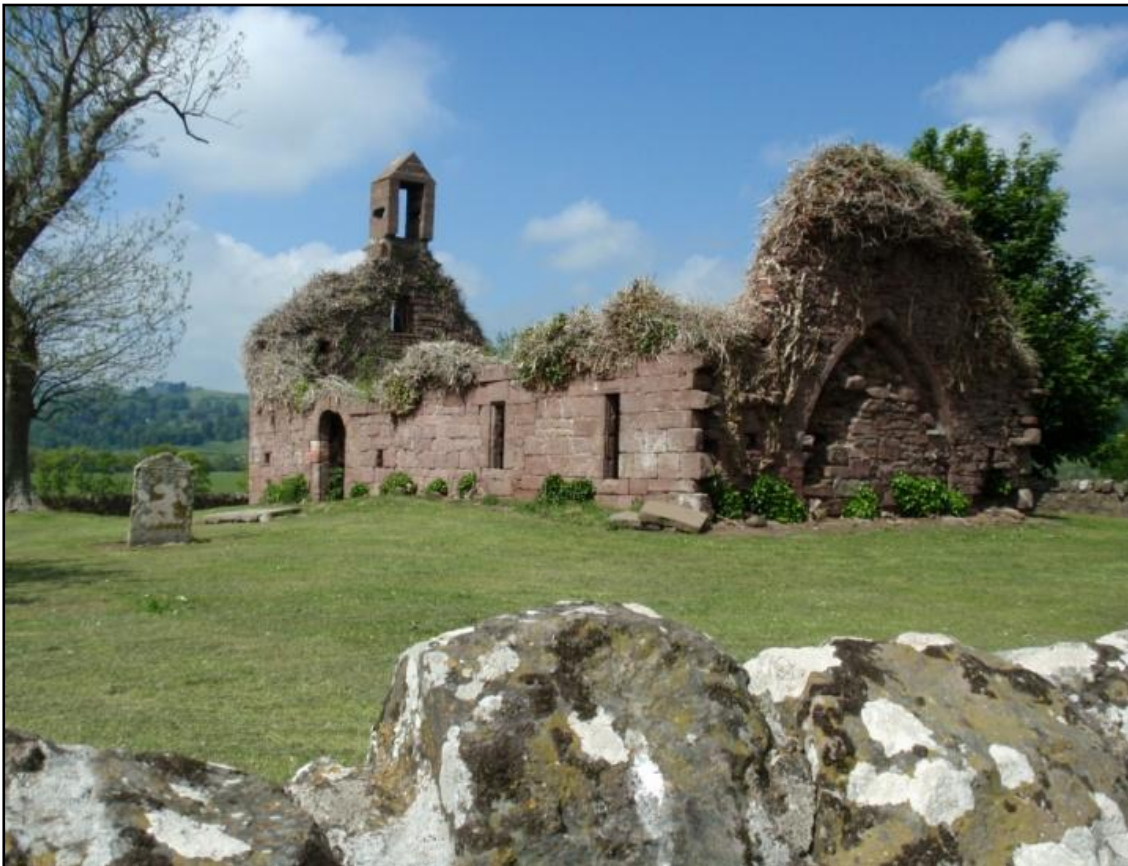
Fig. 1: Westown Kirk [NO 2493 2746], a 16th century, pre-reformation church in ruinous state.

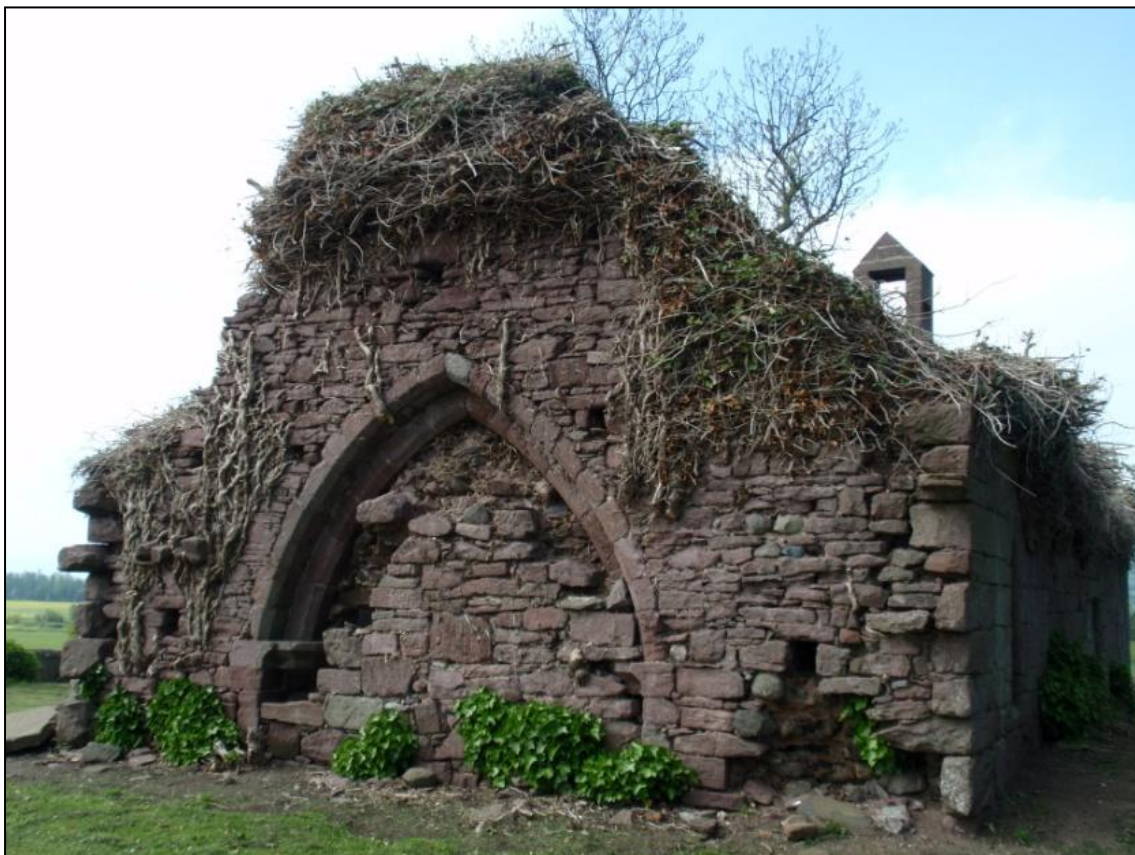
Fig. 3: Eastern gable wall with pointed chancel-arch. The infilled wall probably represents the post-reformation alterations making the building a ‘suitable preaching station’.

The east gable of the church contains a large central pointed arch of dressed stone within a random rubble gable wall of dark purple-red sandstone with occasional whinstone boulders. Most of the sandstone rubble shows parallel bedding and has small block/bed heights typically less than 200mm (Fig. 5). The dressed stone is a similar sandstone, although with larger block/bed heights. The arch has been infilled with a similar random sandstone rubble, generally of a larger block size than the adjacent rubble.

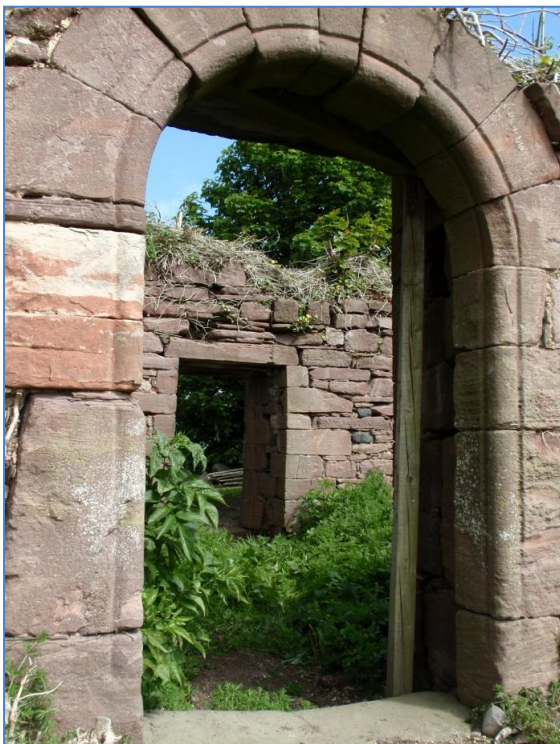
Fig. 4: The two entrances to the building; round headed, roll-moulded archway of south entrance and square headed north entrance.

Two entrances lead into the Kirk, one in the north elevation and one in the south (Fig. 4). The south entrance is round headed with roll-moulded surround; the north is simpler with square head and chamfered arris on either side reflecting the narrowing walls of the door frame. These opposing entrances illustrate the inconsistency of the architectural features within the structure of the building.

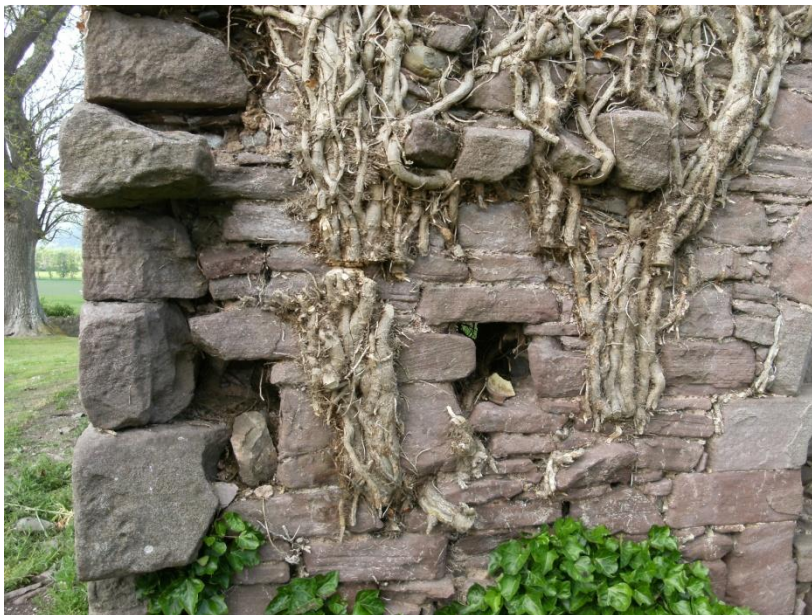
On the east gable the junction of the random rubble and the large block square rubble highlights subtle differences between the two stone types, with the latter having a more grey colour. Along with the difference in bed heights described above, it is therefore considered possible that the sandstone for the random rubble and more formal squared rubble came from different quarry origins.

Fig. 5: The east gable of the church contains a large central pointed arch of dressed stone within a Junction between random rubble and external squared rubble on east gable, showing differences between block sizes and bed heights.

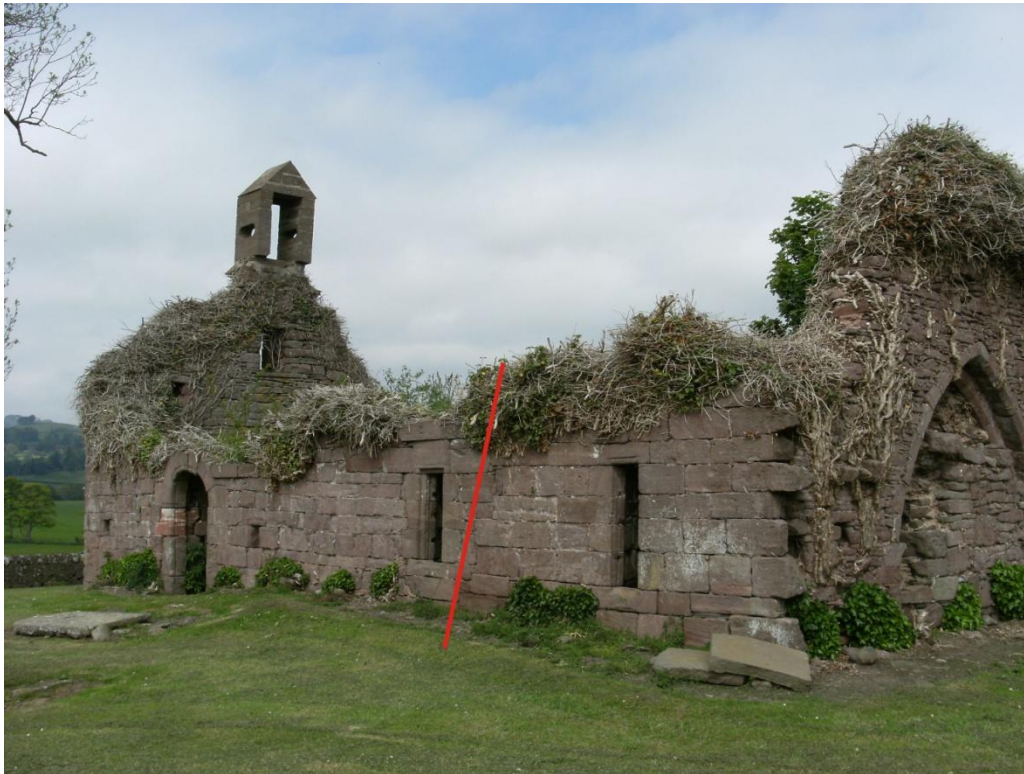
The masonry on the south elevation shows a number of unusual features. The masonry courses in the eastern part of the wall (from the east gable to just before the second window) do not continue in a uniform fashion along the whole wall, and some ‘wedge’ out from east to west along the elevation (Figs. 6 & 7). It appears that the eastern part appears to have been constructed as a ‘separate build’ from the rest of the elevation, and oddly, although the masonry block is itself of high quality, the building style is poorly executed.

Fig. 6: South elevation showing discontinuity in the masonry between the eastern section and the rest of the building (highlighted by vertical line).

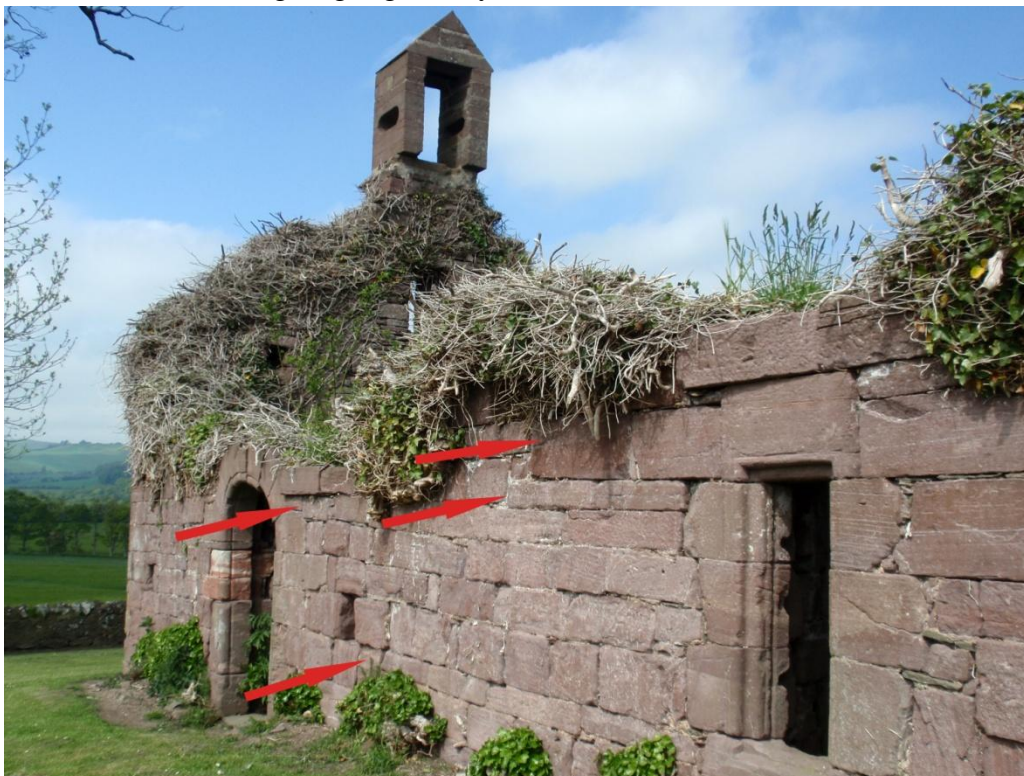
Fig. 7: Detail of south elevation showing 'wedging out' of masonry courses along the wall from east to west (highlighted by arrows).

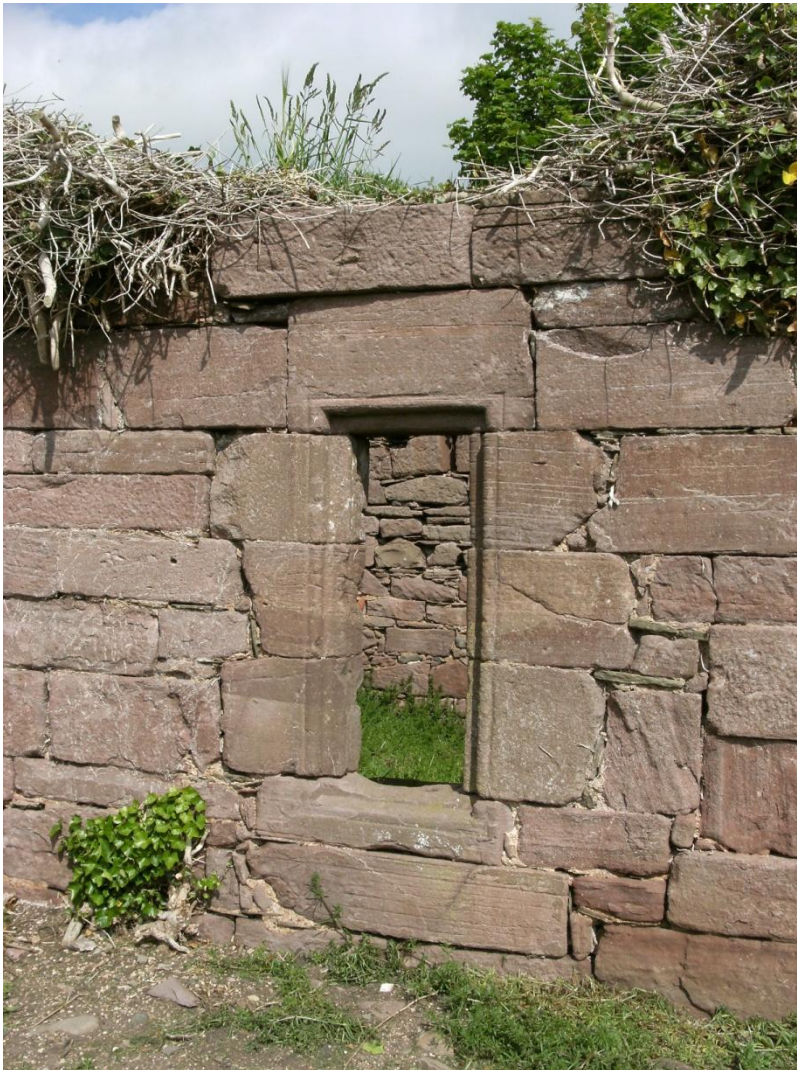
In addition, the two windows on the south wall have unusually poorly detailed stonework. Firstly, the central window has a lintel block that is greater in height than adjacent blocks in the same course (Fig. 8). Secondly, the moulded detail in the lintel block on the easternmost window has been very crudely executed, unlike the detailing in the vertical jambs and sill which have a rounded moulding. Both these features suggest that the lintel stones are not the original blocks for the windows –they have been crudely made to fit, apparently from large squared walling blocks.

Fig. 8: Window on south elevation with lintel block of greater height than adjacent blocks in the same course, suggesting that the lintel stones may not be the original blocks for the windows.

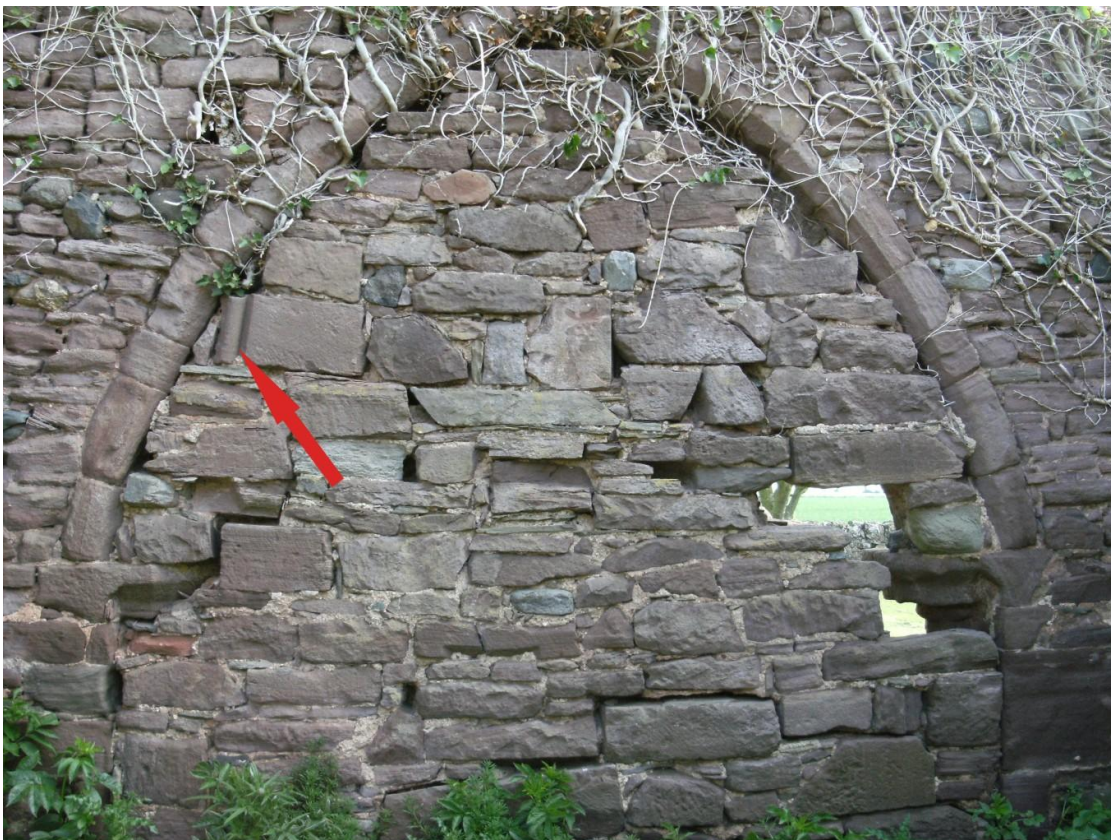
A number of obvious reused stones are present throughout the building. For example, the large arch infill on the east gable (interior) has a block with moulded detail (Fig. 9), with a similar feature at the interior of the west gable (Fig. 10). The interior of the south wall has a number of lintels that appear to be reused grave slabs (e.g. Fig. 11). Furthermore, the door on the north wall has lintel details that have been recut from an originally larger lintel, in order to fit the present doorway; and the block has been placed asymmetrically over the doorway (Fig. 12) suggesting that the lintel has been reused from demolition of a previous wall. In addition, an underlying rymat block has been cut to fit the walling masonry in order to preserve the presumably pre-existing corner detailing (Fig 13), again suggesting the stone has been reused from another building.

Fig. 9: Arch infill on the east gable containing reused masonry block with moulded detail (arrowed).

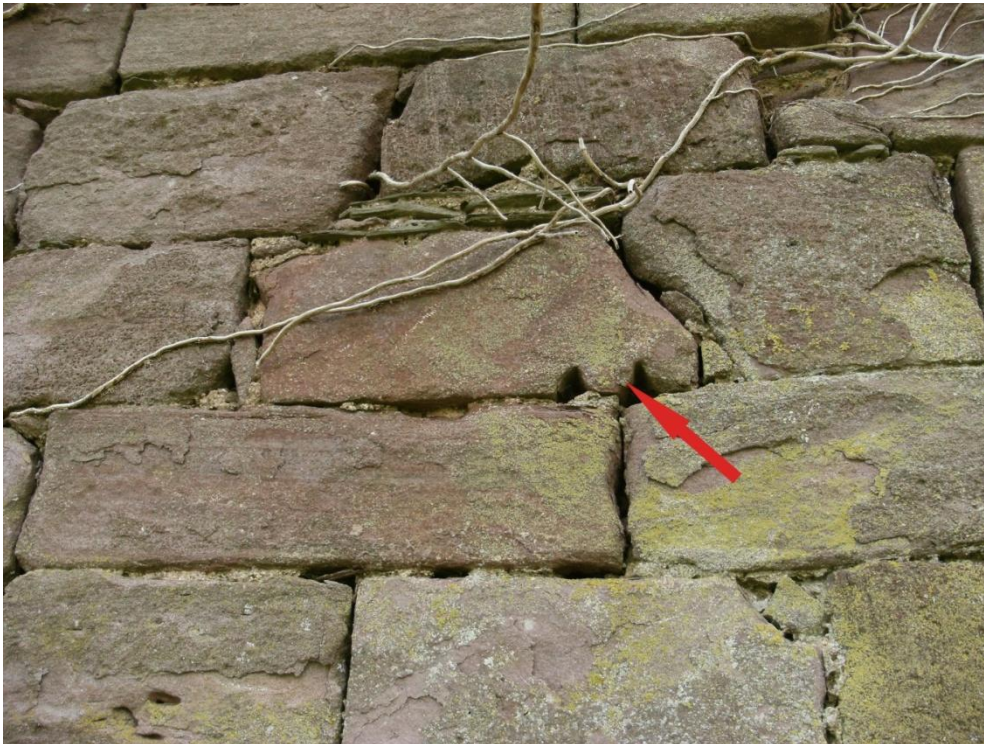
Fig. 10: Reused masonry block with moulded detail (arrowed) on west gable interior.

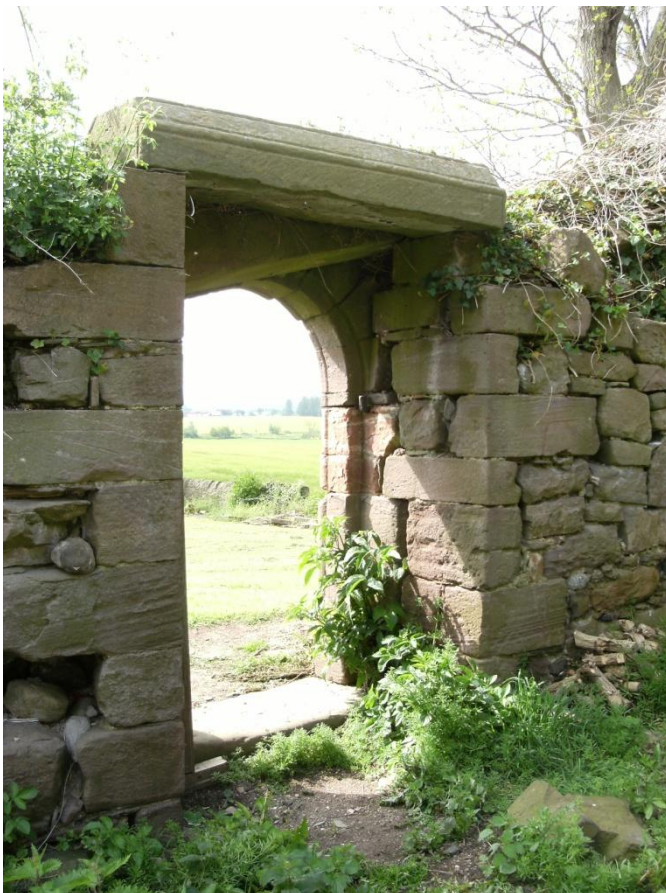
Fig. 11: Entrance to south wall, showing lintel made from reused grave slab.

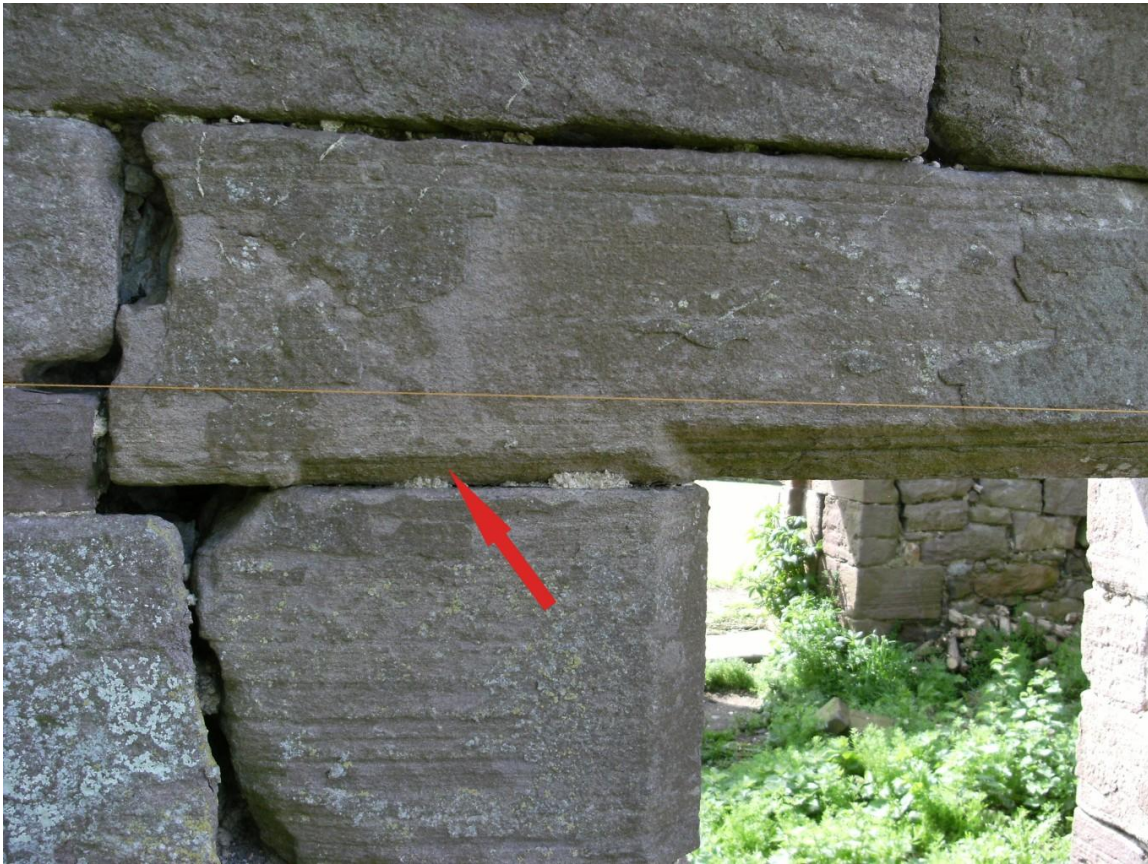
Fig. 12: Detail of lintel to door on the north wall showing detailing from an originally larger entrance (arrowed), recut in order to fit the present narrower doorway, suggesting that the stone has been reused from an earlier building.

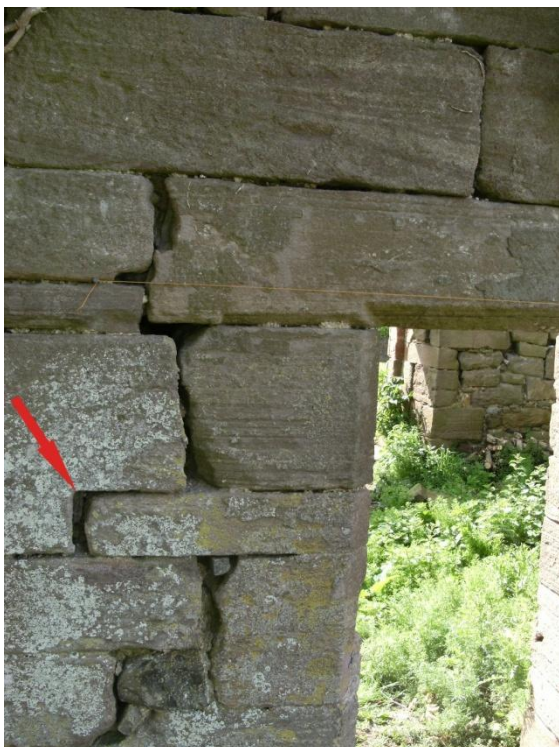
Fig. 13: Entrance in north wall showing rybat block which has been cut to fit the walling masonry in order to preserve pre-existing corner detailing (arrowed), supporting evidence that the stone has been reused from another building.

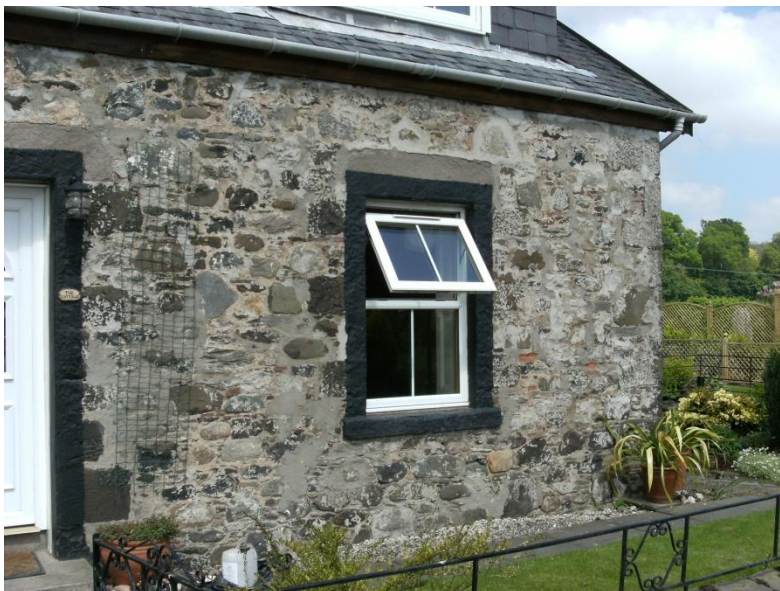
Traditional buildings in the village of Rait, lying in volcanic rocks approximately 2 km northwest of Westown, are constructed with mixed random rubble of purple sandstone/flagstone and whinstone (Fig. 16). The dressings appear to be bedded sandstone/siltstone from the Dundee Flagstone Formation, most of which have spalled and repaired using cement or overpainted. All these rocks directly reflect the underlying geology.

Fig. 16: Traditional cottage in the nearby village of Rait, constructed of random rubble comprising mixed purple sandstones and whinstone boulders, with dressings of purple flagstone (mostly overpainted).

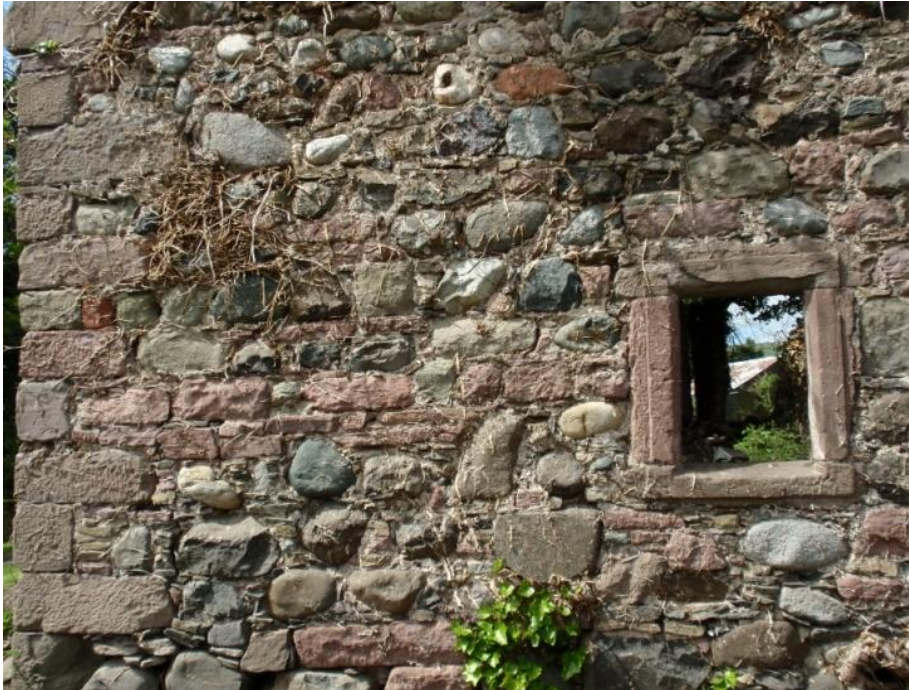
The ruinous Old Parish Church at Rait is a similar scale and plan to that at Westown, considered to be a contemporary pre-Reformation church to Westown Kirk. It is constructed from purple sandstone/siltstone with whinstone boulders, forming random rubble walling (Fig. 17). The dressed stone is a purple sandstone of moderate block size with simple carving details, and the quoins are roughly dressed and relatively small in size compared to those at Westown Kirk. The dressings are detailed in a way that suggests the rubble was formerly harled. Both rubble and dressings are likely to be from Lower Devonian Dundee Flagstone Formation, probably obtained from local sandstone interbeds within the volcanic rocks. This masonry style is that expected of a small village church of relatively low status, and contrasts with the relatively ‘high status’ masonry blocks present at Westown Kirk.

Fig. 17: Rait Old Parish Church contemporary to Westown Kirk. Random rubble walling with significantly smaller block sizes and masonry styles than found at Westown Kirk as illustrated in quoins (left) and the window surrounds.

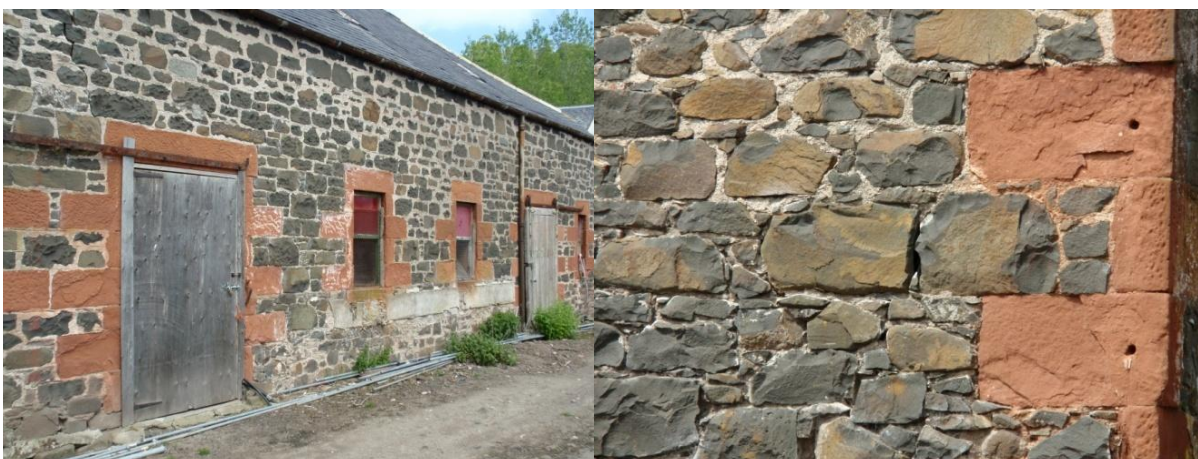
Farm steadings near Rait are built using whinstone rubble which would have been sourced from the local Ochil Volcanic Formation rocks of the Braes (Fig. 18). The dressings are made from vivid red sandstone typical of the Upper Devonian Glenvale Formation, probably sourced from quarries such as that at Ballindean. The red sandstone would provide larger and more easily worked blocks which could be used to span windows and doors, unlike the whinstone which would be only available as small irregular blocks.

Fig. 18: Farm steading just outside of Rait built with locally sourced random rubble whinstone walling and fine grained, orange/red sandstone dressings. The red sandstone would have been sourced from the Ballindean area for its larger block sizes and brought in for door and window surrounds.

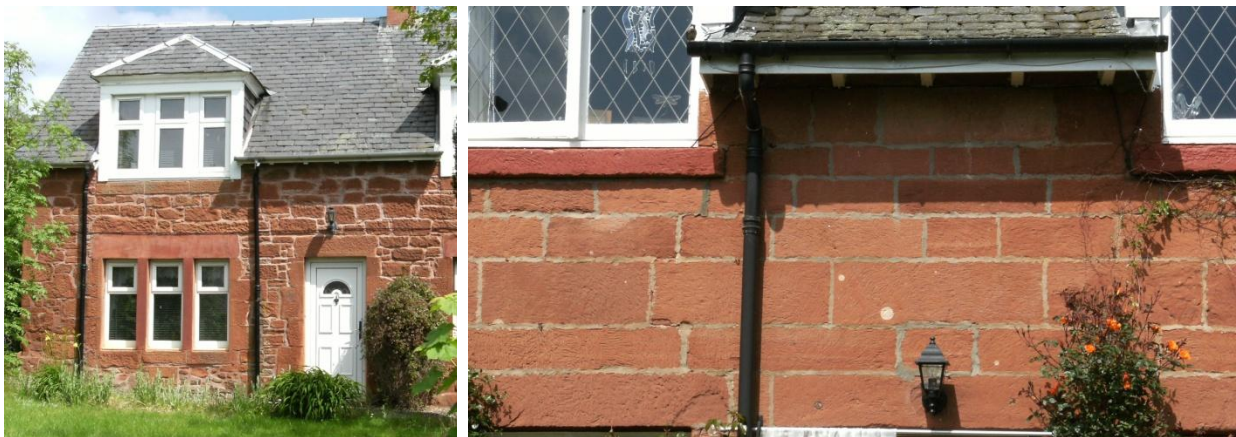
The village of Ballindean, situated approximately 2 km northeast of Westown, is constructed largely using the red sandstone typical of the Upper Devonian Glenvale Sandstone Formation (formerly quarried at Wester Ballindean). The sandstone is a vivid orange red colour with characteristic small white reduction spots (Fig. 19). It has been used mostly as squared rubble walling and for dressings of large block size. The quarry at Wester Ballindean appears to have been a significant supplier of red freestone sandstone to the local area, and has been transported to provide dressed stone for use in combination with local volcanic whinstone rubble. This sandstone is quite distinct from the building stone used for Westown Kirk, despite the Glenvale Sandstone Formation directly underlying the site.

Fig. 19: Wester Cottage at Ballindean. Early 19th century build with squared and coursed fine grained orange/red sandstone walling and dressings. The orange/red sandstone of the 19th century cottages has extremely characteristic reduction spots. None of which was found in the sandstone of Westown Kirk.

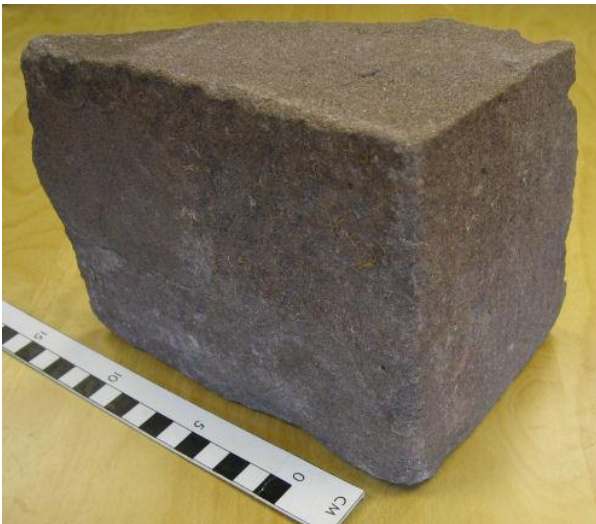
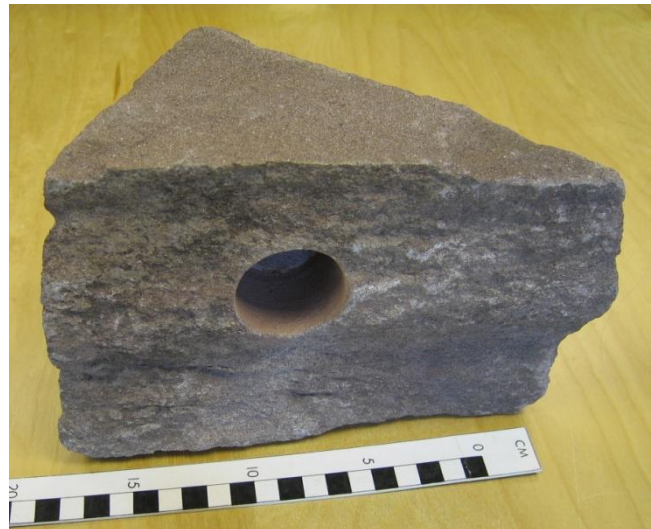
A broken block of formal squared rubble sandstone masonry from Westown Kirk was received for analysis (Fig. 20). The external surface has been chiselled to give a relatively smooth surface. A small core plug c.50mm long and c.30 mm diameter was extracted from the broken inside face of the block. The small sample was taken in order that the masonry block could be reinstated into the building if necessary. It is considered that the sample is representative of the former squared rubble masonry present in the building.

Fig. 20: Broken masonry block from Westown Kirk analysed in this study. Left-hand side: external masonry surface showing remnants of original tooling marks. Right-hand side: broken internal face cored to extract small sample for analysis.

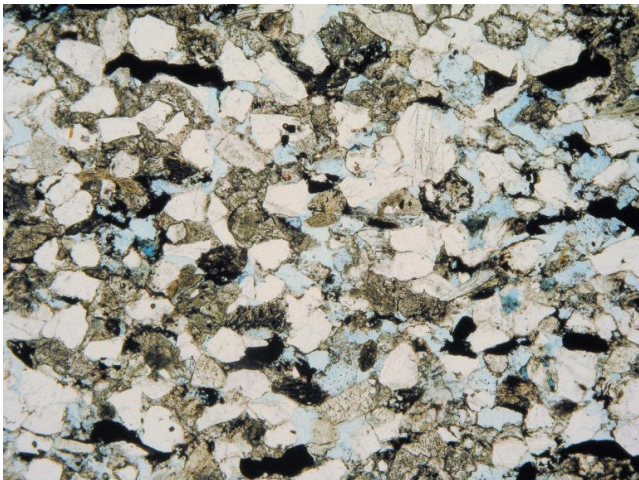
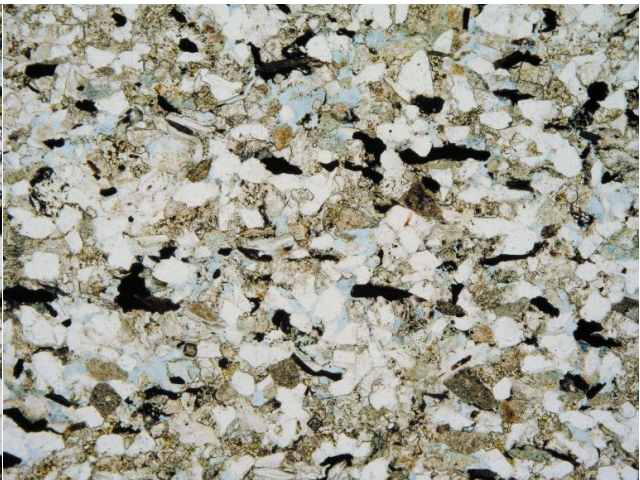
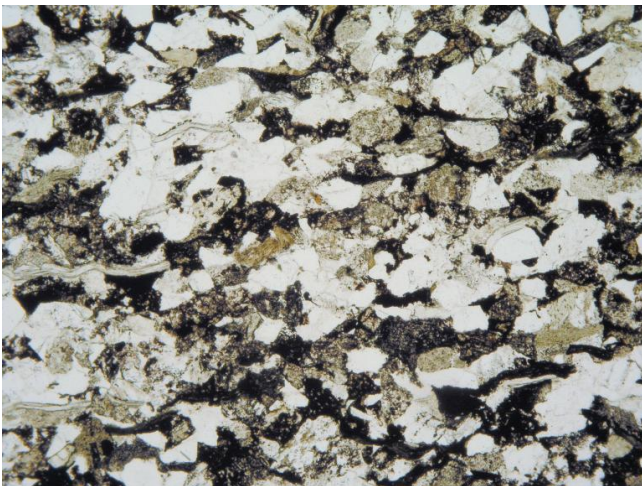
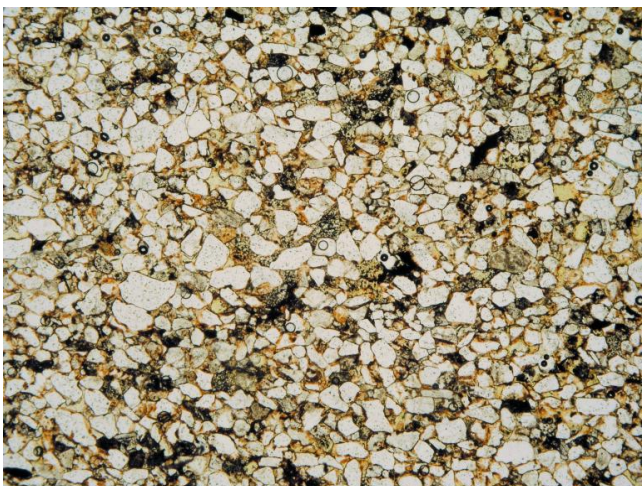
The masonry sample from Westown Kirk was compared microscopically to samples of Glenvale Sandstone Formation, Scone Sandstone Formation and Dundee Flagstone Formation, in order to test whether these geological formations can be ruled out or considered the likely source of the stone (Fig. 22). The Glenvale Formation is quite distinct and different, comprising well rounded quartz grains. The Dundee Flagstone Formation generally contains more darker minerals (iron oxides) and has a variable texture (from coarse grained to very fine grained); although the coarser variety (from Kingoodie quarry near Dundee) does bear similarities to the Westown sample. The sample of Scone Sandstone Formation (sample from the Perth area) is most similar to the Westown masonry, although it should be noted that the Scone sandstones also can be variable. In conclusion, none of the samples examined are identical to the stone from Westown Kirk; it is most similar to the sample from the Scone Sandstone Formation, although a source from the Dundee Flagstone Formation cannot be ruled out.

Fig. 22: Comparison of microscopic thin sections of masonry sample from Westown Kirk with the main geological formations outcropping in the region. The sample from Scone Sandstone Formation is most similar in grainsize, mineral composition and amount of black iron minerals. The two samples of Dundee Flagstone Formation show a range of grainsize from coarse grained (Kingoodie) to fine grained (Pitairlie), both containing abundant dark iron minerals (black). The Glenvale Formation is distinct; finer grained with rounded quartz grains. None of the samples shown are an exact match to the Westown Kirk masonry; the Scone sandstone and coarser grained Dundee flagstone samples are similar.
