Paper E 4

**MONITORING VEGETATION COVER ON MINE DUMPS WITH ERTS-1  
IMAGERY: SOME INITIAL RESULTS**Brian Gilbertson, *Spectral Africa (Pty) Limited, P. O. Box 2, Randfontein,  
Republic of South Africa*

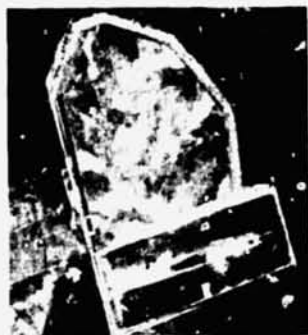
FIGURE 4

Mine dump 1/L/38,39

Mine dump 3/L/5,6

Furthermore, there is a good qualitative relationship between the categories of table 1 and the mine dumps imaged in figure 2, with the more densely vegetated dumps (i.e. those falling in categories 4 and 5) appearing darker than the unvegetated dumps (those falling in categories 0 and 1). In addition, vegetation patterns are visible on the ERTS-1 imagery which are in good agreement with ground truth, i.e. with patterns observed on aircraft overflight photography. This can be seen by comparing figures 3 and 4.
