**ASSESSMENT OF FLOOD DAMAGE IN ARIZONA BY MEANS OF
ERTS-1 IMAGERY**Roger B. Morrison and Maurice E. Cooley, *U. S. Geological Survey, Denver, Colorado,
and Tucson, Arizona***Abstract**

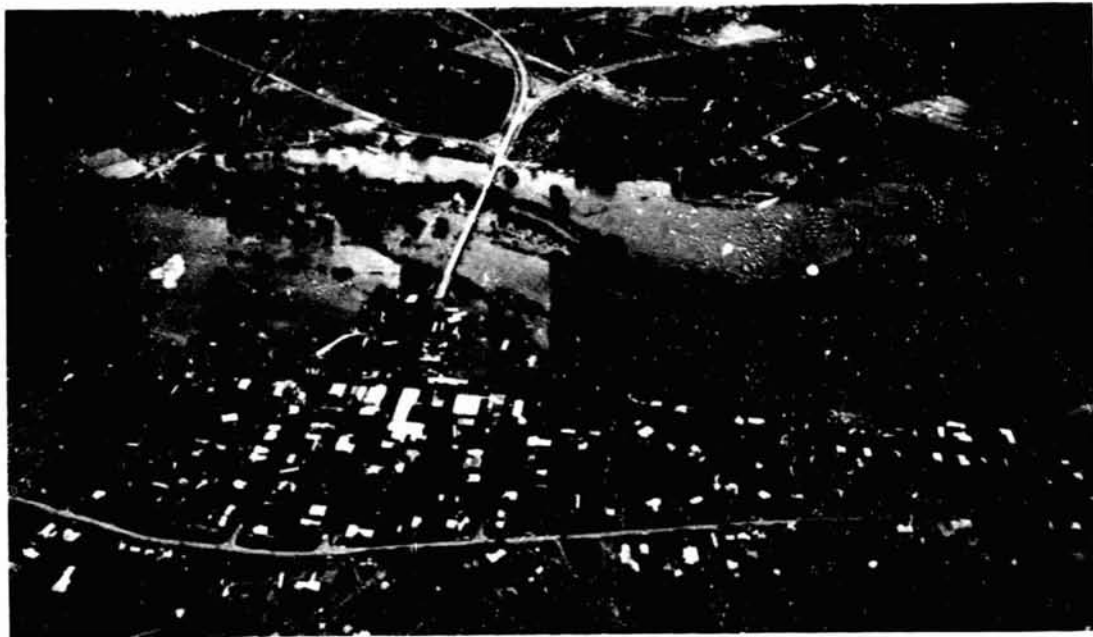
Figure 1. Low-altitude airphoto showing the inundation at Duncan, Arizona, near the crest of the October 20-21, 1972 flood on the upper Gila River. U. S. Geological Survey photograph.

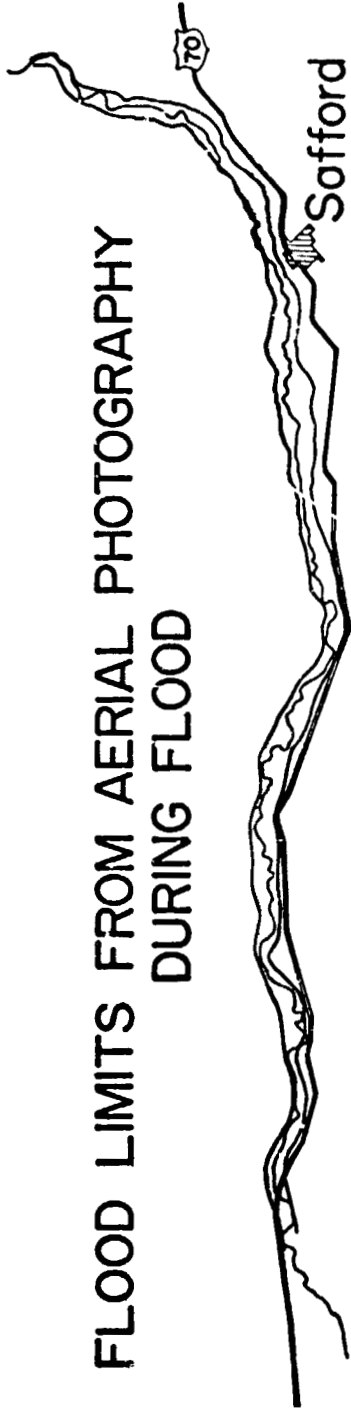
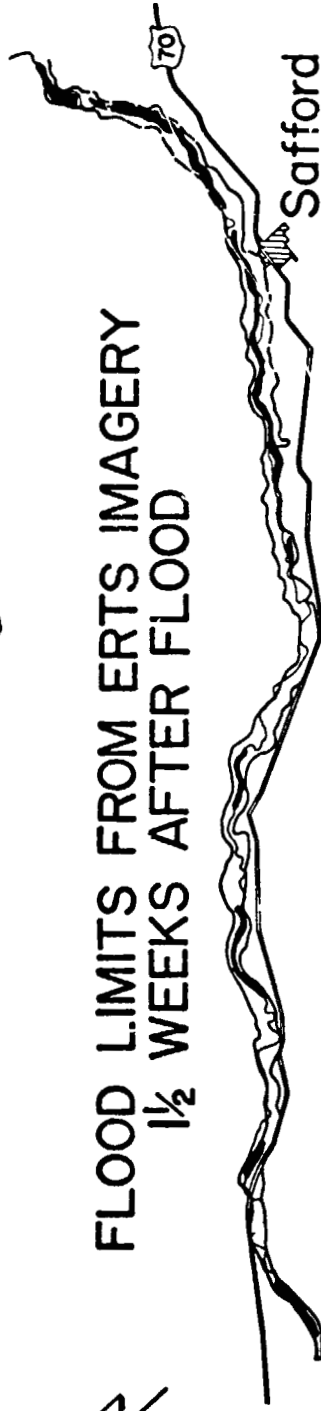
FLOOD LIMITS FROM AERIAL PHOTOGRAPHY
DURING FLOOD

FLOOD LIMITS FROM ERTS IMAGERY
1 1/2 WEEKS AFTER FLOOD

■ Severe sediment deposition/erosion

6. Limits of October 20-21 flood on the upper Gila River in the Safford (Gila) Valley, Arizona, as determined from low-altitude aerial photography taken during the flood and from ERTS-1 imagery taken 1 1/2 weeks after the flood

We also noticed in the ERTS images taken after the Gila River flood that certain reaches of river-channel deposits had widened considerably, compared with the pre-flood images. The channel deposits, sand and gravel, show most clearly on band 5 as a very light-toned strip inside the inundated belt that appears dark on the infrared bands. The greatest widening of the channel-deposit strip is at the upper ends of two intermontane basins, the Duncan-Virden Valley and the Safford (Gila) Valley, where the Gila River debouches from narrow box canyons. Evidently these were the sites of strong sand and gravel erosion and deposition.
