THE EFFECTS OF HIGH-TEMPERATURE BRAZING AND THERMAL CYCLING  
ON THE MECHANICAL PROPERTIES OF HASTELLOY X

Dennis L. Dicus and Dr. John D. Buckley

NASA Langley Research Center  
Hampton, Virginia

Presented at the Symposium on Welding, Bonding, and Fastening

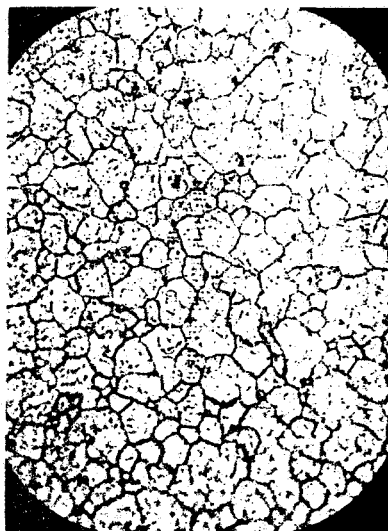
(a) Virgin Hastelloy X.

(b) After brazing with Palniro 1.

(c) After brazing with Palniro 4.

Figure 7.- Photomicrographs of virgin and as-brazed Hastelloy X.

Metallographic studies were conducted on sections cut from brazing alloy-base metal interaction specimens (fig. 3) to observe the effects of the brazing operation on Hastelloy X. Figures 7(a), 7(b), and 7(c), respectively, show the virgin base metal, the base metal after brazing with Palniro 1, and the base metal after brazing with Palniro 4. The Palniro 1 and Palniro 4 brazing operations resulted in grains which were 1.2 and 6 times larger than as-received grains, respectively.
