VEHICLE FOR CIVIL HELICOPTER RIDE QUALITY RESEARCH

William J. Snyder NASA Langley Research Center

Ronald G. Schlegel Sikorsky Aircraft

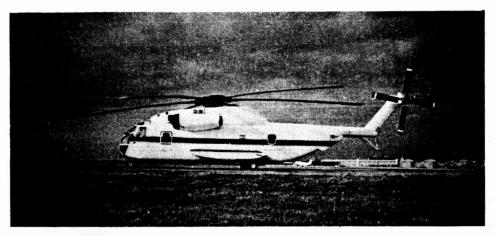
Figure 1.- Civil Helicopter Research Aircraft.

The Civil Helicopter Research Aircraft is a reconfigured CH-53A military transport helicopter (fig. 1). The basic characteristics of the aircraft, as reconfigured, are presented in table I. The aircraft was modified from its baseline configuration by the addition of uprated engines which produce nearly 3 MW (4000 shp) each as opposed to about 2.1 MW (2800 shp) each for the original engines. Uprated transmissions to accept the higher power engines were also incorporated. The present control system, rotors, and avionics are unchanged from the basic CH-53A.

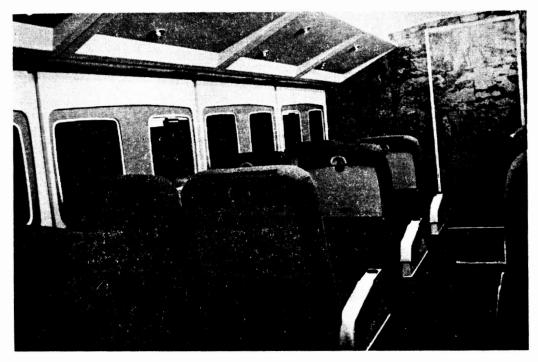
Figure 3.- Civil Helicopter Research Aircraft. Main cabin (looking forward).

<u>Main Cabin.</u> The main compartment (figs. 3 and 4) is a 4.06-m (13.3-ft) long passenger compartment located to the rear of the vestibule between fuselage stations 222 and 382. The passenger compartment contains eight airline quality double seats (seating for a total of 16 passengers) mounted on tracks with a continuously adjustable seat pitch from 76 to 94 cm

(30 to 37 in.) in 2.54-cm (1-in.) increments. The two individual sections of each double seat are separated by an armrest and have individually adjustable backrests. The minimum aisle width, between seat armrests, is 41 cm (16 in.), and the individual seat sections are approximately 43 cm (16.9 in.) between armrests.

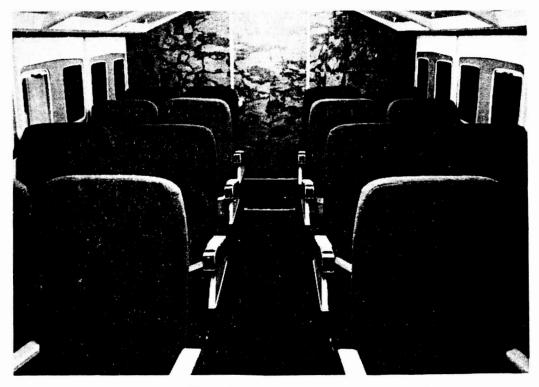
Figure 4.- Civil Helicopter Research Aircraft. Main cabin (looking aft).
