2. Testing of Typical Spacecraft Materials in a Simulated Substorm Environment

N. John Stevens, Frank D. Berkopec, John V. Staskus,
Richard A. Blech, and Steven J. Narciso
National Aeronautics and Space Administration
Lewis Research Center
Cleveland, Ohio

Abstract

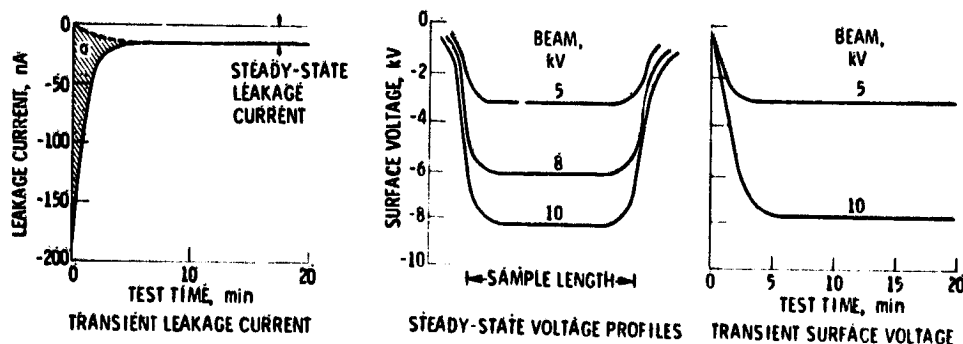
Figure 1. Typical Data Set of Materials Characterization Tests

The typical data set for the testing is shown in Figure 1. A capacitively coupled, noncontacting surface voltage probe is used to verify that the initial surface potential was zero and then swept across the test surface at fixed time intervals after the sample charging started. Since the probe functions with the beam operating, there is no need to interrupt the test to obtain the surface potential data. This procedure is followed for the test duration and results in transient charging curves for each test conditions. Each time the probe is swept across the sample, voltage profiles are automatically obtained. The typical steady-state profiles for insulating films are shown in the figure.

The total leakage electron current to ground is measured as a function of time after the test start. A typical example of the electron current flow to ground is also shown in Figure 1. This current shows the characteristics of capacitor charging; an initial surge decaying with time to a steady-state value. The charge deposited on the surface can be obtained by integrating this transient current (as shown by the shaded area). Once the charge and surface potential are known, the capacitance and energy storage can be computed. The steady-state values of the surface potential and leakage current can be used to compute the effective resistance of the sample.

The same type of data can be used to obtain the discharge characteristics for the samples that experienced discharges. The voltage probe is used to follow the surface voltage through the discharge. In this manner the breakdown voltage and the potential of the surface after discharge can be determined. The transient leakage current is used to determine the charge deposited up to the breakdown and the charge remaining after the discharge. From this data the charge lost and the energy dissipated in the discharge can be computed.

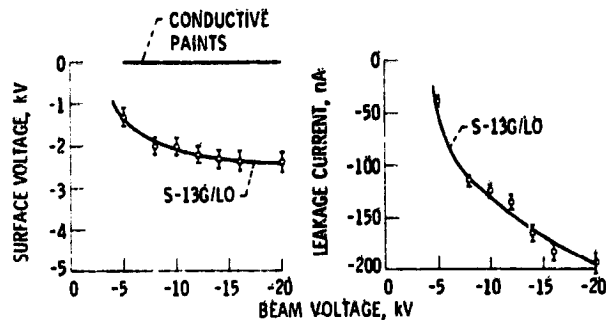
Figure 2. Spacecraft Paints Charging Survey Data

The results of the simulation test are shown in Figure 2. The conductive paints did not charge; the surface potential remained less than 1 V for all beam voltage conditions. There was no apparent physical damage to the samples as a result of these tests. It is planned to conduct long duration tests of these samples to determine if there will be any time dependent degradation due to the electron bombardment.

The nonconductive paint does charge but soon reaches a limiting value of about -2200 V. The behavior is typical of those insulators whose resistance decreases with voltage. The steady-state leakage current values verify this resistance decrease. There were no visible discharges during these tests nor was there any apparent damage to the samples as a result of the tests. It was noted, however, that the sample did "electrofluoresce" under electron bombardment - it glowed in the beam.

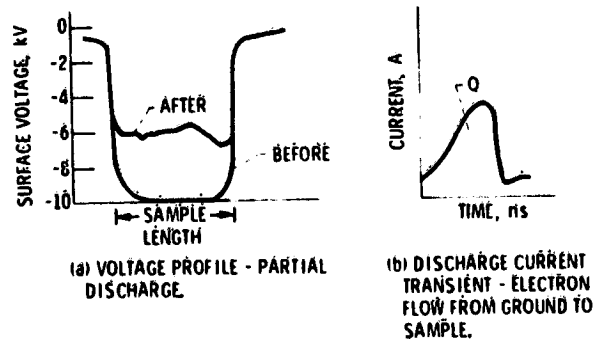
Figure 6. Discharge Characteristics of Silver Teflon Samples

Typical characteristics for the discharges in silvered Teflon samples are summarized in Figure 6. One assumption made in these studies is that a single sweep across the sample provides a voltage profile representative of the entire

VOLTAGE AT BREAKDOWN: -12 kV \pm 1.5 kV
 CHARGE DEPOSITED: 50 μ C \pm 10 μ C
 CHARGE LOST IN DISCHARGE: 20-60 μ C
 ENERGY IN DISCHARGE: 150-400 mJ

The transient current pulses during a major discharge under 20 keV electron bombardment have also been obtained. A typical pulse is shown in Figure 6(b). The duration of this pulse is on the order of 500 nsec while the peak amplitude ranges between 20 and 100 A. The maximum values of charge represented by this pulse (from integration of the area under the curve) are on the order of 15 μ C instead of the 50 to 60 μ C of charge lost in discharge as computed from the surface voltage readings. The replacement current does not appear to compensate for all the charge that is lost in the discharge. A model of the discharge phenomenon is being developed.

sample. This assumption was verified by comparing sample surface potential profiles obtained just before and just after discharge with computed surface voltage values. These values were computed using a one-dimensional model for a silvered Teflon capacitor. These values are -10,700 V before discharge and -6500 V after discharge. These values are in good agreement with the actual probe readings of Figure 6(a). Hence, it appears that the voltage obtained from the probe sweep is representative of the whole sample.

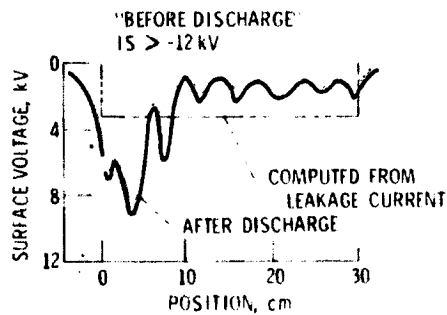
Figure 11. Discharge Characteristics of Open Edge Blanket

VOLTAGE AT BREAKDOWN:	-16.5 kV
CHARGE DEPOSITED:	250 μ C
CHARGE LOST IN DISCHARGE:	200 μ C
ENERGY IN DISCHARGE:	2.0 J

The discharge characteristics of the open edge blankets are shown in Figure 11(a). Here, only the trace after the discharge has been obtained. The -12 kV limitation of the surface voltage probe prevented measuring the surface potential profile before discharges occurred. The agreement between the available voltage trace and computed average voltage is still good. As one can see from these characteristics, it requires a large voltage to cause the breakdown, but when it does discharge the energy dissipated is very large. Almost all of the stored energy in the blanket is lost. The visible discharges from this type of discharge are shown in Figure 11(b). The discharges appear as streaks originating at either vent holes or grounding points and extending across the blanket surface.

The discharge characteristic data are shown in Figures 10 and 11. Generally, the discharge characteristics of the two 0.013 cm Kapton open edge blankets (Figures 8(a) and (b)) were similar. The 0.005 cm Kapton blanket and the sewn edge blankets (Figures 8(c) and (d)) behaved in a similar manner. Therefore, the discharge characteristics will be discussed only in terms of sewn edge blankets and open edge blankets.

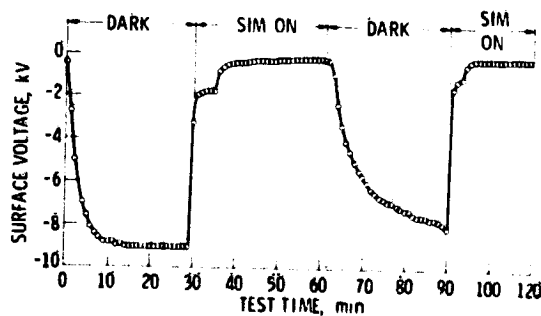
Figure 12. Effect of Sunlight on Kapton Thermal Blankets

A sunlight-eclipse simulation test was conducted using an open edge, Kapton outer layer blanket (Figure 8(a)). The surface voltages measured during this test are shown in Figure 12. The conditions throughout this test were: -10 kV beam voltage with a 1 nA/cm^2 beam current density. The test was started with the sample potential at zero volts and then exposed to the electron flux with the solar simulator off. The sample charged to about -9 kV as expected. The effective resistance of the sample under the dark steady-state conditions was 3.6×10^{11} ohms.

The solar simulator was turned on 30 minutes after the test started and remained on for an additional 30 minutes. The surface voltage and the leakage current changed immediately (the step in the curve was caused by the two-stage turn on requirement of the solar simulator). After 30 minutes in the sunlight (at about 3/4 solar intensity), the surface voltage was decreased to about -200 V and the sample effective resistance reduced by 3 orders of magnitude (to 3.6×10^8 ohms).

At this point the simulator was turned off and the sample allowed to charge up again. The charging rate for this eclipse cycle was slower than the first eclipse cycle. After the 30 minutes in the dark, the surface voltage reached only -7 kV corresponding to an effective resistance of 4×10^{10} ohms. Turning the solar simulator back on drove the the surface voltage back down to the -200 V level.

The test was repeated with the beam voltage set at 20 kV with a 1 nA/cm^2 beam current density. The initial dark eclipse simulation resulted in a series of discharges. When the simulator was turned on, the surface potential dropped again to about -200 V and all discharge activity ceased. After 20 minutes into the second eclipse simulation the potential was only about -6 kV with no discharge activity.

The behavior appears to be related to the photoconductivity effect reported for Kapton.¹⁰ The Kapton material has shown an immediate decrease in bulk resistance with illumination and appears to slowly return to the original properties when returned to dark conditions. The Kapton behavior exhibited in these tests is probably not the result of photoemission from the sample since no other material tested with the solar simulator exhibited such an immediate and pronounced drop. The reduction in bulk resistivity could be enhanced by an increase in the sample temperature. But this should take a finite time to cause the change.

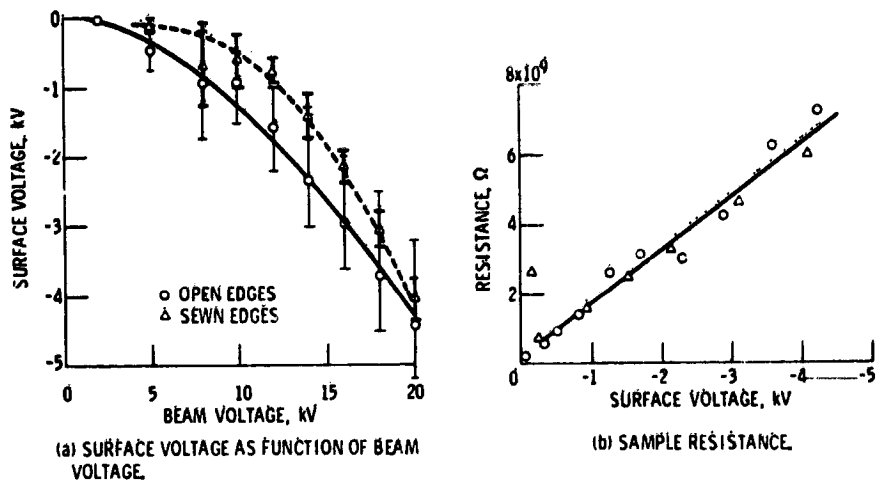
Figure 13. Quartz Cloth Thermal Blanket Charging Survey Data

The test results are shown in Figure 13(a) and (b). The steady-state surface voltage as a function of beam voltage (Figure 13(a)) shows that the surface charges only to slightly more than -4 kV under a 20 kV beam test condition. The characteristic corresponds to a sample in which the resistance increases with the surface voltage. The sample effective resistance is shown in Figure 13(b). The transient leakage current data indicate that there is little, if any, charge stored in these samples.

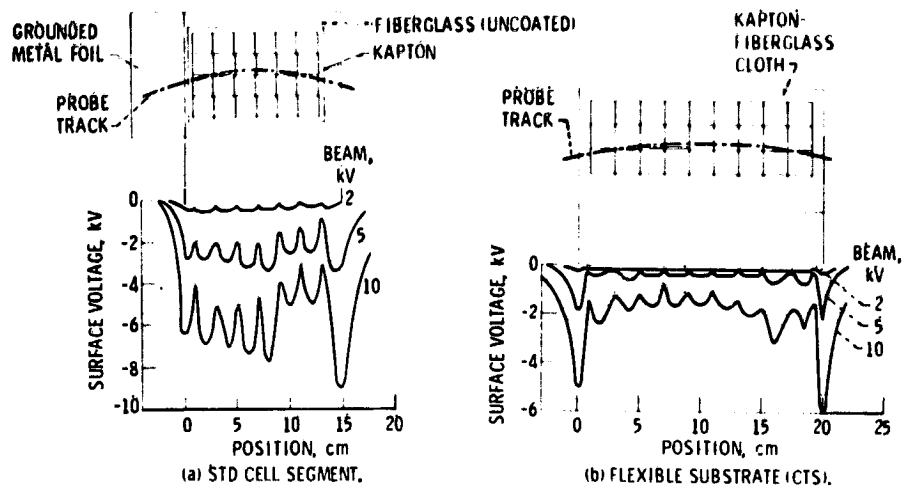
The characteristics of the standard and flexible substrate segments (Figure 15(a) and (b)) are shown in Figures 16 and 17; the conductive coverslide segments will be discussed later. In Figure 16 the voltage profiles across the two segments are shown for various beam voltages. For both segments the effect of the edges is pronounced when the beam voltage exceeds -5 kV. The most severe voltage gradients are produced at the interface between the coverslides and the border. In fact, there is evidence that the border can control the charging of the coverslides (see Figure 16(a)). This effect suggests that material samples should be tested with the flight configuration boundaries in order to evaluate properly the behavior of any particular satellite exterior design.

The steady-state surface voltage reached by the coverslides and the substrates as a function of beam voltage, the charge deposited and energy stored in the segments are shown in Figure 17. The error bars on the voltage curves represent the range of values across the samples.

The surface voltage curve for the standard segment coverslide and the fiberglass are straight lines. This implies that the surface voltage for both is controlled by the secondary emission characteristics of each material with the fused silica being a slightly better emitter.

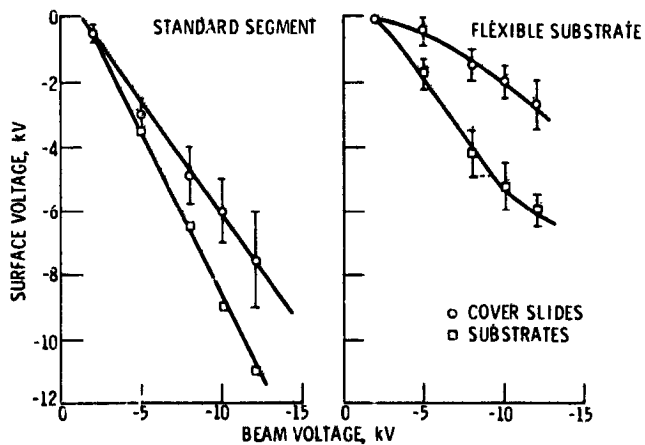
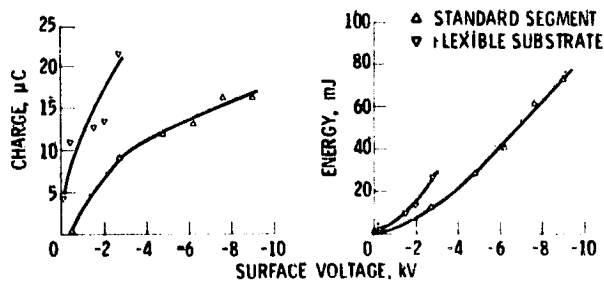
Figure 17

The surface voltage curve for the flexible substrate segment indicates that the cerium doped microsheet coverslides charge to a lesser value than the fused silica and behave as a material whose resistance increases with voltage. This behavior may be the result of the charging of the border and may not be real. This will be verified in future tests on the microsheet alone. The Kapton-fiberglass substrate behaves as expected. The surface voltage is controlled by secondary emission until the surface potential reaches about -9 kV at which point the leakage current influences the voltage and the curve starts to fall off.

The charge deposited on the coverslides of both segments, along with the energy stored, is shown in Figure 17(b) and (c) as a function of the coverslide average voltage. From these curves it is evident that, although the same charge is deposited on the flexible substrate segment as the standard segment, the energy stored in the flexible substrate segment is considerably less. This effect may be due to the charging of the substrate boundaries. In any case, the techniques used in constructing the flexible substrate segment appear to minimize the charging of the segment.

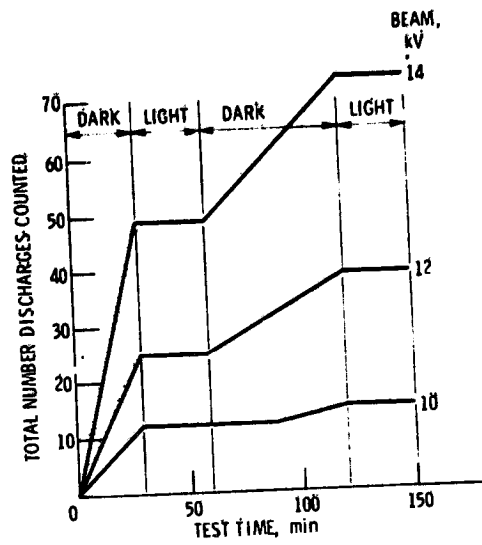
Figure 20. Discharge Characteristics. Eclipse simulation; flexible substrate segment, electron current density, 10 nA/cm²

The flexible substrate segment was mounted in the LeRC facility such that the dielectric side was exposed to the electron flux. A infrared, quartz arc lamp was mounted in the tank so that the light would illuminate the cell side of the segment at about 0.5 solar intensity. Test runs were made at several voltages at a beam current density of 10 nA/cm^2 first with the lamp off for 30 minutes, then with the lamp on for 30 minutes, followed by 60 minutes again in the dark and finally, 30 minutes with the lamp on again. The total number of discharges detected by the loop antenna 50 cm from the segment was counted at each beam current voltage. The results for the -10, -12, and -14 kV beam voltage tests are shown in Figure 20. Similar trends were found in the -16, -18, and -20 kV tests.

As is apparent from Figure 20, the segment experienced numerous discharges when the segment was in the dark initially. When the light was turned on the discharges stopped immediately. When the lamp was again turned off, the discharges occurred again, but at a significantly lower rate. Even the lower rate was terminated when the lamp was again turned on. Therefore, the light on the cell side of the segment seems to stop the discharges that occur when the dielectric side is bombarded with kilovolt electrons while the cell electrical circuit is grounded. The reason for this behavior is either due to the photoconductivity effect in Kapton or thermal effects in the dielectric (there was no attempt to control or measure the segment temperature during these tests).

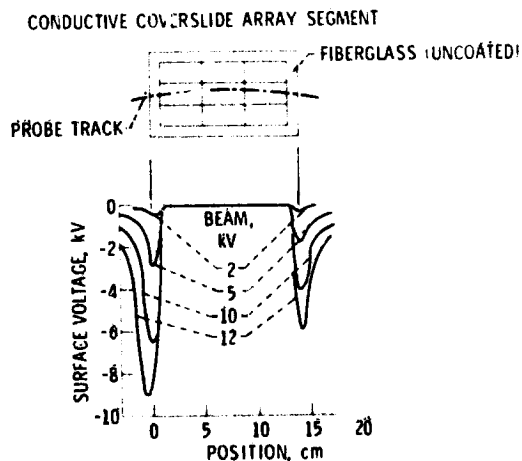
Figure 22. Steady-state Surface Voltage Profiles of Solar Array Segments

This segment was exposed only to a limited test. The voltage profiles obtained are shown in Figure 22. These profiles show that the conductive coverslides remained at ground potential while the surrounding fiberglass boundary charged to rather high potentials. In fact, these reached a point where discharges between the fiberglass and the thin conductive covers were possible. Therefore, the test was stopped. The fiberglass will be covered and grounded and the test will be repeated.

The conductive coverslides did collect currents proportional to the cell area and the beam current, as expected. There were no nonuniformities observed in the voltage profile over the conductive coverslides. The location of the gaps between the cells was barely discernible. The sample was very well behaved. The results again pointed out the need to test samples in flight configurations so that the effects of the surroundings can be evaluated.
