ENVIRONMENTAL EFFECTS ON COMPOSITES FOR AIRCRAFT

Richard A. Pride
NASA Langley Research Center

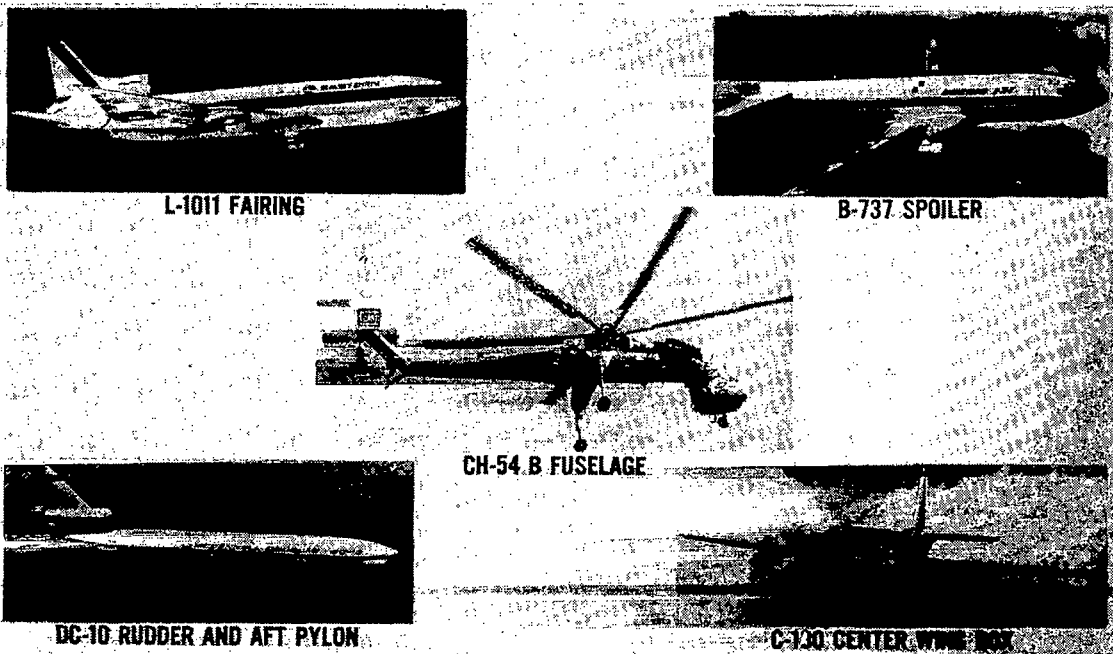
Figure 1.- Flight service evaluation of composite structural components.

A number of composite structural components have been designed, manufactured, tested, and placed in operational service on a variety of aircraft. This operational flight service is monitored periodically to evaluate the long-term experience with composite durability. The types of aircraft and composite components are shown in figure 1. The L-1011 application is six fuselage fairing panels involving two types of Kevlar-49 epoxy composite on each of three airplanes (ref. 1). Three graphite-epoxy material systems are used for the spoilers on 27 Boeing 737 airplanes (ref. 2). A fourth graphite-epoxy material is used in the upper, aft rudder segment on ten DC-10 airplanes (ref. 3), and boron-aluminum composite skin is used in a panel on the aft pylon adjacent to the engine on three DC-10 airplanes (ref. 4). Boron-epoxy is used as a selective reinforcement in the aluminum aft fuselage, or tail cone, of an Army CH-54B helicopter (ref. 5) and in the aluminum center wing box of two Air Force C-130 transports (ref. 6).

The status of these composite structural components in the Langley flight service program, as of January 1, 1978, is given in table I. The boron-epoxy composite in the CH-54B helicopter tail cone has been in service for the longest calendar time, six years, but it has been flown very little compared to the other types of aircraft. The Kevlar-49 epoxy in the L-1011 fairing panels has

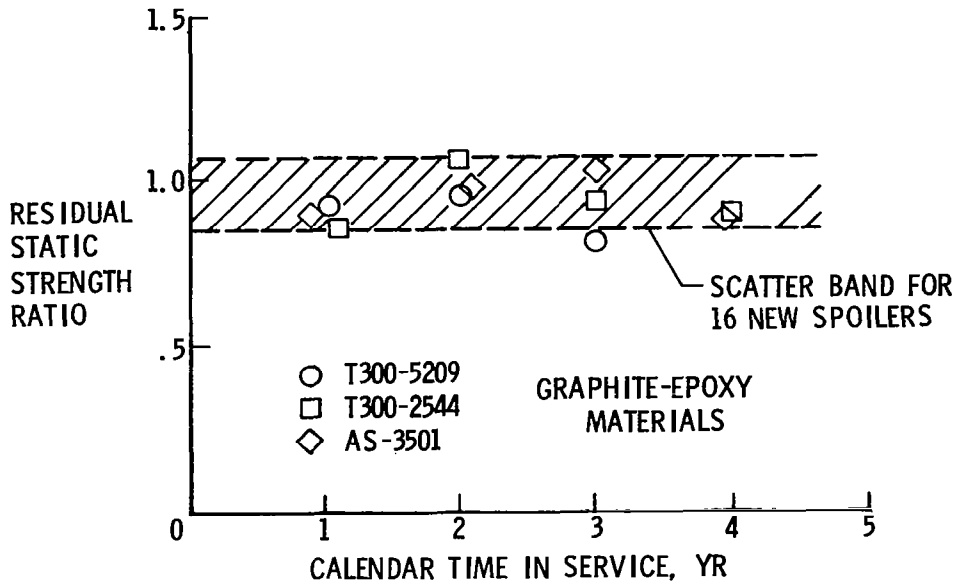
Figure 2.- Residual static strength of graphite-epoxy spoilers.

For destructive testing the spoilers are mounted in the same static test jig as was used for the initial airworthiness certification tests (ref. 2). A distributed load is applied to the outer surface of the spoiler, simulating aerodynamic loads, and the magnitude is increased until failure occurs. Results of these residual static strength tests on the graphite-epoxy spoilers are shown in figure 2. The residual strengths for each material system have been divided by the failure strength of the initial certification test for each material, and the results are presented nondimensionally as a function of the time in service. A scatter band for strength tests of 16 new replicate spoilers manufactured with the T300-5209 graphite-epoxy material has been superimposed on the individual tests of spoilers removed from service. In four years of service, the scatter in strength for the individual spoilers generally falls within the width of the new spoiler strength scatter band; an indication of essentially no degradation in strength.

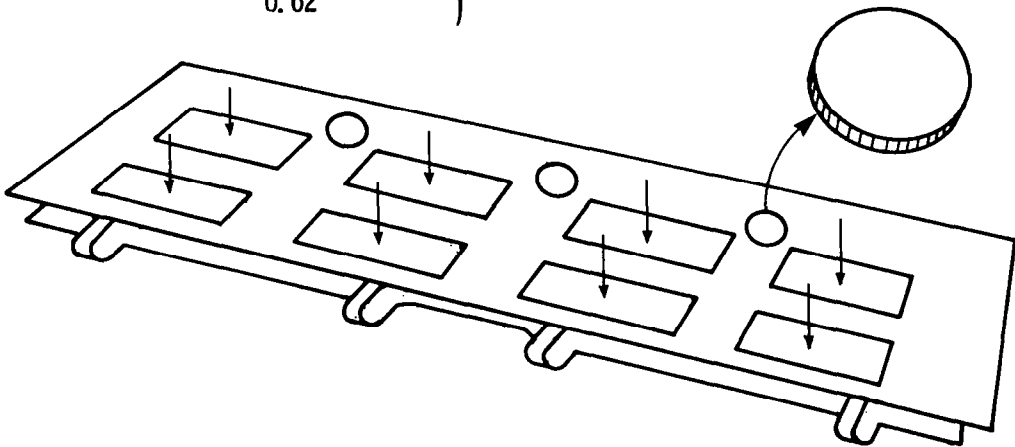
T300-5209 GRAPHITE-EPOXY AFTER
THREE YEARS SERVICE WITH LUFTHANSA
RESIDUAL MOISTURE

0.63 PERCENT	} AV = 0.64 PERCENT
0.66	
0.62

Figure 3.- Spoiler moisture levels determined from plugs.

After several years of unsuccessfully attempting to determine the moisture absorbed by the graphite-epoxy spoilers in service, a technique of cutting plugs from near the trailing edge was developed (fig. 3). The eight rectangular areas shown with an arrow in the center of each represent the whiffletree loading areas for static strength tests. Since failures always have initiated near the leading edge at one of the center hinges, it has been determined that three plugs of 6.4 cm (2.5 in.) diameter could be cut from the region behind the loading areas without influencing the failure load. These plugs, which consist of aluminum honeycomb core, two graphite-epoxy face sheets, two layers of epoxy film adhesive and two exterior coats of polyurethane paint, have about

90 percent of their weight in the composite faces, including the paint and adhesive. A good determination of the moisture level in the spoiler can be made by drying the plug and noting the weight change. After three years of service with Lufthansa Airlines in Germany, plugs taken from a T300-5209 graphite-epoxy spoiler indicated a moisture content of 0.64 percent, based on the composite weight. Somewhat greater significance may be attached to this value when corrections have been determined for relative differences in equilibrium moisture levels in the paint, the composite matrix, and the adhesive.

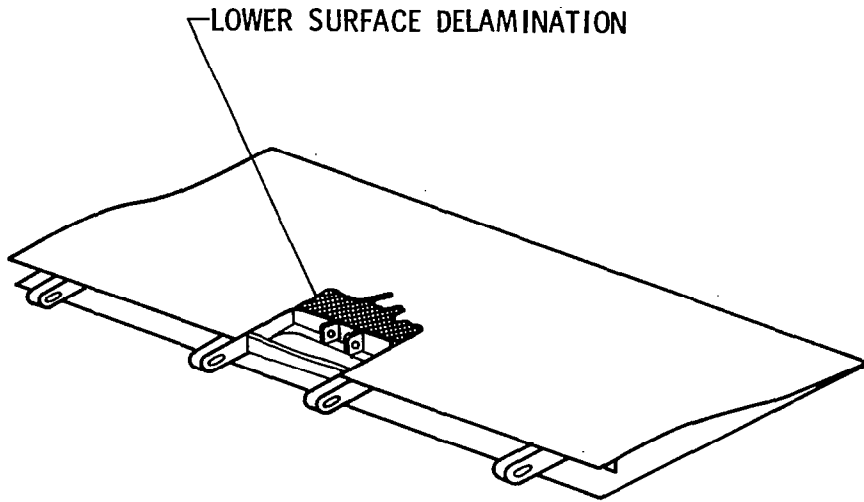
Figure 4.- General area of spoiler delamination.

Subsequent to the introduction into flight service of the graphite-epoxy-skinned spoilers, a development program was undertaken for an all-composite spoiler which included glass-epoxy honeycomb core, molded graphite-epoxy hinge fittings and leading edge spar, and thermoplastic graphite-polysulfone skins (ref. 7). It was recognized that the polysulfone matrix had an environmental sensitivity to phosphate-ester-based hydraulic fluids, and the laboratory testing demonstrated this in elevated temperature, stressed immersions. However, based on the room temperature experience it was believed that the material could be successfully used in flight components with only minor, intermittent exposures to hydraulic fluid leakage from the spoiler actuators. Twelve of these spoilers were fabricated and placed in service on six of the aircraft that were flying graphite-epoxy spoilers. After six months of operational flight service the two spoilers installed on Aloha Airlines were reported to have developed significant delamination of the lower surface skin directly aft of the actuator attachment fitting (fig. 4). Within a month a third spoiler was reported as starting to experience delamination, so it was decided to remove all the remaining graphite-polysulfone spoilers. A closeup view of the delaminated area is shown in the photograph in figure 5. This experience demonstrated the difficulty of performing adequate laboratory accelerated environmental testing and provided a good example of the necessity for flight service evaluation.

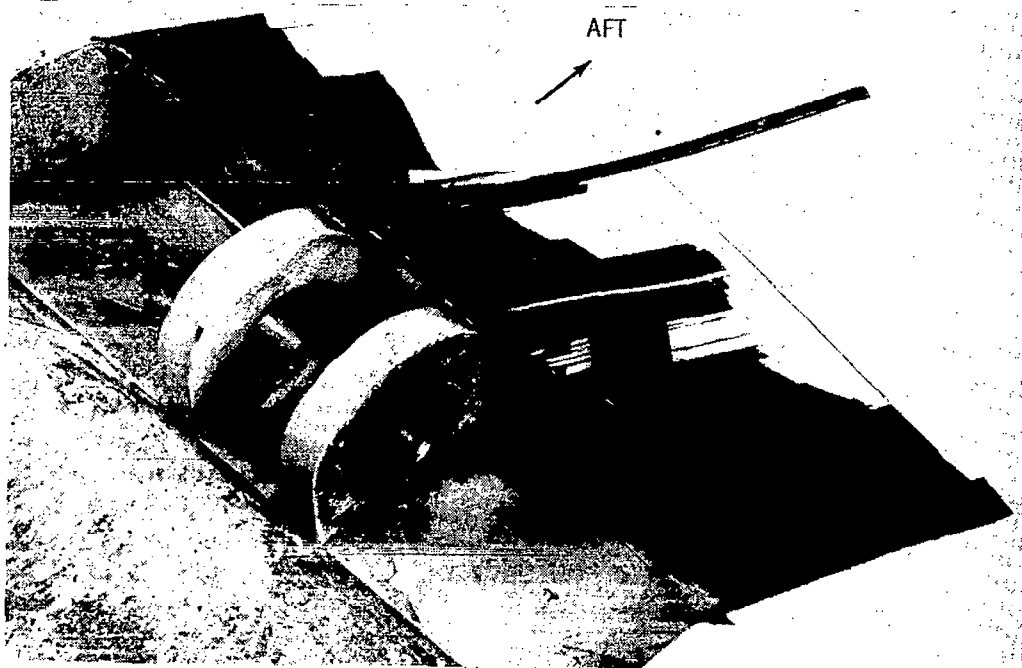
Figure 5.- Delamination of spoiler cover due to hydraulic fluid attack.

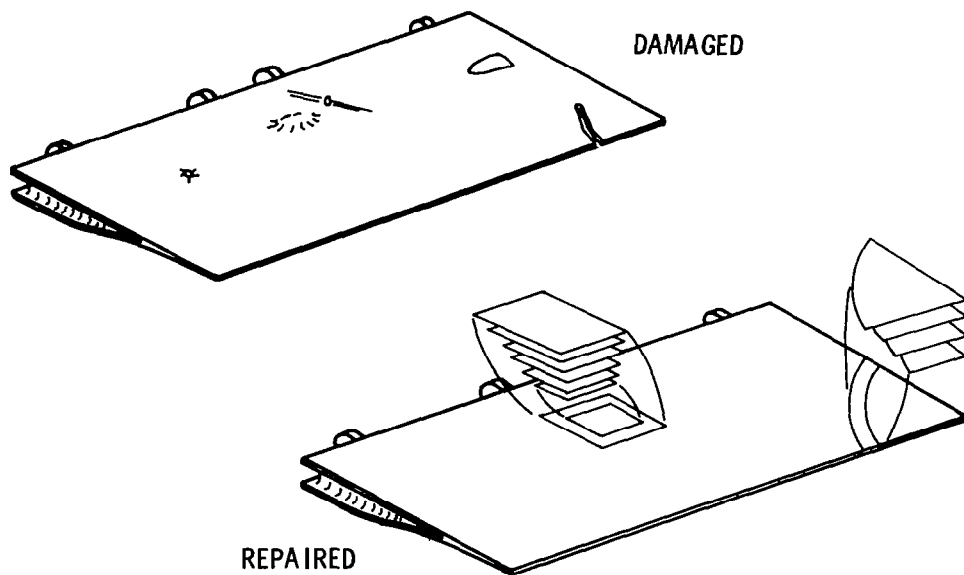
Figure 6.- Graphite-epoxy spoiler repair techniques.

There have been several instances in which the graphite-epoxy spoilers have received damage in service sufficient to require repairs. Examples of these are illustrated in figure 6. On this program, damaged spoilers are removed from the aircraft and returned to The Boeing Company for repair. Repairs are made by cutting out the damaged area, replacing honeycomb core as needed, and replacing graphite-epoxy plies on a one-for-one basis with each ply lapped over the underlying one by about 6 mm (0.25 in.). One piece of adhesive film is placed under the patch assembly and the built-up patch is cured and bonded in one cycle in an autoclave with the spoiler supported in its original assembly tooling (ref. 7). The repaired spoiler is ultrasonically inspected and returned to flight service with the airline which had previously used it.

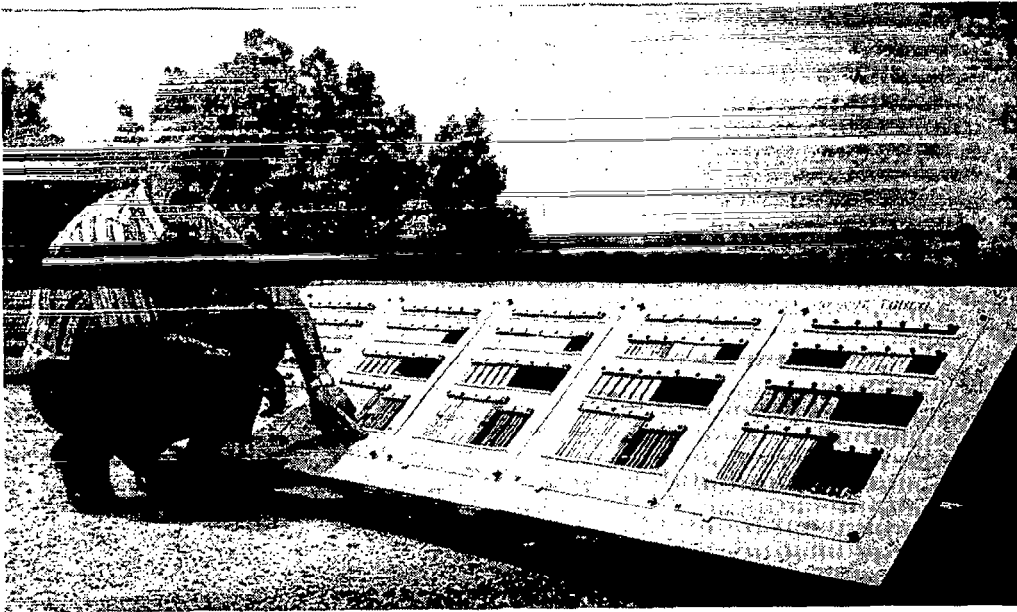
Figure 8.- Unstressed exposure rack.

sites is shown on the map of the world in figure 7. Each of these locations has an exposure rack with unstressed specimens as indicated in figure 8. Each of the five panels mounted in the rack contains triplicate specimens of four graphite-epoxies, one graphite-polysulfone, and two Kevlar-49 epoxies in short beam interlaminar shear, flexure and compression configurations. After one year and three years of exposure a panel is removed from each rack and shipped to Langley Research Center for specimen testing and evaluation.

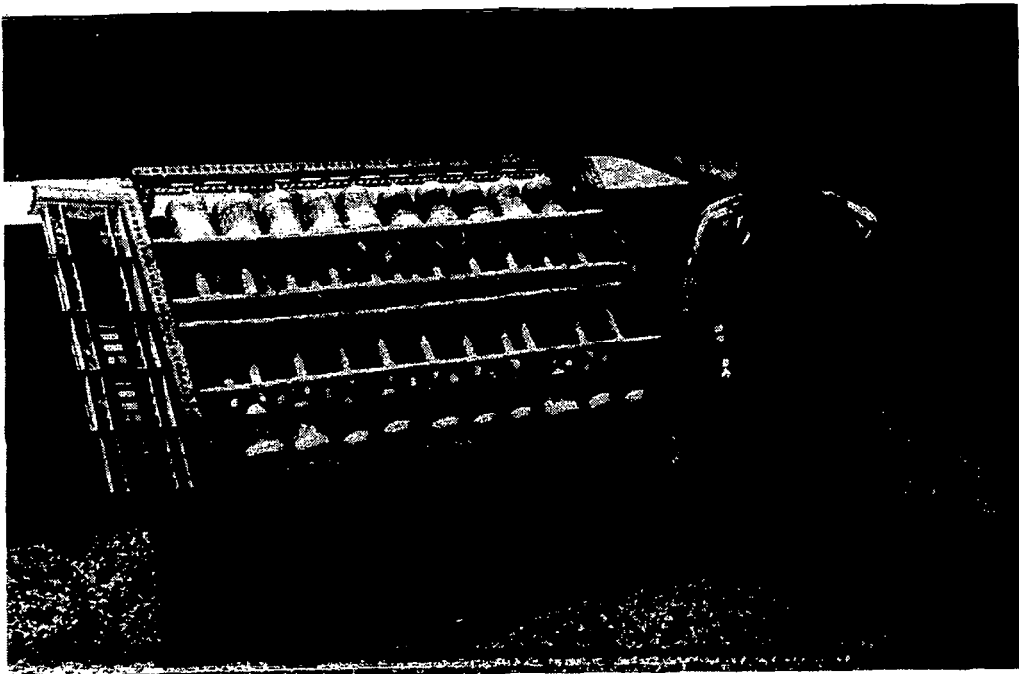
Figure 9.- Stressed exposure rack.

In addition to the unstressed exposures, three racks containing stressed tensile specimens (fig. 9) are also deployed, one each at San Francisco, Seattle, and Langley. Individual specimens are mounted in fixtures which apply a constant load through a compressed helical spring. Unstressed tensile specimens are also placed in these same racks for comparison.

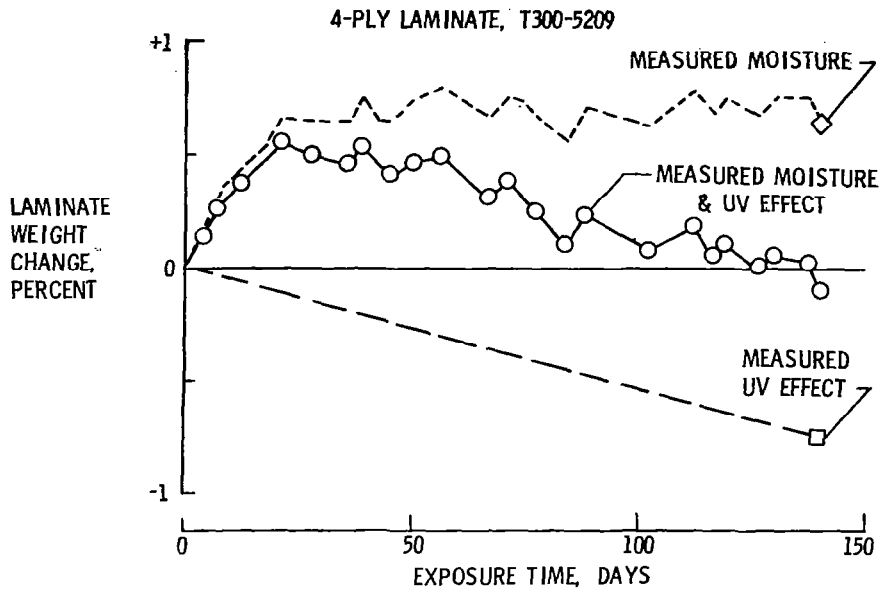
Figure 10.- Weight change in outdoor exposure; 4-ply laminate, T300-5209.

When specimens are removed and shipped to Langley periodically, they are weighed to determine weight changes associated with moisture absorption and weathering. An example of the specimen weight changes with exposure time is shown in figure 10 for a thin graphite-epoxy specimen in the unstressed rack at Langley. The solid curve in the center of the figure drawn through the circular test points is the record of the repeated weighings. The specimen initially gained weight and then began to gradually lose weight as a result of the combined effects of moisture and solar ultraviolet exposure. The exposure of this specimen was terminated after 140 days and the specimen was then dried to a fully dry condition. The weight change associated with this drying indicated the actual measured moisture level in the specimen at 140 days. Comparing the fully dry weight to the initial fully dry weight showed the measured ultraviolet effect of a weight loss after 140 days. Since the ultraviolet effect is a loss from the exposed specimen surface, it is assumed to be linear with exposure time. Corrections can then be calculated for the measured weights at intermediate times, and an interpolated moisture curve can then be plotted as shown by the upper dashed line in figure 10. This curve appears to have reached an equilibrium level of moisture absorption between 0.6 and 0.7 percent. The small fluctuations correspond to changes in the daily levels of relative humidity.

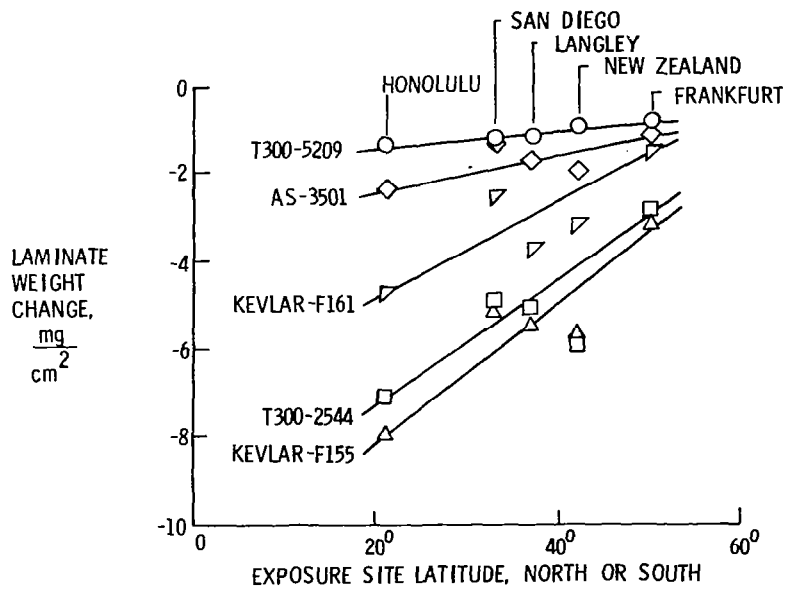
Figure 11.- Weight loss from three years outdoor ultraviolet exposure.

The results of fully drying the flexure specimens from five exposure sites after three years of exposure provided a pattern of weight losses due to ultraviolet exposure as shown in figure 11. For any given material, the weight losses are greater for exposure sites closest to the equator. Variations in the epoxy matrices for the different material systems seem to provide a greater variation in weight loss than changes in exposure site latitude. In all cases the specimens were exposed in an as-laminated condition without any protective coating. The weight losses in three years time correspond to less than 25 percent of one ply thickness.

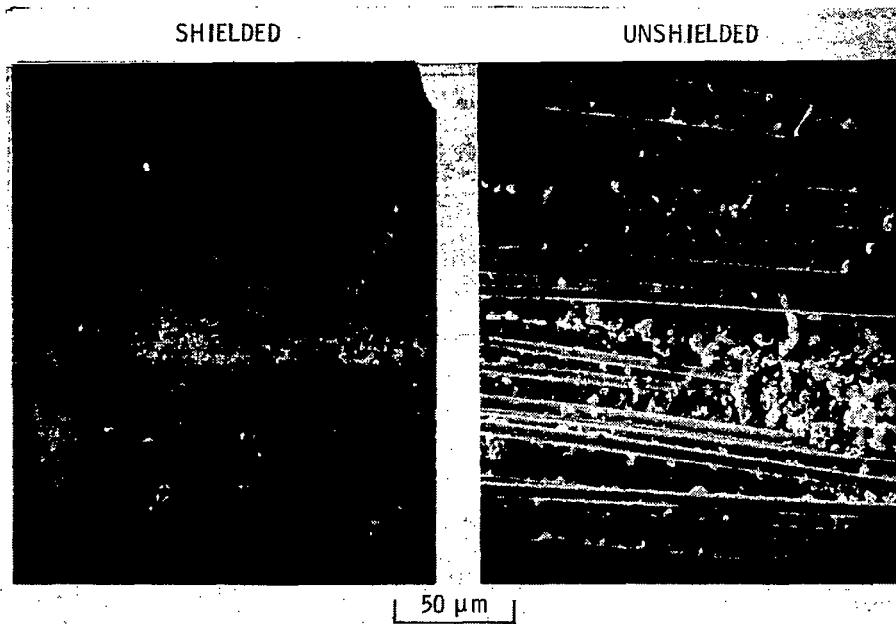
Figure 12.- Graphite-epoxy surface degradation; 3-year outdoor exposure.

Scanning electron micrographs of two areas on one of the T300-5209 graphite-epoxy specimens exposed at the Honolulu site are shown in figure 12. The left-hand area was shielded from the solar ultraviolet by the specimen mounting clamp on the exposure rack. The magnified view is essentially the original as-laminated surface, which is entirely epoxy. The right-hand area was typical of the unshielded portion of the same specimen. In this area the epoxy matrix has been removed by the ultraviolet weathering process, exposing

a layer of individual graphite fibers. Although the effect looks bad, it really is quite superficial in three years time and it can be prevented by painting the exposed specimen surface.

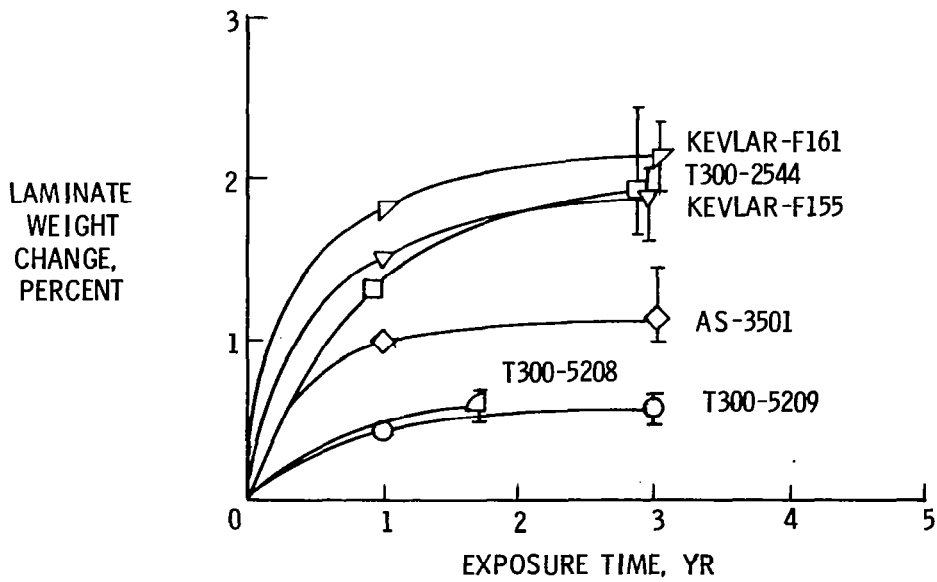
Figure 13.- Moisture pickup after worldwide exposures.

The amount of moisture absorbed by the various composite material systems is shown in figure 13. These results represent the determinations made on flexure specimens after their worldwide outdoor exposures for times up to three years. The weight gains shown have been corrected for the ultraviolet weight losses as described previously for figures 10 and 11. The scatter bands indicated for the three-year exposures contain all the data for triplicate specimens and five exposure sites. In general there is no separation of individual sites by the magnitude of absorbed moisture. The largest variable appears to be the type of epoxy matrix used in the composites. Even the Kevlar-epoxy values are in the same range as one of the graphite-epoxies. Data for T300-5208 graphite-epoxy is only shown for a 1.7-year exposure because the specimens which were made as a part of the graphite-epoxy rudder flight service program were not available to be deployed in the exposure rack panels until 1.3 years after the other specimens were deployed. However, the absorbed moisture for the T300-5208 is essentially the same as for the T300-5209 material, and both appear to be at an equilibrium level of about 0.5 percent of the laminate weight.

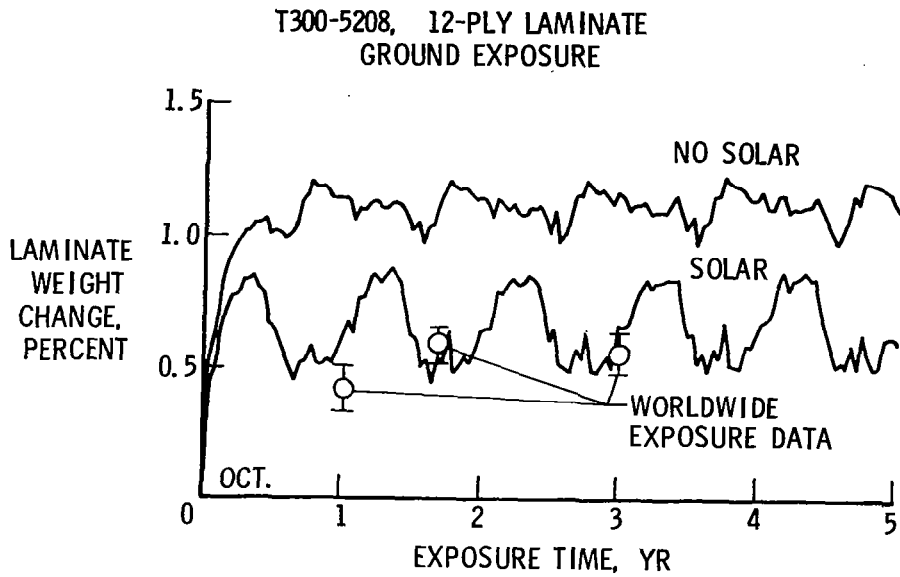
Figure 14.- Comparison of predicted and measured moisture contents; T300-5208, 12-ply laminate; ground exposure.

A comparison of the measured moisture contents for both T300-5208 and T300-5209 materials with predicted moisture contents for a 12-ply laminate of T300-5208 graphite-epoxy is shown in figure 14. The predicted moisture contents are based on calculations using the Fickian diffusion equations with varying inputs for relative humidity and temperature (ref. 8). These varying inputs are taken directly from tape recordings of the weather at Langley Research Center. The predicted curve marked "No Solar" was calculated assuming that the temperature of the specimen was the same as that of the ambient air. This is a reasonable assumption for specimens exposed in shade; however, if the specimens are exposed to the Sun, they will be heated to temperatures well above the ambient air temperature on clear, sunny days. This will increase the rate of moisture diffusion and, more importantly, decrease the local relative humidity at the surface of the specimens. Inclusion of these effects in the calculations results in the lower predicted curve marked "Solar". The weather data for the year 1962 were used repetitively in the calculations, starting at the first of October to correspond with the initial deployment of the exposure racks and specimens. The experimental data points at 1, 1.7, and 3 years are taken from the overall worldwide exposure data previously discussed in figure 13 for T300-5208 and T300-5209 graphite-epoxies. The correlation between prediction and experiment is good.

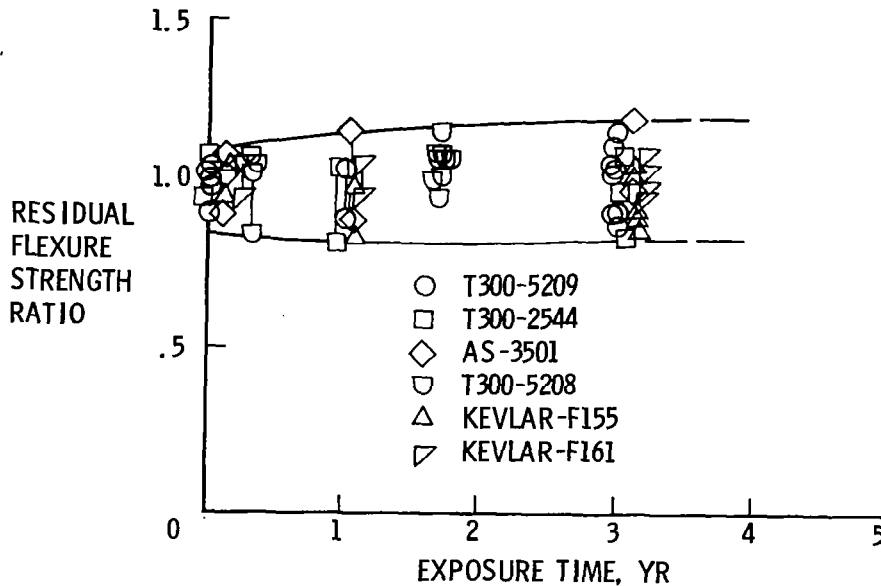
Figure 15.- Residual flexure strength after worldwide exposure.

The observed loss of material from ultraviolet exposure and pickup of moisture from the relative humidity leads to a concern for the effect on residual mechanical properties. Figure 15 shows the results of flexure strength tests performed after various exposure times at all of the worldwide exposure sites for six composite materials. The data are shown in nondimensional form obtained by dividing residual strengths by the initial as-laminated strengths. The width of the scatter band for strength is largely a function of the scatter in triplicate tests from various exposure sites. However, it is not sufficiently greater than the scatter in the initial replicate tests to justify any

conclusions. It is evident that for three years of outdoor ground-based unstressed exposure there has been no indication of degradation in flexure strength. Similar conclusions can be drawn from results of the short beam interlaminar shear and the compression tests also, after three years of unstressed outdoor exposure.

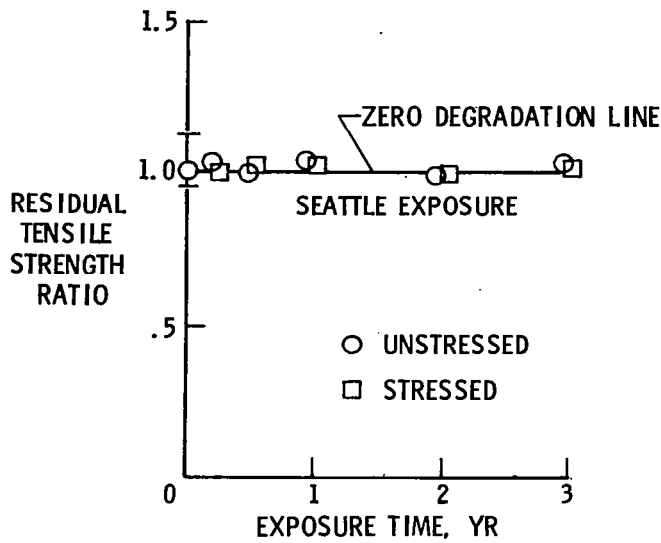
Figure 16.- Residual tensile strength after sustained stress outdoor exposures; T300-5209, $\pm 45^\circ$ laminate stressed at 25 percent ultimate.

To consider the possible influence of constant stress during the outdoor exposure, three sets of tensile specimens have been included in the program. The first set consists of T300-5209 graphite-epoxy material laminated at $+45^\circ$ ply orientation and stressed during exposure at 25 percent of the initial ultimate strength. Exposure and residual strength testing have been conducted in the Seattle, Washington area by The Boeing Company under NASA contract. Results shown in figure 16 indicate essentially no difference between stressed and unstressed exposure and no degradation in tensile strength for up to three years of exposure. The second and third sets of tensile specimens are T300-5208 graphite-epoxy material laminated in a $[0^\circ, +45^\circ, 90^\circ]$ quasi-isotropic ply orientation and stressed during exposure at 40 percent of the initial ultimate strength. Exposure sites for these are located at the San Francisco airport and at Langley. Specimens have been retrieved and tested at Langley after one and three years exposure. The results shown in figure 17 indicate about the same amount of scatter as shown previously for the flexure strengths and indicate essentially no difference between stressed and unstressed exposures and no degradation in tensile strength.

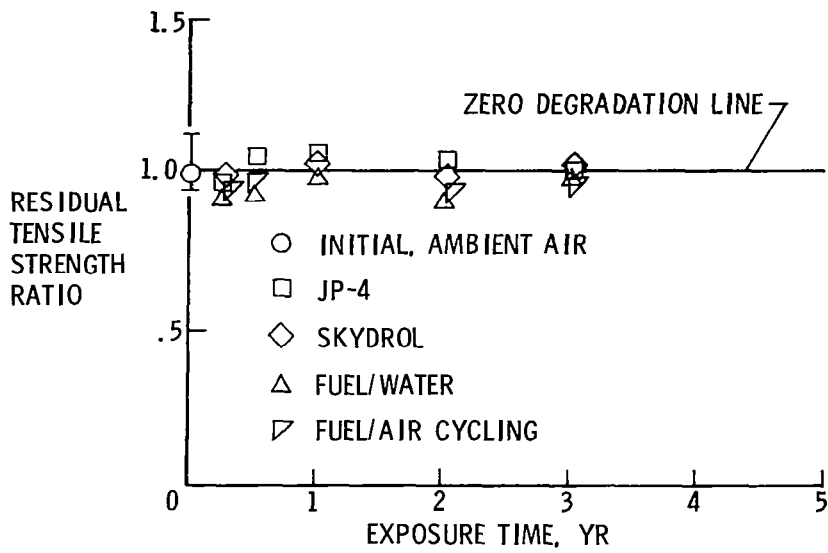
Figure 18.- Effect of fuels and fluids on strength; T300-5209, $\pm 45^\circ$ tensile specimens.

Another type of environmental exposure includes the interaction of composite materials with extended exposure to aircraft fuels and hydraulic fluids. Under NASA contract The Boeing Company has conducted a series of exposures of several composite materials in JP-4 jet fuel, a commercial aviation phosphate-ester hydraulic fluid, a fuel-and-water mixture, and a fuel-and-air cyclic environment. All exposures are outdoors in an unheated shed in the Seattle area. Short beam interlaminar shear and tensile specimens are being exposed. Typical results are shown in figure 18 for T300-5209 graphite-epoxy material laminated at a $+45^\circ$ ply orientation. The data indicate no degradation in tensile strength for up to three years exposure in any of the above environments.

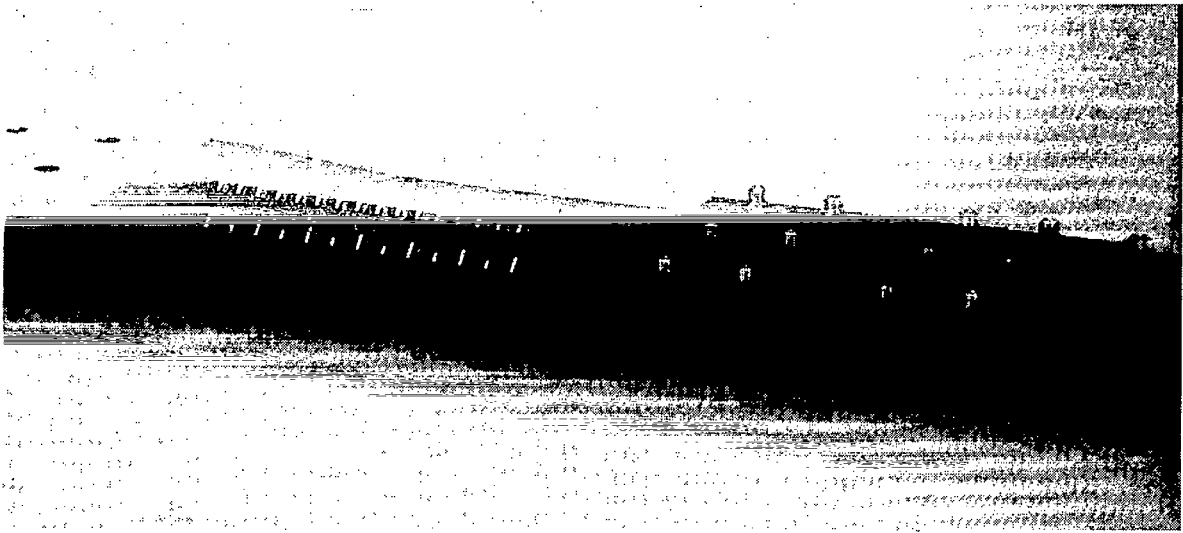
Figure 20.- Bolted joint for graphite-epoxy wing splice.

Technology for designing primary structural discontinuities such as bolted joint wing splices in composite materials is being developed in programs like the one discussed in reference 9. Test specimens with multiple, repeating patterns of bolted fasteners (fig. 20) have been fabricated with laminate thicknesses of 1.37 cm (0.54 in.) and static strength tested successfully. With the validation of the static design, replicate specimens have been fabricated and are under long-term stressed exposure outdoors at Langley as shown in figure 21. The sustained stress level has been set at 25 percent of the static ultimate.

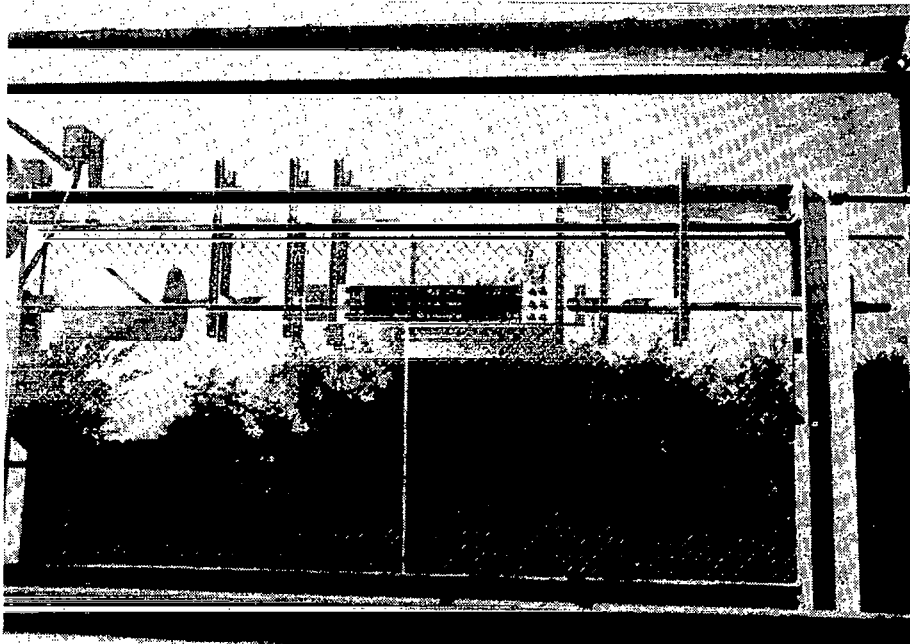
Figure 21.- Wing splice environmental exposure.

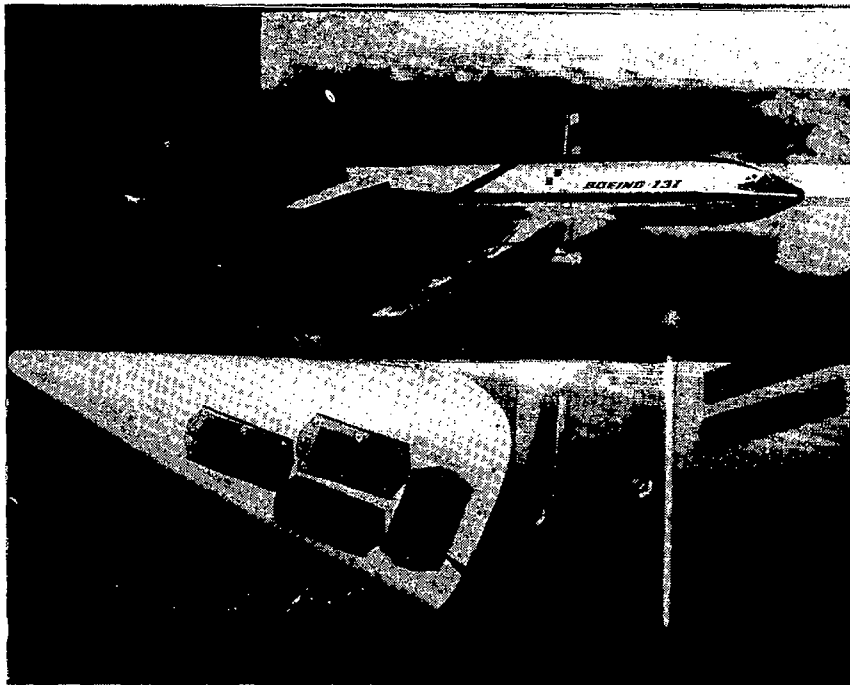
Figure 22.- Exterior moisture pickup in flight.

In order to obtain some information on the rate of moisture diffusion into composite materials in actual flight service, as well as to determine directly the equilibrium levels achieved, two programs have been initiated to fly specimens of three graphite-epoxy material systems on three 737 and three DC-10 transport airplanes which are already involved in the flight service evaluation of graphite-epoxy spoilers and rudders. Moisture pickup in flight on the exterior surface of the 737 airplane will be determined from specimens mounted on both the upper and lower surfaces of the flap track fairing tail cone as shown in figure 22. Specimens are mounted in titanium holding fixtures which are attached to the fiberglass tail cone. Periodically one upper and one lower surface fixture are removed and sent to The Boeing Company where they will be weighed and fully dried. Moisture pickup in flight on interior surfaces of parts which are vented to the atmosphere on DC-10 airplanes will be determined from specimens mounted in a holding fixture attached inside the wing leading edge as shown in figure 23. Periodically these specimens will be removed, weighed, and reinstalled by Douglas Aircraft Company personnel during normal aircraft stopovers at Los Angeles or San Francisco.
