THE IMPORTANCE OF THERMAL-VACUUM TESTING IN ACHIEVING  
HIGH RELIABILITY OF SPACECRAFT MECHANISMS

K PARKER\*

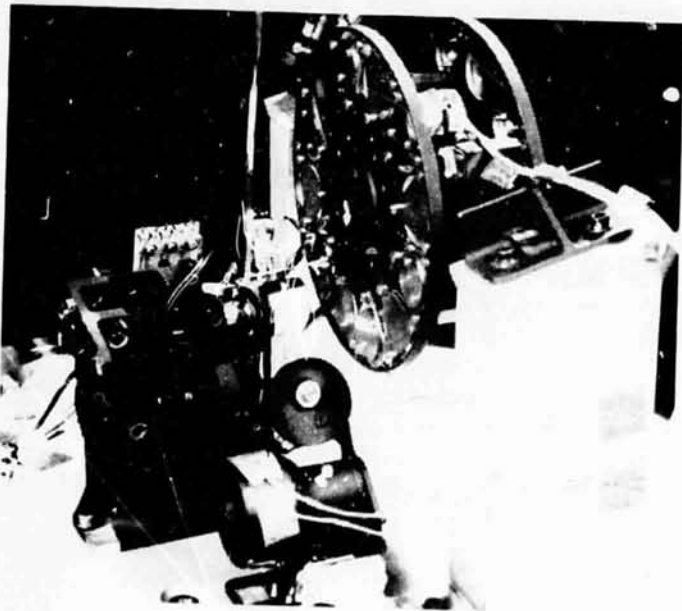
Figure 10. Three Mechanisms  
for the Faint-Object Camera  
of the Space Telescope

Three faint-object-camera mechanisms (filter wheel, refocusing, and shutter mechanisms (Figure 10)) for the Space Telescope were subjected to simultaneous accelerated life tests, each performing in excess of 40,000 actuations. Many measurements have been made on a large number of critical items such as stepper motor, actuator motor, spring assembly, flexure pivots, lead-screw, lead-lubricated bearings, plastic gears, and electromagnetic position sensors. These mechanisms were typical examples of the dilemma often experienced by a mechanism designer, who must guarantee that the complete mechanisms will conform to the required specification but must use components that, although of the highest quality available, are not guaranteed by the various suppliers to fulfill the required specification.
