SPACE SHUTTLE ORBITER AUXILIARY POWER UNIT
DEVELOPMENT CHALLENGES

Renee Lance and Dwayne Weary
NASA Lyndon B. Johnson Space Center
Houston, Texas 77058

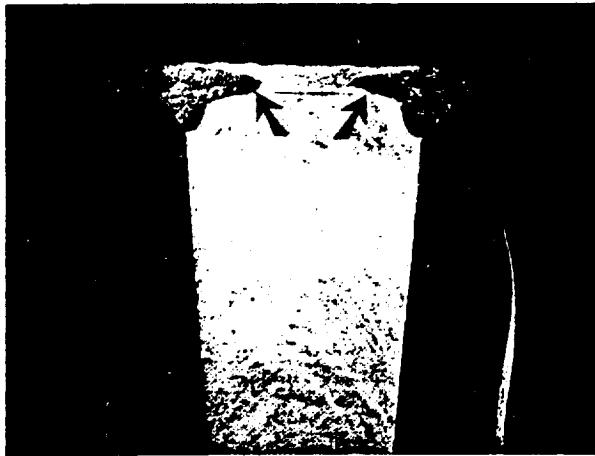
FIGURE 9.- METALLOGRAPHIC SAMPLE OF EB-WELDED JOINT RANDOMLY SELECTED. ARROWS DENOTE UNWELDED AREA IN CENTER OF JOINT (14X).

Increased strength and weldability characteristics were achieved by changing the shroud material from Hasteloy X to Inconel 625. Then, a very precisely controlled electron-beam (EB) weld procedure was developed to ensure full penetration weld across the chord of the blades without overheating the shroud. These actions eliminated the shroud crack problem.

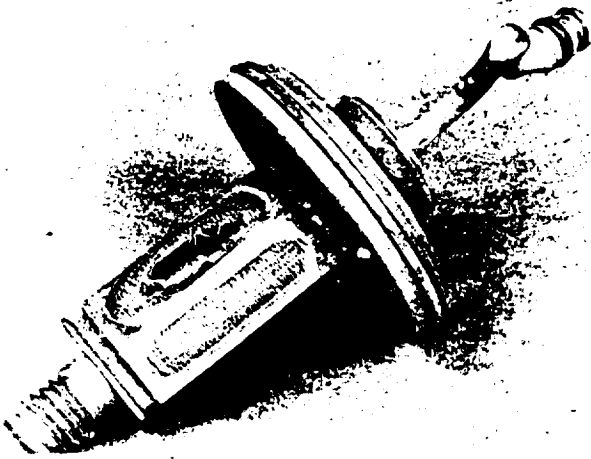
FIGURE 15.- APU GG INJECTOR FAILURE.

Thermal control within the GG was another area of significant concern. Overheating of the injector assembly during soakback after APU shutdown caused damage to the GG, damage to GGVM seals, decomposition of residual fuel in the injector upstream of the injector Rigimesh panels, and damage to the panels themselves (fig. 15). Early corrective actions included using a copper heat shunt between the injector and the GGVM mounting plate to dissipate some of the heat in the injector, and decreasing the thermal mass of the injector such that the incoming fuel could better cool the injector.

Even though these changes resolved the thermal concerns about the operating APU, it was found that if the APU restarted before the injector cooled to less than 400° to 450° F, the fuel would thermally decompose behind the injector panels and cause damage to the injector and would even feed back upstream to damage the GGVM. Limited hot-restart capability was finally achieved by adding an active water cooling system to the GG to be used only for hot restarts. This system injects water into a cavity within the injector. The steam thus generated is vented overboard (fig. 16). Use of this system enables restarts at any time after the cooling process, which requires a 210-second delay, is completed.

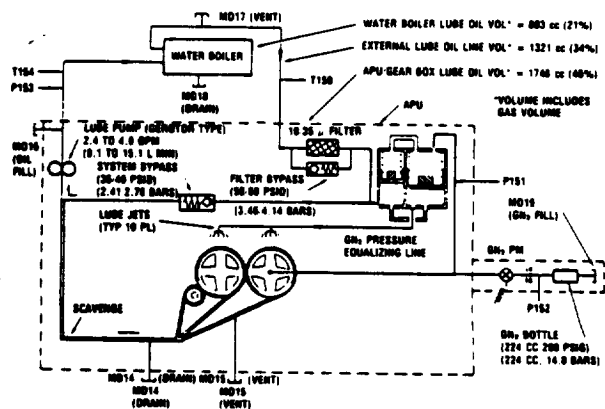
FIGURE 20.- APU LUBRICATION SYSTEM.

During the development test program, it was determined that if the pressure within the gearbox was less than approximately 1 psia, the oil pump was incapable of functioning in a satisfactory manner (i.e., low pressure could develop on orbit because of seal leakage). The problem was primarily due to low net positive suction head (NPSH) pressure at the pump, but because the system is a closed loop which is not completely filled, voids could also form at the pump inlet. It, therefore, became necessary to provide a fluid (gas or oil) for the pump to displace to assure presence of oil at the inlet. This problem was resolved by adding a gaseous nitrogen pressurization system which guarantees a minimum of 4 to 7 psia in the gearbox at startup and during operation (fig. 20).
