Robert G. Hoey

X-15 CONTRIBUTIONS TO THE X-30

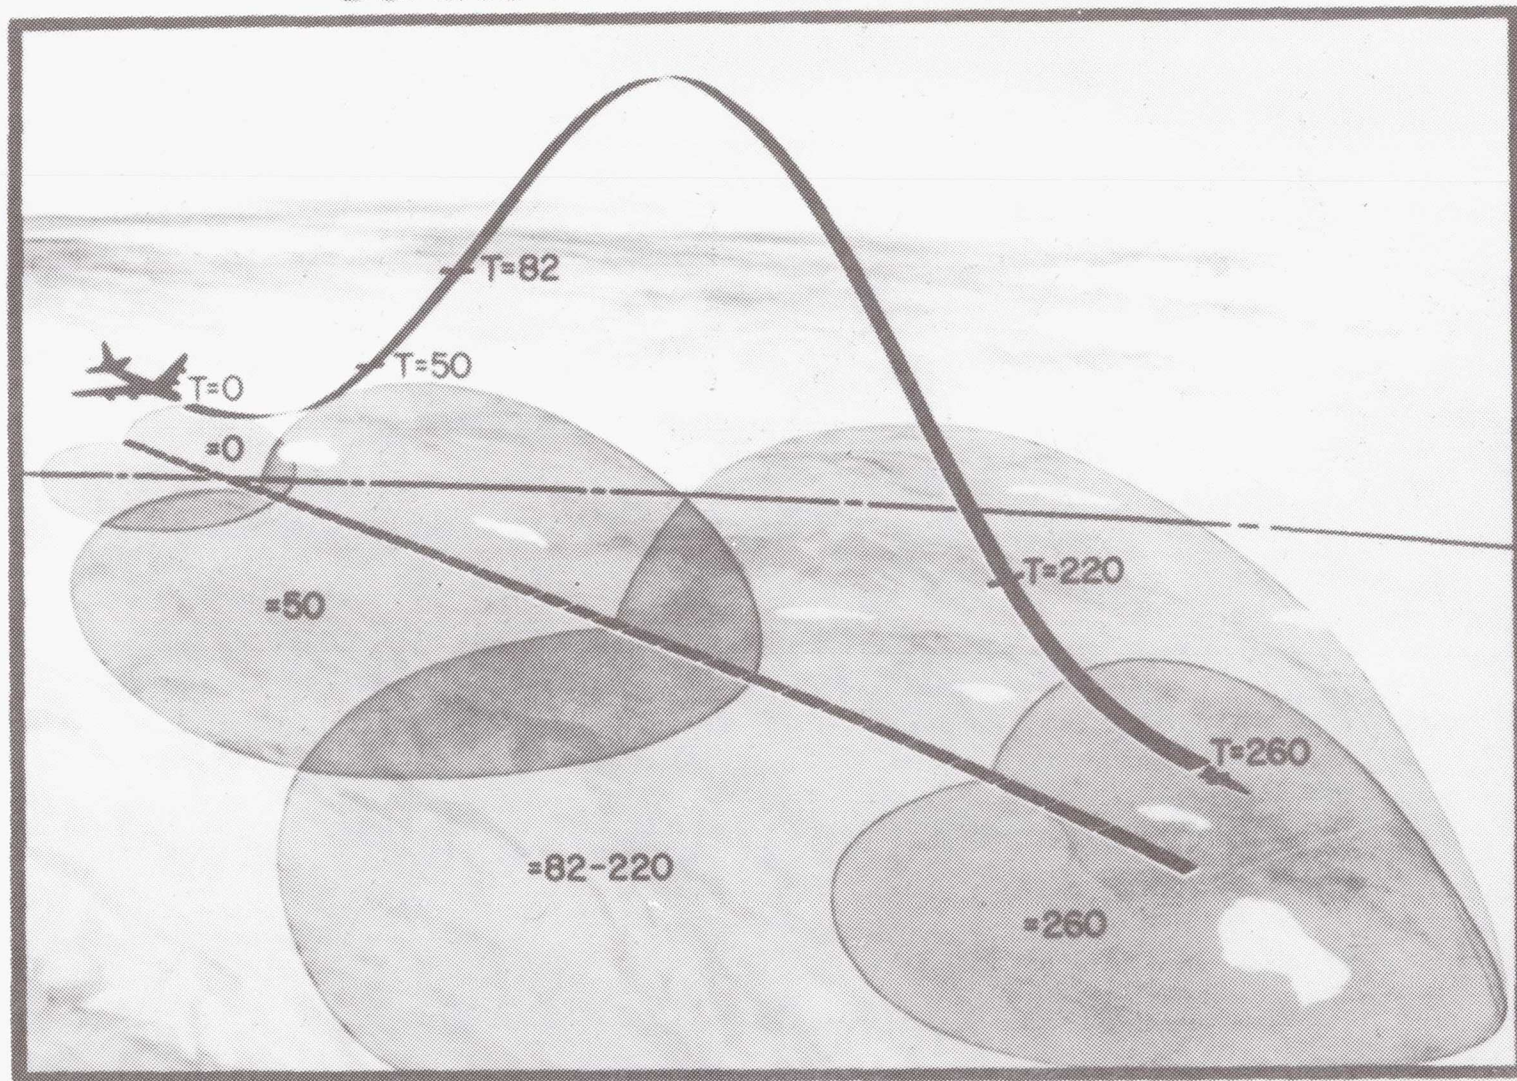
VARIATION OF RANGE CAPABILITY DURING A TYPICAL X-15 FLIGHT

Figure 2. Variation of range capability during a typical X-15 flight.

The energy management for a typical X-15 flight is shown in figure 2. Most of the flights were conducted essentially in the vertical plane. It was most important to establish the proper heading toward Edwards during the first 20 sec after launch, very much like aiming in the direction of the target when firing a gun. The remainder of the powered portion of flight was used to establish the proper pitch angle and engine shutdown velocity, which again is akin to establishing the correct elevation and muzzle velocity of a gun. Once the X-15 engine was shut down, the trigger was pulled and the ballistics were pretty well established for the next few minutes of flight.

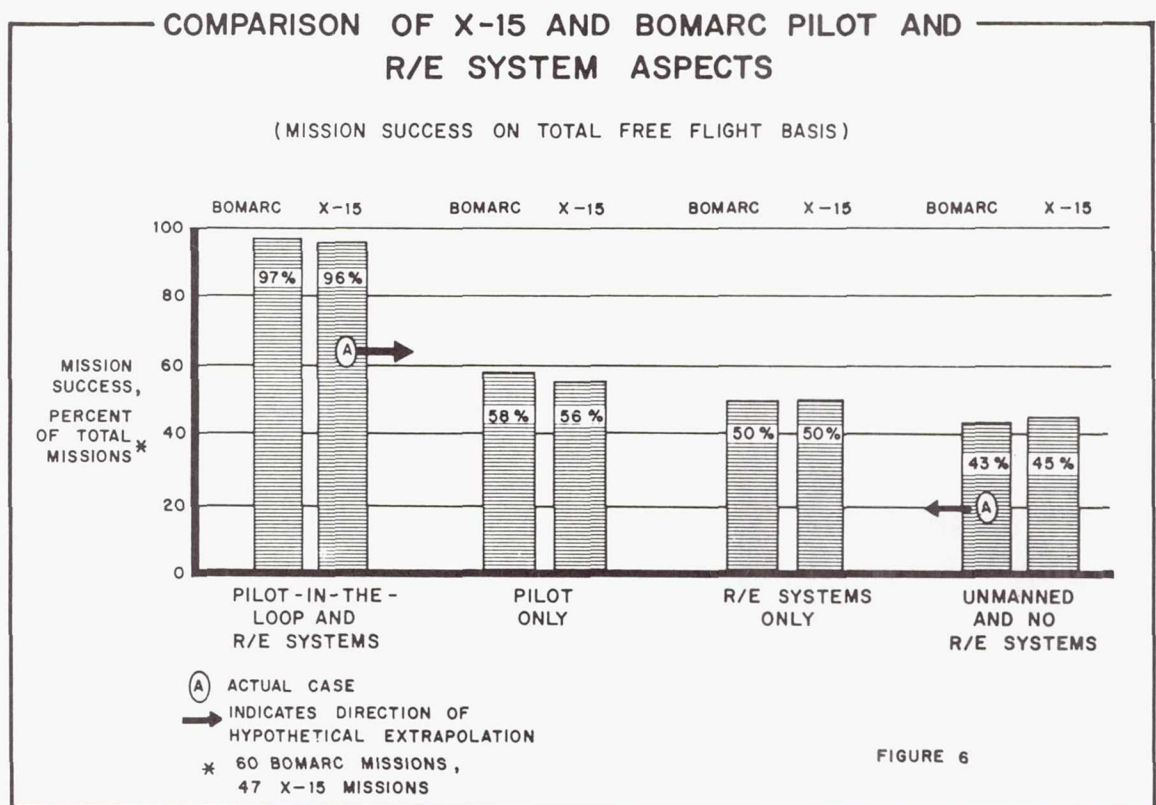
Figure 5. Comparison of X-15 and BOMARC pilot and R/E system aspects.

Of more than academic interest was a parallel, but independent, study conducted by Boeing on the first 60 flights of their BOMARC missile, an unmanned, single-string, ramjet-powered interceptor. The authors collaborated on the ground rules for the study but not on the actual analysis. The similarity of the results as shown in figure 5 is striking, especially when considering that the X-15 study was projecting from a piloted, redundant design to an unpowered, nonredundant design, and the BOMARC study was the reverse. The X-30 will have a crew on board, and mission success should be significantly enhanced if the appropriate levels of redundancy and emergency systems and proper crew integration are designed into the system.

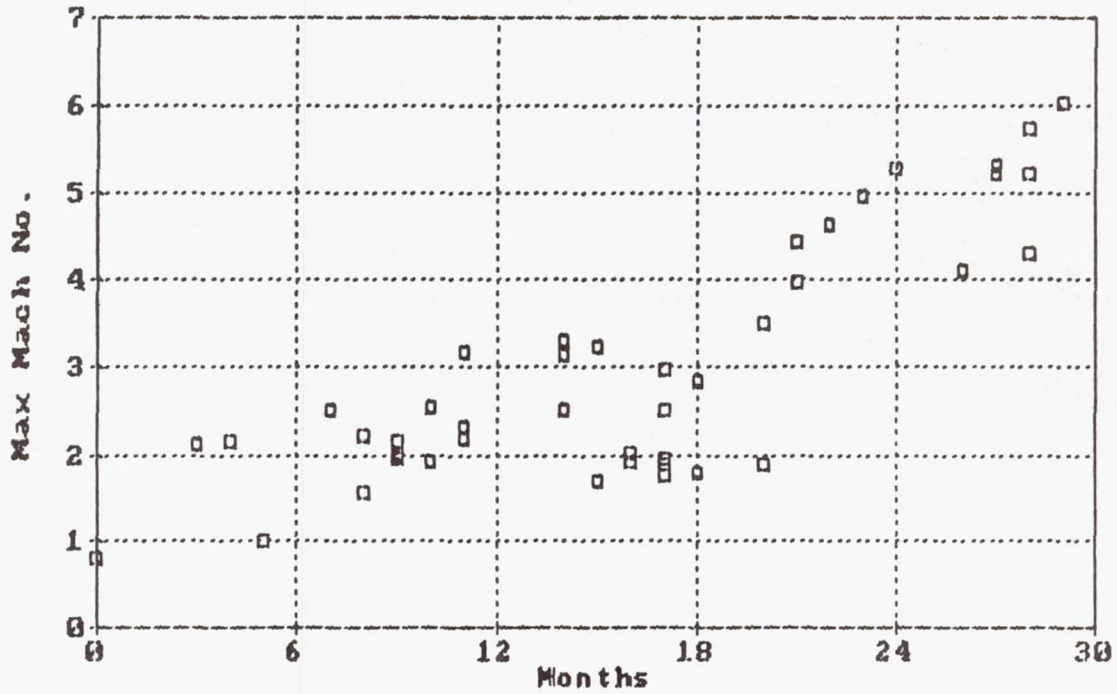
(b) Maximum Mach number history.

Figure 14. X-15 envelope expansion for first 45 flights.

The chronology of the initial envelope expansion of the X-15 is shown in figures 14(a) and 14(b) for the first 2 1/2 years of the flight test program. The altitude envelope for the -11-powered airplane reached 136,500 ft in a little over a year. The first -99-powered flight was flown 18 months after the first glide flight and the design altitude was reached 16 months later. The -11-powered airplane exceeded Mach 3.0 within a year. The max speed flight to 6.04 was flown 11 months after the first flight with the -99 engine. About half the people on the program thought that this pace was too slow and that we should be more aggressive. The other half thought it was much too fast and that we should do more research along the way. The real benefit was the luxury to choose whatever pace we thought was right.
