NASA/TM—1998—208539

Final Report on Life Testing of the Vapor Compression Distillation/Urine Processing Assembly (VCD/UPA) at the Marshall Space Flight Center (1993 to 1997)

*P. Wieland, C. Hutchens, and D. Long
Marshall Space Flight Center, Marshall Space Flight Center, Alabama*

August 1998

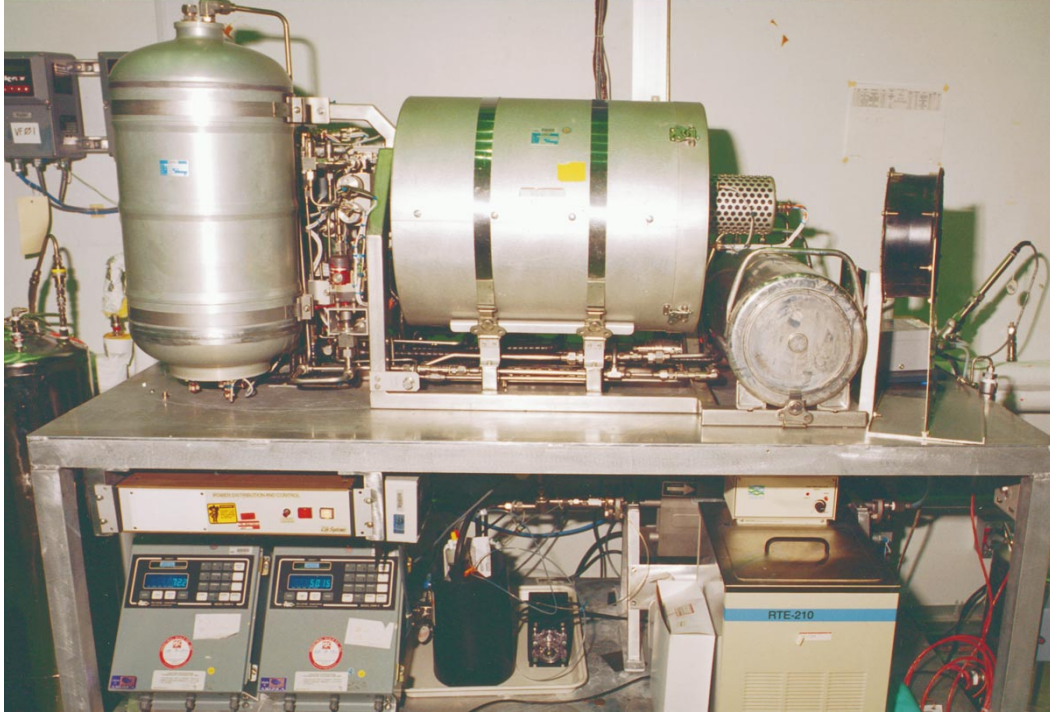
Photographs of the VCD-5 and VCD-5A are shown in figures 2 and 3. As shown schematically in figure 4, the VCD-5 and VCD-5A each consist of a wastewater storage assembly (WSA), a fluids control assembly (FCA), a fluids pump assembly (FPA), a distillation assembly (DA), a recycle filter tank assembly (RFTA), a pressure control assembly (PCA), a purge pump assembly (PPA), and sensors for measuring conductivity, temperature, pressure, rotation speed, and electrical current level. These components are described below.

Figure 2. Photograph of the VCD-5.

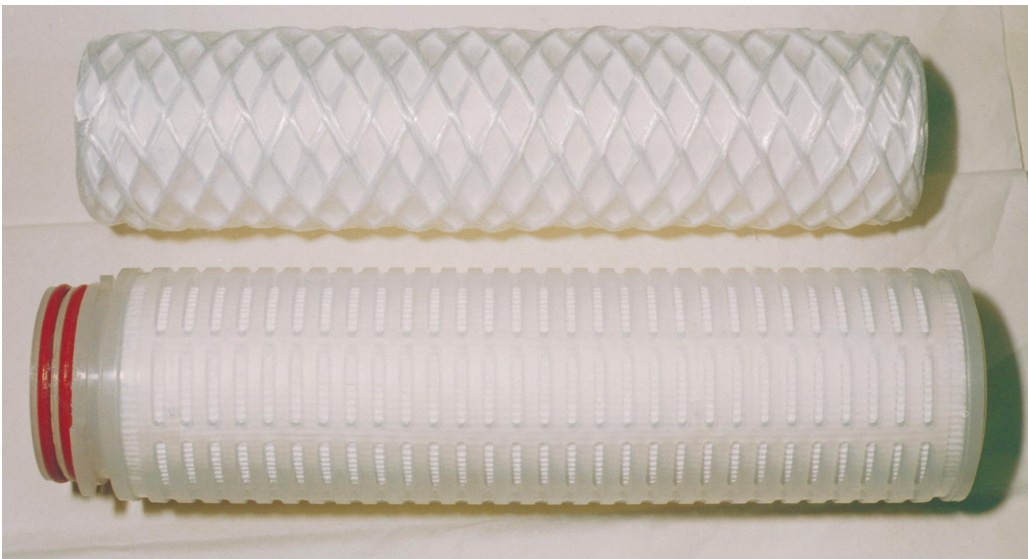
Figure 8. VCD/UPA filters (top: 25 µm pore size, bottom: 10 µm pore size).

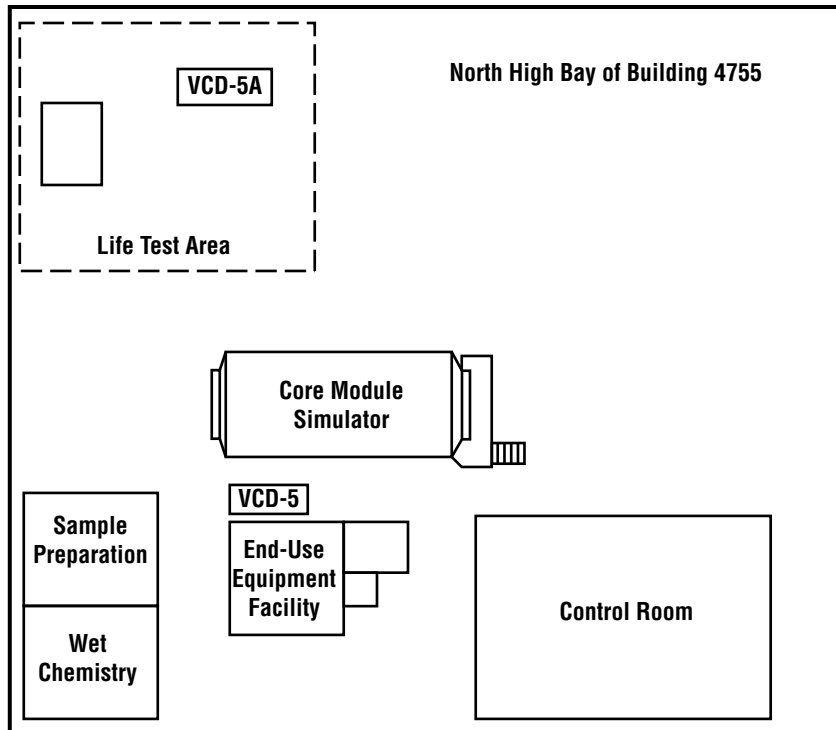
The VCD/UPA life testing was performed at MSFC in Building 4755, in the ECLS test facility shown in figures 11 and 12. The test facility provided all necessary utilities and data collection and monitoring capabilities. The VCD-5 was located next to the End-use Equipment Facility (EEF) and the VCD-5A was located in the northwest corner of the north high bay. Urine was collected in the EEF (as shown in figure 13) and a restroom, and pretreated using Oxone® (Oxone is a registered trademark of the DuPont Company) and sulfuric acid (in liquid form and, later, in solid tablet form as planned for use on *ISS*) prior to processing in the VCD-5A. The EEF was designed, built, and integrated with the ECLSS WRT to provide wastewater typical of that expected to be produced onboard *ISS*.^{8, 10}

Figure 12. Schematic of the ECLS test facility at MSFC.

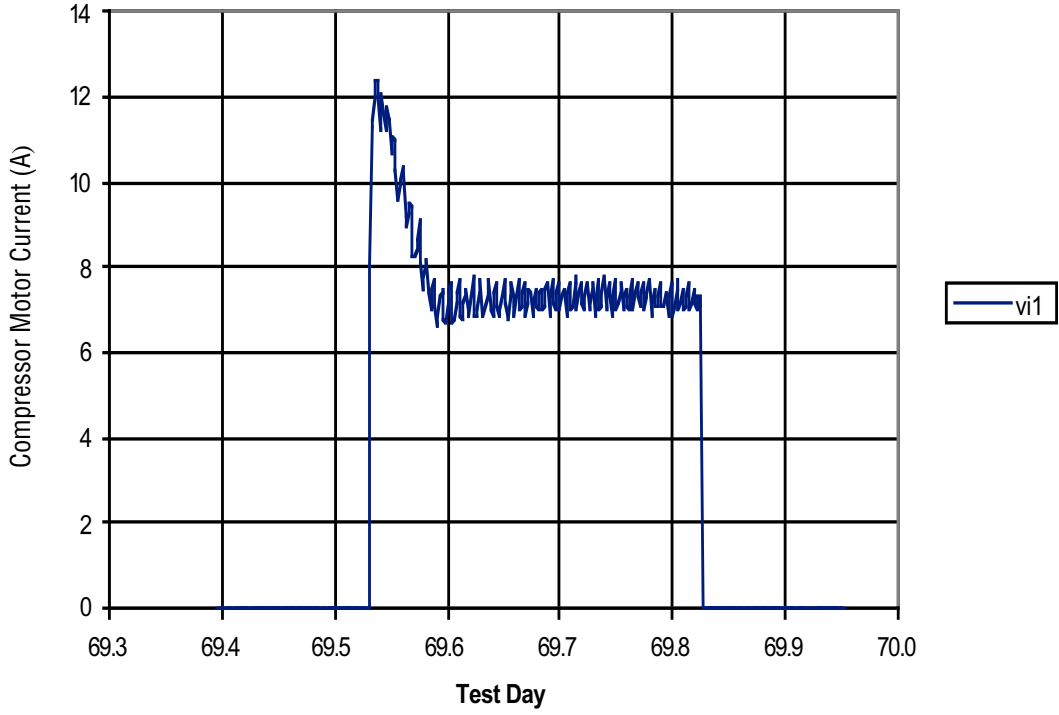
Figure 16. VCD-5 typical compressor motor current (I1).

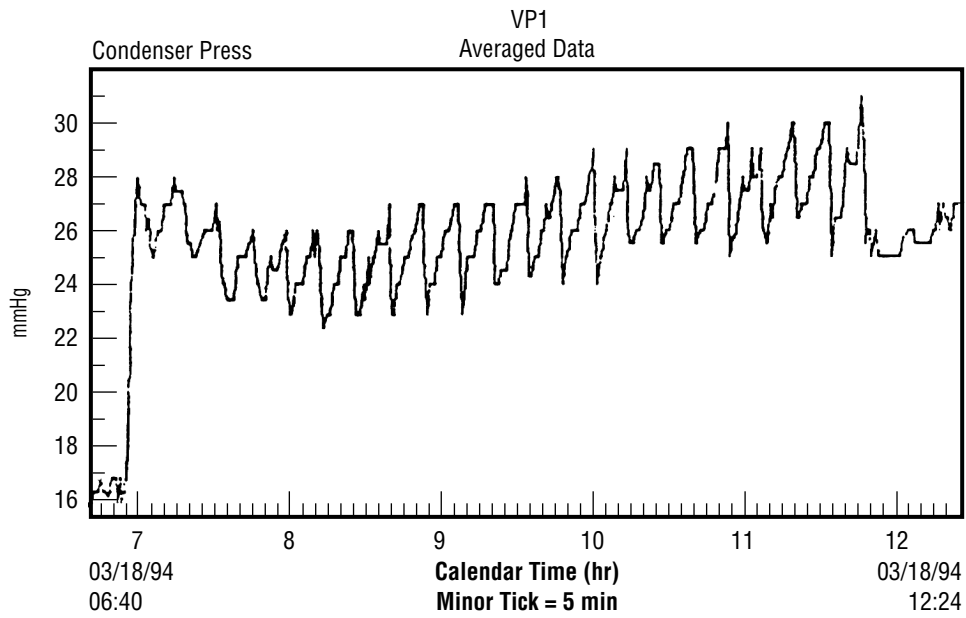
Figure 32. VCD-5A typical condenser pressures (P1).

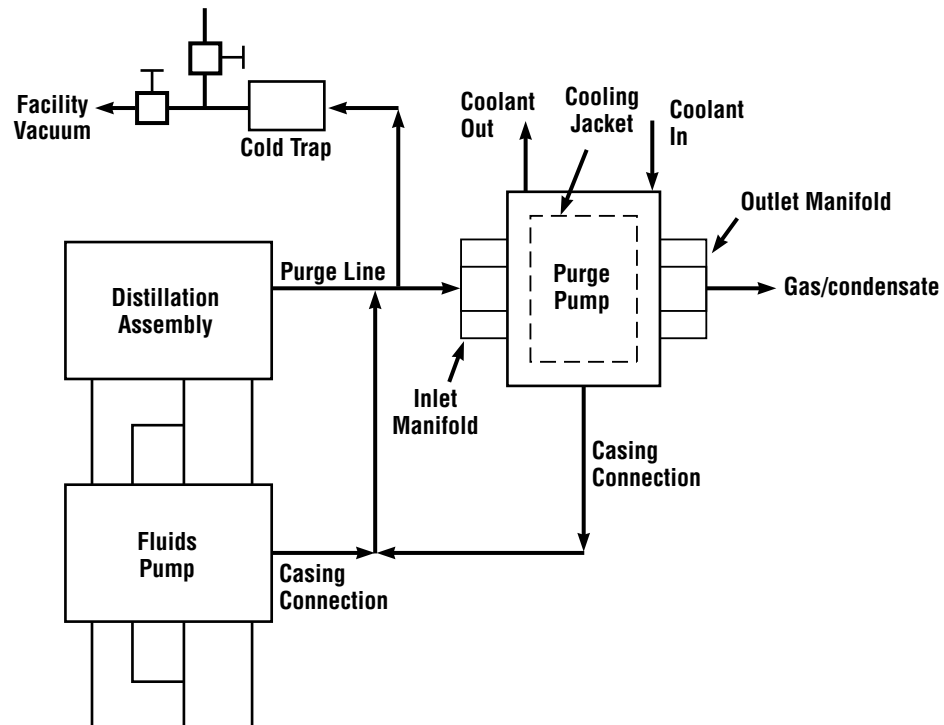
Figure 35. Facility vacuum connection to the purge and fluids pumps.

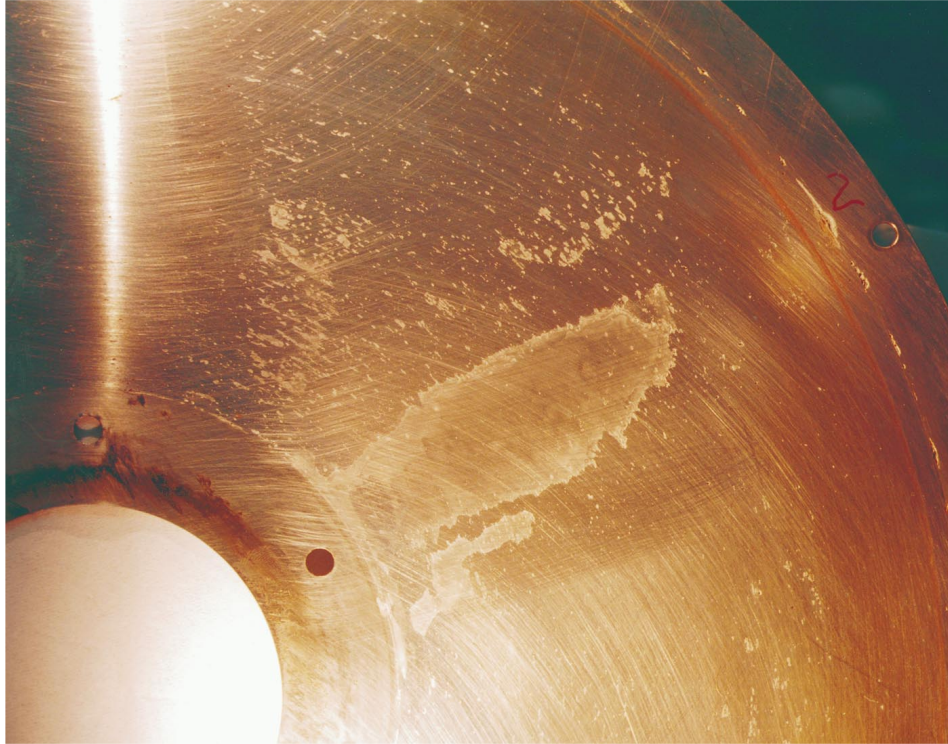
- An O-ring seal was missing between the condenser end plate and the drum. However, there was no indication of liquid leakage, so the metal-to-metal contact apparently provided an adequate seal.
- Some slight corrosion was evident between the condenser end plate and the drum spokes, as shown in figures 37 and 38.

Figure 37. VCD-5A end plate showing light corrosion.

Figure 38. VCD-5A distillation drum spokes showing light corrosion.

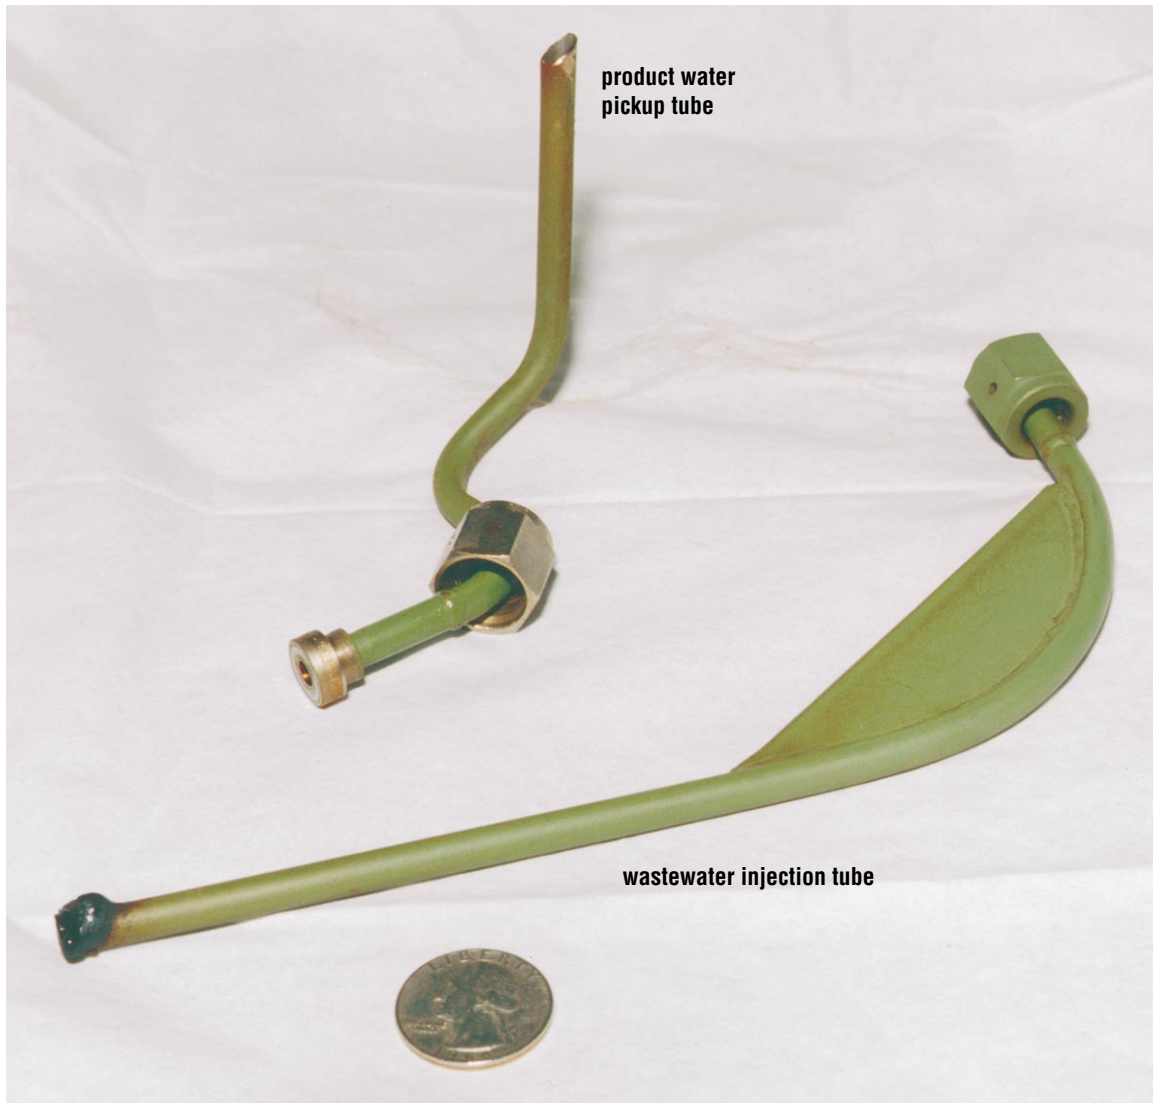
- The wastewater injection tube had a small “blob” of solids (3.2 to 6.4 mm (1/8 to 1/4 in.) thick) around the end of the tube, as shown in figure 39. The opening of the injection tube was not restricted. This material was hard and was removed as a “chunk.”

Figure 39. VCD-5A wastewater injection tube and product water pickup tube.

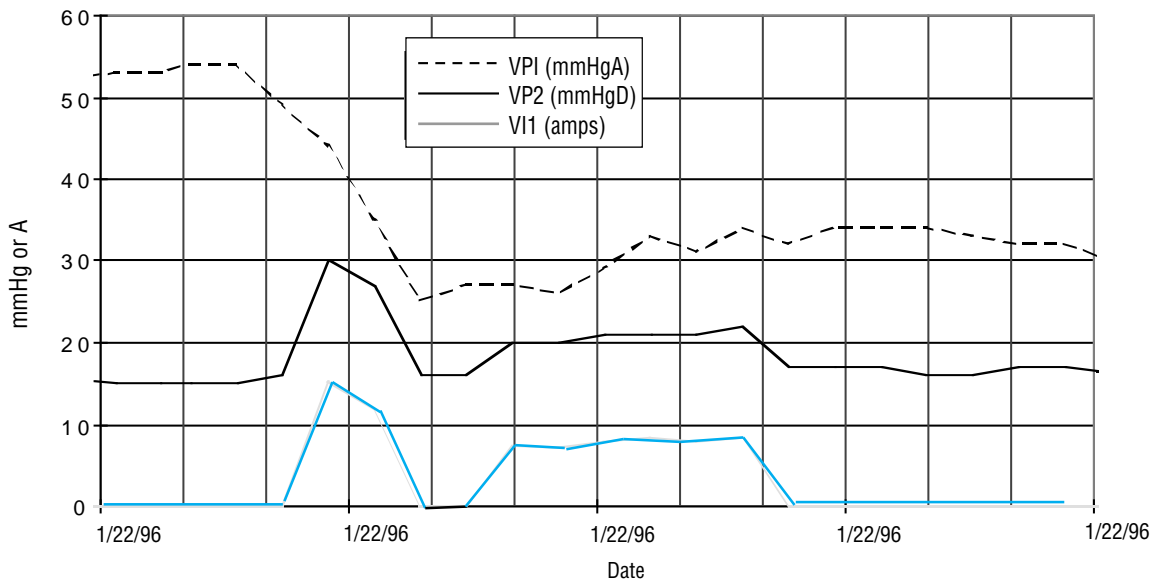
However, after a period of no operation (such as over a weekend), the unusual behavior was repeated and shutdown occurred about one hour after startup on the following Monday. When the unit was restarted, again, it operated normally and on subsequent days during the week operation was normal. On Monday of test week 159, January 22, 1996, the condenser pressure increased to 54 mmHg and the VCD-5A required additional power to bring the pressure down to normal operating conditions (32 to 45 mmHg). I1 started at 15A and after 15 min dropped to 12.6 A. I1 then jumped to 18A after 45 min in normal and an alarm caused a shutdown. The VCD-5A was immediately restarted and ran nominally with I1 remaining around 8A. The VCD-5A ran nominally for the remainder of the week, as shown in figures 41 and 42.

Figure 41. VCD-5A compressor temperature (T1) after repairs in January 1996.

Figure 42. VCD-5A compressor motor current (I1), condenser pressure (P1), and compressor differential pressure (P2) after repairs in January 1996.

On Monday of test weeks 160 and 161, shutdowns were caused by a spike in I1 of the compressor motor. During troubleshooting in February 1996 to determine the cause of the high current draw during startup, the following actions were performed with the indicated results:
