Overview of 10 inch Diameter HTPB Hybrid Motor Testing with Liquid Oxygen at Stennis Space Center

Timothy E. Knowles¹ and Darren Kearney²
Lockheed Martin Space Systems Company, New Orleans, Louisiana, 70129

Ryan Roberts³
National Aeronautics and Space Administration, Stennis Space Center, Mississippi

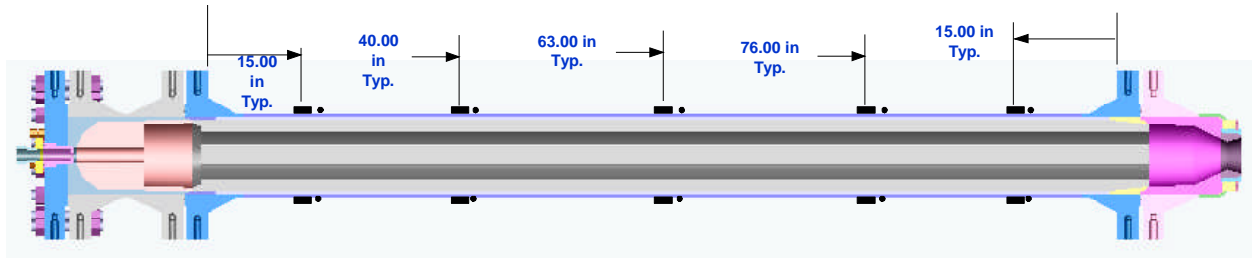
Figure 1 – Cross-section of the 10 inch diameter hybrid rocket motor with strain gage and thermocouple location indicated.

Two hybrid motors were cast in a 10-inch diameter Schedule 40, carbon steel pipe with bolt-on forward and aft domes containing the staged combustion heaters and the post combustion chamber, respectively. Each test article will contain a maximum of 250 lb of cured HTPB fuel. The fuel grains were of Double-D configuration. The Double-D configuration refers to a two port fuel grain where the cross-section of the port is a 2 inch wide segment of a 6 inch diameter circle (looks like a skinny letter D) with these ports mirror imaged back to back. The motor and associated components are designed for an operating pressure of 500 psi, a maximum sea level thrust of 6500 lbf, and burn duration of 25 seconds (ref. figure 2). This design will incorporate the Michoud Operations staged combustion heater system that uses electric igniters and a small gaseous oxygen flow throughout the test. The stub nozzles were made from ATJ graphite with a throat diameter of 3.7 inches and an exit of 4.7 inches for an expansion ratio of 1.61. The fore and aft domes are lined with an insulation cast from phenolic resin bonded into the case with a high temperature adhesive. The center section of the motor case (the fuel grain) of the first test motor was insulated with medium grain extruded graphite bonded into the case with a high temperature adhesive and was cast with a room temperature cured formulation of HTPB. The second motor was cast with an elevated temperature cured formulation of HTPB in an uninsulated case. The motors were designed for an LO2 flow rate of 19 lbm/s (ref. figure 3) and also require approximately 1.5 lbm/s of gaseous oxygen delivered to a total of 4 separate staged combustion heaters at a pressure of at least 900 psig upstream of the regulating orifice. The motor case was tapped for pressure measurements in the chambers before and after the fuel grains. The motors were also instrumented with strain gages and thermocouples and on the second motor, accelerometers.

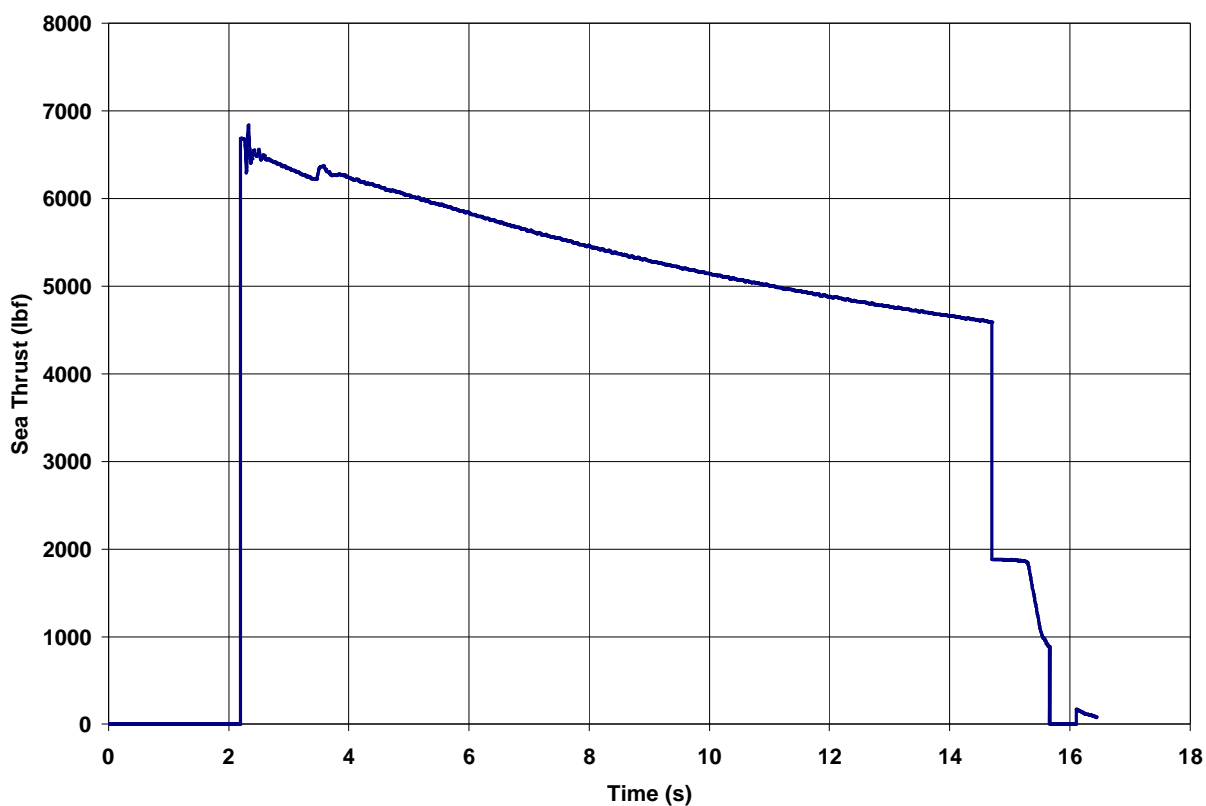
Figure 2 – Predicted Sea Level thrust for the HTT-01 test of 10 inch HTPB Double “D” Hybrid Motor with a nozzle expansion ratio of 6.8:1 and firing duration of 12.5 seconds

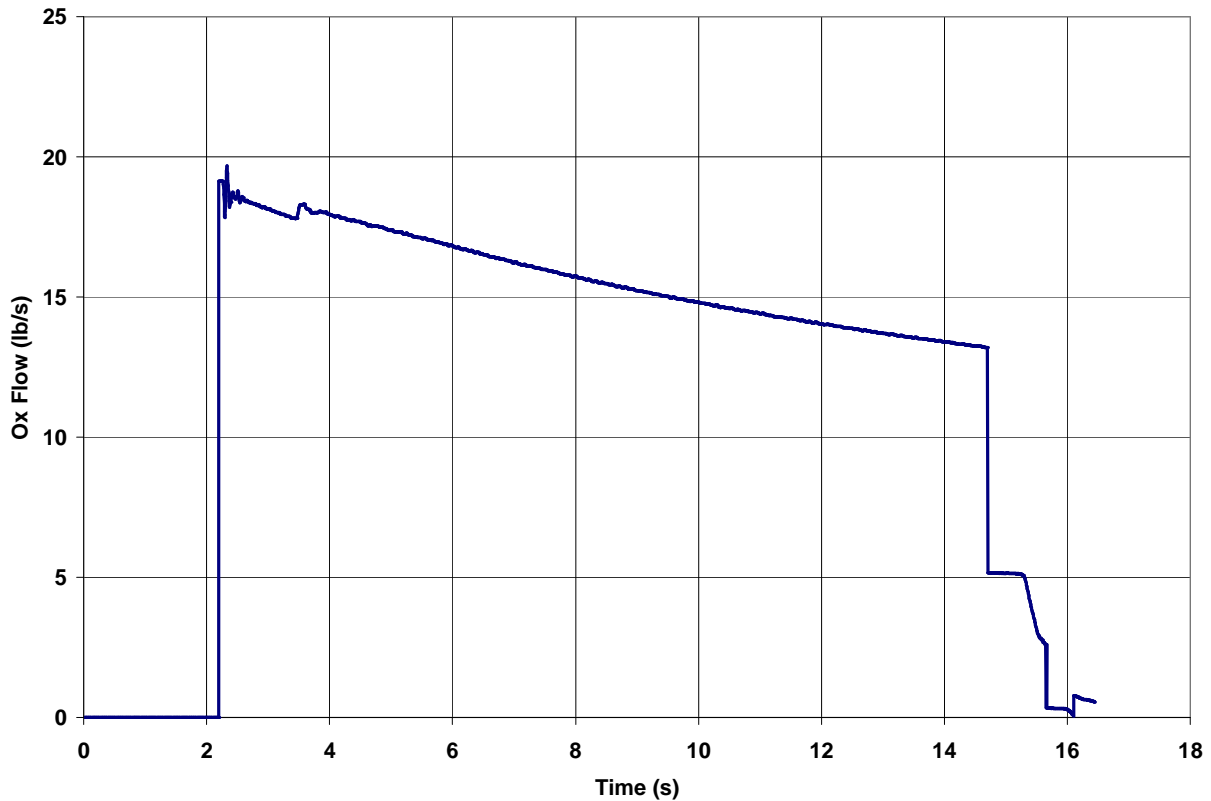
Figure 3 – Predicted LO2 Flow Rate for the HTT-01 test of the 10 inch HTPB Double “D” Hybrid Motor

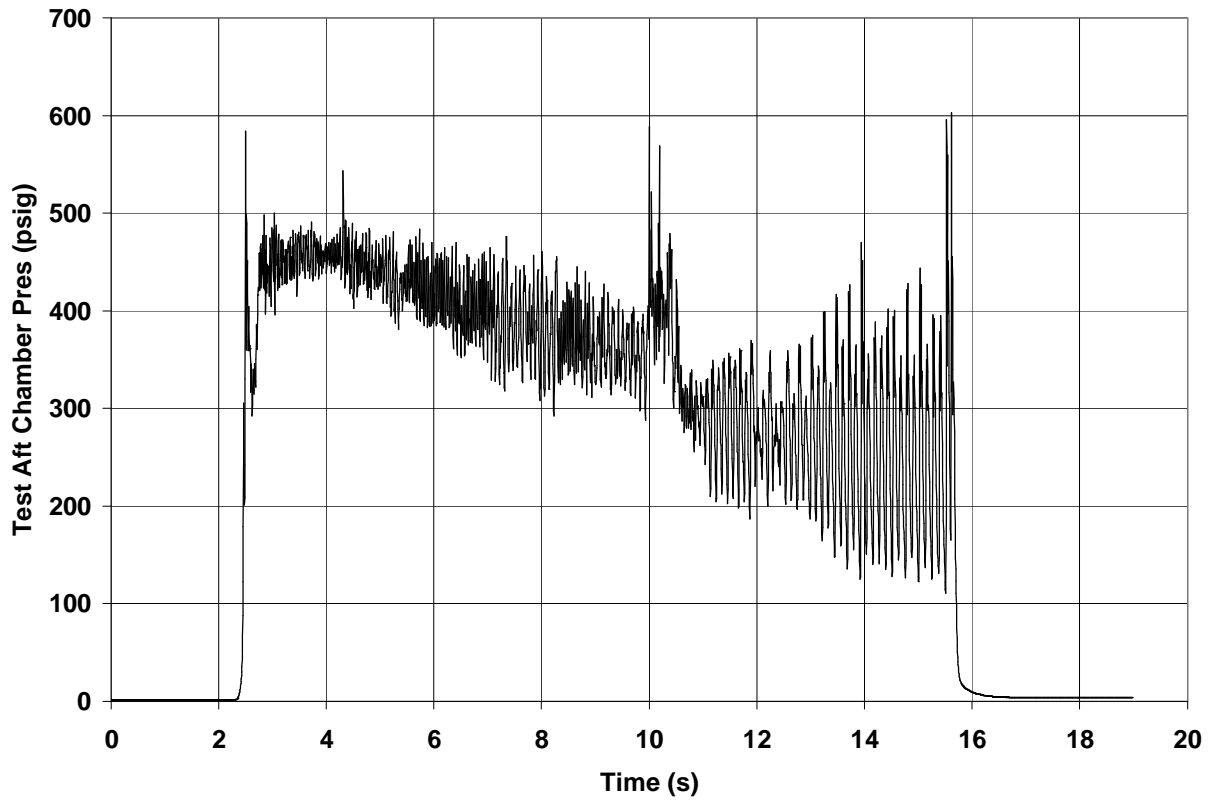
Figure 4 – Actual HTT-01 Forward Chamber Pressure vs. Time Profile

As previously indicated the first test was to be partial duration so that measurements of the remaining fuel could be made and compared to analytically predicted residuals. The facility was prepared and the test was run on December 5th, 2003. The test was run for the planned burn duration of 12.5 seconds. At 7.4 seconds into the burn there was a significant change in the sound of the motor and the exhaust plume began to flicker, at the same time the chamber pressure and thrust spiked and then dropped back to a level lower than previous trend and the predictions (ref. figures 3 and 4). The remaining seconds of burn time were completed with lower and erratic performance. After the motor cooled and personnel were allowed back out to the test stand a visual inspection of the motor through the nozzle opening was performed. Looking through the nozzle it was obvious that a large portion of the fuel web had torn loose and had been ejected through the nozzle, ref. figure 5.

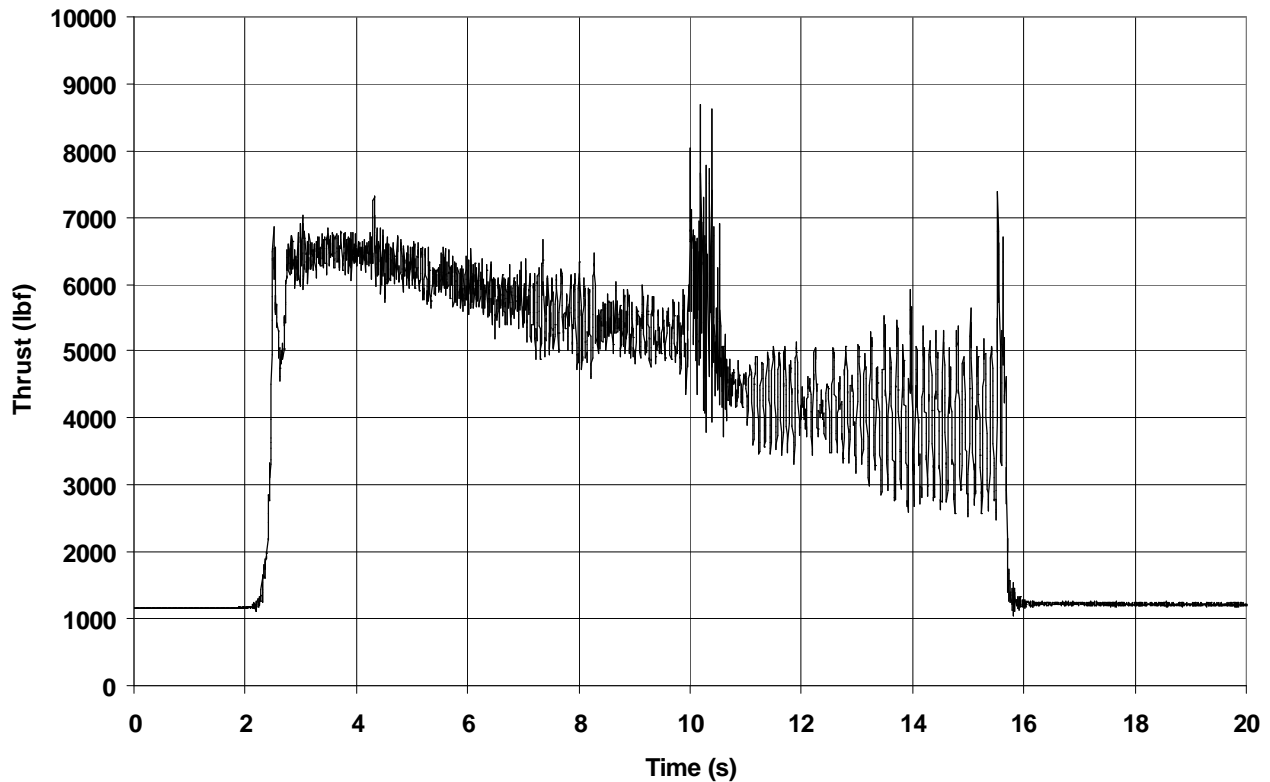
Figure 6 – The actual HTT-01 thrust vs. time plot

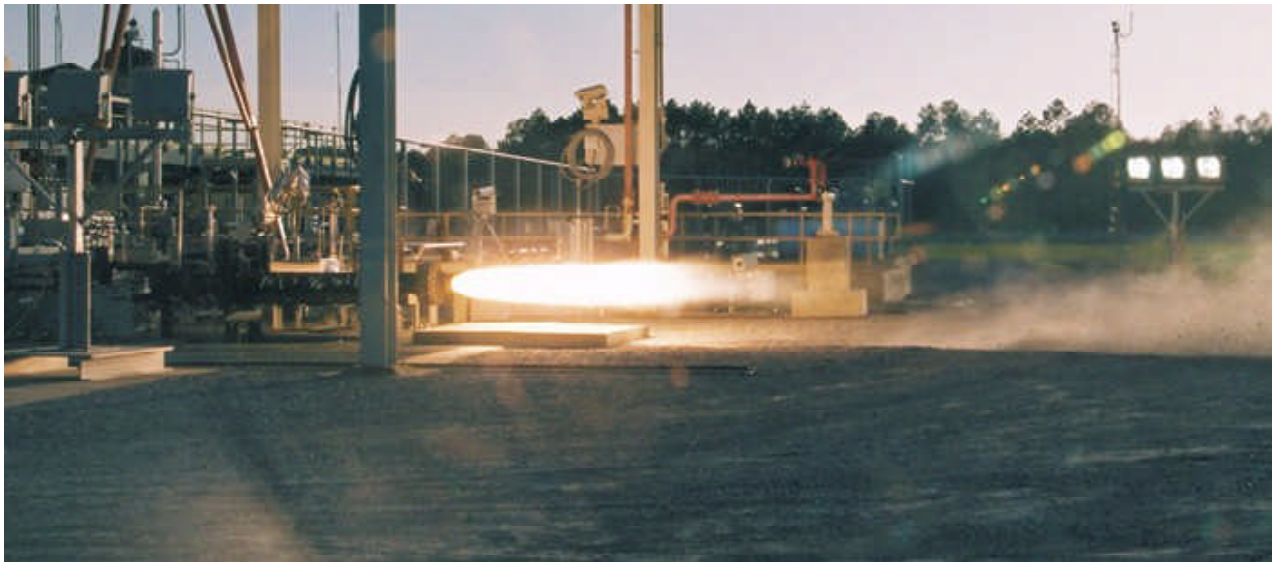
Figure 6 - Picture of the HTT-02 Motor during test

As previous indicated the HTT-02 test was of partial duration terminating prior to predicted web failure to ensure an accurate post-test measurement of fuel depletion. The facility was prepared and the test was run on May 19th, 2004 (ref. figure 7). The test was conducted for the planned duration of 7.5 second motor burn time. The motor was shutdown normally and a quick inspection revealed that fuel web was intact. The test goals were met as the fuel web remained intact the injectors were not damaged and we got good data from all measurements.

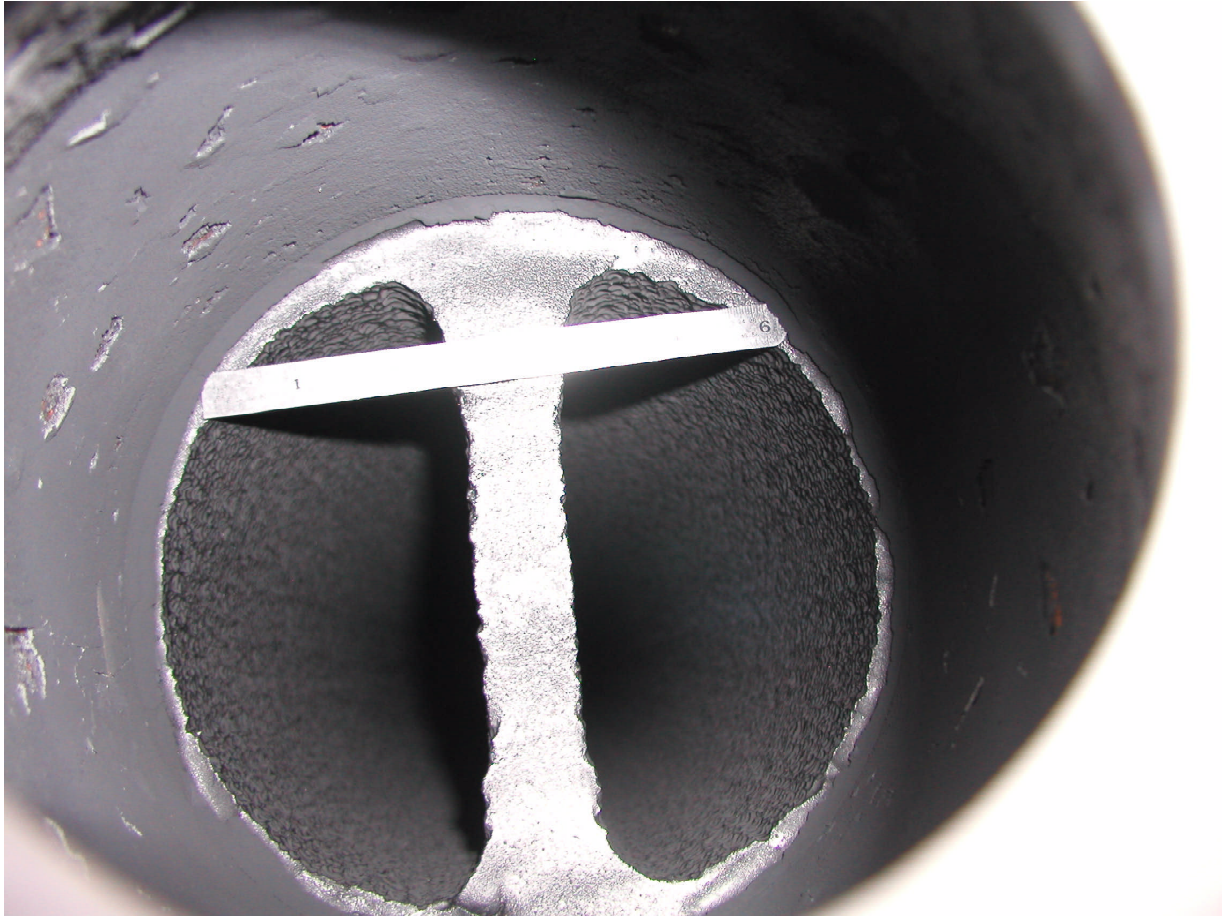
Figure 7 – The HTT-02 Post Test fuel grain as viewed through the nozzle

The web thickness was measured at the ends of the web (ref. figures 8 and 9) and the motor was weighed to establish the average regression rate. The measurements at the ends of the web overestimate the regression due to entrance and exit effects. Weighing the motor provided a better indication of the average regression of 61 mils per second. The motor experienced a chamber pressure oscillation mid-way into the burn. In reviewing the HTT-01 data the chamber pressure oscillation was attributed to the fracture of the fuel grain web but because the web in this case was still intact the oscillation must have a different cause.

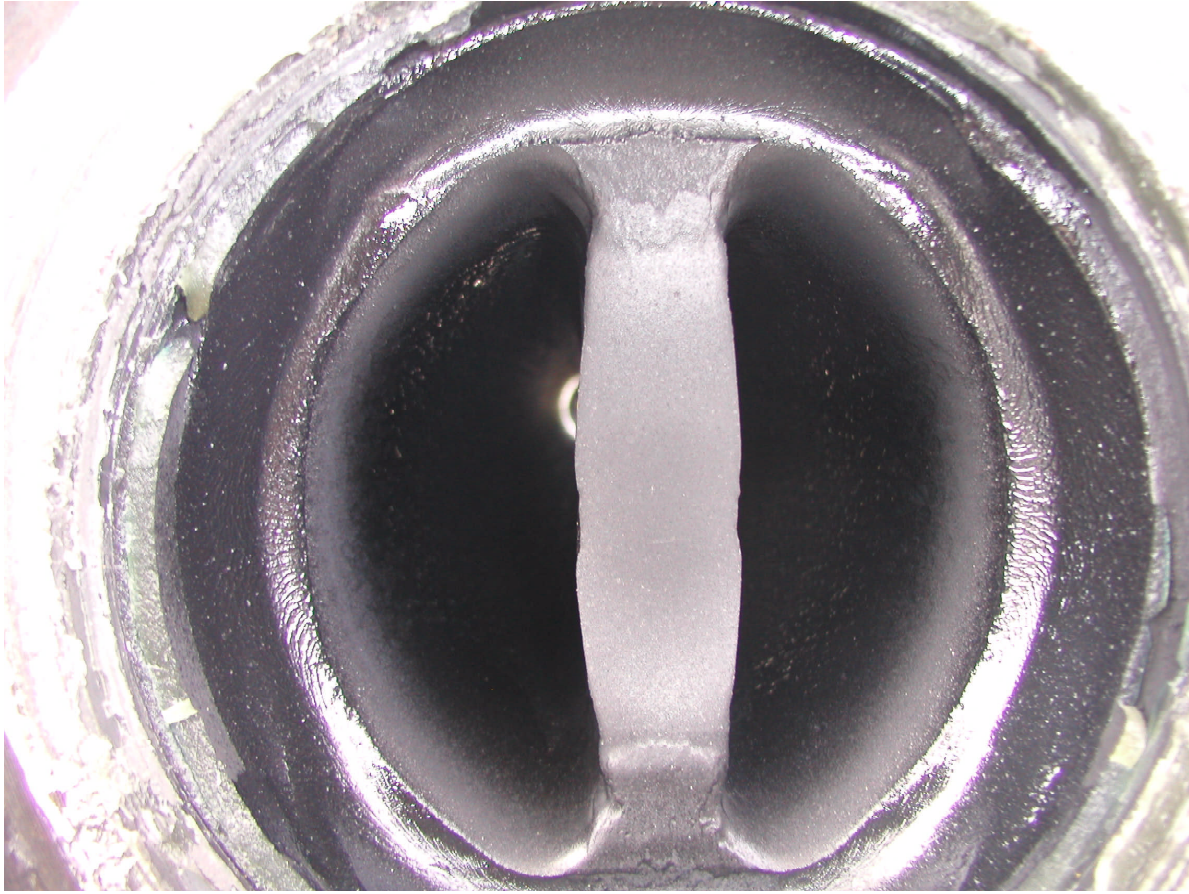
Figure 8 – The HTT-02 Post Test fuel grain as through the head end

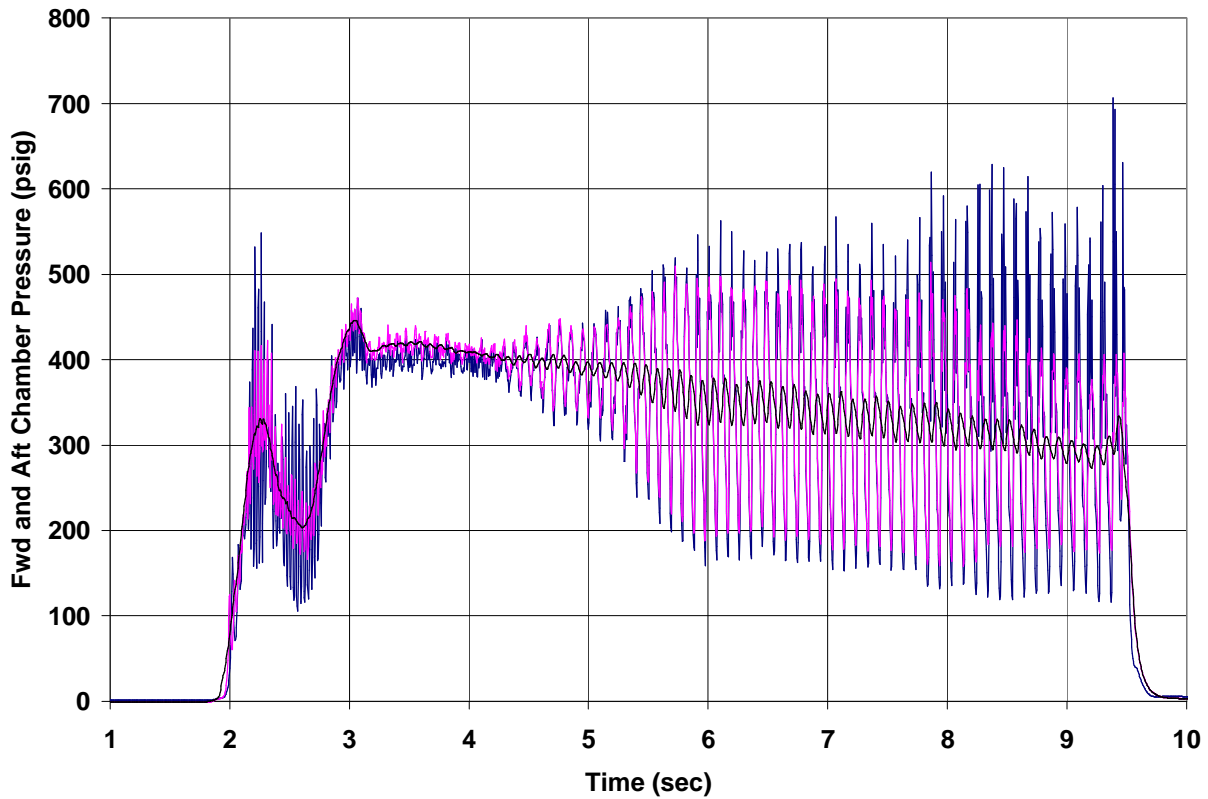
Figure 9 – The HTT-02 Chamber pressure plot

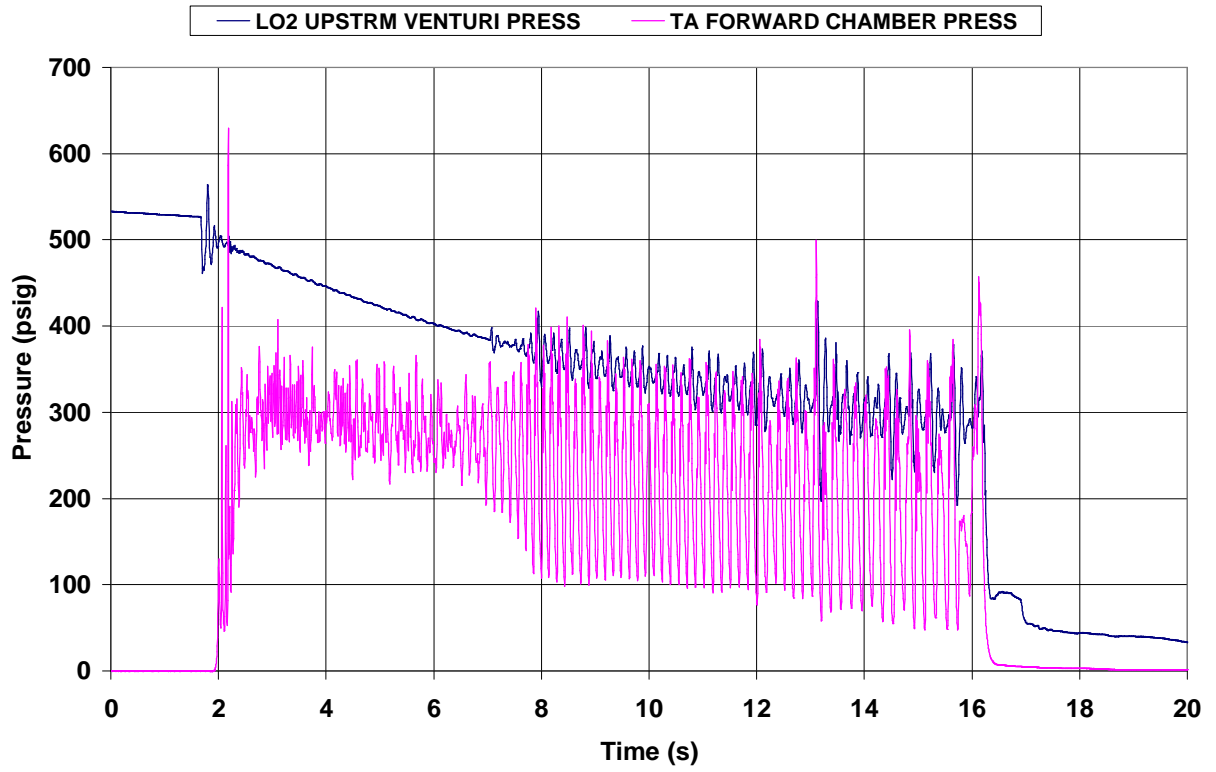
Figure 10 – The HTT-03 Venturi and chamber pressure comparison

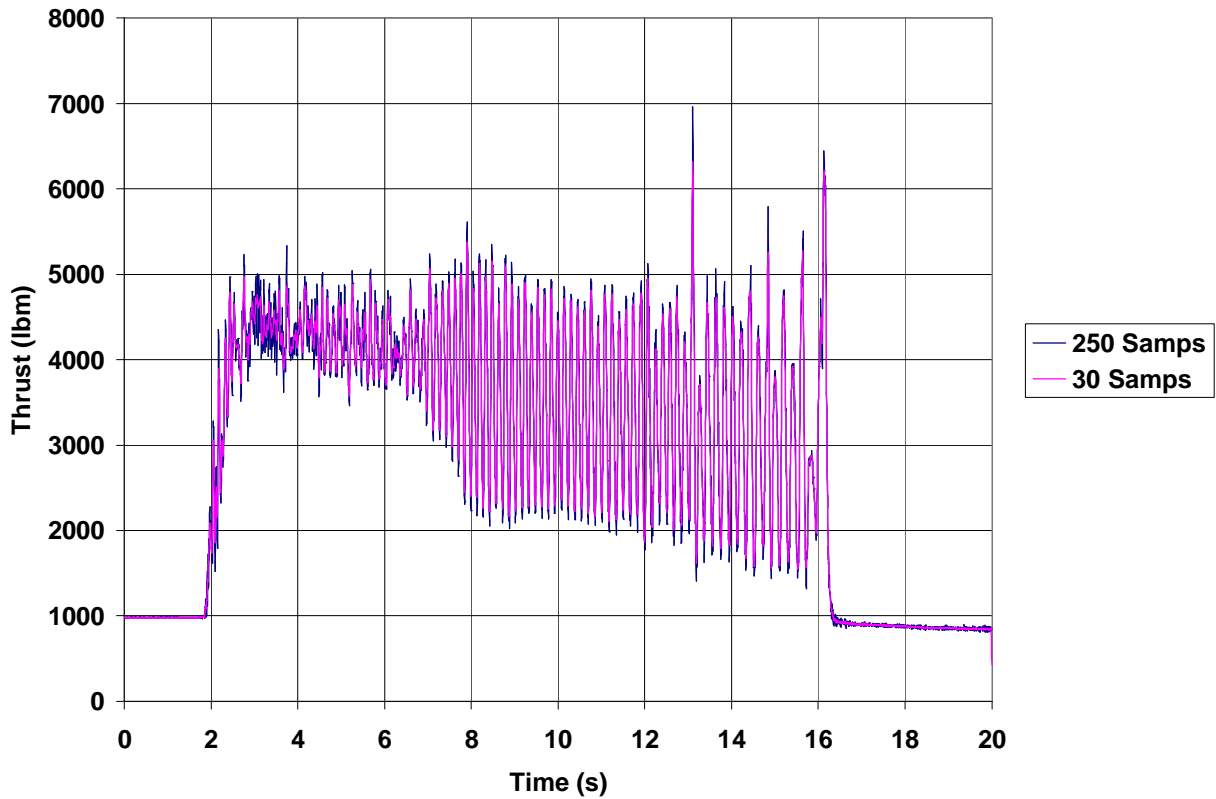
Figure 11 – The HTT-03 Thrust Plot

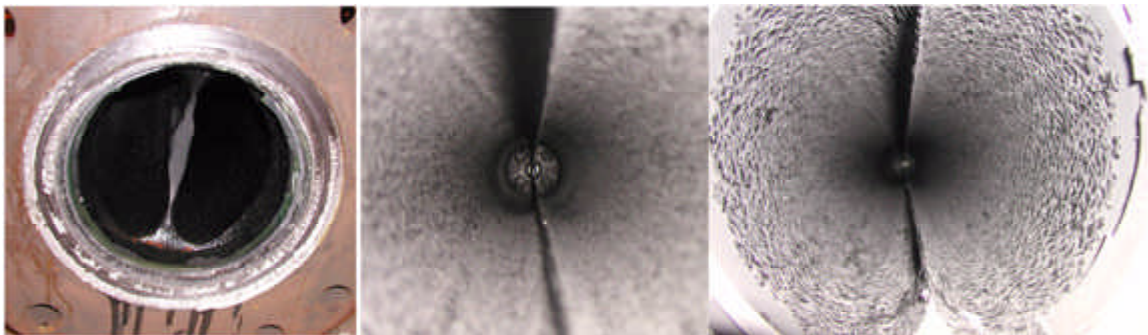
Figure 12 – The HTT-03 multiple Post Test fuel grain shots from various positions

The HTT-03 was a continuation of the second test using the same partially expended fuel grain from HTT-02. That test demonstrated the potential for multiple burns, restarting a hybrid motor with this fuel and would establish the total available burn time for this fuel grain geometry and LO₂ flow combination. The partially burned fuel grain lit properly and burned at the expected thrust and pressure levels. The chamber pressure began to oscillate mid-way into the burn. The pressure oscillation coupled back into the feed system and was evident in the venturi inlet pressure, ref. figure 10. After the firing the fuel grain was inspected. The analysis predicted the web would get thin and then fail prior to shutdown. It appears that the web failed at a thickness of about three sixteenths of an inch. This data indicates that multi-port hybrid motors with high strength fuel are capable of burning out to an acceptable level of unusable propellant.
