NASA/TM—2005-213860

Investigations of Shuttle Main Landing Gear Door Environmental Seals

Joshua Finkbeiner, Pat Dunlap, and Bruce Steinetz
Glenn Research Center, Cleveland, Ohio

Prepared for the
41st Joint Propulsion Conference and Exhibit
cosponsored by the AIAA, ASME, SAE, and ASEE
Tucson, Arizona, July 10–13, 2005

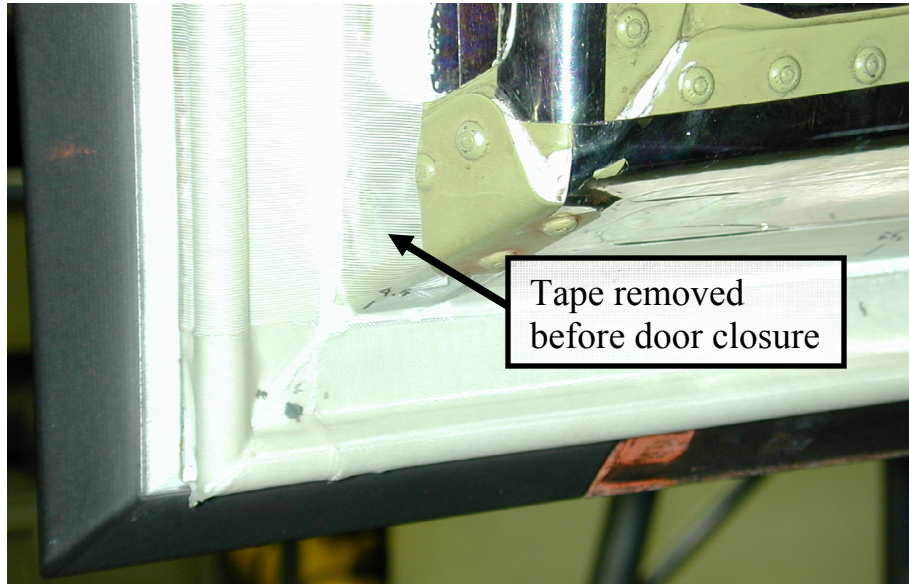
Figure 2.—Photograph of environmental seal installed on Main Landing Gear Door. The tape behind the seal is used for masking and is removed before the door is closed.

The Thermal Protection System (TPS) of the Space Shuttle Orbiter protects the vehicle and crew from the extreme temperatures of reentry. The TPS contains breaks to allow for opening the landing gear doors and extending the landing gear as shown in figure 1. The MLG doors are highlighted in the photograph. The MLG doors include both a thermal barrier and an environmental pressure seal to prevent hot reentry gases from entering the MLG bay and damaging the interior of the vehicle. Figure 2 depicts a close-up view of one of the MLG doors with its installed environmental seal.

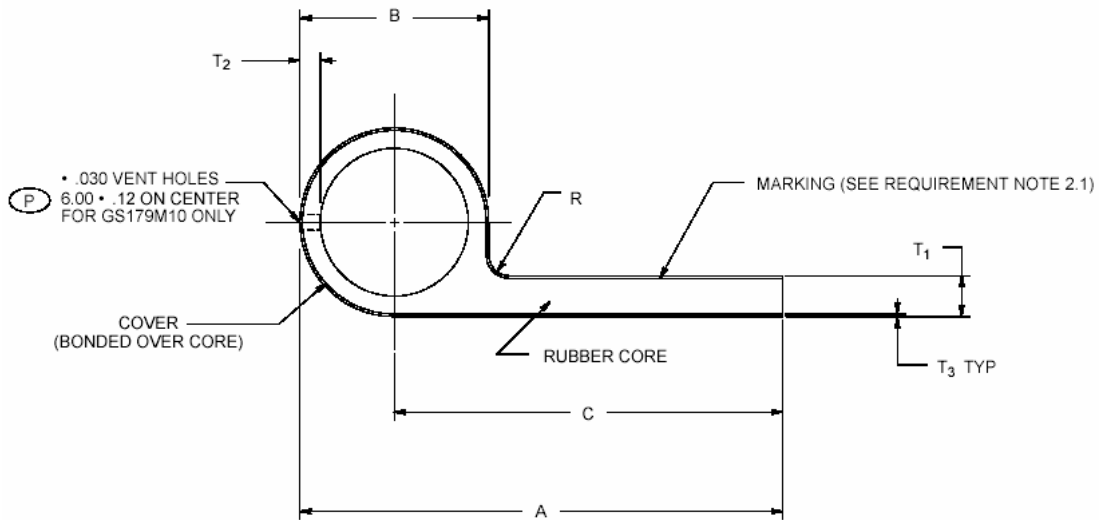
Figure 3.—Schematic of Shuttle MLG door environmental seal (taken from Northrop Grumman Standard GS179M).

The environmental seal design consists of a bulb seal with an attached tail, both constructed of a silicone rubber (ZZ-R-765, Class IIIa, Grade 50) core overwrapped with Nomex fabric. Small vent holes are punched into the seal material in the front of the seal bulb and are spaced roughly 6 in. apart. These holes allow pressure in the seal bulb to vent to vacuum while the Shuttle is in orbit. The seal was produced by Kirkhill Rubber (Brea, CA) under Northrop Grumman specification number GS179M10. A schematic of the seal design is shown in figure 3 with specific dimensions presented in table 1. The seal certification documents (Rockwell International 05-GS17M10C) assert that the seal leakage may not exceed 3 SCFM/ft for a differential pressure of 1 psid.

TABLE 1.—DIMENSIONS OF SHUTTLE MLG DOOR ENVIRONMENTAL SEAL
[All dimensions are in inches, tolerances are specified as ± 0.020 in.]

A	1.55
B	0.44
C	-----
R	0.12
T ₁	0.08
T ₂	0.06
T ₃	0.010

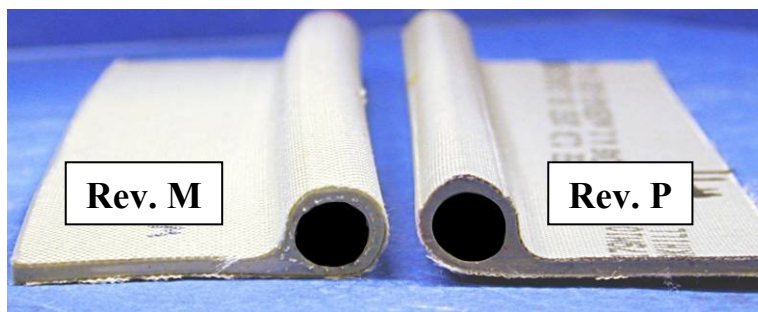
Figure 4.—Photograph comparing as-received Rev. P seal to as-received Rev. M seal. Note the presence of Nomex fabric impregnation of Rev. M seal bulb.

Two seal revisions were evaluated in this study and are shown in figure 4, both in their as-received conditions. The first seal, revision M (Rev. M), featured a Nomex fabric mesh impregnated in the silicone rubber core material. This contrasted with the new revision P (Rev. P) seal, which did not contain the fabric impregnation. Furthermore, the coloration of the rubber material in the Rev. P seal was slightly different than that of the Rev. M seal, indicating a possible difference in the composition of the rubber. The Rev. P seal was noticeably less stiff to the touch than the Rev. M seal.

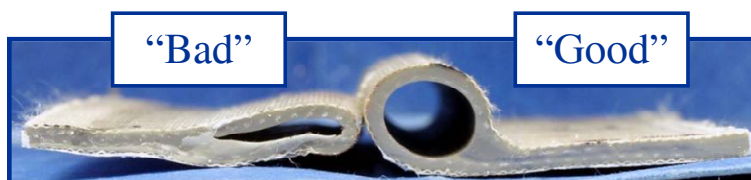
Figure 5.—Photograph of flown Rev. M seals removed from OV-103. Both seals show signs of permanent deformation, with the “bad” specimen showing heavy deformation and the “good” specimen showing light deformation.

Several samples of both Rev. M and Rev. P. seals were tested in this investigation. Two manufacturing lots of as-received Rev. P seal were evaluated, having lot numbers 024025753450019 (lot -0019) and 024025753450021 (lot -0021). In addition, several Rev. M seals were investigated, including both as-received and flown specimens. The flown seal was removed from the starboard MLG door of OV-103. The bulb of the flown seal had sustained “permanent” deflection which varied in severity along its length. The two extremes of the permanent deformation are shown in figure 5. The “good” seal specimen exhibited approximately 0.035 in. of permanent deformation in the bulb compared to the as-received state, while the “bad” specimen had sustained heavy permanent deformation varying between 0.110 and 0.160 in. with a near-fully collapsed bulb.

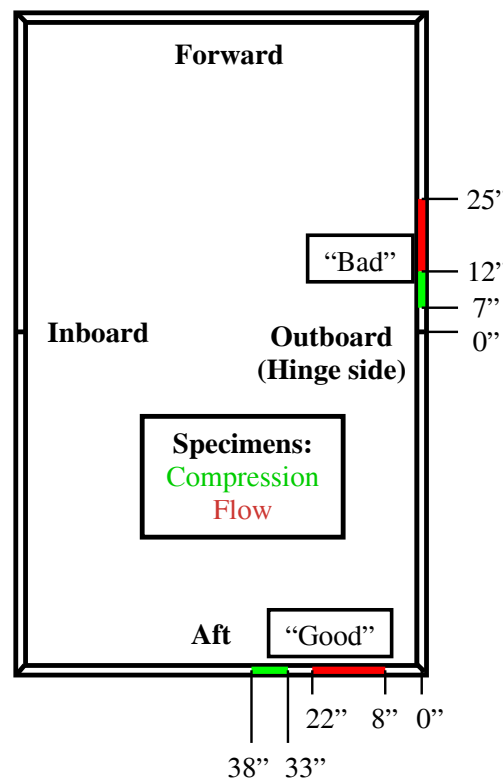
Figure 6.—Schematic of starboard MLG environmental seal removed from OV-103 along with locations of the flow and compression specimens removed from the seal. Locations of the flow specimens are shown in red, and locations of the compression specimens are shown in green.

A schematic of the flown seal layout is shown in figure 6. Note that the outboard direction refers to the direction pointing toward the wing tips of the vehicle relative to the door and is synonymous with the hinge line of the door. As shown in the figure, the seal was received in six sections. The forward and aft

sections were each a single length of seal while the inboard and outboard sections were each comprised of two lengths of seal. Also noted in figure 6 are the locations where the flow and compression specimens were removed from the seal. Flow specimens are denoted in red and compression specimens are denoted in green. Where necessary, the seal samples were trimmed to 5-in. lengths for compression tests and 12-in. lengths for flow tests.

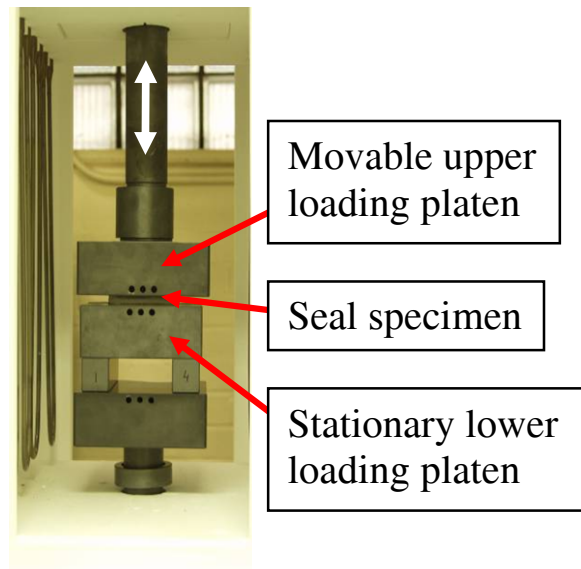
Figure 7.—Photograph of compression specimen in contact with loading platens.

Figure 7 depicts a seal compressed between the two loading platens. Prior to insertion of the seal specimens, parallelism of the upper and lower compression platens was adjusted to within 0.001 in. After the bonded seal specimens were placed on the stationary lower platen, the movable upper platen was brought into contact with the seal. For these tests, contact was defined using a 0.2 lbf preload applied to the seal. A set of gage pins with ± 0.0002 -in. accuracy was then used to check the gap size (distance between surface of aluminum mounting plate and contact surface on upper platen), which was nominally measured to be 0.455 ± 0.006 in. This corresponded to the bulb diameter of approximately 0.430 in. plus 0.02 in. of room temperature vulcanized silicone rubber (RTV).

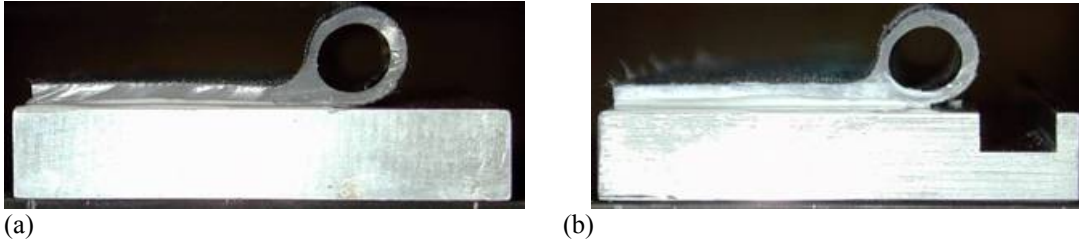
Figure 8.—Photographs of mounted MLG environmental seal (a) without a groove and (b) with a groove in the aluminum mounting plate.

As shown in table 2, initial exploratory tests were performed on the as-received Rev. P seals to assess the effects of loading rate, mounting plate configuration (groove or no groove), and amount of RTV behind the seal bulb. Figures 8 and 9 depict the different mounting plate configurations and amounts of RTV, respectively. These tests were conducted to better simulate the actual installation conditions of the MLG environmental seals and to provide a roadmap for the systematic tests performed later.

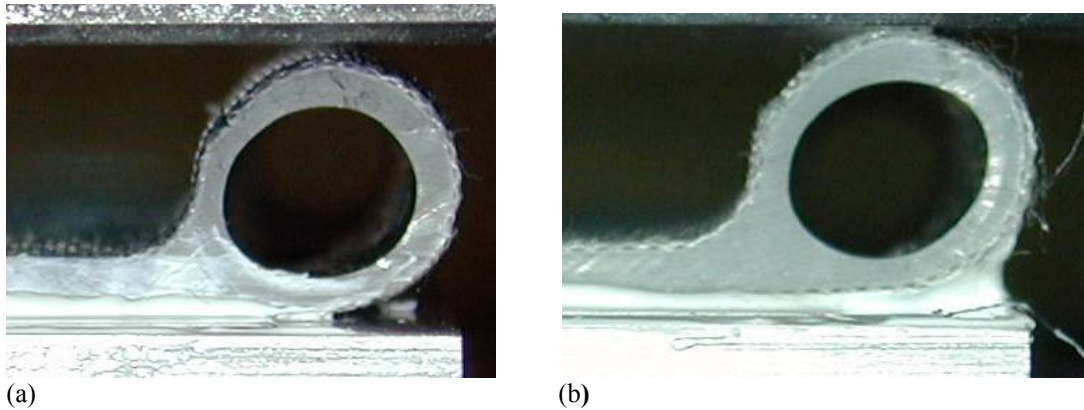
Figure 9.—Photographs of MLG environmental seal (a) with a clean bond line (i.e., no RTV fillet) (b) and with an RTV fillet behind the seal bulb.

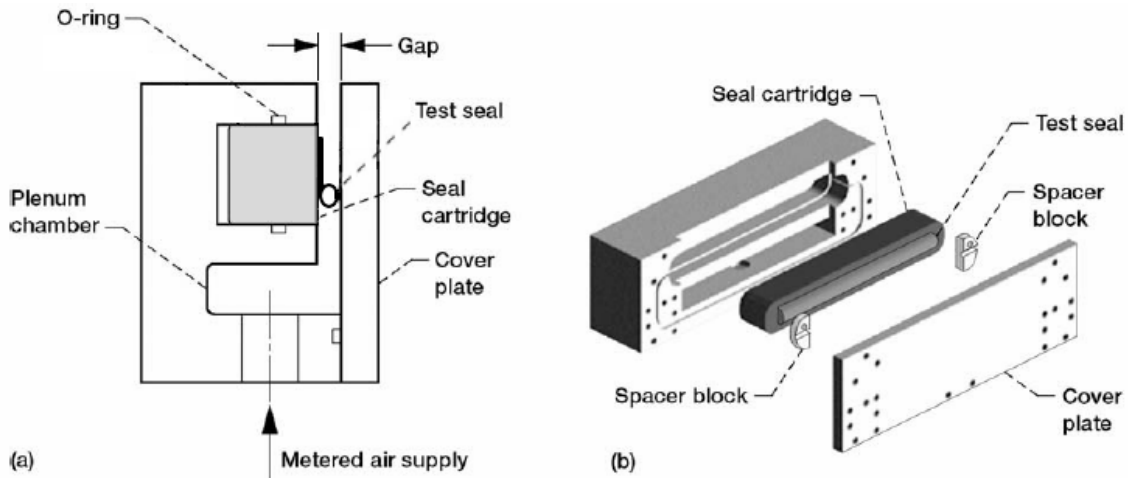
Figure 10.—Assembly of Linear Flow Fixture.

The cartridge assembly was then installed in the linear flow test fixture as shown in figure 10. An elastomeric o-ring sealed the perimeter of the cartridge (fig. 10 (a)), preventing leakage from passing around and behind the cartridge. A second o-ring sealed below the cover plate and partially through the spacer blocks (fig. 10(b)), ensuring that the primary leakage path was across the test specimen. Small metal-to-metal contacts existed between spacer blocks and the cover plate where the o-ring terminated. This junction was sealed with a small amount of RTV which was allowed to cure before testing commenced. The cover plate was then bolted onto the fixture.

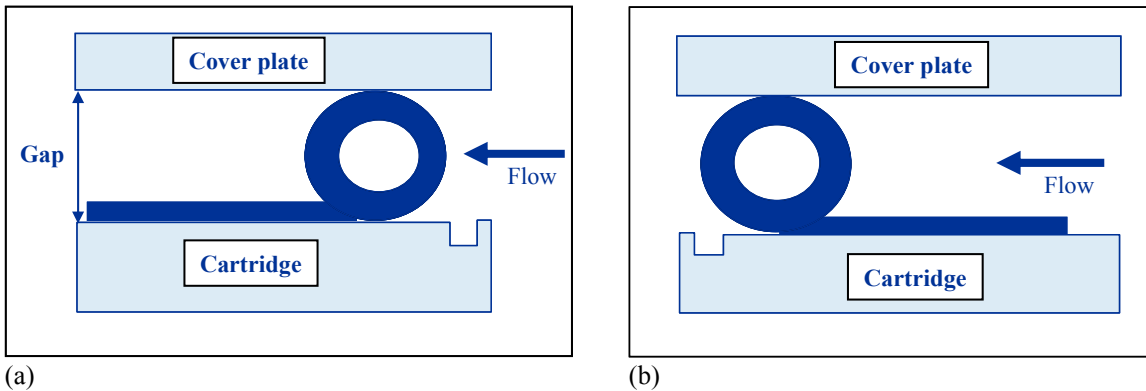
Figure 11.—Schematic of flow test setup for MLG door seal simulating (a) the bulb-first descent case and (b) the tail-first ascent case for the Shuttle Orbiter.

Figure 11 shows a cross-section schematic of the test setup. As observed in this figure, the gap setting established the amount of compression. The seals were installed on a flat plate which simulated the actual configuration of the MLG door seal. At each compression level, the seal was tested in two orientations. In the first

orientation, the seal was pressurized from the bulb side (fig. 11(a)) which simulated the pressurization imposed on the seal during Orbiter descent (i.e., high pressure outside of vehicle). The entire cartridge was then rotated 180° and pressurized from the tail side (fig. 11(b)) to simulate the Orbiter ascent case (i.e., high pressure in MLG bay).

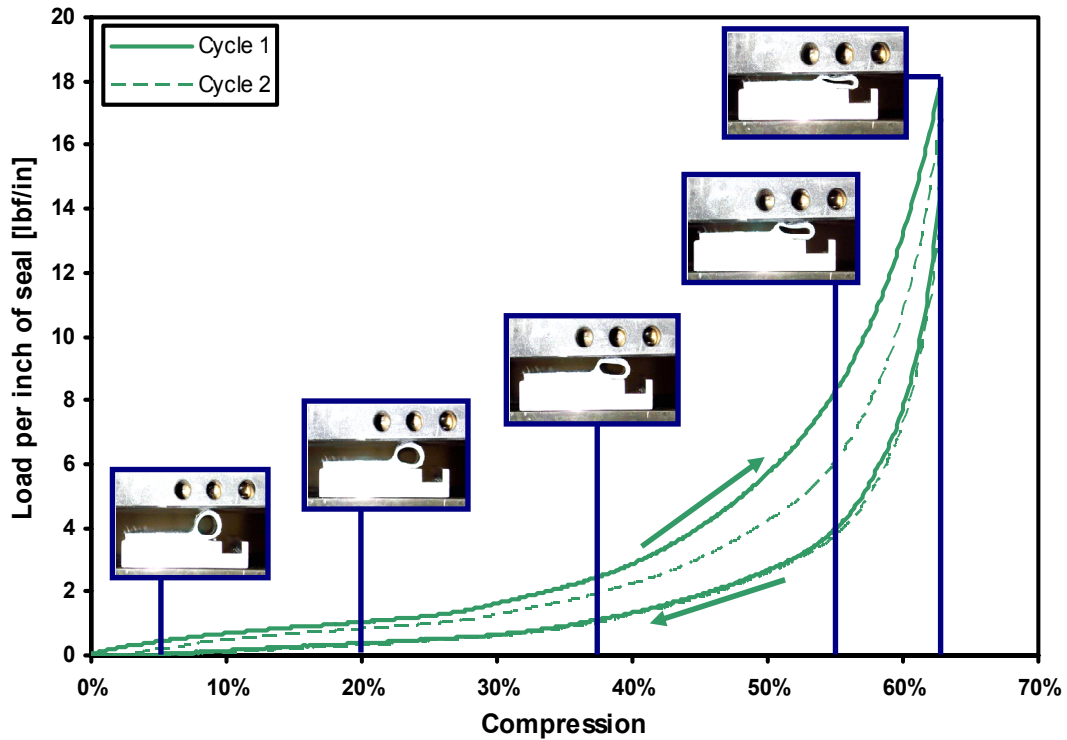
Figure 12.—First two cycles of exploratory load versus compression results of Rev. P seal (Test MLG-RTC-P0.1a): groove in mounting plate, 0.002 in./sec loading speed, no RTV fillet.

Figure 12 presents the first and second loading cycles of the exploratory test on the Rev. P seal test MLG-RTC-P0.3a, the case with an included groove, no RTV fillet, and a loading speed of 0.002 in./sec. Note that the arrows in the figure indicate the loading and unloading portions of the curve. Five photographs of the seal under compression are displayed in the graph with lines pointing to the reference compression level for each photograph. Of note in the photographs is the buckling-like behavior along the top of the seal bulb. The center of the upper portion of the bulb moved away from the platen at high compression levels, forming a “kidney-like” shape. Figure 12 is representative of the first five exploratory tests listed in table 2, with these five tests demonstrating nearly identical behavior. The increased loading rate and the inclusion of the groove in the aluminum did not affect the load versus compression behavior of the seal.

Figures 12 and 13 both demonstrate a drop-off in load in the loading portion of the second cycle when compared to the first cycle and show signs of permanent deformation in the seal bulbs. The second loading cycle of figure 12 shows no applied load until roughly 2.5 percent of the original seal bulb diameter. The second loading cycle of figure 13 demonstrates similar behavior until a compression of 5 percent is attained, followed by a larger reduction in second cycle load throughout the remainder of the loading portion of the cycle. Even though the overall loading for the second cycle of the seal with the RTV fillet is lower than the first cycle, the general shape of the loading curve is maintained. This is demonstrated by a slight increase in the slope of the curve at approximately 30 percent compression.

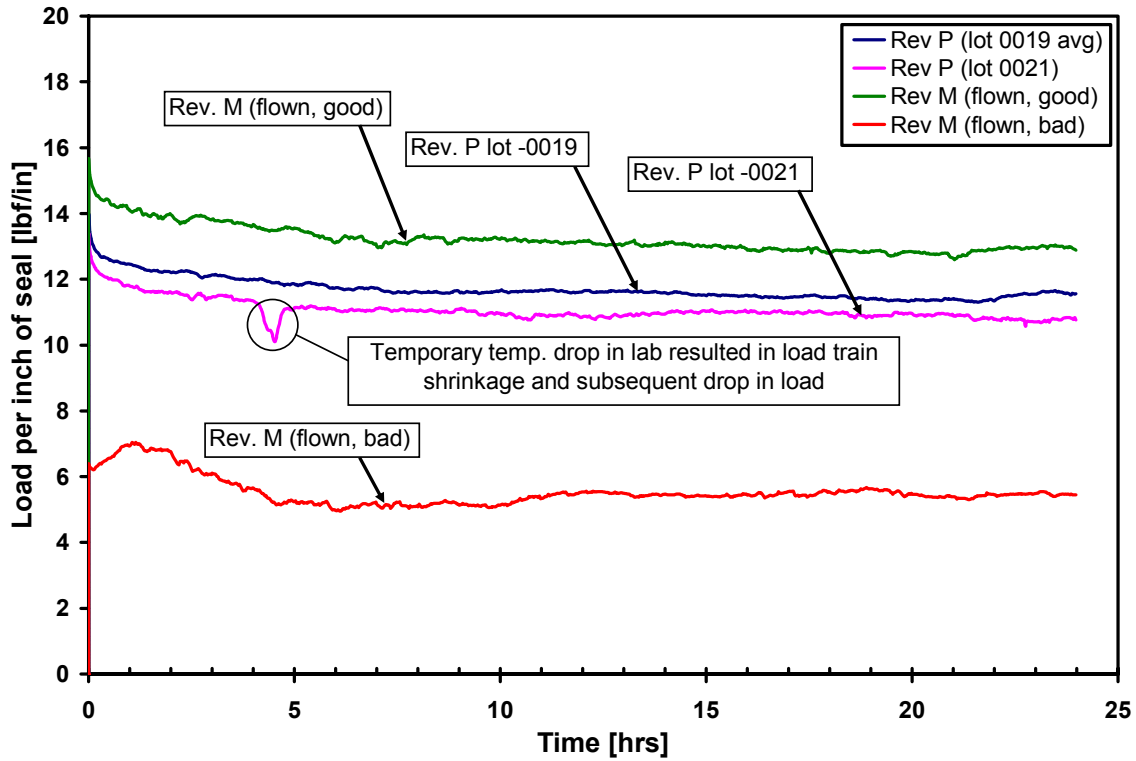
Figure 15.—Load versus time plot of 24 hr compression tests on as-received Rev. P and flown Rev. M seals. The seals were held at 63 percent compression for the duration of the test.

Figure 15 shows the load versus time plot for 24-hr compression tests of the “good” and “bad” flown Rev. M seals, an average curve of three as-received Rev. P lot -0019 seals, and a curve from a single as-received Rev. P lot -0021 seal. The seals were compressed to a level of 63 percent of the as-received diameter during the duration of the test.

The “good” flown Rev. M seal exhibited the highest loads for the duration of the 24-hr test, followed by the as-received Rev. P seals, and finally by the “bad” flown Rev. M seal. The “bad” flown Rev. M seal exhibited an initial increase in load followed by a drop-off shaped differently than the other seals, which may have been due to drift in the actuator amounting to approximately 0.001 in. For the other three seals, the load decreased by ~20 to 25 percent during the duration of the test. Most of the drop in the load occurred during the first hour, during which the load dropped by roughly 15 to 20 percent.

Of note is the small drop-off in load in the Rev. P lot -0021 seal between 4 and 5 hr into the test. During this time, the temperature in the laboratory dropped slightly, resulting in a thermal contraction of the load train and a subsequent drop in load. The temperature in the lab was brought back to nominal conditions when this drop was recognized and the test proceeded similarly to the other tests (except for the “bad” Rev. M seal).

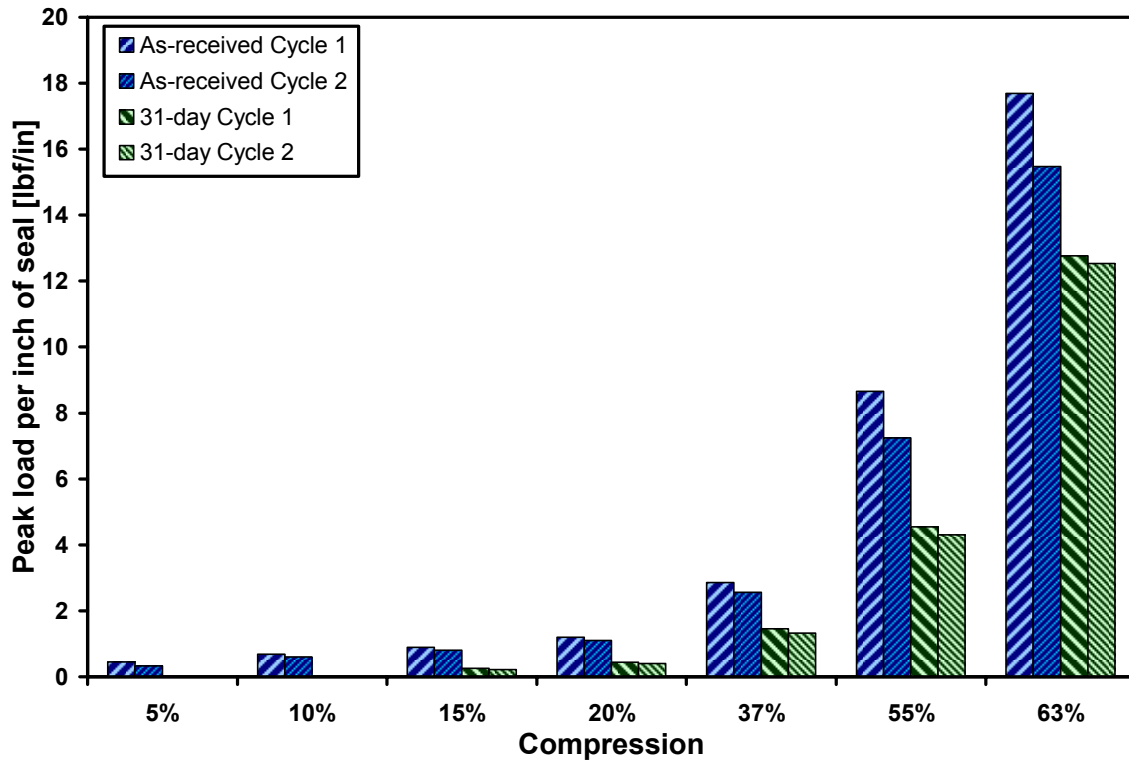
Figure 16.—Peak loads versus compression of first and second incremental loading cycles of as-received and 31-day Rev. P seals.

Figure 16 presents a bar chart comparing the peak loads of the first two cycles of an as-received Rev. P seal to the first two loading cycles of the post-31-day test seal for various compression levels. The 31-day test seal generated no load for compressions of 10 percent and lower; this is an expected result because the seal took on approximately 12 percent permanent deformation while it was compressed for 31 days. Upon contact with the platen

and throughout the remainder of the test, the 31-day test seal generated loads lower than those generated by the as-received seal. At the highest compression level of 63 percent, the 31-day test seal generated loads amounting to ~80 percent of those generated by the as-received specimen.

For all compression levels, the change in load between the two loading cycles was less for the 31-day test seal than for the as-received specimen. This may be due to the permanent set already present in the 31-day specimen. From figure 13, it is known that much of the permanent deformation of a seal occurs during the first hour of compression. Figure 16 appears to indicate that a seal with some permanent deformation takes on additional permanent deformation more slowly than a seal in the as-received state.

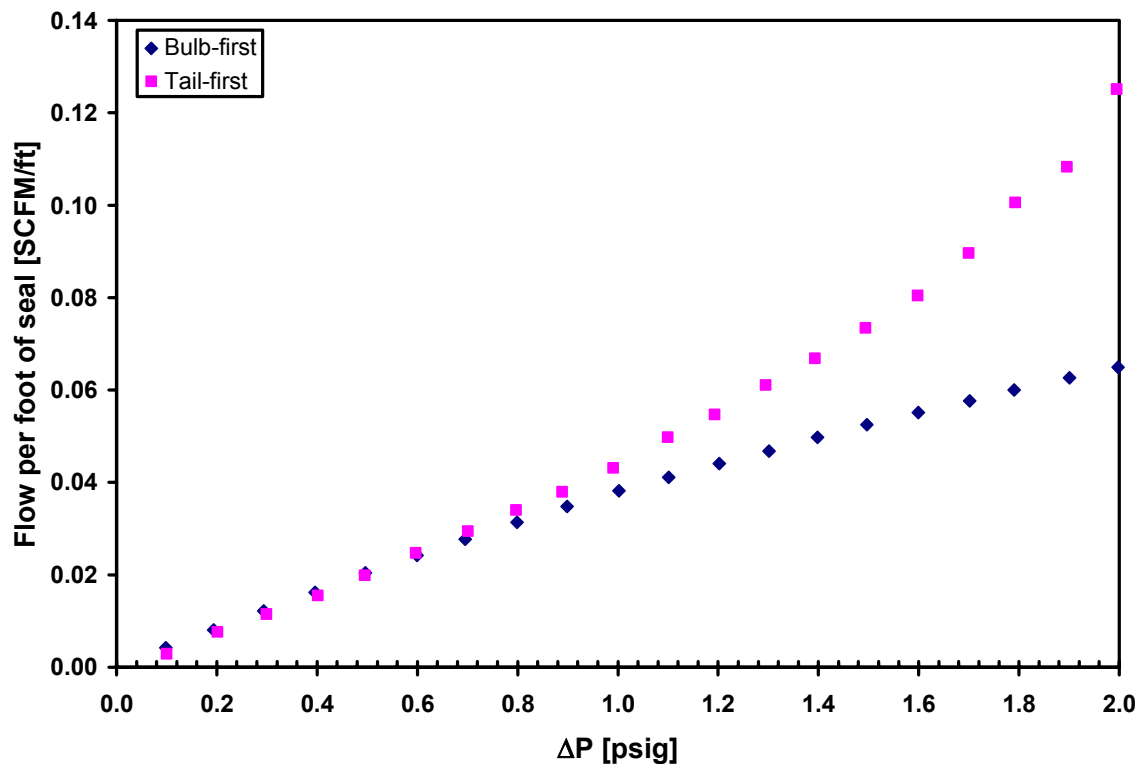
Figure 17.—Flow versus ΔP data for Rev. P seal MLG-RTF-P3 at 15.8 percent compression, pressurized from both the bulb side and the tail side.

Figure 17 presents a sample data set of flow versus pressure differential across the seal from Rev. P seal MLG-RTF-P3 in both the bulb-first (i.e., pressurized from the bulb side) and tail-first (i.e., pressurized from the tail side) orientations with a nominal gap size of 0.387 in. and a measured compression of 15.8 percent (nominal compression was 15 percent). The seal in the bulb-first orientation demonstrated a concave-down shape in its flow versus pressure curve, indicating an improvement in seal performance with increasing differential pressure. Conversely, the leakage across the seal in the tail-first orientation was measured to have a concave-up shape with increasing pressure, indicating a reduction in seal performance with increasing differential pressure.

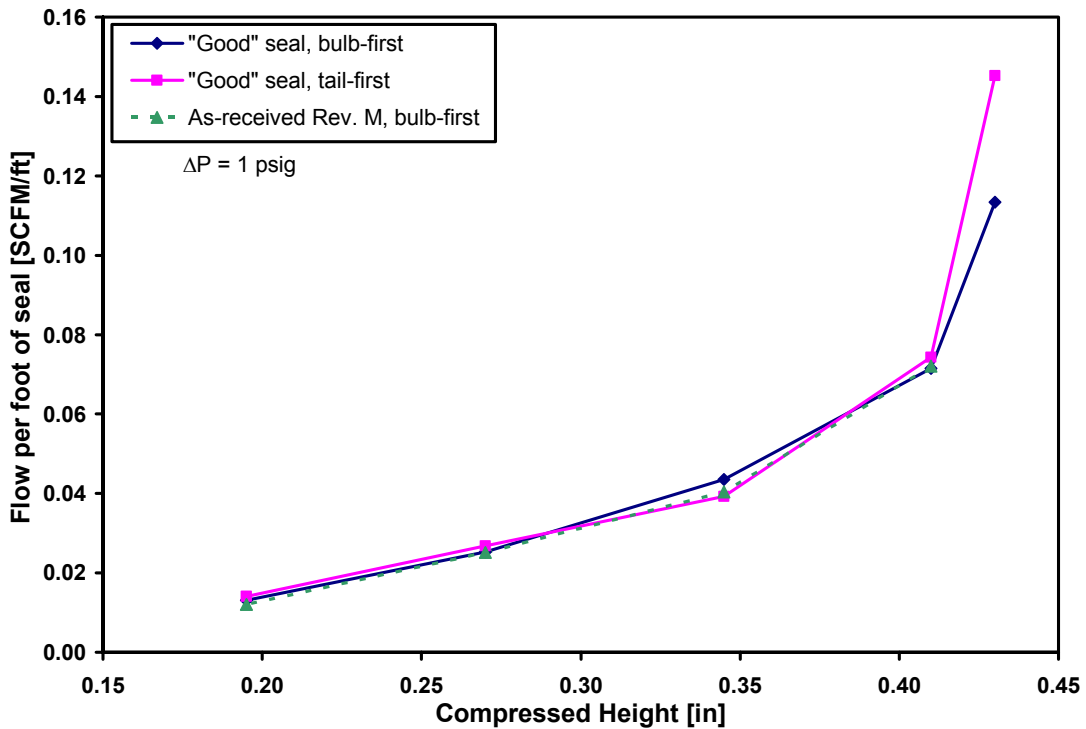
Figure 20.—Flow versus compressed height for “good” flown Rev. M seal (bulb-first and tail-first) as well as as-received Rev. M seal for 1-psig pressure drop.

Figure 20 presents flow results for the “good” flown Rev. M seal as well as an as-received Rev. M seal. The “good” flown seal was tested with a pressure drop of 1 psig in both the bulb-first and tail-first orientations, and the as-received Rev. M flow data is identical to that shown in figure 18. Note that the results are presented in terms of compressed height (i.e., final compressed height of the seal bulb) instead of percent compression. This is because percentage compression is defined in terms of an as-received seal bulb diameter, whereas the flown seals exhibited varying degrees of deformation. The compressed height axis is reversed from the percent compression axis in that a low percent compression equates to a high compressed height. The “good” flown seal in the bulb-first and tail-first orientations produced comparable flow rates except for a compressed height of 0.430 in., where the flow rate across the seal in the tail-first orientation was higher than that for a seal in the bulb-first orientation. In addition, the “good” flown seal had comparable flow performance to the as-received specimen.
