Status of Thermal NDT of Space Shuttle Materials at NASA

ABSTRACT

Details of the analysis technique that has been developed to allow *insitu* inspection of a majority of shuttle RCC components is discussed. Additionally, validation testing, performed to quantify the performance of the system, will be discussed. Finally, the results of applying this technology to the Space Shuttle Discovery after its return from the STS-114 mission in July 2005 are discussed.

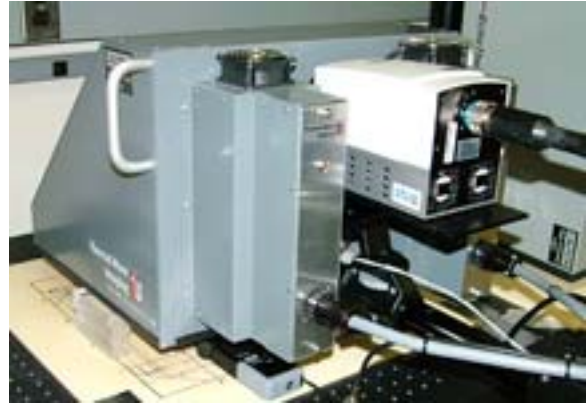
Figure 2 – Photographs of the two hoods used with the EchoTherm® thermography system. (a) “Straight” hood and (b) “Right angle” hood.

The flash thermography system for this inspection is the commercially available Echotherm® system from Thermal Wave Imaging (TWI). The system features one of two hoods, both containing a 320 x 256 Phoenix® infrared (IR) camera with two 4800-Joule xenon photographic flash tubes. The first hood is a “straight” hood typically provided with the commercial system. This hood (shown in figure 2a) has dimensions of 36.8 cm wide by 26.7 cm deep by 40.6 cm tall and is configured such that the IR camera views the inspection surface directly. When the Phoenix® camera is added to the back of the flash hood the total height of the inspection system (maximum clearance needed from the inspection surface) is increased to 71.1 cm. The flash of the “straight” hood produces a flash energy density of 7.15 joules per square centimeter at the mouth of the hood. This was calculated from the final temperature increase of a 0.635 cm thick sample of RCC and the nominal thermal properties of RCC. The flash of the “straight” hood flash lamps provides a uniform illumination within 10% across an area of 24.8 cm x 32.7 cm of a flat reference standard at the mouth of the hood as determined from measurements of the temperature rise of the RCC material.

Because of OPF clearance limitations it is necessary to have a custom “right angle” hood built to accommodate *insitu* inspection of the orbiter wings. The “right angle” hood (shown in figure 2b) has dimensions of 43.2cm wide by 36.8 cm deep by 34.3 cm tall and is configured such that heating and imaging of the inspection surface is accomplished by reflecting off a mirror mounted at 45° to the surface. The “right angle” hood produces a flash energy density of 6.0 joules per square centimeter at the mouth of the hood. This was calculated from the final temperature increase of a 0.635 cm thick sample of RCC and the nominal thermal properties of RCC. The flash of the “straight” hood flash lamps provides a uniform illumination of within 7.3% across an area of 24.8 cm x 32.4 cm of a flat reference standard at the mouth of the hood as determined from measurements of the temperature rise of the RCC material.

The hoods are connected to a base station which houses the system computer and power sources for the various components. Thermographic inspection is accomplished by placing the hood on the section of material to be inspected. The bottom of the hood completely surrounds or sits atop the material, depending on the dimension of the specimen. The flash lamps are triggered either by operator controls on the hood or by the computer. Thermographic images of the specimen are captured by the Phoenix® infrared camera for a predetermined amount of time and stored in the computer for further analysis. The camera’s noise equivalent temperature difference, cited by the manufacturer, is 0.025°C operating the detector array in the 3 to 5 micrometer wavelength range. External optics, consisting of a wide-angle lens, using germanium optical elements, increases the system field-of-view by a factor of approximately two. The expanded field-of-view of this lens is 41° horizontally and 31° vertically.

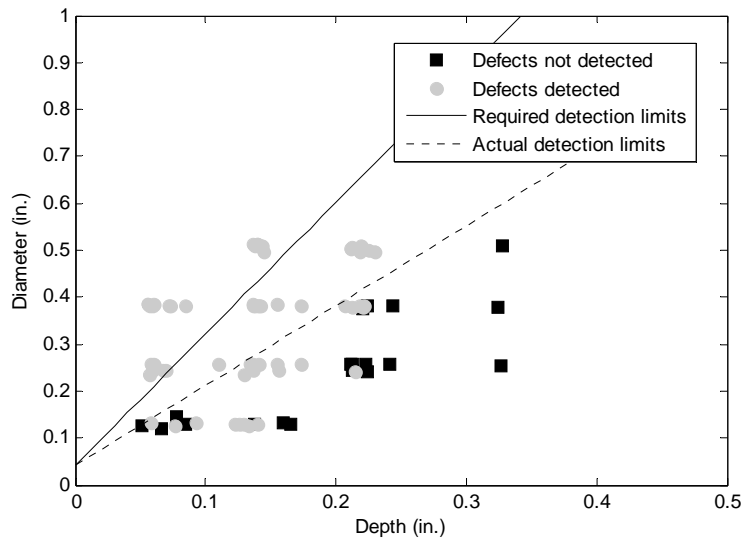
Figure 8 – Results for detection of flat-bottom holes in RCC material using the “straight” hood configuration.

Figures 8 and 9 present graphs of the diameter of defect versus the depth of that defect for all defects. The defects detected are shown as solid circles; those not detected are shown as solid squares. Additionally, the required detection envelope is indicated by the solid line and given by the equation:

where D is the diameter of the defect and d is the depth. The dashed line is the experimentally determined detection envelope. This testing indicates the system is able to detect flat-bottom hole defects in this structure with the required accuracy of 100% (28 of 28 required defects) for the “straight” hood and 96.4% (27 of 28 required defects) for the “right angle” hood.

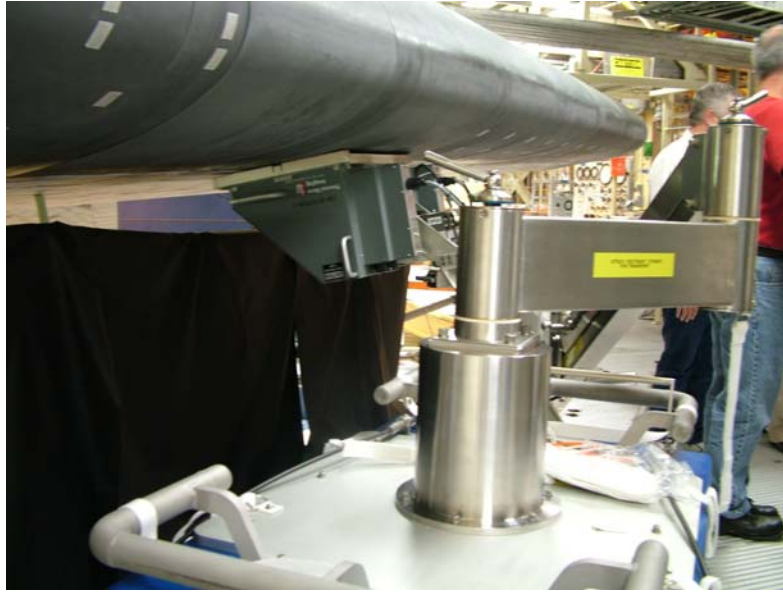
Figure 10 – Photograph of the manipulator system and the “right angle” hood/camera assembly performing an inspection in the OPF at KSC on the Space Shuttle Discovery following STS-114.

The complete thermography system was applied to the Space Shuttle Discovery upon its return from flight STS-114 in August of 2005. Figure 10 shows the system deployed in the OPF performing an inspection on the left wing RCC material. Figure 11 shows the results obtained during the inspection process. The image shown in figure 11a is a photograph of the inspection region with a suspect area pointed to by an NDE technician. The PCA processed thermal image shown in figure 11b shows the indication consistent with damaged RCC material.
