# Radio Frequency (RF) Attenuation Measurements of the Space Shuttle Vehicle

**Abstract**—Following the loss of Columbia, the Columbia Accident Investigation Board (CAIB) provided recommendations to be addressed prior to Return To Flight (RTF). As a part of CAIB Recommendation 3.4.1 – Ground Based Imagery, new C-band and X-band radars were added to the array of ground-based radars and cameras already in-situ at Kennedy Space Center. Because of higher power density considerations and new operating frequencies, the team of Subject Matter Experts (SMEs) assembled to investigate the technical details of introducing the new radars recommended a series of radio frequency (RF) attenuation tests be performed on the Space Shuttle vehicle to establish the attenuation of the vehicle outer mold line structure with respect to its external RF environment. Because of time and complex logistical constraints, it was decided to split the test into two separate efforts. The first of these would be accomplished with the assistance of the Air Force Research Laboratory (AFRL), performing RF attenuation measurements on the aft section of OV-103 (Discovery) while in-situ in Orbiter Processing Facility (O

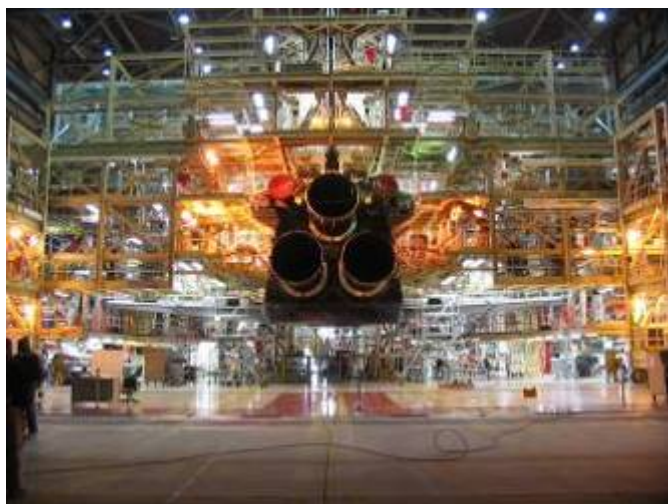
Figure 1. Space Shuttle Discovery in OPF 3

Three different radii would be used: 95 feet, 105 feet, and 115 feet. Each radius would be driven four times, once for each height setting. The radii and angle of measurement were selected based on the ability to collect and plot data across three cylindrical surfaces, thus establishing a vector direction that might aid in identifying any unexpected vulnerabilities, and the expected line of sight exposure of the monitoring radar as OV-103 launched into space. Fig. 1 shows OV-103 in-situ in OPF 3, just prior to measurement/data collection.

OV-103 RF attenuation measurements were planned for an in-situ process, with OV-103 in place inside OPF 3. The measurements were to be based on classical shielding effectiveness measurement techniques. In other words, data would be collected with the “shield” not in place between the transmitter and receiver elements, and with the “shield” in place between the transmitter and receiver elements. To accomplish this, NASA and the AFRL planned a measurement process using the AFRL Mobile Diagnostic Laboratory (MDL). The MDL is a one-of-a-kind RF diagnostic measurement system, typically used for radar cross section measurement of aircraft on the ground. It is a highly customized four wheel drive Ford van, has an environmentally controlled interior, and runs on commonly available diesel fuel. For this measurement, an Élan 2000 Radar transmitter was used as the RF source. Four receive antennas were mounted on the side of the van, height adjustable from 10 to 25 feet, in 5 foot increments. The instrumentation plan was to locate six different transmitting antennas inside the aft section of the Orbiter vehicle, one in close proximity to each of the three engine controllers, and one in close proximity to each of the three aft avionics bays. The receive antennas would be mounted on the MDL, which would be driven in three semicircular paths, with radii centered on an imaginary vertical line extending upward from avionics bay 6.

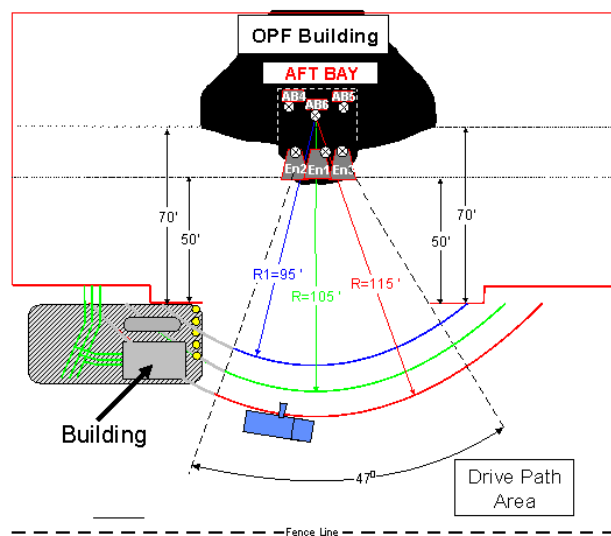
Figure 2. Geometry of MDL, OV-103, and OPF

Fig. 2 shows the planned geometry between the MDL, OV-103, and the OPF, as described above. The test frequencies were chosen to coincide with the new monitoring radar frequencies in X-band and C-band, which included the existing range radar operating frequency range. Calibration was performed by using a single transmitter outside the aft section, centered below avionics bay 6, and located at the center of the MDL path radii. The results of the OV-103 measurements were found to be commensurate with expectations as compared to existing commercial and military aircraft of similar design to the Orbiter.

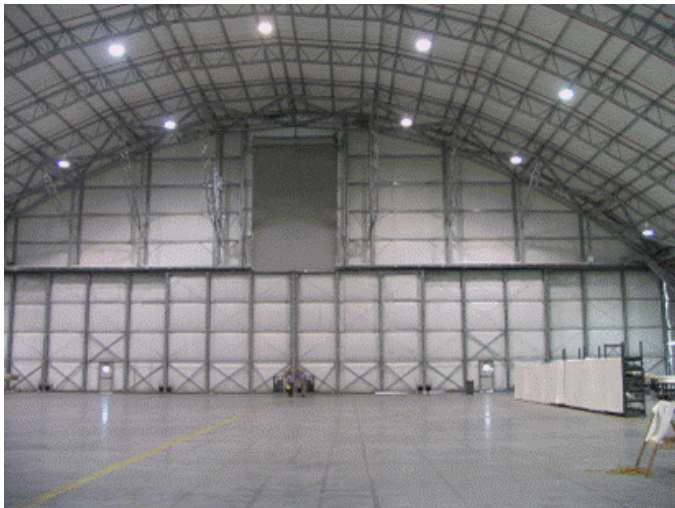
Figure 3. Space Shuttle Landing Facility (SLF) Hangar

The hangar measurements were performed over about a week's time. NIST performed measurements over 3200 individual frequencies, over an 8 octave span. PAX River performed over 54 separate swept measurements over a 14 GHz span. Hangar Q and field uniformity reported by both NIST and PAX were acceptable for the Orbiter test. Ambient reported by both NIST and PAX did not contain radio frequency energy that would interfere with successful Orbiter attenuation measurements. A picture of the SLF hangar is shown in Fig. 3 below.

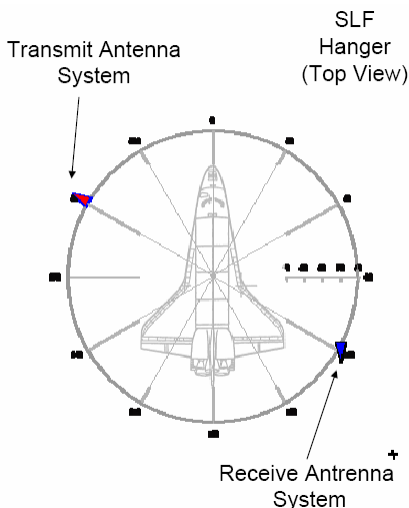
Figure 4. NIST Reference and Measurement Clock Layout

A clock pattern was laid out surrounding OV-105, and used to control the positioning of transmit antenna platforms on which were mounted two each TEM horns and 3115 horns, as well as acting as the carrier for the vector network analyzer to collect and store the data until download onto a laptop for further processing. Fig. 4 shows this clock pattern approach as employed by NIST to establish a baseline prior to actual data collection. The measurement process used the same layout and clock position approach, with the exception that the receive antennas were located inside the vehicle.

off-the-shelf software, a readily available vector network analyzer, two analog optical links which provide low loss, high dynamic range, and eliminate common mode interference, NIST-developed transverse electromagnetic (TEM) horns, operating from 30 MHz to 1.5 GHz, common 3117 dual ridged horns, operating from 1 GHz to 18 GHz, and a dual-band architecture. Both magnitude and phase data were collected, allowing for sophisticated time and frequency domain signal processing, using very low power levels and obtaining a high acquisition speed.

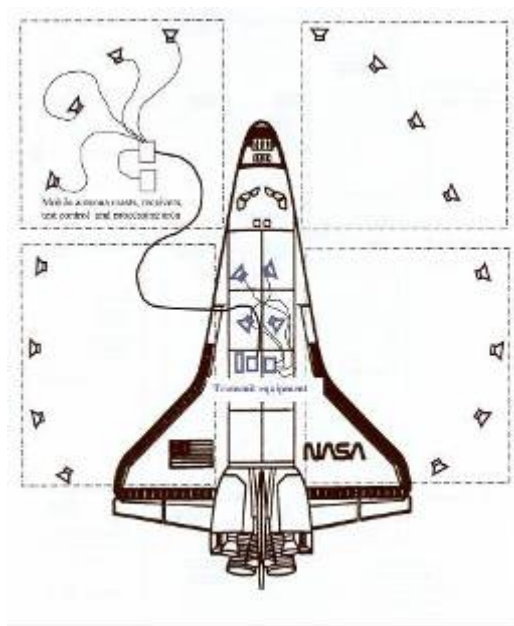
Figure 5. PAX River Antenna Array Layout

antennas was placed inside the aircraft. The array was then moved to various locations for internal spatial sampling. Fig. 5 shows the antenna array layout approach as utilized by PAX River for this test. Frequency averaging, or electronic stirring, was used to simulate the physical boundary movement of the RF standing wave patterns and augment the statistical sampling in the cavity.

PAX River performed their measurements once NIST completed their effort, from about 4 GHz to 18 GHz. PAX River measurements were performed using a series of classic reverberation techniques. Traditionally, a reverberant shielding effectiveness test is performed using "nested reverberation chambers." The field in each chamber is "stirred" using an electrically large metallic tuner that is capable of suitable displacement at the lower frequency range of the test. Statistically, this "stirring" produces a very uniform field over a revolution of the tuner. Since it was physically impractical to construct and locate a tuner that would be large enough to be effective in a chamber of the size of the SLF hangar, this test used several antennas placed around the aircraft to provide spatial sampling instead of displacement sampling. An array of

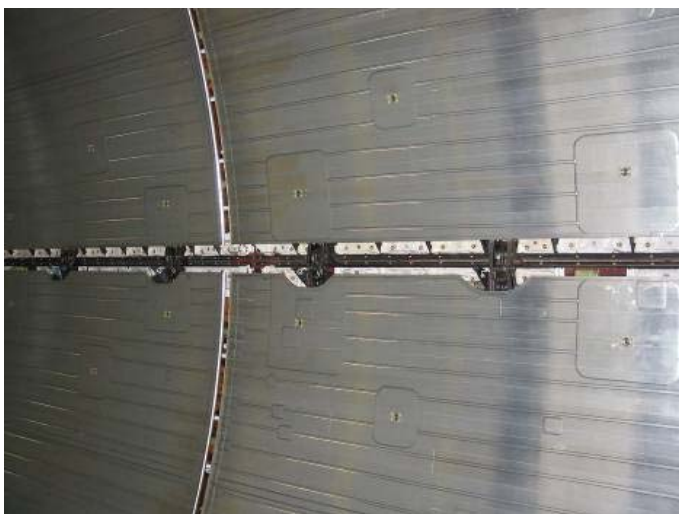
Figure 6. Payload Bay Door Seam, Looking Up

Several factors are believed to have affected the data from the payload bay. The NIST measurement technique transmits from outside the vehicle, with the antennas aimed at the vehicle, whereas the PAX River measurement technique transmits from inside the vehicle, with the receive antennas aimed away from the vehicle. The NIST measurement equipment exhibited its worst signal to noise ratio performance in the frequency overlap region. The payload bay doors have a longitudinal seam that runs the length of the payload bay, and two semi-circular seams at either end of the payload bay. Fig. 6 shows a view of the payload bay door seam looking up from inside the payload bay.

These seams are interrupted at regular distances by latch mechanisms. This configuration appears to form a set of distributed dipole antenna elements. These dipoles may have been electrically excited to differing degrees by the presence of RF signals transmitted by the NIST and PAX River antennas. It is currently unknown how any re-radiation from these dipoles may have interacted with the hangar volume.
